Godden Mackay Logan

Doonside Residential Parcel and Parklands Bungarribee Precinct, Western Sydney Parklands Heritage Impact Statement

Report prepared for Landcom
August 2007

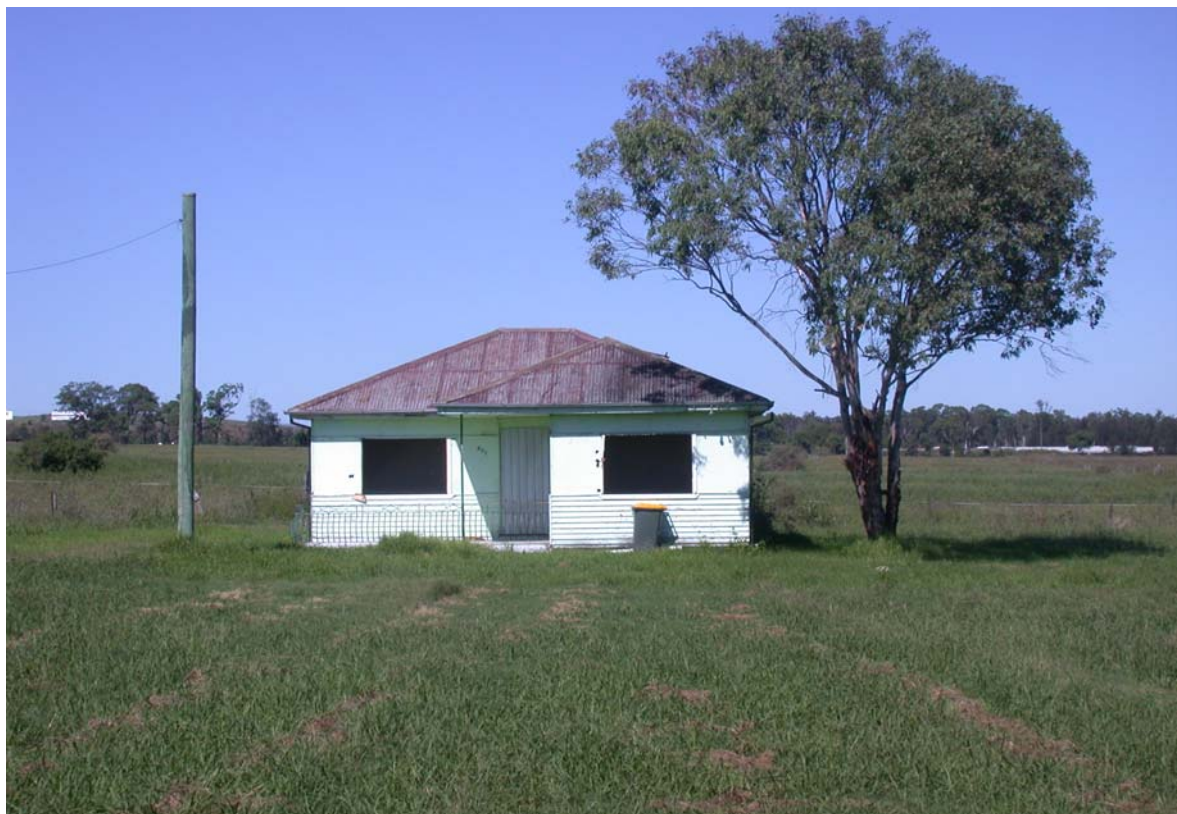
Figure 4.24 View to the south showing 671 Great Western Highway, potentially the location of the Red Lion Inn. The boundary fence of the Bungarribee Precinct is on the right of the photograph.

The extant structure at 733 Great Western Highway with a large front yard area is possibly related to the early Dean phase (see Figure 4.23). The location of the Red Lion Inn is likely to be on the highway at the eastern edge of the Parklands Precinct (to the east of Eastern Creek), in the approximate location of the extant fibro house at 671 Great Western Highway (see Figure 4.24).

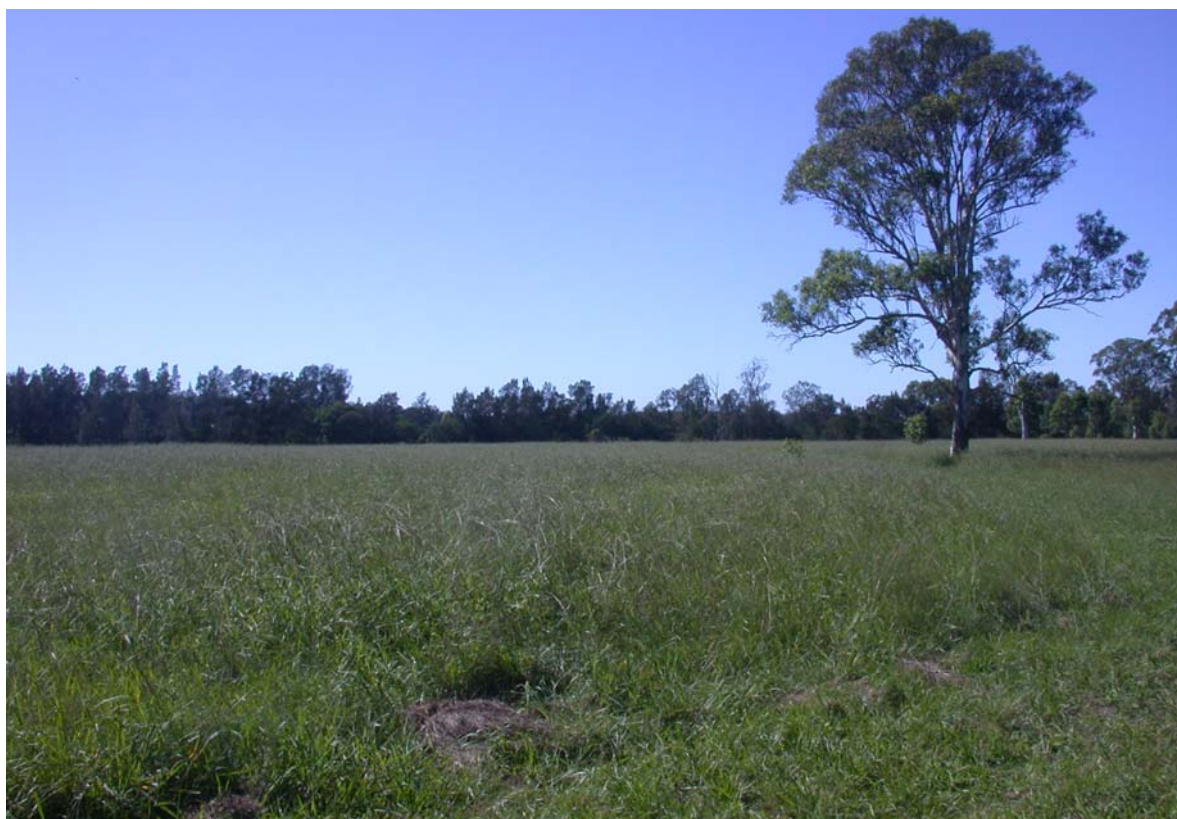
Figure 4.25 View to the east showing the location of the former Mansell Farm sites. The trees in the background indicate the location of Eastern Creek. Note the high grass obscuring any evidence of the former farm site.

The site of the Mansell Farm was located in the northwest portion of the study area and was in use prior to subdivision in 1917 (see Figure 2.4). Austral Archaeology identified, and investigated with archaeological test excavation, three sites in this area, resulting in the exposure of brick footings and two wells (see Figure 4.21). Inspection of this area of the site in 2007 did not reveal any remains of the Mansell Farm complex; however, detailed survey was not undertaken and the high grass coverage hindered any visual inspection (see Figure 4.25).

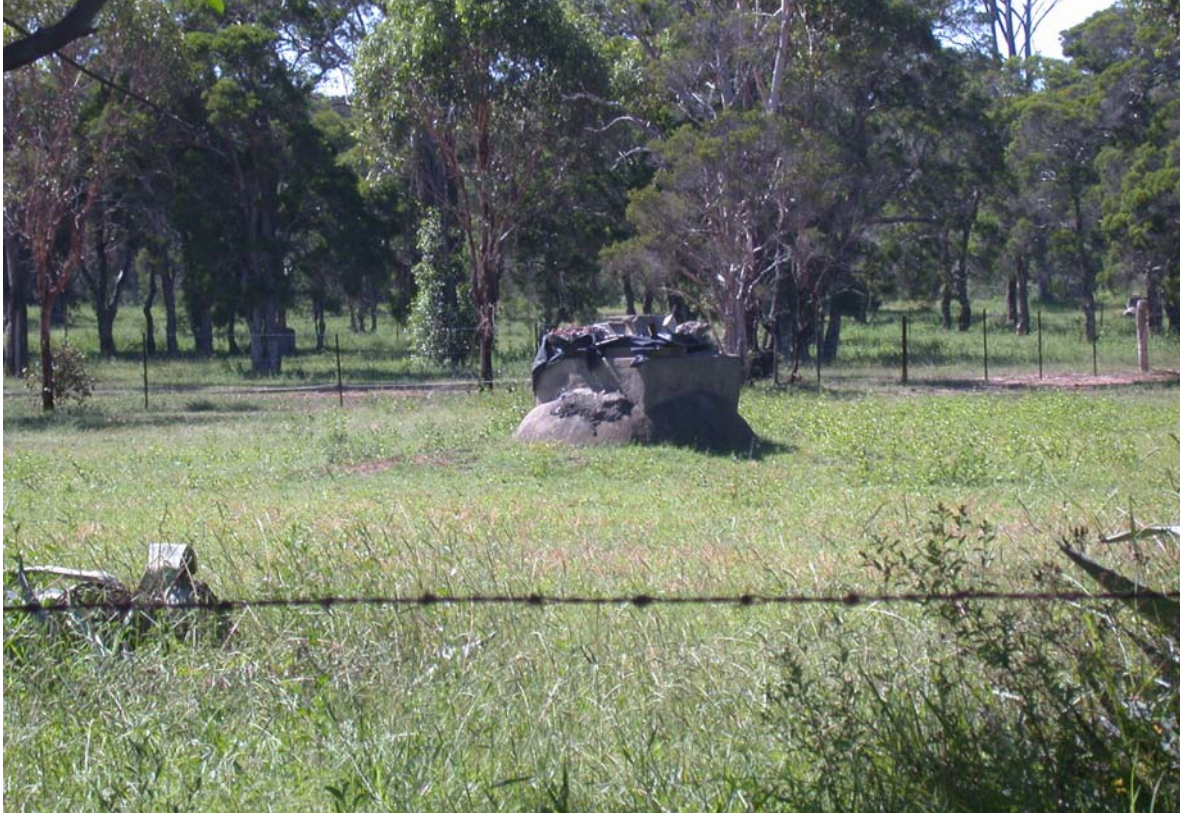
Figure 4.26 View to west showing cistern located at south end of Pikes Lane.

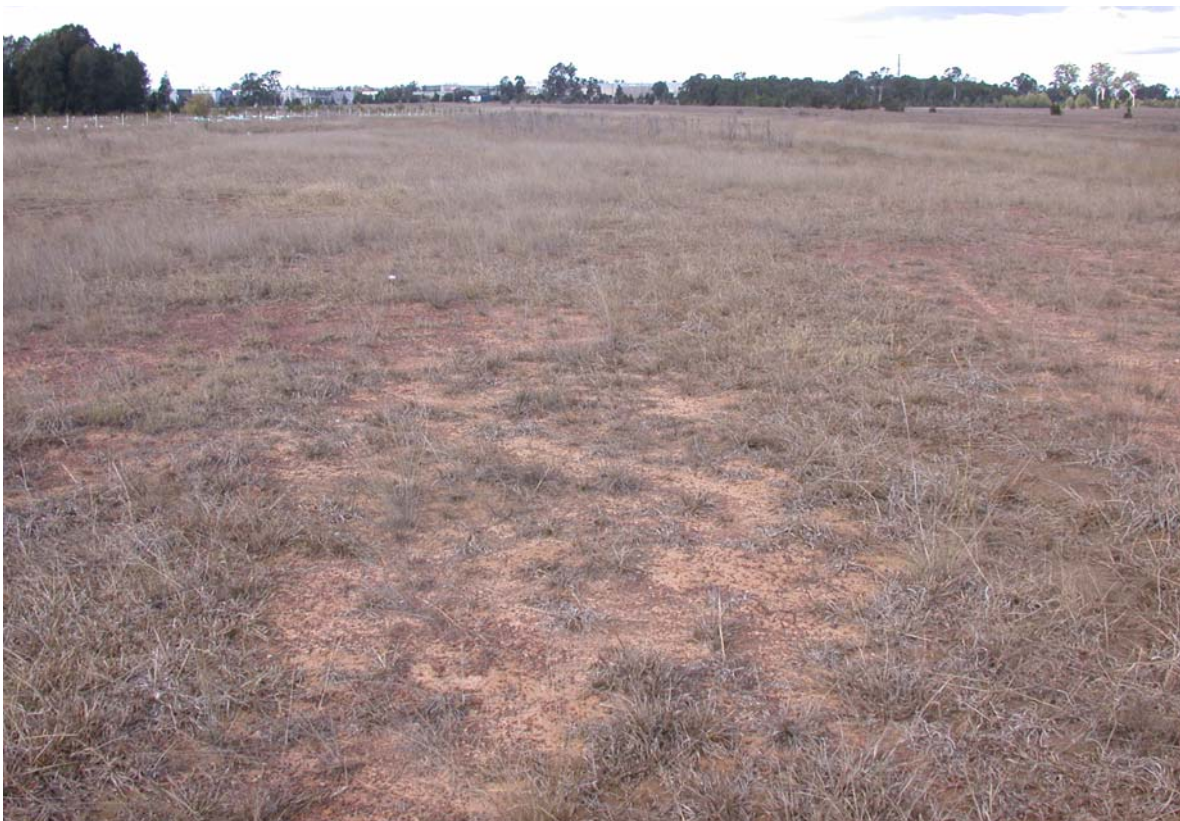
Figure 4.27 View to east showing the location of the former airstrip.

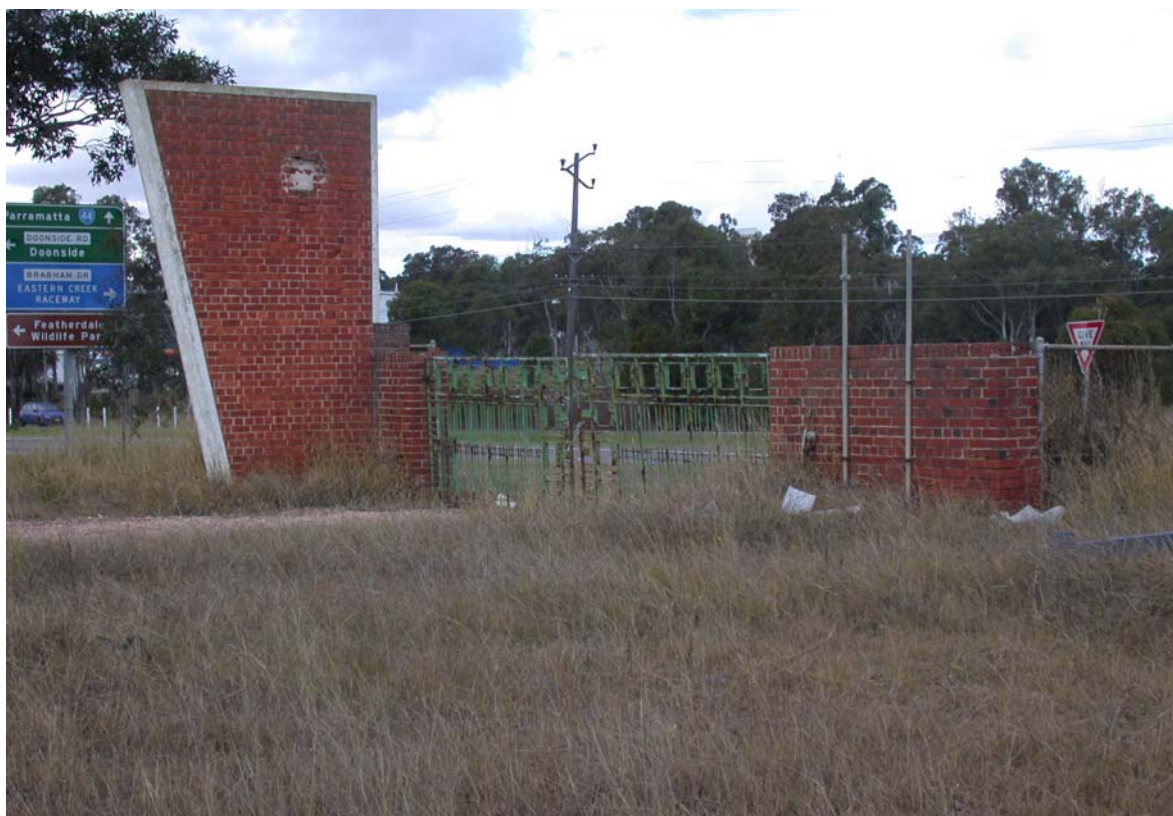
Figure 4.29 View to the southeast showing the extant OTC entrance.

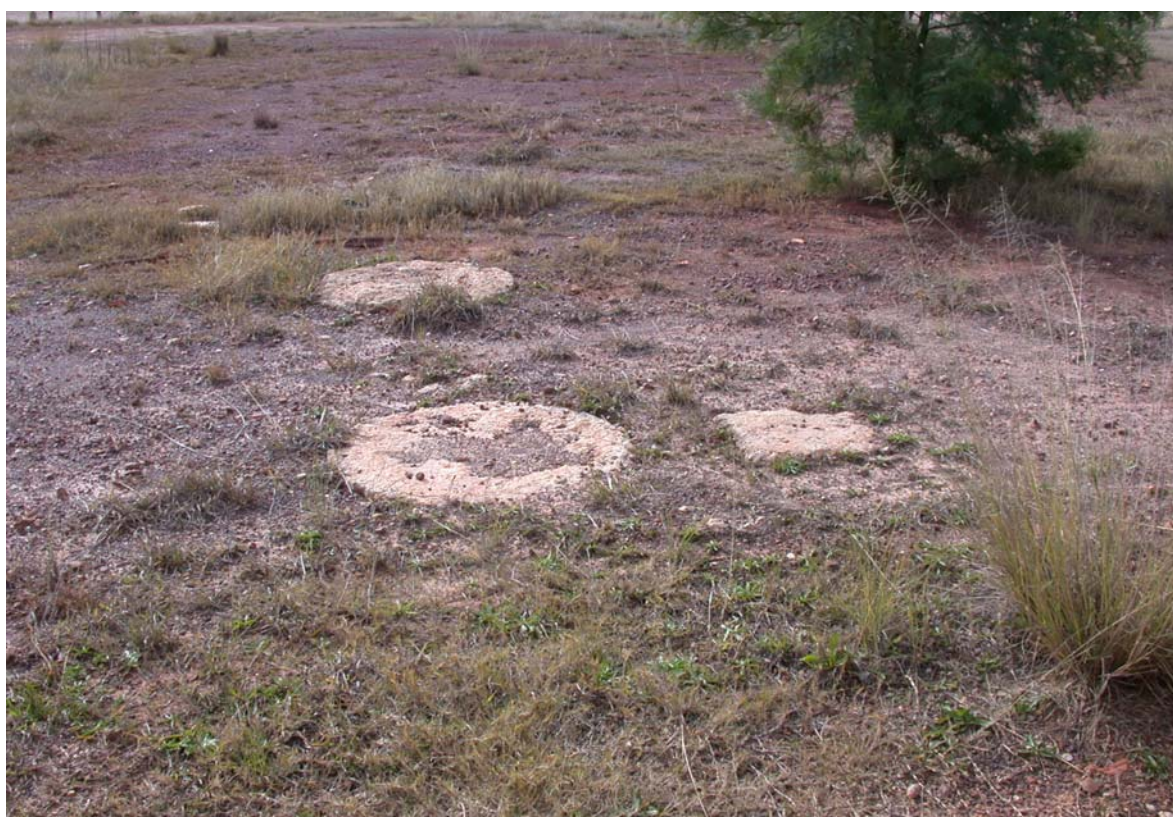
Figure 4.30 View to the east showing the potential transmitter aerial pad.
