Bon Marche Building, Broadway
Terrace Buildings & former
Apothecary Building

Broadway and Harris Streets
Ultimo

Conservation Management Plan

APRIL 2019

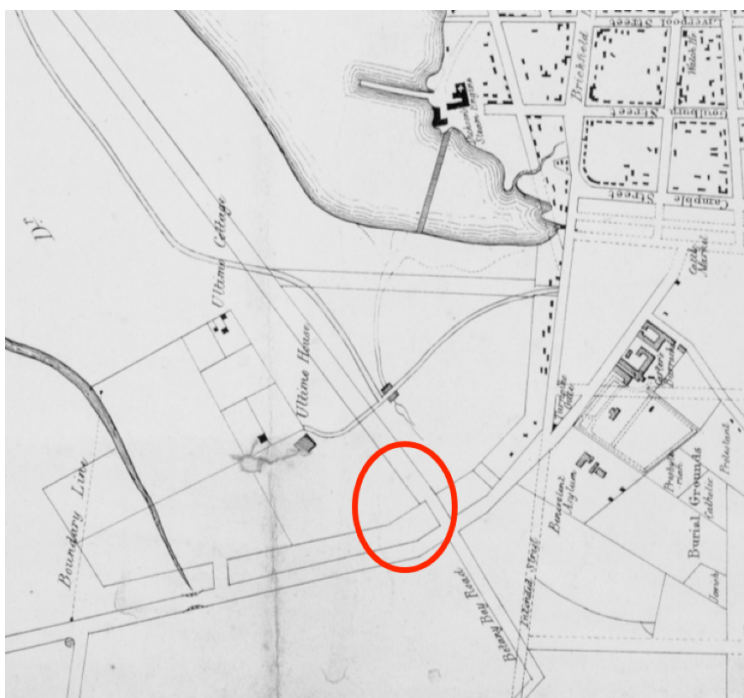
Figure 17: Detail from 'Plan of Sydney with Pyrmont' dated 1836 (no surveyor stated). Depicted was the strip of allotments, 132 feet deep, along the frontage to George Street that Dr Harris released for sale in 1834. The survey plotted Harris Street and noted the change in the width of the new street at the intersection with present day Broadway (narrower width in the 1834 sales.). Source: National Library of Australia (T1551)

The sales of 1834/36 initiated by Dr John Harris (1754-1838) generally were of blocks 132 feet deep from the Broadway/George Street frontage; this distance is demonstrated by the original northern boundary of Nos. 1-13 Broadway. Originally there was a laneway at the rear of this allotment (since closed and absorbed by the mid nineteenth century development), in the same way Bijou Lane is today to the north-east of the subject sites.

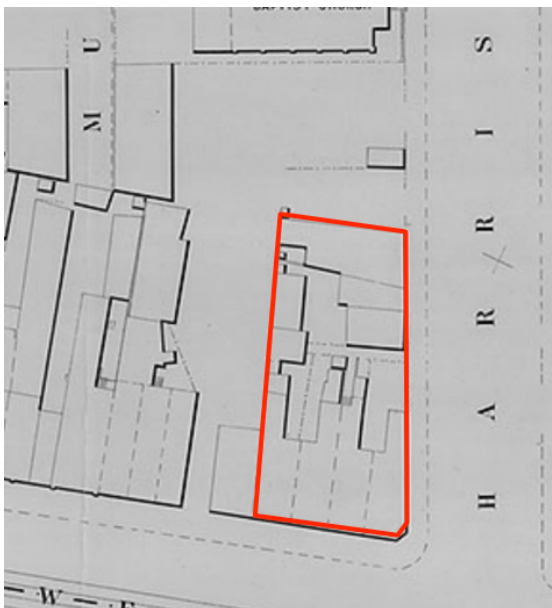
Figure 20: Detail from Sydney Sheet E4 of the Lands Department's Metropolitan Detail Series dated 1886. Details shown for site of Nos. 1-7 Broadway and Nos. 769-773 Harris Street. Note the buildings now respect the Harris Street building line. Source: State Library of NSW (Map Z/ M Ser 4 811.17/1)

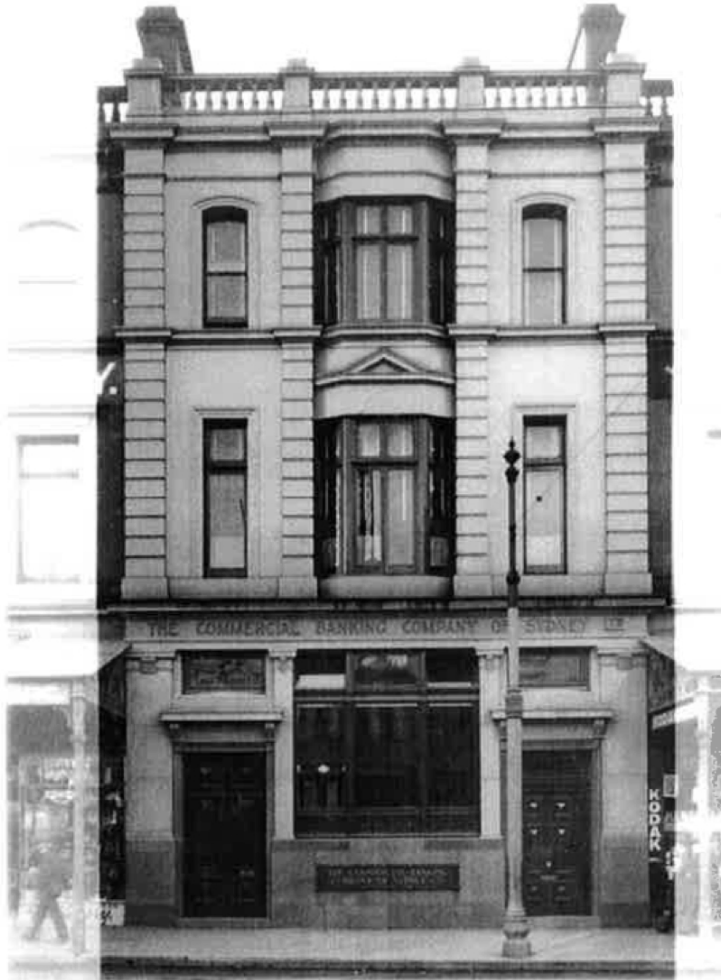
Figure 29: The street façade of no 11. Not dated, but pre 1925 as it depicted the posted street awning. Source: Conybeare Morrison & Partners, 'The Terraces & The Bon Marche Buildings, Lifting of the Heritage Listings', August, 2000

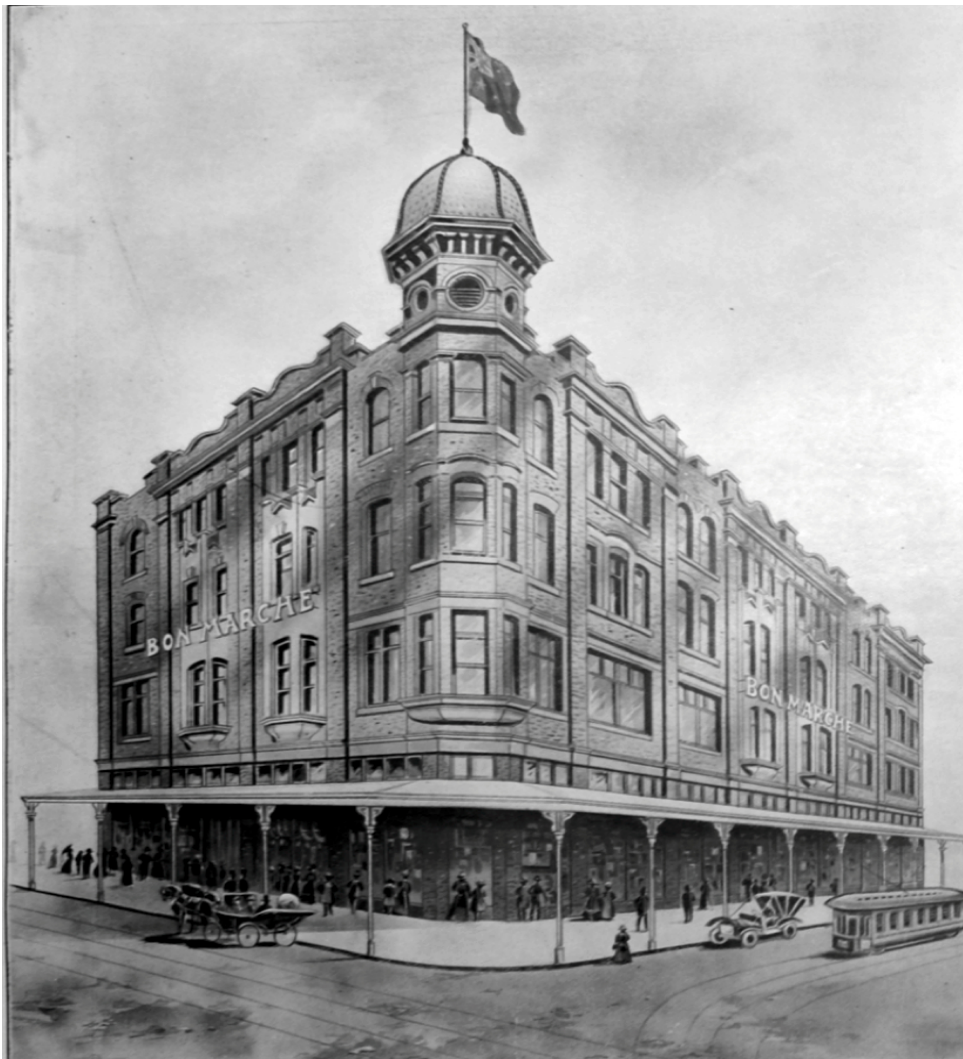
Figure 35: Architects McCredie and Anderson's sketch perspective of the Bon Marche store of 1909. Source: *A Souvenir of the Success of Marcus Clark & Co. Ltd*, Marcus Clark & Co, 1911,

With the Harris Street elevation being northerly, the interiors were naturally well-lit, and were supplemented by both electricity and gas originally. As mains electricity supply was in its infancy, presumably a DC supply was generated on-site. The basement level was illuminated by prismatic street lights (removed in 1940).

Internally there was a passenger lift midway within the floorplan, and a goods lift beside the original north wall. There was one central staircase. Unfortunately, no photographs of the original interiors or any detailed descriptions have been located.

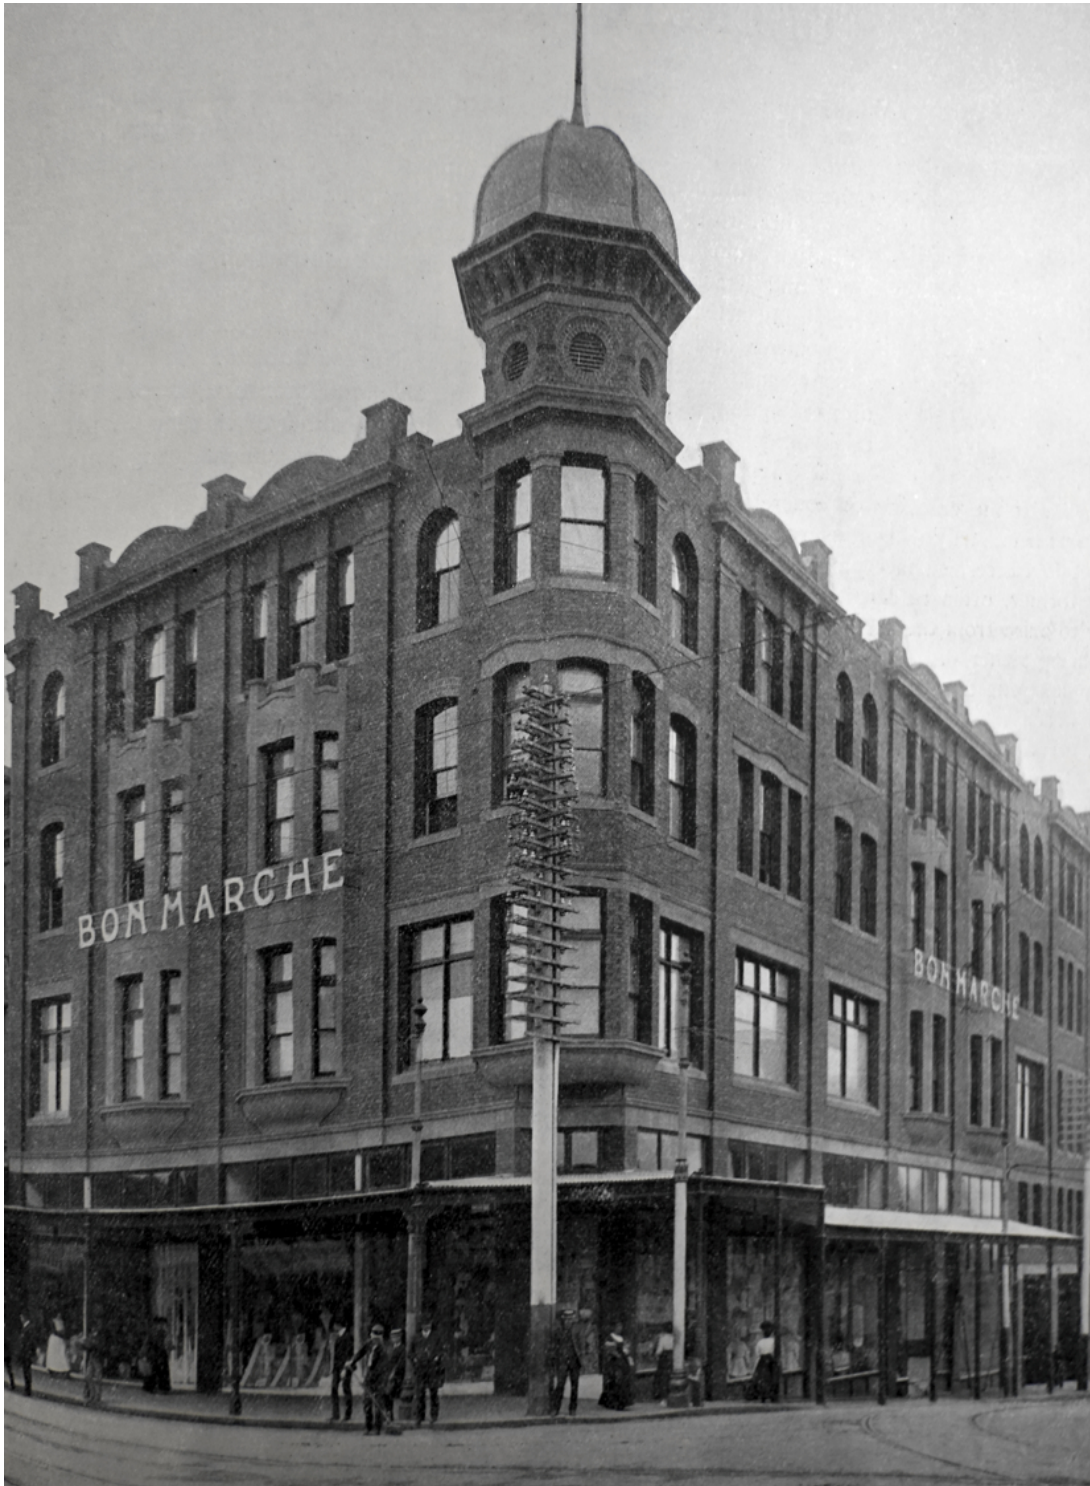
Figure 36: The Bon Marche store as completed in 1909. Not dated, but ca 1909-1914. Note top lights above the posted street awning for illuminating the interior. Source: *The Salon*, March 1914

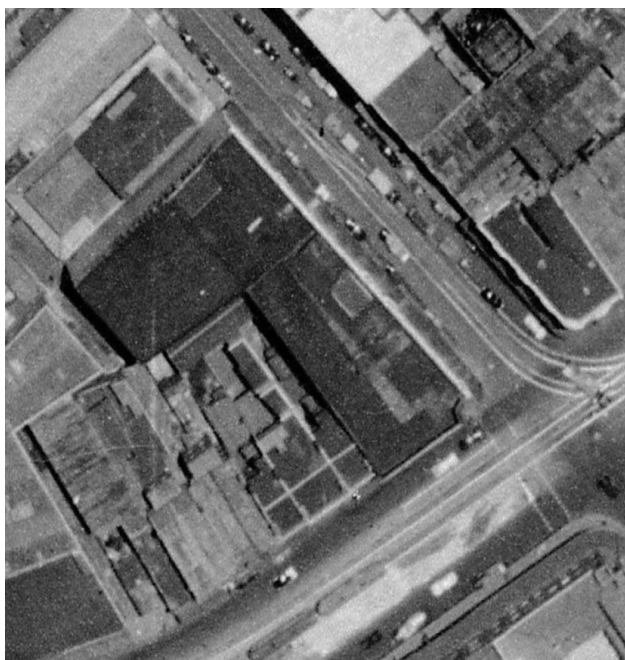
Figure 42: Detail from aerial photograph of 1949. Depicted was the roof forms as completed in 1909 and 1928. Source: Sydney City Archives

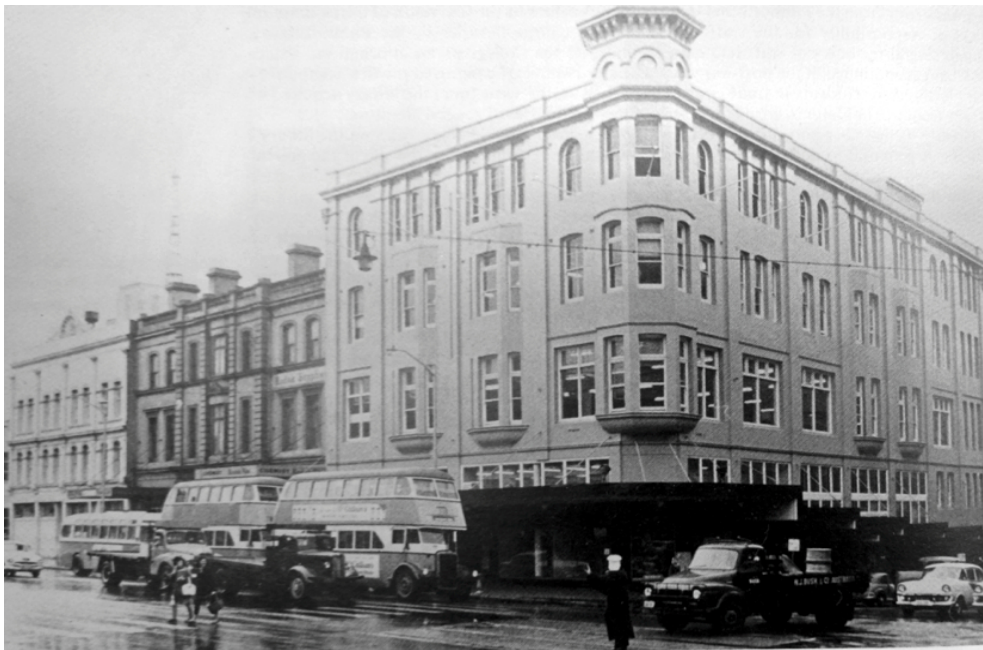
Figure 43: The former store in 1965 and after alterations for conversion into uses by the Sydney Technical College. Associated with this conversion probably was the cement rendering of the facades, and changes to the detail of the parapet. The timber framed sashed windows appear to date from the 1909 build. Source: Neill, N, *Technically & further: Sydney Technical College, 1891-1991*, Hale & Iremonger, 1991, p.100

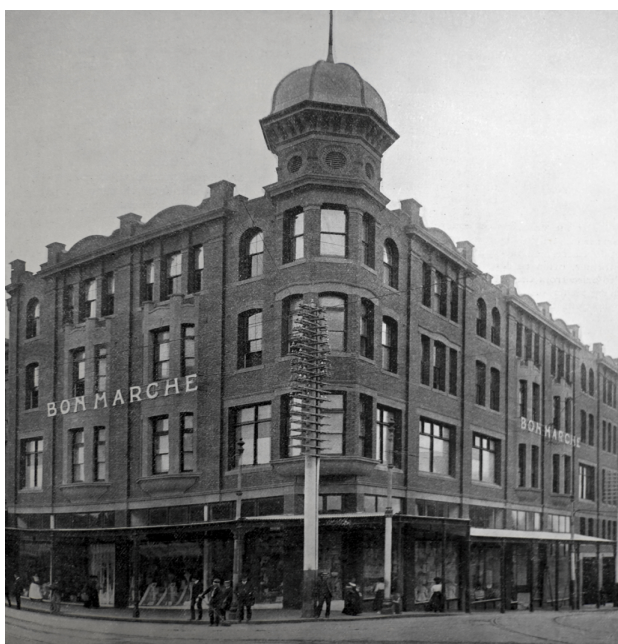
Figure 55: The Bon Marche store as completed in 1909. Source: *The Salon*, March 1914. Note the face brickwork and window head and sill detailing and the posted street verandah. The brickwork is monochrome and not patterned. The built form is restrained and has very little ornamentation or decoration.

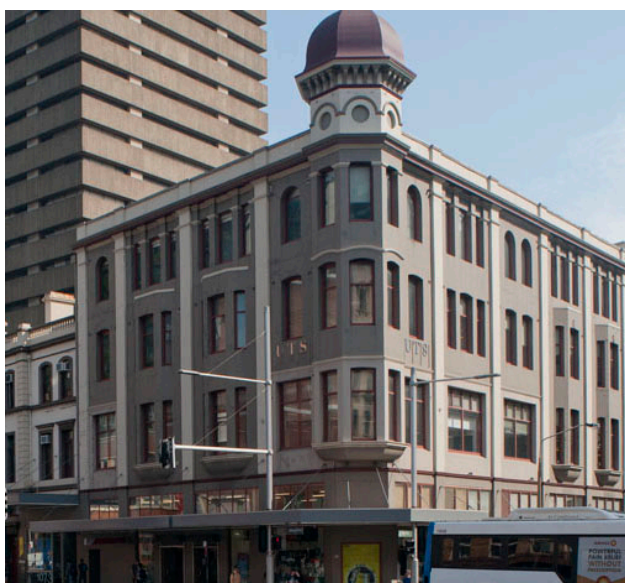
Figure 56: The Bon Marche store today. Note loss of original awning & shopfronts, cement rendering of walls, removal of parapet decorative detail. Though not visible in this photograph, the cupola still retains its apex flagpole. The current colour scheme changes the visual presentation of the building from the original brickwork by adding emphasis to the vertical pilasters and parapet.

- Loss of parapet decorative detail
- Replacement of all windows with powder-coated aluminium framed windows
- Cement rendering of the exterior walls over the original brickwork in 1965 when the building was refurbished by the NSW Department of Public Works, Government Architects Branch for Sydney Technical College for educational uses
- Modernisation of all ground floor shopfronts to both street frontages (Broadway and Harris Street)
- Installation of modern suspended awnings to both street frontages
- Changes to some window openings.

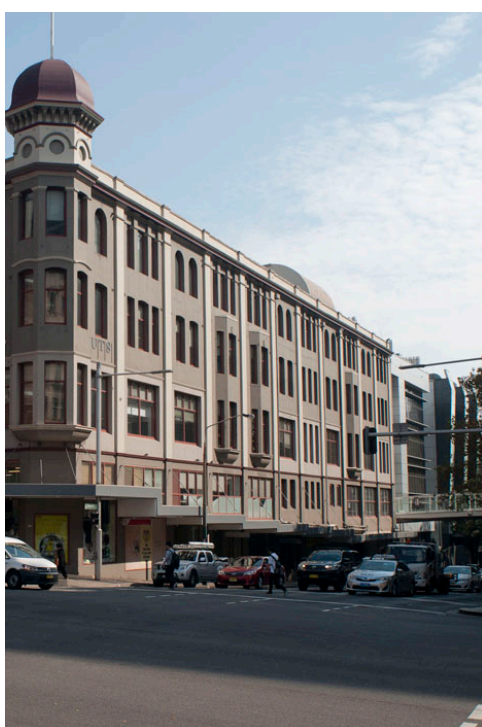
Figure 58: (Left) View of Bon Marche building east elevation to Harris Street. Note 1st floor walkway over Harris Street at far right.

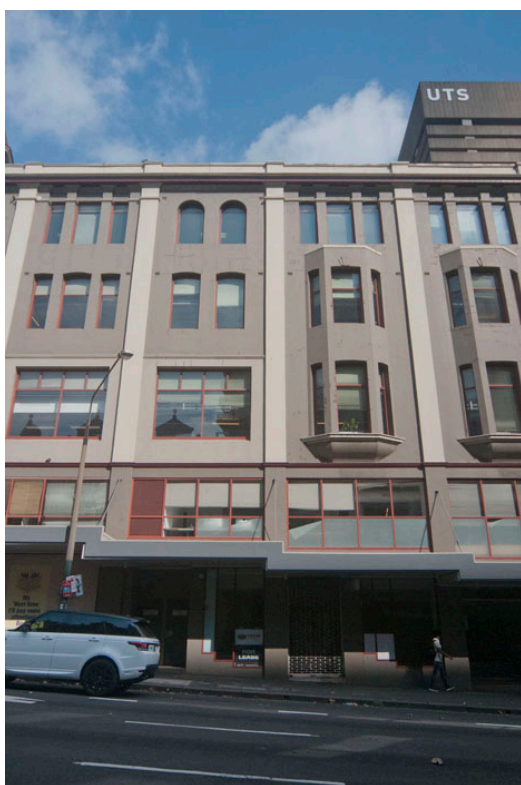
Figure 59: (Left) View of part of Harris Street elevation of former Bon Marche building showing use of frosted glass in some windows.

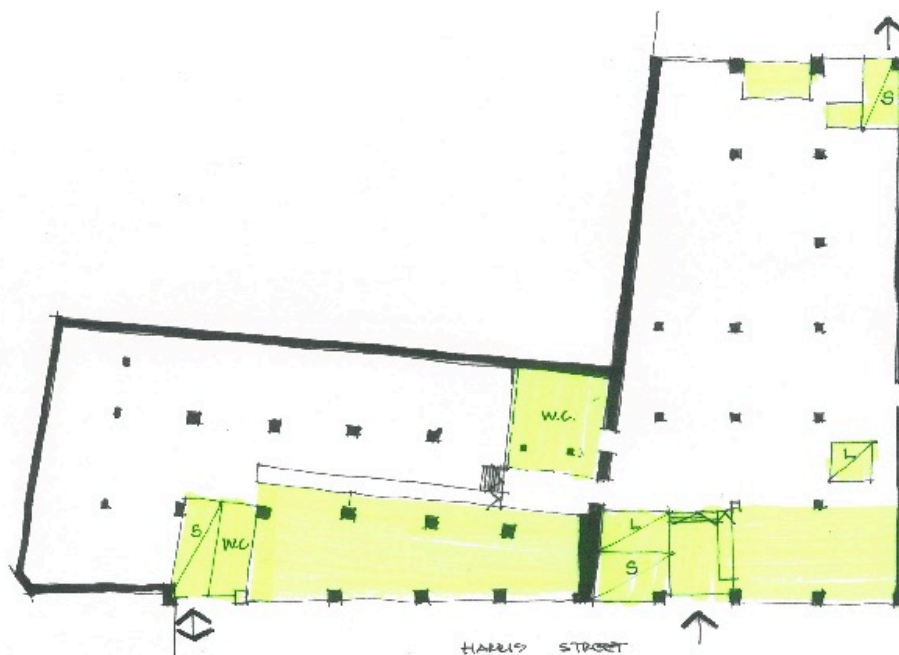
Figure 70: Bon Marche Building Level 1. The left hand end of the building (south) is a basement below Broadway with the shopfronts, added in the 1970s stepping down as Harris Street falls to the north. The former loading docks, occupying the northern 6 bays of the building have been infilled with new floor levels. The areas shaded yellow have had changed levels, floors removed and new elements such as stairs and lifts inserted.

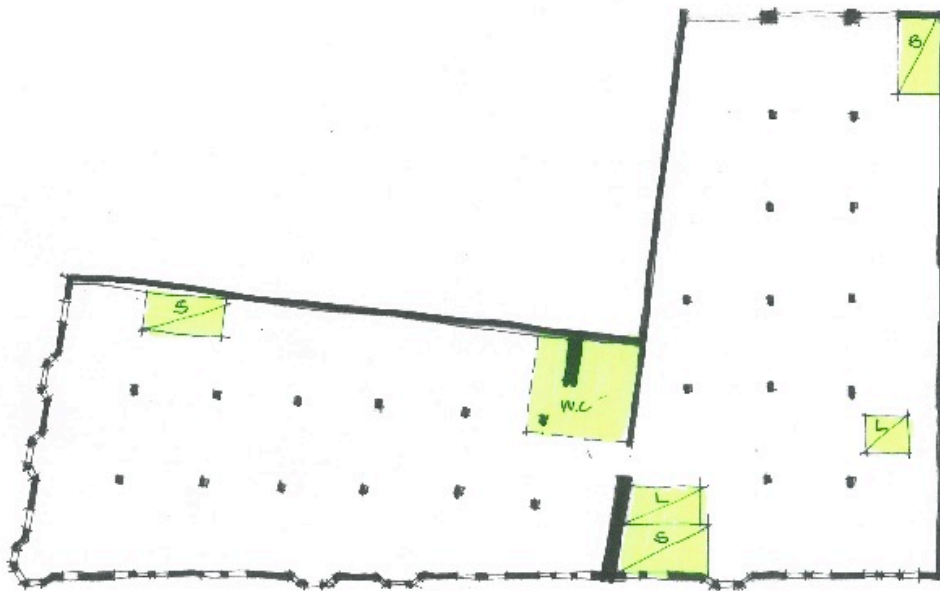
Figure 72: Bon Marche Building Levels 3 and 4. The floor has had relatively little overall change (although now subdivided with new services throughout). The timber column grid and timber floors appear to remain on much of the floor. The areas shaded yellow have had changed levels, floors removed and new elements such as stairs and lifts inserted.

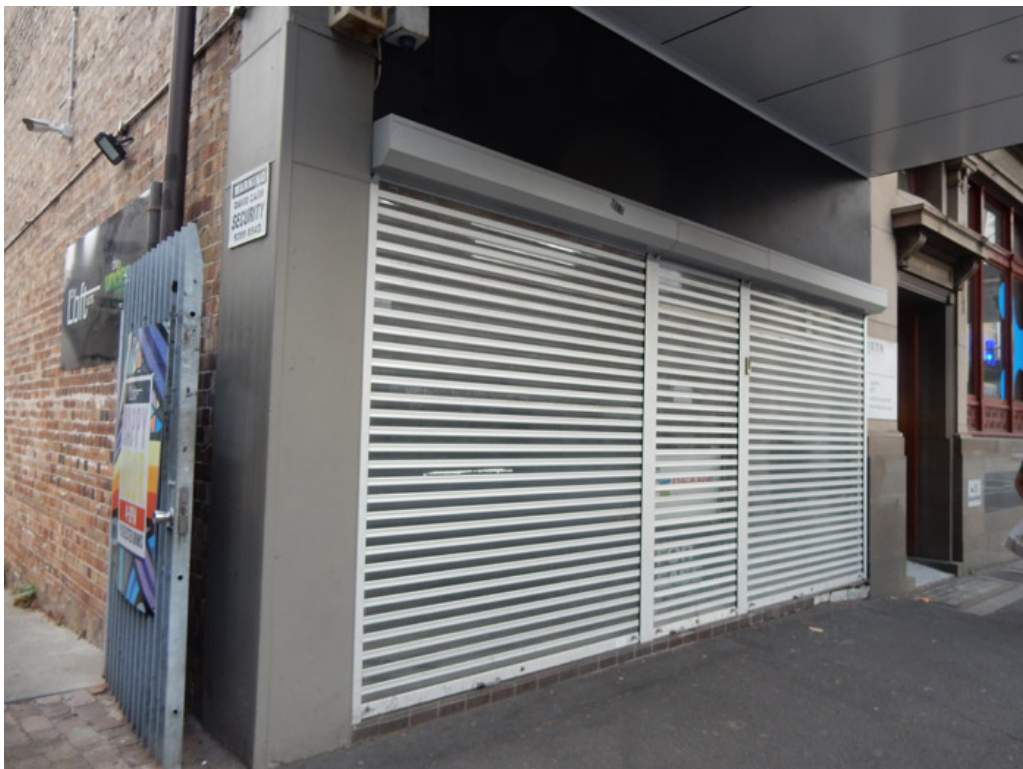
Figure 87: Modern shopfront to the shop formerly 13 Broadway

- the ground floor shopfronts to Nos. 9 and 13, which are recent,
- the replacement of the original post-supported awnings to Nos. 9 and 13 with modern awnings.
- To the former bank at No. 11, the replacement of the southern entry door with a glazed door within the original door opening (noting that the northern entry door is original).
- The installation of air conditioning condenser units to various window openings to the Broadway façade of all three terraces.

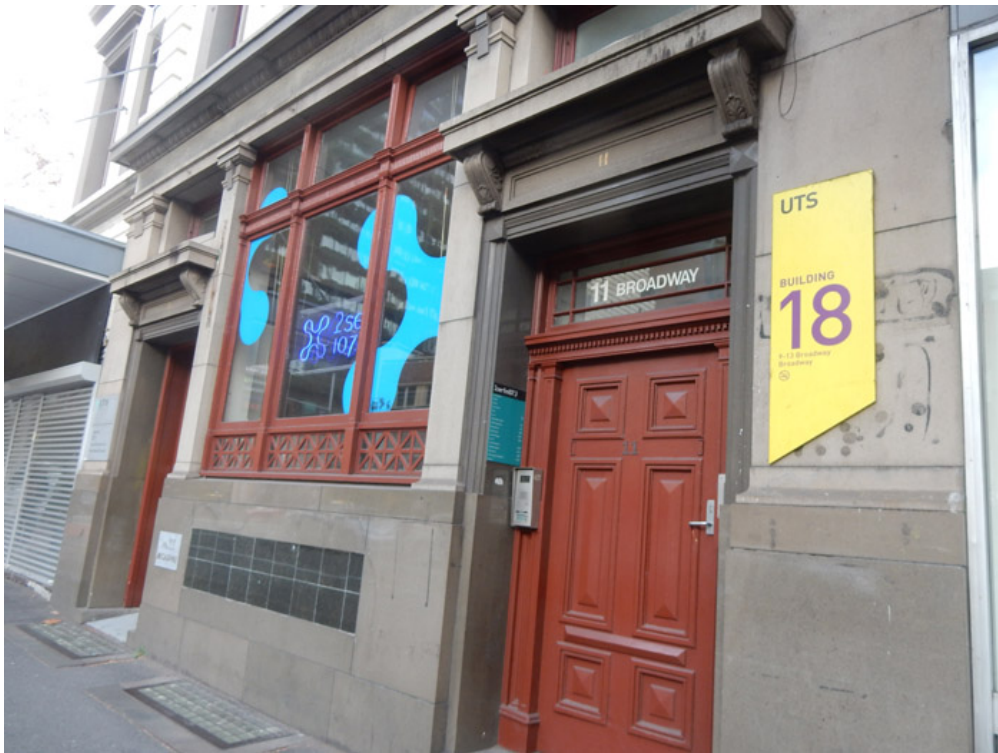
Figure 88: Shopfront to the former bank (formerly No. 11 Broadway), which is largely intact, note the pavement lights to the basement.

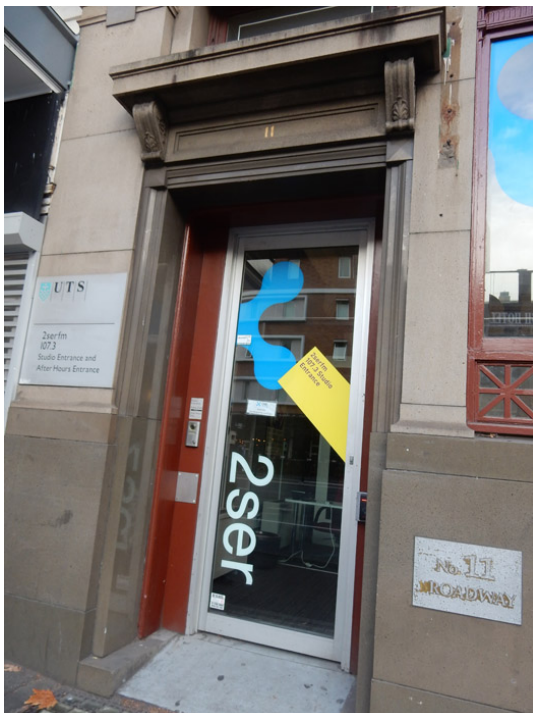
Figure 89: (Left) modern glazed doorway on the western side of the shopfront to the former bank and the later step to form a ramp (formerly No. 11 Broadway)

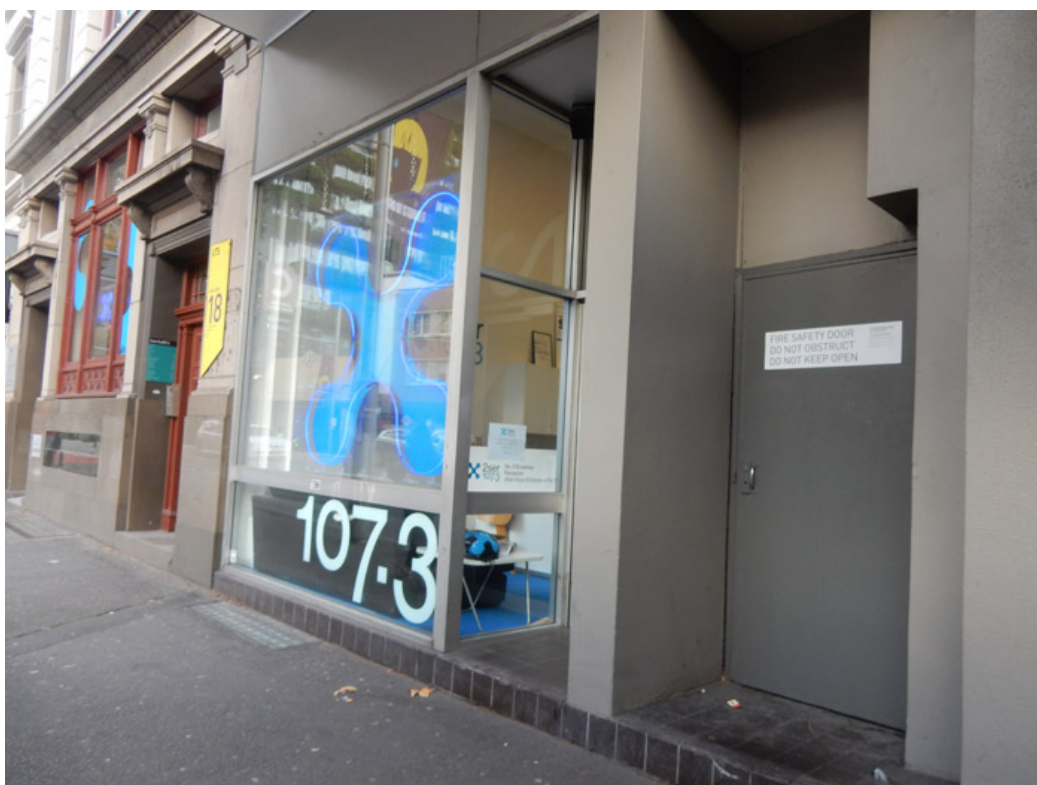
Figure 90: Modern shopfront to the terrace formerly No. 9 Broadway. Note access door at far right opens onto a passageway which is the historical link through to the former Apothecary building at the rear.

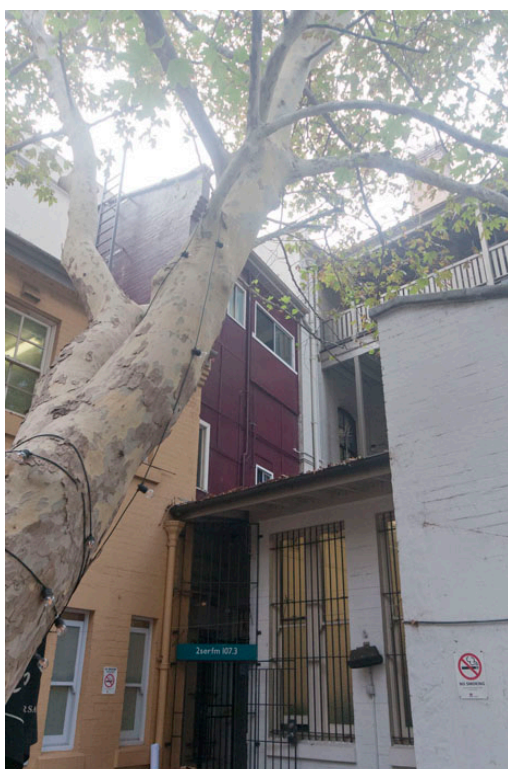
Figure 97: (Left) junction between rear of former No. 13 Broadway and former bank (formerly No. 11) showing areas of infill to former upper verandah area.

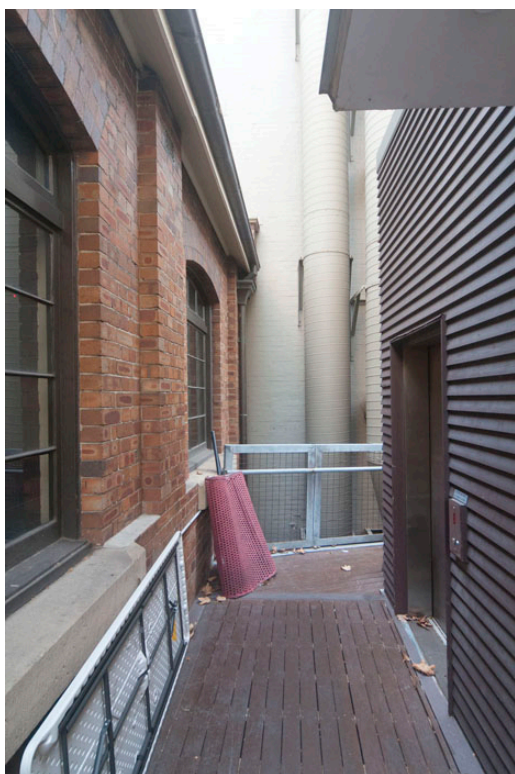
Figure 103: (Left) 1st floor level, connecting deck between the former Apothecary building (at left) and the rear of the former bank. Note lift doors to rear of the former bank wing.

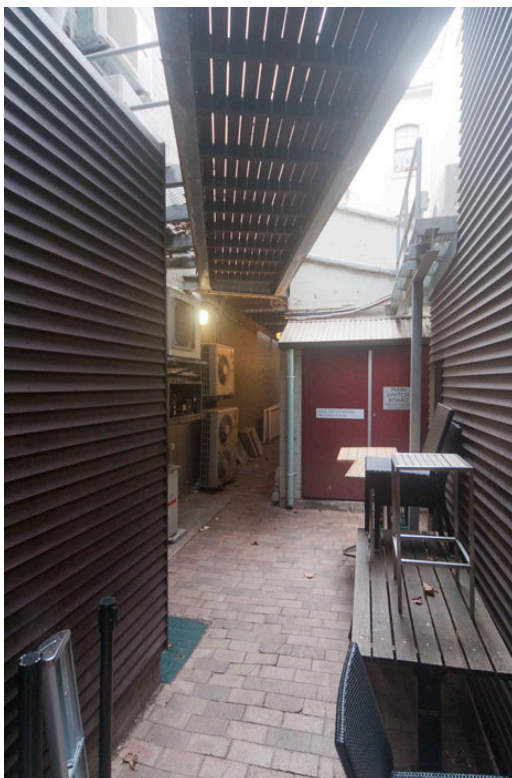
Figure 107: (Left) View of the rear of the terrace formerly No. 9 Broadway with walkways, later enclosures and AC plant visible.

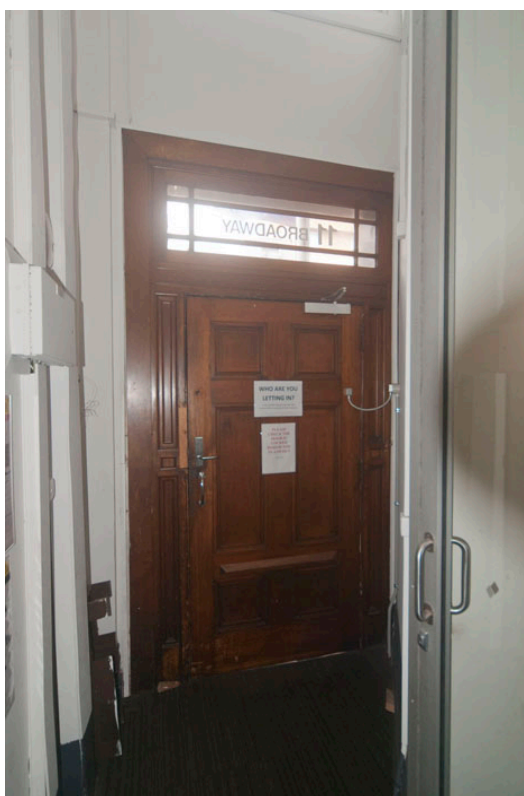
Figure 110: (Left) Original eastern front door to former Bank (formerly No. 11 Broadway)

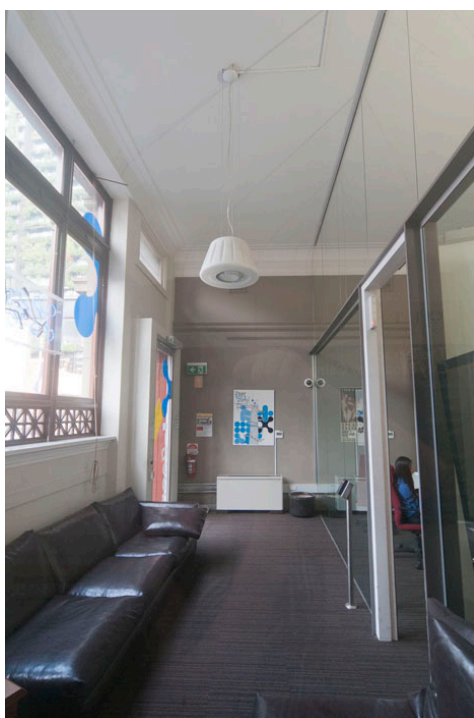
Figure 111: (Left) View of modern office fitout within the former banking chamber to No. 11, noting that this is reversible as it has not damaged cornices or skirting boards.

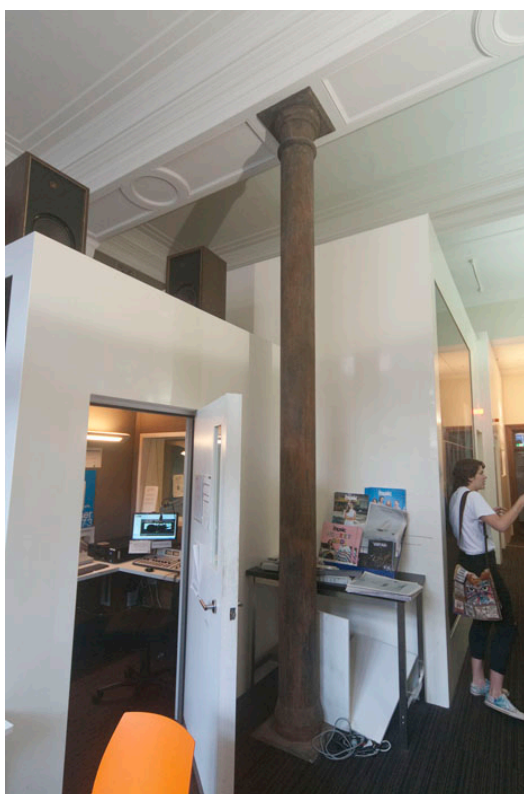
Figure 113: (Left) Former banking chamber to No. 11 with column and original ceiling detail

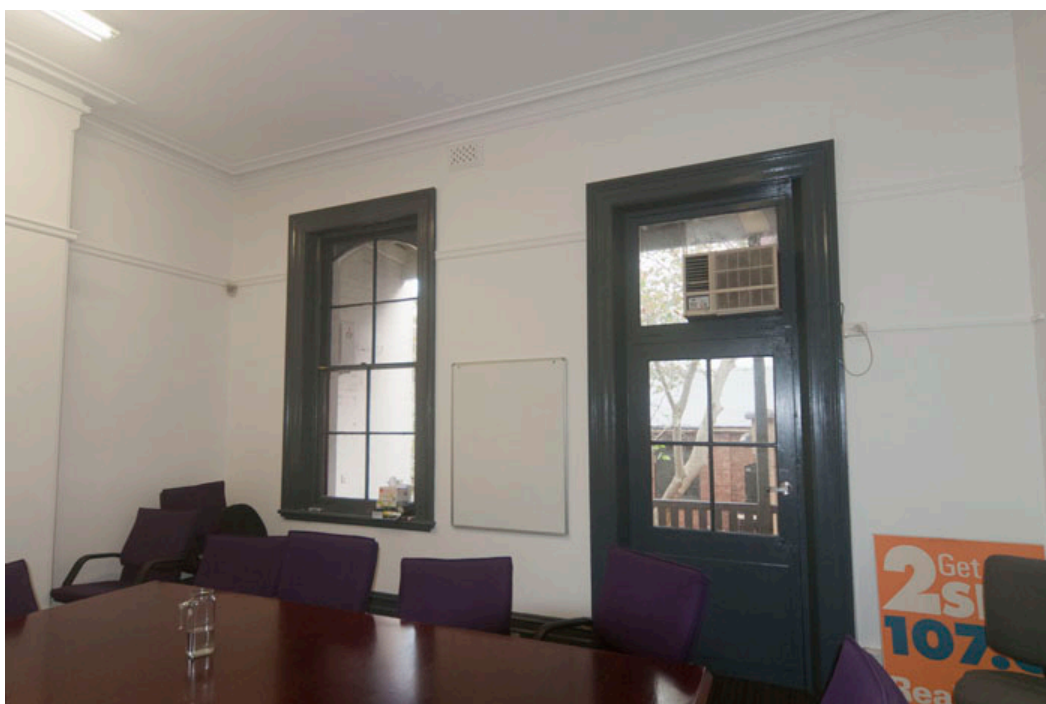
Figure 115: Original window and door to rear of ground floor of No. 11

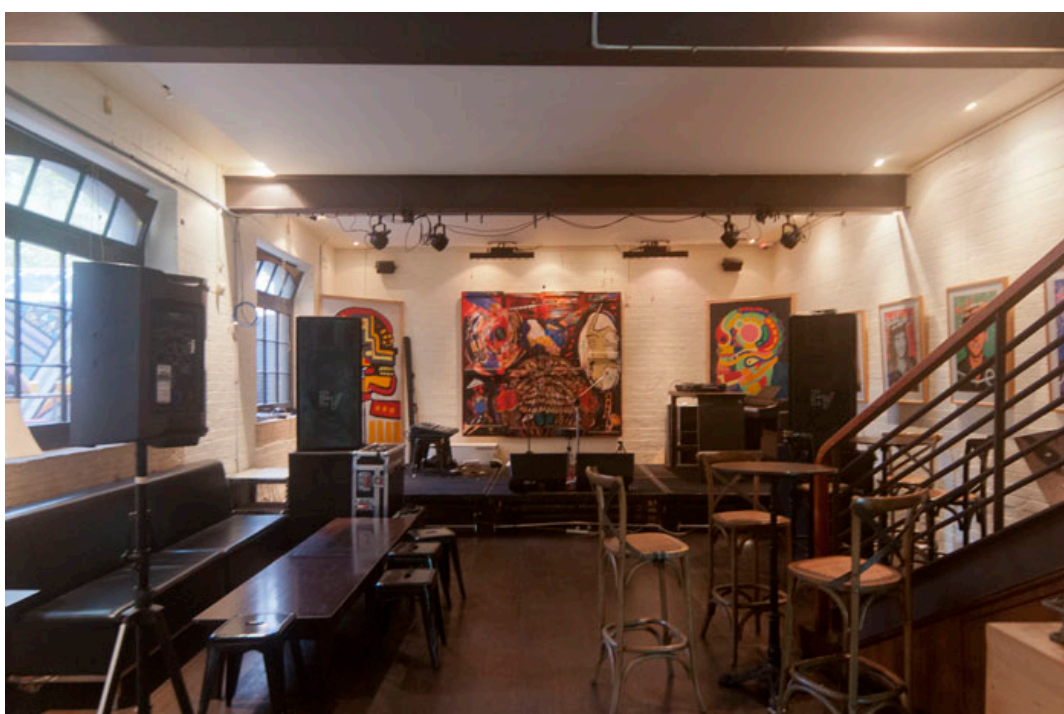
Figure 122: Ground floor interior of the former Apothecary building with modern staircase at right

The interior of the former Apothecary building has been stripped out and refitted for restaurant & venue use. The brickwork to the walls is exposed in the interior. All interior fittings including the staircase are recent. The roof structure and timber boarded roof linings appear early.

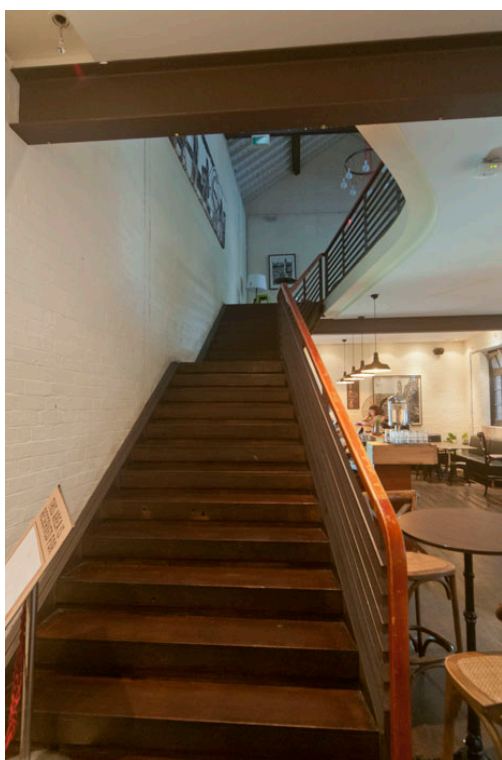
Figure 123: (Left) Modern staircase within the former Apothecary building

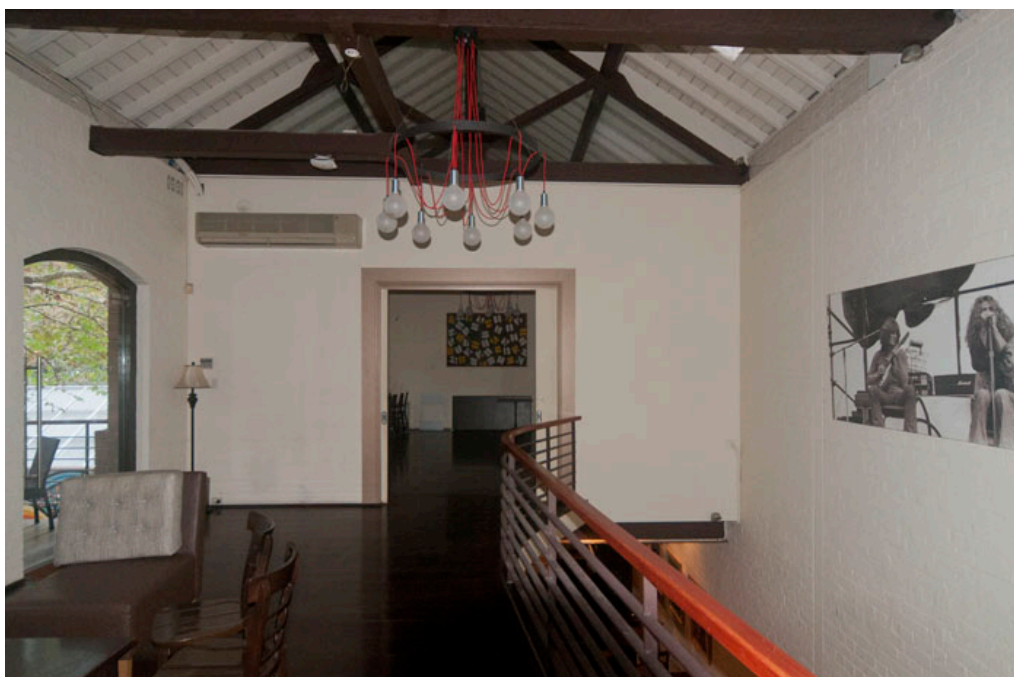
Figure 124: 1st floor level of the former Apothecary building with exposed roof framing.

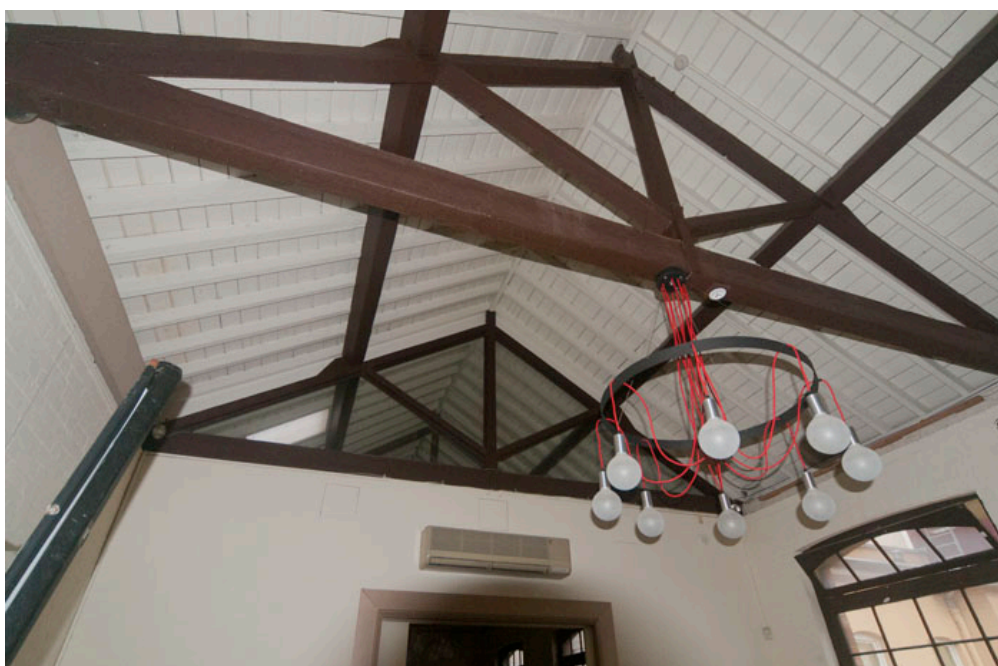
Figure 126: View of the 1st floor level of former Apothecary building exposed roof framing and timber ceiling lining
