Preliminary Site Investigation  
Concept Plan Modification

TX Australia Site - 15 Richmond Avenue, Willoughby

2 April 2020

57864/128678 (Rev 2)

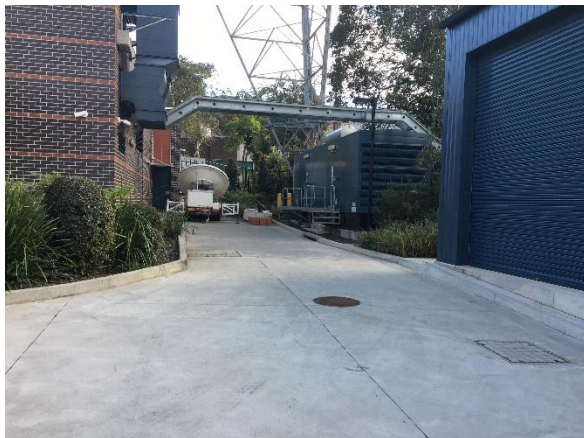
**Photograph 1:** Building beneath the TX Tower and associated infrastructure

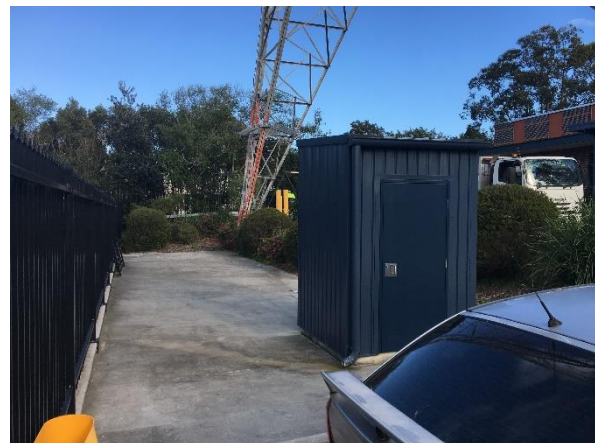
**Photograph 2:** small shed and overhead TX Tower with garden beds

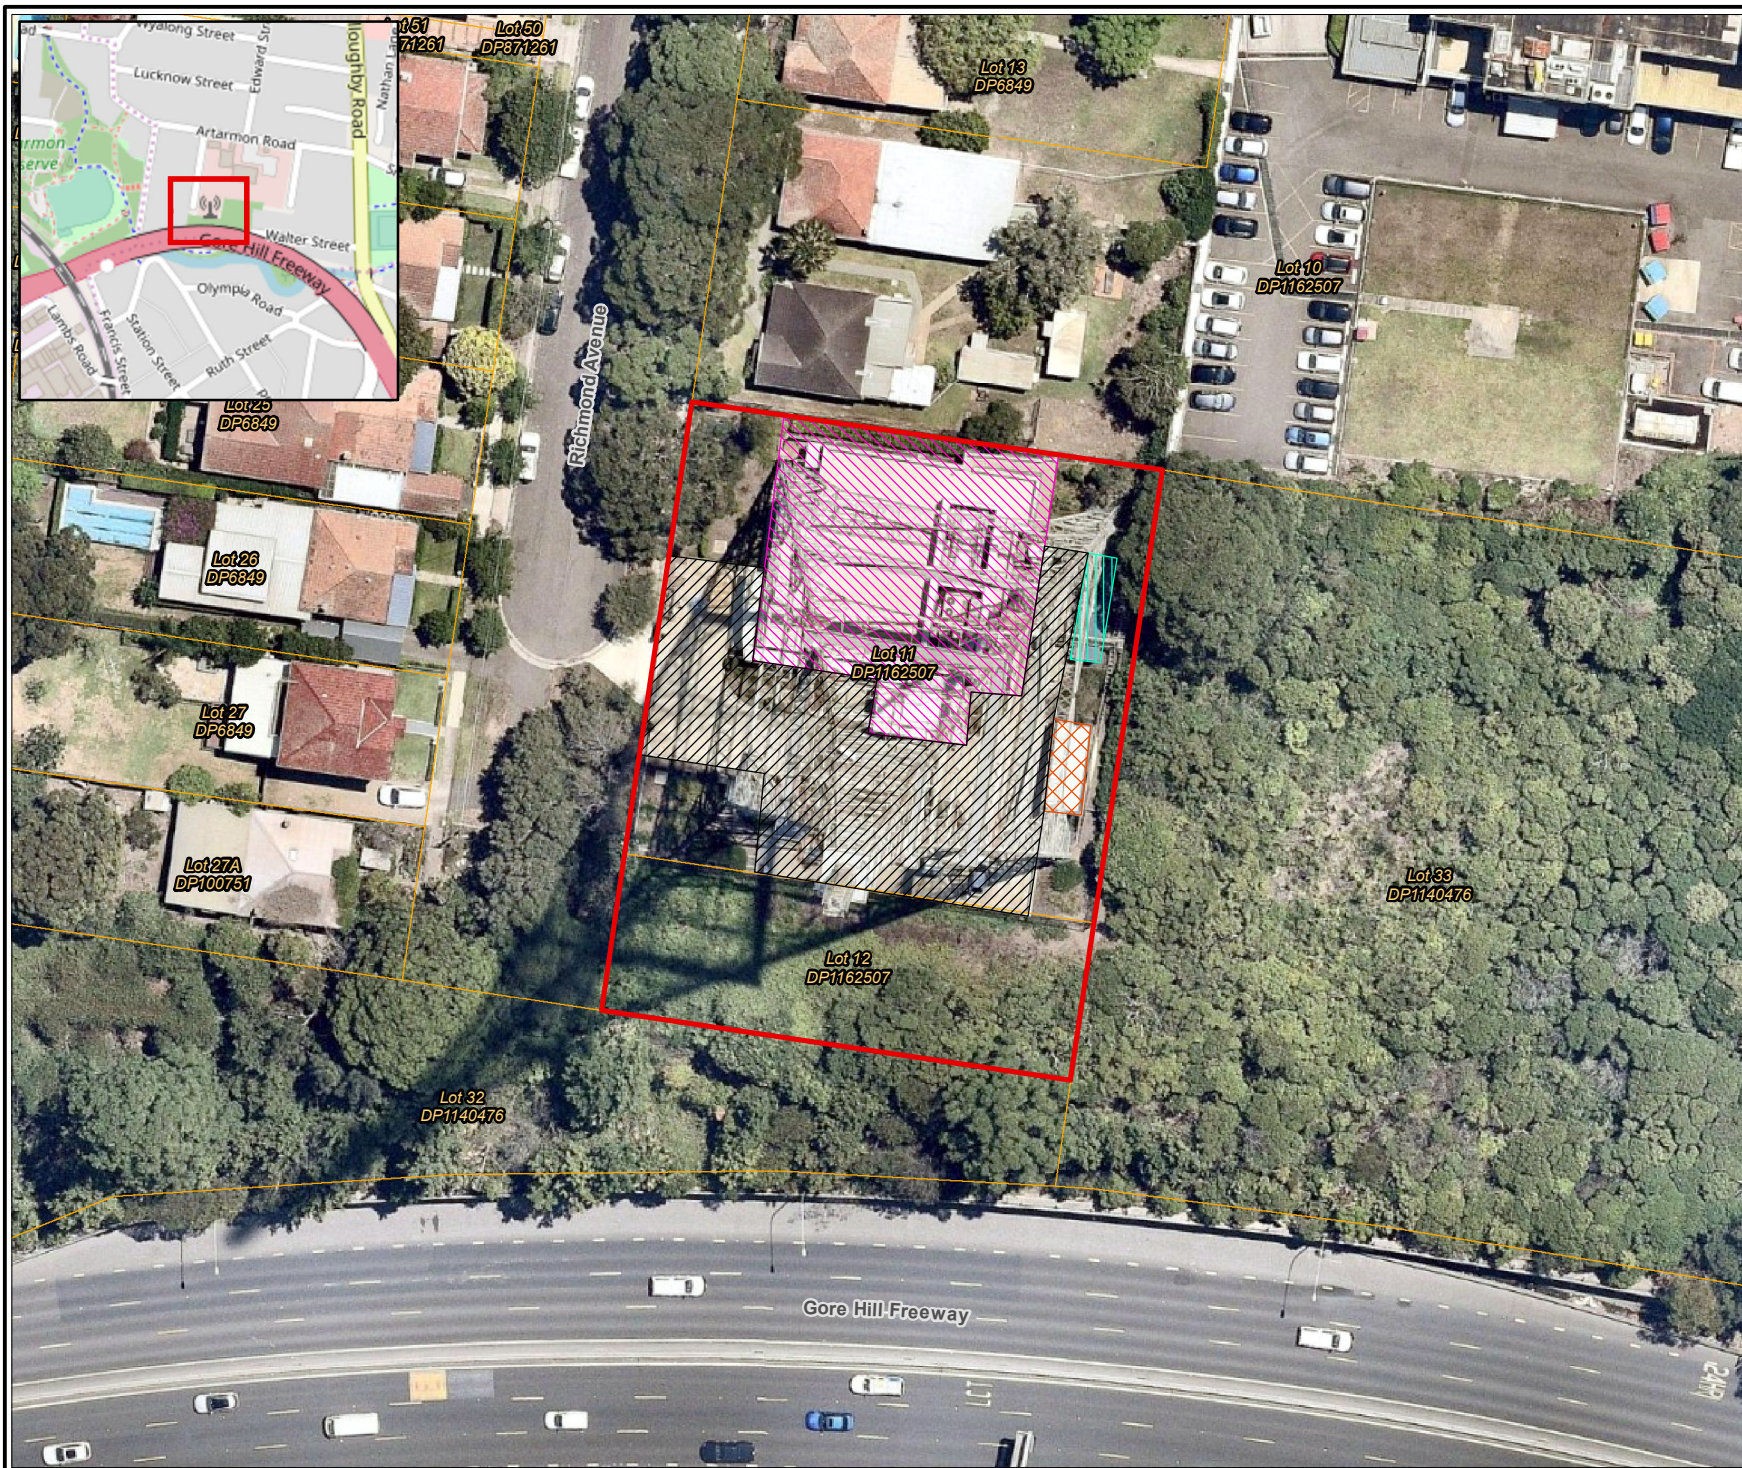
**FIGURE 2**

The site comprises a rectangular shaped parcel of land bound by Richmond Avenue to the west and Gore Hill Freeway to the south. The site is currently utilised for a TX Australia Pty Ltd TV transmission tower (TX Tower) and associated services/infrastructure (**Photograph 1** and **2**). A modern building of brick construction was located beneath the TX Tower and was noted to be of brick construction. It is noted that the building was not accessed at the time of the site inspection. An adjoining vacant land parcel comprising dense vegetation occupies the southern portion of the site (Lot 12 DP 1162507), with vegetated vacant land extending further south, comprising a steep embankment sloping down several metres to the Gore Hill Freeway to the south. Based on a review of topographic maps<sup>2</sup>, the site appears to have been subject to cut and fill activities in order to accommodate existing site levels.

**SITE LAYOUT**

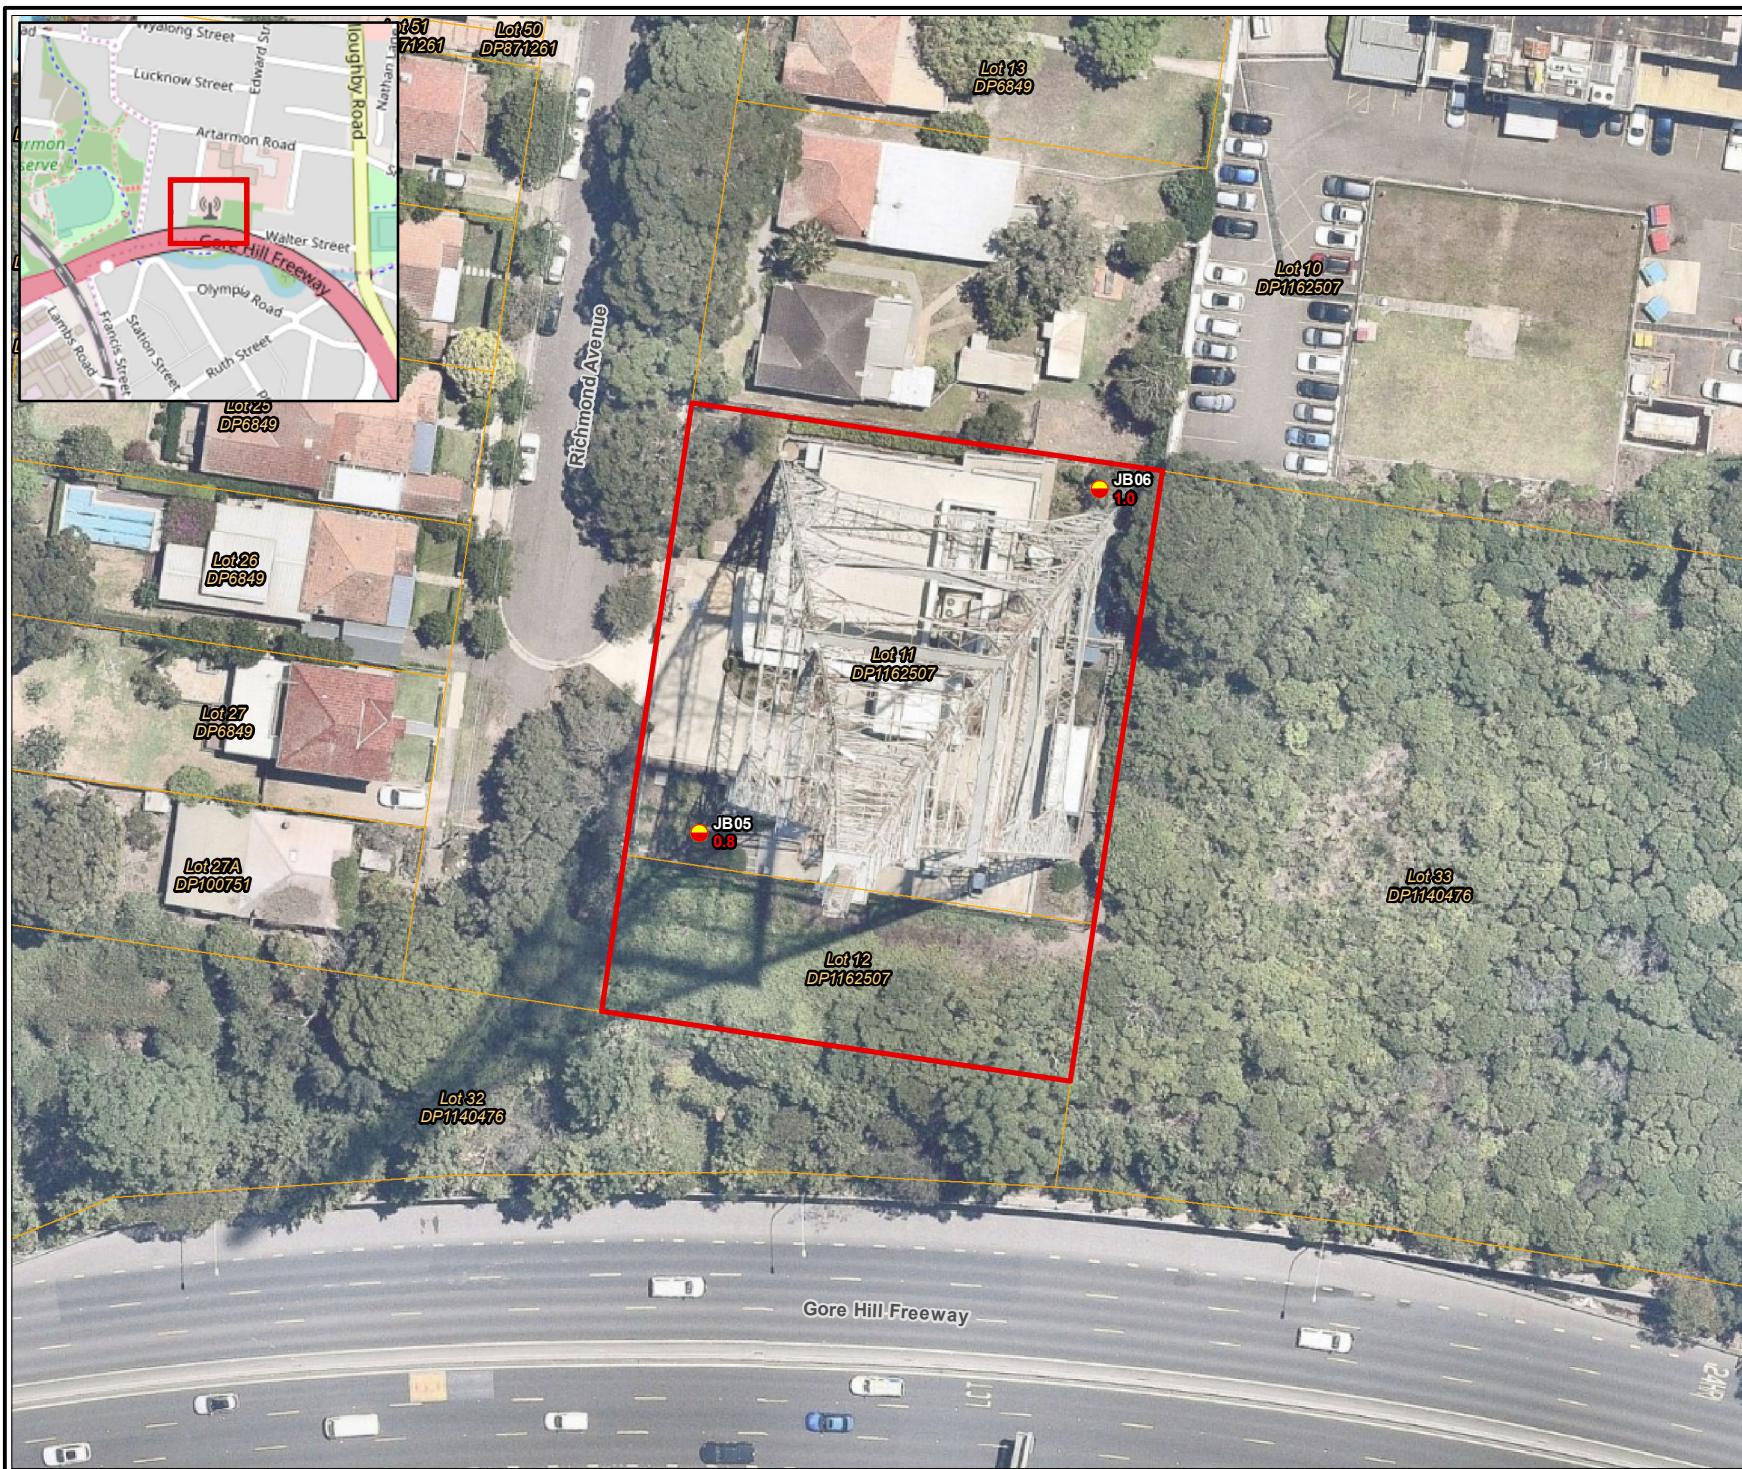
**FIGURE 3**

JBS&G (2019) completed a review of land contamination information supplemented with the collection of limited quantitative soil contamination data for a property located at Willoughby (Nine Network Australia Televisions Studios). The investigation is noted to have comprised an assessment area incorporating the site and larger parcel of land to the north and northeast of the site.

- Fill materials at the site were noted to generally comprise silty sand topsoil to 0.25 m bgs, sandy gravelly clay to between 0.8 m and 1.0 m bgs. Natural sands and weathered sandstone bedrock were encountered underlying fill materials. No odours or ACM were observed at either sample locations. Trace ash was noted in fill materials at a depth of 0.4 m bgs at sample location JB06.

It is noted that for a site area of 0.28 ha, EPA (1995) *Sampling Design Guidelines* recommend a minimum of nine systematic sample locations for site characterisation. Further investigation is required to appropriately assess potential contamination and site suitability.
