**Section 75W Modification No. 8 to Concept Approval MP\_07\_0166  
Central Church Precinct, Wahroonga Estate**

**Ecological Impact Assessment – Asset Protection Zones within E2 Zone – Central Church Precinct, Wahroonga Estate**

Ecological Impact  
Assessment – Asset  
Protection Zones within E2  
Zone – Central Church  
Precinct, Wahroonga Estate

## Photopoint Photographs

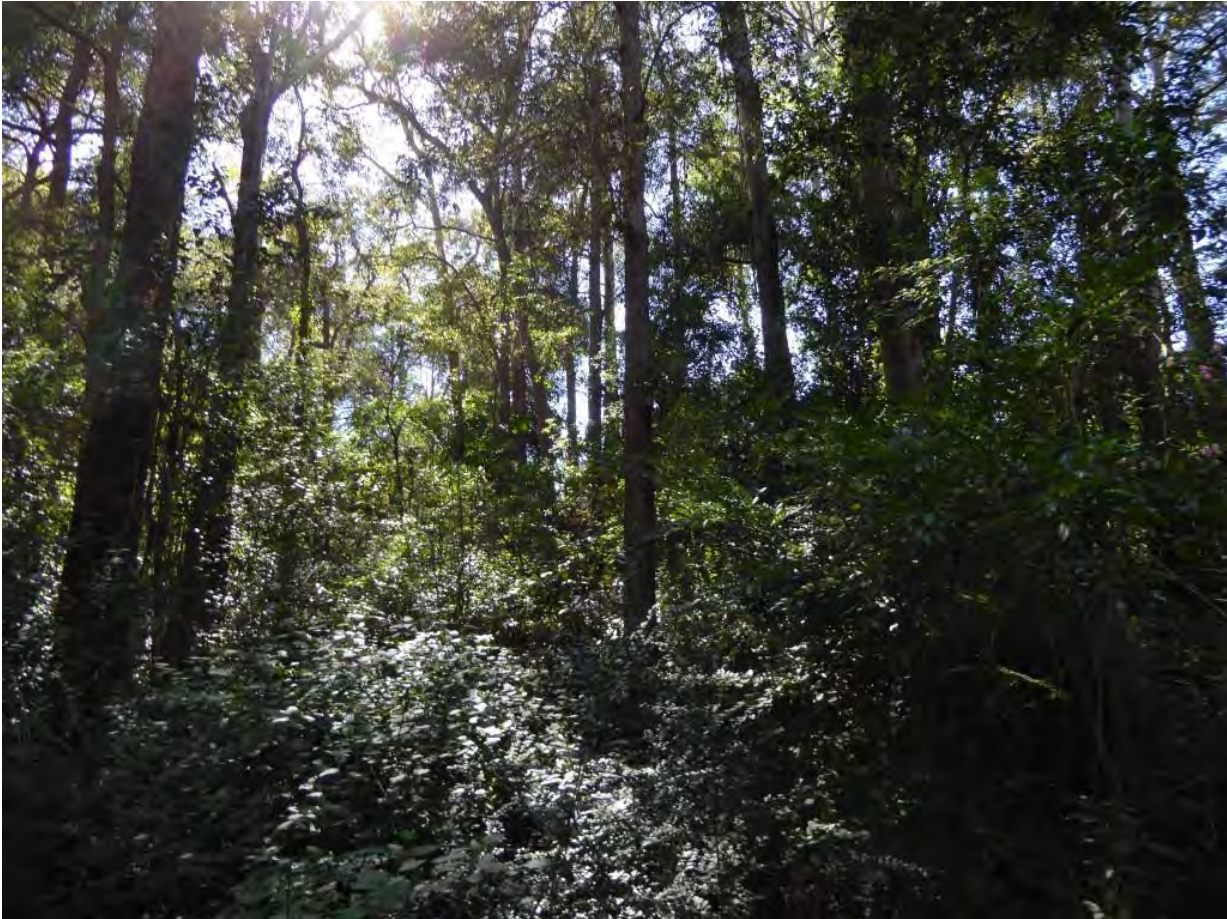
**Photograph 1 BGHF with Privet dominated understorey adjacent to APZ Area Assessed**

The Vegetation Protection Line was initially aligned to exclude areas of high-quality vegetation from the APZs. Prior to being managed as an APZ, these areas were already highly degraded as they were the interface between bushland and urban areas, including hard stand surfaces and lawns comprised of exotic grasses. Based on observations in adjoining areas to the APZs, there is unlikely to be any benefit to allowing natural regeneration without further management. Areas immediately adjacent to the APZs within the Conservation Area in which management has not yet been undertaken have a sparse to absent ground layer due to shading by the dense shrub layer and mid-storey of exotic species (Photograph 1), predominately *Ligustrum lucidum* (Broad-leaved Privet), *Lantana camara*, and *Ligustrum sinense* (Small-leaved Privet).

The combined fertility of the shale and shale influenced soils and introduced nutrients from the proximity of these areas to an urban catchment creek, has resulted in a situation in which the understorey has become dominated by exotic species. The density of regrowth of these exotic species (thousands of *Ligustrum sinense* seedlings are present in the ground layer of some of the APZ areas), if left unmanaged to regrow, would further prohibit regrowth of canopy species as well as native understorey and ground layer species through competitive exclusion.

Without extensive ongoing management, including both revegetation and long term weed management, it is extremely unlikely that ceasing management of the APZs would result in any substantial level of natural regeneration, and over time native species richness and cover will further decline as weed regrowth occurs.

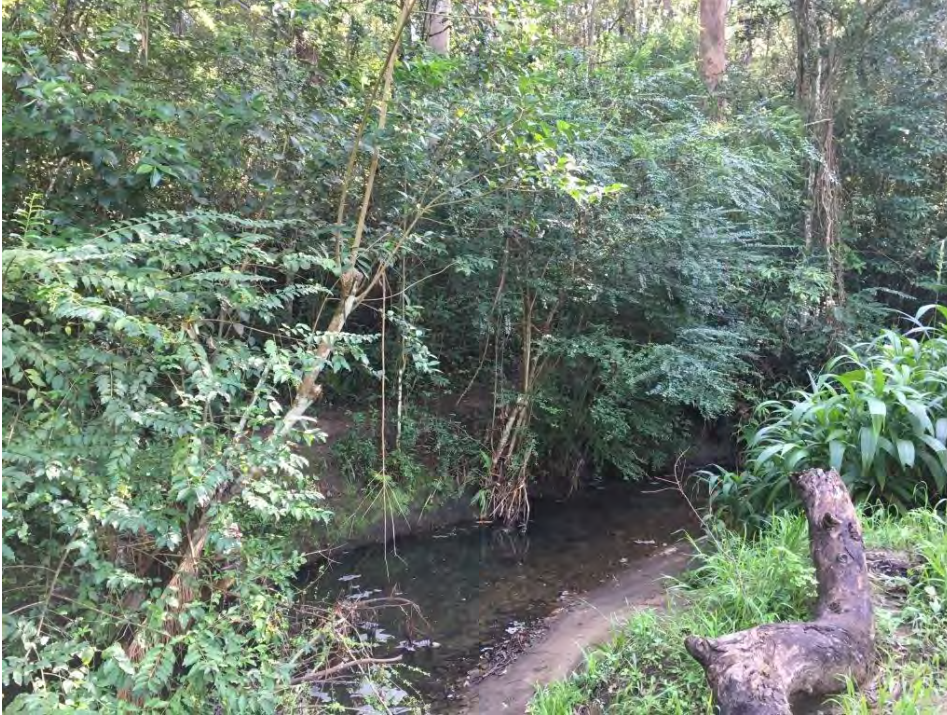
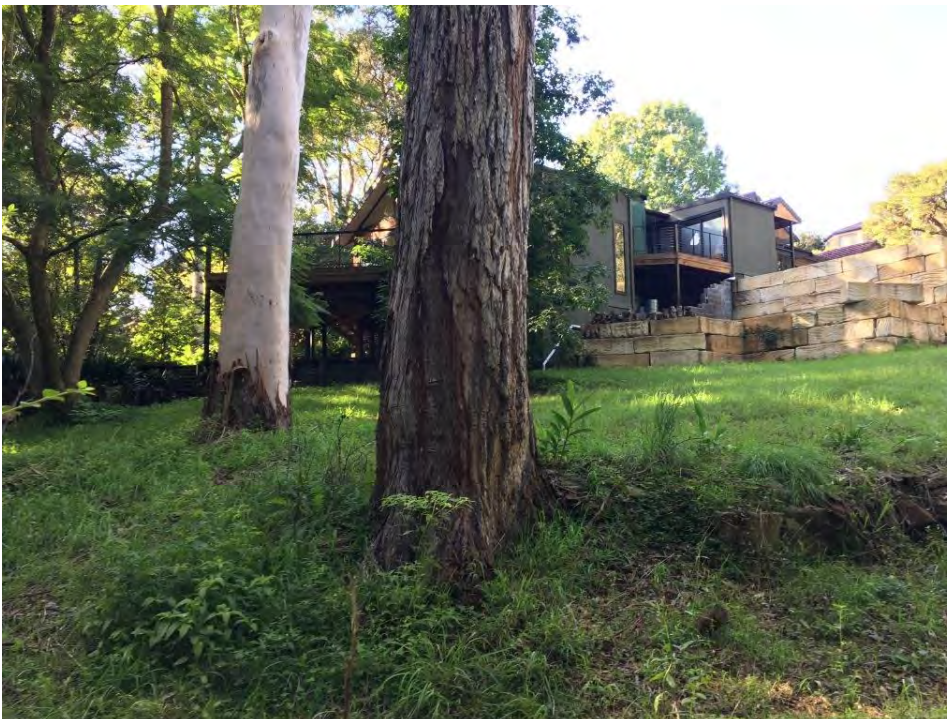
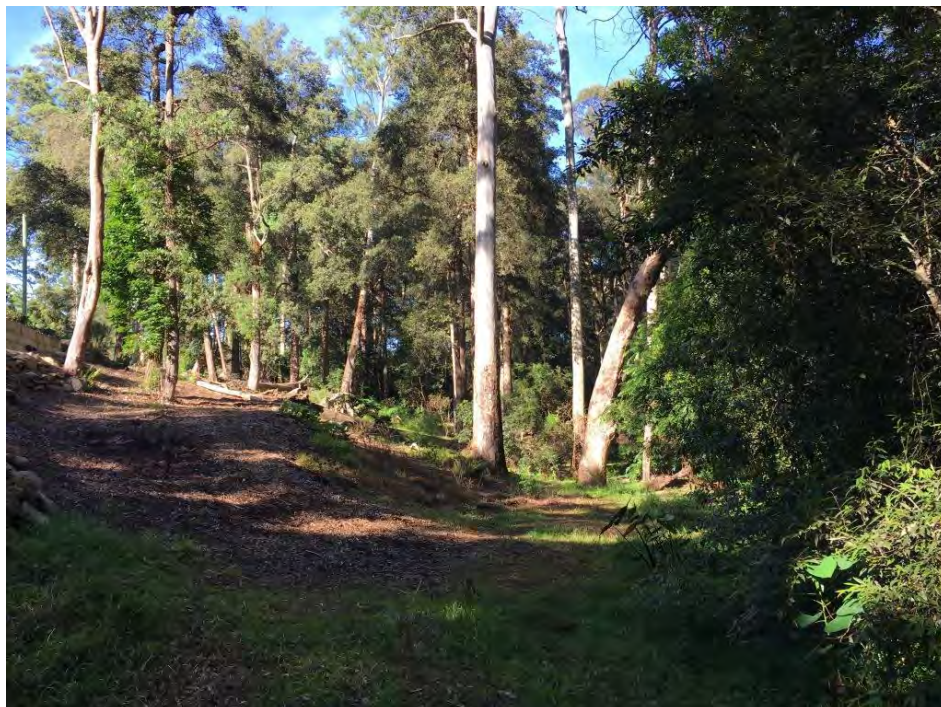
## B.1. Photopoint 1

The results of the site survey, which detail the condition of vegetation at each photopoint, are presented in **Table 1** below. Photos for each photopoint are included in **Appendix B**.

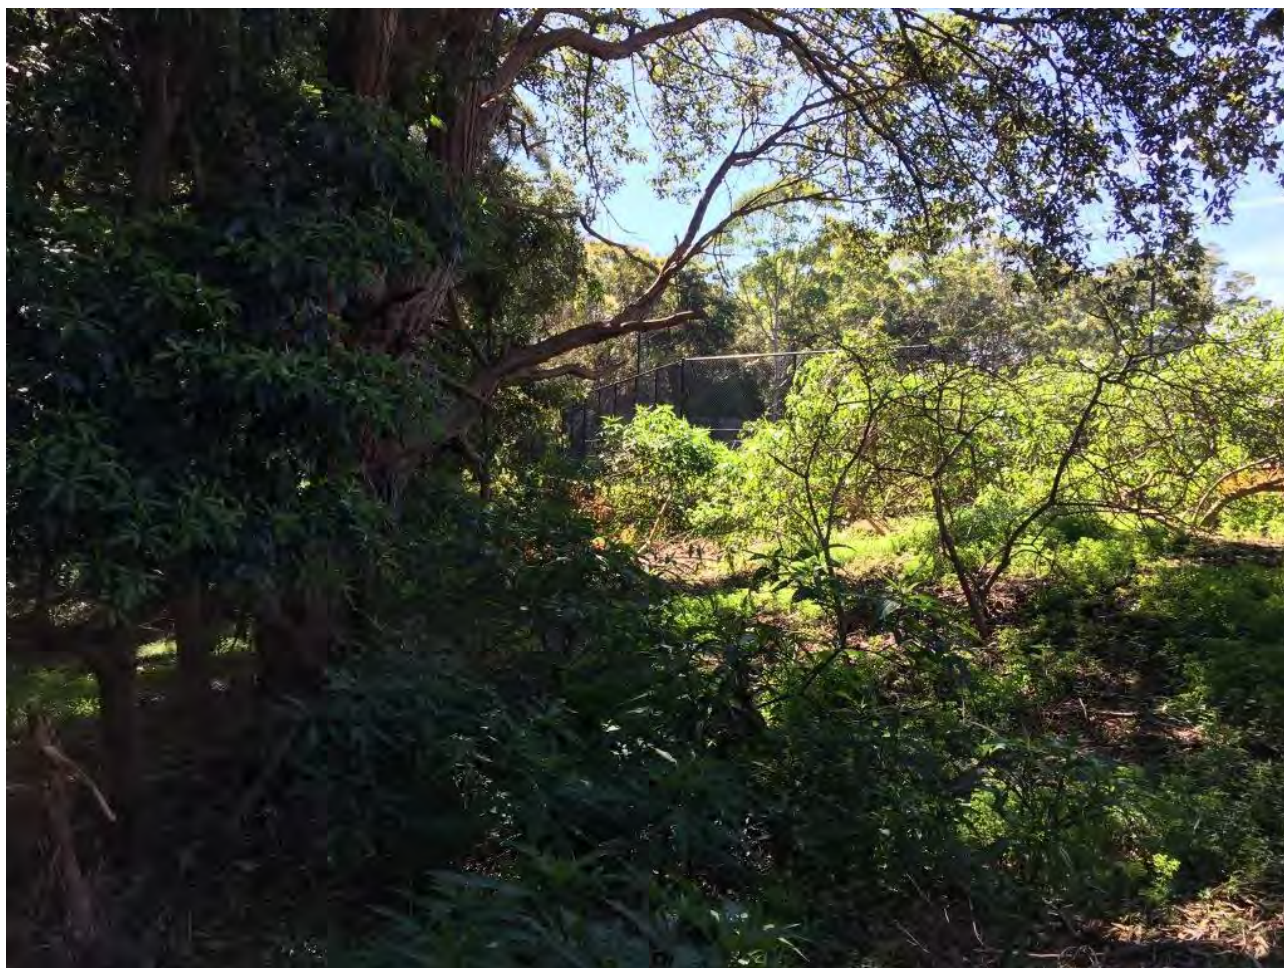
Photograph 46 North

Due to an error only one photograph was taken at Photopoint 12 (facing north).

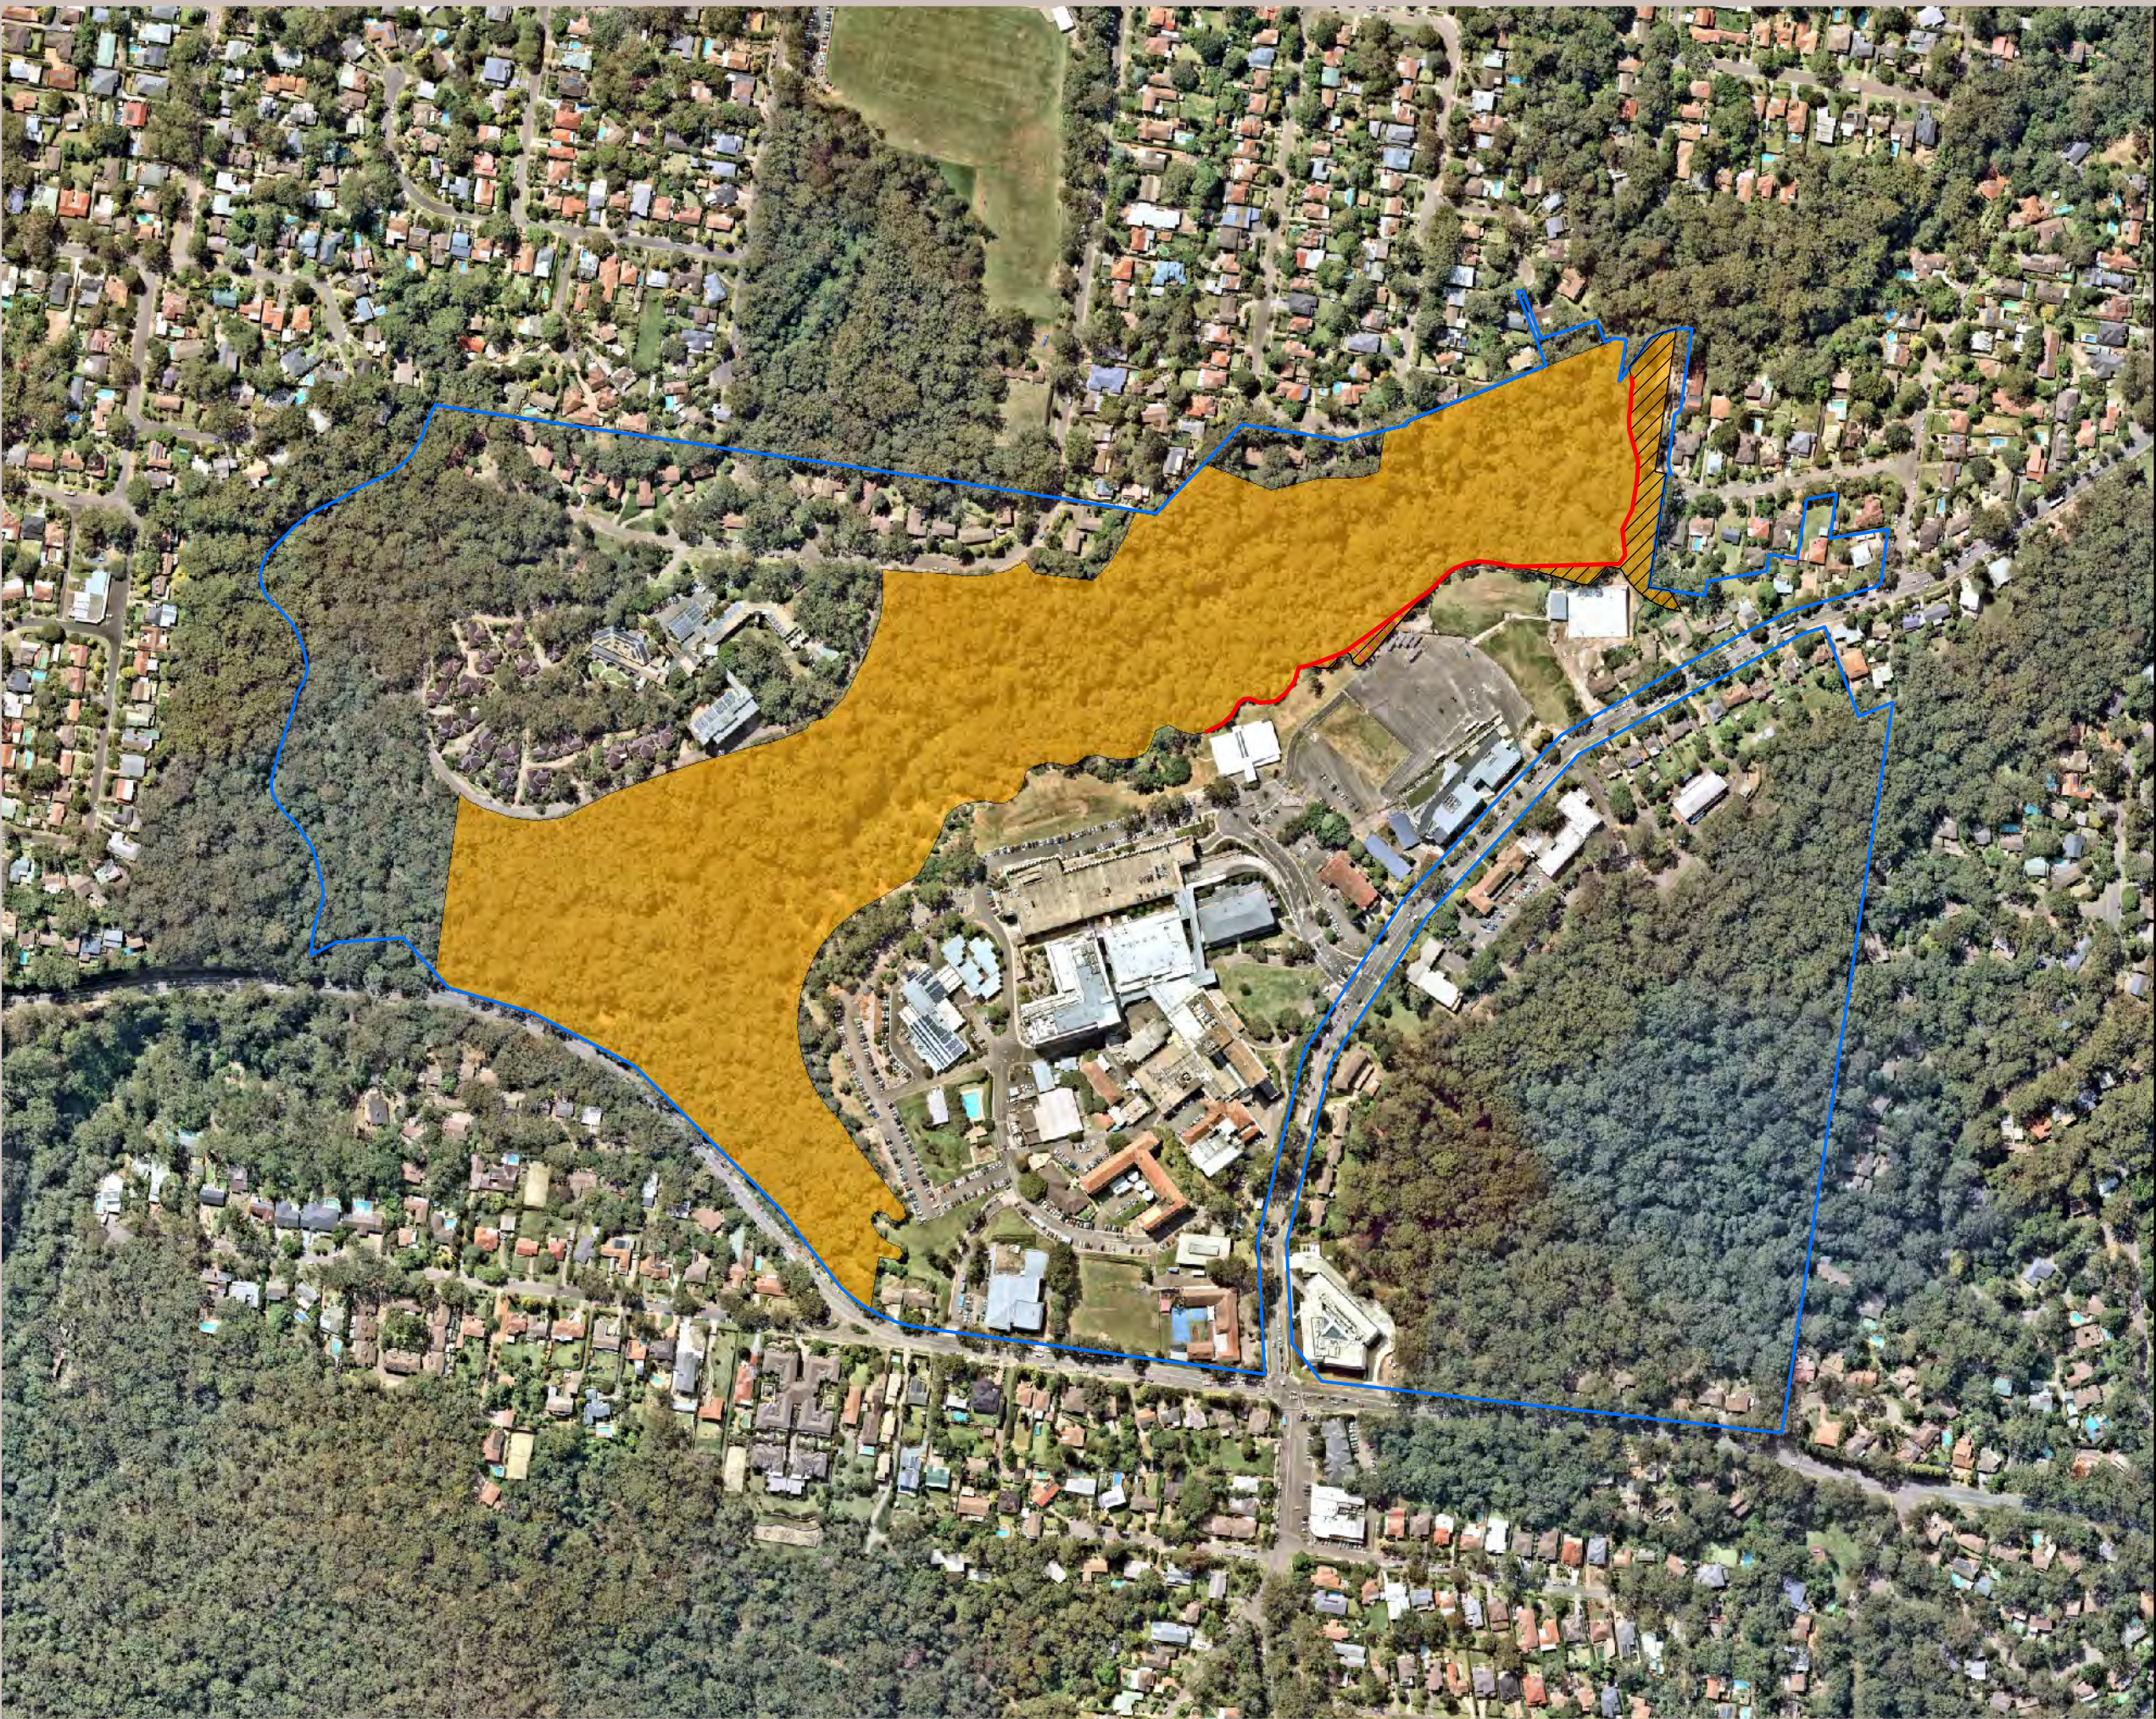
Figure 1. Location of the E2 Conservation Zone and Vegetation Protection Line

A Cumberland Ecology botanist undertook a site inspection on 19 March 2020 of all areas of the Project area within APZs associated with the Central Church Precinct (**Figure 1**) and additional nearby APZ areas within the Conservation Zone to the north. The site inspection consisted of undertaking fourteen rapid assessments of vegetation at photo points, starting with the northern extent of the area assessed and working towards the south. Each point was spaced approximately 20-30 m from the last and the data collected at and surrounding the point consisted of:

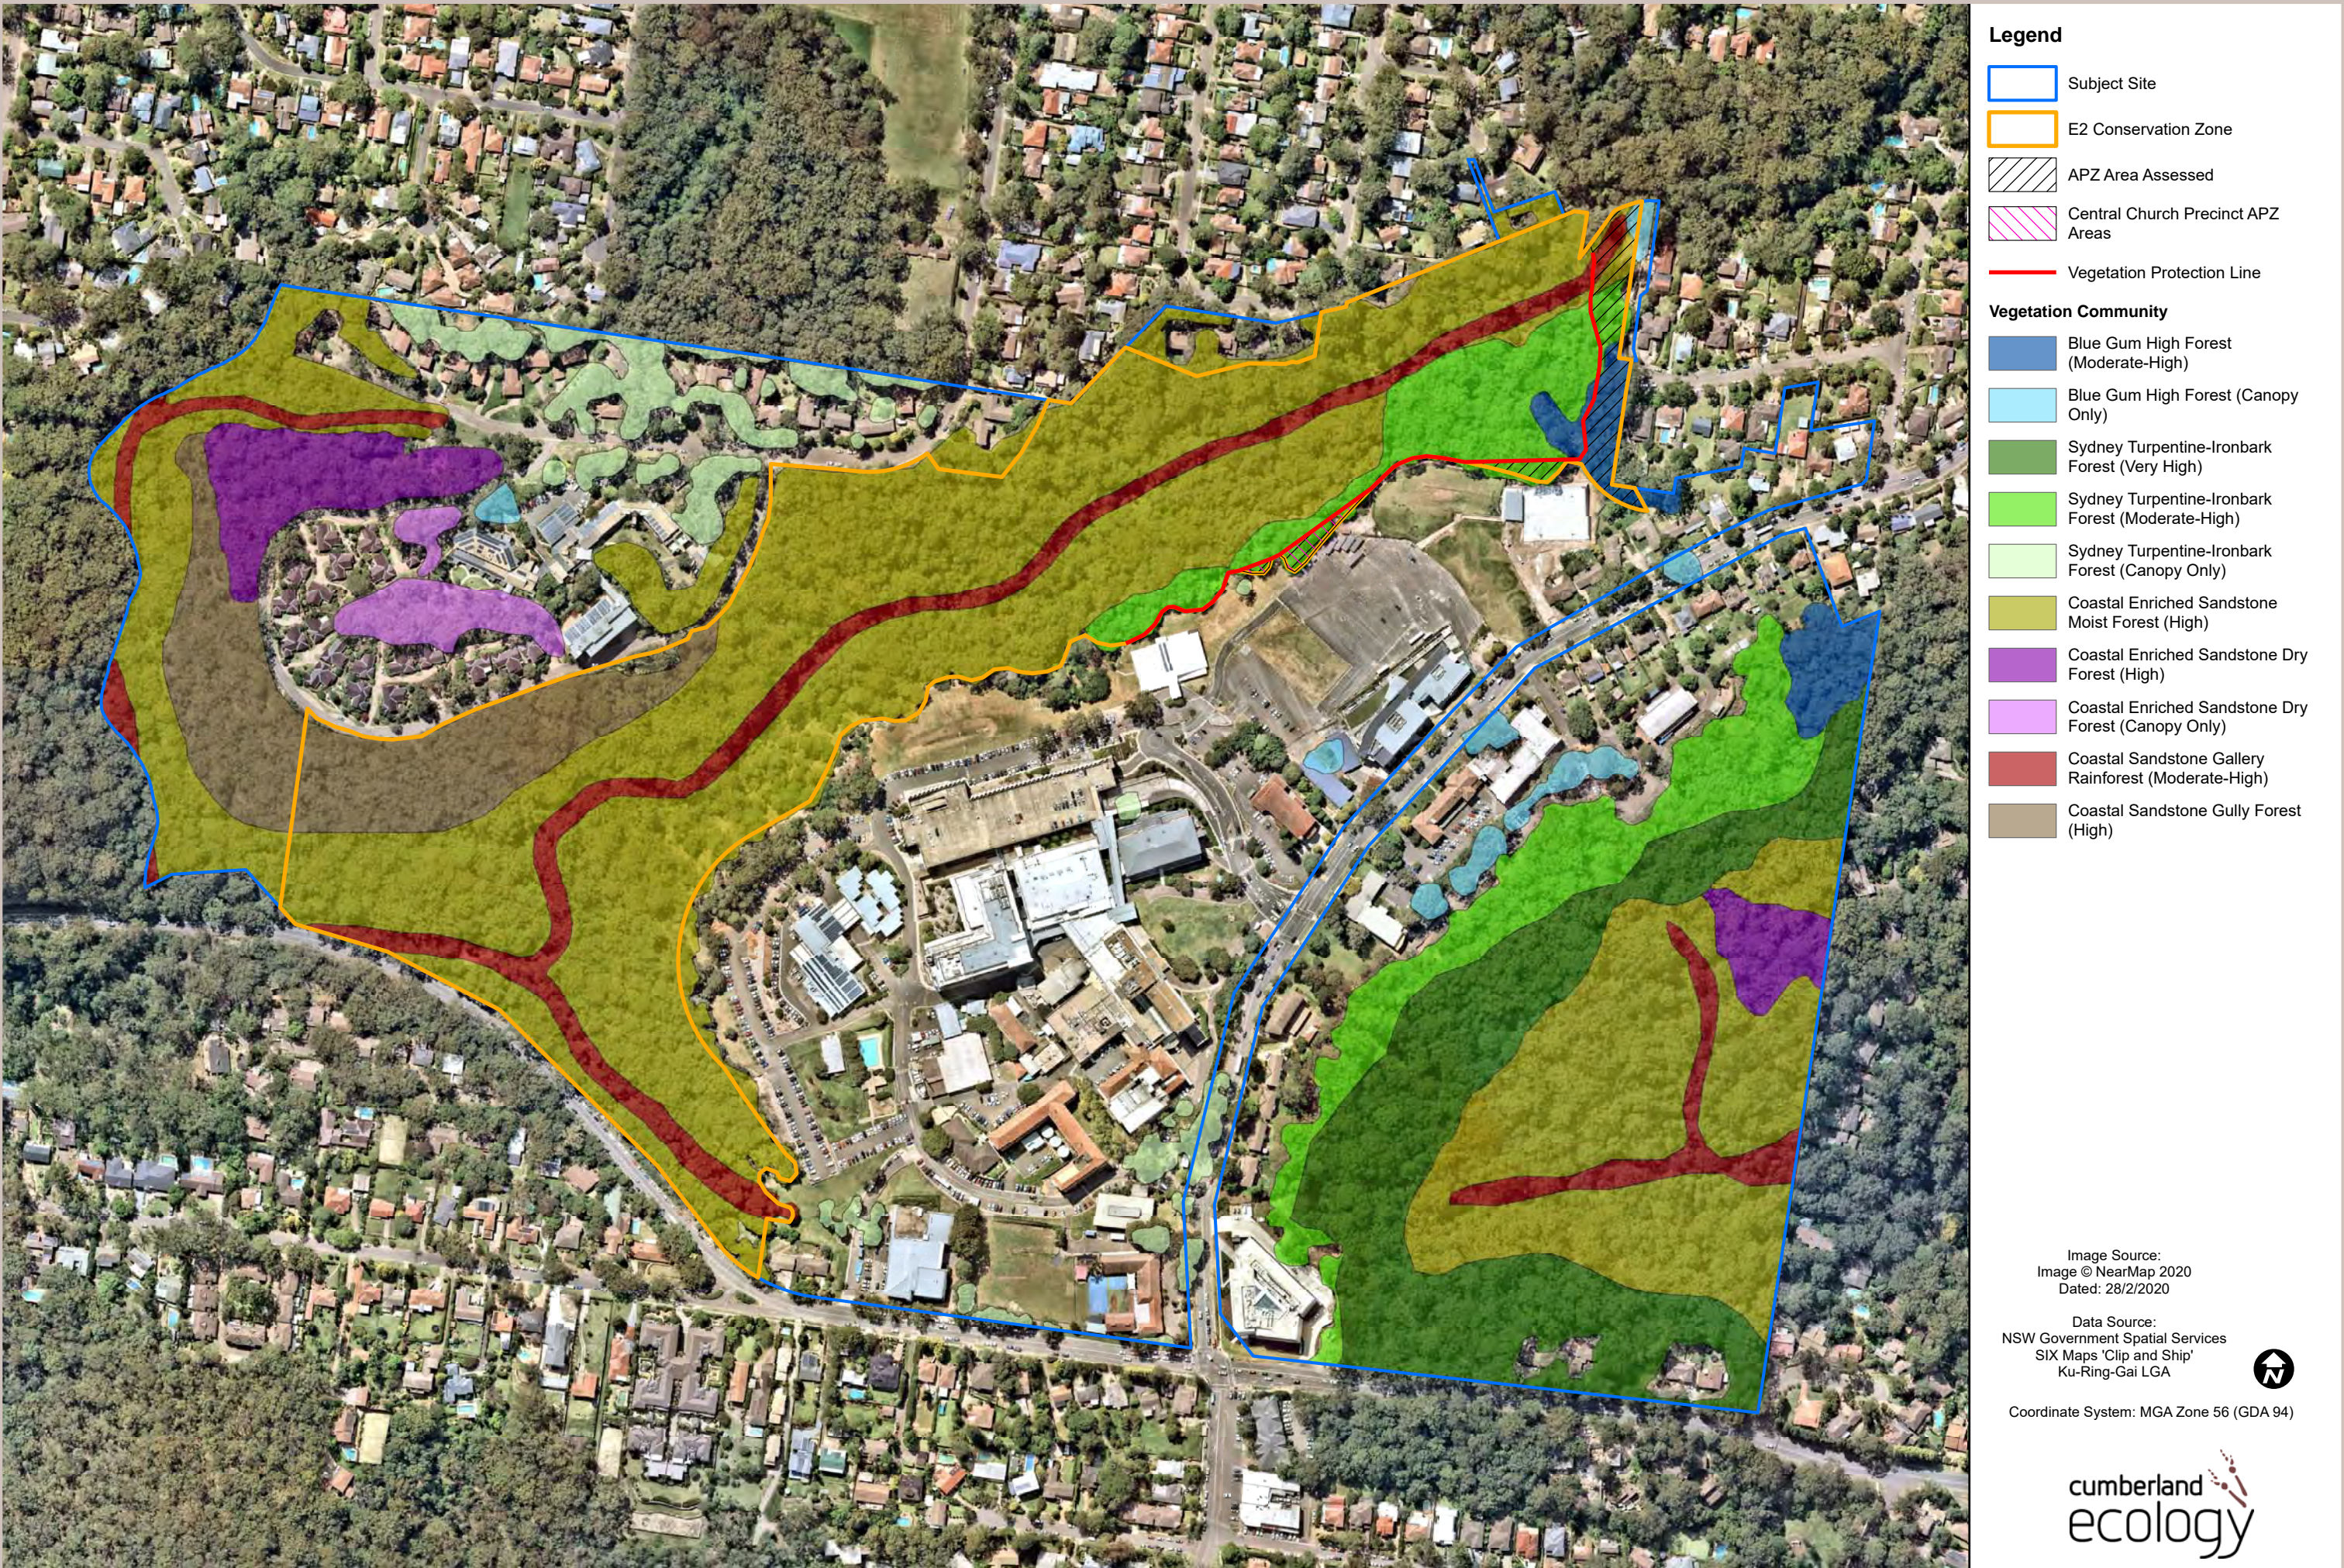
Figure 2. Vegetation communities within the E2 Conservation Zone

The vegetation communities within the APZ areas assessed and the wider Conservation Area and subject site are shown in **Figure 2**. The majority of the vegetation present consists of degraded occurrences of two Threatened Ecological Communities, listed under both the NSW *Biodiversity Conservation Act 2016* (BC Act) and the Commonwealth *Environment Protection and Biodiversity Conservation Act 1999* (EPBC Act). These communities are:

- Blue Gum High Forest in the Sydney Basin Bioregion (BGHF) – Listed as Critically Endangered under the BC Act and EPBC Act; and
- Sydney Turpentine-Ironbark Forest in the Sydney Basin Bioregion (STIF) – Listed as Critically Endangered under the BC Act and EPBC Act.

Only STIF is present directly within APZ Areas associated with the Central Church Precinct.

Small areas of two additional non-threatened ecological communities are present in the north of the area assessed. These communities, as described under the broad-scale mapping scheme Native Vegetation of the Sydney Metropolitan Area (OEH 2016) are:

- Coastal Enriched Sandstone Moist Forest (CESMF); and
- Coastal Sandstone Gallery Rainforest (CSGR).

Areas of these communities within the APZ area assessed are highly degraded, predominately consisting of a native canopy only.

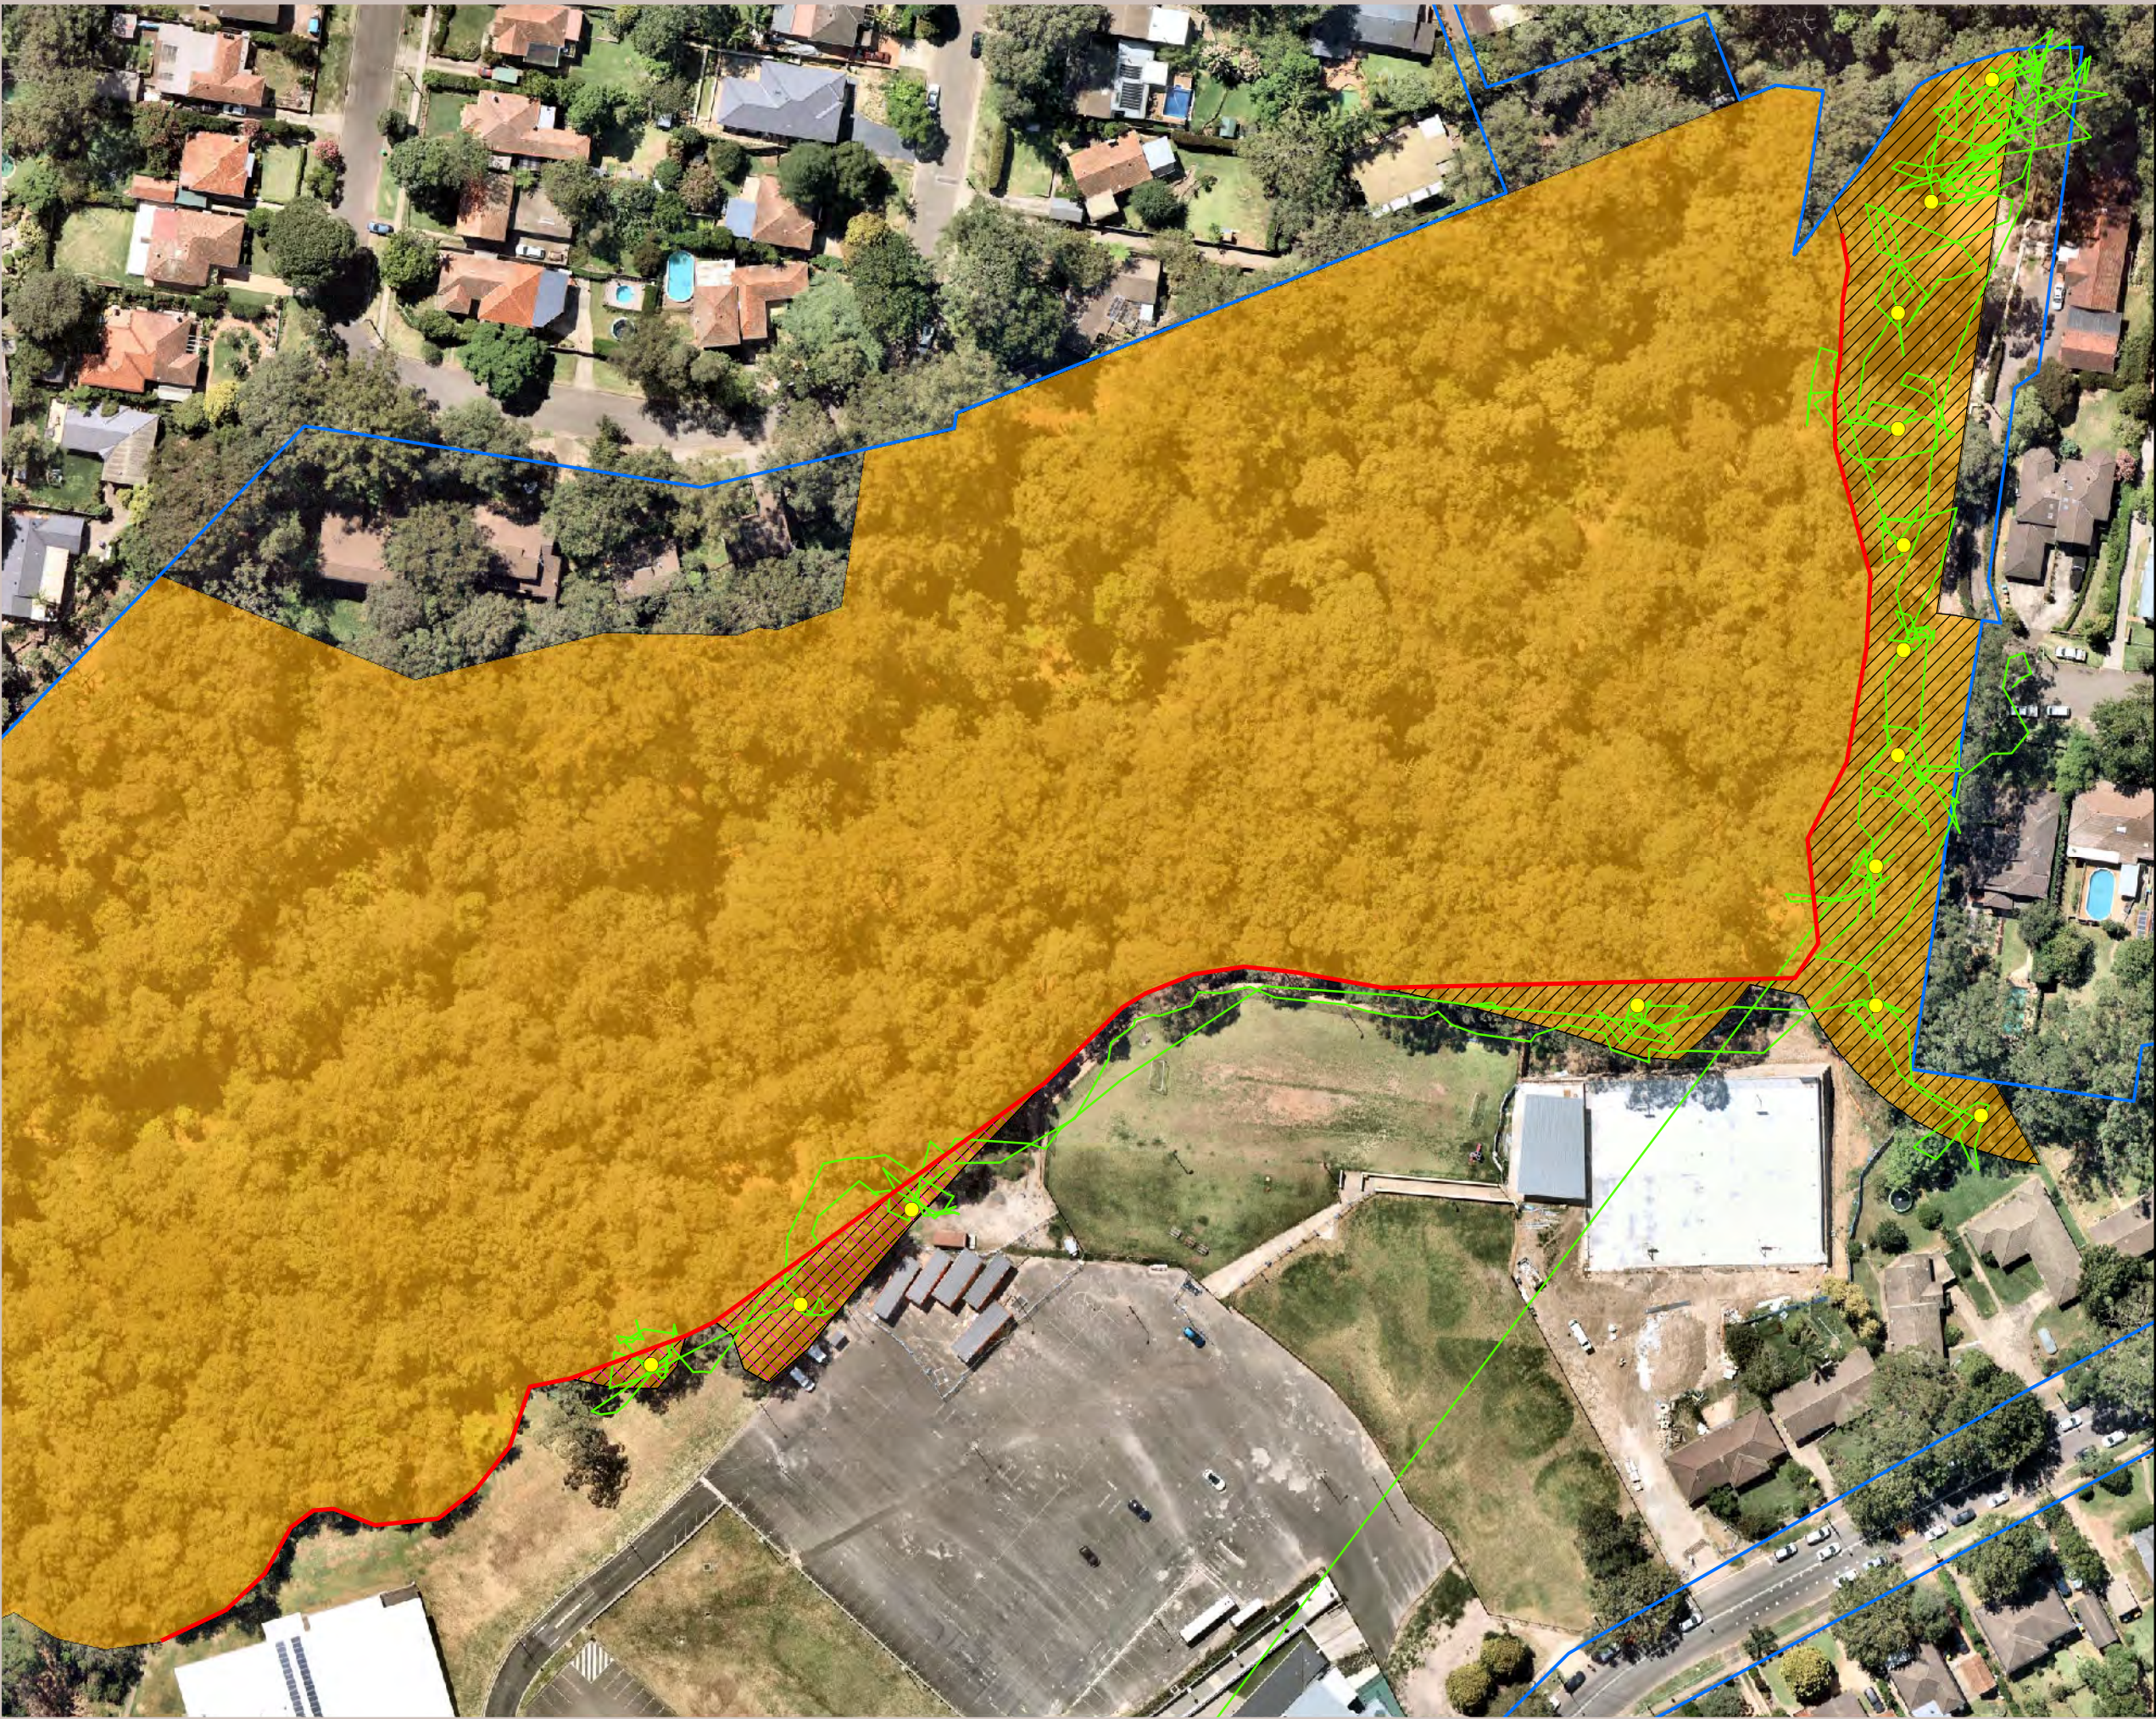
Figure 3. Photopoint locations

- Four photographs (North, East, South, and West);
- Estimate of height range of vegetation in canopy, sub-canopy and shrub strata;
- Canopy and sub-canopy species present;
- Any overlap in canopy and sub-canopy which may require trimming;
- General condition of each stratum (i.e. dominance of exotics);
- Dominant species in each stratum (Canopy, sub-canopy, shrub layer, and ground cover);
- An estimation of whether any removal is required to thin the shrub layer; and
- Fauna habitat.
