**REPORT  
ON  
GEOTECHNICAL INVESTIGATION**

**CONCEPT PLAN APPLICATION  
CALDERWOOD URBAN DEVELOPMENT PROJECT**

*Prepared for:*  
**DELFIN LEND LEASE LTD**

**PROJECT 48742  
MARCH 2010**

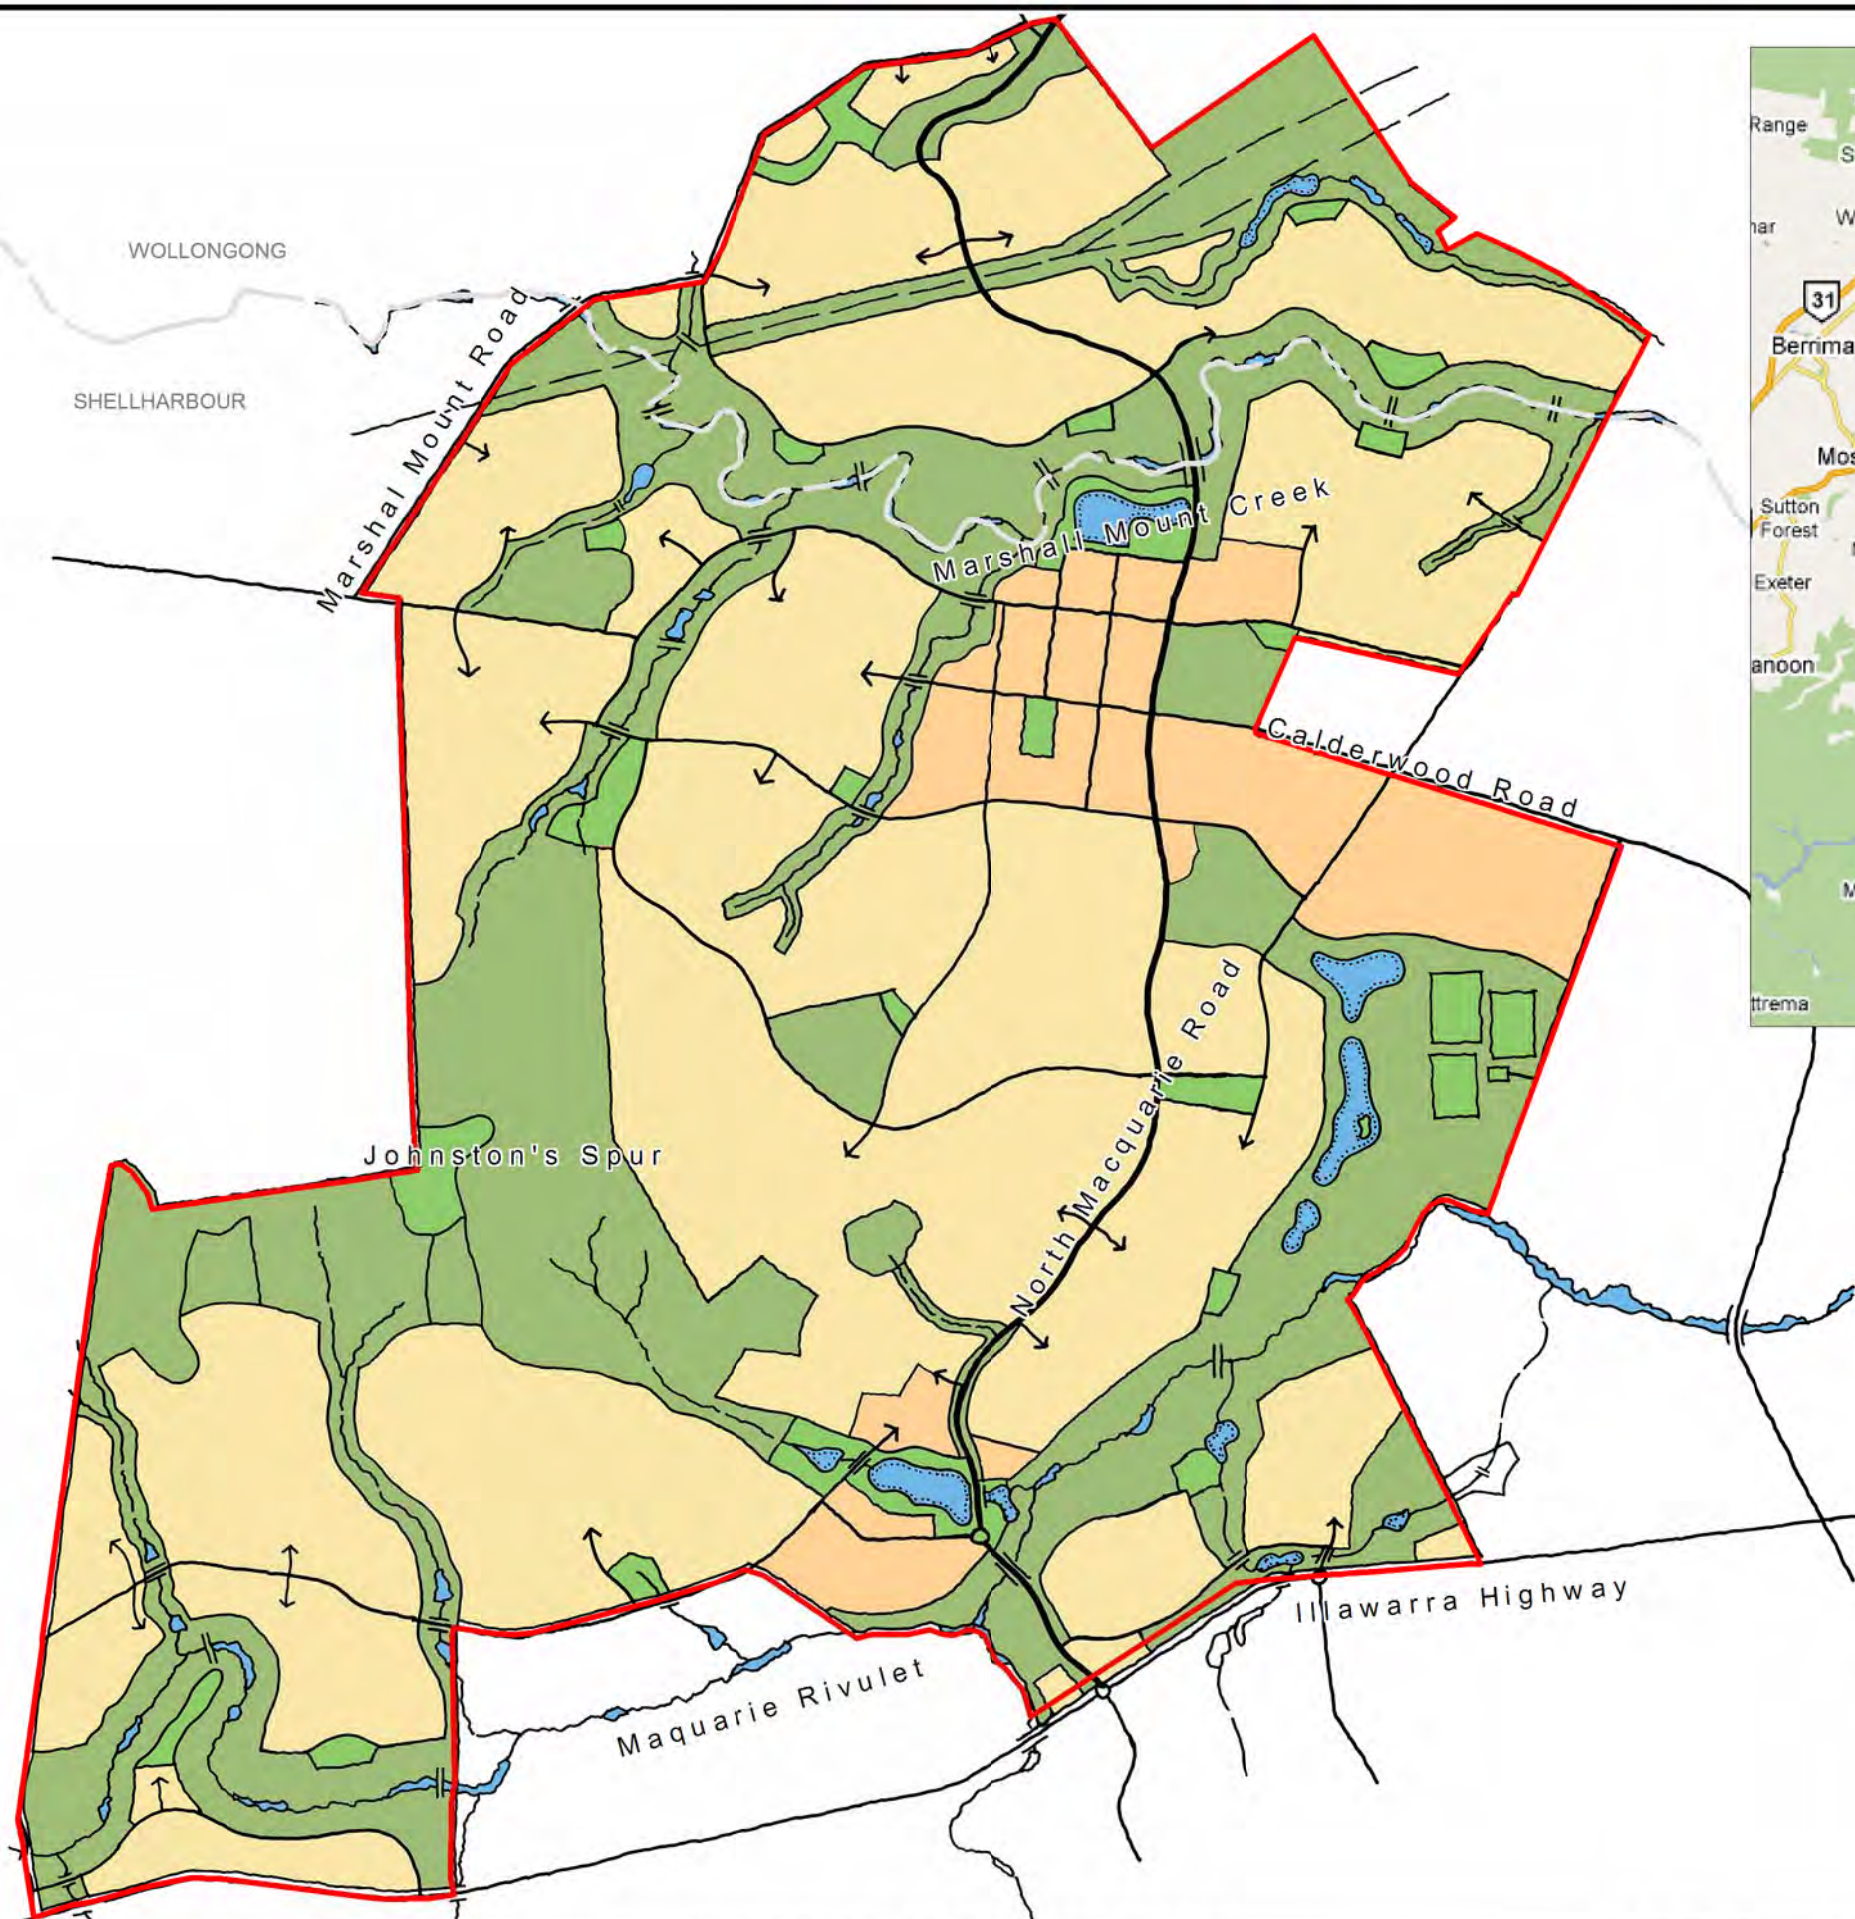
DRAWING: 1

- Groundwater levels during the investigation were found to be in the range of 2.5 – 4.5 m below ground surface level (refer to the blue text on Drawing 1). Due to the proximity of the water table to the ground surface, further investigation is required to ascertain the seasonal high groundwater level in future stages of the development;

Comparison of the development layout (refer Drawing 1) and the distribution of zones of instability indicates that the majority of the proposed development areas are located on stable land. There are sections of the proposed residential areas that extend into zones of *Less stable land* or *Moderately unstable land*. Instability in the zone can be expected if development does not have regard to site conditions, with the most likely areas of instability being in gully heads and in areas of thick soil accumulation affected by seepage, especially if excavations for deeper road cuttings are required in areas of deep clay soils. Consequently, it is recommended that all proposed developments in these zones are subject to detailed investigation by appropriately qualified geotechnical practitioners.

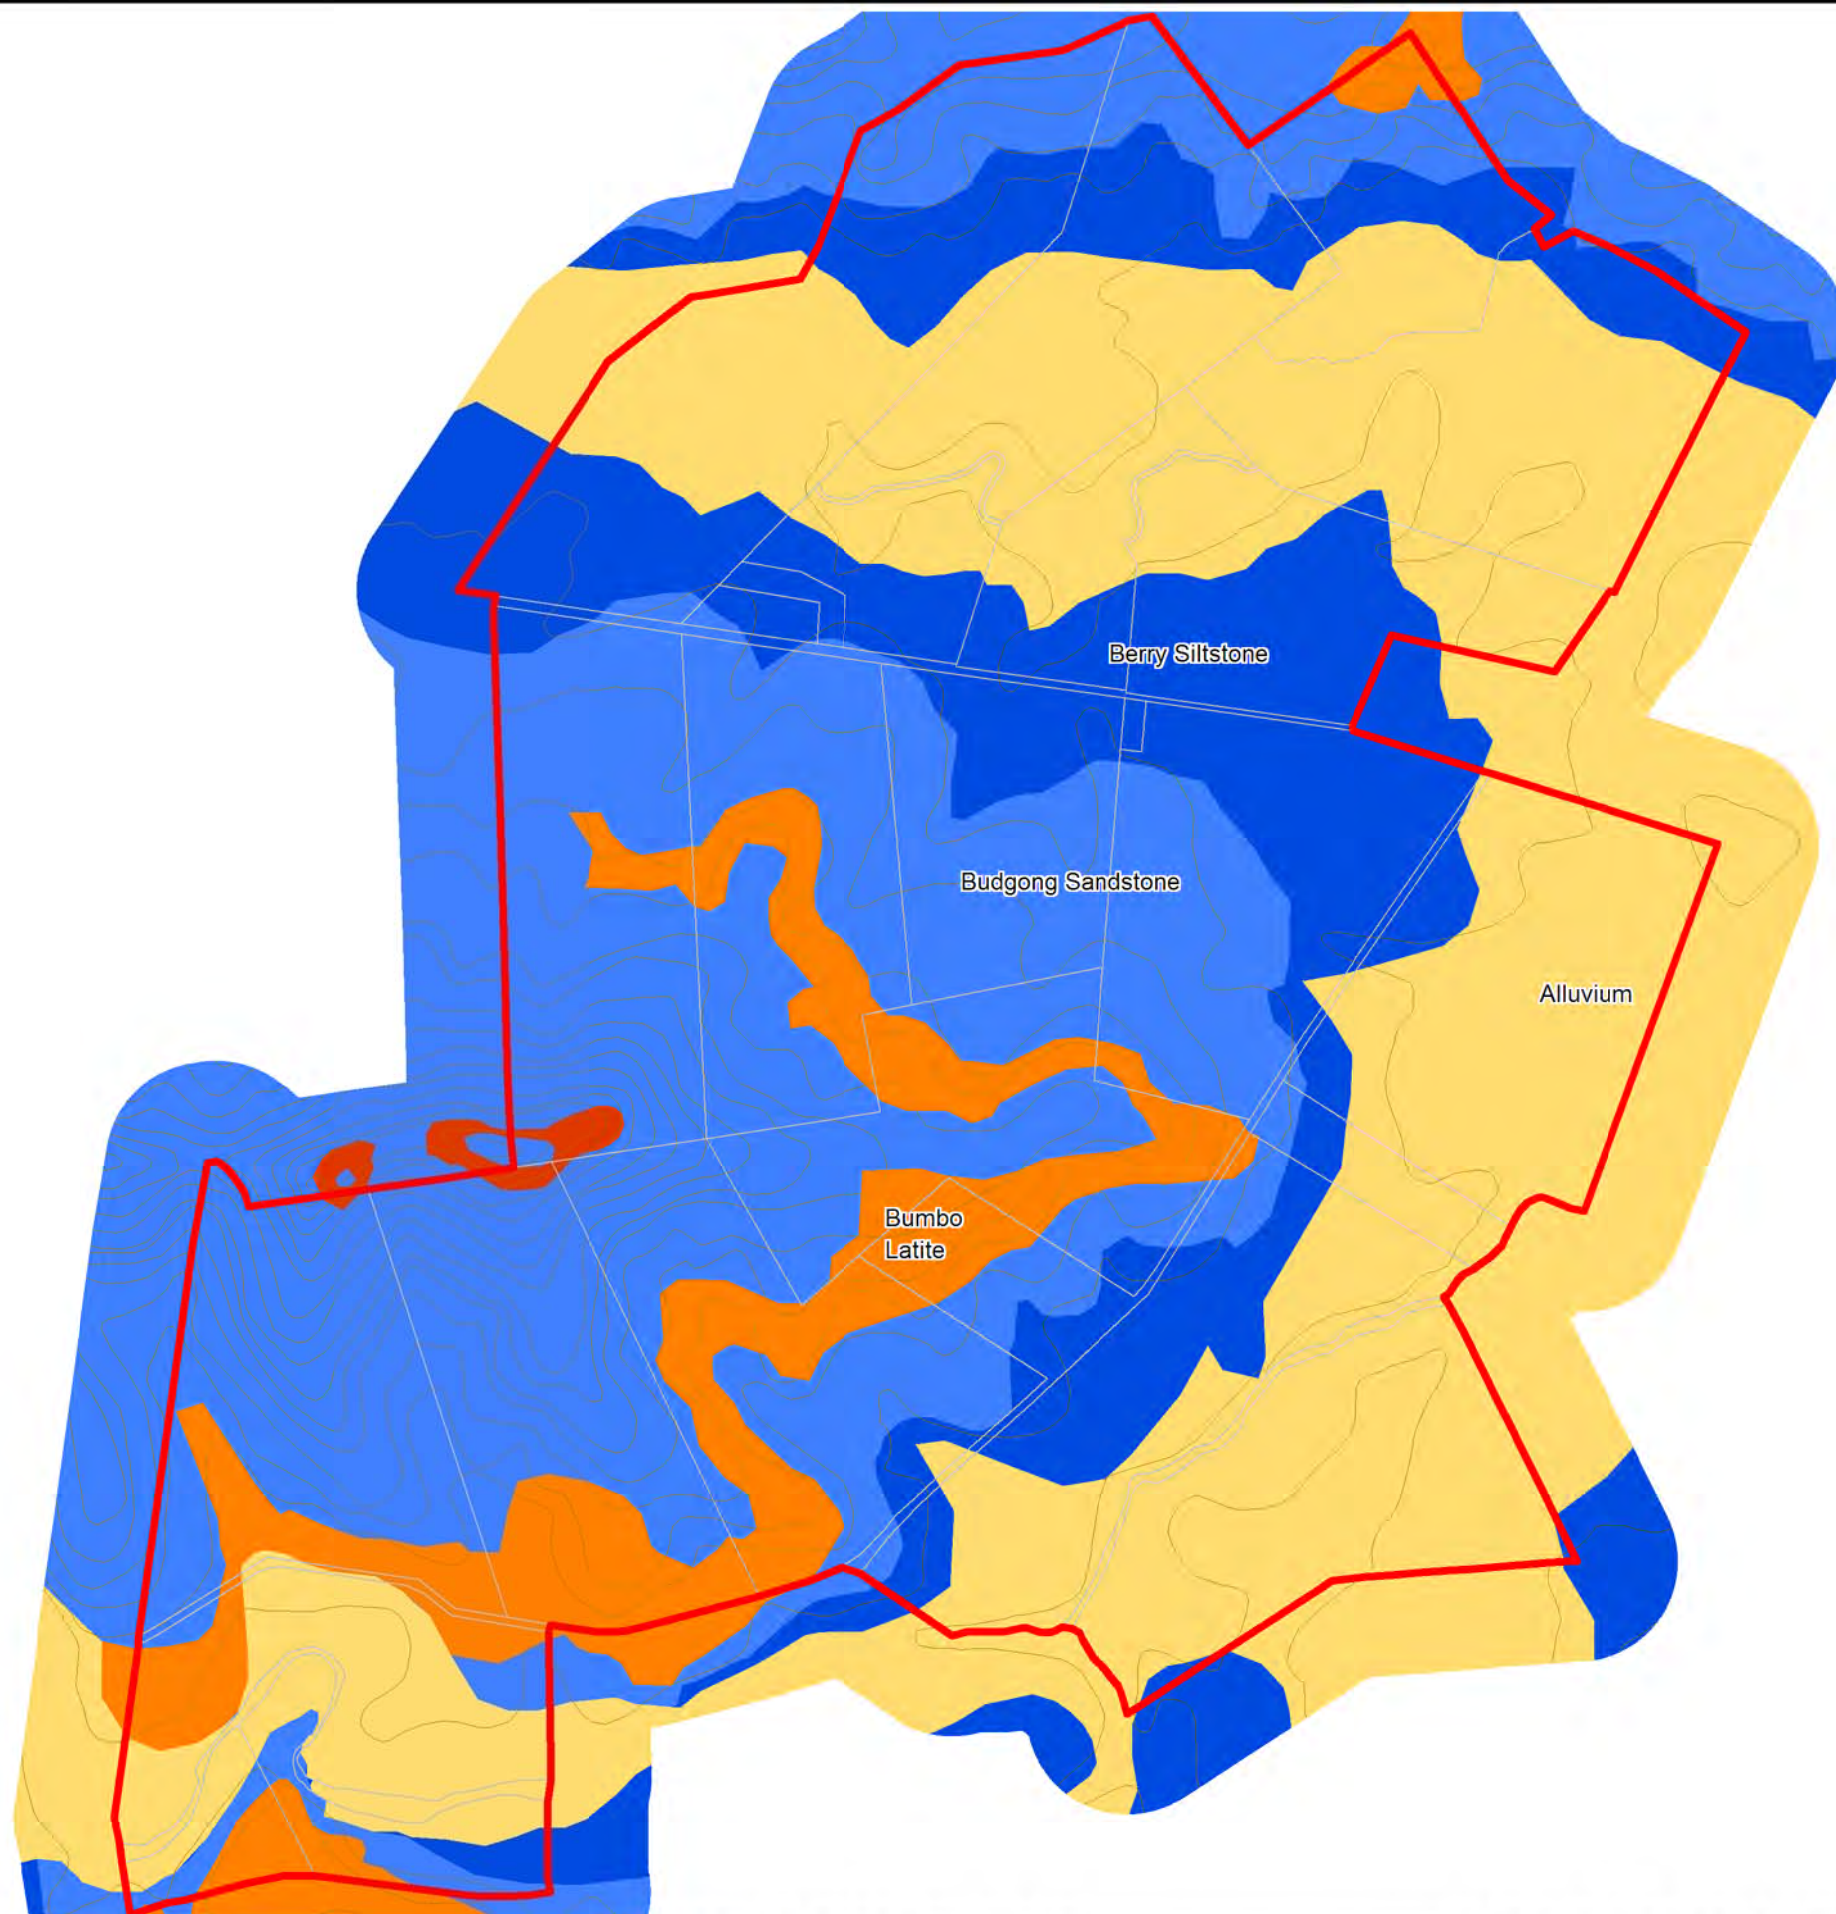
- Site Boundary
- Qa - Alluvium
- Psc - Cambewarra Latite
- Psgb - Bumbo Latite
- Psg - Budgong Sandstone
- Psb - Berry Siltstone
- 10 m Contour

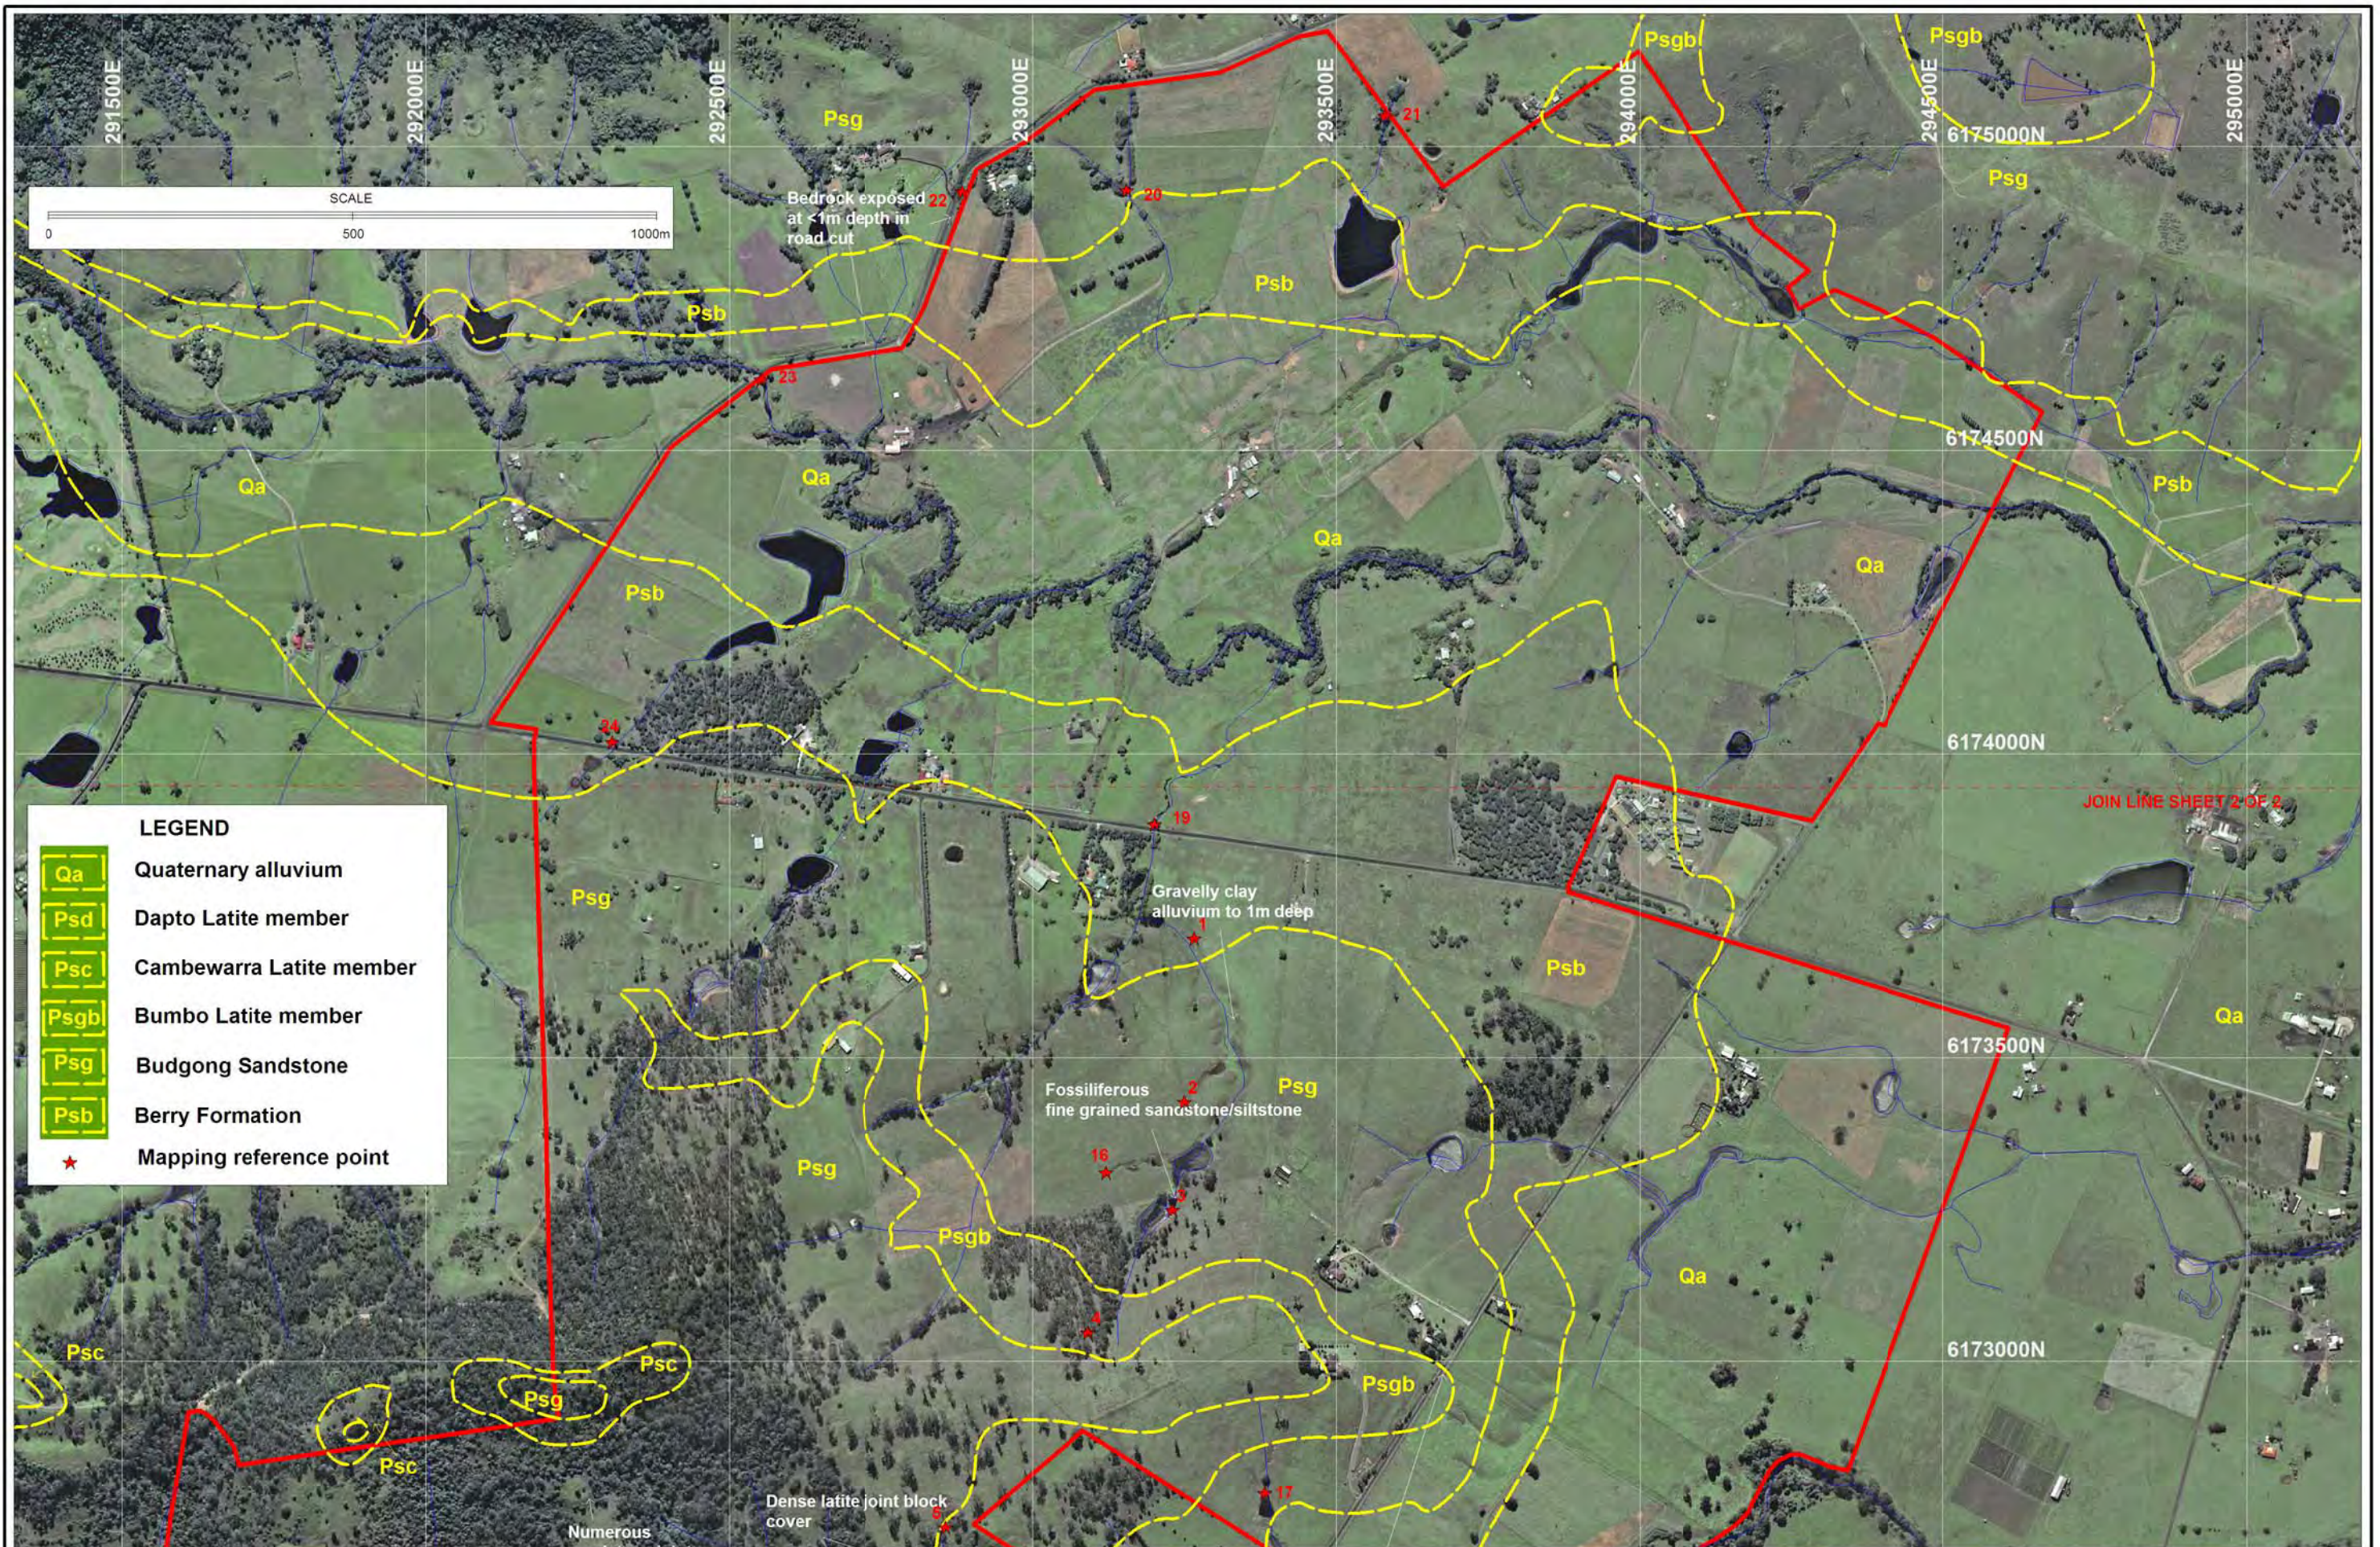
DRAWING No: 7 Sheet 2

The main items noted during geological mapping on 11 and 12 November 2009 are summarised below and are additionally shown on Drawing 7 (Sheets 1 and 2) and Drawing 8 (Sheets 1 and 2). Drawing 7 shows the location of the Mapping reference Points, referred to below, as well as the approximate boundaries of geological units as determined from a combination of published mapping (References 1, 2 and 5) and the results of the test pitting and drilling of the current investigation.

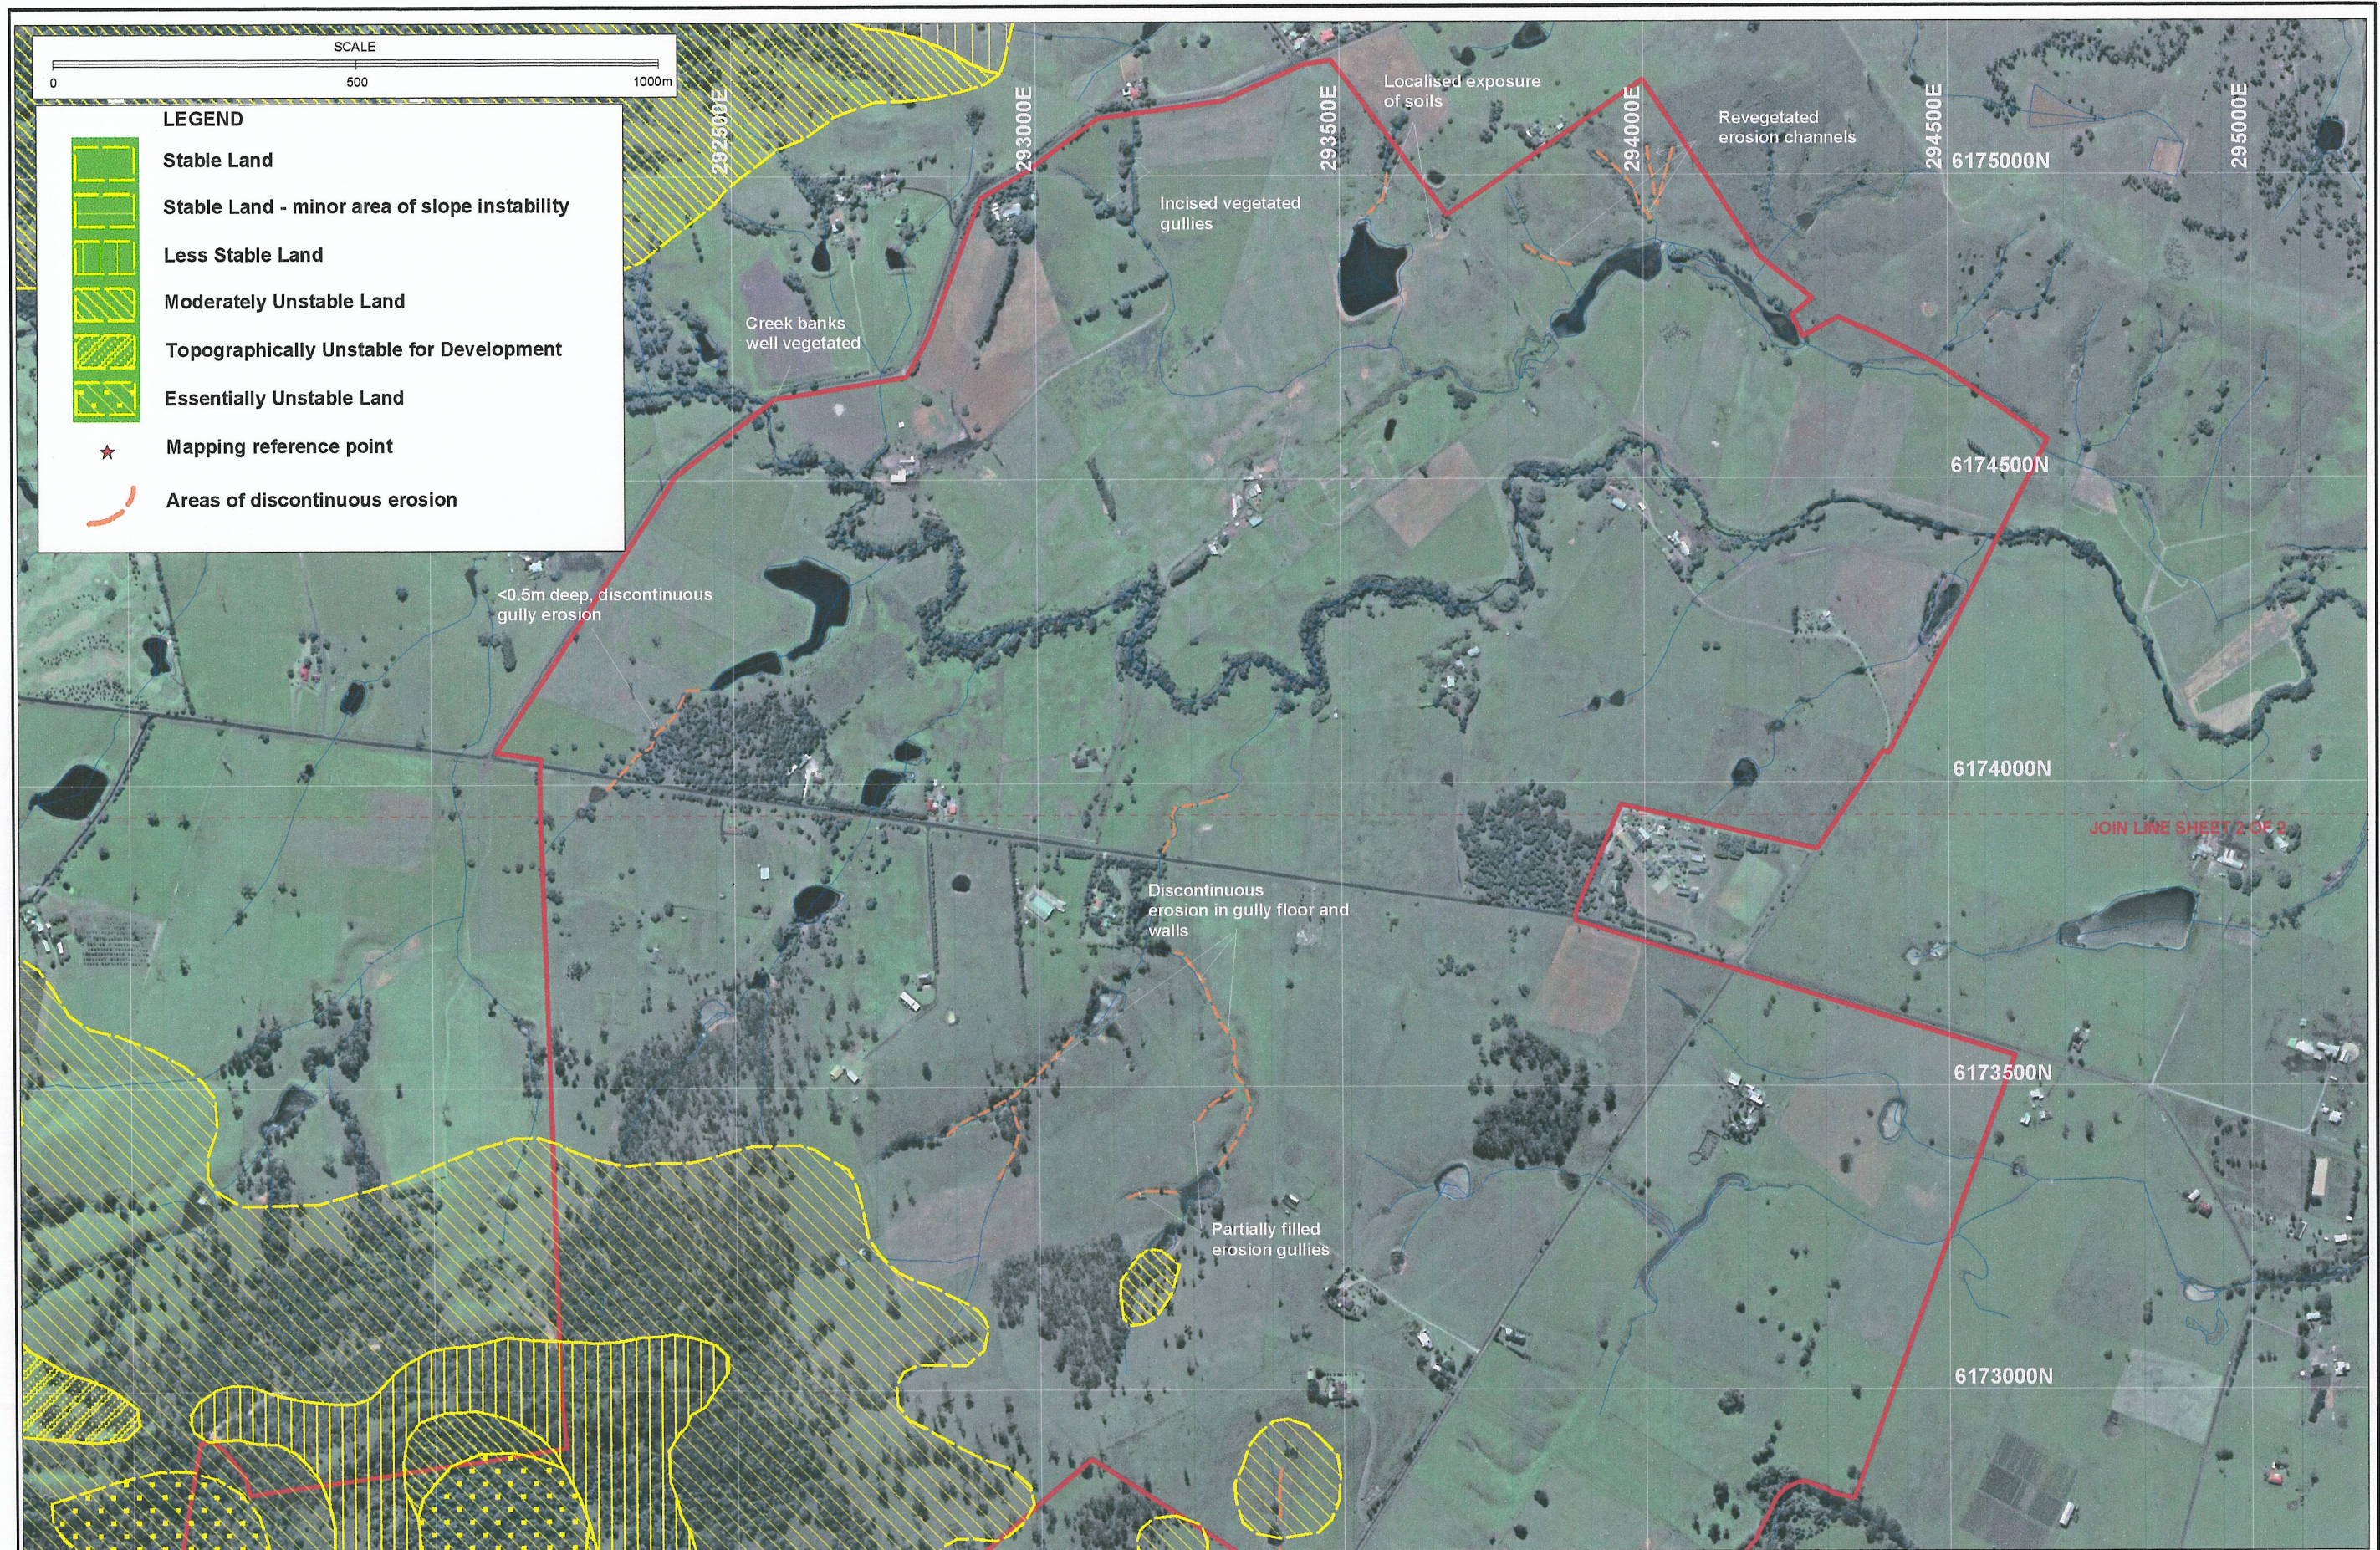
DRAWING No: 8 Sheet 1

TITLE: **SLOPE INSTABILITY HAZARD ZONING**  
CONCEPT PLAN APPLICATION: GEOTECHNICAL STUDY  
CALDERWOOD URBAN DEVELOPMENT PROJECT
