Huntlee New Town Stage 1A (MP 07_0116) and 1B (MP 08-0229) Project Applications

We refer to comments received from the *Department of Water and Energy (DWE)* concerning the above major project, in a letter dated the 23rd December, 2008. This letter responds to the comments provided in DWE's letter. As requested by DWE, further information is presented to detail the proposed treatment of riparian corridors in the Stage 1 Project Application Area.

1. ASSESSMENT OF EXISTING WATERCOURSES

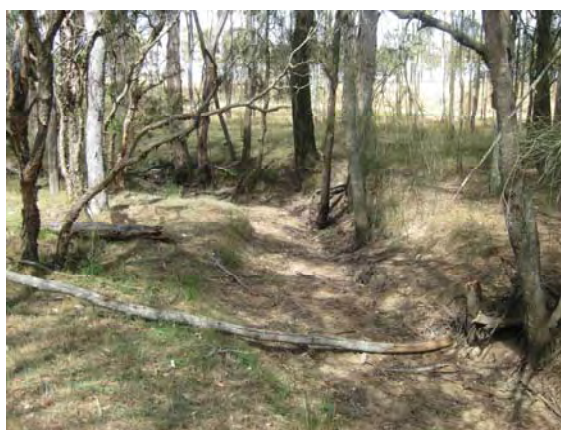
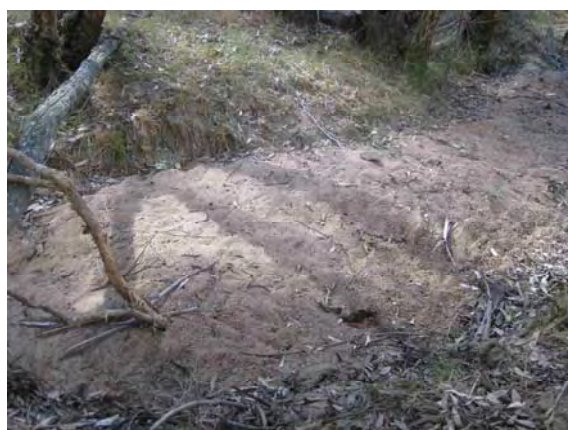
The lower section of Tributary 1 below the existing farm dam generally consists of a small channel, approximately 2-3m wide and 0.5 to 1m deep. The channel is generally in good condition with evidence of minor erosion in some areas. Generally, existing riparian vegetation is established approximately 30m either side to the channel, forming a total 60m corridor of riparian vegetation (*refer to **Figure 1***). Generally, the riparian vegetation is limited to established trees with some lower-story vegetation. **Photo 1** shows a typical section of the watercourse.

Photos 1 and 2 – The lower section of Tributary 1. **Photo 1** on the left, shows a typical section of the watercourse below the farm dam. **Photo 2** on the right, shows accumulated sediment, which is likely the result of erosion from the upstream farm dam

There is evidence of significant accumulation of medium to coarse sediment in some sections of the channel downstream of the farm dam (*Refer to **Photo 2***). It is likely that this sediment accumulation is the result of significant channel erosion occurring immediately downstream of the farm dam. The erosion has caused a head cut which extends up to the dam wall (*refer to **Photo 3***) and around both sides of the dam (*refer to **Photo 4***), where it appears the dam spills. The head cut has resulted in significant bed lowering and widening in the section of channel approximately 30 metres downstream of the dam (*refer to **Photo 3***).

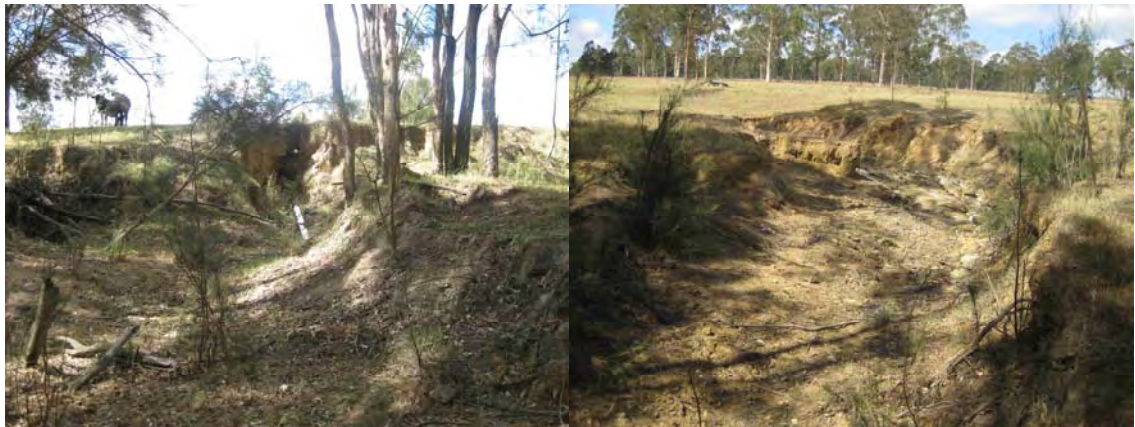
Photos 3 and 4 – Taken immediately downstream of the existing farm dam. **Photo 3** on the left, shows significant bed lowering and widening of the channel downstream of the farm dam. **Photo 4** on the right, shows a significant head cut to the right of the dam.

- Reconstruct sections of the watercourse which are significantly eroded. This will primarily be associated with the removal of farm dams and some crossings.

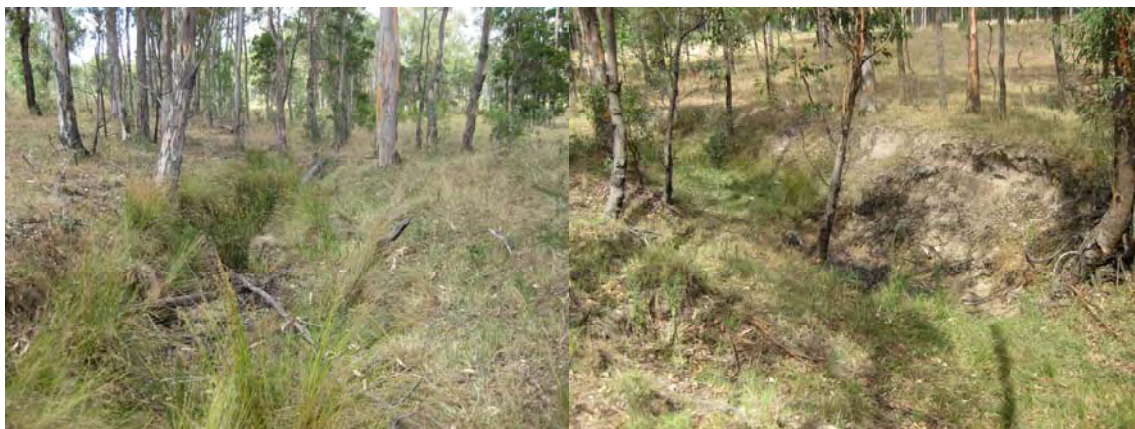
Upstream of the farm dam, the watercourse is similar to the section downstream of the dam. However, the riparian vegetation is limited to approximately 10-15m either side of the channel, resulting in a total vegetated corridor of 20 to 30m width (*refer to **Photo 5***). Similar to the downstream section, there is minor channel erosion in some areas (*refer to **Photo 6***).

Photos 5 and 6 – Taken upstream of the existing farm dam. **Photo 5** on the left shows a typical channel profile. **Photo 6** on the right shows some minor bank erosion.

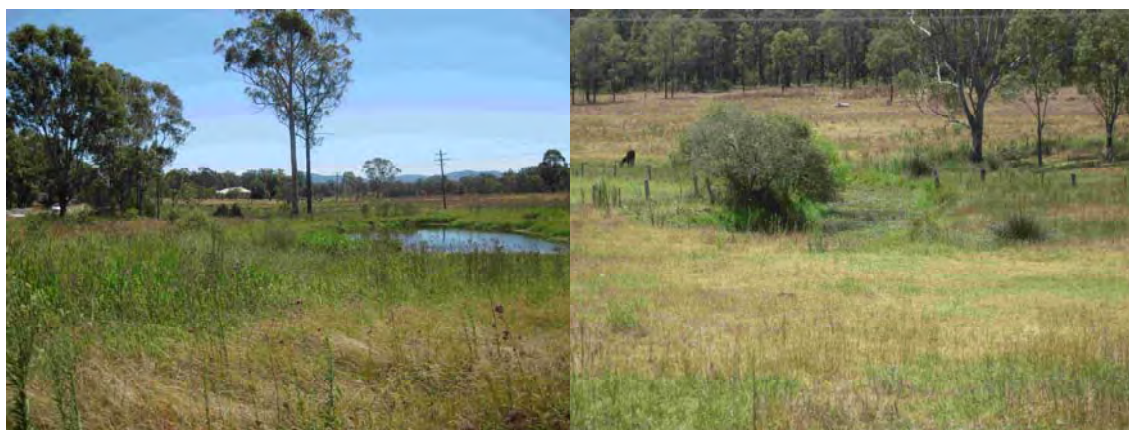
The lower section of the watercourse (*in the vicinity of the proposed Basin 5*) is highly disturbed by urban and agricultural activities. Generally stock has direct access to the channel (*refer to **Photo 8***). There are a number of small on-line farm dams and crossings in this section of the watercourse (*refer to **Photo 7***). Generally, there is no significant channel erosion. However, riparian vegetation appears to be predominately pastoral grasses and non-indigenous species.

Photos 7 and 8 – Taken in the lower section of Tributary 2 (*at the proposed Basin 5 location*). **Photo 7** on the left shows, one of the many small online dams in the lower section of the watercourse. Both photos show that there is a lack of any native riparian vegetation.

- Remove all existing farm dams in the Stage One Project Application Area.
- Remove all existing fence and road crossings from the CRZ. All proposed road crossings will be reconstructed in accordance with DWE Guideline "*Guidelines for Controlled Activities: Watercourse Crossings*".

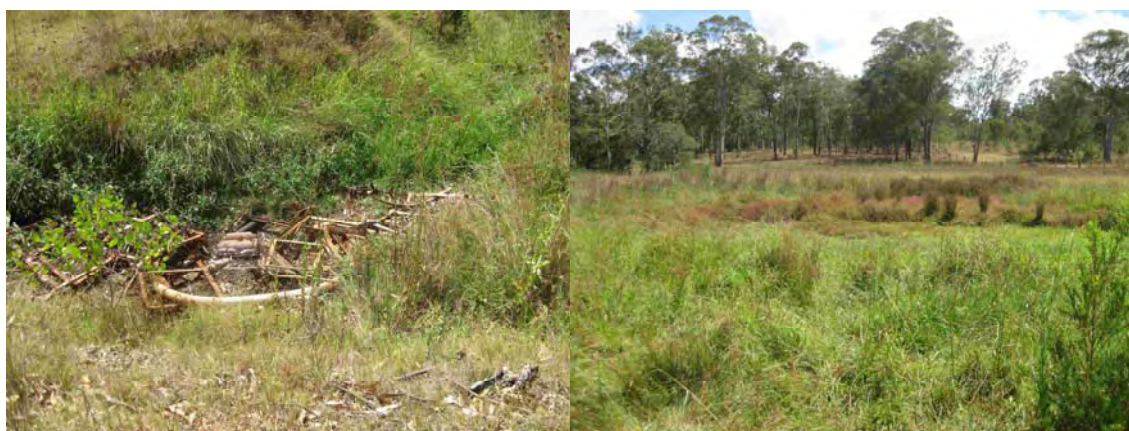
Additionally, it appears there has been illegal dumping of fill and rubbish in some areas of the lower section of the watercourse (*refer to **Photos 9 and 10***).

Photos 9 and 10 – Taken in the lower section of Tributary 2, between Basins 4 and 5. **Photo 9** on the left shows a highly disturbed section of the watercourse, where weed invasion and rubbish dumping is apparent. **Photo 10** shows areas of the watercourse where fill has been illegally dumped.

- Remove all non-indigenous vegetation from the riparian corridor.
- Retain all existing native riparian vegetation within the CRZ and where required, enhance riparian vegetation to consist of a fully structured vegetation corridor, including ground cover, shrubs and trees.

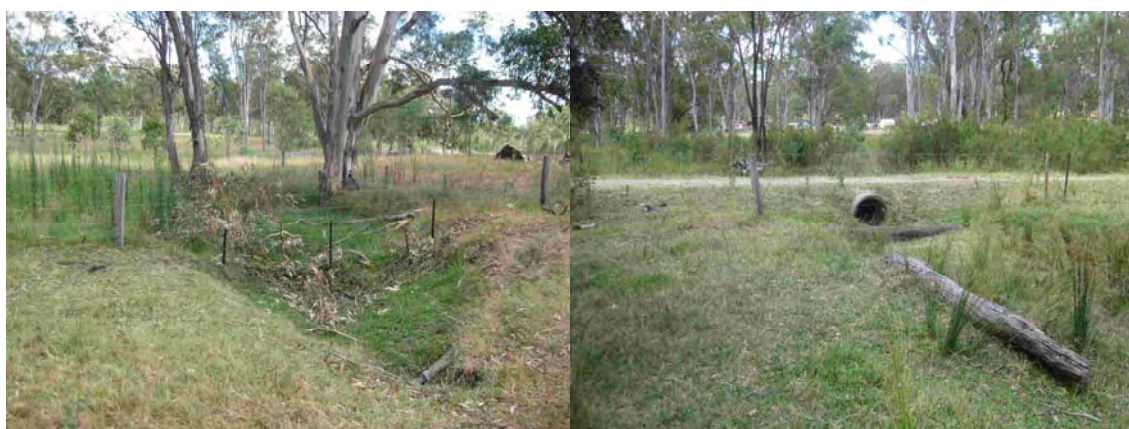
The middle section of Tributary 2 is generally in better condition than the lower section. There are no significant signs of channel erosion, and the riparian zone is generally lightly vegetated with a mix of native and non-native species. There are numerous fence and road crossings (*refer to Photos 11 and 12*) located along the watercourse. There is evidence of minor localised scour in the vicinity of these crossings. Stock has direct access to most sections of the watercourse. This section of the watercourse would be described as being moderately disturbed.

Photos 11 and 12 – Taken in the middle section of Tributary 2, near Basin 4. **Photo 11** shows one of the many fence crossings. Fence crossings can capture debris which can cause localised scour of the channel. This is apparent in **Photo 11**. **Photo 12** shows one of the many culverted road crossings.

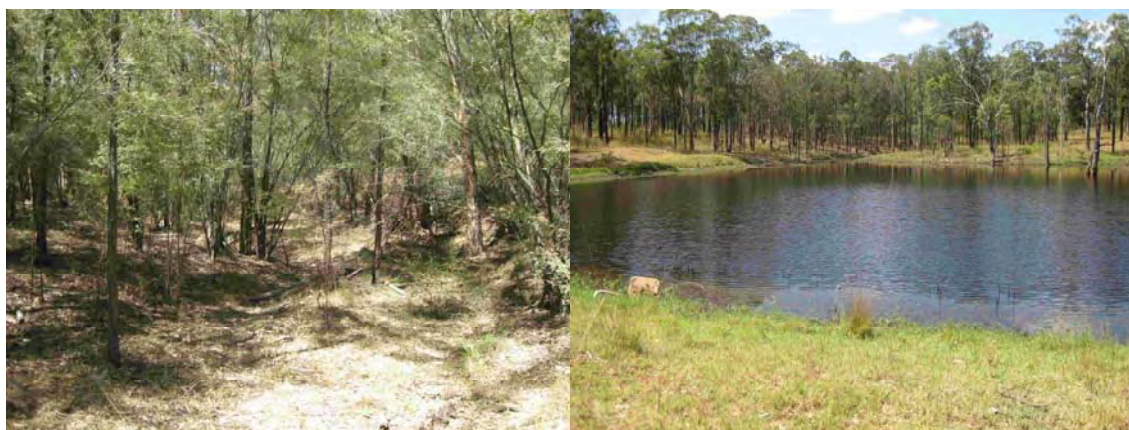
There is a large online dam dividing the middle and upper sections of Tributary 2 (*Refer to **Photo 14***). Unlike the dam in Tributary 1, there is no evidence of scour downstream of the dam. The primary watercourse feeding the dam is a first order stream, which would be described as undisturbed (*Refer to **Photo 13***).

Photos 13 and 14 – Taken in the upper section of Tributary 2, above Basin 3. **Photo 13** shows a section of the watercourse upstream of the dam (*Photo 14*). The upper section of the watercourse is relatively undisturbed. **Photo 14** is looking upstream from the large online dam.

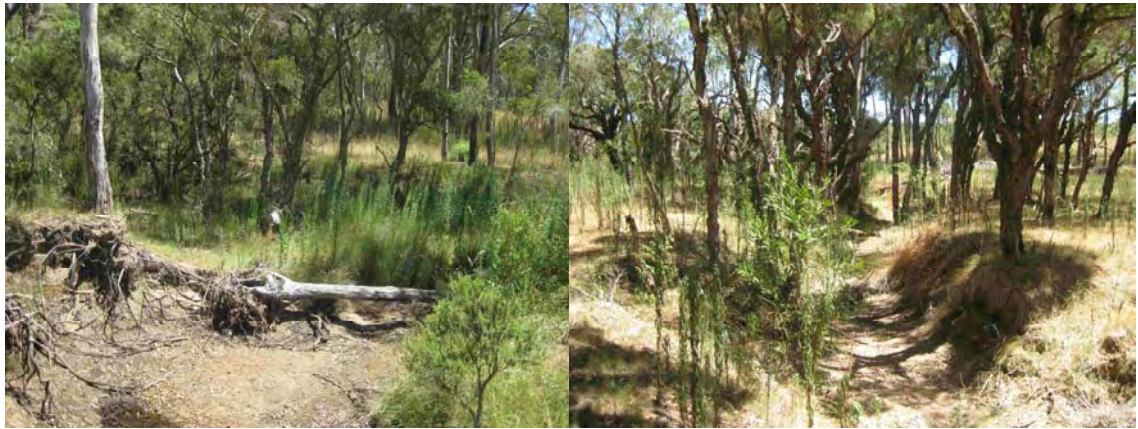
The most significant watercourse is Dominicks Creek, which traverses the northern portion of Large Lot Area 1. Dominicks Creek is generally in good condition. In most places, there is a well defined channel (*refer to **Photo 15***). There is some moderate channel bank erosion in the section approximately 100m downstream of the Wine Country Drive Culverts (*refer to **Photo 16***). This erosion is generally localised with no evidence of bed lowering. The downstream section of the watercourse is in good condition (*refer to **Photo 15***). Riparian vegetation generally extends between 5 to 30m from the channel. There are some non-indigenous weeds growing amongst the native riparian vegetation (*refer to **Photos 15 and 16***). Dominicks Creek would be described as being slightly disturbed.

Photos 15 and 16 – are taken of Dominicks Creek. **Photo 15** on the left shows some moderate erosion of the channel bank, in a section approximately 100m downstream of the Wine Country Drive Culvert. The middle and lower sections of the creek are in good condition. However, there are some weed species present in the riparian vegetation (*refer to **Photo 16** on the right*).

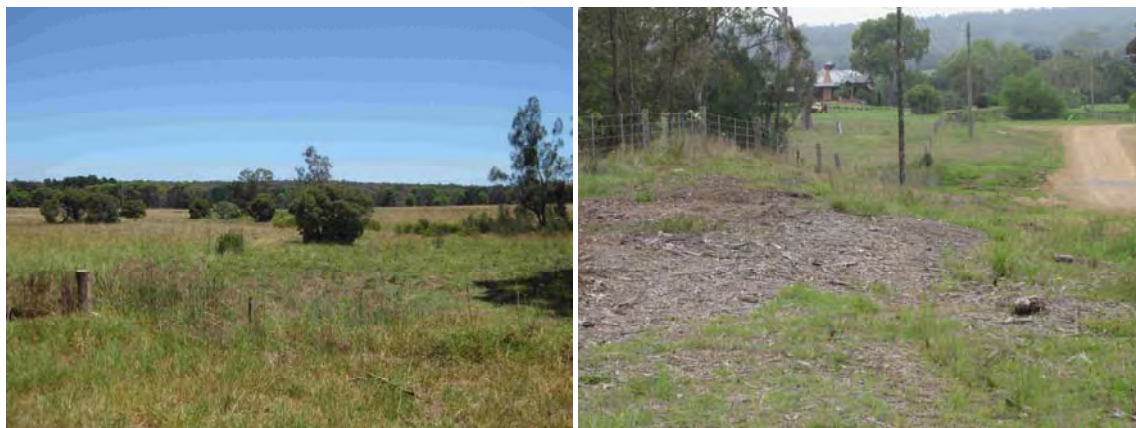
The second watercourse in Lot Area 1 traverses through the middle of the site. Technically this watercourse is a second order stream. However, there is no established creek channel or riparian vegetation. Additionally, stock has access to the entire watercourse (*Refer to **Photo 17***). This watercourse would be described as being significantly degraded. There is a third watercourse traversing the south-western tip of the development area. This water course is located on flood prone land, and is outside of the proposed development area.

There are three first order watercourses located in Lot Area 2. The first crosses the north western tip of the development area. The second is adjacent to Old North Road, in the southern portion of the development area. **Photo 18** shows the crossing of the southern watercourse at Old North Road. The third crosses the eastern tip of the development area. All three watercourses in Large Lot Area 2 would be described as moderately disturbed.

Photos 17 and 18 – show other watercourses in the Large Lot Area. **Photo 17** on the left, shows the second order stream which traverses the middle of Large Lot Area 1. The photo, which was taken from Wine Country Drive, clearly shows that there is no established channel and little riparian vegetation. **Photo 18** on the right is taken from Old North Road, showing the 1st order stream crossing Old North Road.

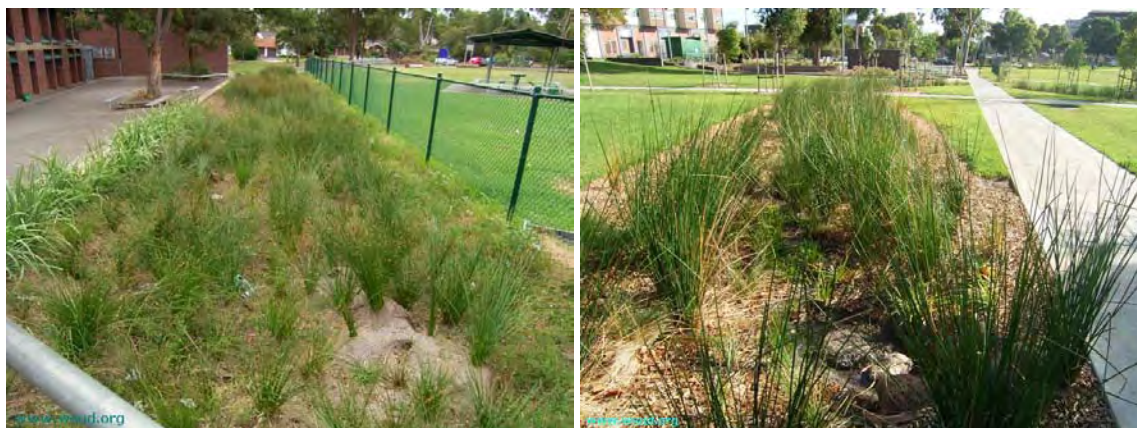
Source: www.wsud.org

It is proposed to provide a 10m vegetated buffer in sections of the existing watercourse which are described as slightly disturbed or undisturbed (*refer to Section 1 and Figures 1 and 2*). As documented in the Stormwater Report, in some areas, it is proposed to include bio-retention basins as part of the vegetated buffer. The bio-retention basins would be fenced, with public access restricted. Bio-retention basins would be vegetated with select native plant species which would assist in the water quality treatment. This would effectively buffer the CRZ from the edge effects of the proposed urban areas. The images below display typical bio-retention basins.

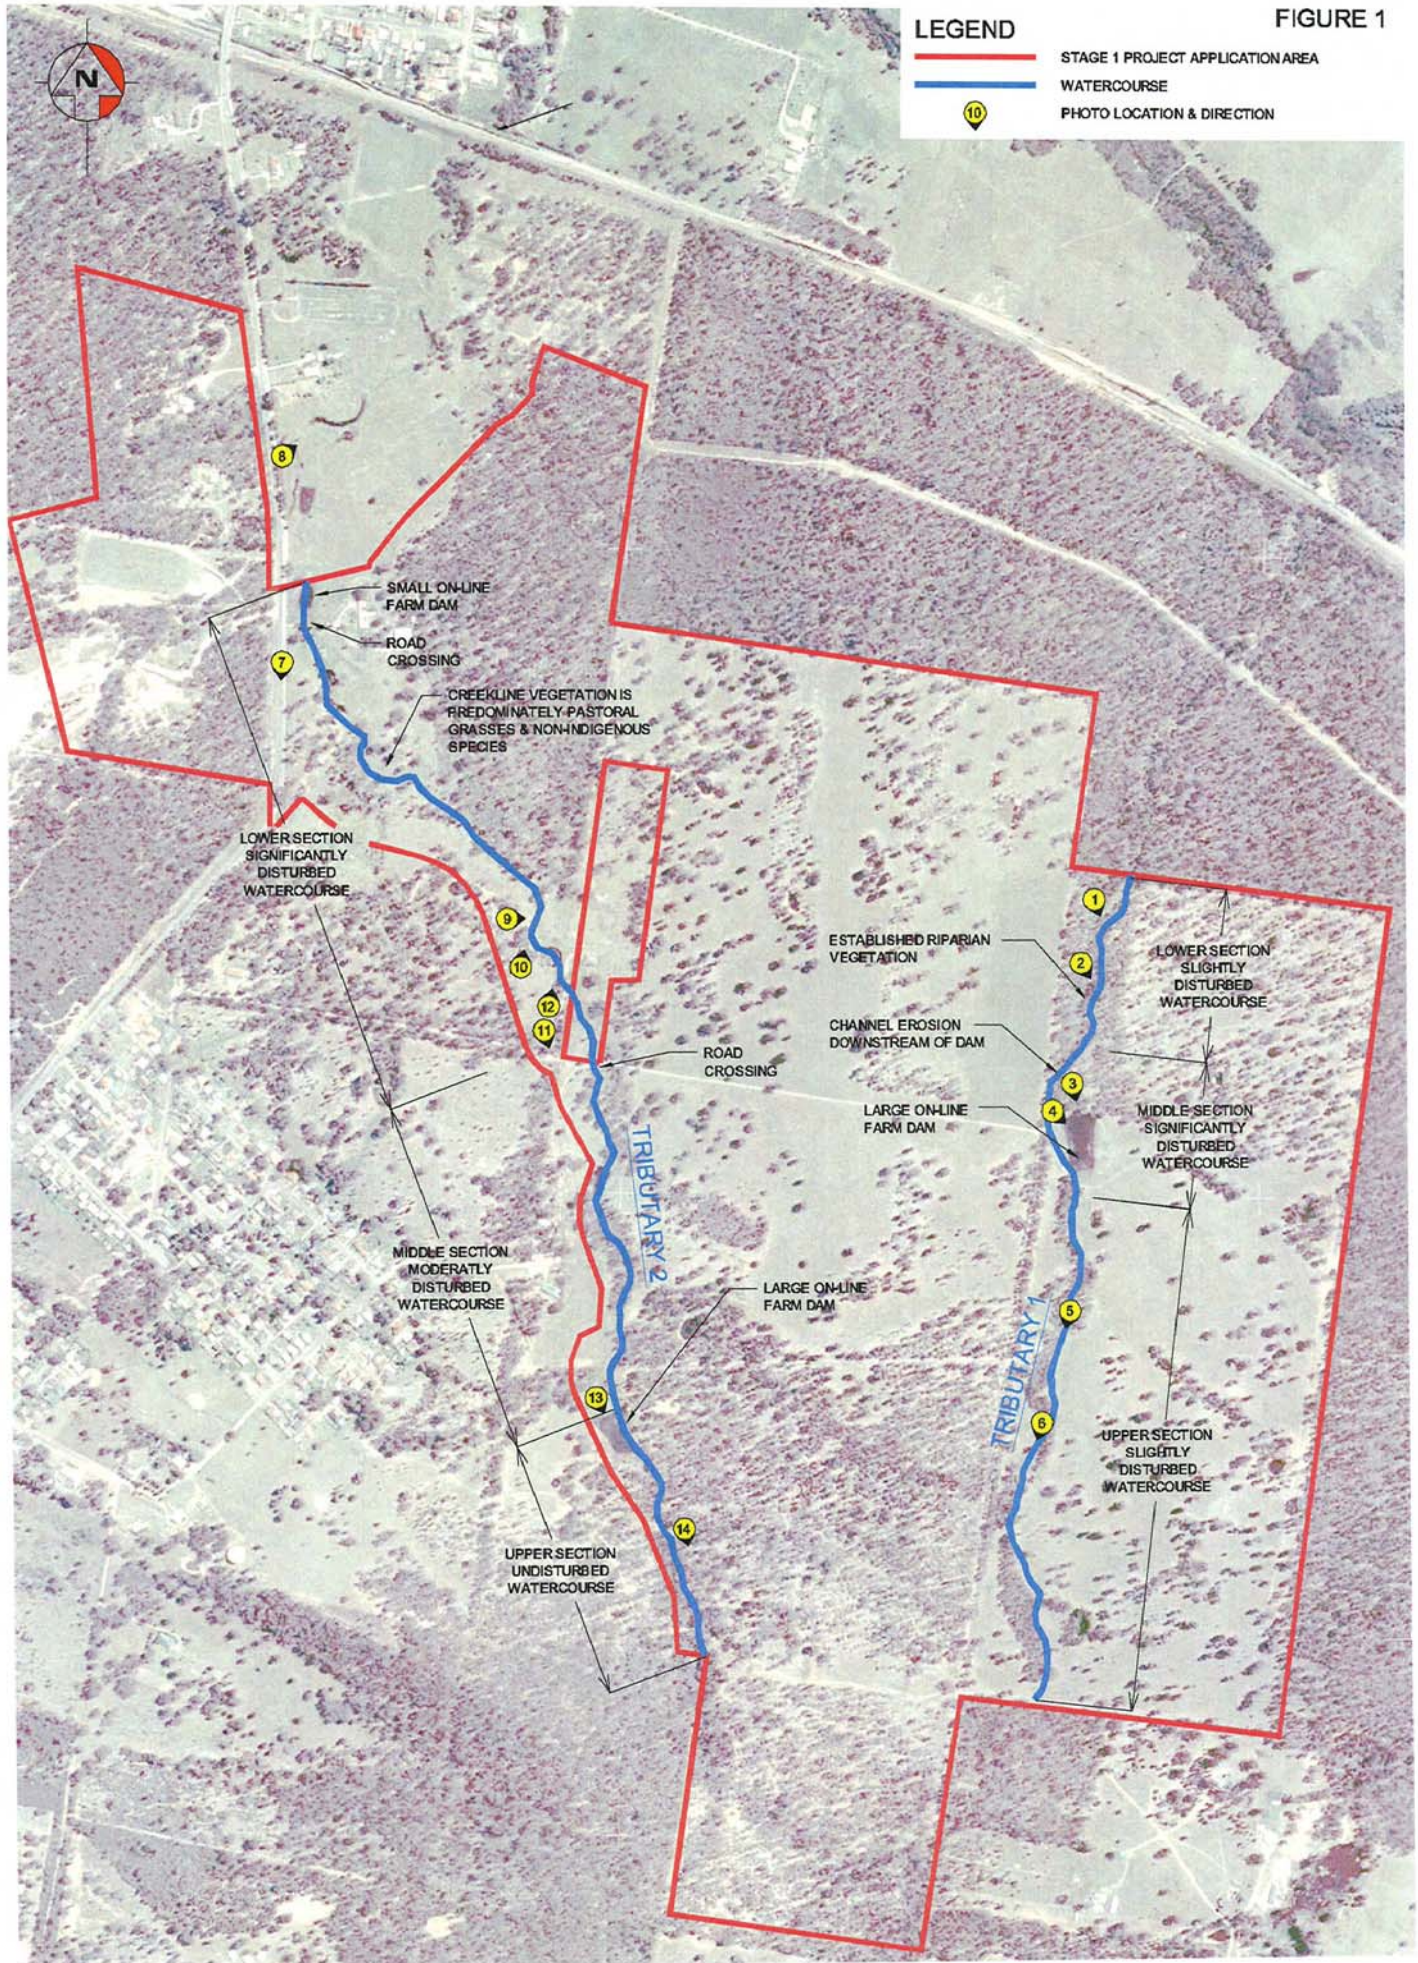
FIGURE 1

The following discussion should be read in conjunction with **Figures 1 and 2**, which details the locations of the photographs and provides general notes to support the following discussion.

Each section of watercourse was described as either significantly disturbed, moderately disturbed, slightly disturbed or un-disturbed. The results of this assessment are summarised in **Figures 1 and 2**.
