#### 4.7.4 Schooling

## 4.8 Post-War Developments

## 6 Historic Physical Evidence

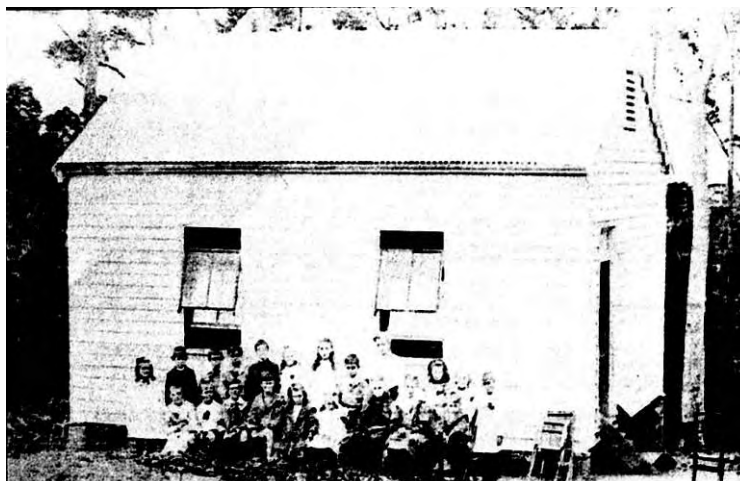
**Figure 4.27 Wahroonga Adventist School located at 124 Fox Valley Road c.1905 (Merritt Kellogg Museum).**

The Wahroonga Adventist School was established to meet the educational needs of the children of staff members. The first classroom of the school was a room at the rear of the Sanitarium hospital building (2005 School Newsletter). Before long this room was needed by the hospital, so a small timber building was erected on land behind the present shop at 124 Fox Valley Road (Figure 4.27).

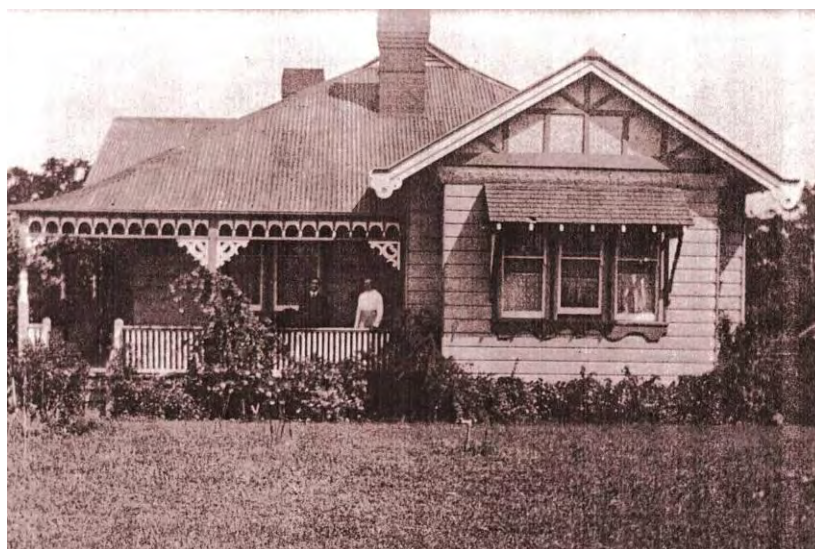
**Figure 4.29** Coorajeba home of the Kress family, demolished to make way for the new church (Source: Merritt Kellogg Museum).

Drs Daniel and Lauretta Kress were founders of the hospital and the family residence, Coorajeba, the “home of the medicine man”, was built in c.1907. However, as the Kresses were recalled to the USA in 1907, the cottage must predate this time (Figure 4.29). The cottage was removed in the 1950s to make way for the new Wahroonga Adventist Church.

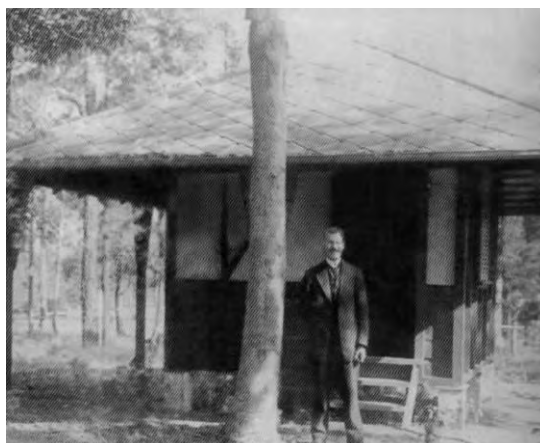
**Figure 4.30** T J Roberts, the night watchman in front of his shelter house (Patrick 2003:82).

In 1918, a nurse built a ‘shaded one room building for the nightwatchman’ which has also been identified as being the old mortuary (Patrick 2003:83, Cook 1991:390) (Figure

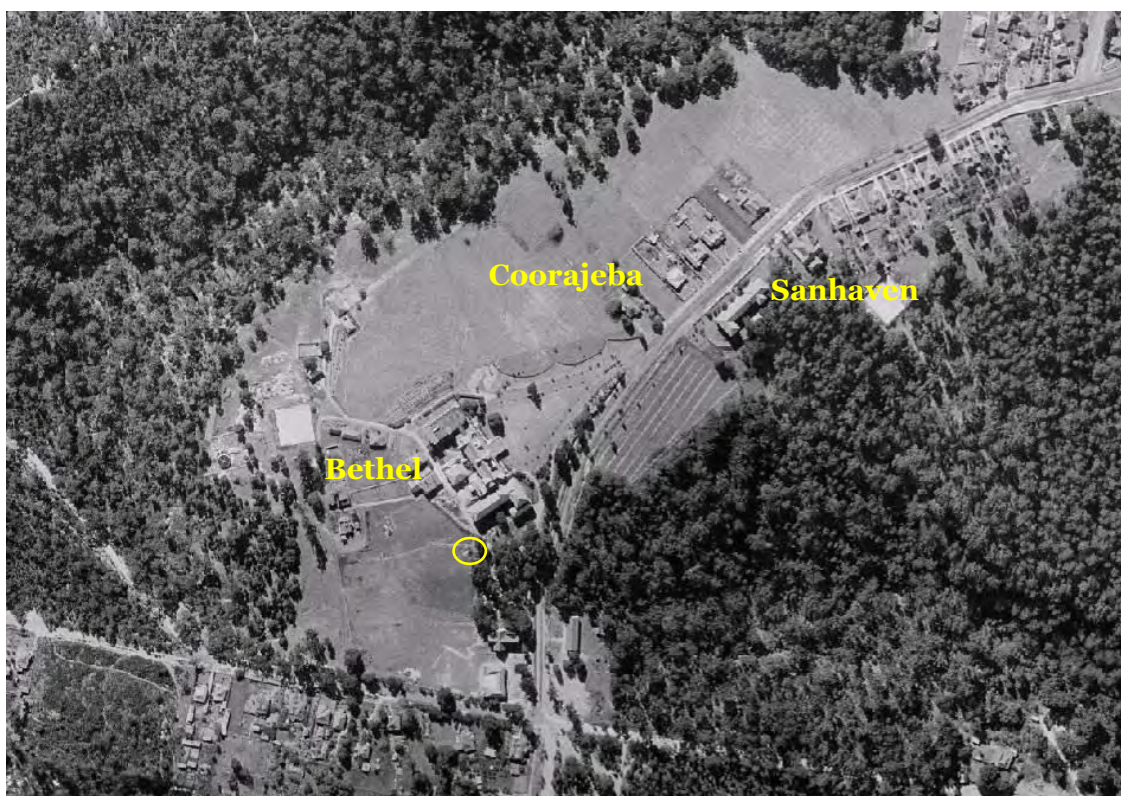
**Figure 4.31** 1943 aerial showing Bethel, Coorajeba, Sanhaven and a tentative location for the nightwatchman's shelter (circled)

4.30). The small building was probably located on the site of the later nurses' residential block (Figure 4.31).

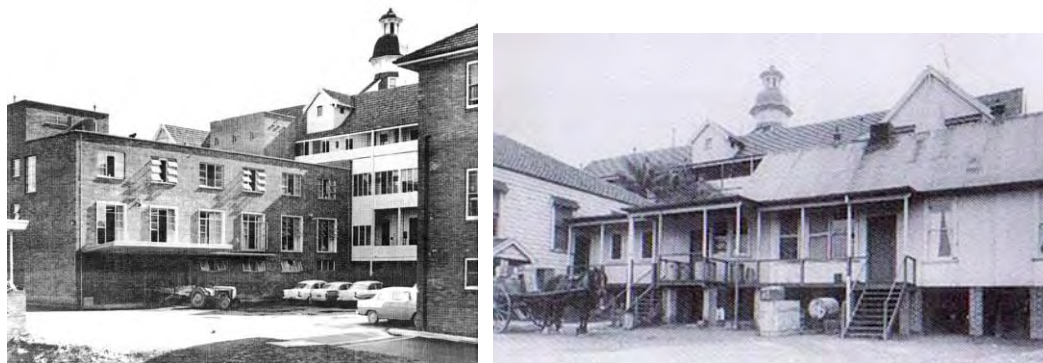
**Figure 4.33 New services building (left) replaced original kitchen (right) (Merritt Kellogg Museum).**

In 1961, a new three-storey services building built to provide space for classrooms, the kitchen, staff and patient dining rooms, doctors' offices, X-ray laboratory and medical records (Figure 4.33) (Patrick 2003:105). This building was extended in 1989.

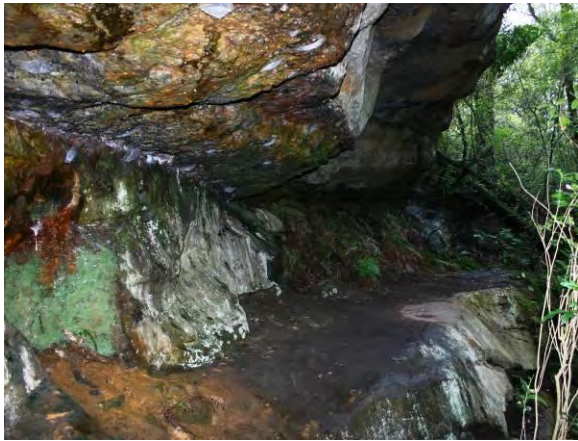
**View of north eastern end of shelter site 45-6-2040**

The previously recorded site 45-6-2040 was relocated; however the two quartz artefacts recorded in 1989 were not relocated. Evidence of recent use of the shelter includes broken glass bottles and other rubbish, large pieces of charcoal from recent fires, and spray-painted graffiti on a section of the shelter wall. It is anticipated that the artefacts have been disturbed through this recent use of the shelter.

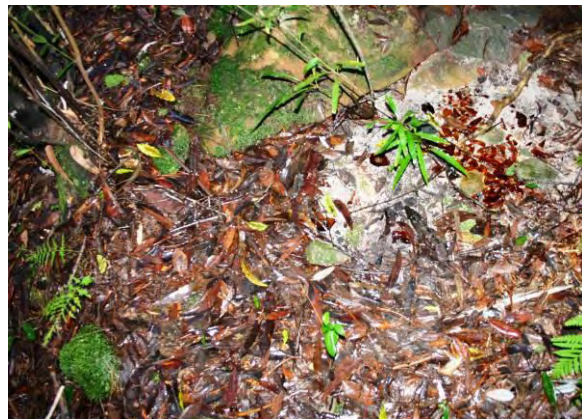
**Example of ground exposure in shelter**

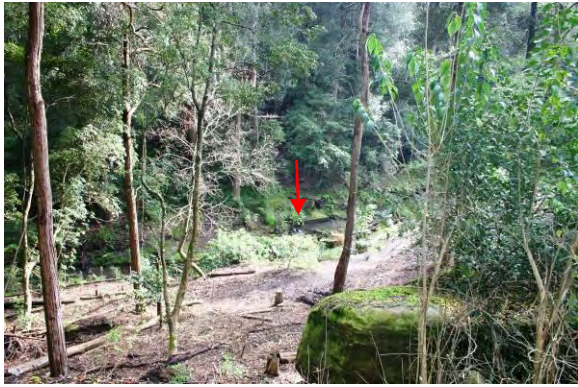
**Evidence of clearing for pathways, and drainage (arrowed)**

The banks on each side of the creek are relatively steep, with a relatively level area of approximately 10-20m immediately adjacent to the creekline. Sheer sandstone cliffs and shelter outcrops dominate the north western side of the creek, particularly in the area of site 45-6-2040. Some of these shelters have evidence of modern use, including rubbish and graffiti. Vegetation was dense away from the creekline and the pathways, although there was evidence of some clearing in the area, particularly near paths and on the south eastern side of the creek. Cleared vegetation has been placed into plastic garbage bags which are in piles near the creek. Some revegetation/rehabilitation efforts are also evident, particularly on this south eastern side of the creek. Apart from this clearing, disturbance of the creekline is mainly the result of the introduction of paved and unpaved pathways, and the construction of service access hatches in the vicinity.

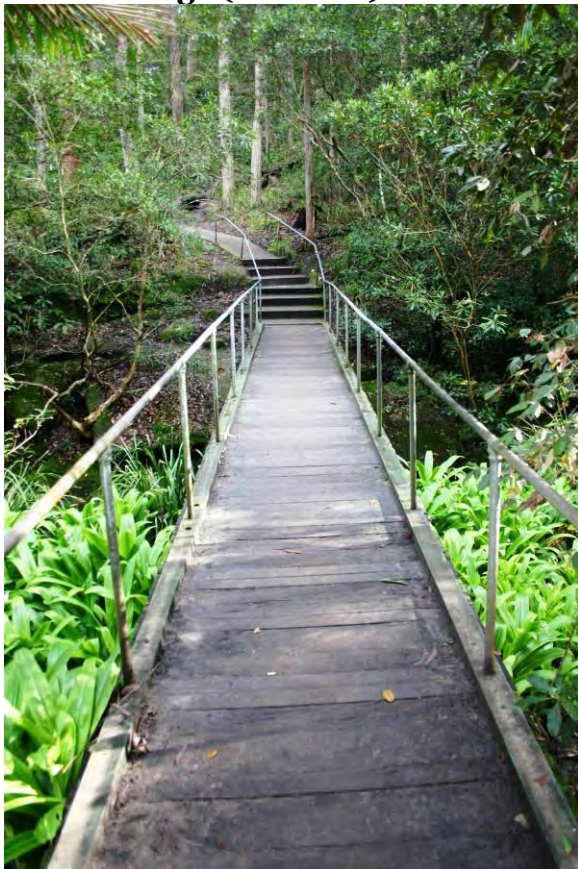
**Formal bridge across Coups Creek**

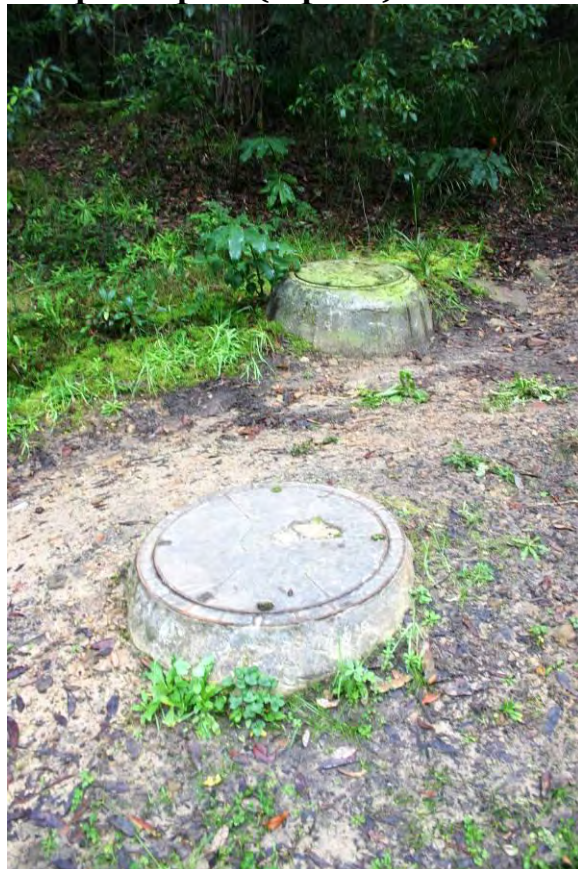
**Service access hatches near creek**

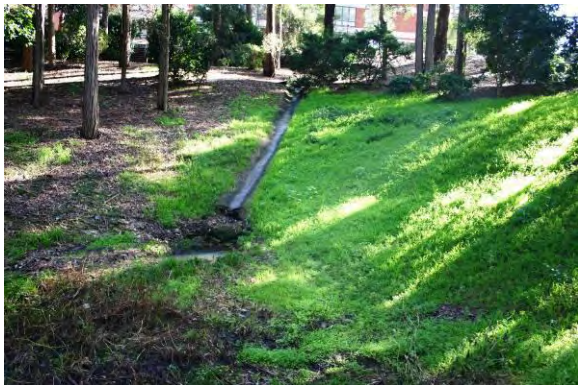
**Concrete drain into depression behind Administrative Headquarters building**

Apart from clearance of vegetation, including the removal of large trees and lantana, disturbance in the north western section of the BGHF area appears to have resulted from the nearby buildings on Fox Valley Road. A small amount of rubbish was present throughout the area. A small cement drain has been constructed behind the Administrative Headquarters building, which pools into a small depression. Pedestrian use of the area was evident in a small track behind the Fox Valley Road buildings. The landscape in this area is a moderately steep slope, and it is considered an unfavourable area for Aboriginal occupation.

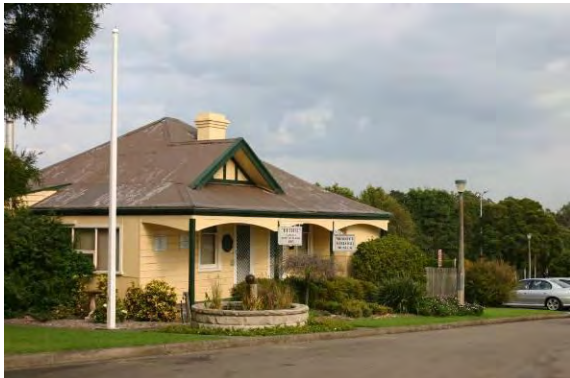
**Bethel, the Merritt Kellogg Museum with memorial well and landscaping/garden**

Bethel cottage, built in 1915 as labour and delivery rooms, was the original maternity wing, and later served as a staff residence. The cottage opened as the Museum in 2003 and now houses the Merritt Kellogg Museum collection. It is a timber-framed weatherboard cottage with gable end and wide eaves beneath a corrugated steel roof.

The cottage is aligned north south and overlooks the modern tennis court. It has been well maintained and retains much of its original fabric with simple timberwork of the balcony, fascia and Federation detailing of the decorative spandrel panels, timber door with glass panels.

A garden bed at the north of the cottage includes some low shrubbery forming the letters “SAN”. There is a memorial well at the northeast corner, which was initiated by the Sydney Sanitarium & Hospital Class of 1964, and dedicated in 2004 “in memory of nursing graduates and trainees who have died while actively working for the Seventh Day Adventist Church”.

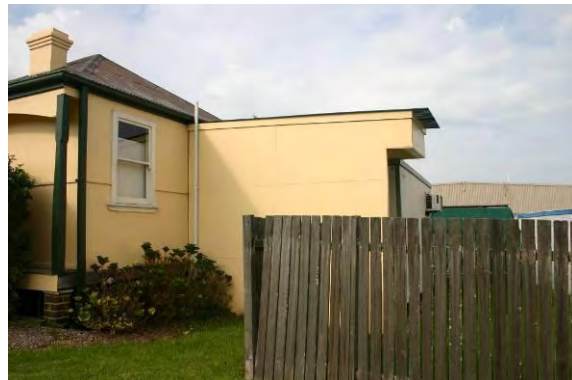
**Southwest corner**

The verandah originally ran across the front and each side. The east and west side verandahs of the cottage have been extended. The east extension has been treated as a natural part of the cottage with weatherboarding, whereas the west verandah has been infilled and clad with asbestos cement (fibro) sheeting. Extensions to the rear are also clad in fibro.

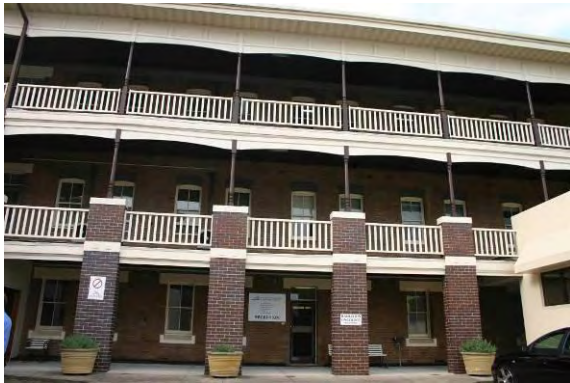
**The west front elevation of the Shannon Wing. The removal of the balcony from the north elevation is demonstrated by the exposed balcony joists (arrowed right).**

The Shannon is a handsome three-storey face brick building, originally with a verandah on at least three sides of each floor (see for example Figure 4.15 and Figure 4.20). Brick pillars support the first floor verandah while the upper floor verandah, and roof, is supported by turned timber columns. The upper verandah has a pressed-metal ceiling, deep timber fascia and the balustrades are simple timber posts. The building retains much of its original fittings and fixtures, including moulded plaster ceilings, staircase

balustrades, windows, floors, skirting boards, and some doors. The wooden flooring on both balcony levels is in a poor state of repair.

The building is becoming increasingly difficult to maintain, the balconies are unsafe, particularly the top floor, and is no longer consistent with the requirements of a modern health facility. Pigeons pose a problem and health risk and, despite all attempts, still manage to get into the building, with resultant bird lice infestations.

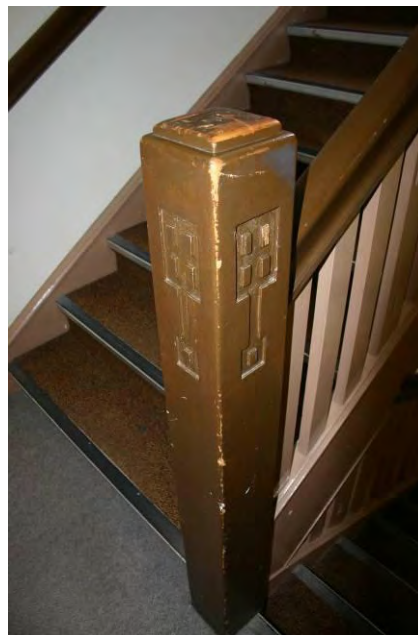
**Staircase and newel detail**

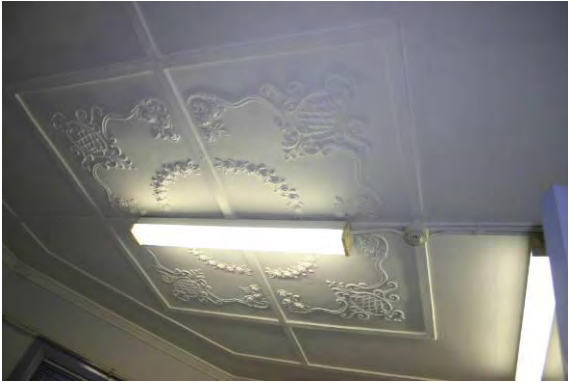
**A moulded plaster ceiling**

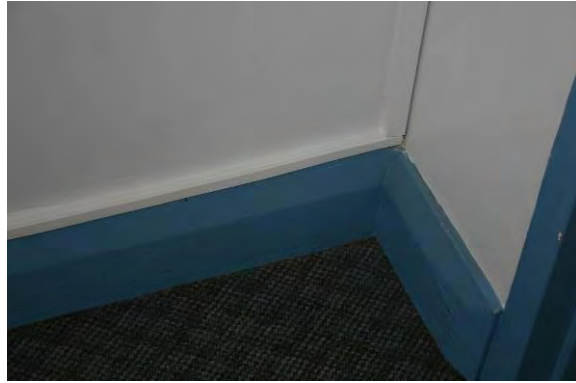
**Blue skirting board on third floor**

Each floor has been colour-coded with walls painted in different colours: pink and mauve on the first floor, cream and brown on the second floor, and yellow and blue on the third floor.

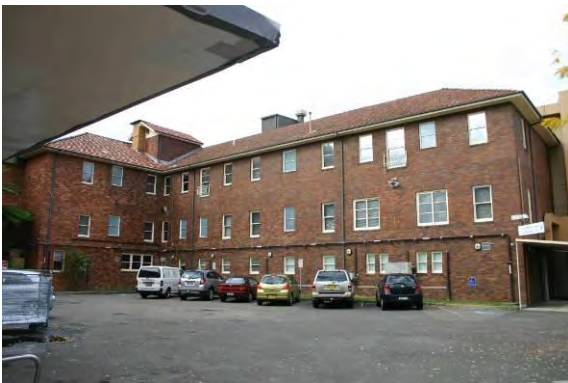
**Maternity wing south elevation**

The four-storey maternity wing was built in 1933, as an addition to the original Sanitarium with medical and obstetric beds. It was extended in 1989-90 to upgrade the maternity facilities and to include physiotherapy and hydrotherapy. Built three years after the Administration Building, it reflects that building in the pale face brickwork and use of fanlight windows over French doors and Juliet balcony overlooking Fox Valley Road. Although there are original elements of the original internal detailing, modifications and upgrades have resulted in the building exhibiting little that would distinguish it from a modern hospital wing. Services, in particular air-conditioning, have been installed in the spaces created by inserting false ceilings.

The small scale of ward rooms, the concrete framing and loadbearing brickwork means that internal modifications are difficult and economically prohibitive.

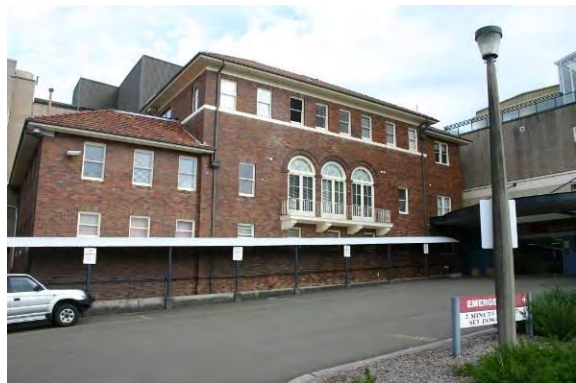
**Maternity wing north elevation**

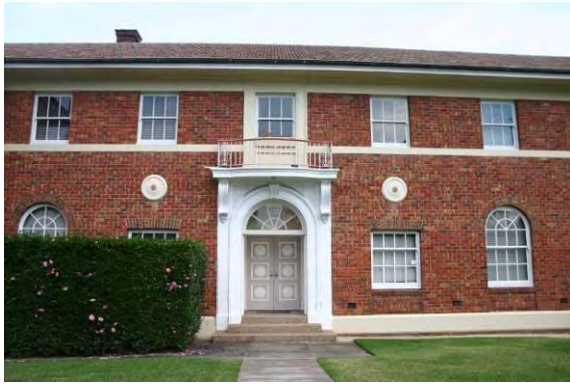
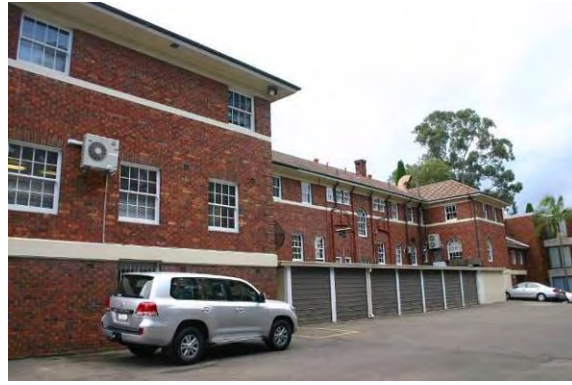
**Administrative Headquarters west Administration building east elevation elevation**

The Administration Building was built in 1931 as the Australasian Conference Association Office of the Seventh Day Adventist Church and houses administrative offices and conference rooms. It is a handsome, two-storey face brick structure with terra-cotta tiled roof in the interwar Georgian revival style. The 1986 addition housing the Sanitarium Health Food Company offices adjoins to the north of the building and created a new entry vestibule. The addition has been sensitively achieved with face brickwork reflecting the original and reuse of original windows in walls. There is a fanlight window over the original entry door surmounted by a Juliet balcony, reflected on the opposite of Fox Valley Road in the north elevation of the 1933 Maternity Wing.

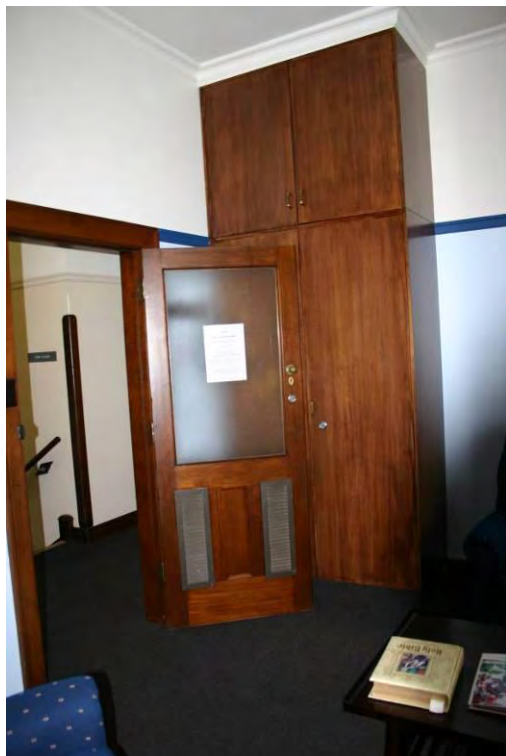
**Original timber detailing of built-ins and fittings**

The original wing of the building retains the original internal detailing, with timber built-in cupboards, skirtings, panelling, stair balustrades and much of the original fixtures. Some of the furnishings also appear to be original. Installation of modern services has included air-conditioning and video/teleconference facilities; however, there are no elevators or disabled access facilities in the original wing.

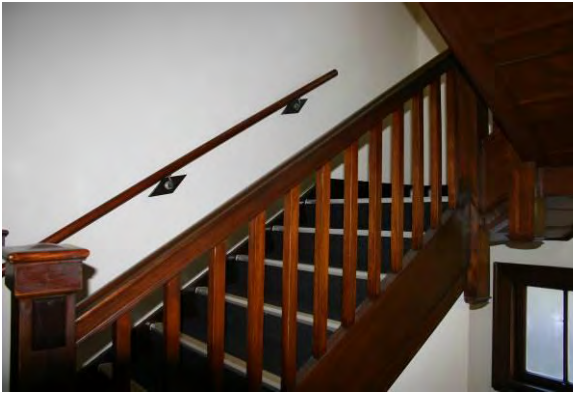
**The staircase**

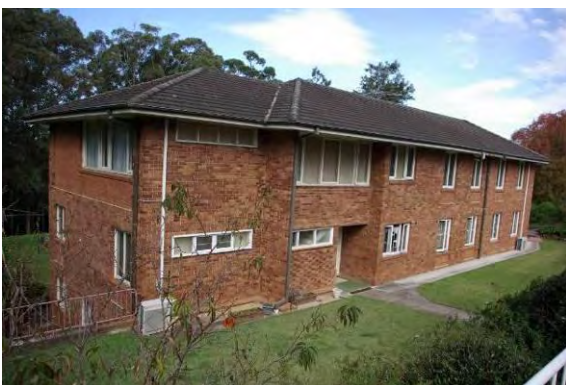
**Ladies Hostel west elevation**

The Ladies Hostel is a pale face brick three story old-style apartment with the ground/basement at the rear of the building as it slopes away from Fox Valley Road. Although a generally austere building, there are infill wall sections of textured brick detailing and the internal safety grills on the ground/first floor windows present as an additional decorative feature.

The building has been renovated within the last decade, but retains original features, including staircases, windows and built-in storage areas. An apartment on the upper floor has been extended by infilling the stair landing.

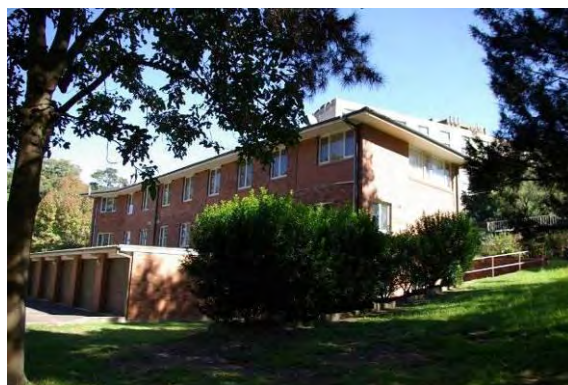
**Ladies Hostel east elevation**
