TITLE: **Soil Landscape Sheet**
Wahroonga Estate, Fox Valley Road, WAHROONGA NSW

PROJECT No: 45569.00

TITLE: Preliminary Concept Plan
Wahroonga Estate
Fox Valley Road
WAHROONGA

APPENDIX B
Australian Geoguide LR8

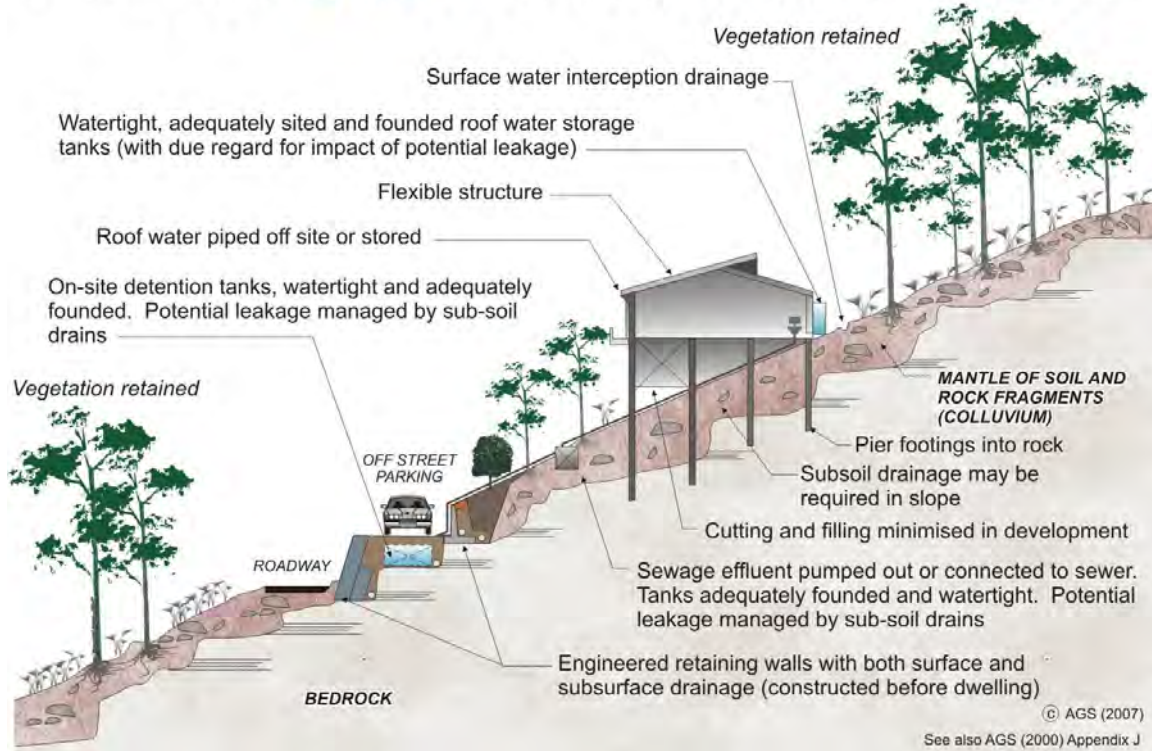
EXAMPLES OF GOOD HILLSIDE CONSTRUCTION PRACTICE

Roadways and parking areas - are paved and incorporate kerbs which prevent water discharging straight into the hillside (GeoGuide LR5).

Cuttings - are supported by retaining walls (GeoGuide LR6).

Retaining walls - are engineer designed to withstand the lateral earth pressures and surcharges expected, and include drains to prevent water pressures developing in the backfill. Where the ground slopes steeply down towards the high side of a retaining wall, the disturbing force (see GeoGuide LR6) can be two or more times that in level ground. Retaining walls must be designed taking these forces into account.

Sewage - whether treated or not is either taken away in pipes or contained in properly founded tanks so it cannot soak into the ground.

Surface water - from roofs and other hard surfaces is piped away to a suitable discharge point rather than being allowed to infiltrate into the ground. Preferably, the discharge point will be in a natural creek where ground water exits, rather than enters, the ground. Shallow, lined, drains on the surface can fulfil the same purpose (GeoGuide LR5).

Surface loads - are minimised. No fill embankments have been built. The house is a lightweight structure. Foundation loads have been taken down below the level at which a landslide is likely to occur and, preferably, to rock. This sort of construction is probably not applicable to soil slopes (GeoGuide LR3). If you are uncertain whether your site has rock near the surface, or is essentially a soil slope, you should engage a geotechnical practitioner to find out.

Flexible structures - have been used because they can tolerate a certain amount of movement with minimal signs of distress and maintain their functionality.

Vegetation clearance - on soil slopes has been kept to a reasonable minimum. Trees, and to a lesser extent smaller vegetation, take large quantities of water out of the ground every day. This lowers the ground water table, which in turn helps to maintain the stability of the slope. Large scale clearing can result in a rise in water table with a consequent increase in the likelihood of a landslide (GeoGuide LR5). An exception may have to be made to this rule on steep rock slopes where trees have little effect on the water table, but their roots pose a landslide hazard by dislodging boulders.

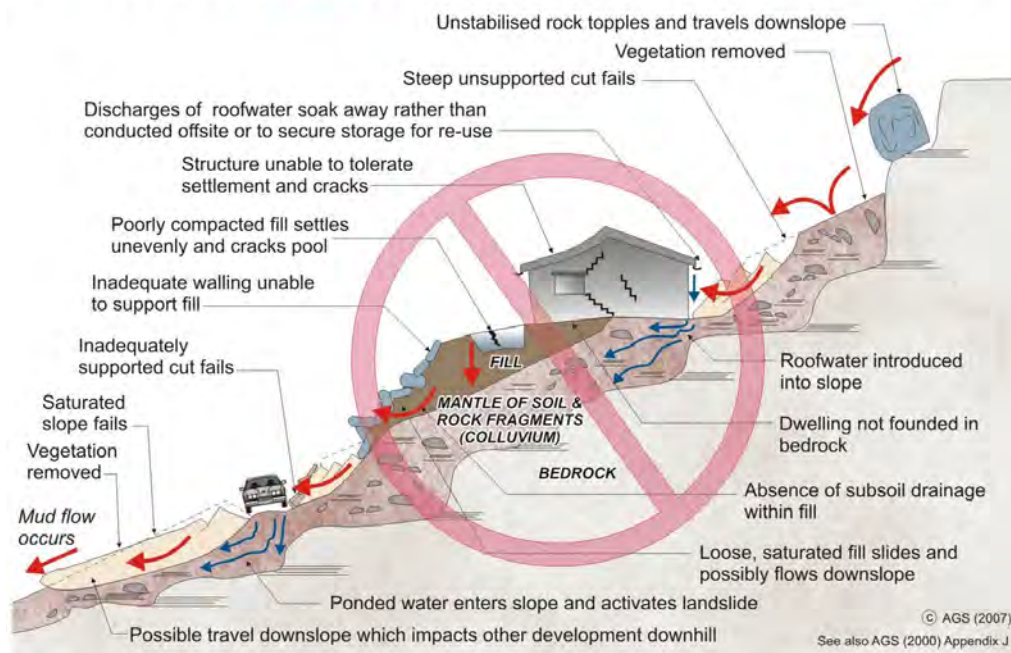
EXAMPLES OF **POOR** HILLSIDE CONSTRUCTION PRACTICE

Roadways and parking areas - are unsurfaced and lack proper table drains (gutters) causing surface water to pond and soak into the ground.

Cut and fill - has been used to balance earthworks quantities and level the site leaving unstable cut faces and added large surface loads to the ground. Failure to compact the fill properly has led to settlement, which will probably continue for several years after completion. The house and pool have been built on the fill and have settled with it and cracked. Leakage from the cracked pool and the applied surface loads from the fill have combined to cause landslides.

Retaining walls - have been avoided, to minimise cost, and hand placed rock walls used instead. Without applying engineering design principles, the walls have failed to provide the required support to the ground and have failed, creating a very dangerous situation.

A heavy, rigid, house - has been built on shallow, conventional, footings. Not only has the brickwork cracked because of the resulting ground movements, but it has also become involved in a man-made landslide.

Soak-away drainage - has been used for sewage and surface water run-off from roofs and pavements. This water soaks into the ground and raises the water table (GeoGuide LR5). Subsoil drains that run along the contours should be avoided for the same reason. If felt necessary, subsoil drains should run steeply downhill in a chevron, or herring bone, pattern. This may conflict with the requirements for effluent and surface water disposal (GeoGuide LR9) and if so, you will need to seek professional advice.

Rock debris - from landslides higher up on the slope seems likely to pass through the site. Such locations are often referred to by geotechnical practitioners as "debris flow paths". Rock is normally even denser than ordinary fill, so even quite modest boulders are likely to weigh many tonnes and do a lot of damage once they start to roll. Boulders have been known to travel hundreds of metres downhill leaving behind a trail of destruction.

Vegetation - has been completely cleared, leading to a possible rise in the water table and increased landslide risk (GeoGuide LR5).

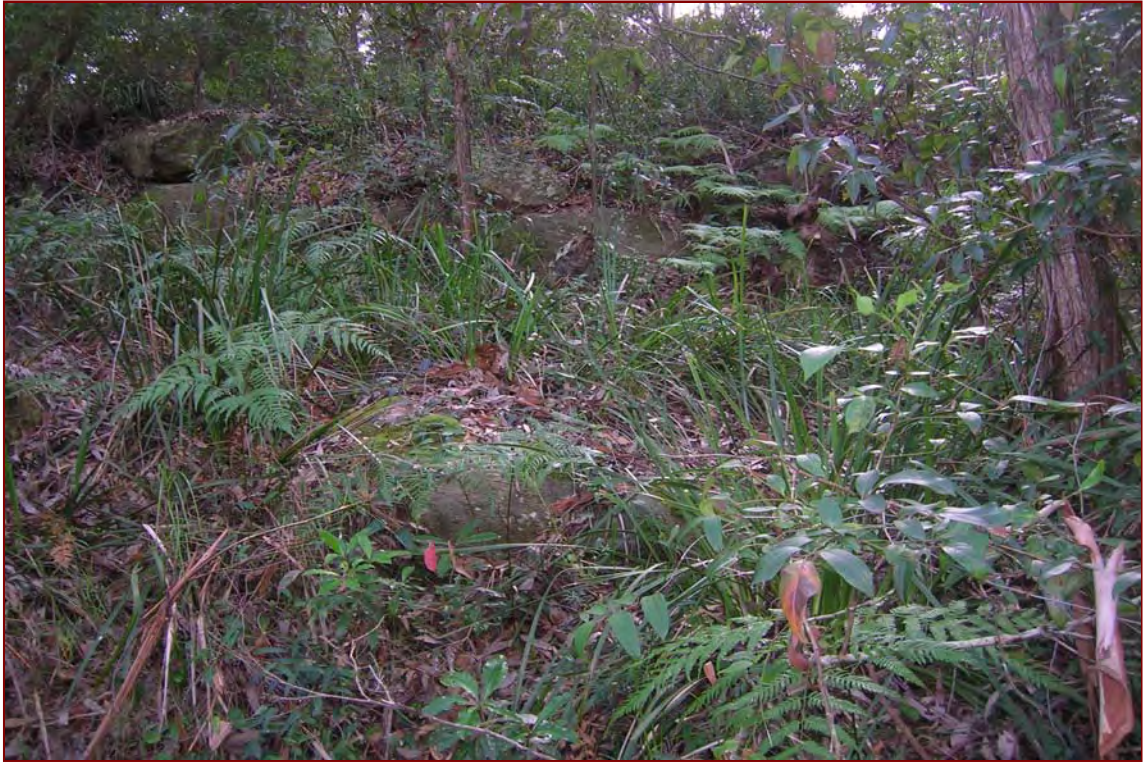
PHOTO 1: Sandstone Outcrops

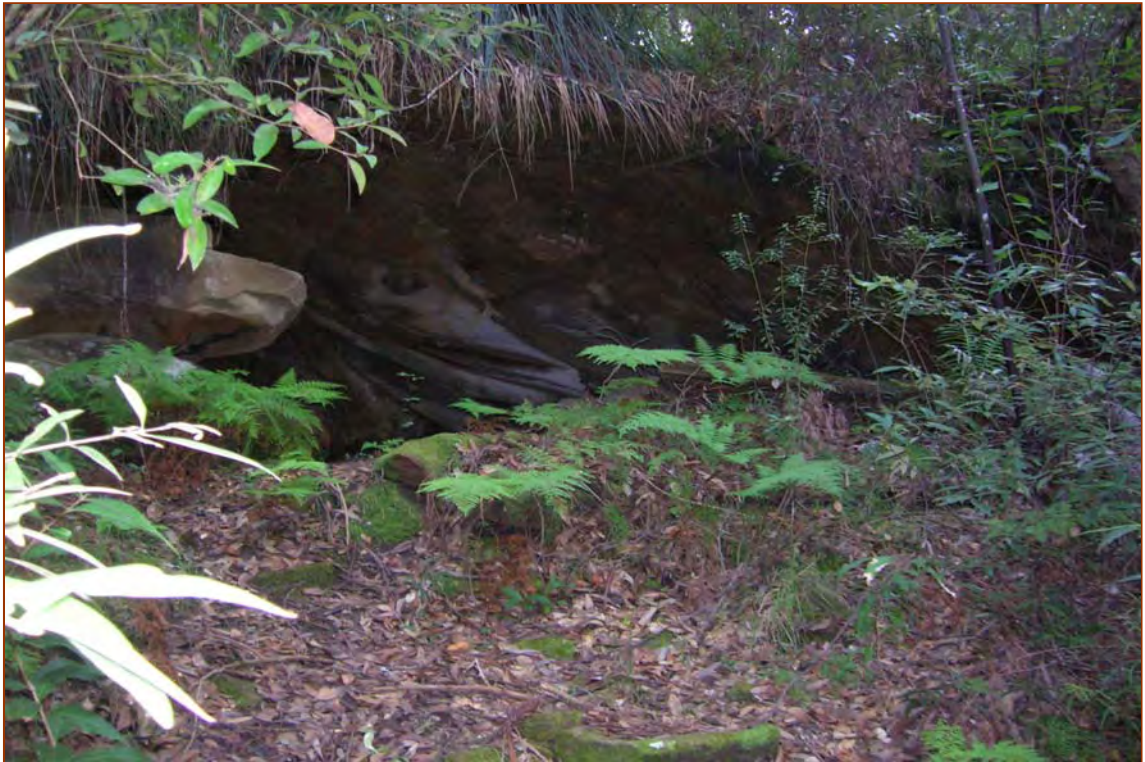
PHOTO 2: Sandstone Outcrops

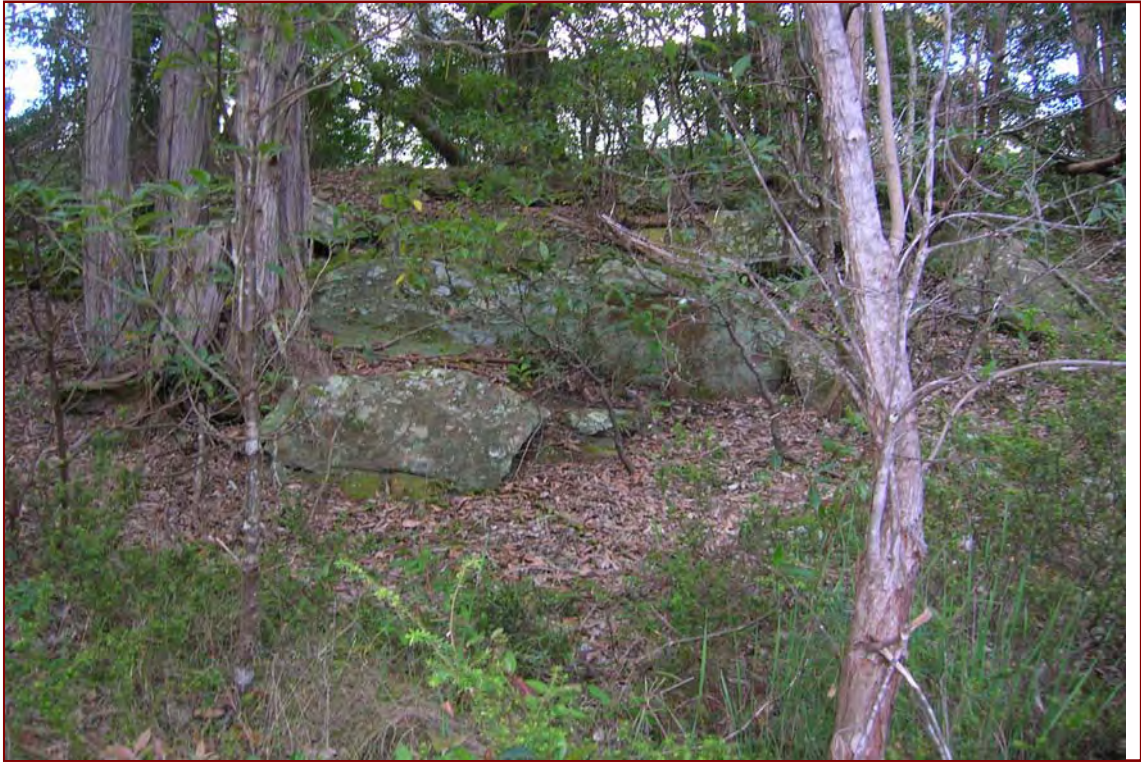
PHOTO 3: Sandstone Floaters

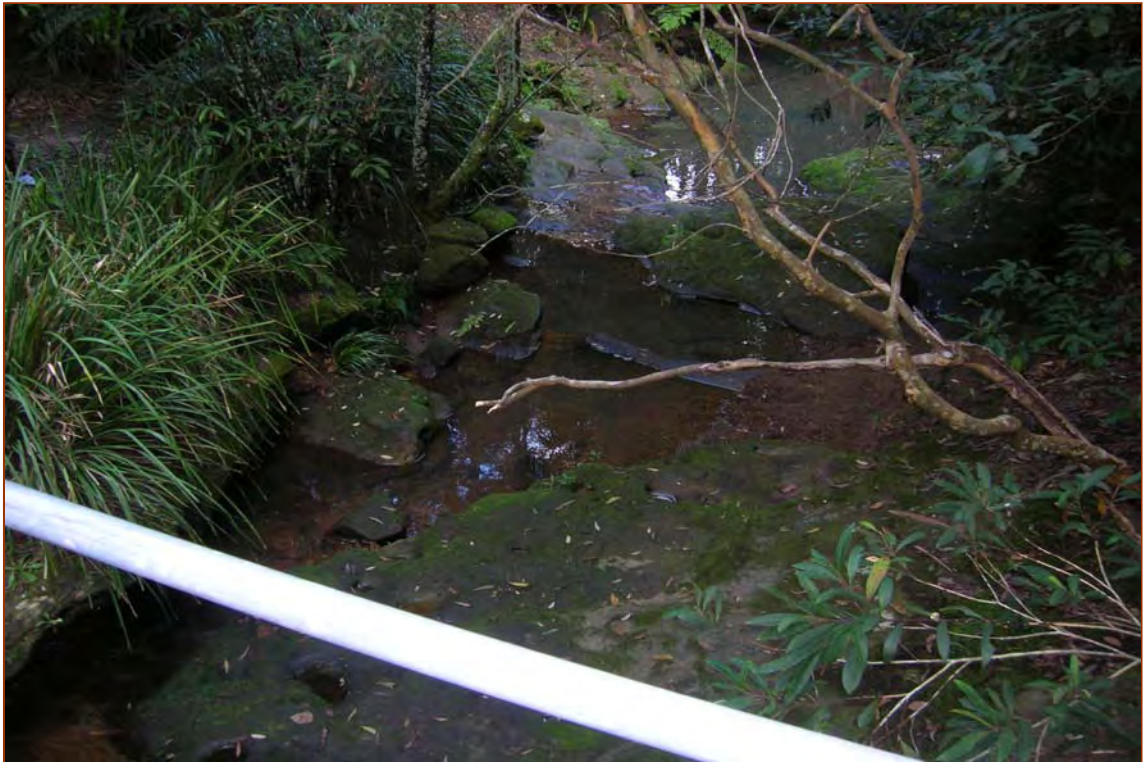
PHOTO 4: Exposed Sandstone in Creek Bed

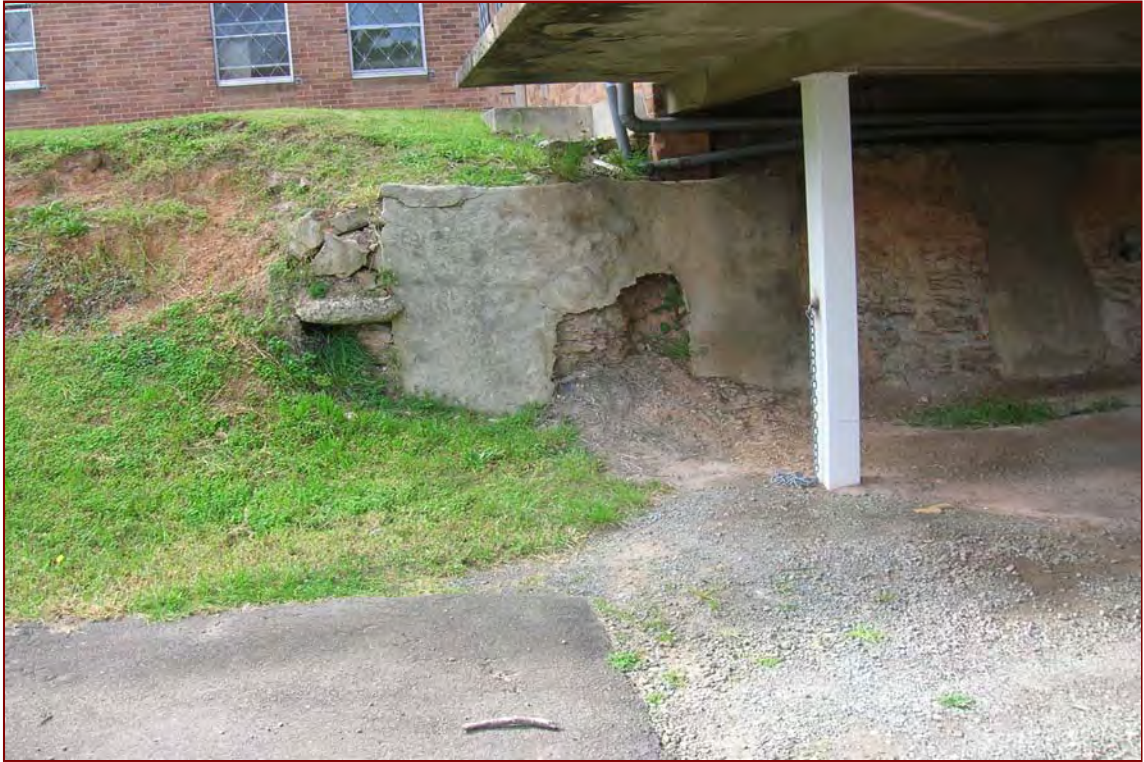
PHOTO 5: Exposed Shale

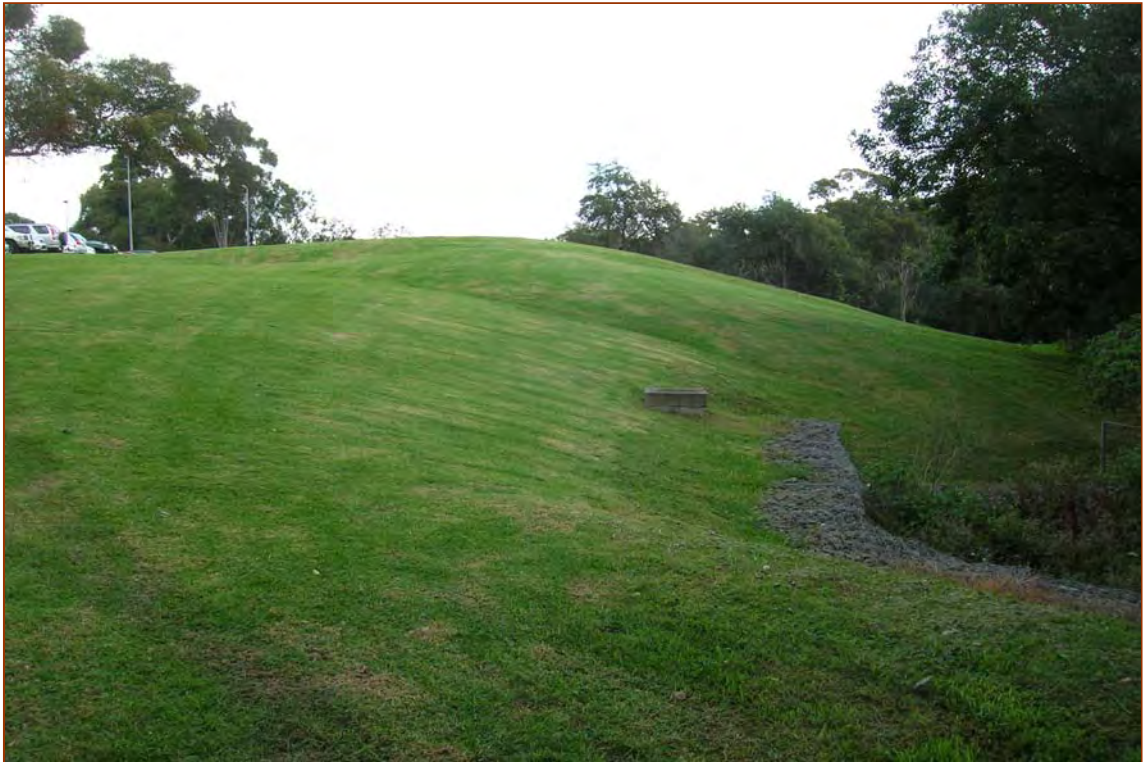
PHOTO 6: Filling at edge of carpark

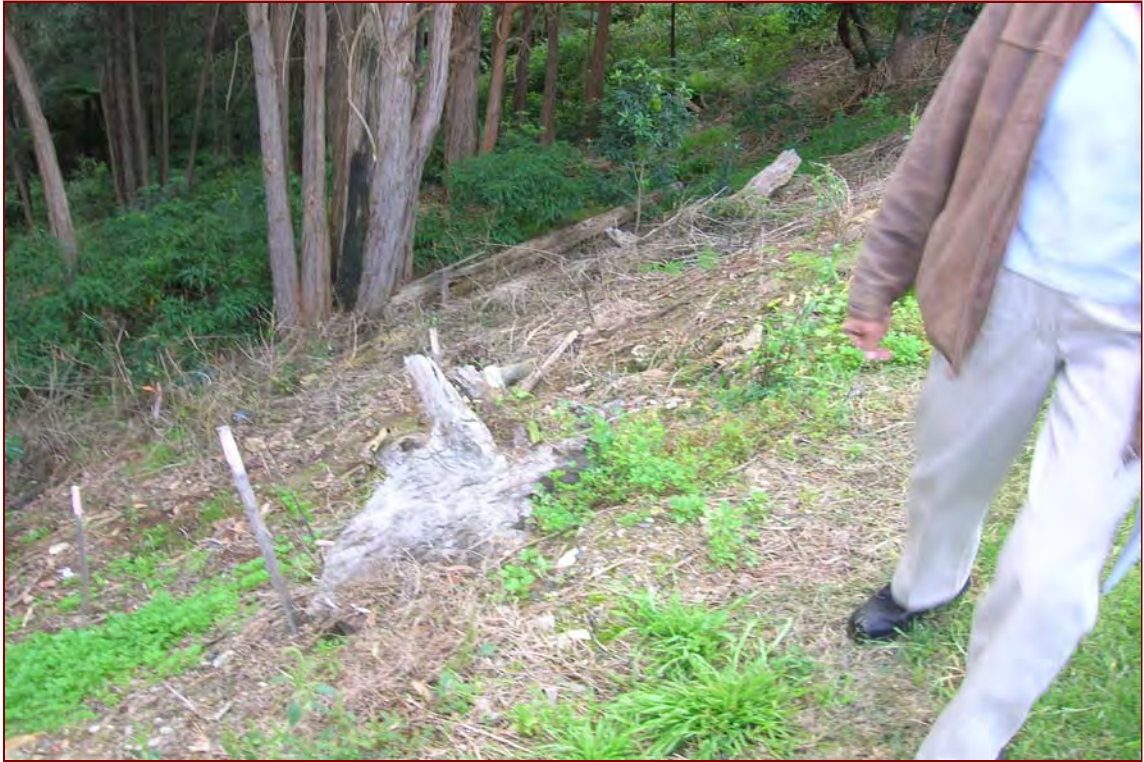
PHOTO 7: Filling near edge of carpark

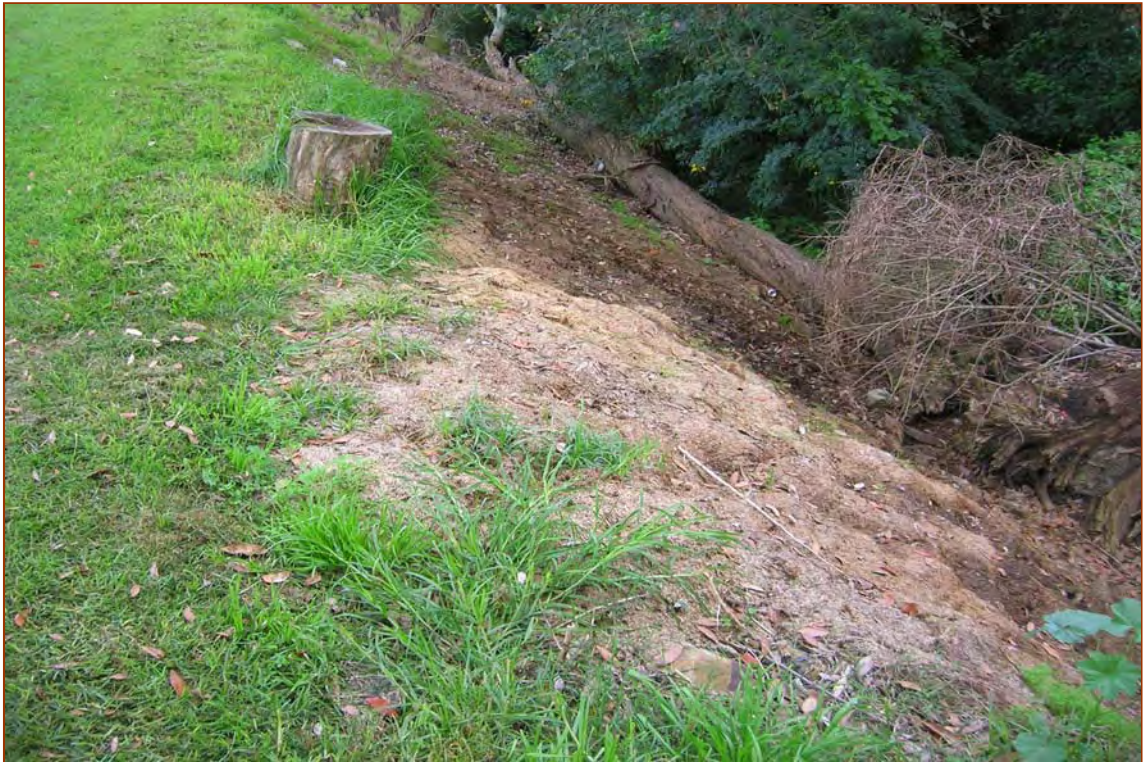
PHOTO 8: Filling near edge of carpark

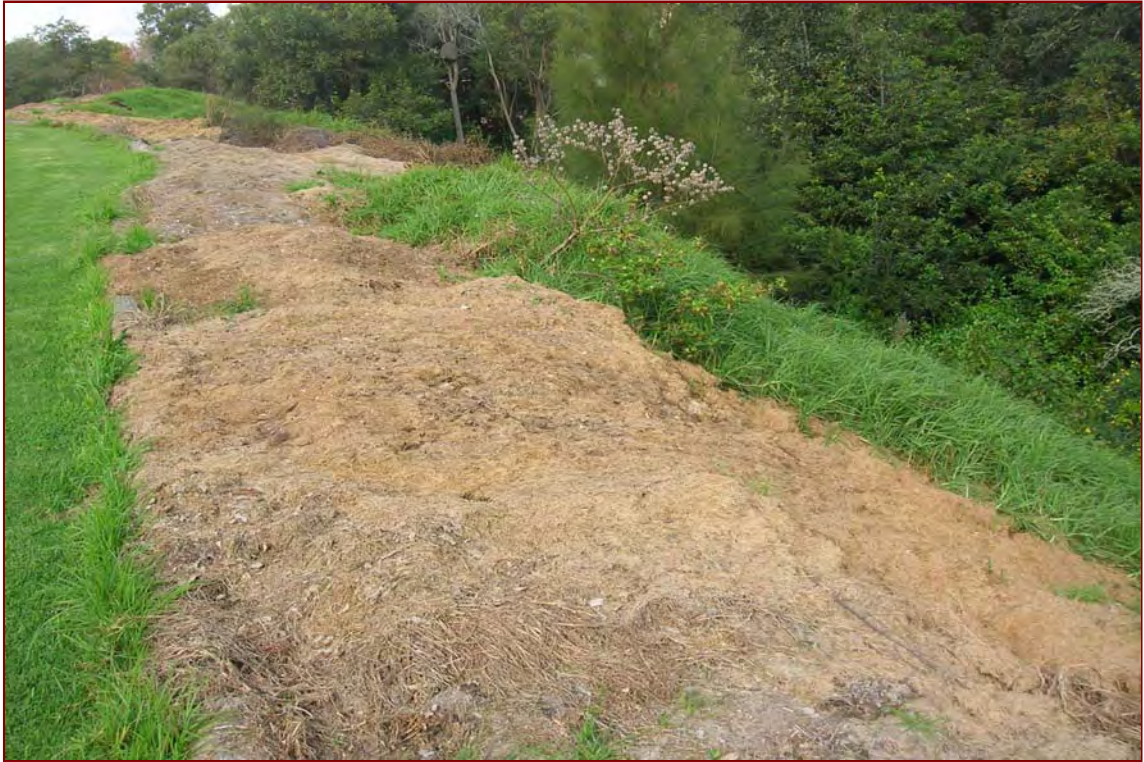
PHOTO 9: Filling (grass cuttings) near edge of carpark

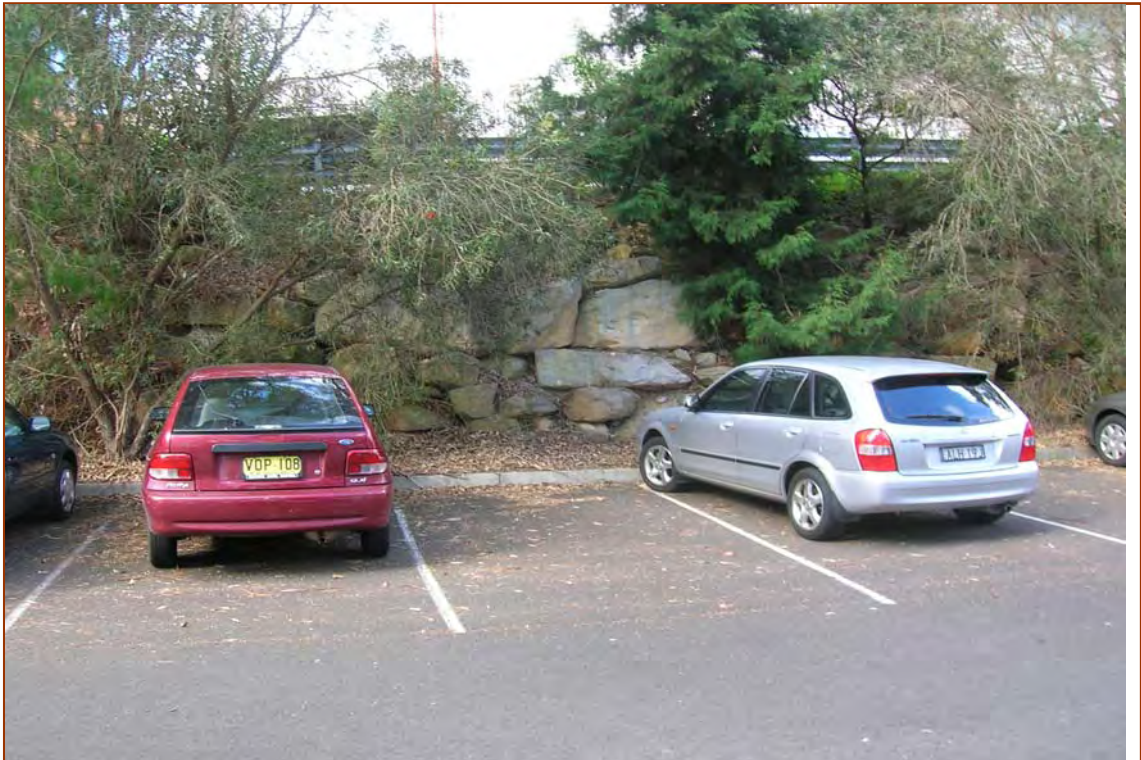
PHOTO 10: Sandstone Block Retaining Wall
