**CONTAMINATION ASSESSMENT - SAN Hospital
185 Fox Valley Road, Wahroonga**

client:	TAYLOR THOMSON WHITTING
project:	CONTAMINATION ASSESSMENT - SAN HOSPITAL 185 FOX VALLEY ROAD WAHROONGA, NSW
title:	SITE LOCALITY PLAN
project no:	GEOTLCOV23462AA-AG
figure no:	1

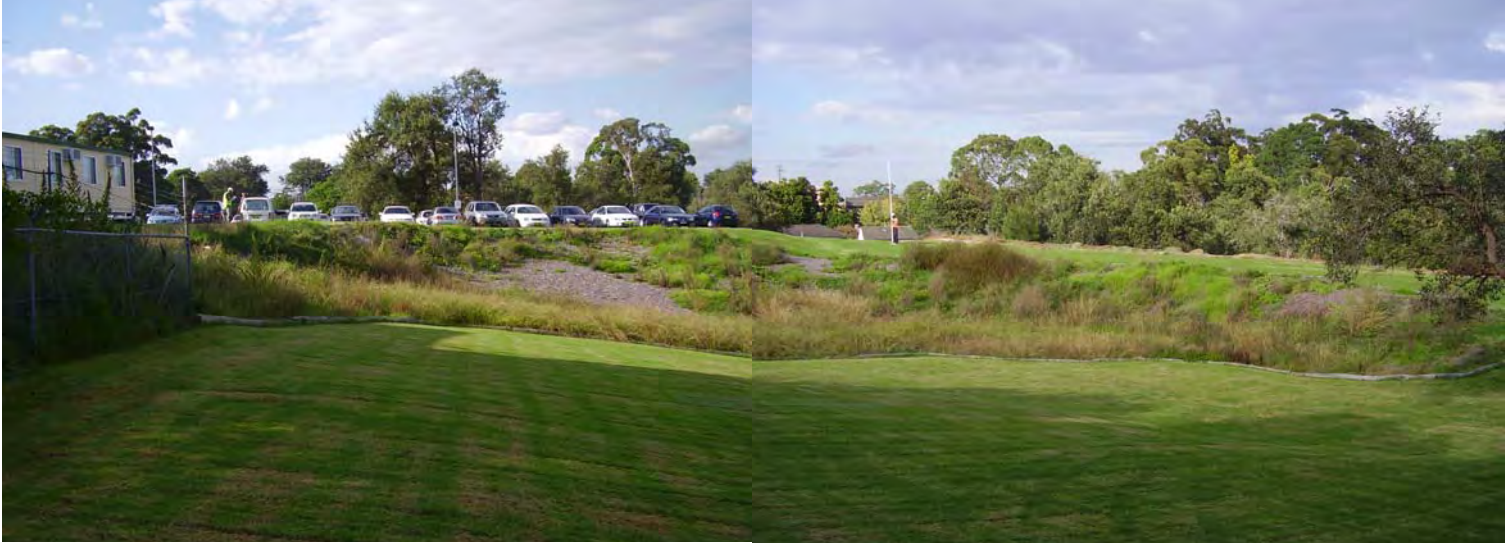
Photo1: Looking east from the north western corner of the proposed Building 3 towards the retention basin centrally located within the study area

Photo 2: Looking west along the fill batter slope located immediately south of the proposed Building 3 southern boundary. The slope was covered with grass cuttings and overgrown vegetation with fragments of brick and concrete also noted

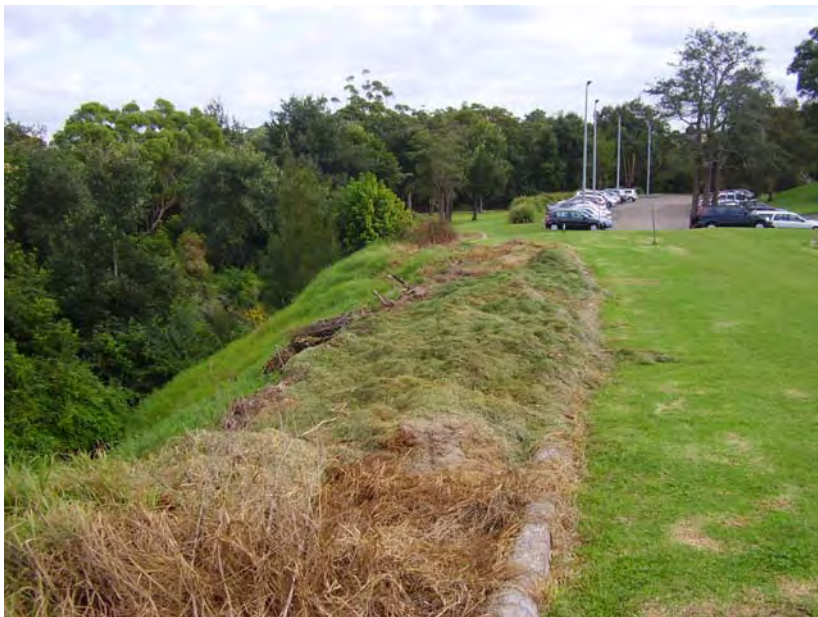
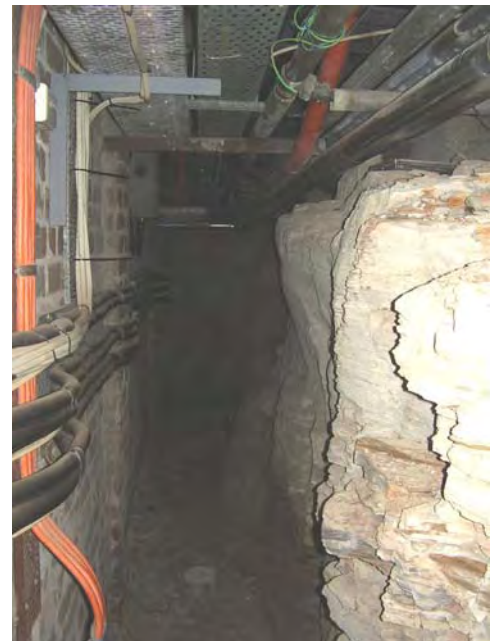
Photo 3: The footing access area for the basement of Building 4. Note the shale located immediately beneath the footings and other service pipes/cables

A stairway leads to the basement from within the building. Within the basement in rooms titled "South Wing Switch Room" and the "Electrical Store Room", brick strip footings supporting a concrete slab associated with the ground floor were visible. The footings were resting on shale which was clearly visible since the basement had been cut into it.

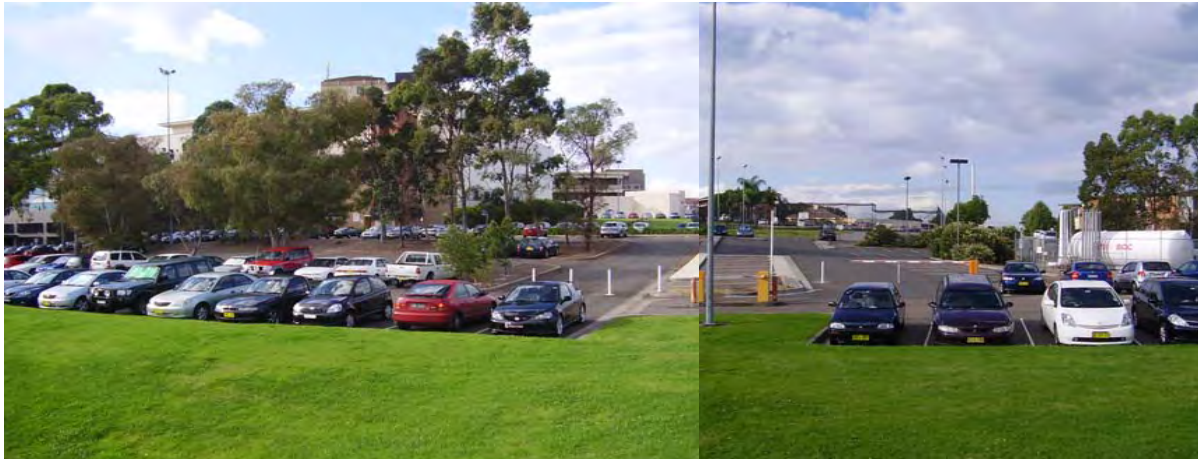
Photo 4: Looking south near the north western corner of the proposed Building 2 study area. Note the liquid oxygen tank located west of the study area.

Adjacent to the western portion of the carpark an aboveground storage tank containing liquid nitrogen was noted within a steel fence compound. Immediately to the south and southeast, the carpark was bound by the Operating Theatre Block and the SAN clinic. Additional carpark areas and the Fox Valley Centre were located to the east and northeast approximately 1m to 2m above ground surface level of the study area.

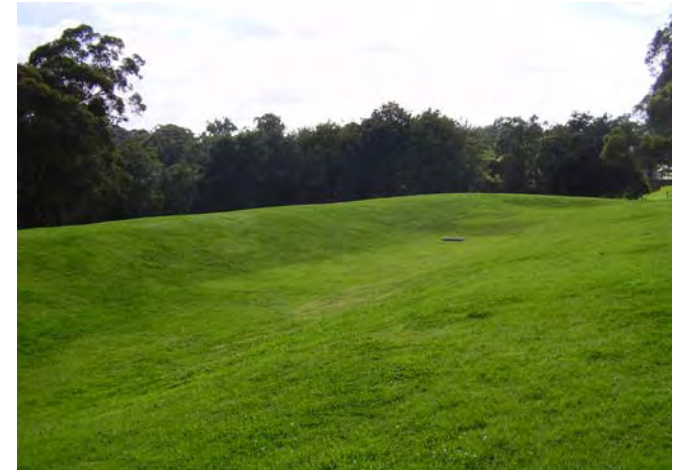
Photo 5: The retention pond located north of the carpark and the proposed Building 2 foot print.

Photo 6: Looking east towards the car parking area and proposed Building 2 footprint. Note the gradual slope of the study area from the higher southern boundary to the to the lower northern boundary

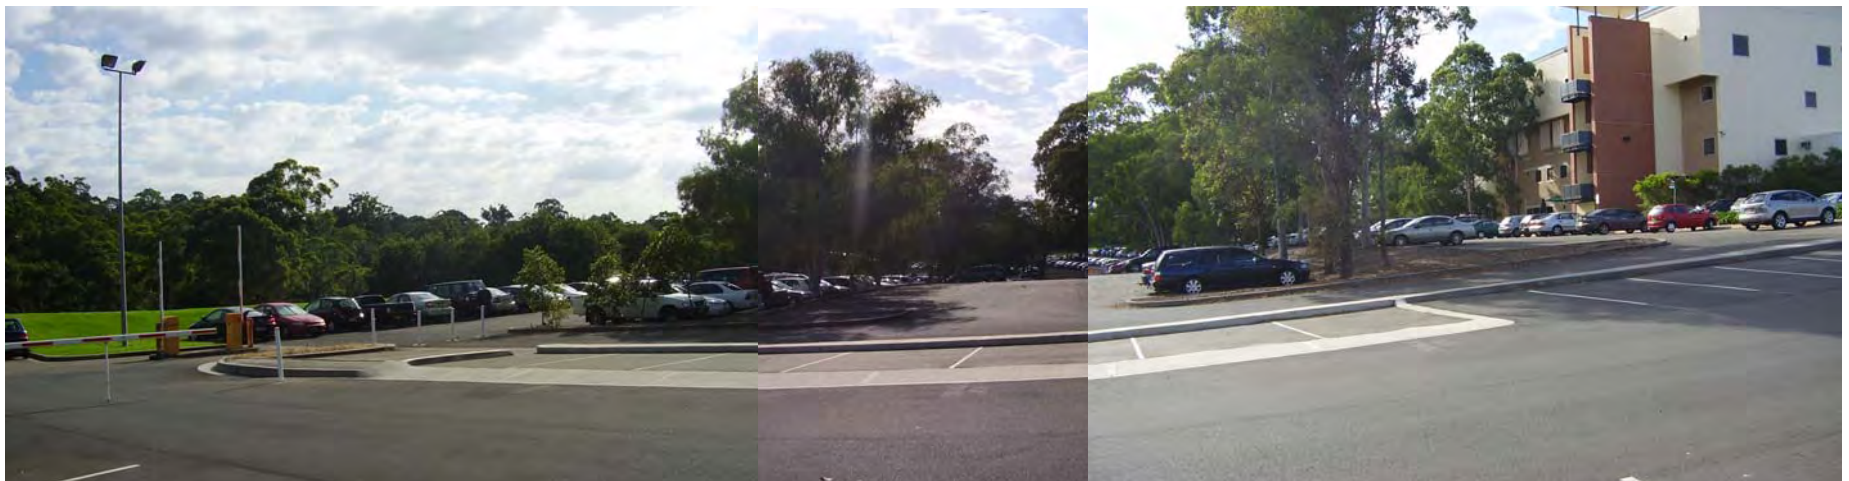
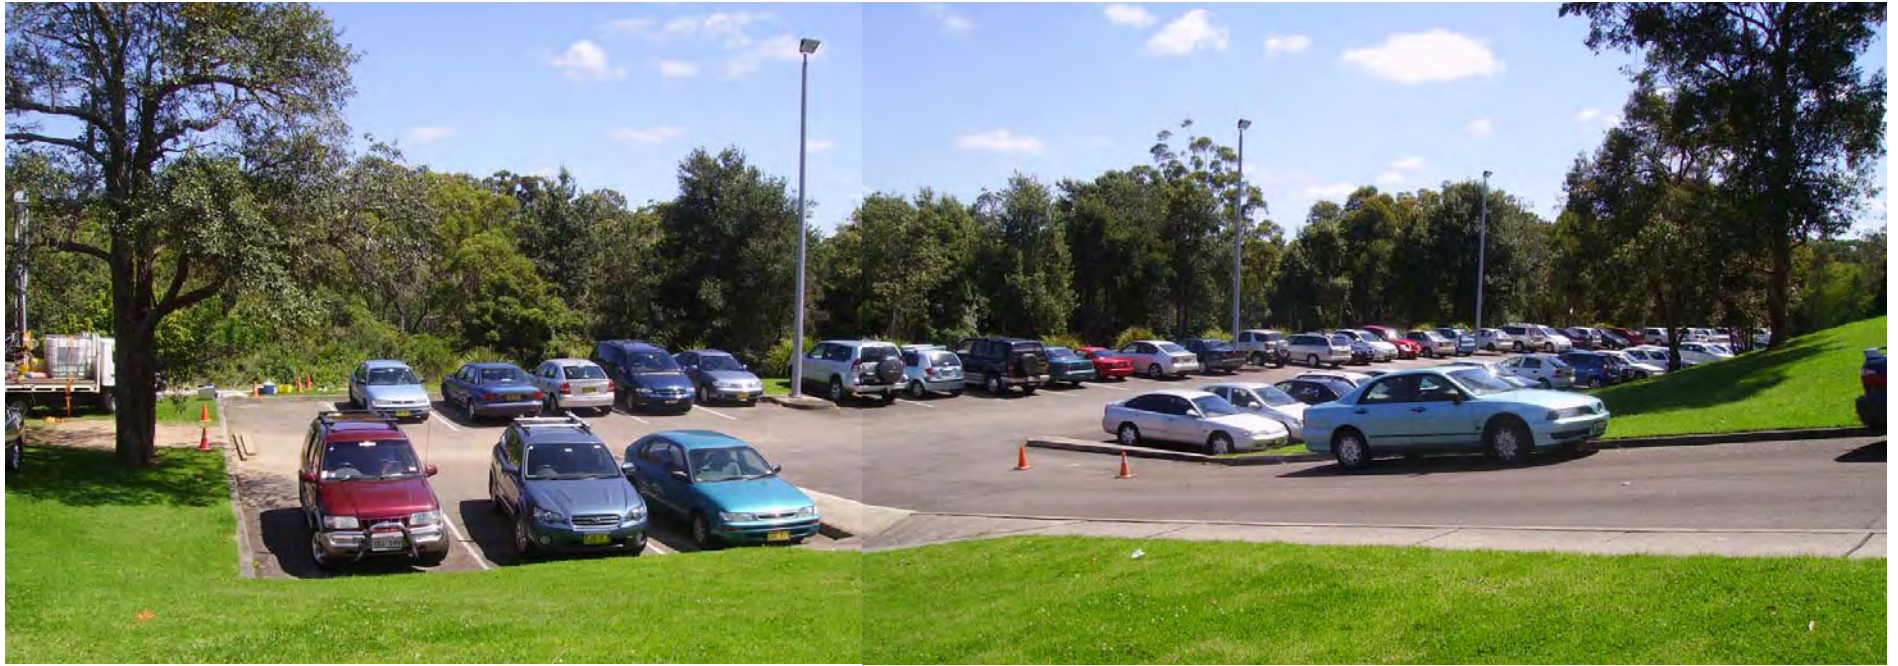
Photo 7 (Above): Looking northwest towards the car parking area of the proposed Building 1 footprint.

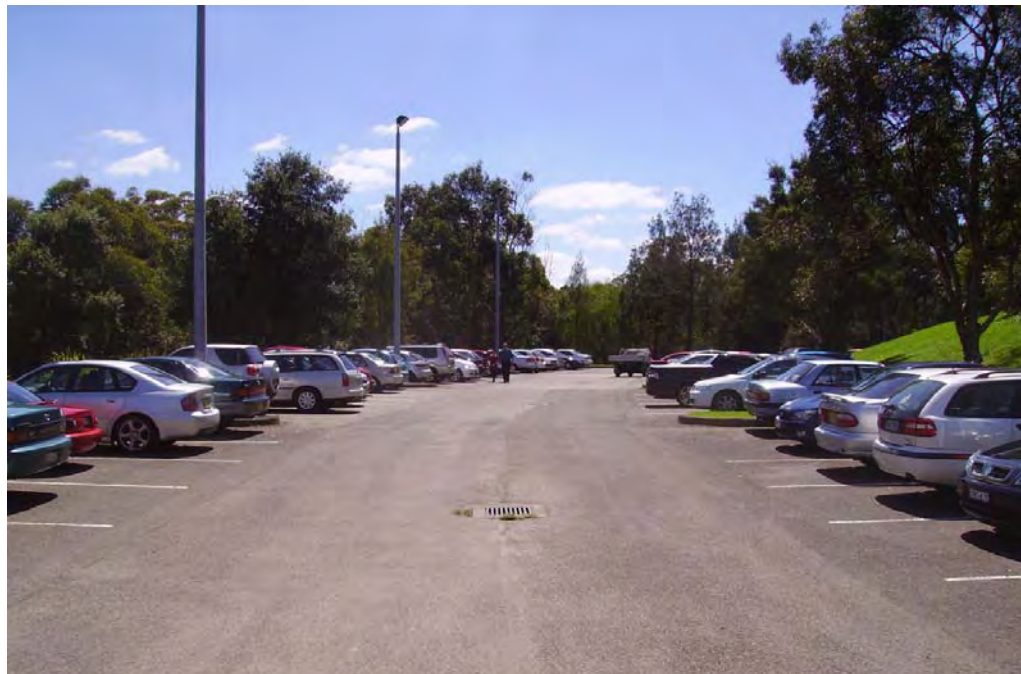
Photo 8 (Left): Looking north along the car parking area of the proposed Building 1 footprint.
