6.8 Visual

6.8.1 Existing Conditions

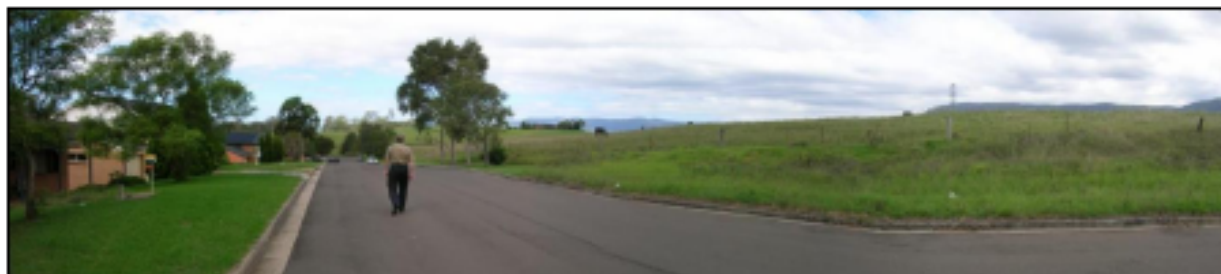
Panoramic view showing the relationship between the existing dwelling houses at Penrose and the subject site. The site gently rises from Goolagong Street towards the site.

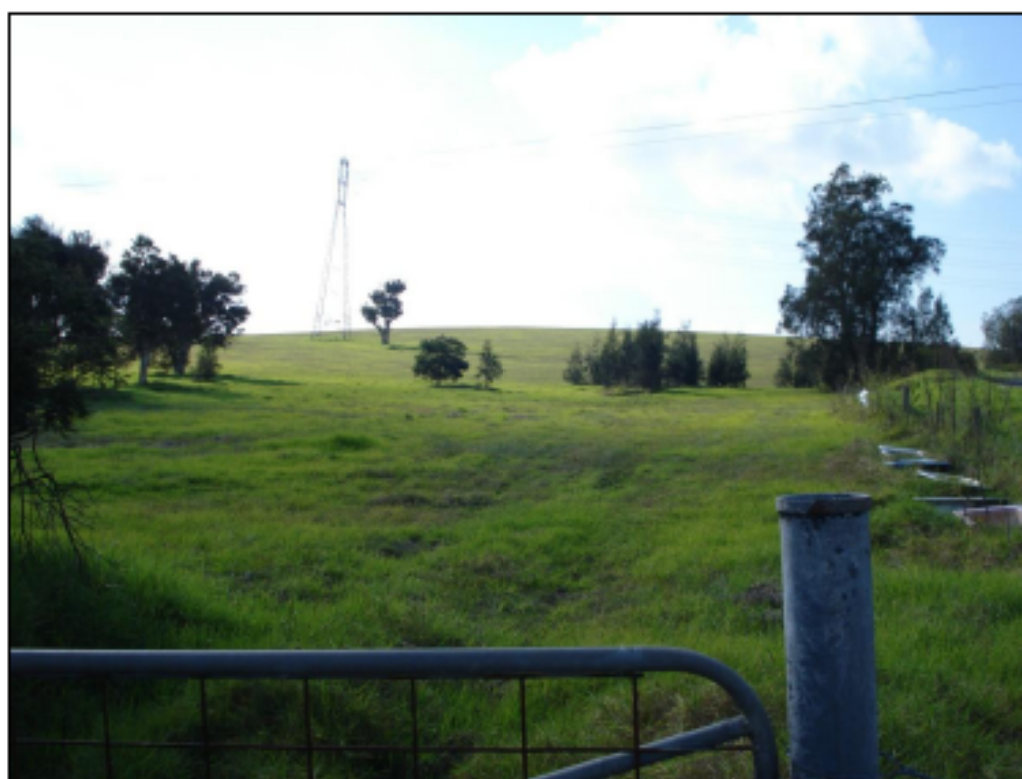
View from street level, showing the existing electricity powerline high on the site.

- The current land use of the subject site is open grassland sustaining limited grazing activities. A number of small trees scattered around the site. An electricity power line is located on the site and traverses the site in a north-south direction. Other than grassland, the majority of the site is clear of vegetation.

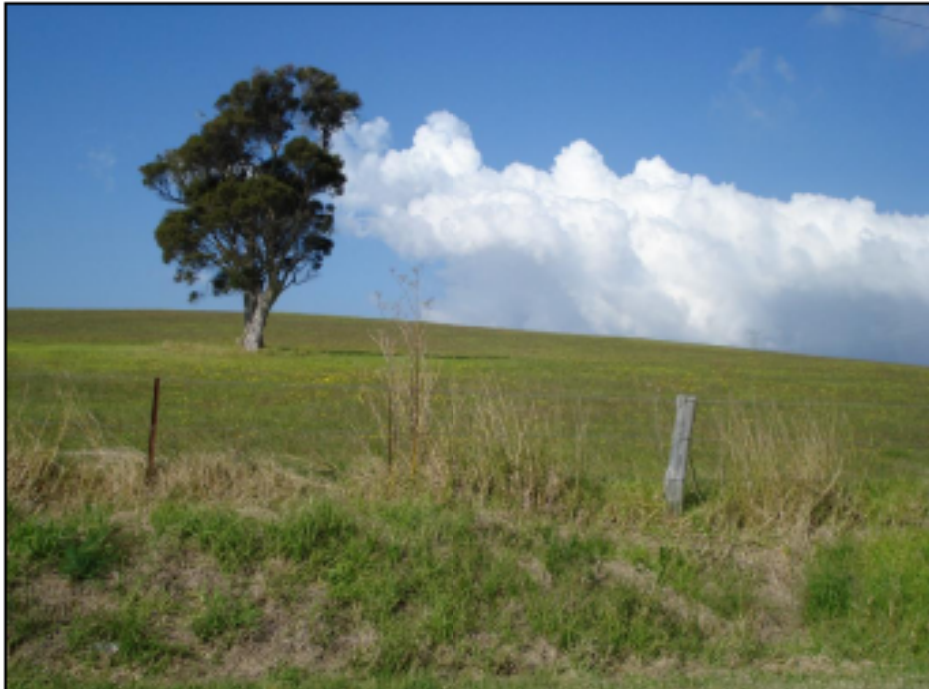
View of the hill top plateau area. Limited vegetation exists on the site.

- The site is characterised by relatively flat grounds. The topography gently rises to the central part of the site from the existing road levels. There is an obvious plateau towards the centre of the

site, with an elevation of RL49m. This rise forms a clear ridgeline that forms the catchment and sub catchment of the unnamed creek and the existing stormwater system. The ridgeline is evident visually and on the topographic map. Existing dwellings at Penrose are located at a lower level (RL 30-40m). Their view towards the site is characterised by a small hill and cleared land.

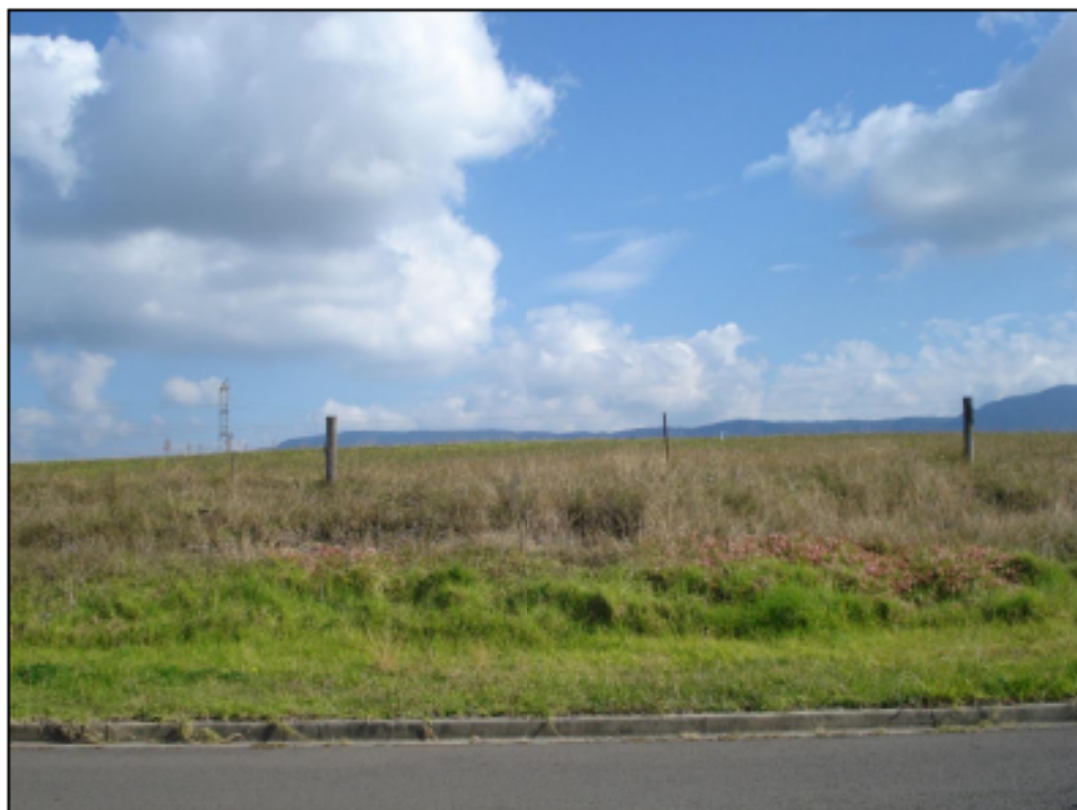
View from Goolagong Street looking towards the site showing the difference in grades. The escarpment is slightly visible in the background.

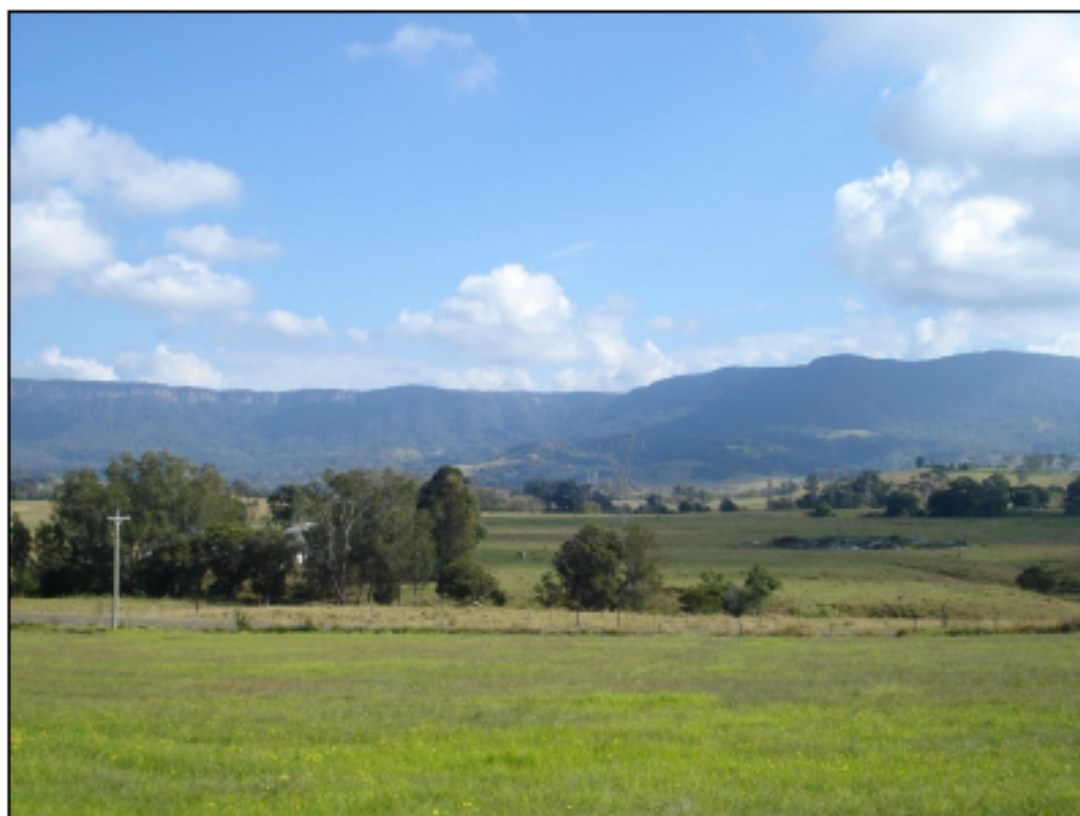
View from the site looking north. The escarpment is more prominent in this direction.

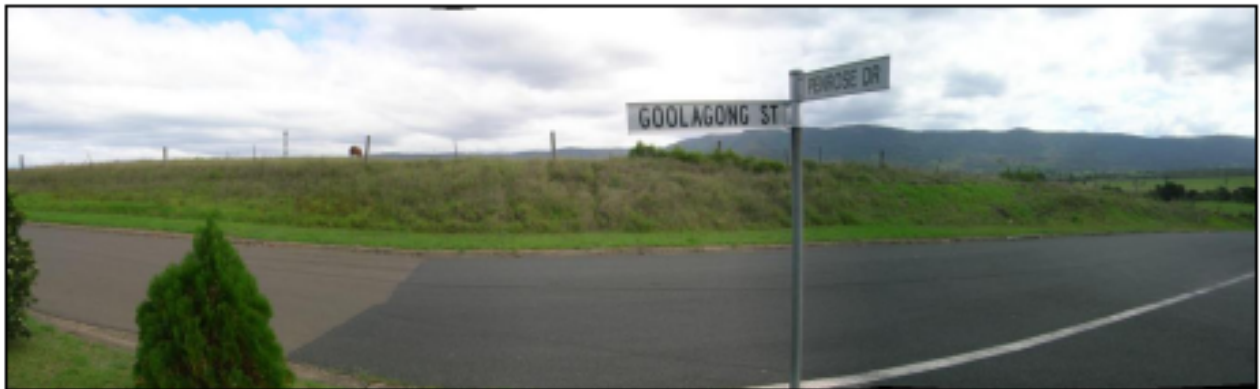
View from the existing residential area at Penrose looking into the site. The view is dominated by the gentle slope up to the site in the foreground and the escarpment in the background.

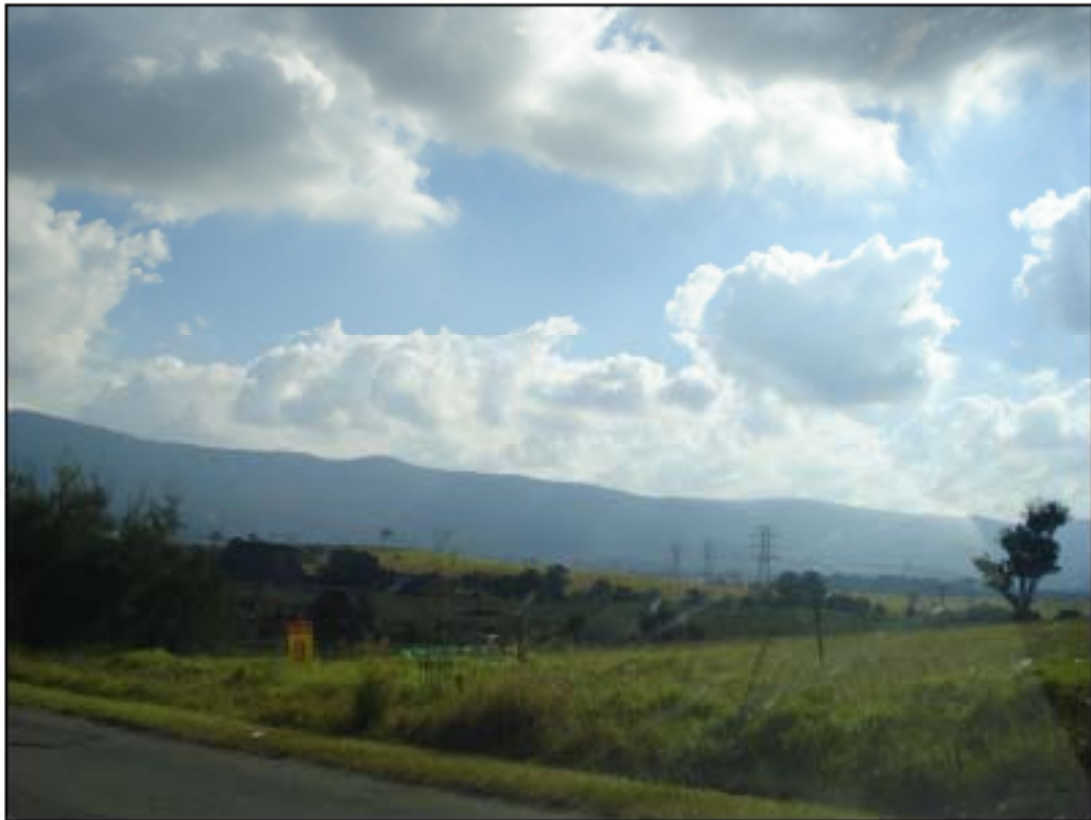
View along Huntley Road looking north towards the site. The view is characterised by the expansive area of rural properties in the foreground and middle ground, and the Illawarra escarpment in the background.

From the south looking north, the site fronts Huntley Road and the view is dominated by the expansive rural property. Again, the ridge line of the small hill on the site forms the edge of the view and the existing electricity transmission tower is visually prominent in this location.
