3.6 Chapman Lane

Chapman Lane, also known as Chaplin Street and Chapman Street, provided access from Liverpool Street through the centre of the nineteenth century block. It allowed night-soil access to the allotments on Victoria Street. A small lane opening off Chapman Lane, Wethered Street, provided the same service for most of the Liverpool Street allotments. Chapman Lane appears to have been formed as part of the original 1850s subdivision of this block.

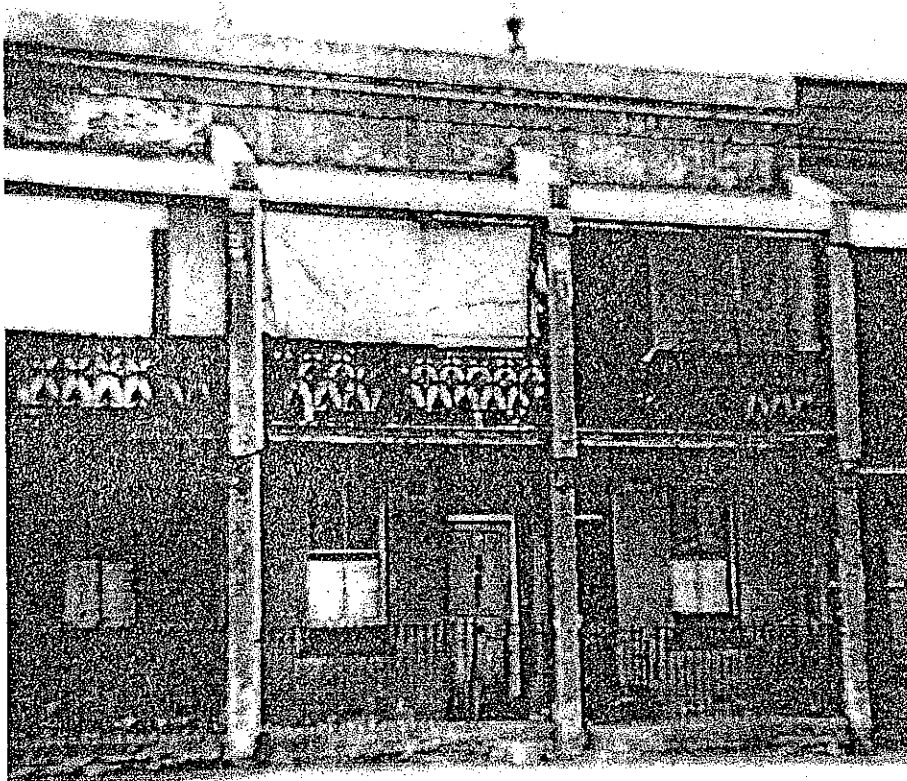
View of 12-18 Chapman Lane in 1933
(Source: Sydney City Archives, NSCA CRS 51/1612)

These blocks are also shown as undeveloped in 1865¹²⁰. They were developed between 1871 and 1877; by the latter year they were the property of Edwin Penfold¹²¹. They were constructed as a row of four terraces each one having progressively smaller yards as the lots diminished in size towards the south. By 1880 the terraces had become the property of Thomas Penfold¹²². They remained in the hands of the Penfold family into the 1890s¹²³.

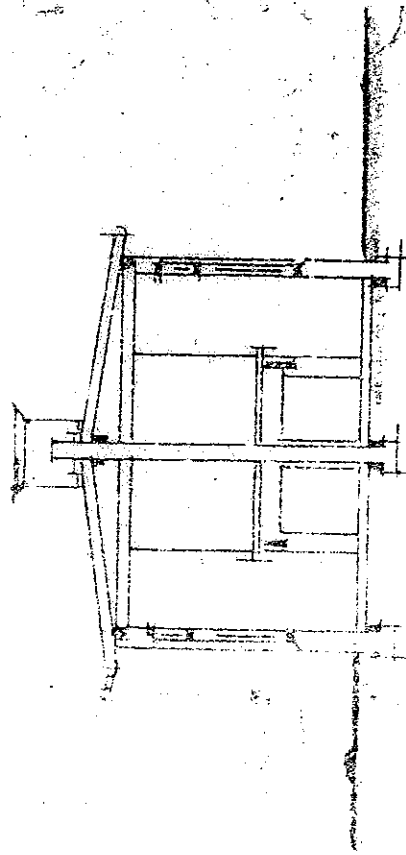
122-10-11-240105 469/11/10
12-14-16-18 CHAPLIN ST
DARLINGHURST.

SECTION

There is a plan of alterations proposed for these terraces in 1911. It appears that it was intended to add a separate small service wing behind each terrace to house a small kitchen and laundry with the exception of No. 18 Chapman Lane which had too small a yard to encompass anything but a very small kitchen. There is no evidence to show whether these works proceeded¹²⁴.

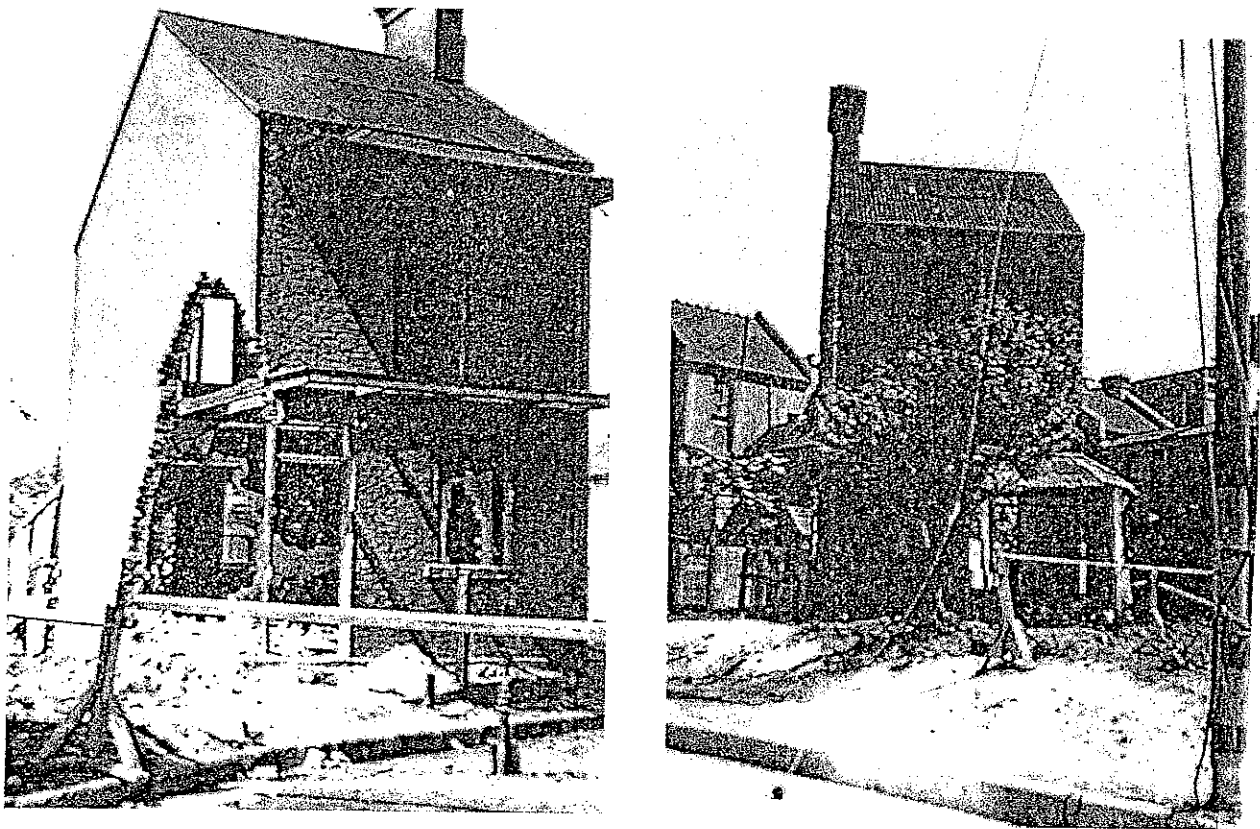
Two views of 20 Chaplin Street before and during demolition
(Source: Sydney City Archives, NSCA CRS 51/1697, NSCA CRS 51/1692)

This small building with its small yard and out-house is recorded on the 1885 survey when it was shown to run next to the back fences of the terraces on Burton Street¹²⁹. It was still present in 1891¹³⁰ but it is claimed to have been demolished by 1899¹³¹. However, there is a photograph of a two-storey building being demolished at 20 Chaplin Street in 1937. The style of the building suggests that it was the original terrace constructed here in 1880.

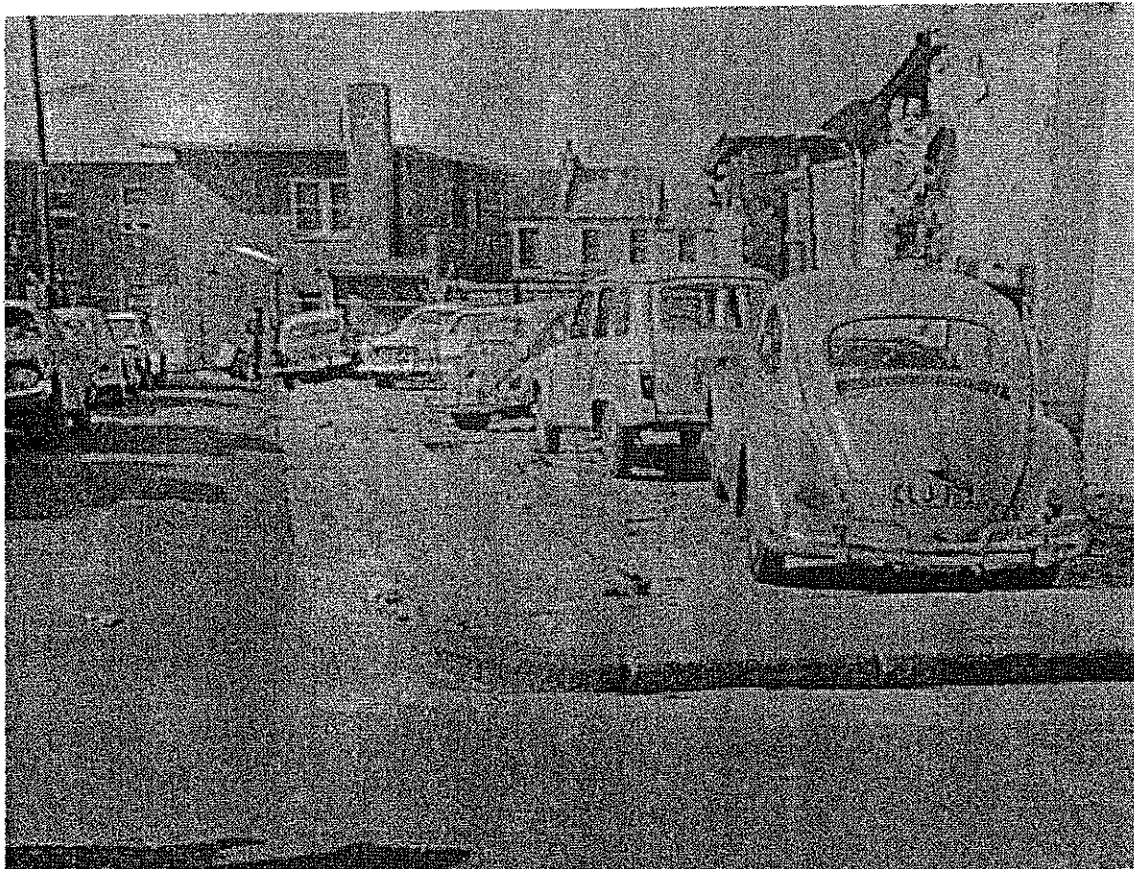
Wethered Street in 1969 looking east. The buildings to the right are the old houses then in a ruinous condition.

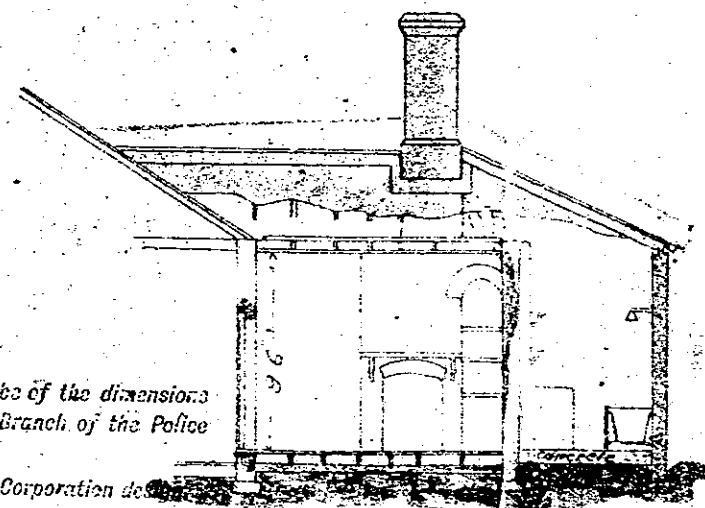
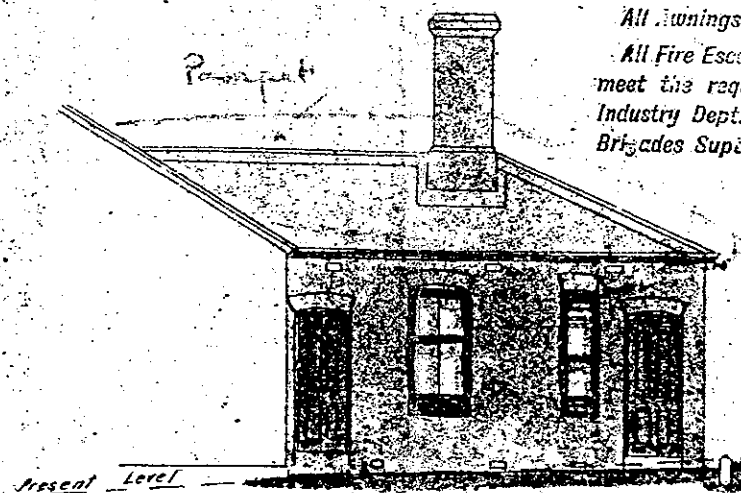
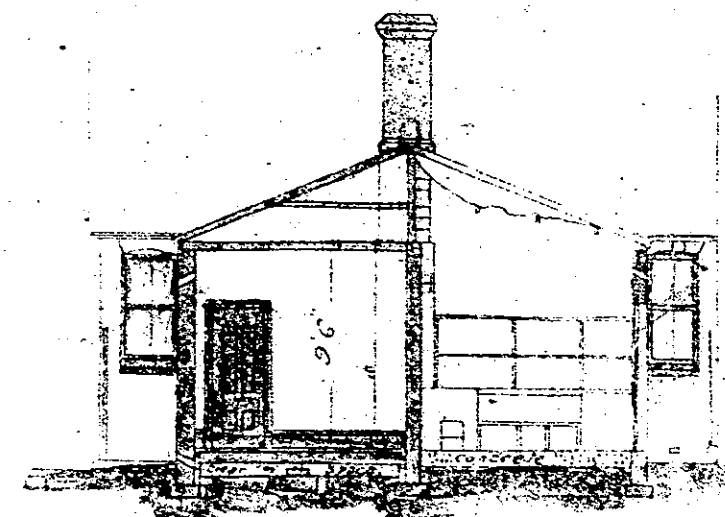
Alterations Proposed to 45 & 47 West St Darlinghurst

Present Cottage at Rear to be taken away.
Present Kitchens to be taken down & new built
as shown, along course &c as recommended by
Council.

By the 1930s the terraces were still occupied but, by this date, the formerly detached service wings had been joined to the back of the terraces¹⁵⁸. This work is shown on a Council Plan of the 1912. They are shown here to enclose kitchens and bathrooms in each wing¹⁵⁹.

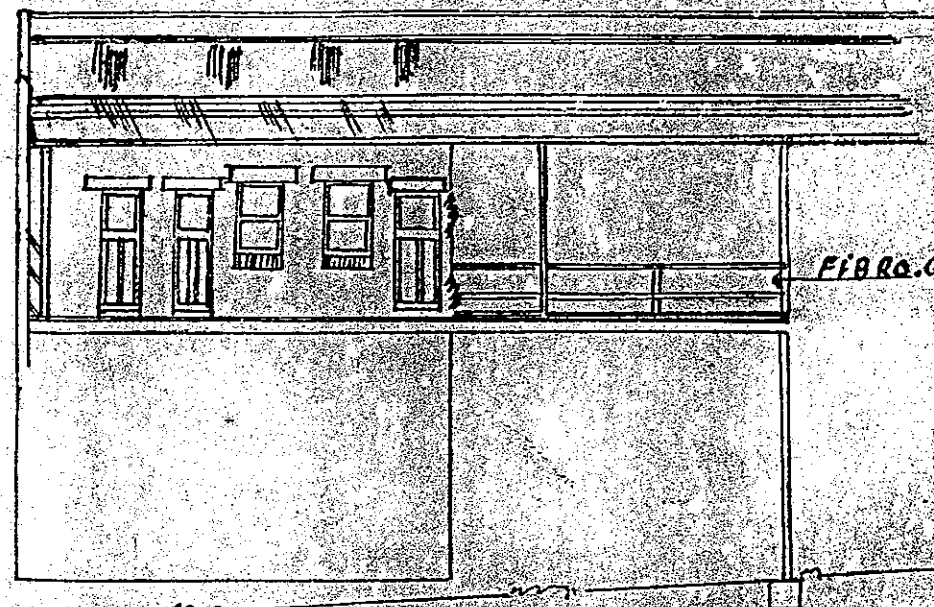
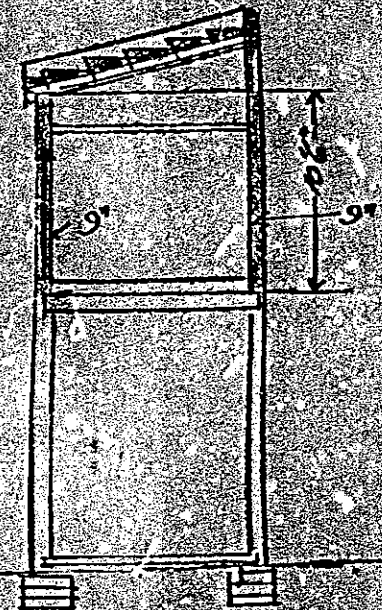
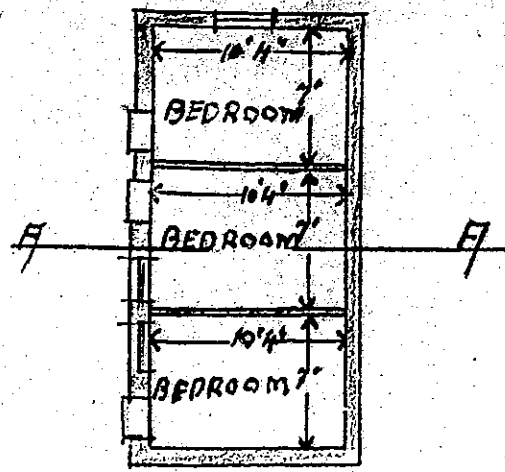
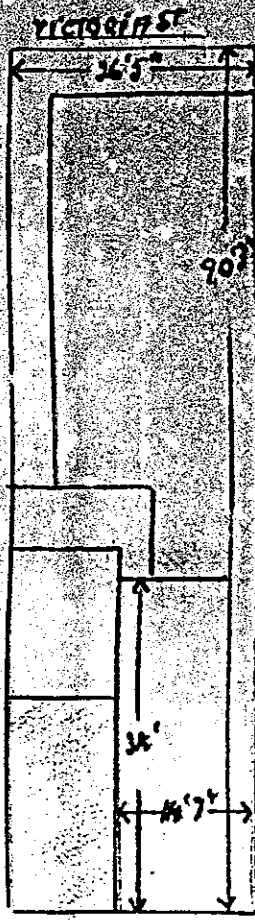
PROPOSED ADDITIONAL
STORY. HT REAR
OF 374 VICTORIA STREET
DARLINGHURST
FOR NURSE DENNEY

ELEVATION

SECTION H-F

PLAN

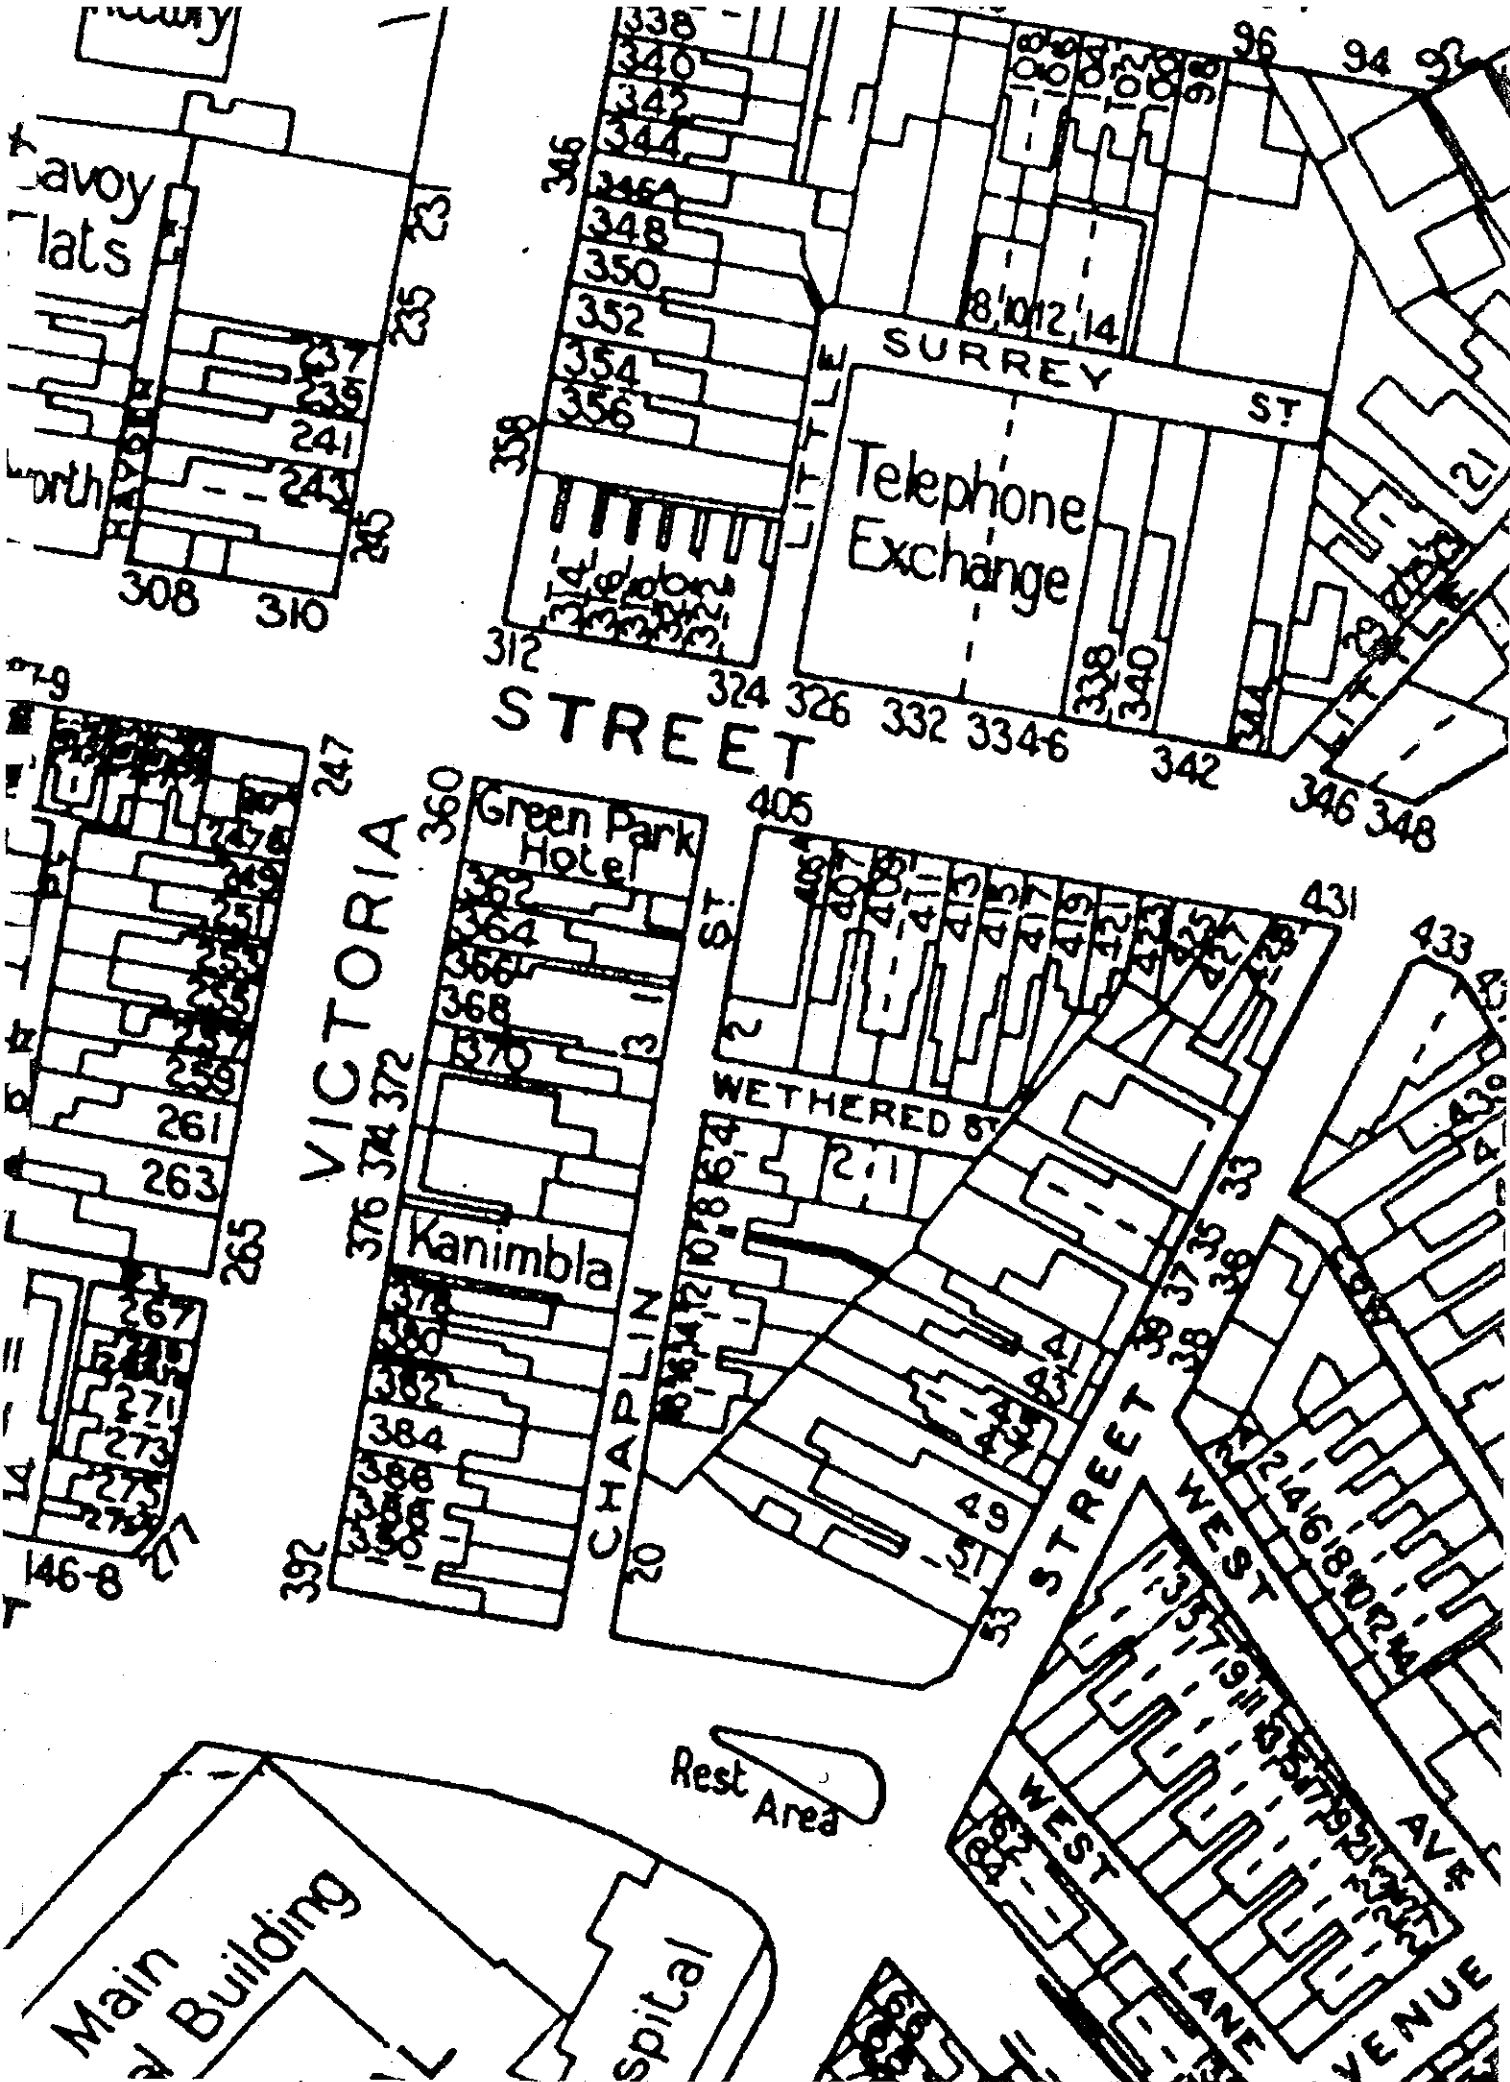
The study area in 1948
