Stage 1 Land Contamination Assessment:  
Lot 22 DP 607750 and Lot 4 DP 258024  
Corner Avondale Road and Huntley Road,  
Huntley, NSW

P0802279JR01\_v2  
May 2009

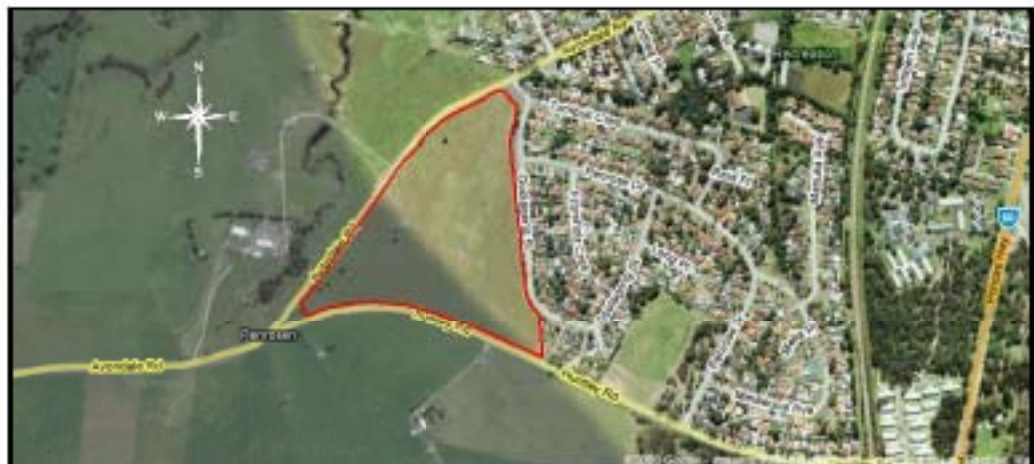
Figure 1: Site location.

The subject site (Lot 22 DP 607750 and Lot 4 DP 258024) is located at the corner of Avondale Road and Huntley Road, Huntley, NSW and is within the Wollongong City Council Local Government Area. It is bordered by Huntley Road to the south, Avondale Road to the west and north, and Goolagong Street to the east (Figure 1).

The site is currently pasture and has an area of approximately 10.5 ha. Refer to Attachment A for a site plan. Surrounding land use is generally low density residential to the east and rural pastures west and south of the site.
