1.3.2 Site Analysis

1.4 Site Character

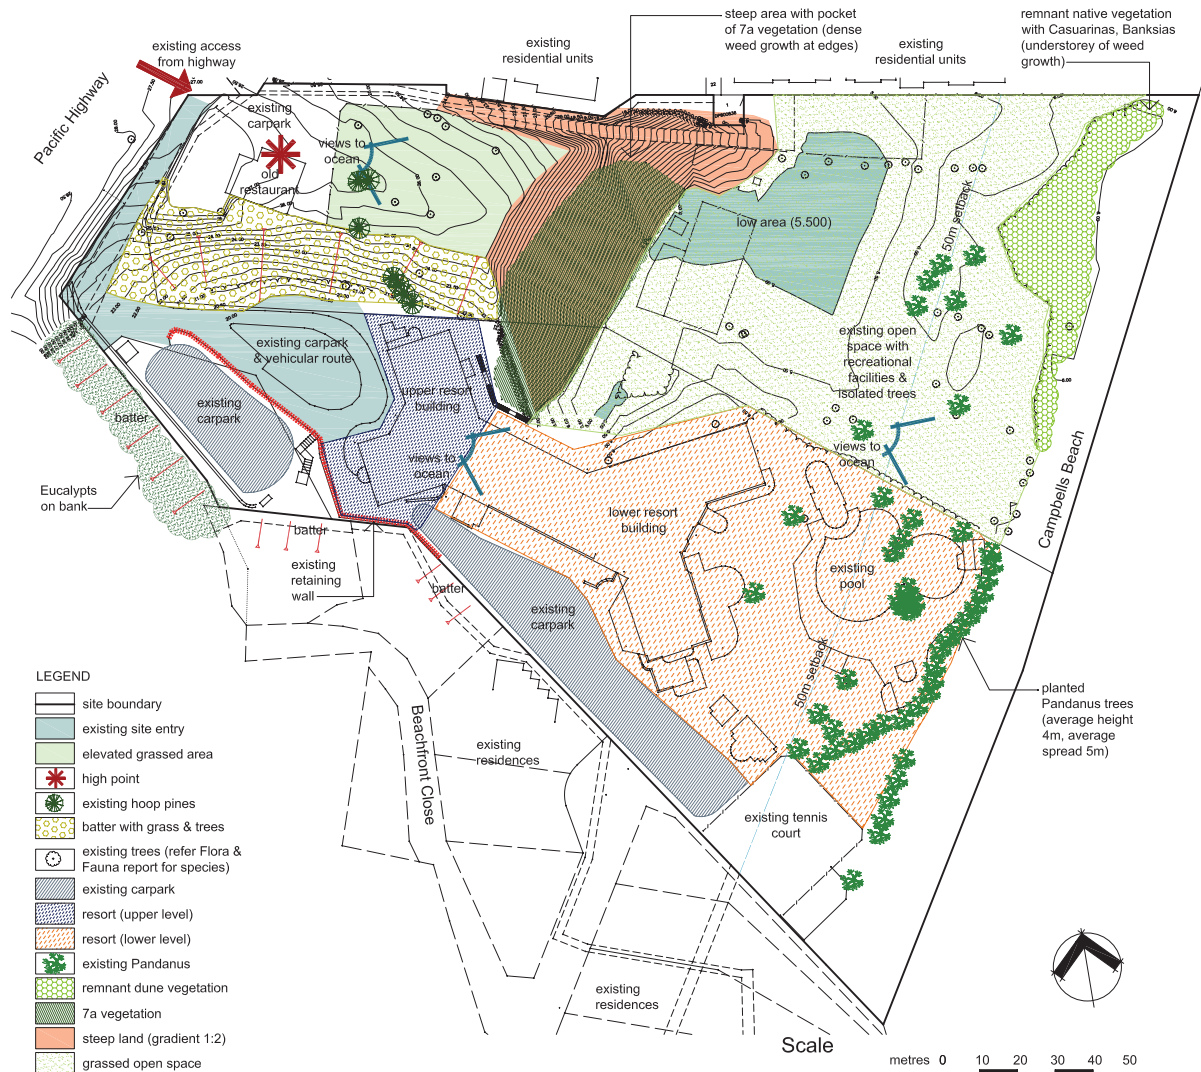
Illustration 4 - Site Analysis

Illustration 4 provides an overview of the significant site characteristics and existing vegetation.

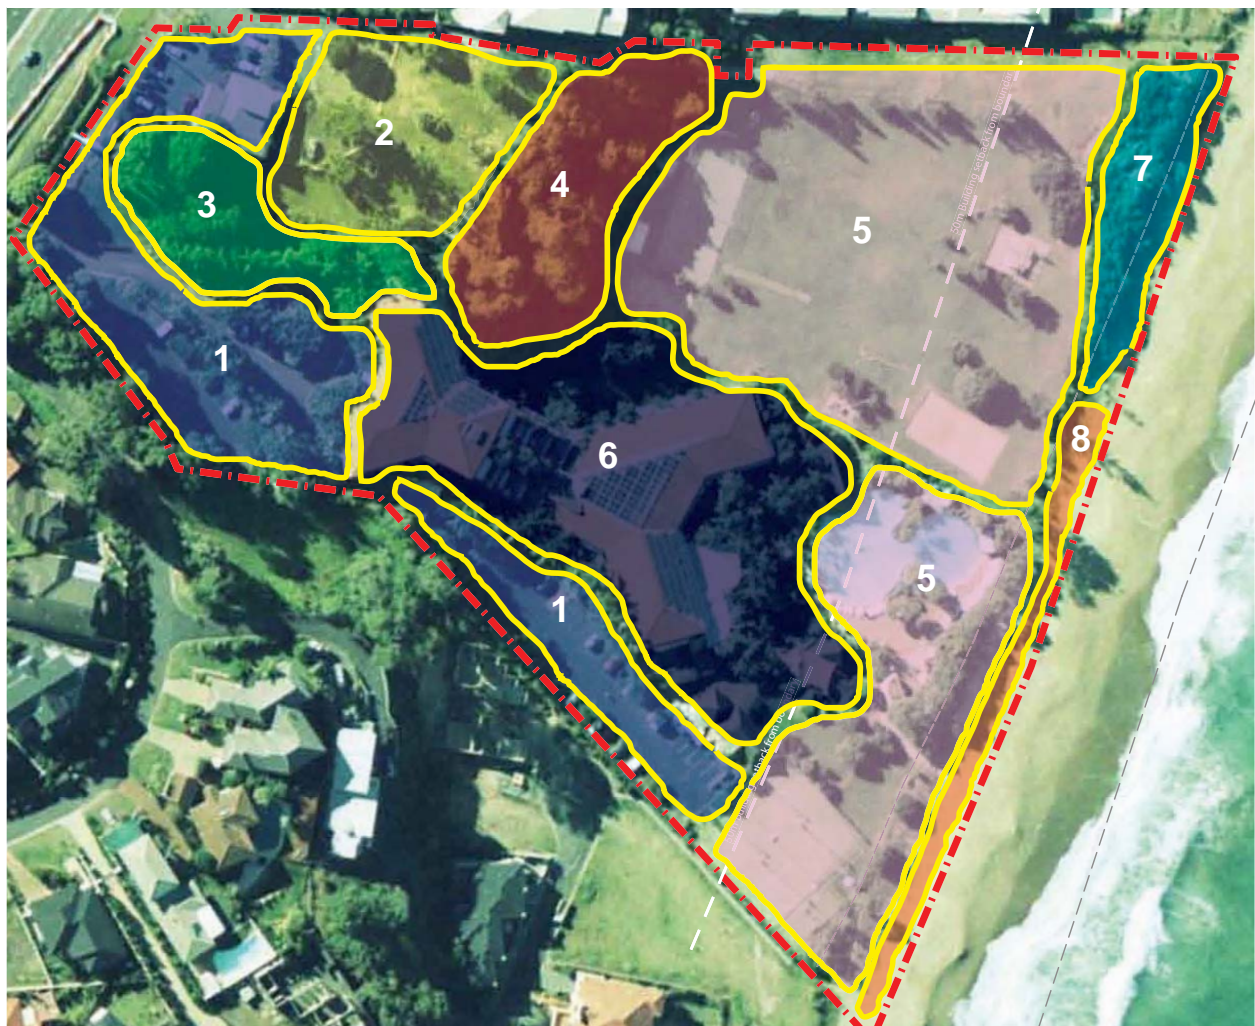
Illustration 5 - Site Character Analysis

The following illustration identifies key site character areas with a description of each character area type following.

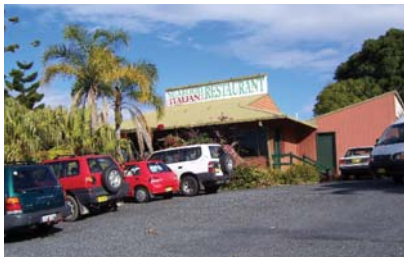
former Italian restaurant and carpark

This character area type includes two locations. The first is the existing entry to the former Pelican Beach Resort, Italian restaurant and associated carparking. The second is located south of the lower resort building and is an elongated carparking area with landscaping. The existing character of these locations is of a highly modified landscape with a focus on built infrastructure including road pavement, kerbing, services, drainage and signage. Both areas include retaining walls along their southern extent. The landscape surrounds to these areas are also highly manipulated with a focus on gardens of exotic species, in particular, palms and sub-tropical species. The lower carparking area includes a number of shade trees, however, due to the limited size of planting beds these are mostly struggling with the growing conditions. These locations were, during operation, highly maintained, however, they now appear dated. Some garden areas includes species that are now environmental weeds or are deemed inappropriate plant choices by the local authority e.g. Umbrella Trees.

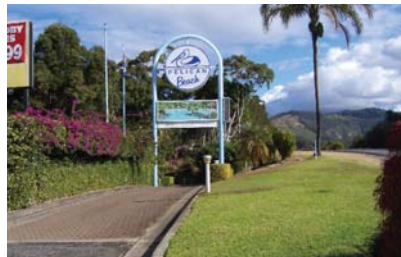
entry to former Pelican Beach Resort

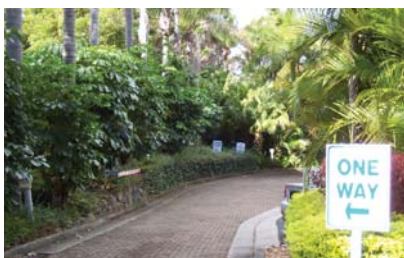
loop road outside former resort entry

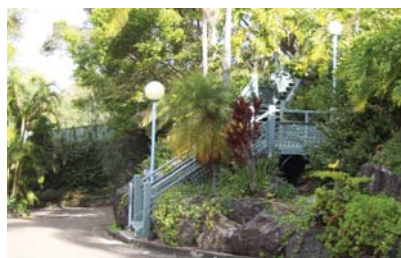
retaining wall and landscaping between access & carpark

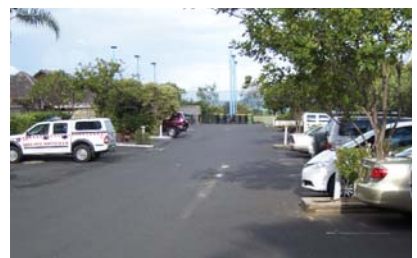
lower carpark

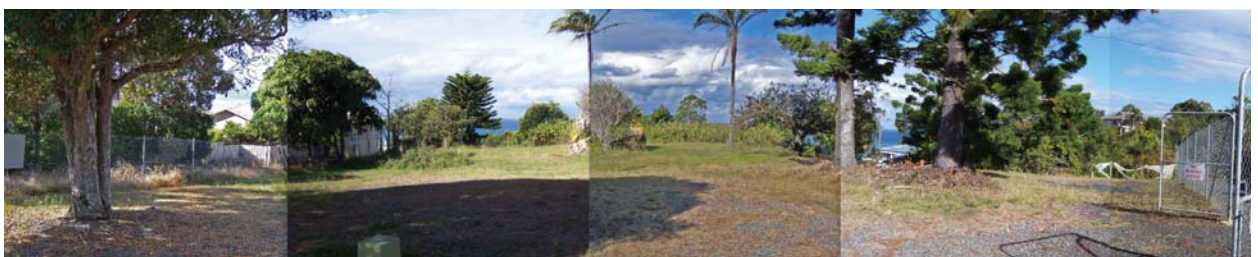
grassed spur with planted landscape trees and views to the ocean

This character area type is located on the highest part of the site, east of the former Italian restaurant. The area is a grassed spur with an easterly aspect. It overlooks the pocket of 7(a) vegetation and the lower part of the site. This area includes a scattering of isolated trees. The most visually obvious of these are a pair of Hoop Pines just to the south of the ridgeline, a single Hoop Pine further to the south and a line of four Hoop Pines on the southeastern extent of the grassed area. Other trees include a Lilly Pilly, Mango tree and a Norfolk Island Pine. Given the age and species of these trees, it appears that all the trees at this location have been planted at some stage. A number of the Hoop Pines are showing signs of illness with yellowing foliage. Features of this location are the elevation, the easterly aspect and the ocean views.
