# Pipers Creek Stage 1 Report

R.B17295.001.00.doc

April 2009

| <b>Synopsis :</b> | This report presents the baseline flooding and stormwater management assessments. |

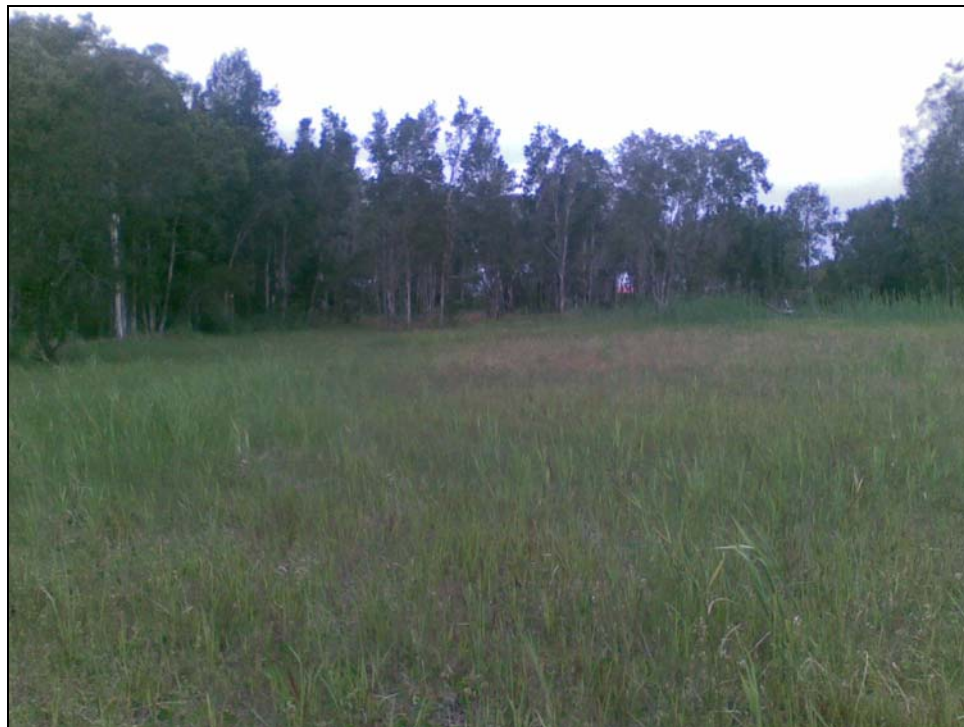
**Figure 2-1 Front portion of site looking towards Forster Keys**

The portion adjacent to the Reserve boundary and extending into the site for approximately 50m is flat with elevations varying between 0.2 to 1.0 m AHD (averaging about 0.5m AHD) apart from a small portion behind the Lakeside Tavern which exists at about 1.8 m AHD. Figure 2-1 provides a photograph taking in the front portion of the site looking south towards Forster Keys.

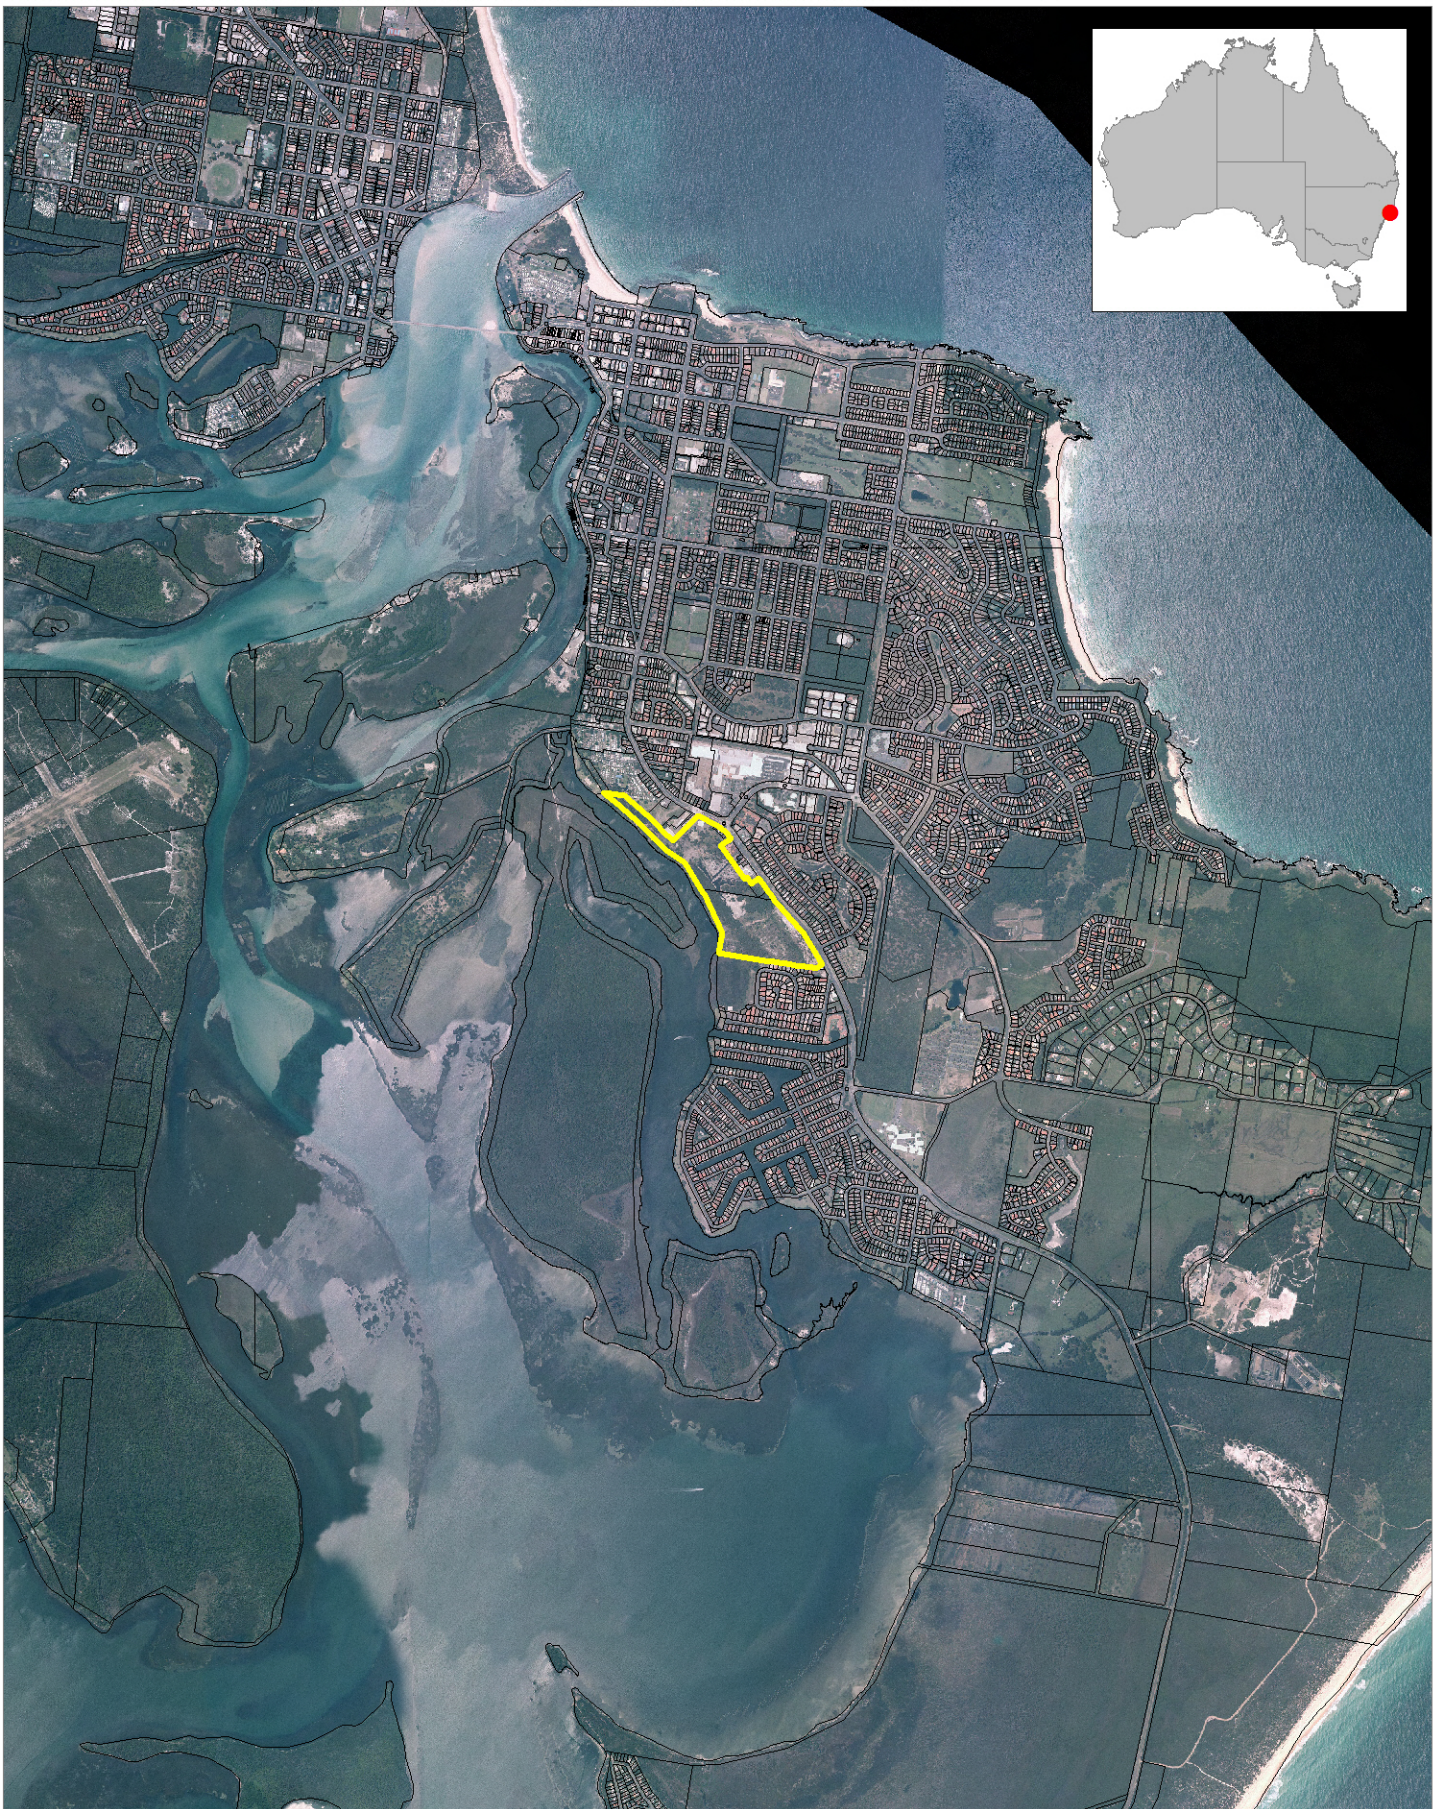
Figure:  
**2-2**

The site is located on The Lakes Way, South Forster as shown in Figure 2-2. The site extent includes Part Lot 20 DP 22631, Lot 148 DP 651471 and Lot 37 DP 1023220 and has a total extent of approximately 24ha.

Title:  
**Site Extent and Locality**

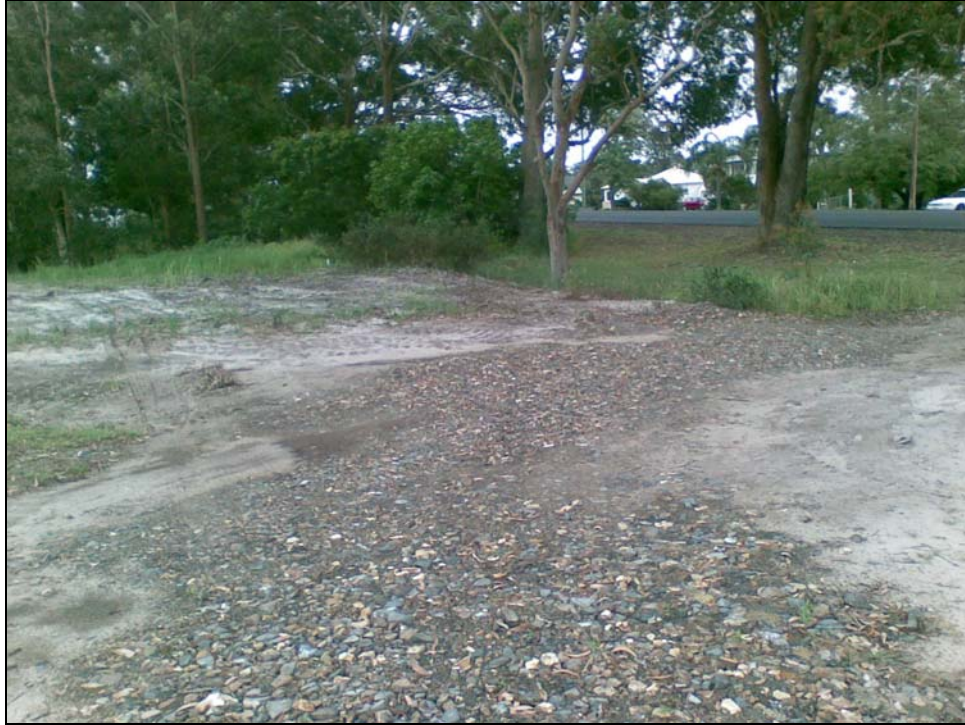
**Figure 2-4 Front portion of site looking towards The Lakes Way**

The portion adjacent to the boundary on The Lakes Way extending about 50m into the site (excluding allotments owned by others, e.g. Barclays Marine) is flat with elevations varying between 2.0 to 4.3 m (averaging about 3.0m AHD). Figure 2-4 provides a photograph taken in the front portion of the site at a location to the south of Barclays Marine.

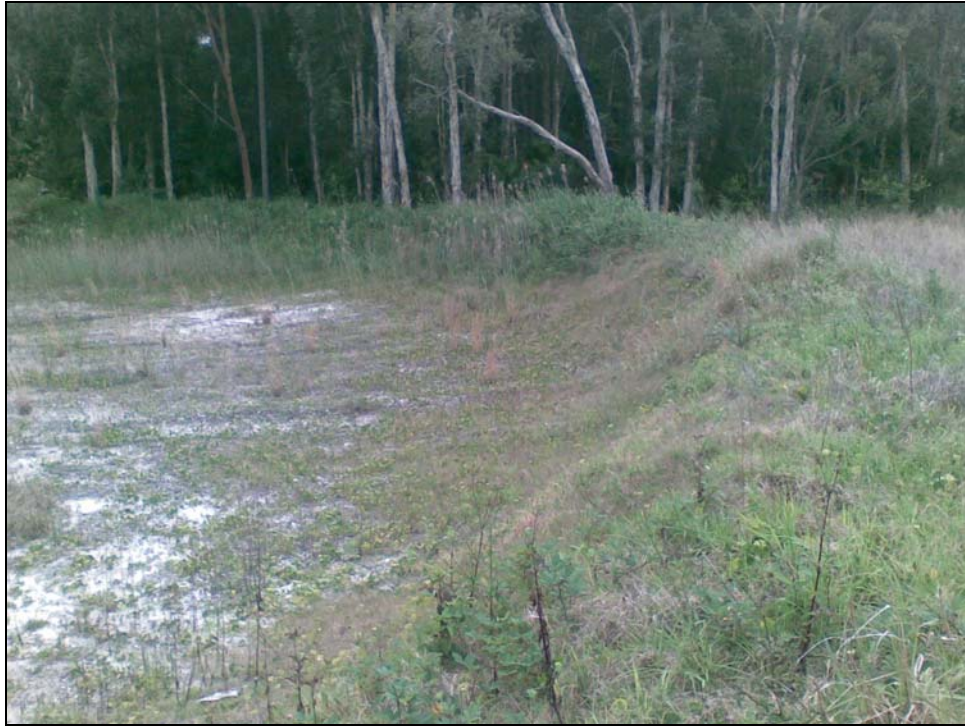
**Figure 2-5 Embankment in middle section of site**

The middle portion of the site shows evidence of existing fill activities and as such has an unusual topography. While this portion would still be described as flat across the whole, it has a number of what appear to be filled access tracks and embankments to water bodies (most of these were empty at the time of inspection) as shown in Figure 2-5.

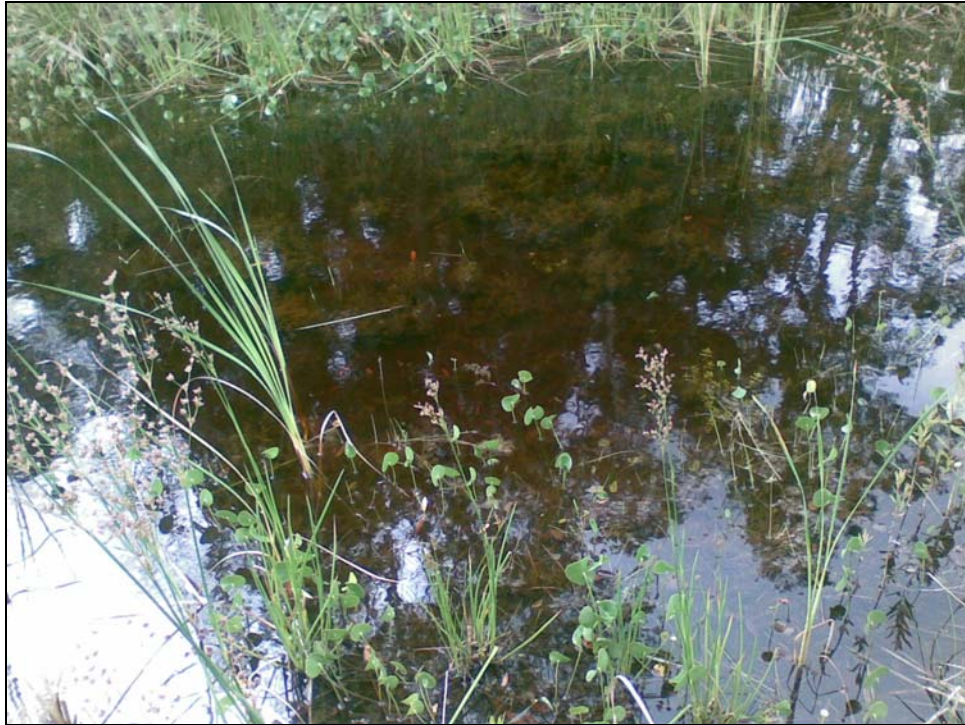
**Figure 2-6 Water in basin in middle portion of site**

The larger basin immediately to the south appears to have a tidal connection to Pipers Creek. It is also shallow enough to potentially allow for groundwater to surface. Water was noted to occur in the shallowest portion of this depression (i.e. its northern end) at the time of inspection (November 2008) as shown in Figure 2-6.
