Contamination Assessment Summary
RISE Concept Plan – MP08-0234 application
Bilambil Heights
New South Wales

Prepared for:
Terranora Group Management

April, 2009

Summary

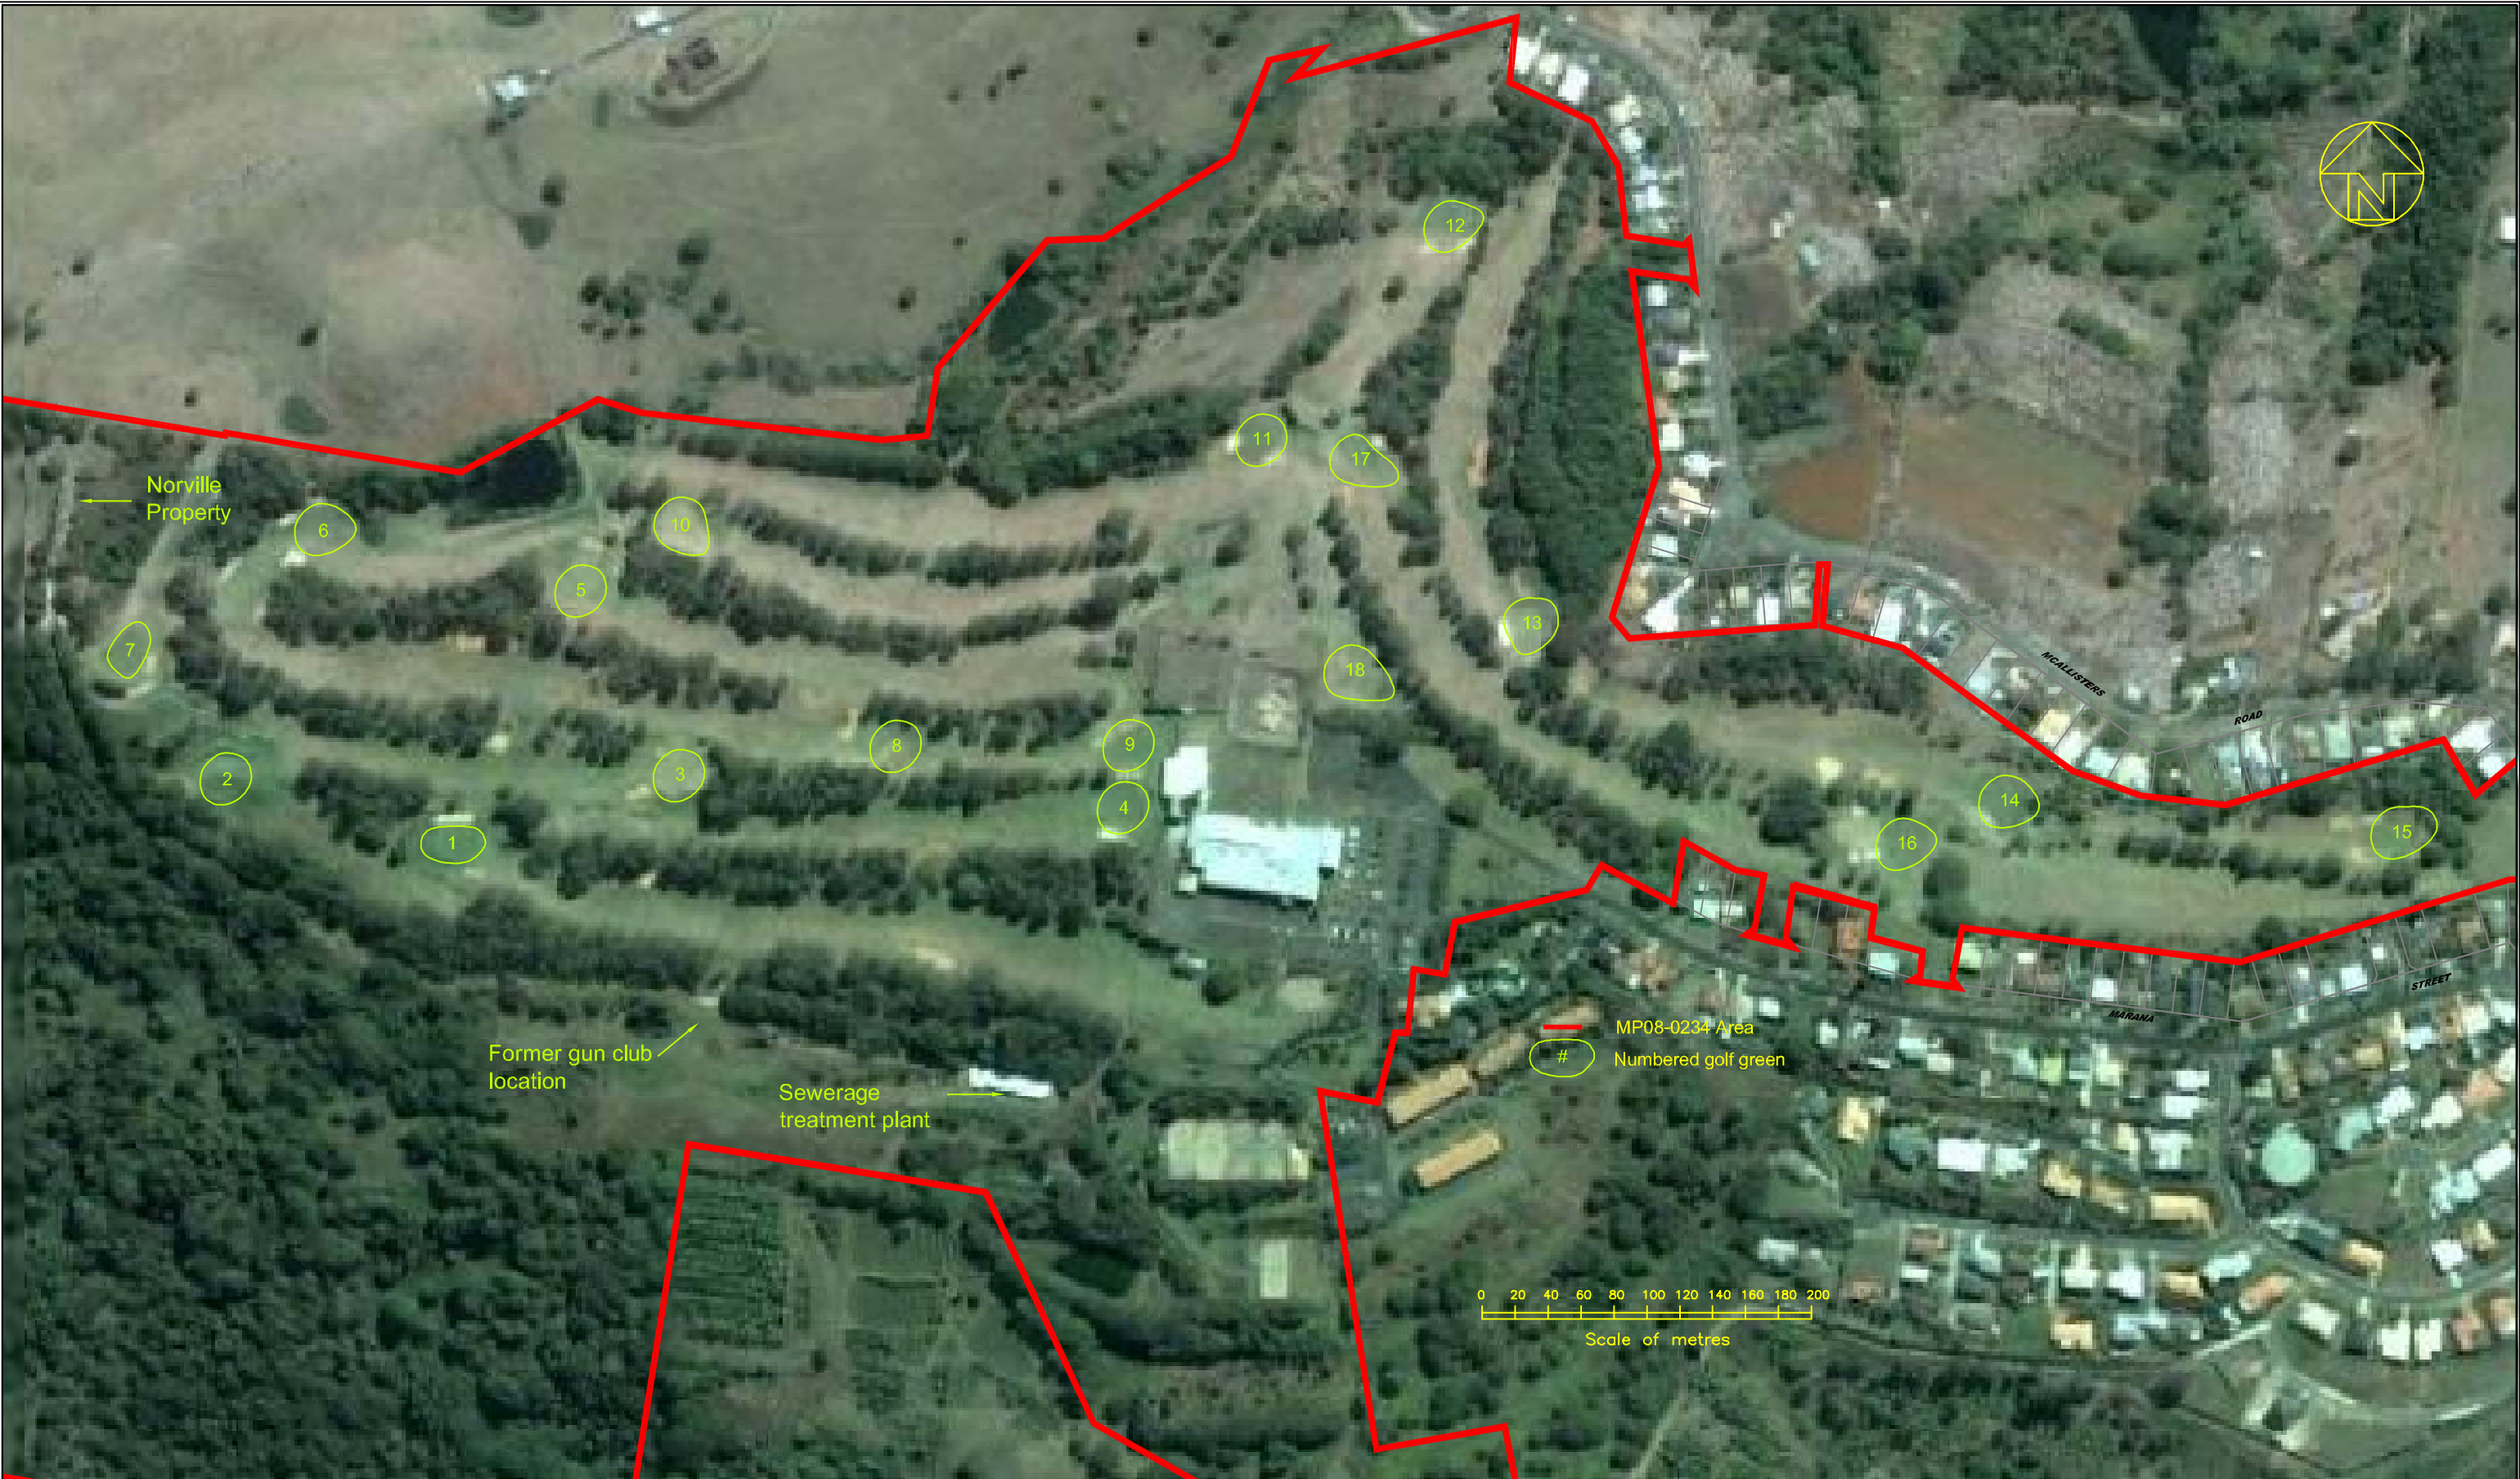
The HILs presented in the NEPM Guidelines state that the levels of Aldrin and Dieldrin for a composite of three (3) samples should not exceed 3.33mg/kg. As the Dieldrin concentrations exceeded the NEPM HILs guidelines within the greens on the 12th, 14th and 15th holes, remediation of this soil is required. The 16th green OC pesticide concentration (2.96mg/kg) is considered to be marginally elevated due to the composite sampling technique used and would be deemed subject to further investigation.

Figure GJ0495.4.3 shows the indicative locations subject to this contamination investigation

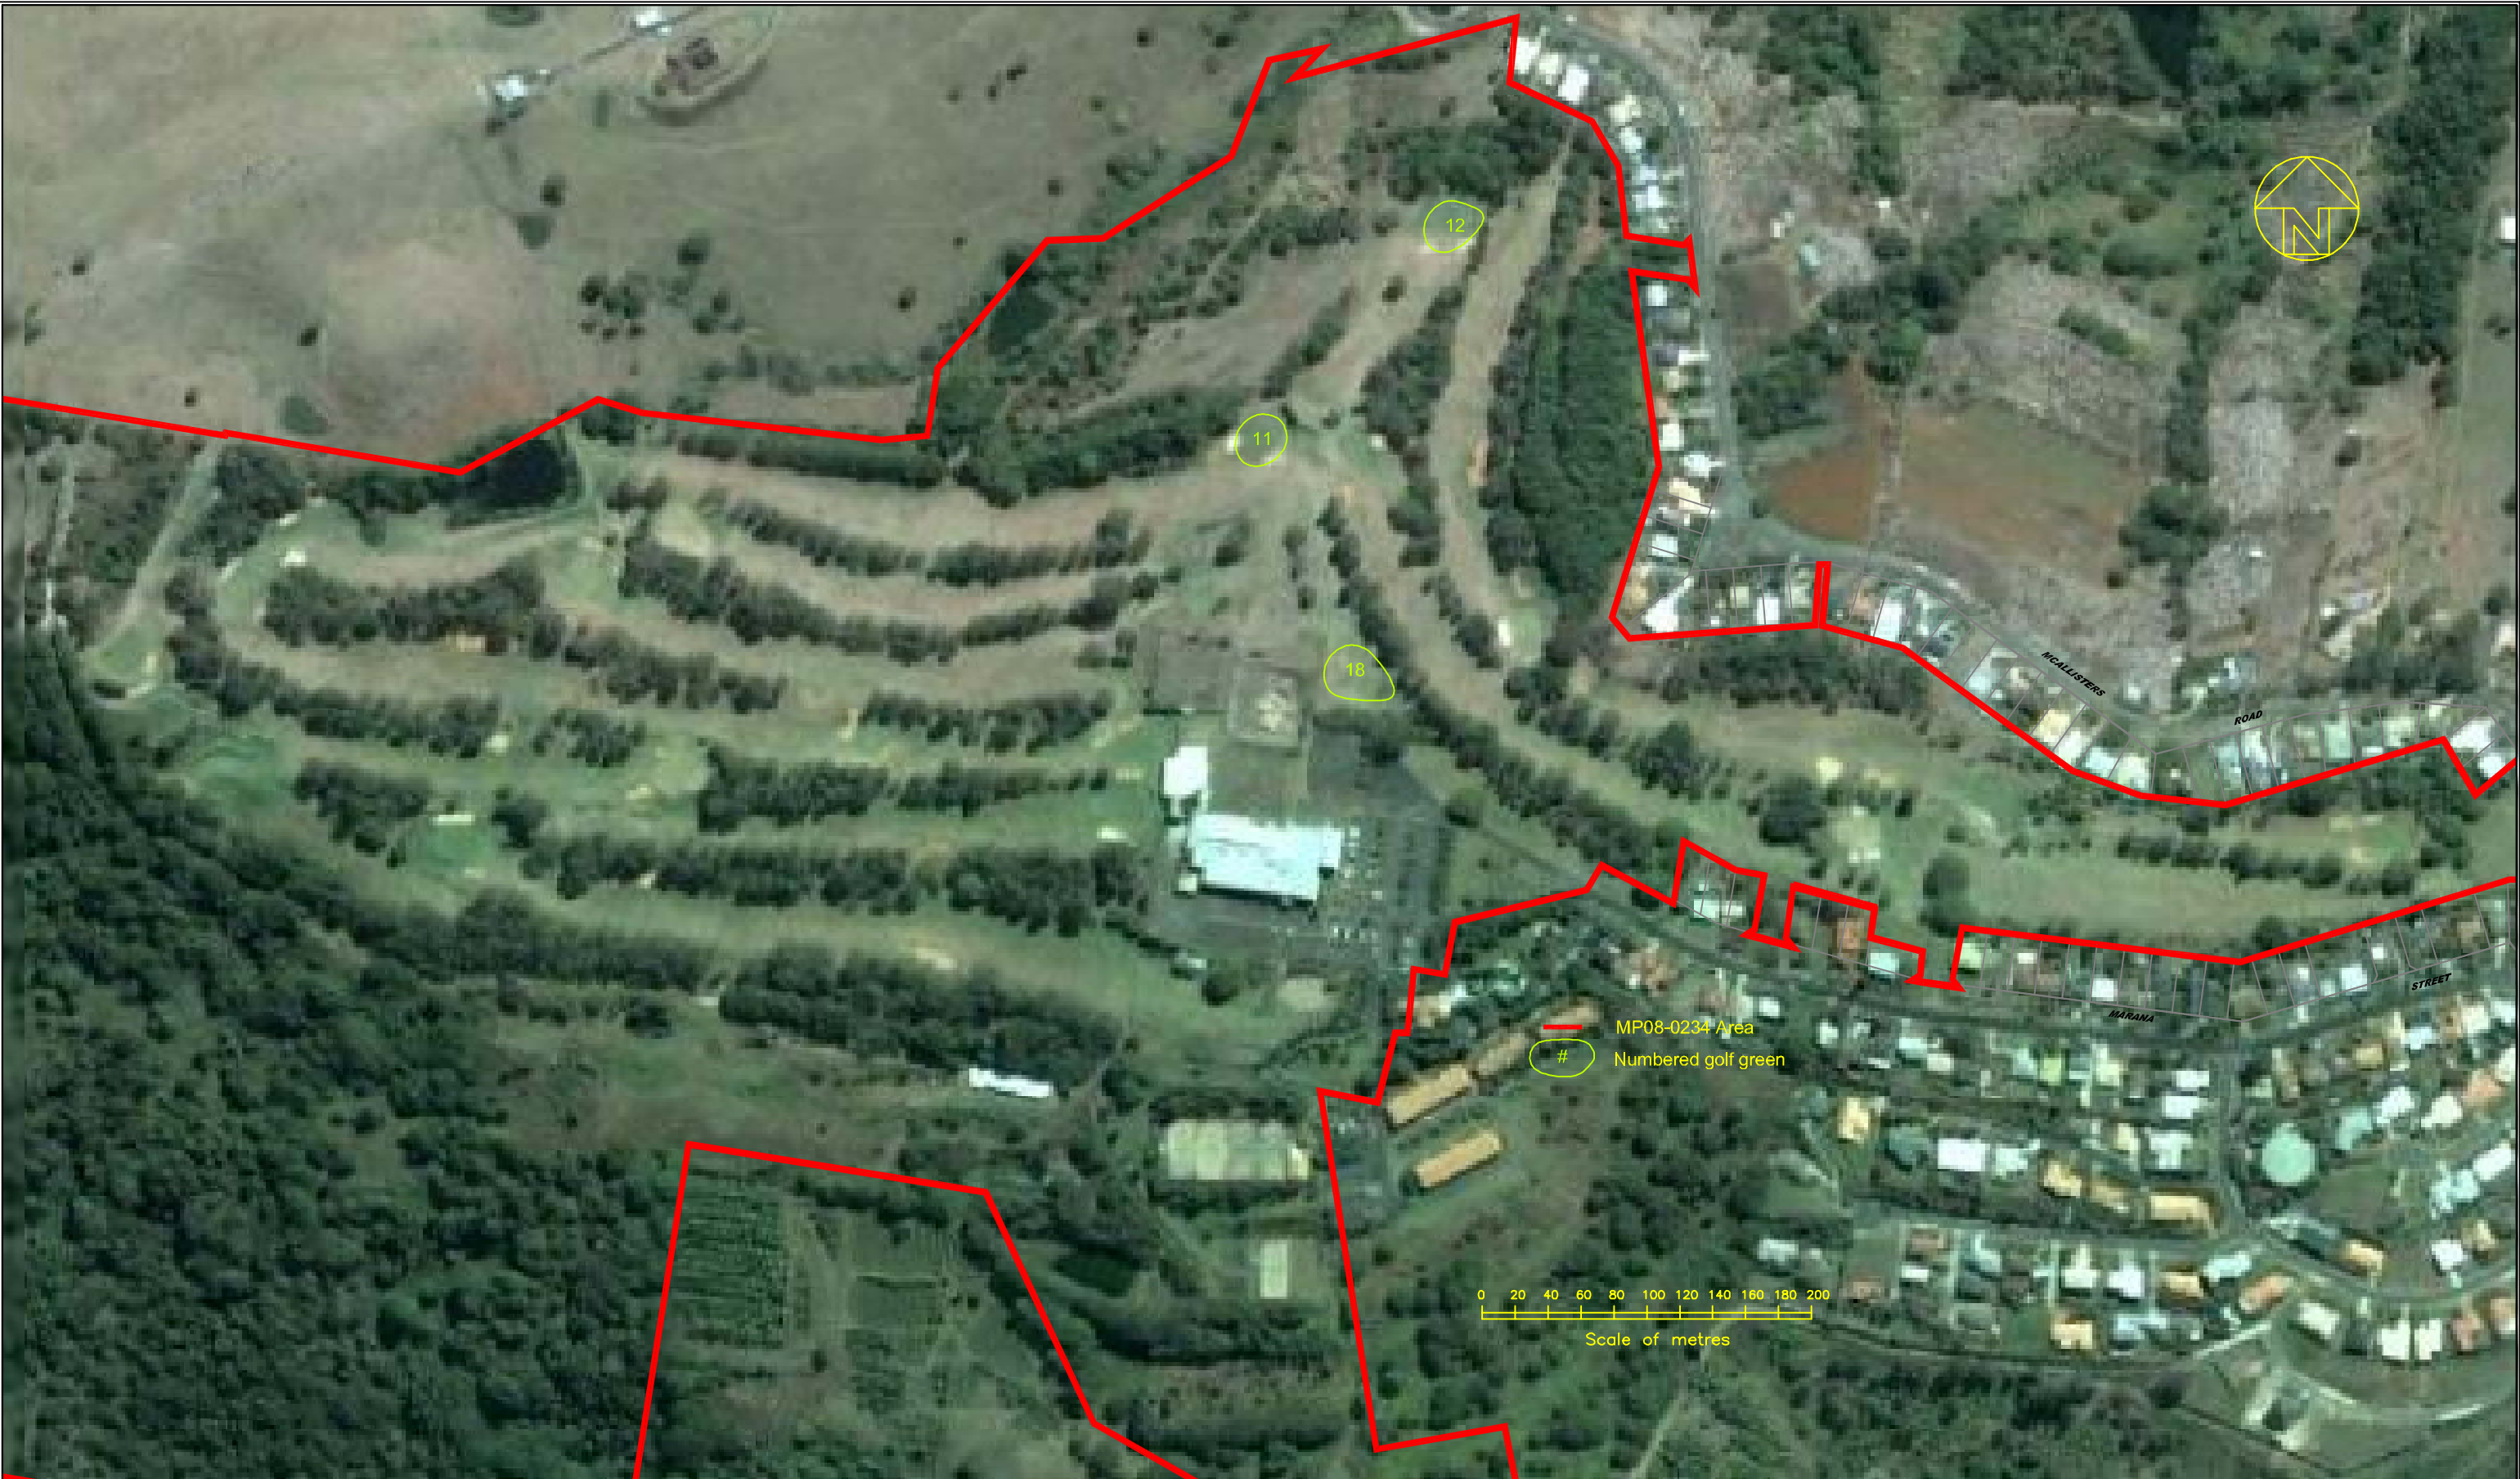
The HILs presented in the NEPM Guidelines state that the combined levels of Aldrin and Dieldrin should not exceed 3.33mg/kg. the Dieldrin + Aldrin concentrations were below the NEPM HILs guidelines for composite sampling.

Figure GJ0495.4.4 shows the indicative locations subject to this contamination investigation

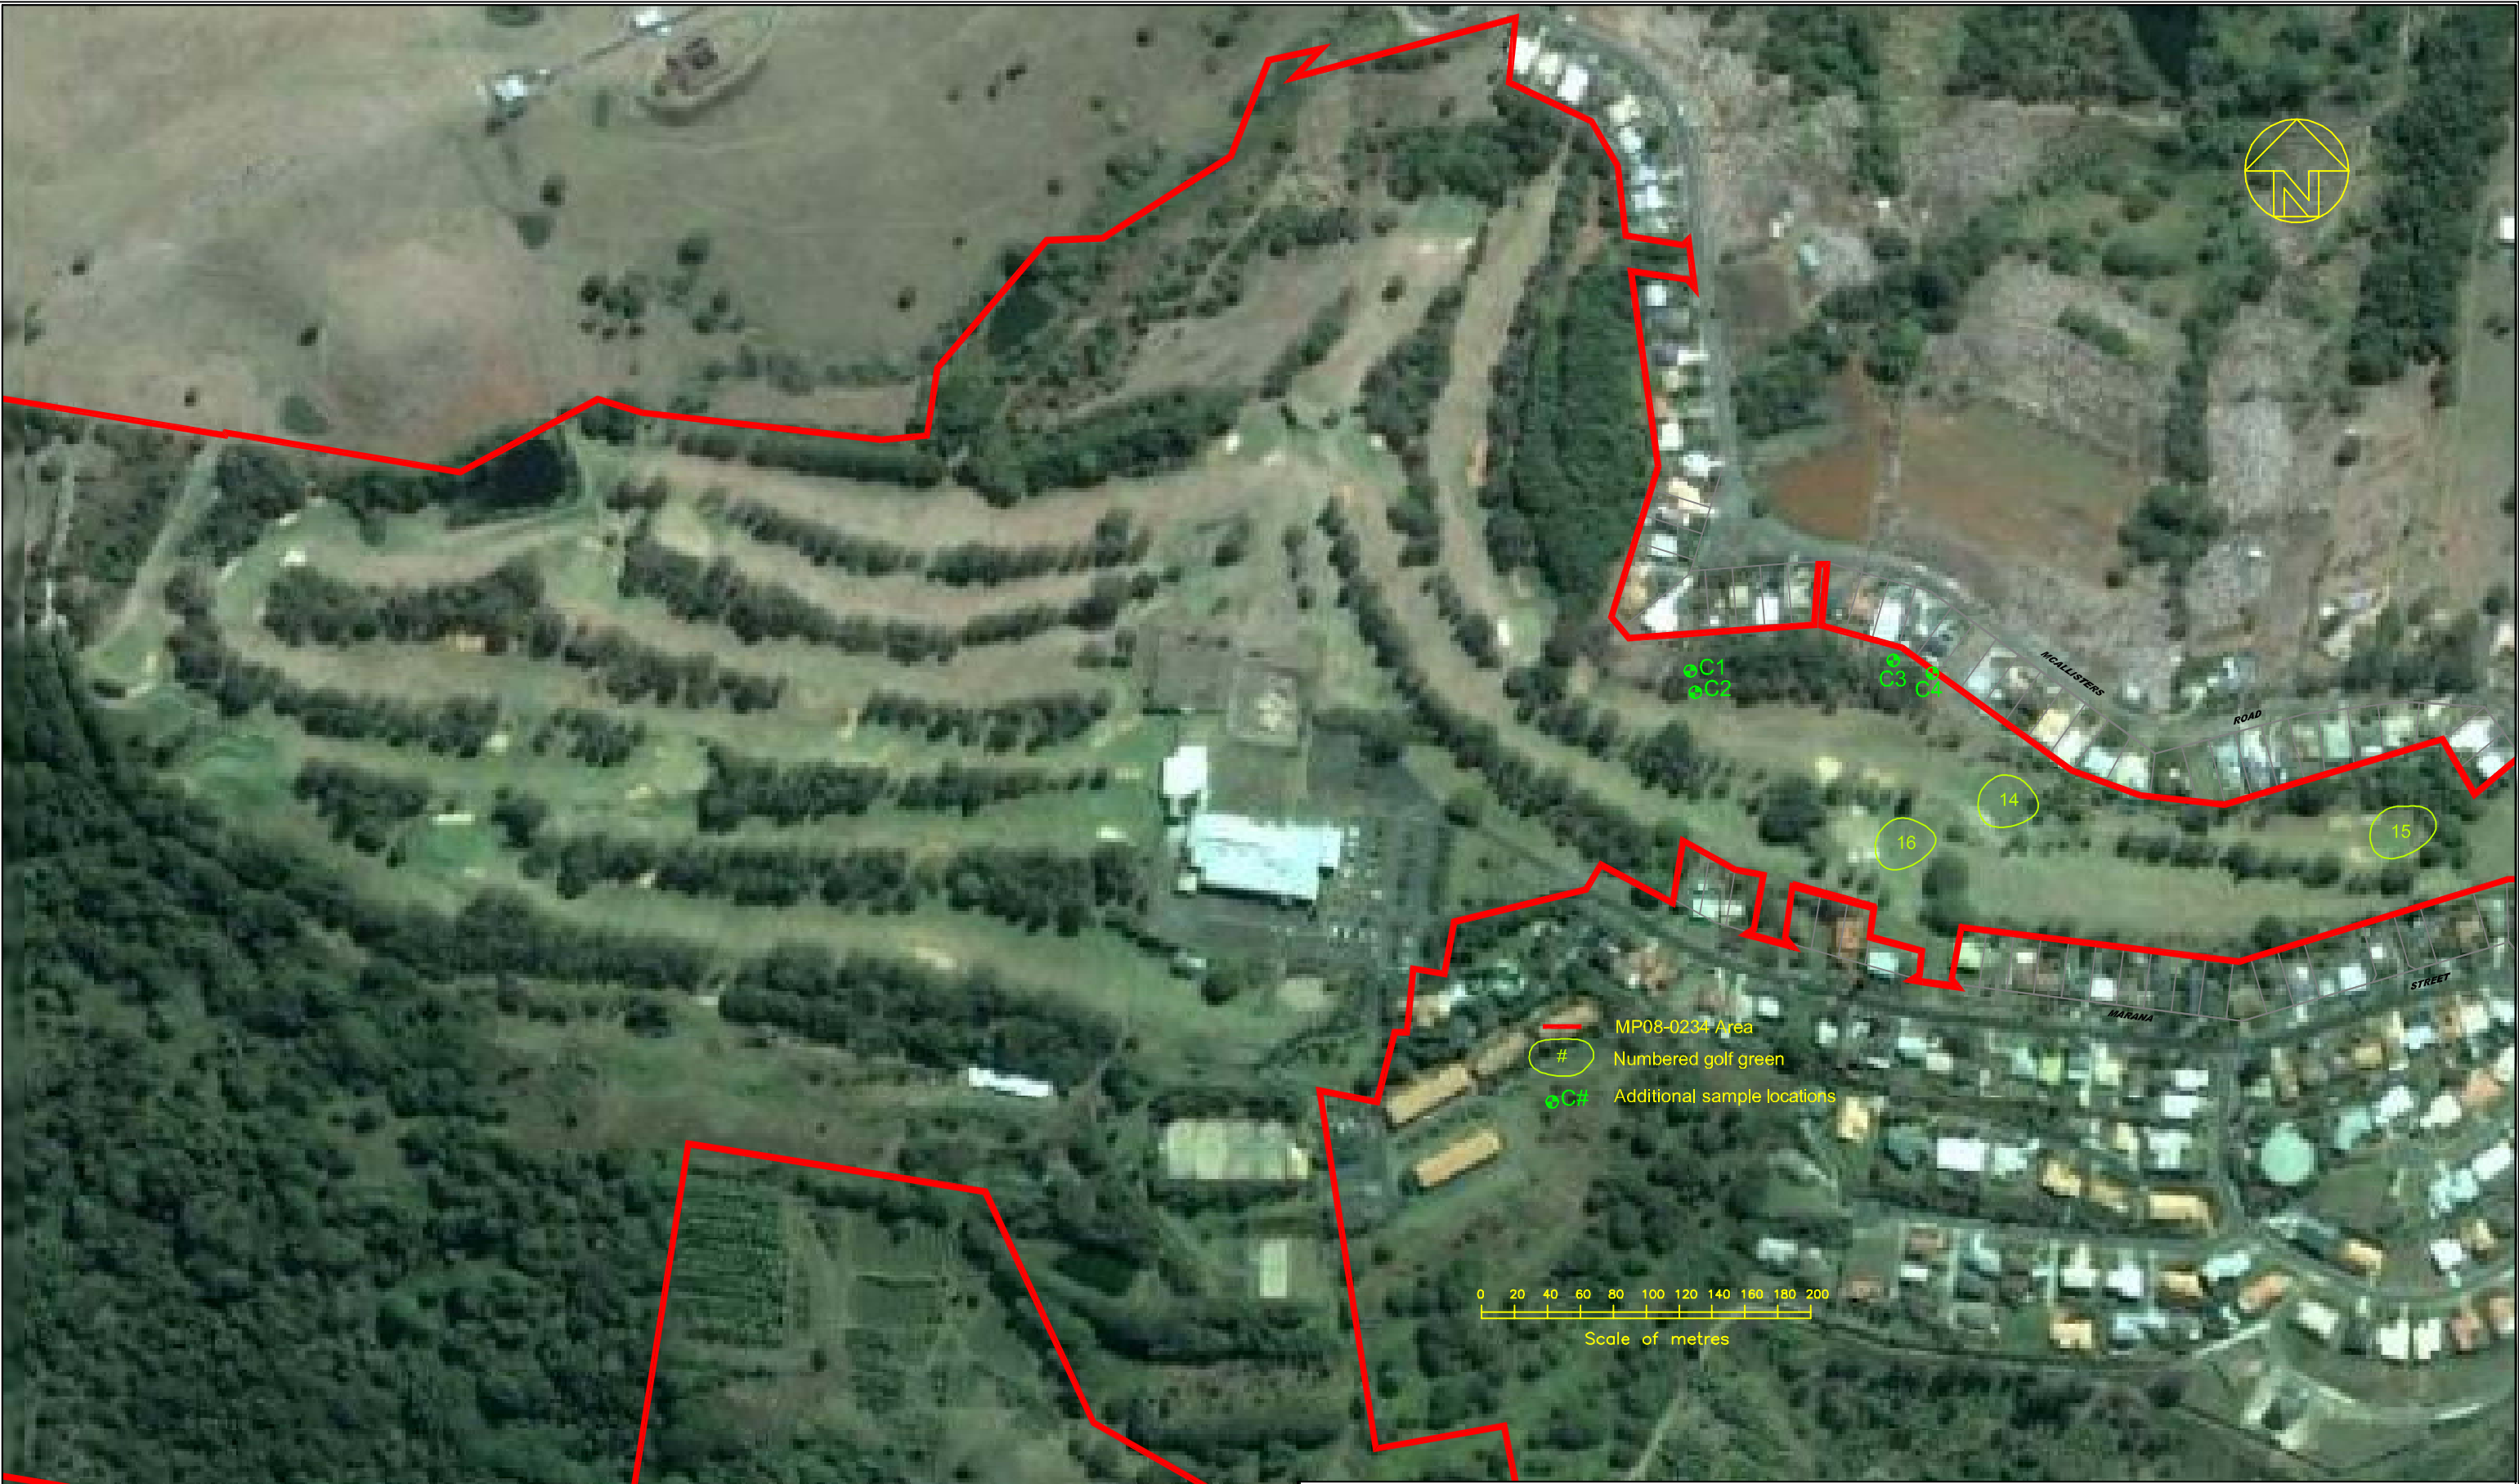
Laboratory results identified elevated combined Aldrin + Dieldrin concentrations of 8.76mg/kg (15th green). Although none of these samples exceed the HILs (10mg/kg), Dieldrin & Aldrin levels were at elevated concentrations in reference to the EILs.

Figure GJ0495.4.5 shows the indicative locations subject to this contamination investigation

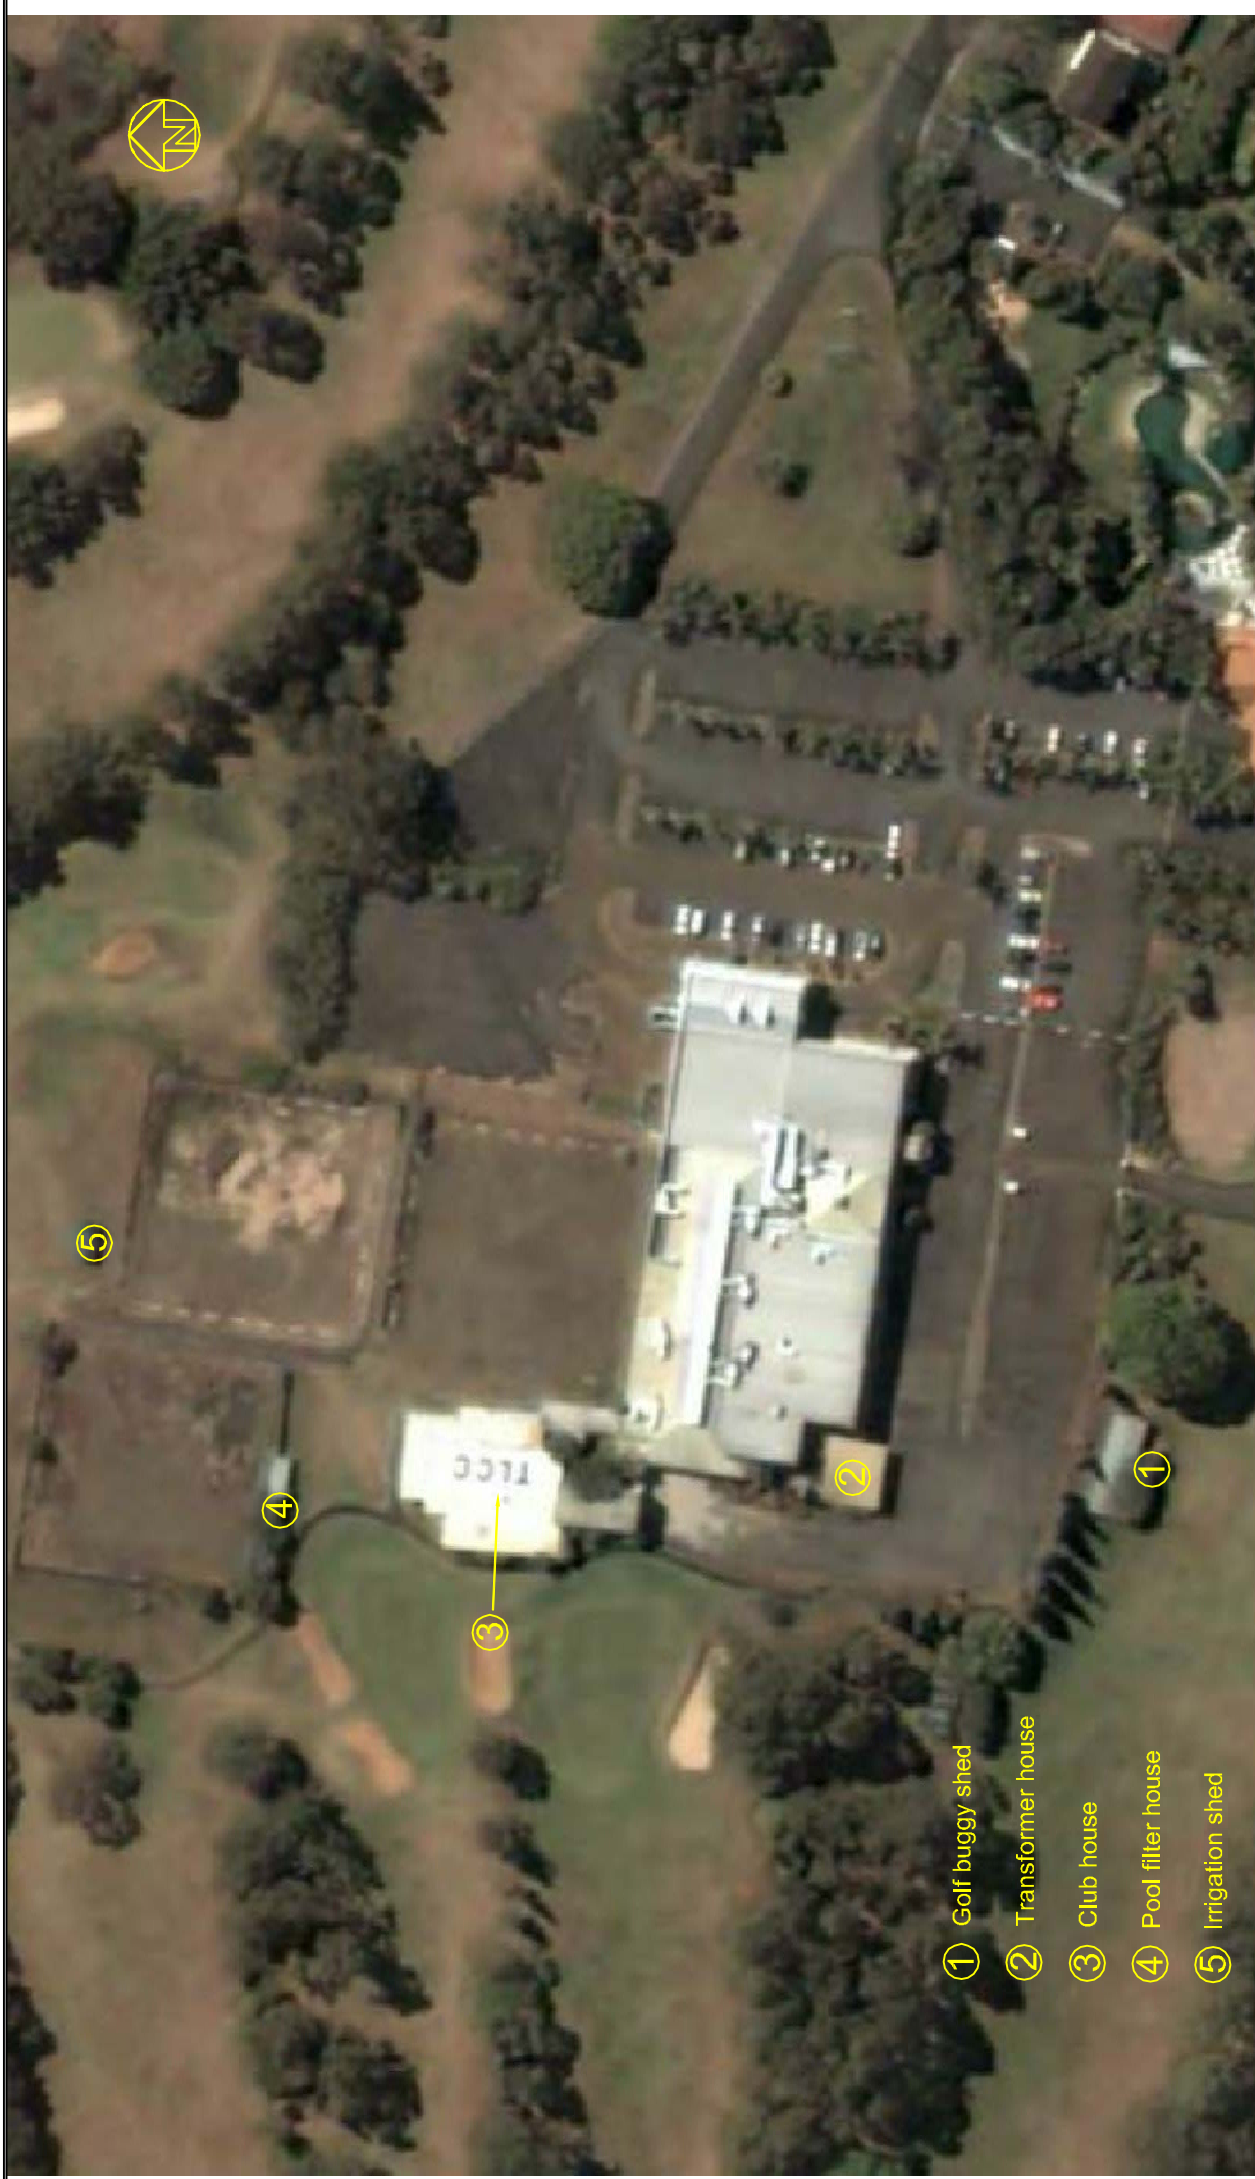
Figure GJ0495.4.6 shows the indicative locations subject to this contamination investigation

- ① Golf buggy shed
- ② Transformer house
- ③ Club house
- ④ Pool filter house
- ⑤ Irrigation shed

The report recommended that sub-slab investigations for OC/OP pesticides be undertaken on each of the outbuildings prior to the removal of the slabs, simultaneously with the investigation of the country club building proper.

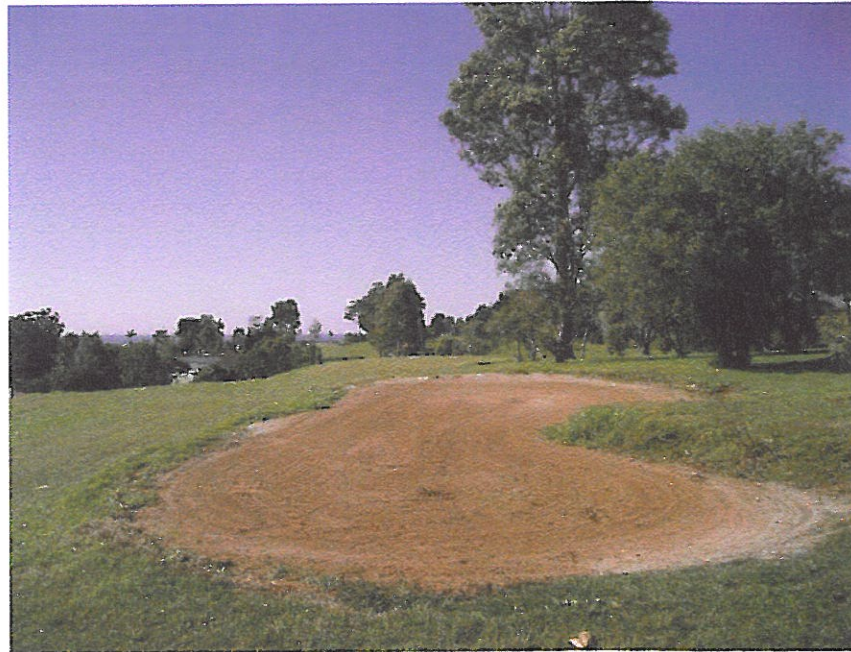
Plate 2. This view is from the centre of the site facing east and shows a sand bunker, golf green and northern fairway.

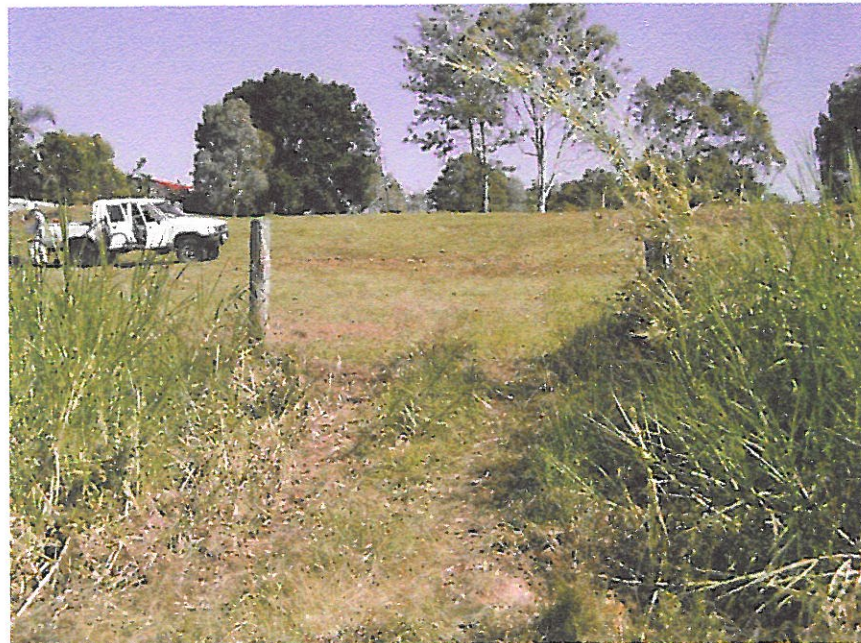
Plate 3. This photograph was taken from the eastern portion of the site bordering McAlisters Road. The view displays the easterly facing slope which appears to have been used as a former site access.

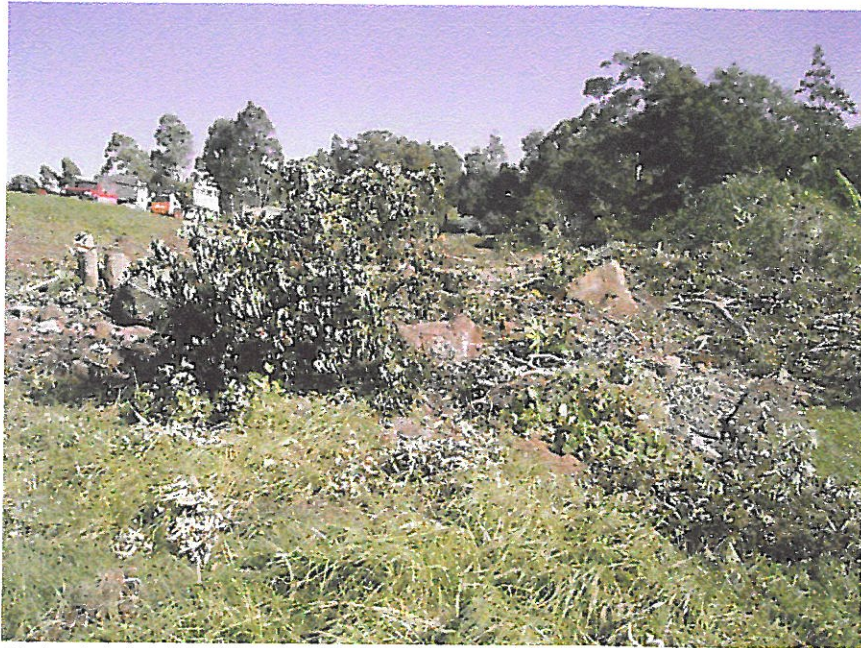
Plate 4. Displays the boulder stockpile location which was located on the northern site boundary. Tree maintenance works in the immediate area of the stockpile limited further inspection of this area.

- A stockpile of rocks and a small amount of miscellaneous waste material was identified at the northern portion of the site. It is likely that this material originated from clearing of the land during the construction of the golf course and could include some remnants from previous structures on, or in the vicinity of, the site. It is therefore recommended that the contents be further investigated, catalogued and sampled for asbestos, arsenic, OC and OP compounds to establish the contaminant potential. This would be done as part of a stage 2, detailed site investigation. Based on these results, further inspection may be required during the excavation of the stockpiled area and representative samples collected and analysed for contaminants by suitable qualified scientists. These actions would confirm whether or not the stockpile material was free of likely contaminants.

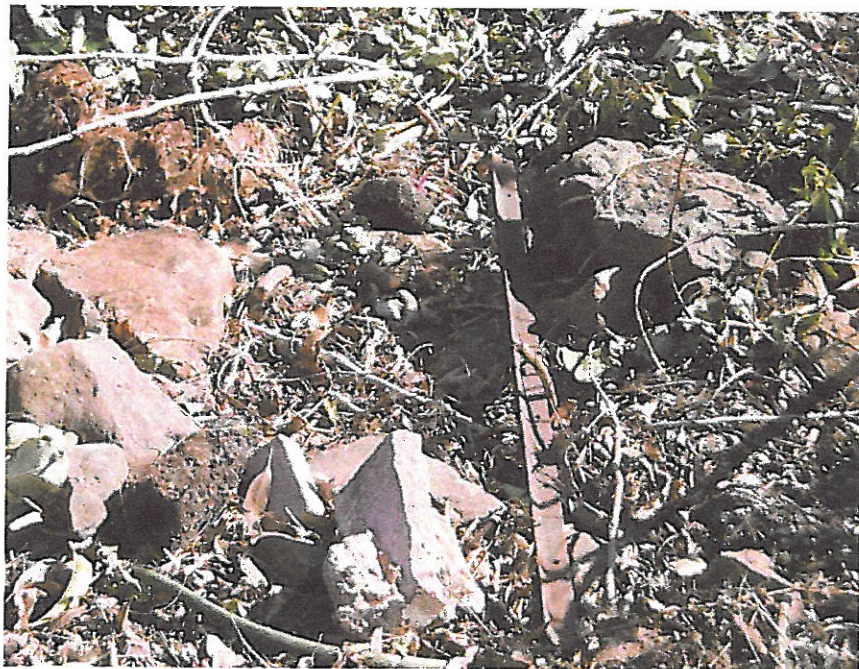
Plate 5. Displays a portion of the contents of the boulder stockpile materials. This photograph identifies boulders, concrete fragments, and a steel rod (star picket).

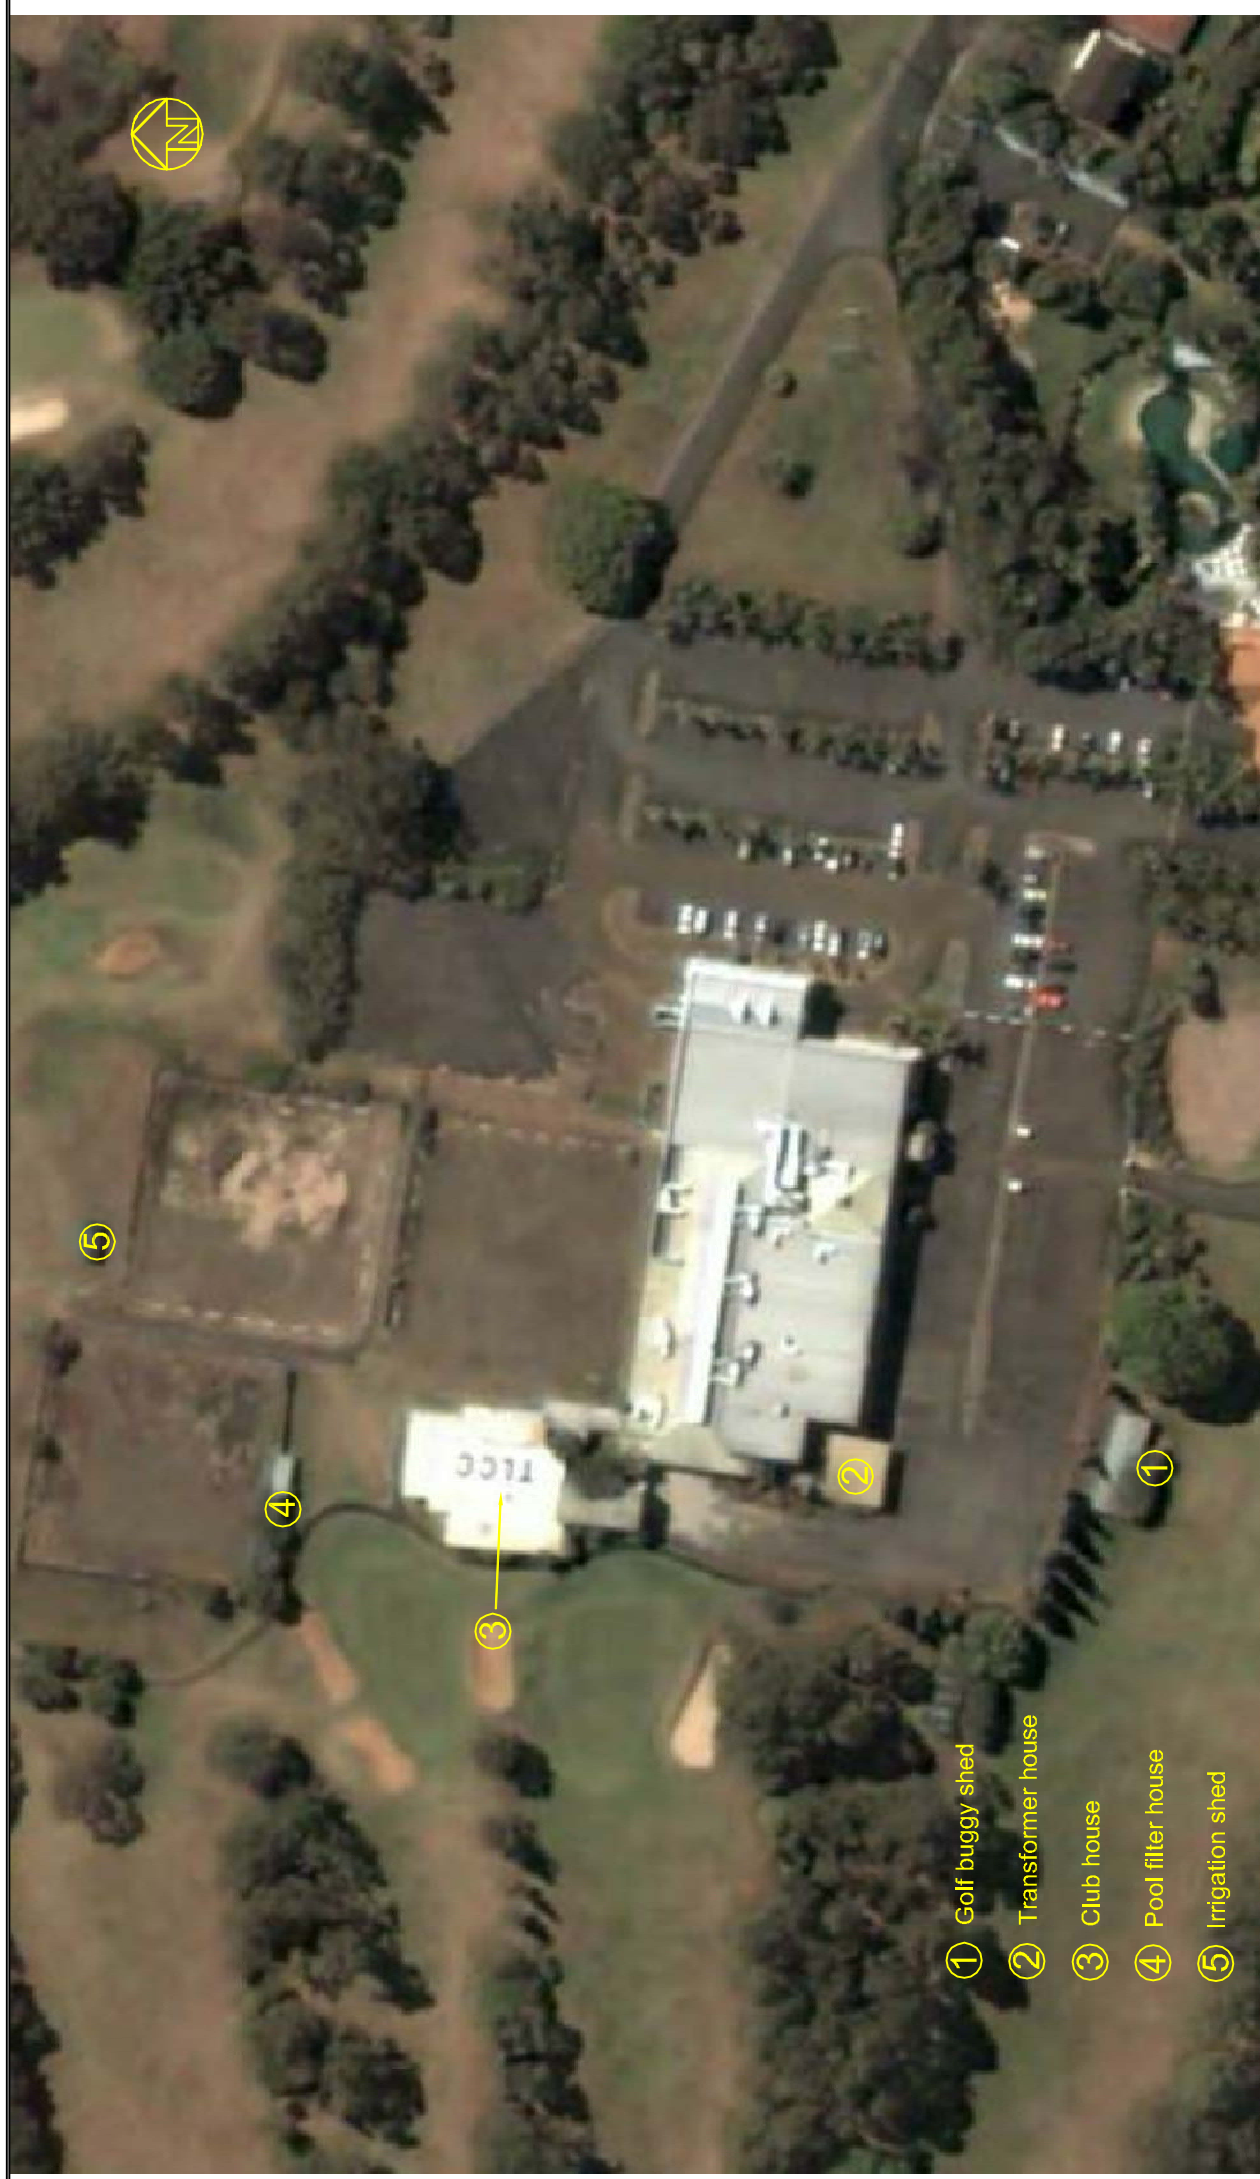
- ① Golf buggy shed
- ② Transformer house
- ③ Club house
- ④ Pool filter house
- ⑤ Irrigation shed
