Tillegra Dam

Planning and Environmental Assessment

Fluvial
Geomorphology

WORKING
PAPER

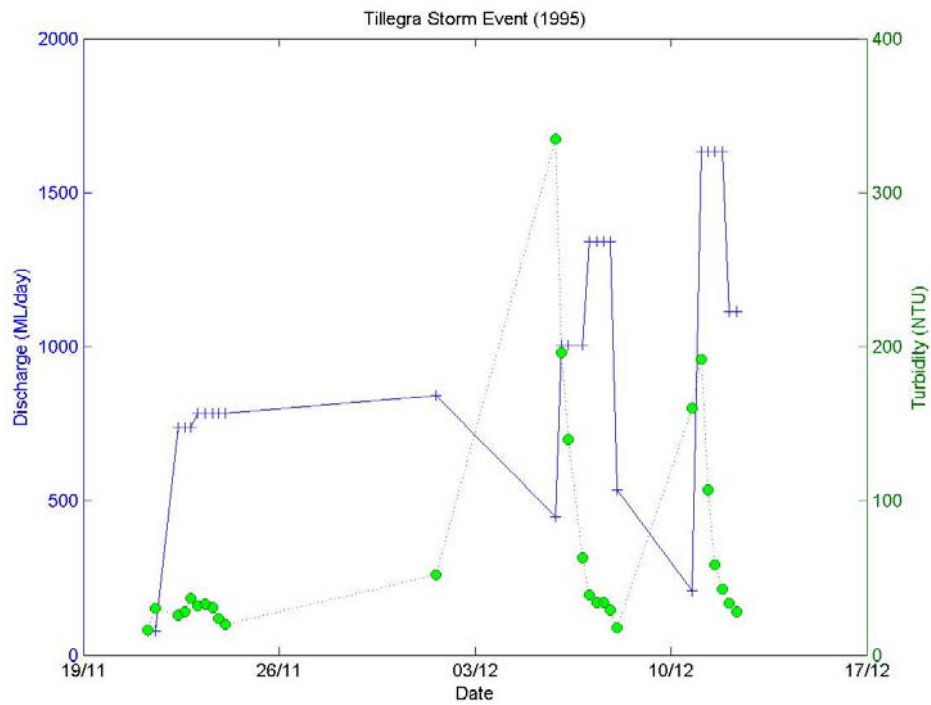
Figure 3. Detailed turbidity sampling during storm events at the Tillegra Dam site in late 1995. The blue line shows discharge (scale on left axis) while turbidity is shown by the green dots (scale on right axis).

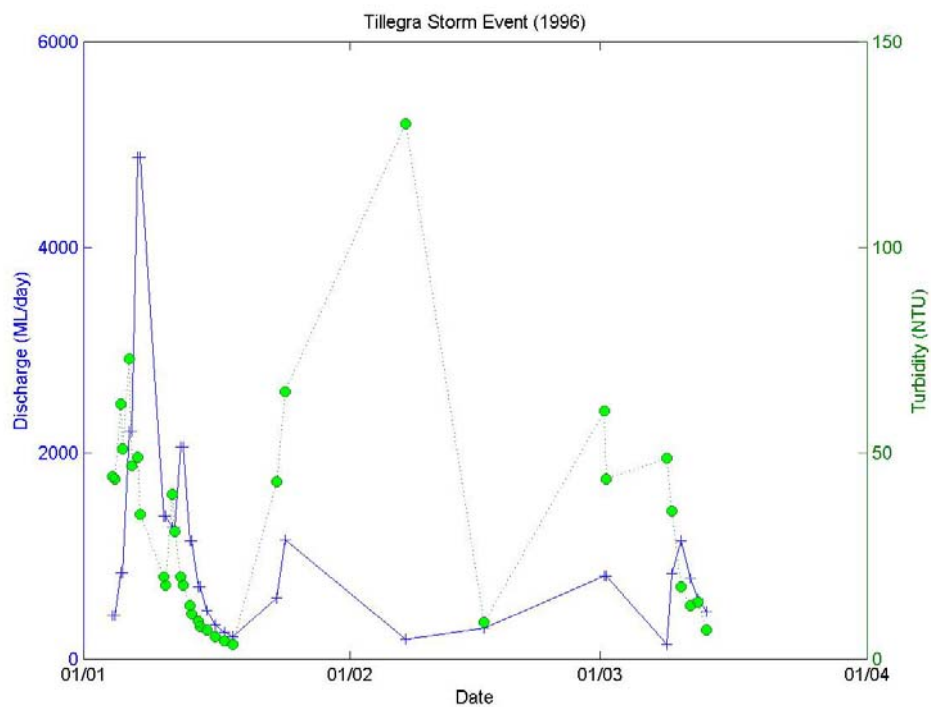
Figure 4. Detailed turbidity sampling during storm events at the Tillegra Dam site in late 1996. The blue line shows discharge (scale on left axis) while turbidity is shown by the green dots (scale on right axis).

The relationship between peak discharge and turbidity was not simple, with high turbidity peaks evident in both small and large events (Figure 2). A further factor that complicated the relationship was that for closely spaced events (eg Figure 3), it was not uncommon for the turbidity peak of the second event to be lower than the first, even if the second discharge peak was higher (this is known as sediment exhaustion). In addition, while turbidity often followed the discharge trace closely through storms, there were also peaks between storms that were not caused by elevated discharge (perhaps by stock impacts or conducting in-channel works – see for example 7 February 1996 in Figure 4).

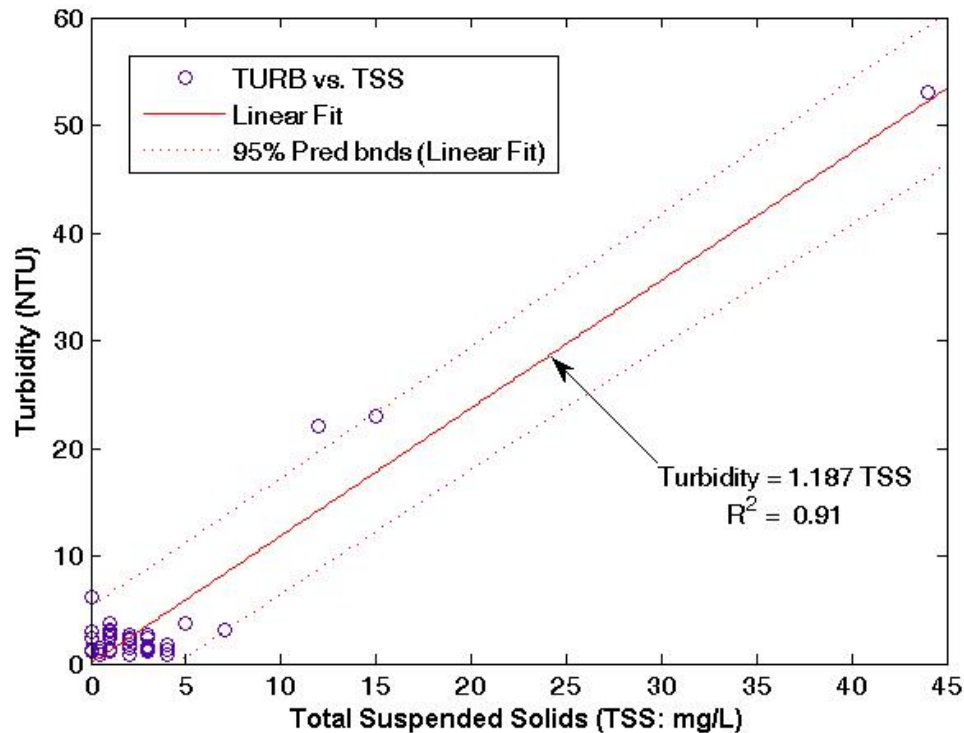
Figure 5. Relationship between 40 coincident measurements of total suspended solids and turbidity.

Despite the paucity of overlapping turbidity and total suspended solids data, a relationship was found between these two parameters (Figure 5). It was evident that despite the high value of Pearson's correlation coefficient ($R = 0.954$) the relationship between these variables was heavily influenced by the three largest values. It is also noted that the highest value of around 50 NTU was considerably lower than the highest recorded values (200 – 300 NTU). Although the data were less than ideal, they were the only available data on which to base an estimate of suspended sediment load.

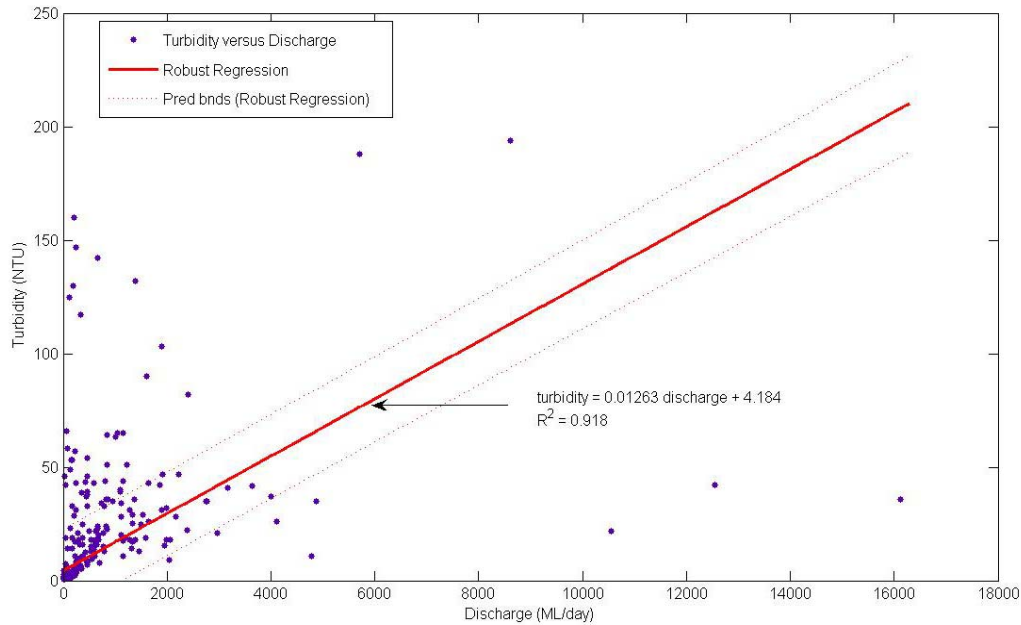
Figure 6. Relationship between 264 turbidity records and the discharge measured on the day.

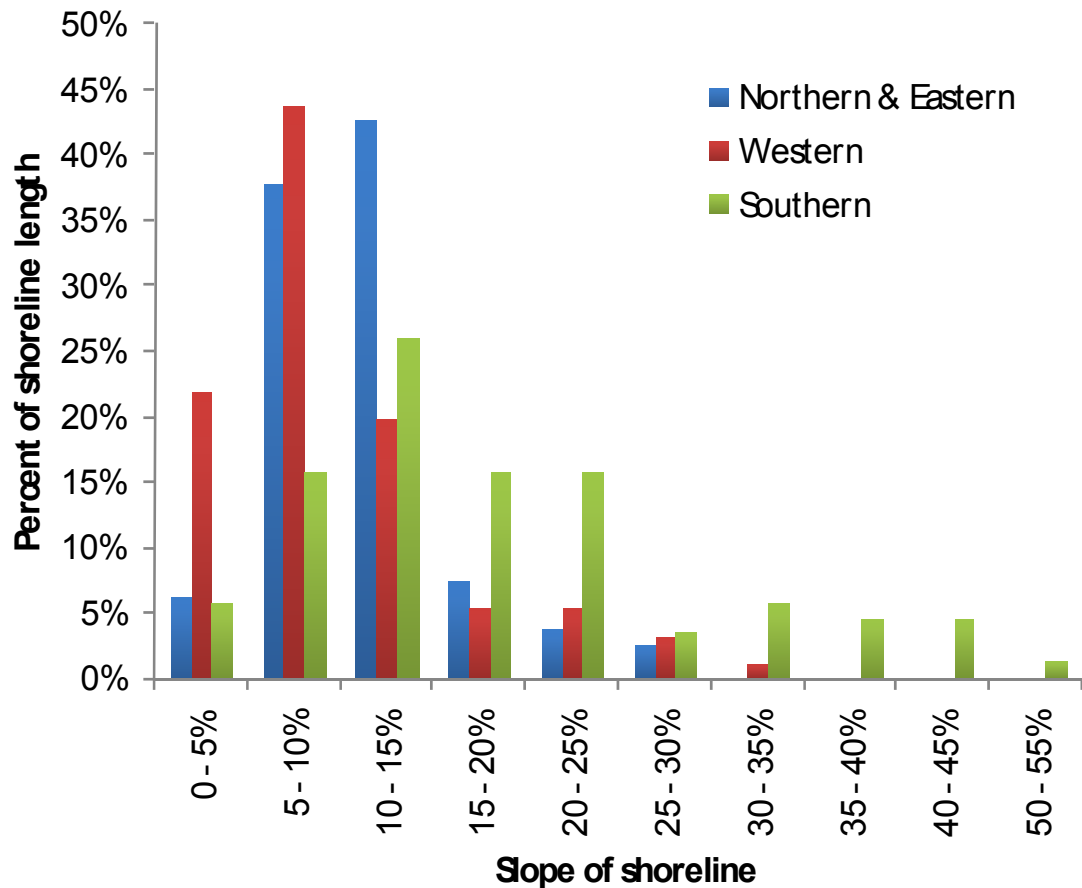
Figure 12. Slope of shoreline around rim of Proposed Tillegra Dam storage for three defined zones.

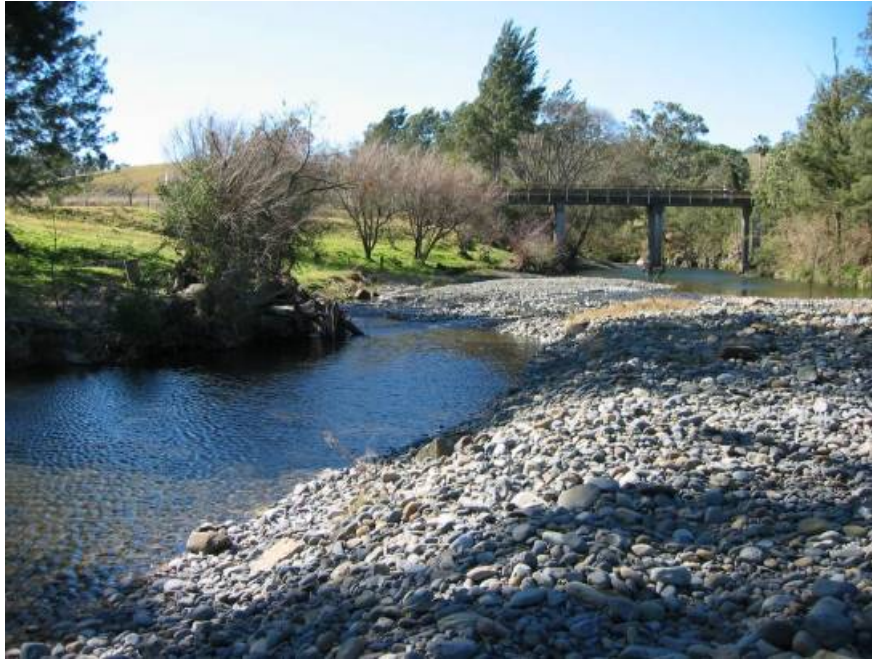
Figure 15. Williams River at Munni bridge. E 56 375017; N 6426443; 204° bearing (upstream); 13:08 hr; 10/08/2007. Flow 15 ML/d. Engineered log jam built in 1999 on left foreground.

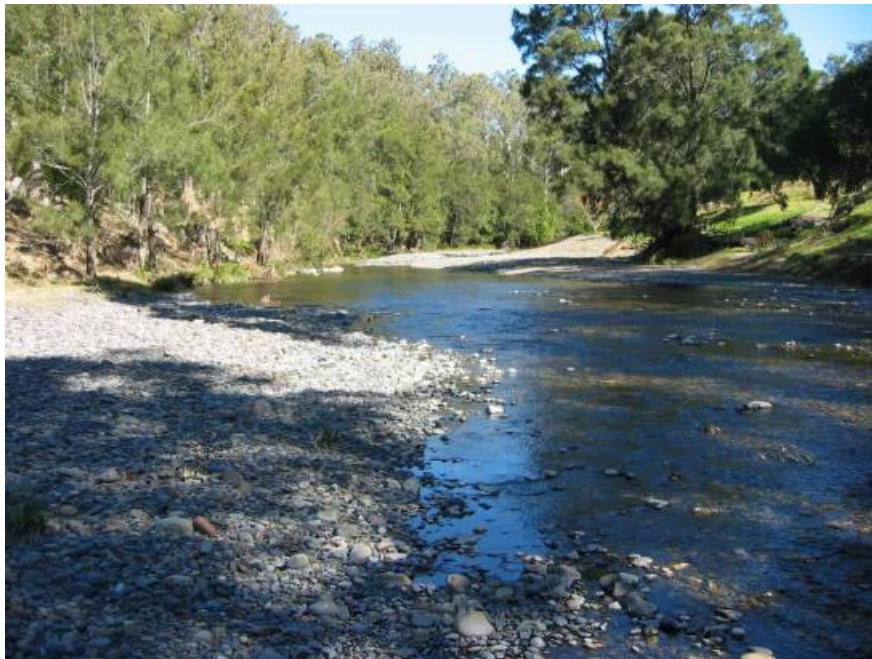
Figure 16. Williams River at Tillegra Bridge. E 56 376466; N 6423424; 168° bearing (upstream); 12:57 hr; 10/08/2007. Flow 15 ML/d. Photograph taken immediately upstream of bridge.

These two reaches extend from the headwaters of the Williams River through Munni (Figure 15) to the site of the proposed dam at Tillegra (Figure 16). Brooks et al (2006) estimated that the Williams River at Munni expanded in cross-sectional area by 50 percent after the 1940s. This was attributed to channel and riparian zone disturbance since European settlement, particularly desnagging, and that channel expansion accelerated with the onset of river training works (which included desnagging) in the 1960s coincident with a series of large floods (Brooks et al 2004; Brooks et al 2006).

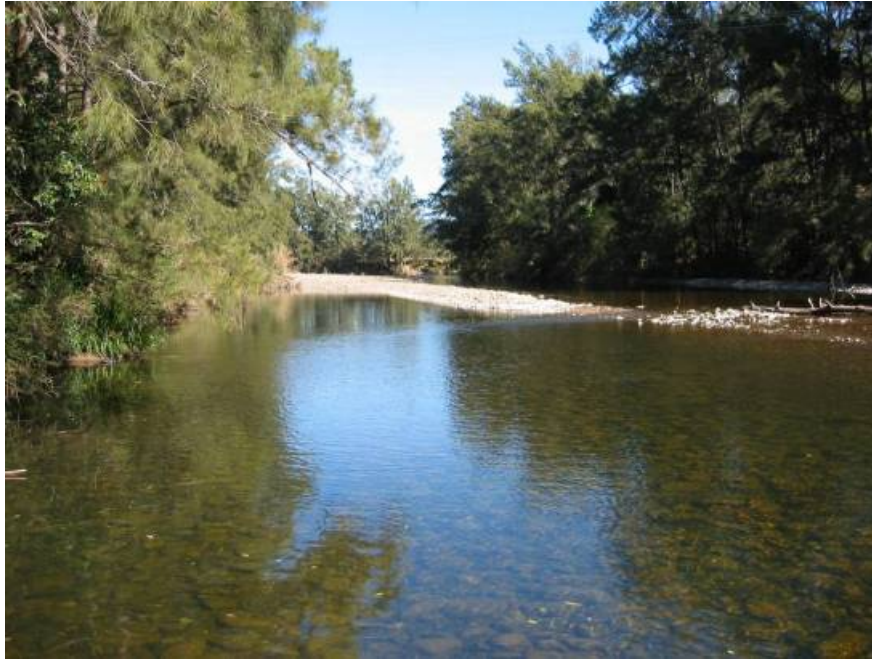
Figure 17. Williams River at Bandon Grove. E 56 379194; N 6425397; (upstream); 12:06 hr; 10/08/2007. Flow 70 ML/d.

The reach of river from Tillegra downstream to Mill Dam Falls receives inflows from the regulated Chichester River, plus other smaller unregulated tributaries. This reach covers a long distance, passing through Bandon Grove (Figure 17), Fosterton (Figure 18), Dungog (Figure 19), Thalaba Bridge crossing near Alison/Warragulla (Figure 20), Glen William Bridge (Figure 21), and ending at Mill Dam Falls, also known as Glen Martin (Figure 22).

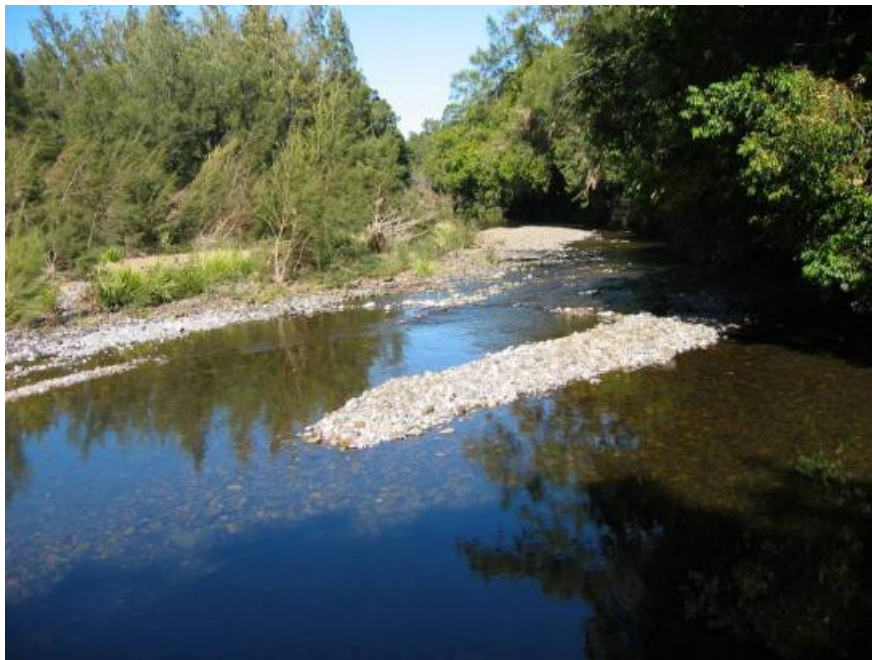
Figure 18. Williams River at Fosterton (Newells Crossing). E 56 382194; N 6422876; 132° bearing (downstream); 11:34 hr; 10/08/2007. Flow 70 ML/d. Photograph looking downstream from bridge. Flow 70 ML/d.

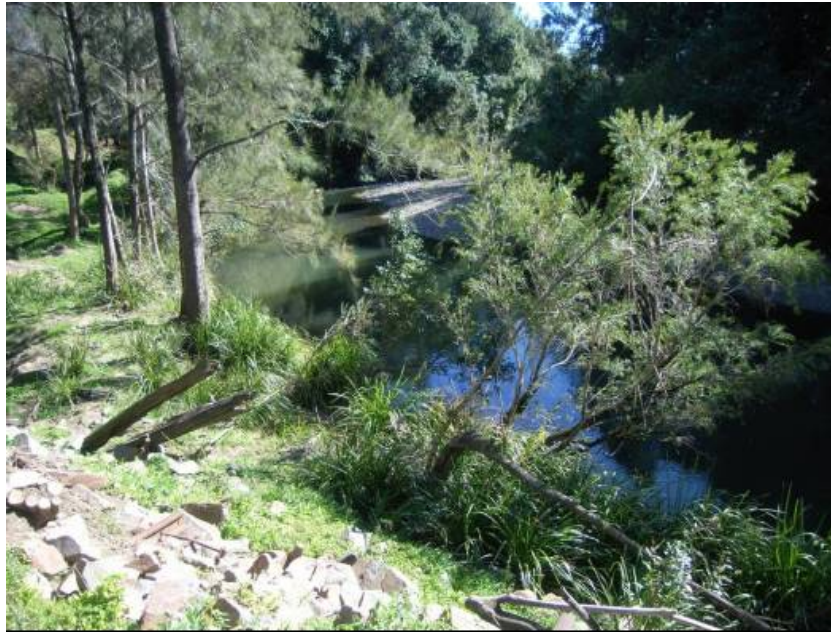
Figure 19. Williams River at Dungog, upstream of Coorei Bridge. E 56 383575; N 6414936; 320° bearing (upstream); 10:59 hr; 10/08/2007. Flow 82 ML/d.

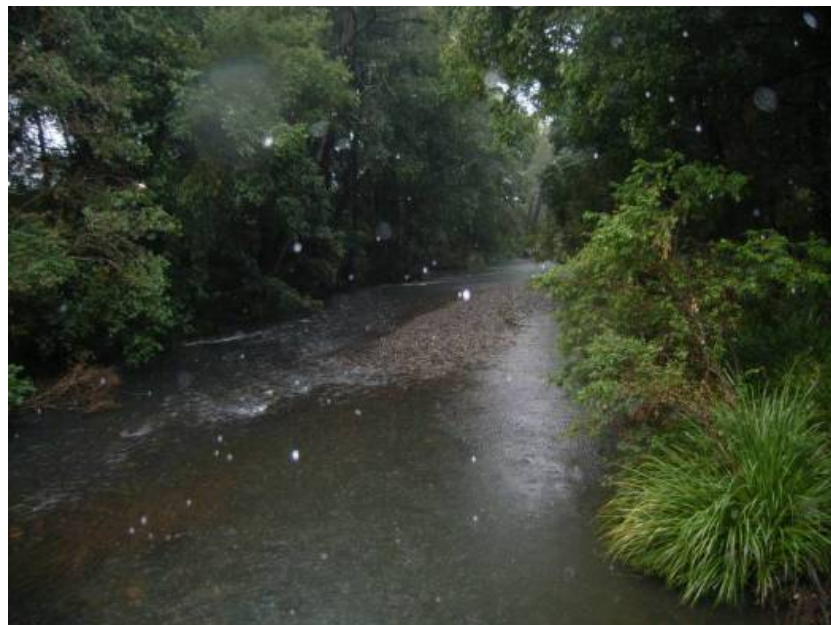
Figure 20. Williams River at Thalaba Bridge, Alison Road. E 56 383602; N 6406840; (downstream); 14:11 hr; 20/08/2007. Flow approx. 300 ML/d.

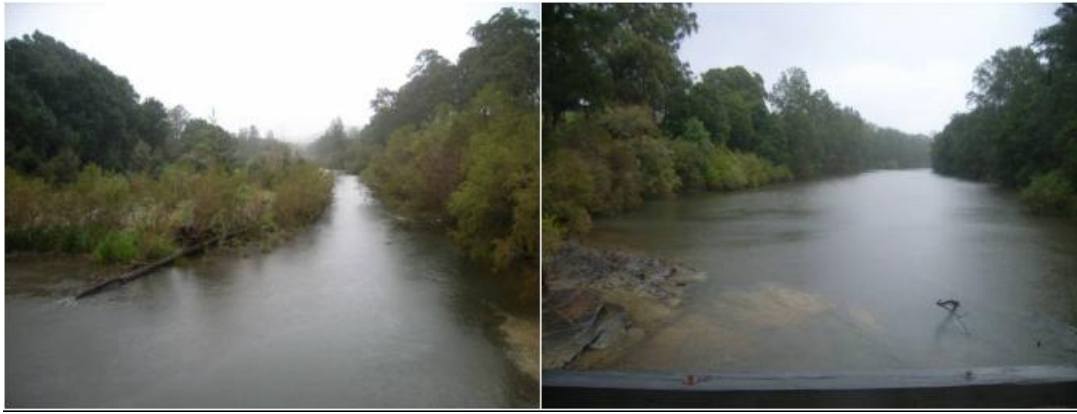
Figure 21. Williams River at Glen William Bridge, Pine Brush Road. E 56 387191; N 6401215; left is 66° (downstream) showing vegetated island (left side of photograph) and right is 268° (upstream) showing rock bar (left foreground); 14:28 hr; 20/08/2007. Flow approx. 1,400 ML/d.

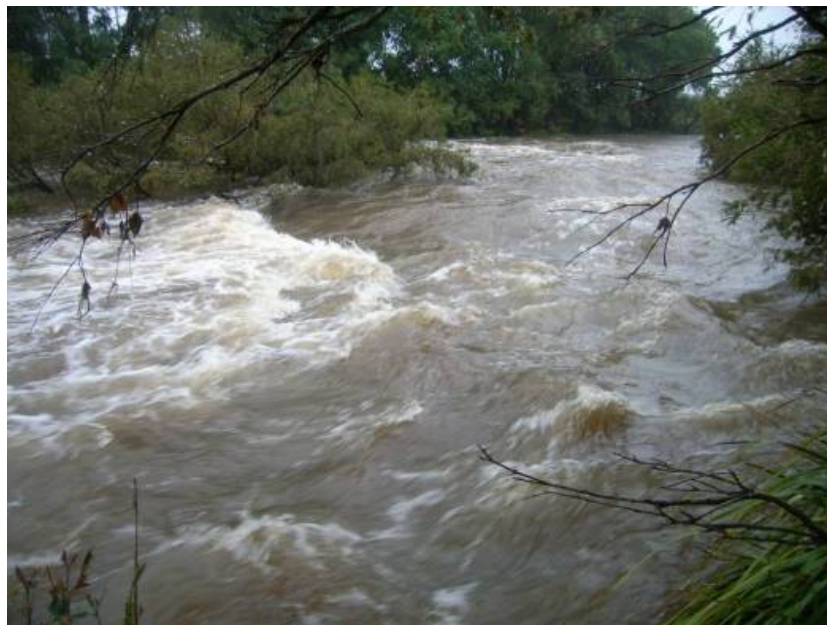
Figure 22. Williams River at Mill Dam Falls, just downstream of Glen Martin gauge. E 56 387219; N 6397012; 50° bearing (upstream); 15:44 hr; 20/08/2007. Flow approx. 3,200 ML/d.

The Williams River downstream to Glen Martin is reasonably high gradient, and the bed material remains dominantly coarse grained (gravel to cobble). There is a substantial rock bar Glen William Bridge (Figure 21) and Mill Dam Falls represents a major hydraulic and bed control, with a rapid forming in this location at high flows (Figure 22). Coarse gravel benches and bars are present at Mill Dam Falls.

A site located 6.7 km upstream of S12, with similar morphology to the upper part of S12, was inspected on 10 May 2008. At the time, the riffle was fully inundated by a flow of approximately 500 ML/d (Figure 57). The Mill Dam Falls were inspected on 20 August 2007 when flow was approximately 3,200 ML/d. At that discharge the rock bar at the Falls was completely inundated and formed a swiftly flowing rapid (Figure 22).

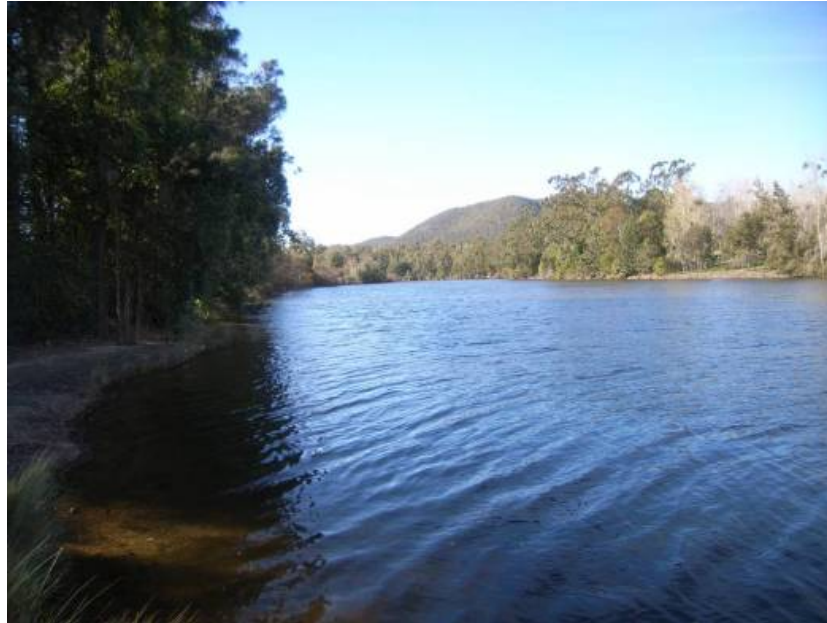
Figure 23. Williams River at Clarence Town. E 56 385889; N 6393357; 102° bearing (upstream); 19:18 hr; 10/08/2007. Flow 87 ML/d.

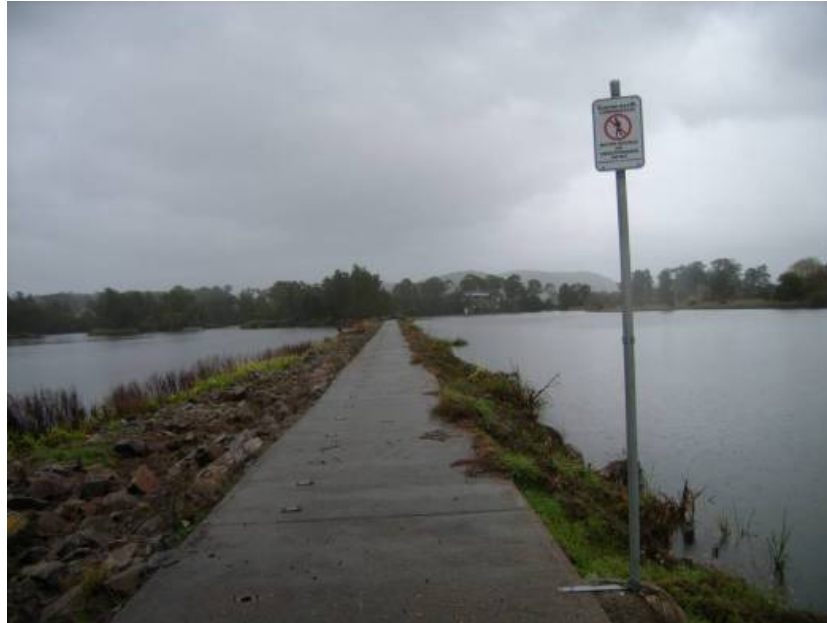
Figure 24. Williams River at Seaham Weir. E 56 381655; N 6385598; 303° bearing (left to right bank); 16:32 hr; 20/08/2007. Flow approx. 3,300 ML/d.

Seaham Weir (Figure 24) was constructed in 1968 and later sealed in 1978. The initial construction altered the reach of the river between Mill Dam Falls and the weir, from that of a free flowing tidal estuary to a brackish pool. Later sealing prevented salt water penetrating the pool. The Healthy Rivers Commission of NSW (1996 p. 31) reported that there was anecdotal evidence that construction of the weir caused die-back of phragmites beds lining the lower parts of the banks, and that allowing stock to drink directly from the now freshwater pool resulted in decline of bank vegetation, erosion and degradation of water quality. The Healthy Rivers Commission of NSW (1996 p. 31) referred to a report by Patterson Britton and Partners (1996) that ongoing variations in water levels within the weir pool associated with the operation of the weir gates, cattle access, and the impact of waves generated by some power boats along the river were inhibiting the re-establishment of riparian and aquatic vegetation.

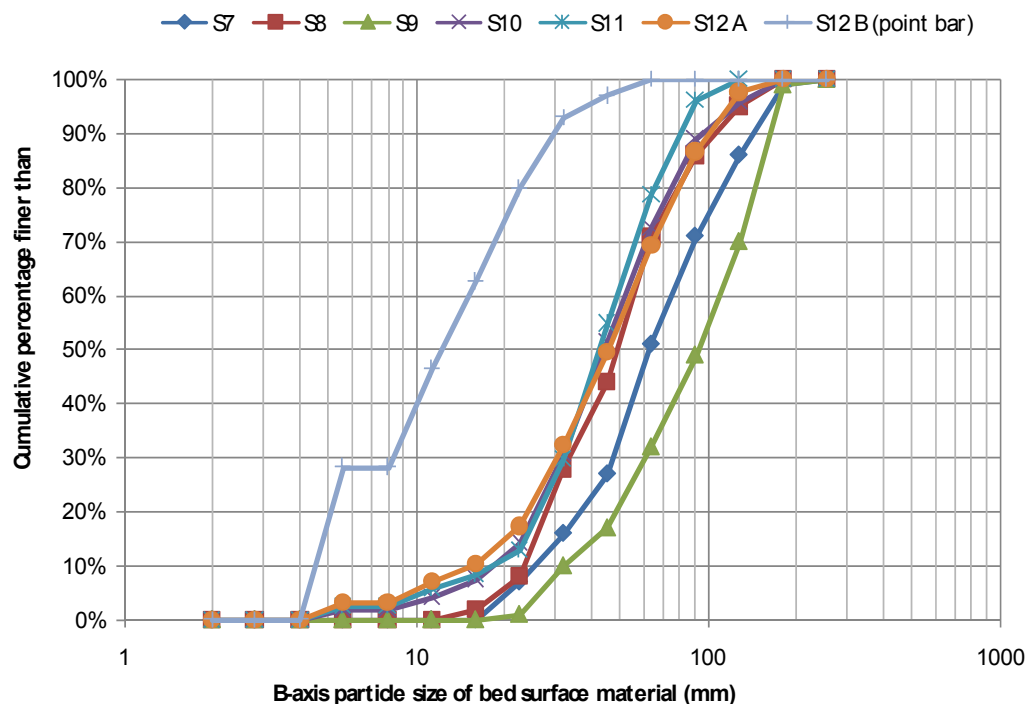
Figure 25. Measured bed material particle size distributions, based on B-axis size of 100+ particles sampled from riffle crests. Sample S12 B was sampled from a point bar and represented a lobe of finer-grained, recently deposited, material, while S12 A was from the riffle crest. Sampling site denoted S12 was located at Glen William, 6.7 km upstream of the site designated S12 for the purposes of hydraulic modelling (Glen Martin), but the measured particle size at Glen William was judged to be representative of the reach down to Glen Martin.

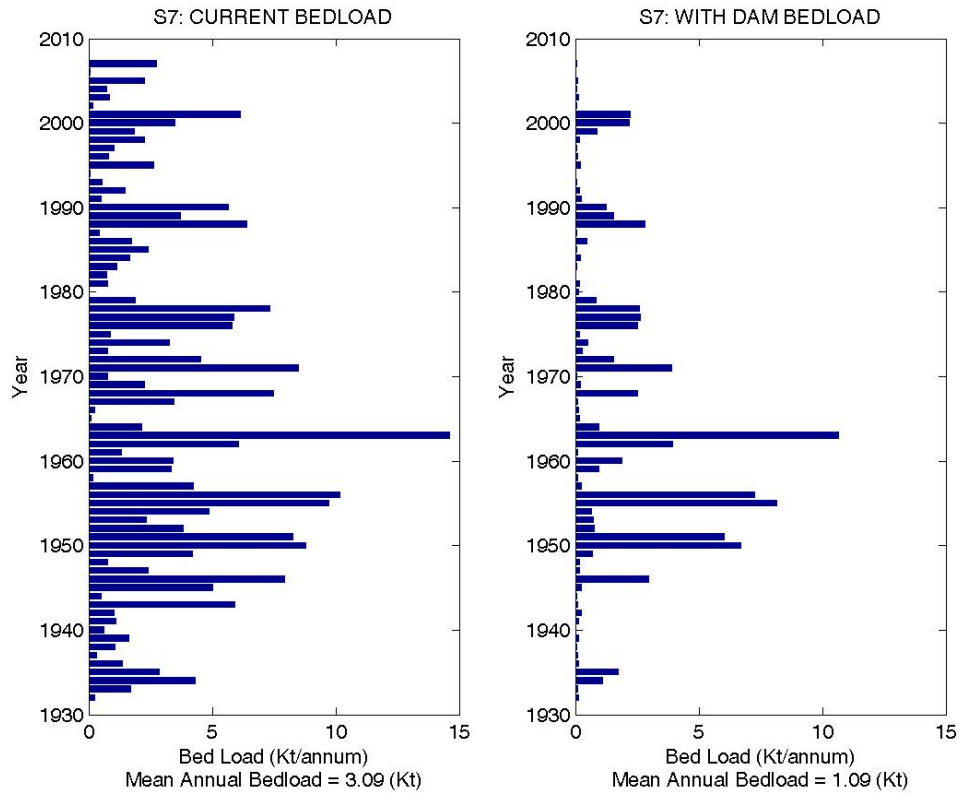
Figure 26. Predicted annual bedload transport series' and mean annual transport rate over the period of record for 'current' and 'with dam' flow scenarios at Site S7.

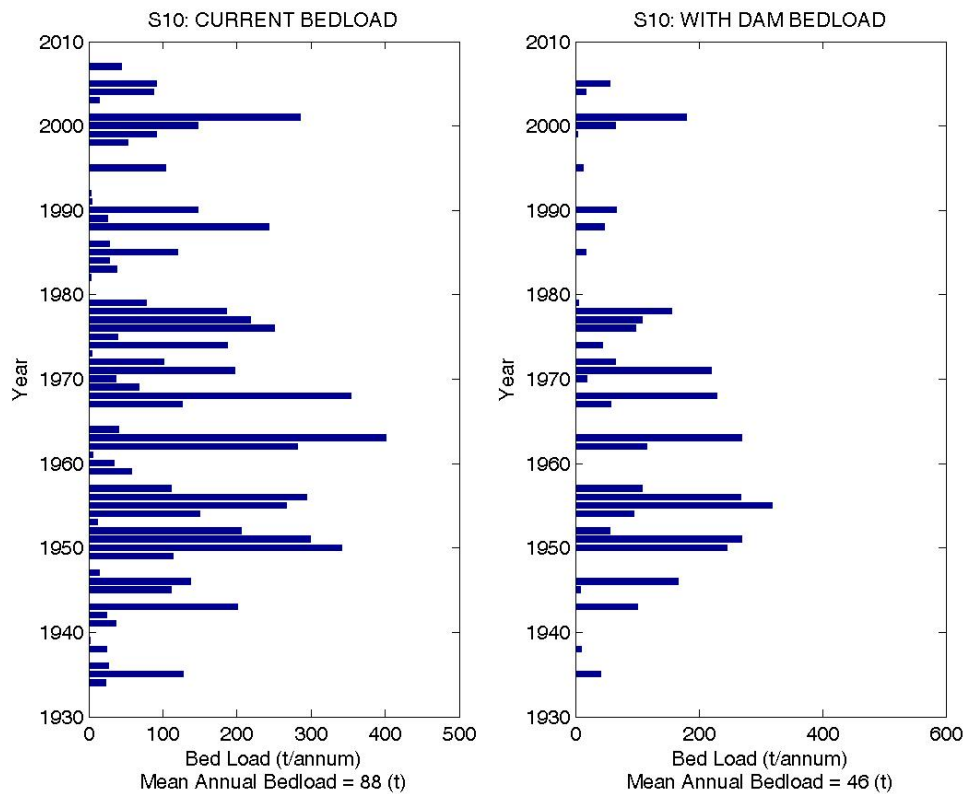
Figure 29. Predicted annual bedload transport series' and mean annual transport rate over the period of record for 'current' and 'with dam' flow scenarios at Site S10.

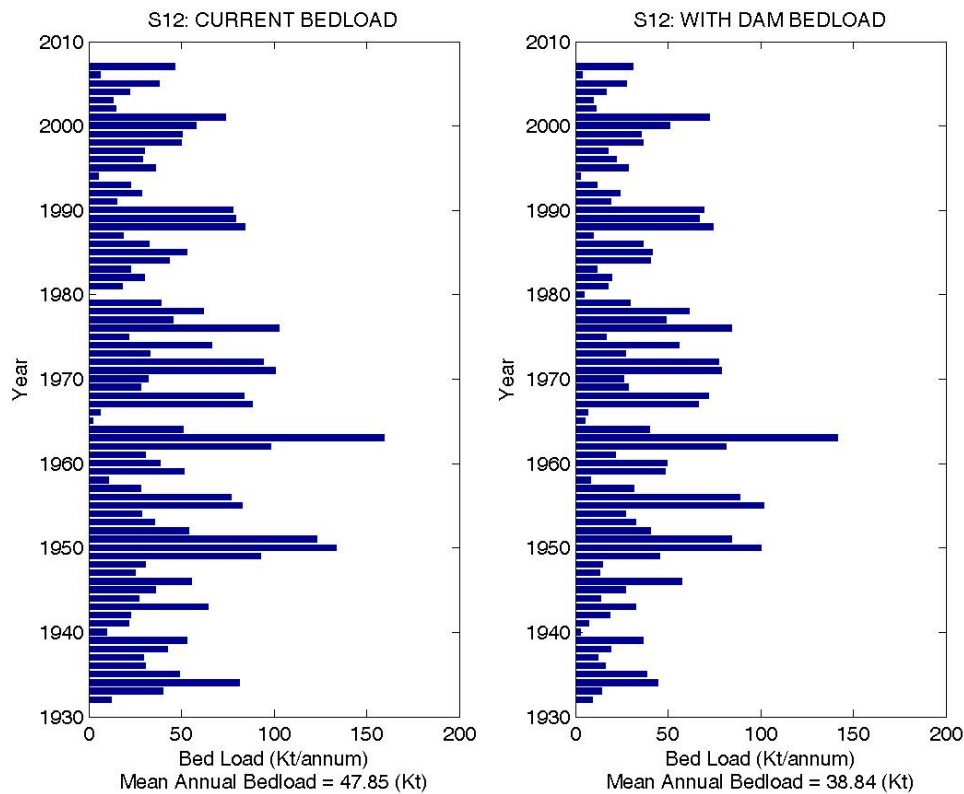
Figure 31. Predicted annual bedload transport series' and mean annual transport rate over the period of record for 'current' and 'with dam' flow scenarios at Site S12.

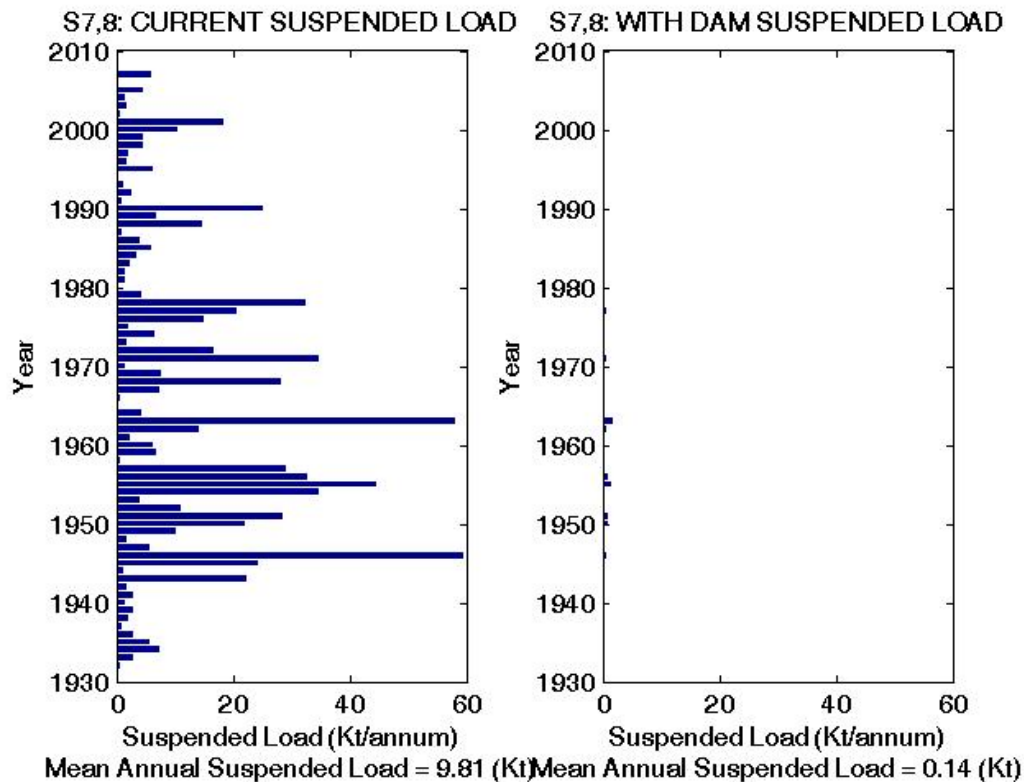
Figure 32. Estimated suspended sediment load (thousands of tonnes per annum) for the Williams River at the Tillegra Dam site.

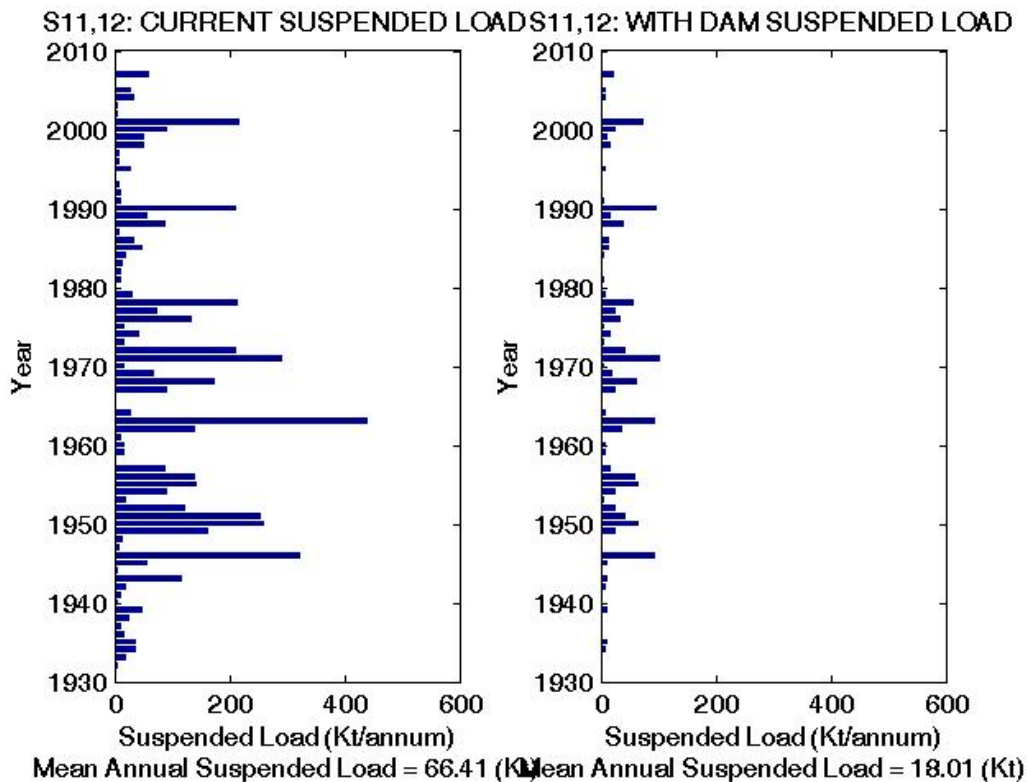
Figure 34. Estimated suspended sediment load (thousands of tonnes per annum) for the Williams River at Sites 11 and 12

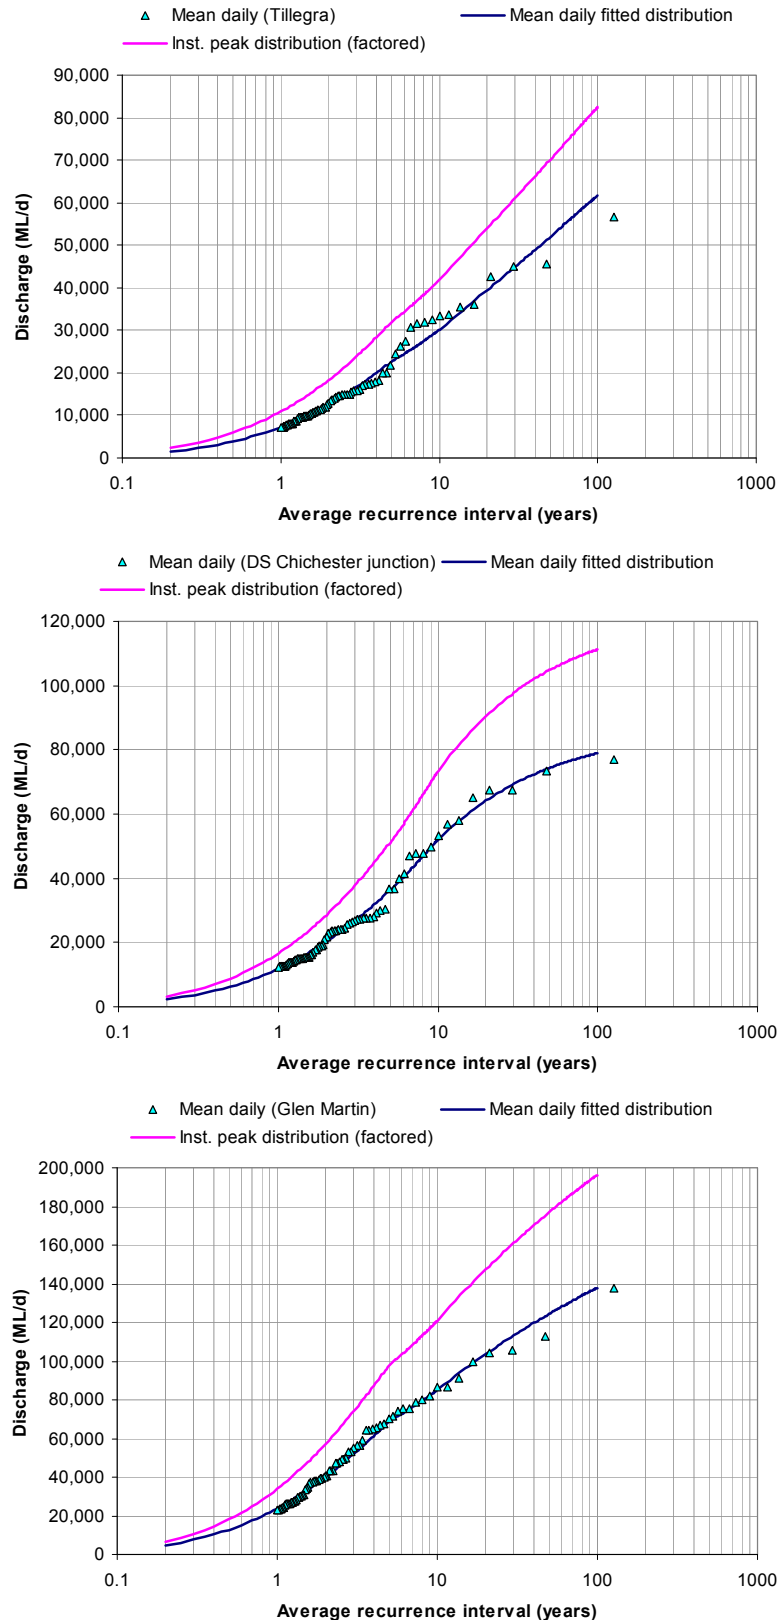
Figure 35. Flood frequency distributions for the Williams River, current scenario. Flood data plotted using the Cunnane plotting position formula ($\alpha = 0.4$). Curves are polynomial fitted to annual exceedance series for ARI <10 years, and for ARI ≥ 10 years, Generalised Pareto (Tillegra and Glen Martin) or Johnson's SB (DS Chichester junction) distributions fitted to annual maximum series.

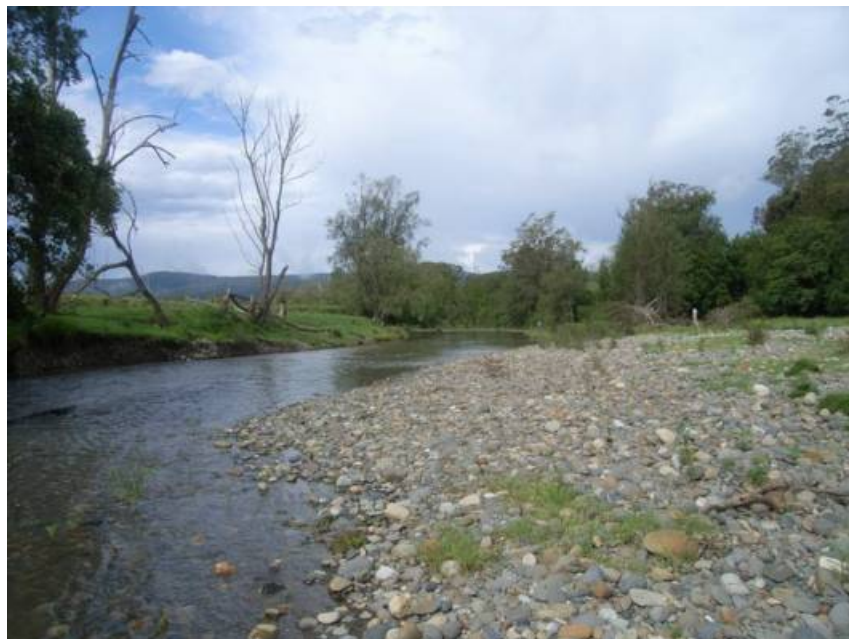
Figure 40. Typical view of Williams River channel (at S8), being relatively free of macrophytes. E 56 378688; N 6424613; View is downstream; 14:12 hr; 3/12/2007. Flow approx. 340 ML/d.

The bed of the river was observed to have few macrophytes present (Figure 40). The analysis indicated that hydraulic conditions were usually sufficient to exceed the thresholds associated with rupturing macrophyte stems, so it was not surprising that this plant form was uncommon (Table 15).

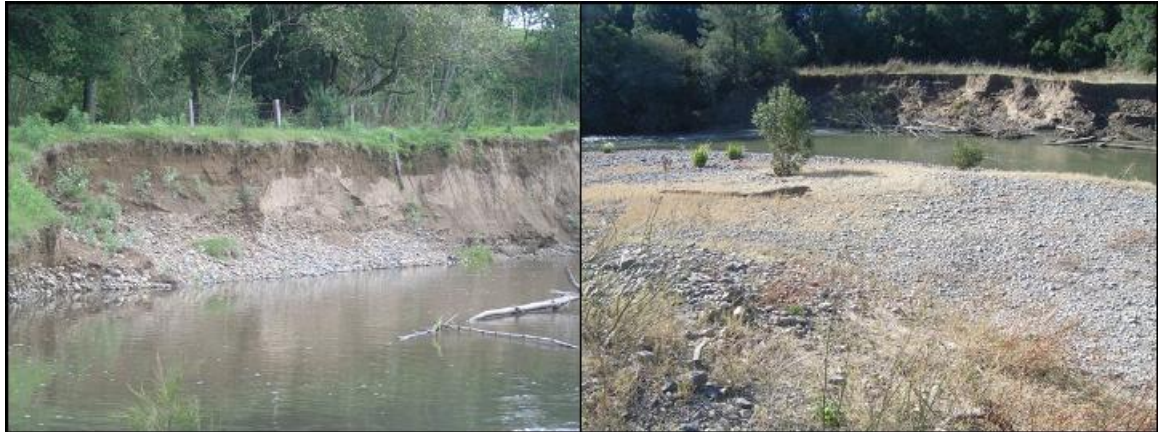
Figure 41. Actively eroding banks on the Williams River. Left is S8 (3/12/2007) and right is site 6.7 km upstream of S12 (10/05/2008).

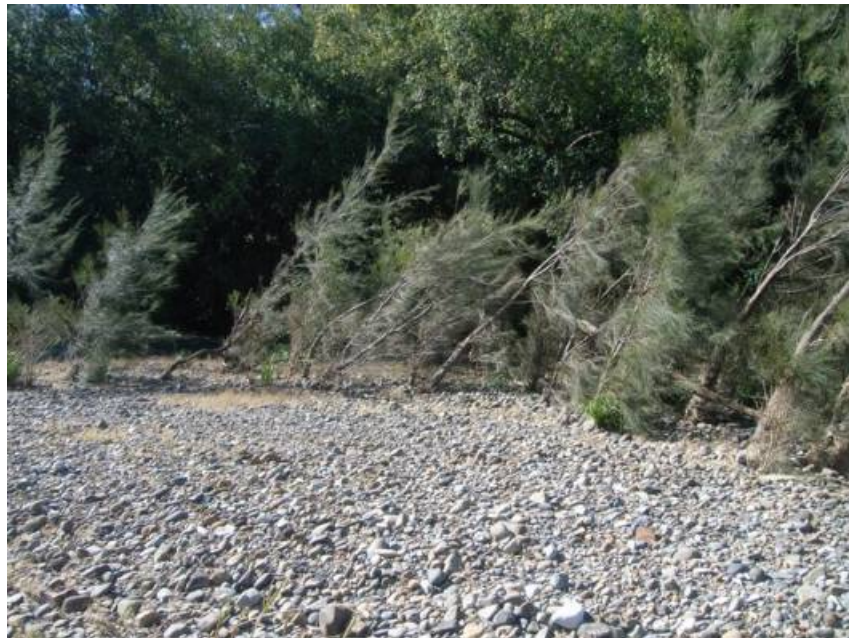
Figure 42. Casuarina saplings adjacent to a riffle in the bed of the Williams River 2 weeks after experiencing total immersion in a flood (peak 69,000 ML/d). Site located 6.7 km upstream of S12, on the property at the end of Glen William Church Road. E 56 388357; N 6401099; View is right to left bank; 13:32 hr; 10/05/2008. Flow approx. 500 ML/d.

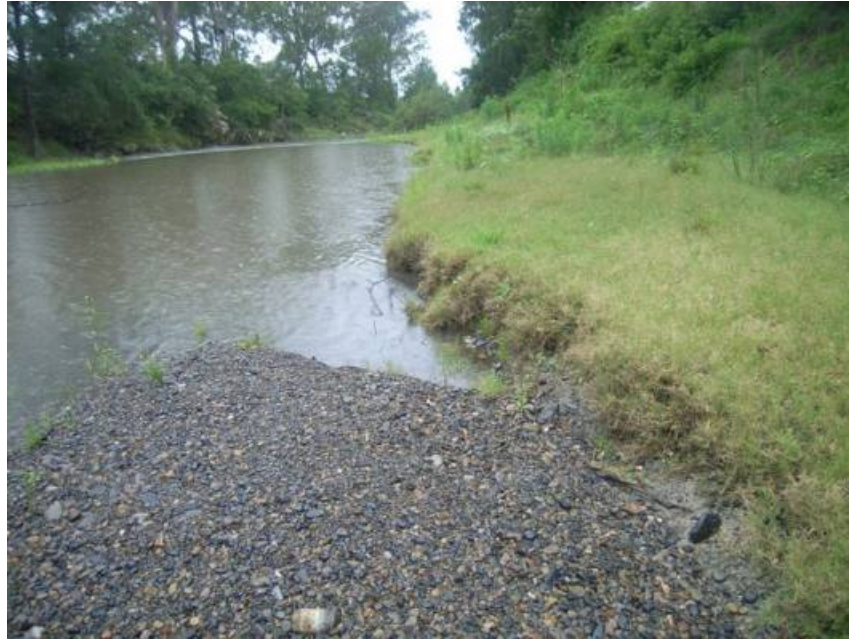
Figure 43. Well grassed, stable, low gravel bench on the Williams River at S7, just downstream of the proposed Tillegra Dam site. E 56 376717; N 6423438; View is downstream; 12:21 hr; 3/12/2007. Flow approx. 350 ML/d.

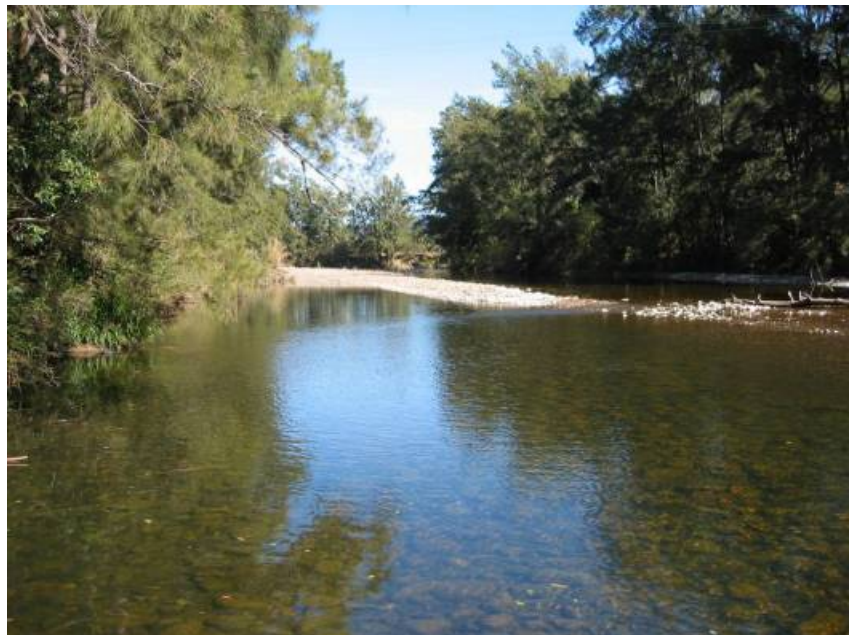
Figure 44. Typical clean bed material, free of fine surface sediment and heavy biofilm build-up. Taken at Bandon Grove, just downstream of Chichester River junction, between S8 and S9, on 10/08/2007. Flow approx. 70 ML/d.

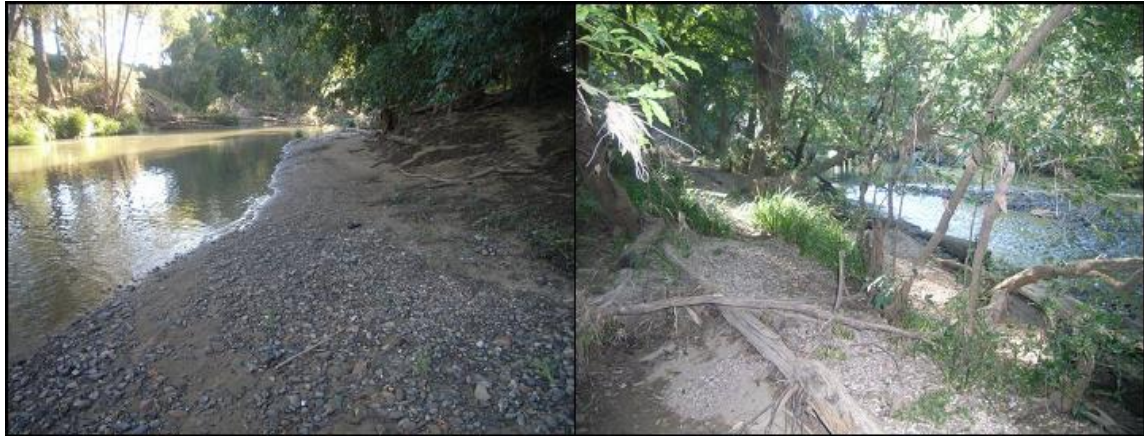
Figure 45. Sand and fine gravel deposits on the lower bank of the inside bend (left), and within dense riparian vegetation (right) at S11. E 56 383601; N 6406784; 15:55 hr; 10/05/2008. Flow approx. 460 ML/d.

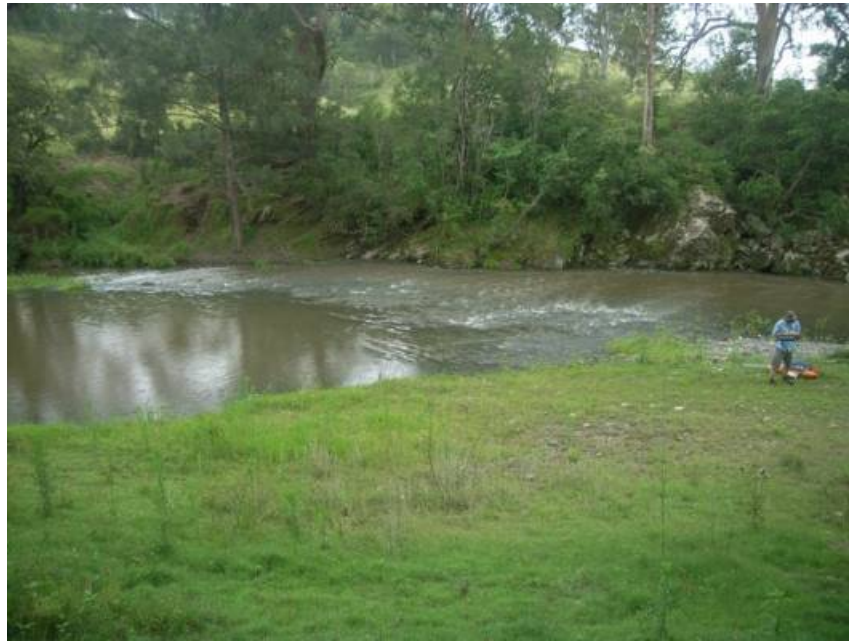
Figure 46. Fully covered riffle in middle of Site S7, just downstream of the proposed Tillegra Dam site. Low grassed gravel bench in foreground. E 56 376717; N 6423438; View is right bank to left bank; 12:21 hr; 3/12/2007. Flow approx. 350 ML/d.

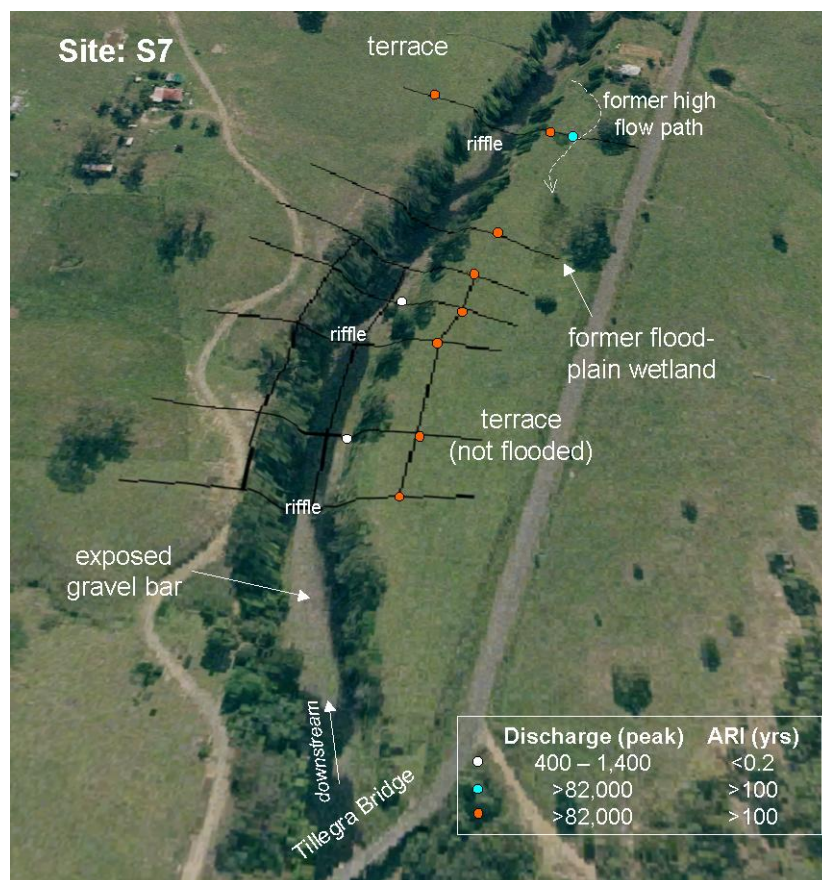
Figure 47. Site S7, showing major morphological surfaces and the discharge required to inundate them (instantaneous flow). Image is LiDAR generated DEM with draped aerial photograph.

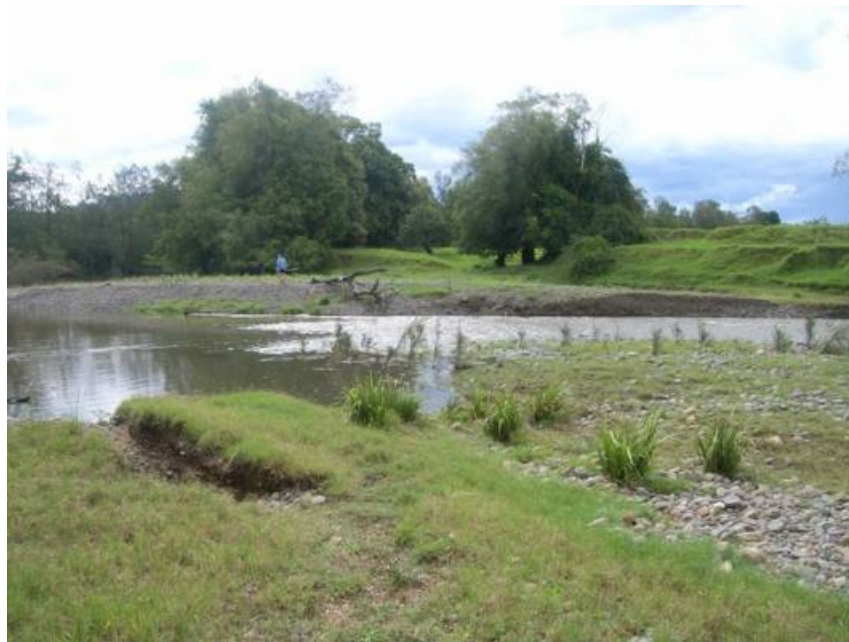
Figure 48. Fully covered riffle at Site S8. E 56 378701; N 6424587; View is right bank to left bank; 14:08 hr; 3/12/2007. Flow approx. 340 ML/d. Low gravel bar in foreground, and high gravel bar in background.
