Tillegra Dam

Planning and Environmental Assessment

Fluvial
Geomorphology

WORKING
PAPER

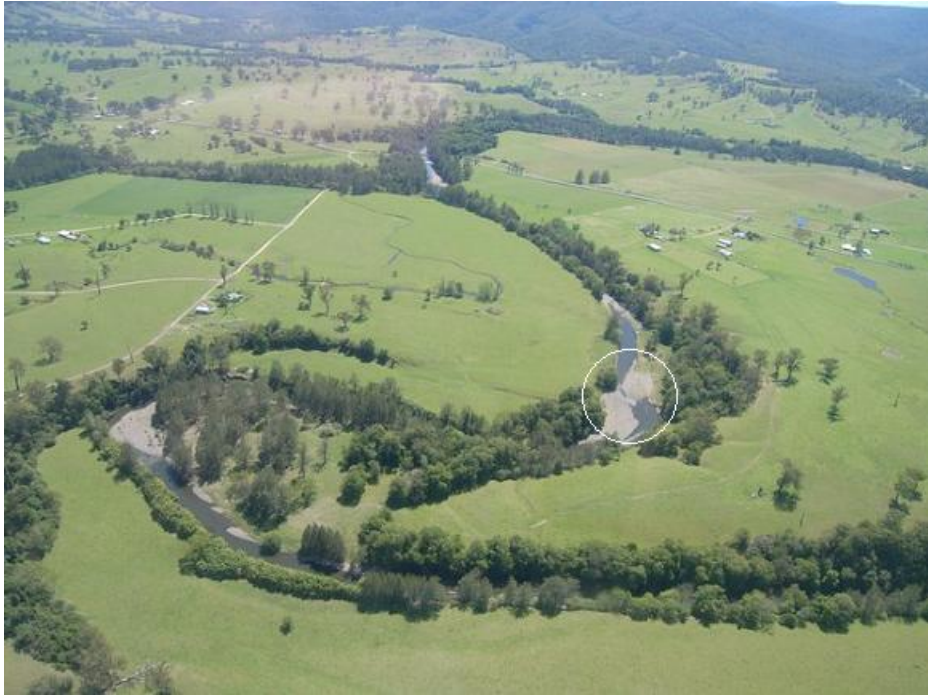
Figure 49. Site S8 from the air, with riffle depicted in Figure 48 circled. View is downstream. Taken at 08:42 hr; 14/11/2007. Flow approx. 78 ML/d.

Site S8 was located just upstream of Chichester River junction (Reach 3). At a flow of 340 ML/d the central riffle was almost fully inundated (16.6 m width) to an average depth of 0.20 m (range 0.11 – 0.42 m) (Figure 48). This was a relatively narrow riffle, and it was observed to be narrower at 78 ML/d (Figure 49). The low gravel bars were inundated at flows in the range 1,000 – 3,000 ML/d while the higher gravel bar on the upstream left side of the site required 10,000 – 11,000 ML/d for inundation (Figure 50). There were other horizontal surfaces present at this site, inundated across a range of discharges. The upper valley surface was infrequently inundated. The ARI was around 30 to 60 years, meaning that this surface was effectively a terrace.

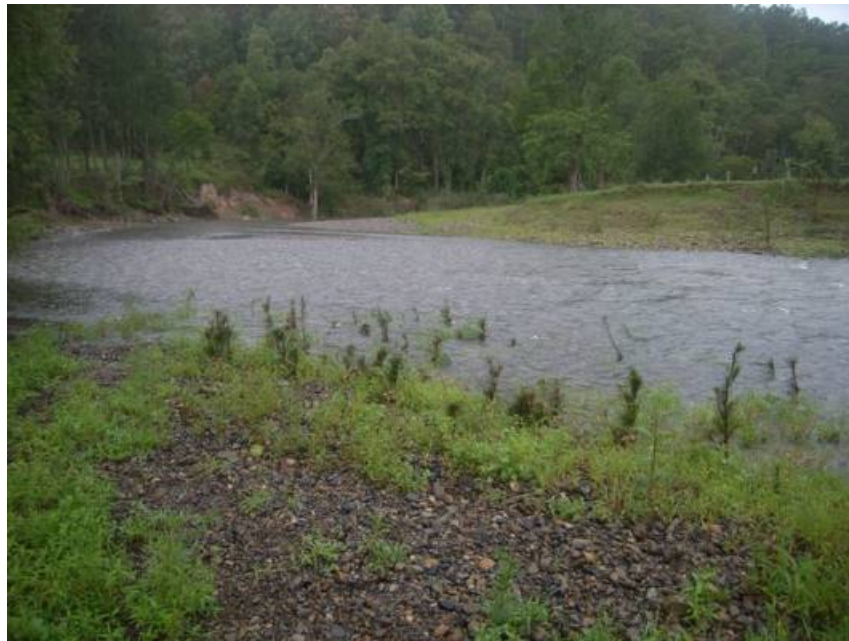
Figure 51. Fully covered riffle at Site S9. E 56 380820; N 6423586; View is downstream; 16:40 hr; 3/12/2007. Flow approx. 750 ML/d.

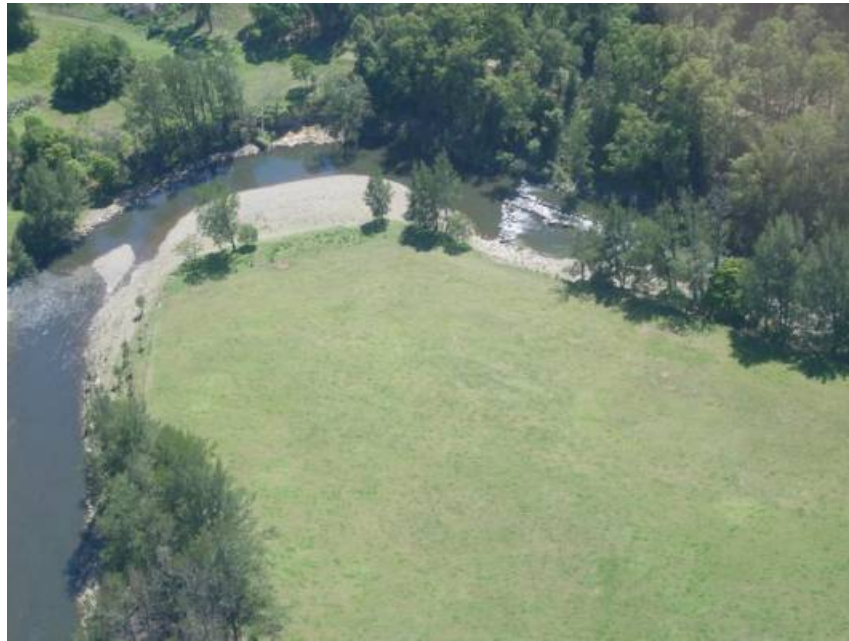
Figure 52. Partly covered riffle (left of picture) at Site S9. Taken from helicopter at 08:38 hr; 14/11/2007. Flow approx. 190 ML/d. Flow is left to right.

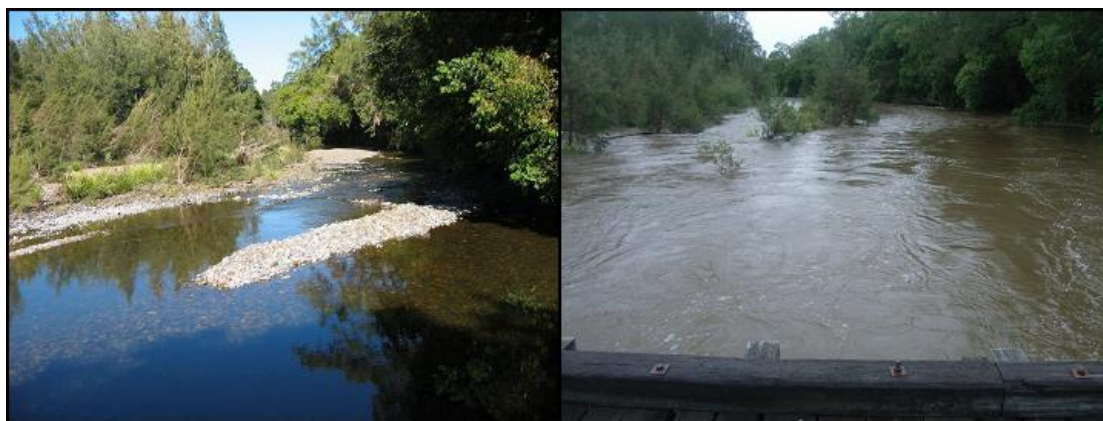
Figure 55. View downstream from Fosterton Bridge, just upstream of S10, E 56 382194; N 6422876. Left view taken at 11:34 hr; 10/08/2007; flow approx. 70 ML/d. Right view taken at 07:29 on 4/12/2007; flow approx. 2,000 ML/d.

Site S10 was located 1 kilometre downstream of Fosterton Bridge, or approximately 8 km downstream of Chichester River junction (Reach 3) (Figure 54). Low flows of 70 ML/d exposed a large area of gravels, while flows of 2,000 ML/d fully inundated the bed of the channel with fast flowing water (Figure 55). There was a low bench present that required 27,000 ML/d for inundation (Figure 54). The left floodplain was lower than the right floodplain. The left floodplain was inundated by the 3 to 7 year ARI event. The right floodplain had two levels, one inundated by the 11 year ARI event and one by the 14 year ARI event (Figure 54).

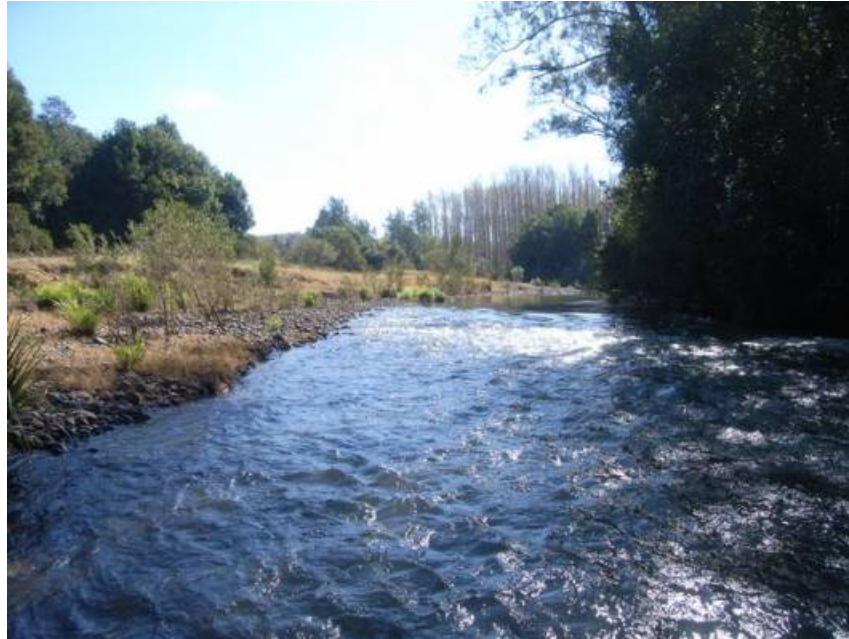
Figure 57. Riffle site 6.7 km upstream of S12, E 56 383602; N 6406840. View is upstream. Taken at 13:58 on 10/05/2008; flow approx. 500 ML/d.

A site located 6.7 km upstream of S12, with similar morphology to the upper part of S12, was inspected on 10 May 2008. At the time, the riffle was fully inundated by a flow of approximately 500 ML/d (Figure 57). The Mill Dam Falls were inspected on 20 August 2007 when flow was approximately 3,200 ML/d. At that discharge the rock bar at the Falls was completely inundated and formed a swiftly flowing rapid (Figure 22).
