Tillegra Dam

Planning and Environmental Assessment

Aboriginal
Heritage

Tillegra Dam Aboriginal Archaeology Environmental Assessment Report

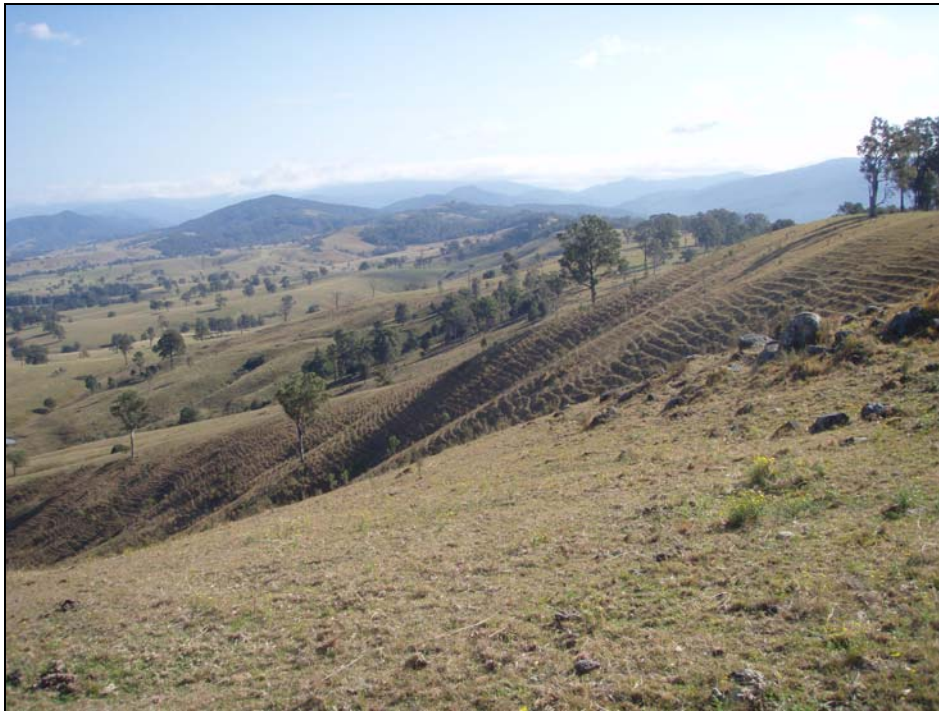
Figure 4.1. Accelerated soil creep on slopes within the impact area

Short dendritic first and second order drainage lines are regularly distributed around the hill slopes and exhibit moderate gully erosion at their confluence with the Williams River. Minor to moderate sheet erosion and small landslips and slumps are reported as erosional problems for the area (Henderson 2000). Accelerated soil creep due to livestock movement has been observed directly within the impact area (Figure 4.1). No obvious sediment traps apart from the colluvial lower slopes and floodplain elements are evident in the impact area suggesting eroded materials are transported rapidly away from the area.

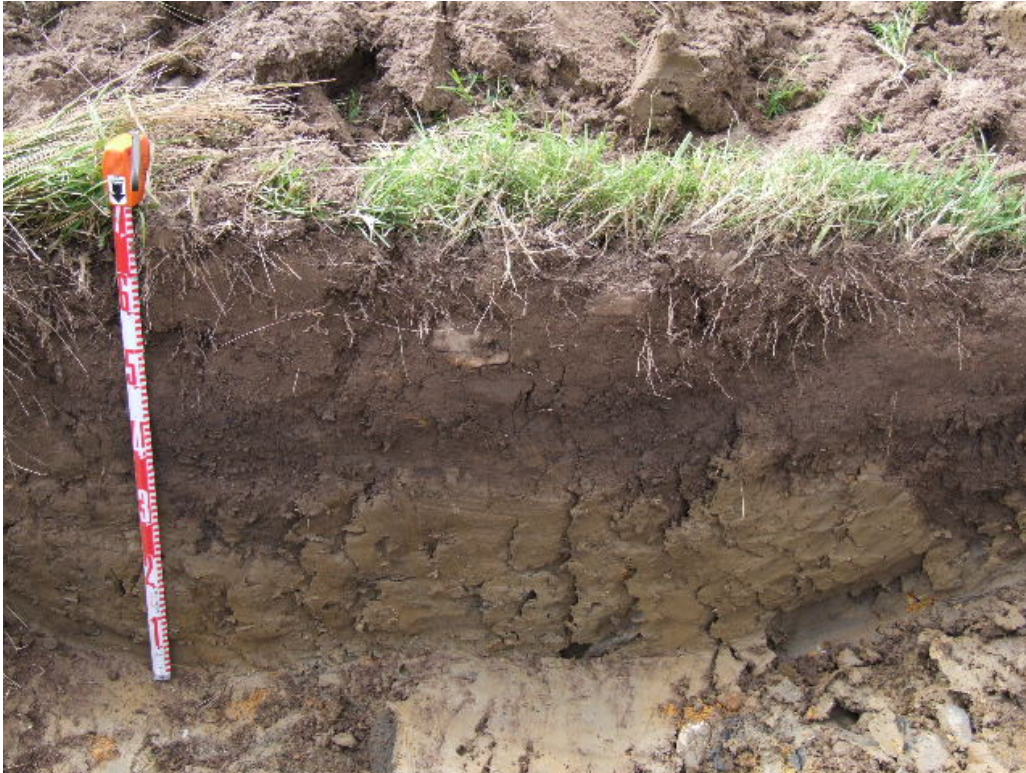
Plate 2: Typical alluvial soil profile

Areas B1 and B2 were characterised by alluvial soils with mottled clays at the base of each trench (Plate 2). Area B3 was in an elevated area away from any flood plain. Outcropping rock was observed near the testing area. Frequent gravels were observed in the trench along with shales and ironstone ‘coffee rock’ inclusions (Plate 3).

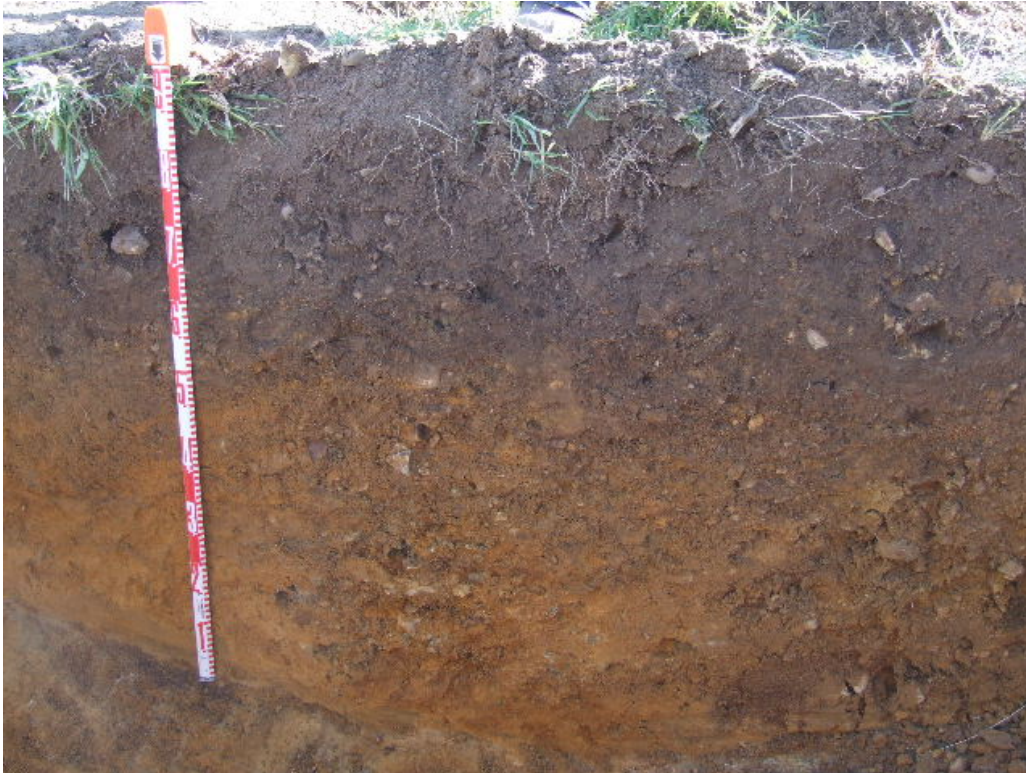
Plate 3: Profile of B3-T1

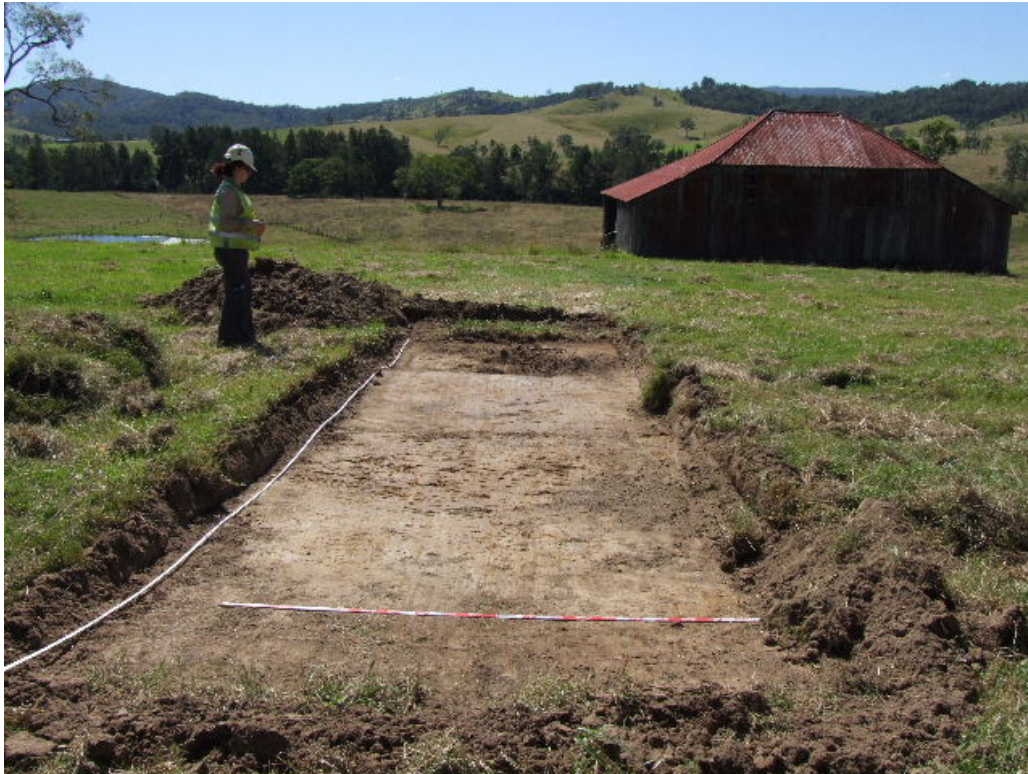
Plate 4: Trench D1-T3 end level facing north toward the Williams River

Two discrete areas were excavated as Area D. Area D1 is an elevated bench above the floodplain of the Williams River adjacent to Munni House (Plate 4). The area offers elevated position and access to the river as demonstrated by the use of a swimming hole and a locally known still existing passage to the river used in historic times. Five trenches were excavated in this area totalling approximately 83.35 square metres in surface area. Trench D1-T1 was a small (2 metre) trench excavated to examine the local stratigraphy. No artefacts were recovered from this trench. All the other trenches (D1-T2, D1-T3, D1-T4 and D1-T5) contained artefacts. The trenches were all sufficiently

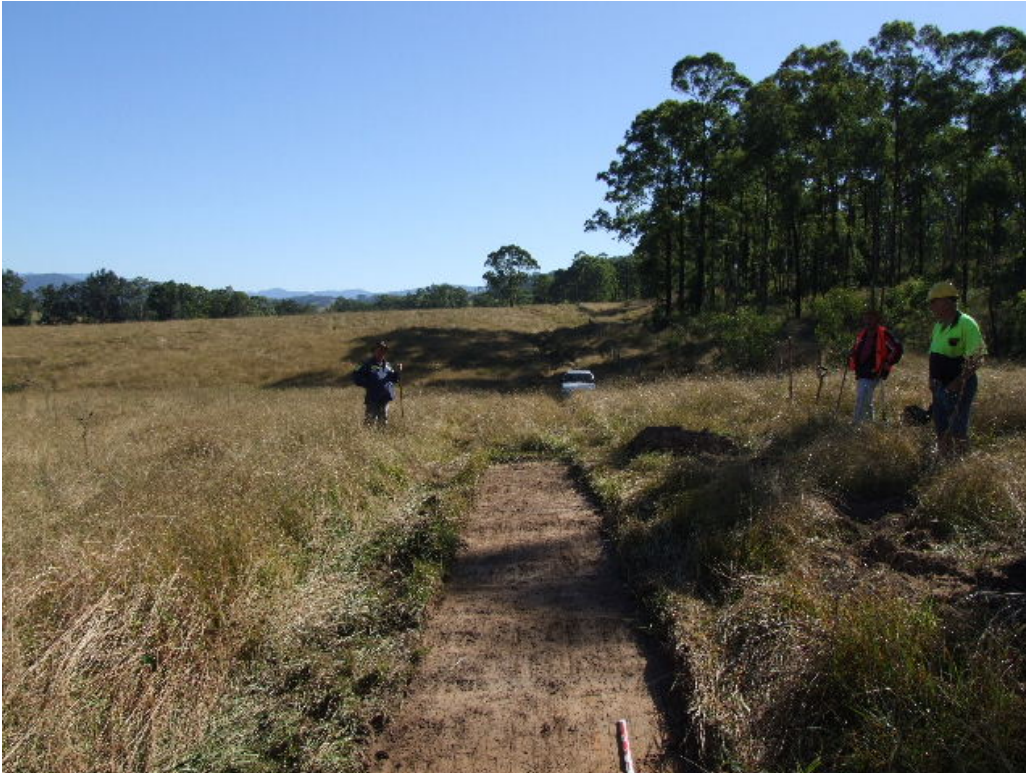
Plate 5: Area E1 facing north

Five trenches in two discrete locations totalling approximately 48 square metres surface area were excavated Area E. Three trenches (E1-T1, E1-T2 and E1-T3) were excavated on the terraces above an unnamed tributary creek near its confluence with the Williams River close to the proposed dam wall site (Plate 5). A dark brown silty loam at top of the deposit graded gradually to a light grey fine grained silt with ironstone and manganese inclusions. Some shale was also present.

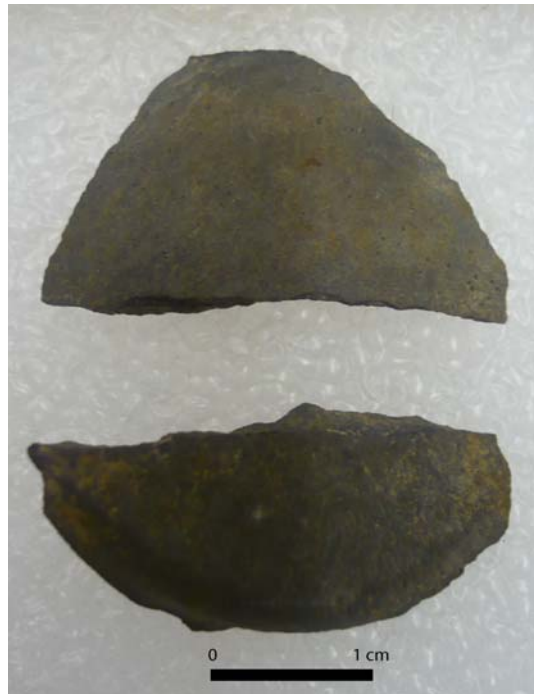
Figure 1. Refitting artefacts, D4IS-19 Distal fragment (bottom), DAIS-22 proximal fragment (top)

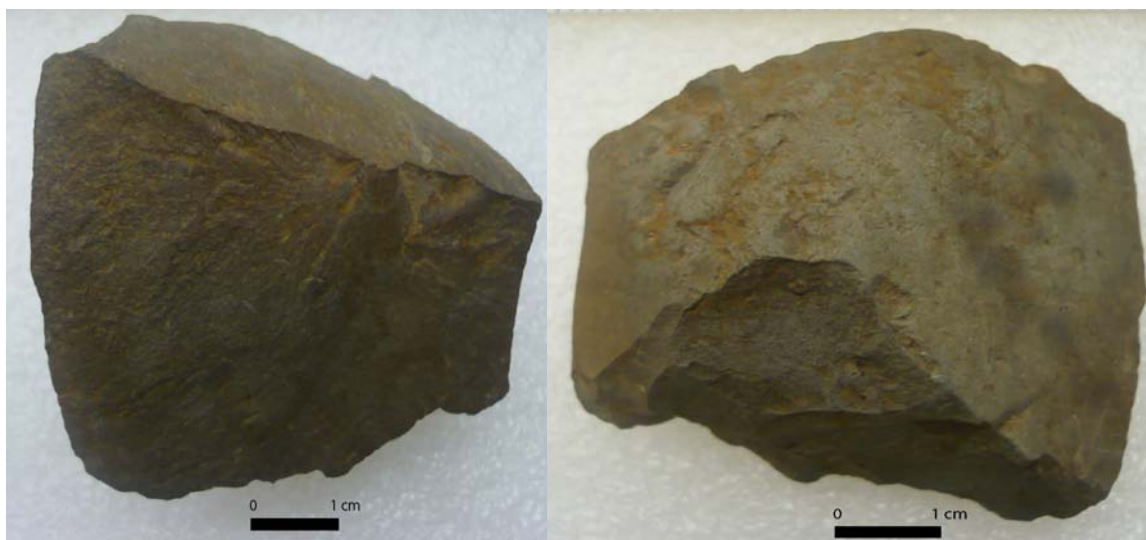
Figure 4. B1-24. Ventral view of a complete flake with stepped retouch (left), dorsal view of a complete flake with stepped retouch in Quadrant 3.

Five artefacts were retouched to form tools; this represents 14.6% of the assemblage (Table 4). Three of the tools were made from hornfels, one from FGS and another from basalt. A variety of scrapers were recovered with different types of retouch. Those with step and notch retouch presumably indicate a ‘heavy-duty’ use (Figure 4, Appendix D). No evidence of backing, generally attributed to the mid-Holocene, was present in the assemblage, although this may be a product of the raw material types; e.g. FGS raw materials are more often found with backing retouch.
