Hunter Water Corporation

## TILLEGRA DAM DESIGN - CONSULTANCY 361802

Storage Rim Stability and Seepage Potential  
Engineering Geotechnical Report

Report No. 08–GN31A–R2 Final Report V 4.1  
February 2009

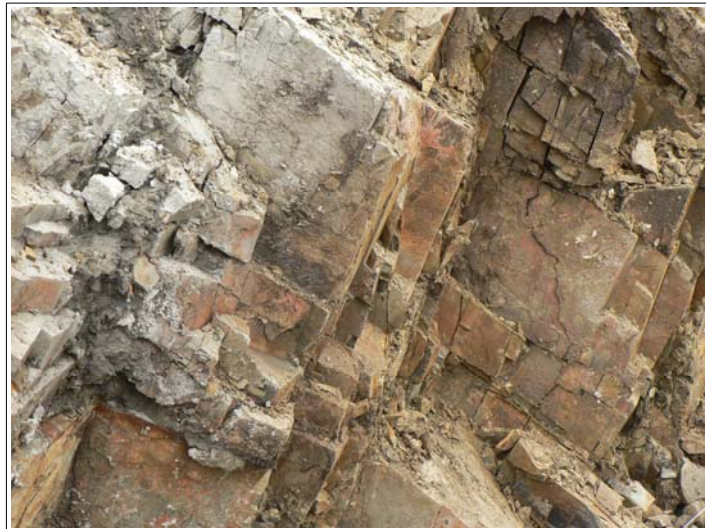
TF2 – Meta-shale, bedding dipping upstream at 65° to 70°

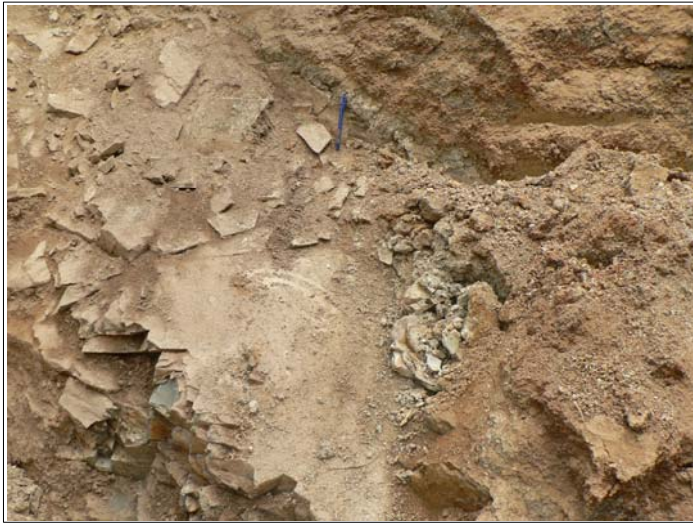
TF7 – Fault plane dipping downstream

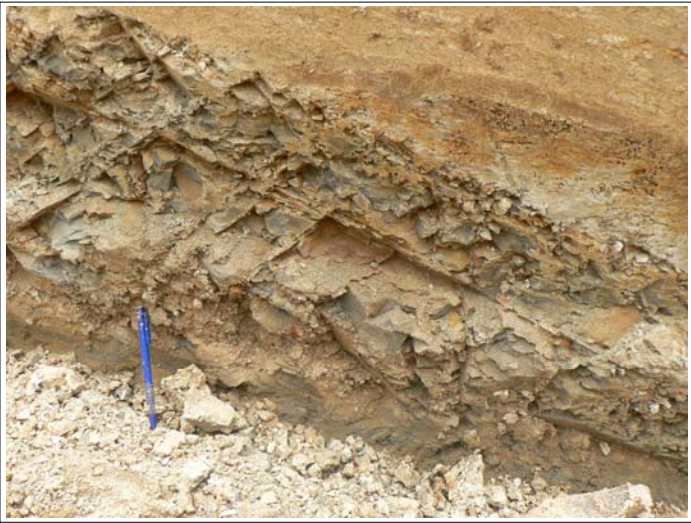
TF9 – Shearing parallel to fault plane

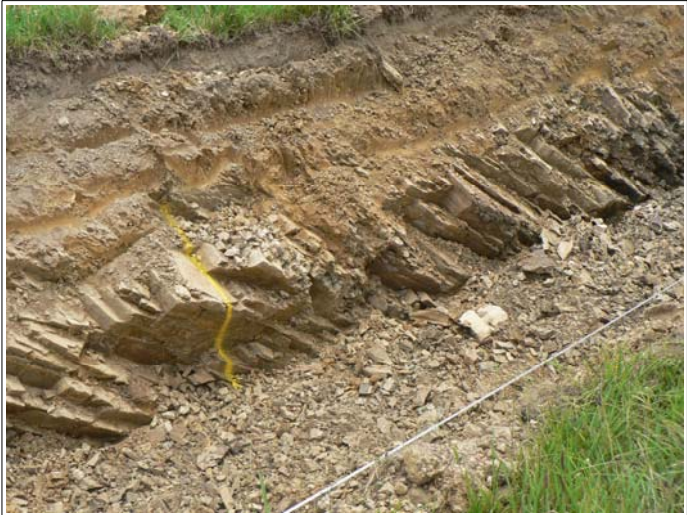
TF13 – Meta-shale, bedding dipping downstream at 40°

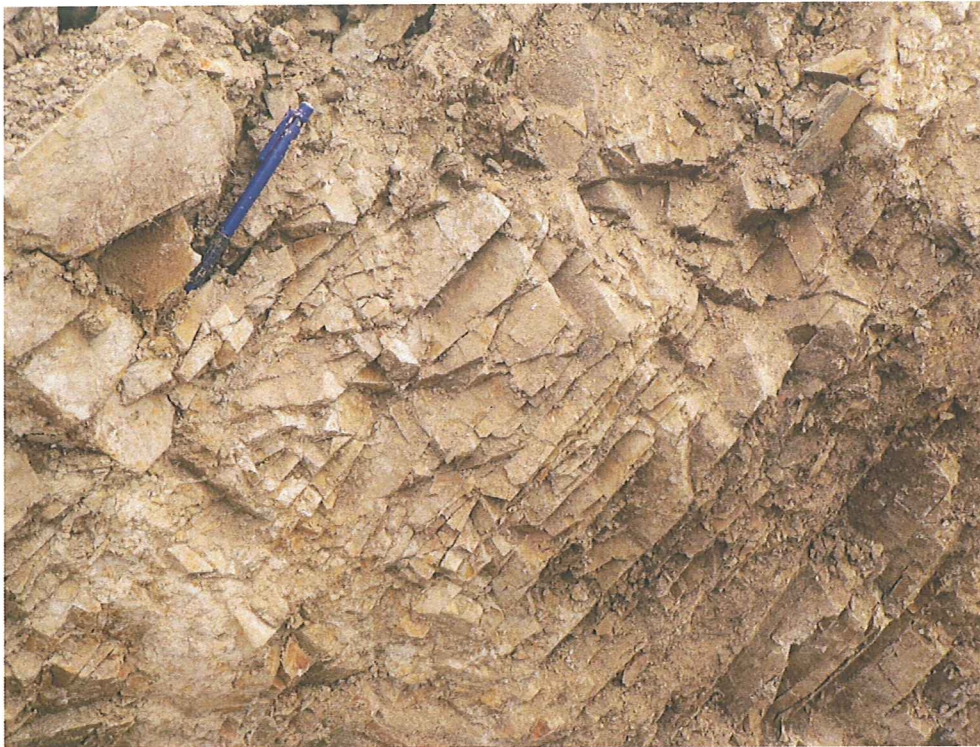
**Plate TF1.** Chn.4.3m. Meta-shale, bedding dipping upstream at 50° in direction 250°M.

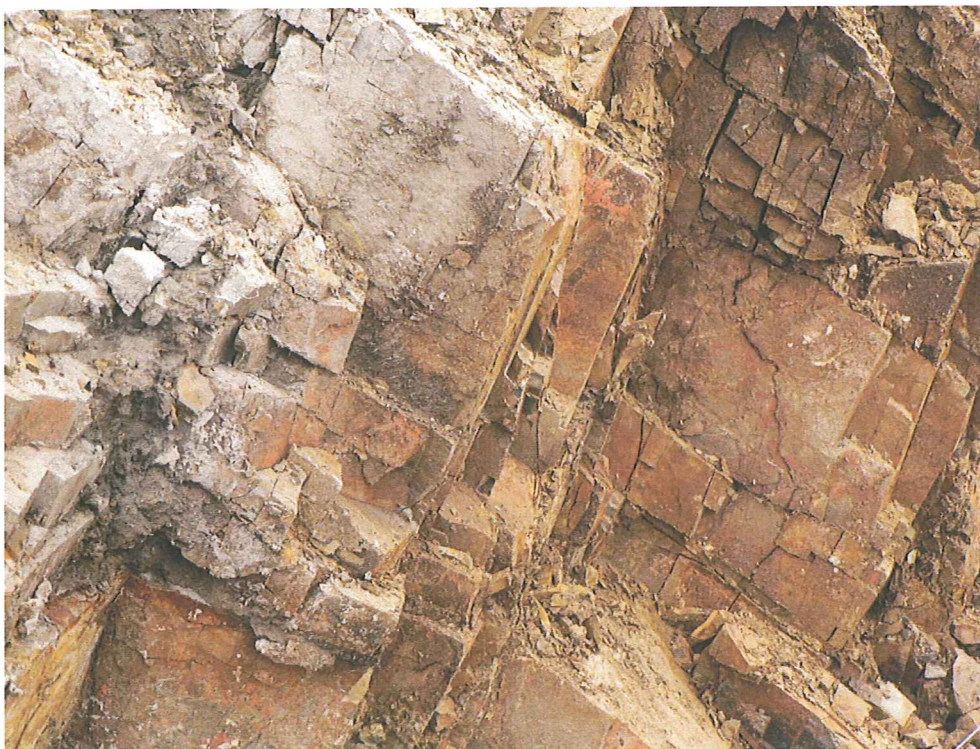
**Plate TF2.** Chn.8.3m. Meta-shale, dipping upstream at 65° to 70° in direction 275°M.

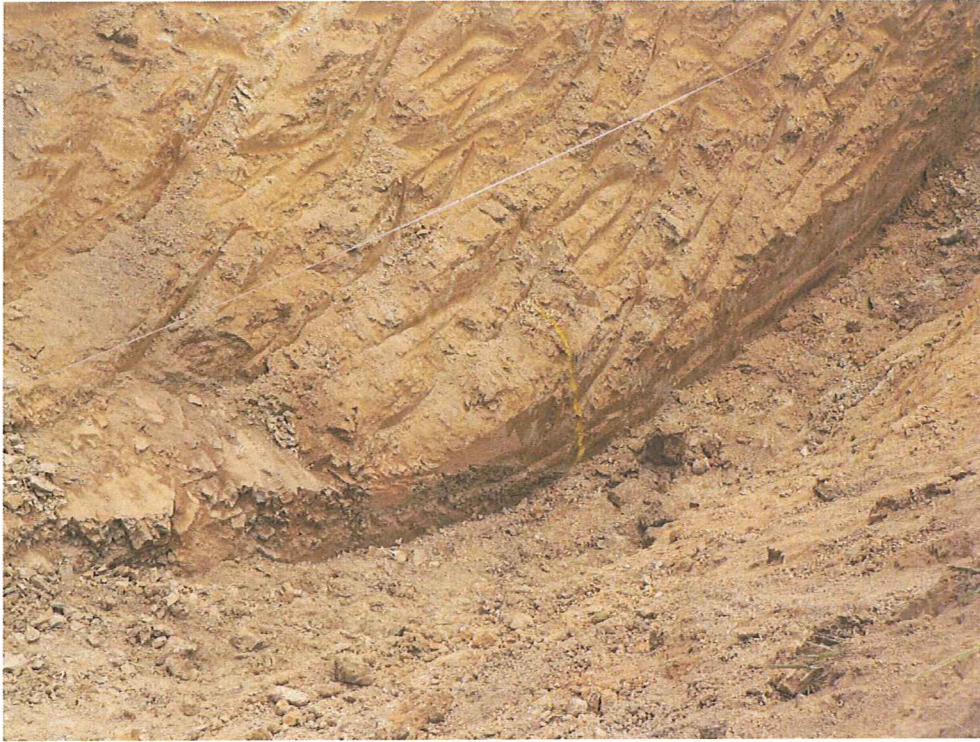
**Plate TF3.** Chn.17m to 22m. General view of the fault plane dipping downstream (to the right of the photograph).

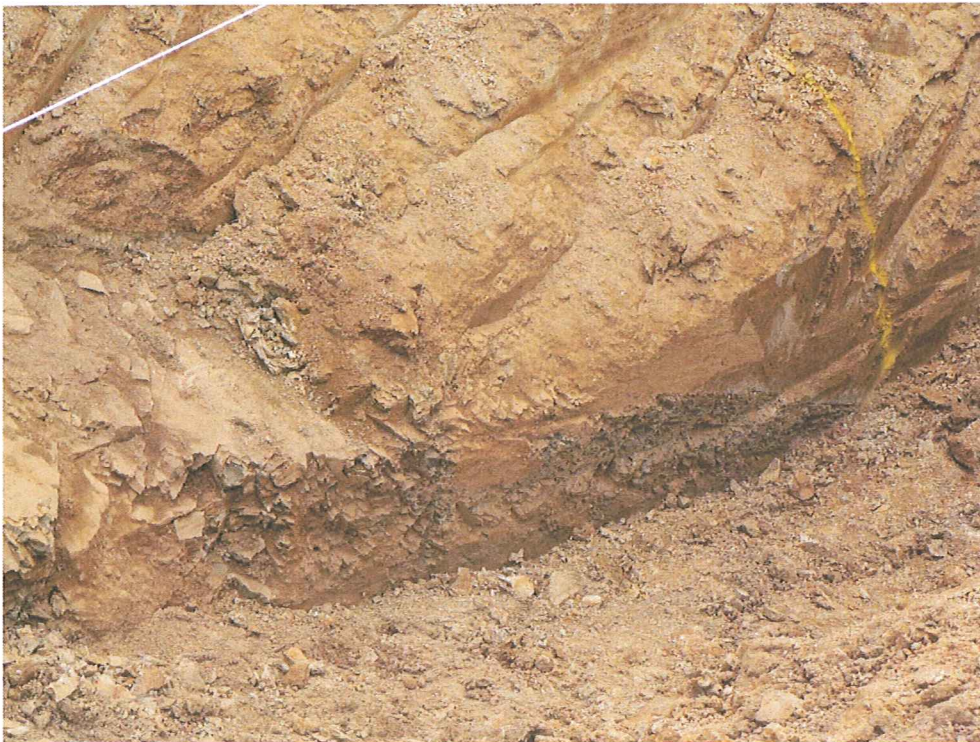
**Plate TF4.** Chn.17m to 22m. Fault plane dipping (downstream) into the floor of the trench.

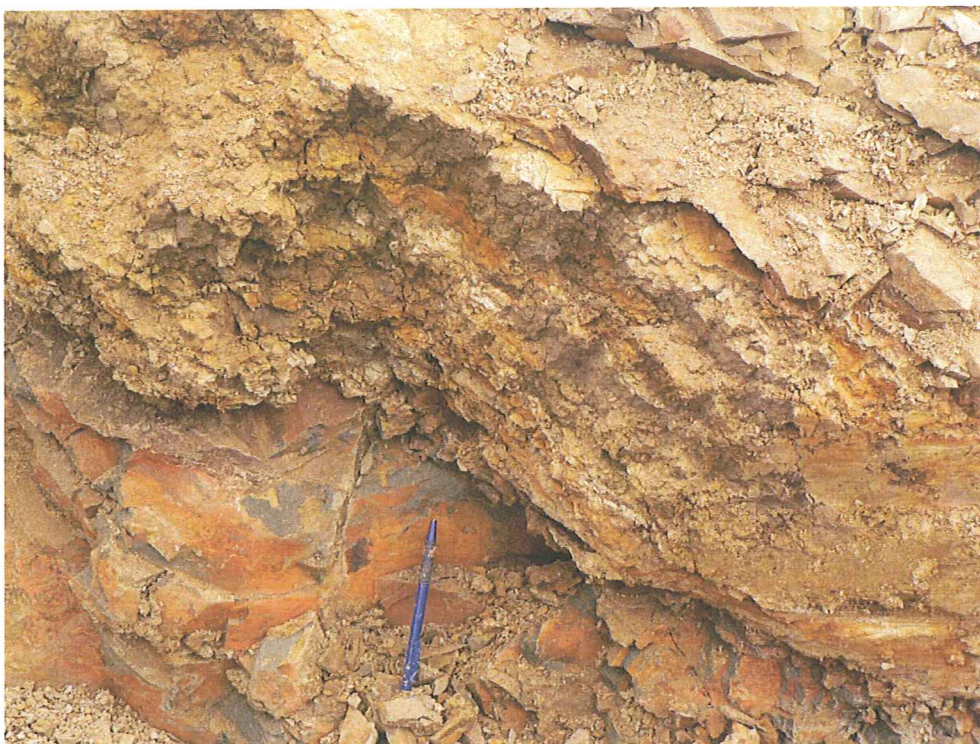
**Plate TF5.** Chn.11.4m. Fault plane dipping downstream (to the right of the photograph). Brecciated zone overlying meta-shale.

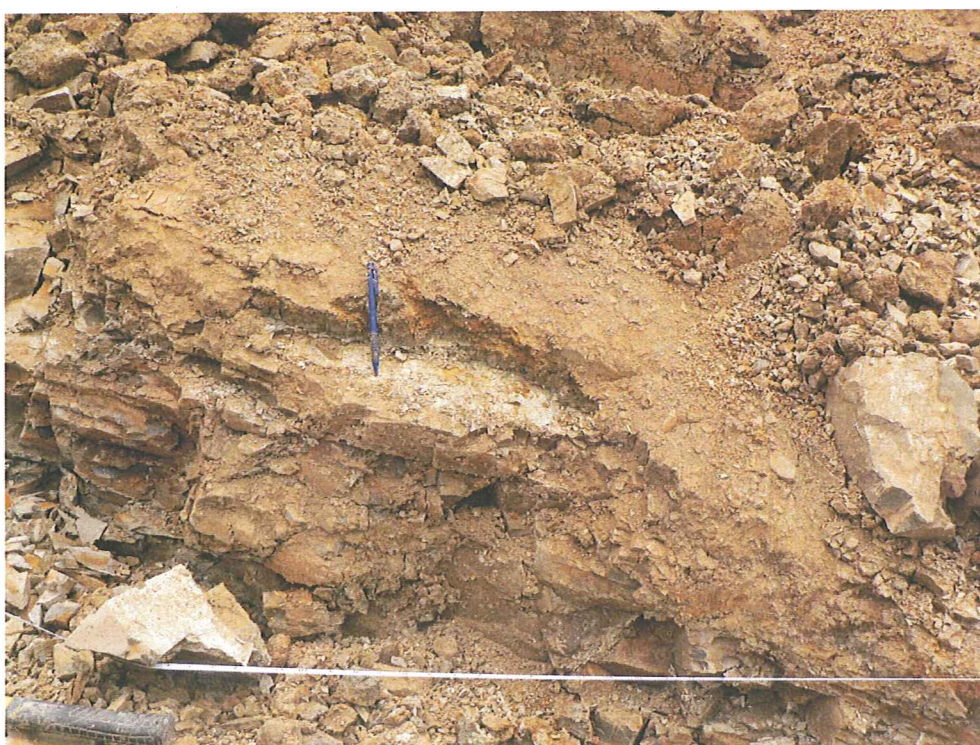
**Plate TF6.** Chn.14.3m. Fault plane dipping downstream, with shearing parallel to the fault plane.

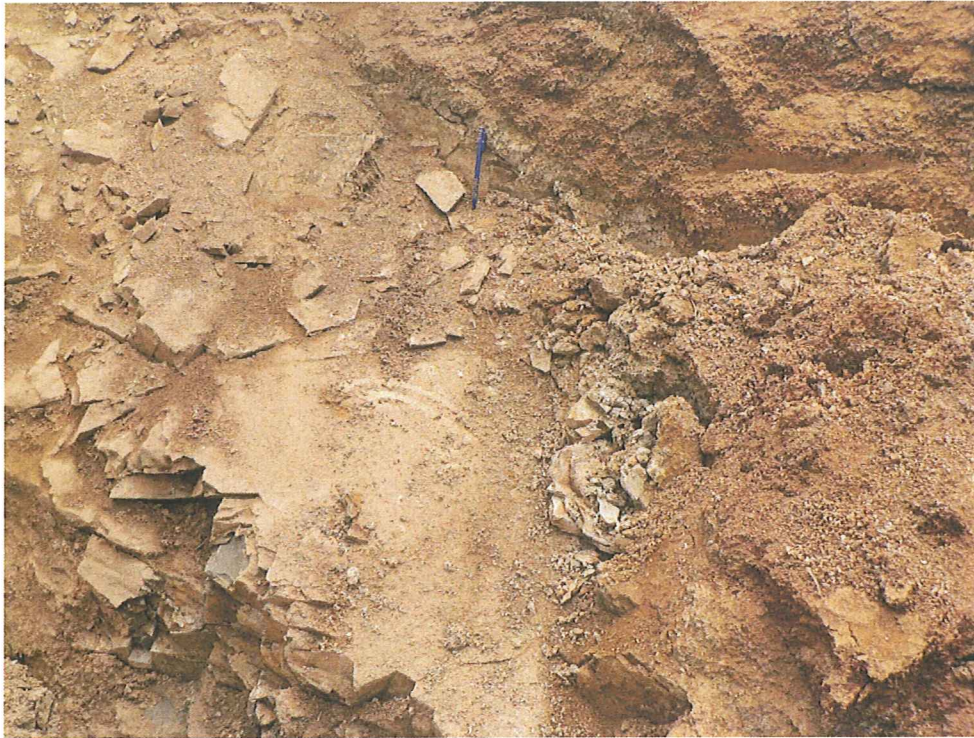
**Plate TF7.** Chn.19.5m. Fault plane dipping downstream.

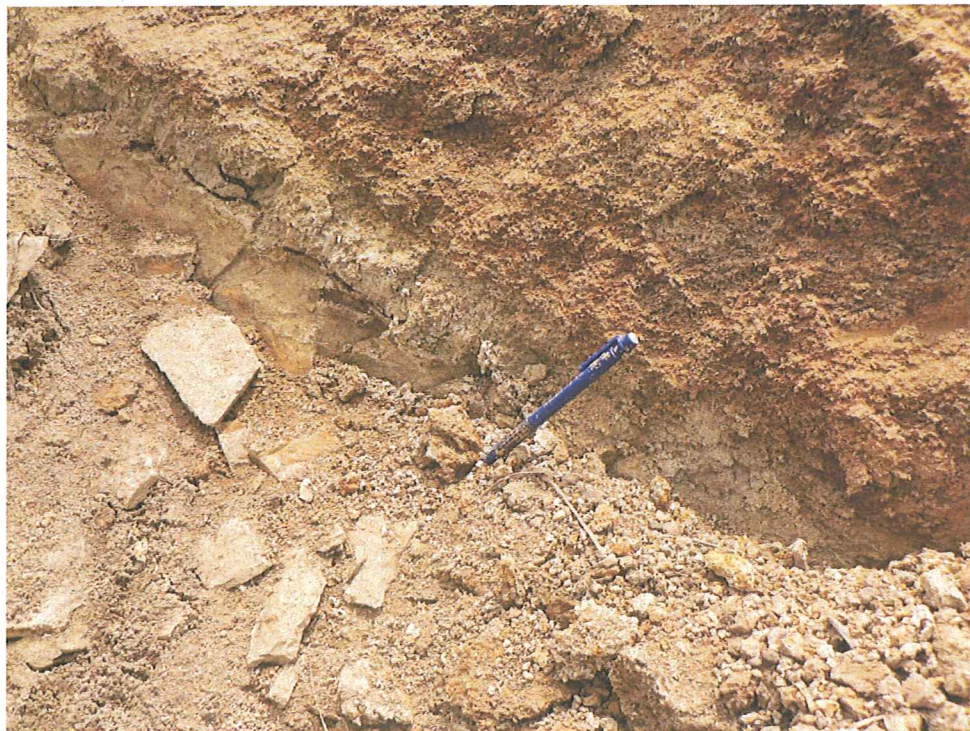
**Plate TF8.** Chn.19.5m. Narrow clayey zone (pale grey), immediately above the fault plane.

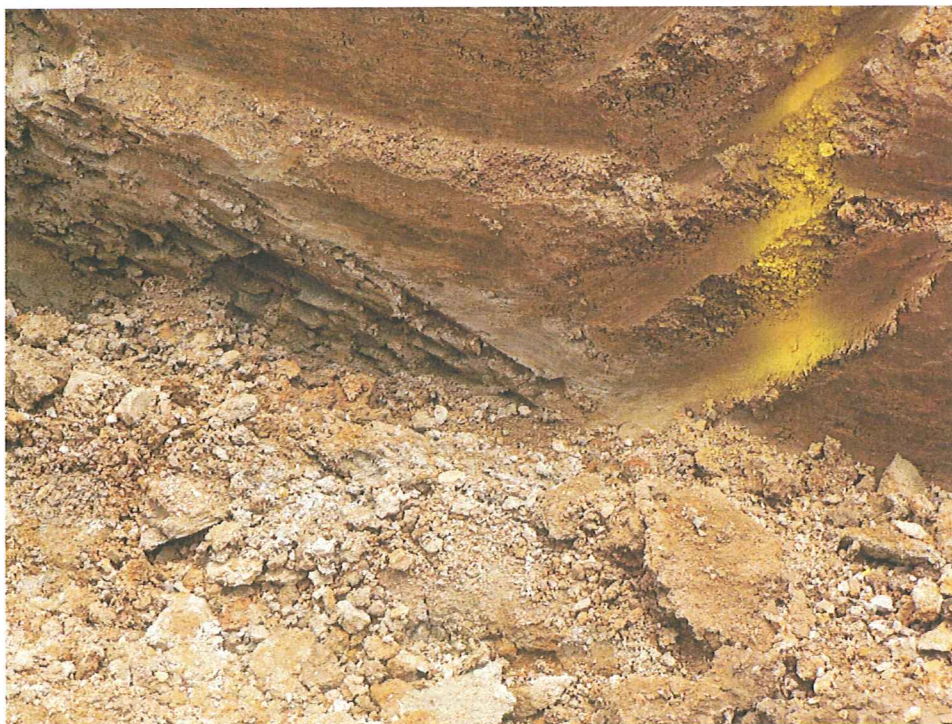
**Plate TF10.** Fault plane dipping into the floor of the trench.

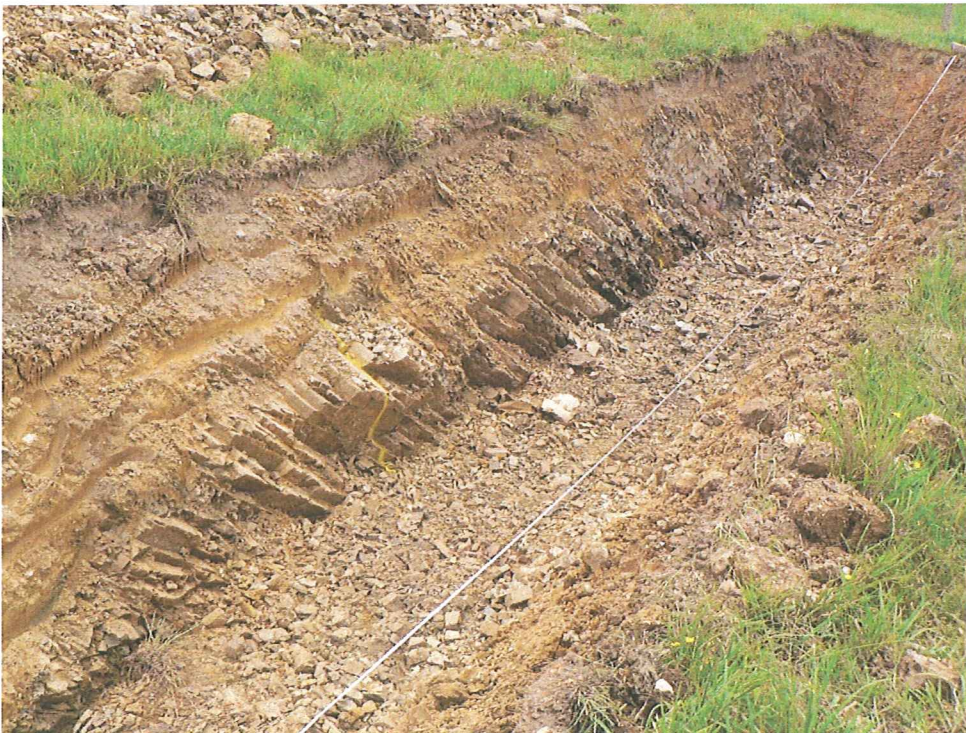
**Plate TF12.** Chn.37m to 52m. General view of the meta-shale downstream of the fault zone (dipping downstream at  $40^{\circ}$  to  $30^{\circ}$  in direction  $060^{\circ}\text{M}$  to  $072^{\circ}\text{M}$ ).

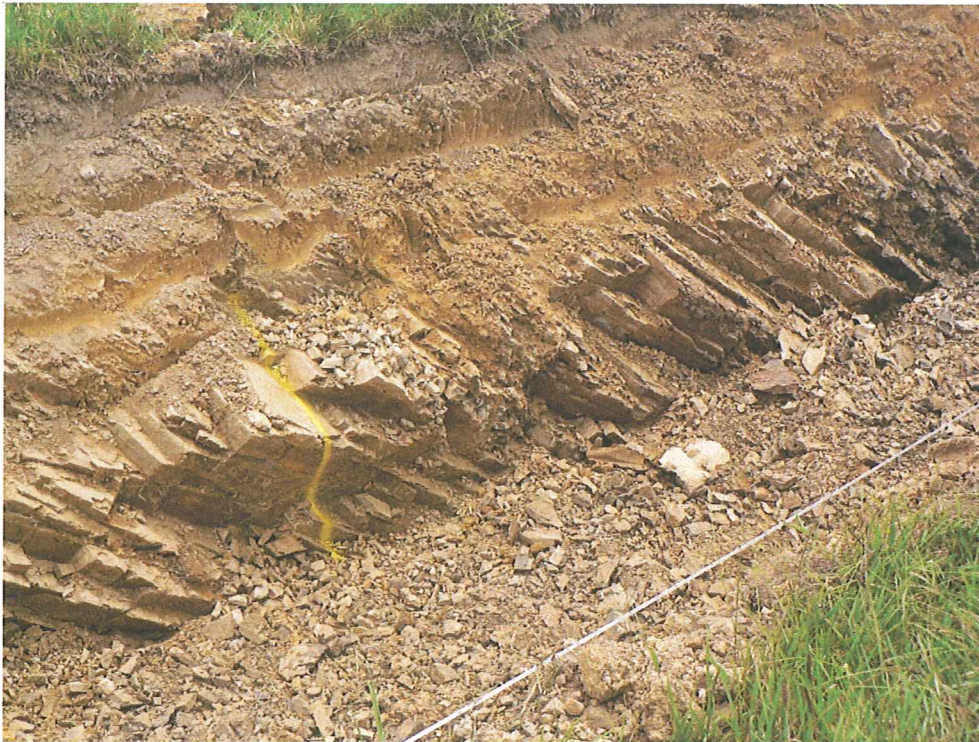
**Plate TF13.** Chn.37m. Well defined bedding dipping downstream at  $40^\circ$  in direction  $073^\circ\text{M}$ .

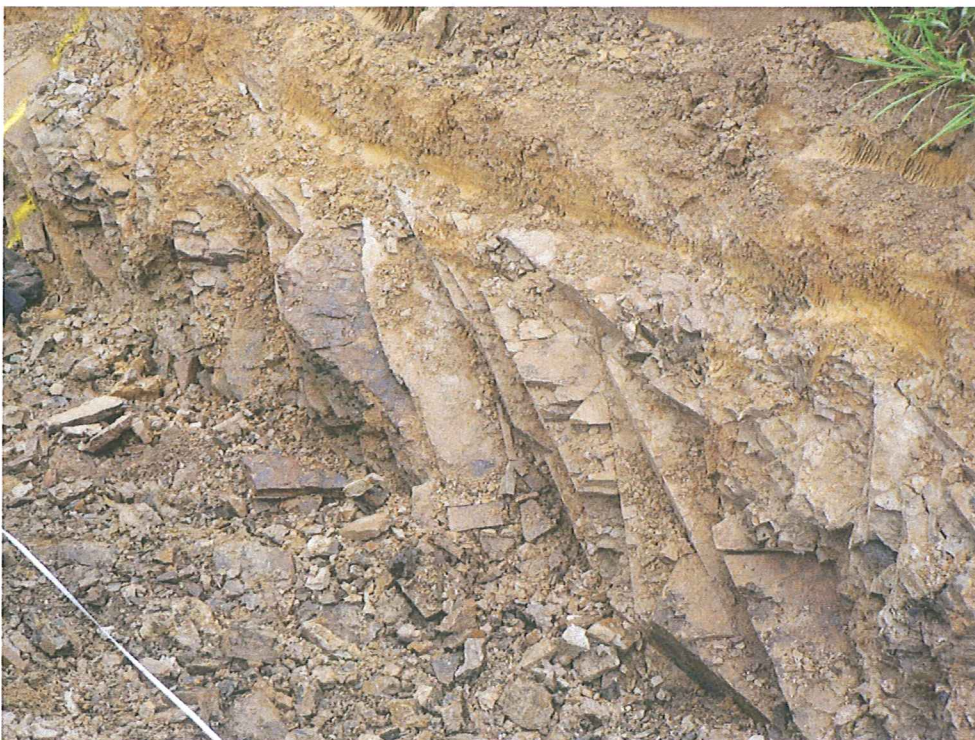
**Plate TF14.** Chn.39m. As above (refer to **Plate 13**).

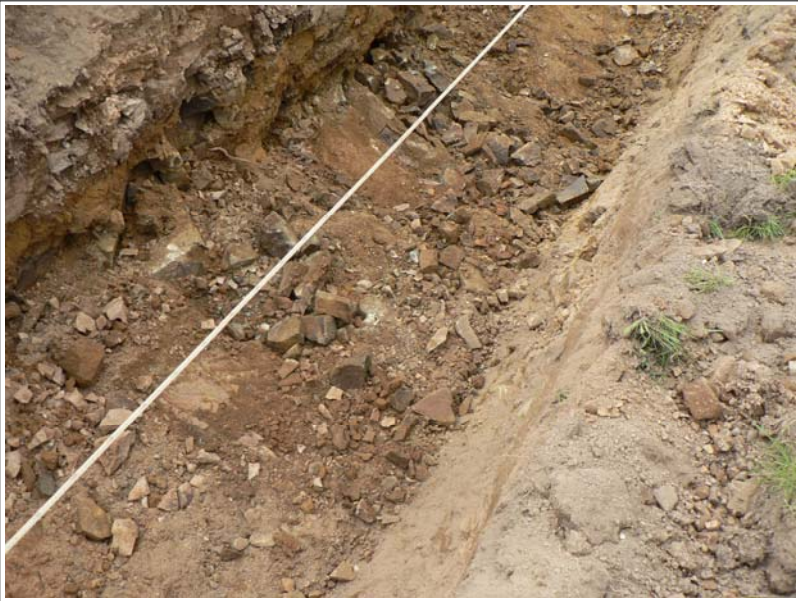
**T1A – Refusa/difficult digging on moderately weathered/slightly weathered tuffaceous sandstone**

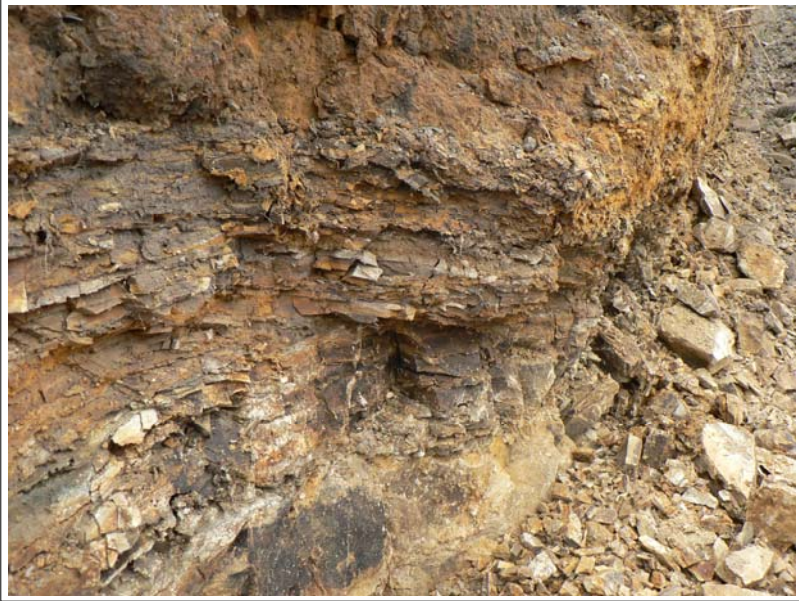
**T1B Contact between meta-shale and underlying tuffaceous sandstone**

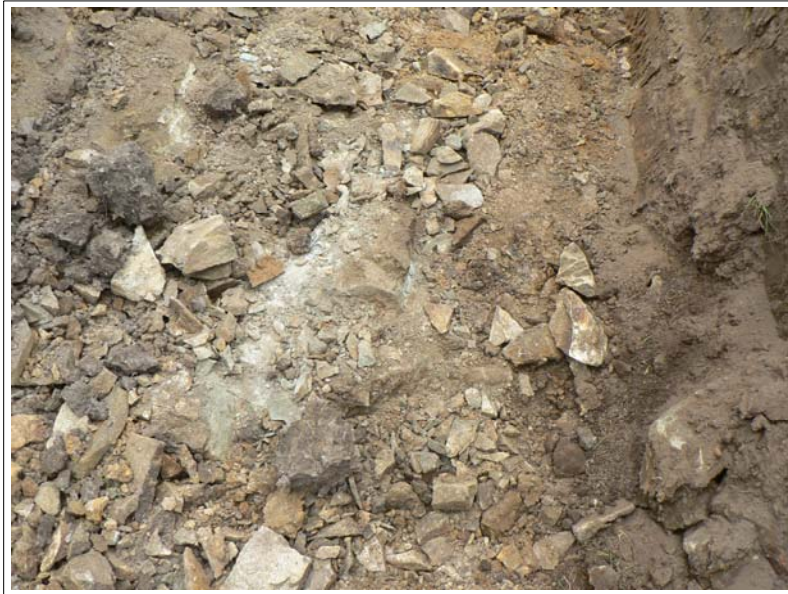
T2A – Refusal on slightly weathered tuffaceous sandstone

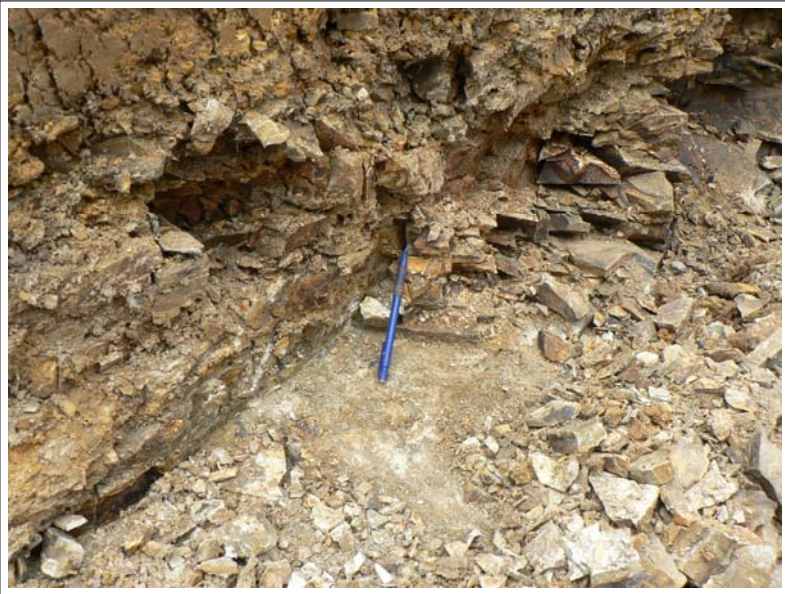
T2B – Contact between meta-shale and underlying tuffaceous sandstone

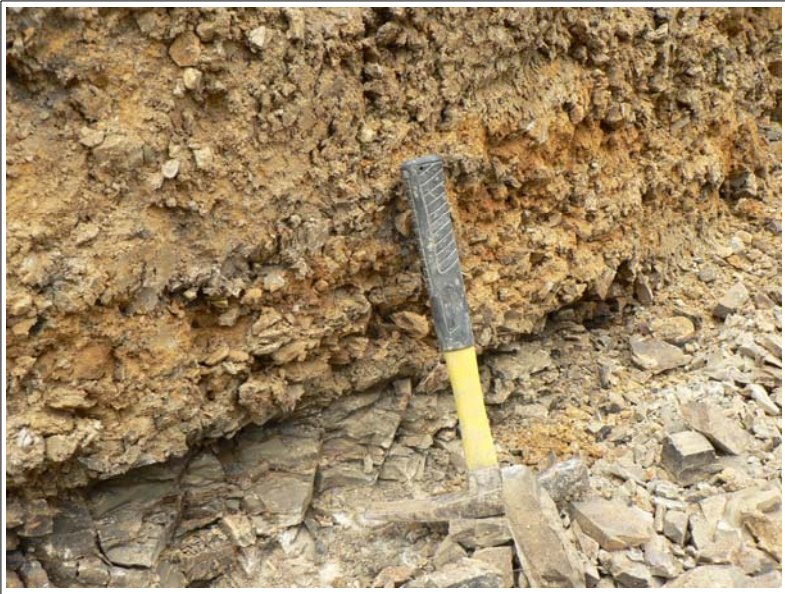
T2C – Gravelly silty clay overlying meta-shale

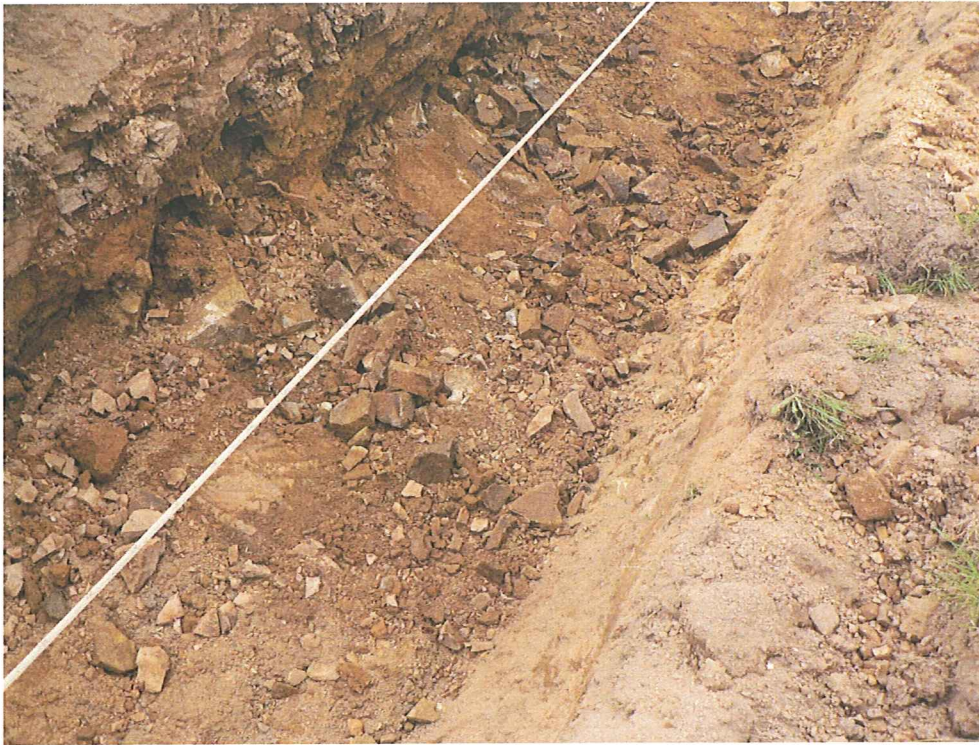
**Plate T1A.** Chn.4.5m to 10m. Refusal/difficult digging on moderately weathered/slightly weathered tuffaceous sandstone.

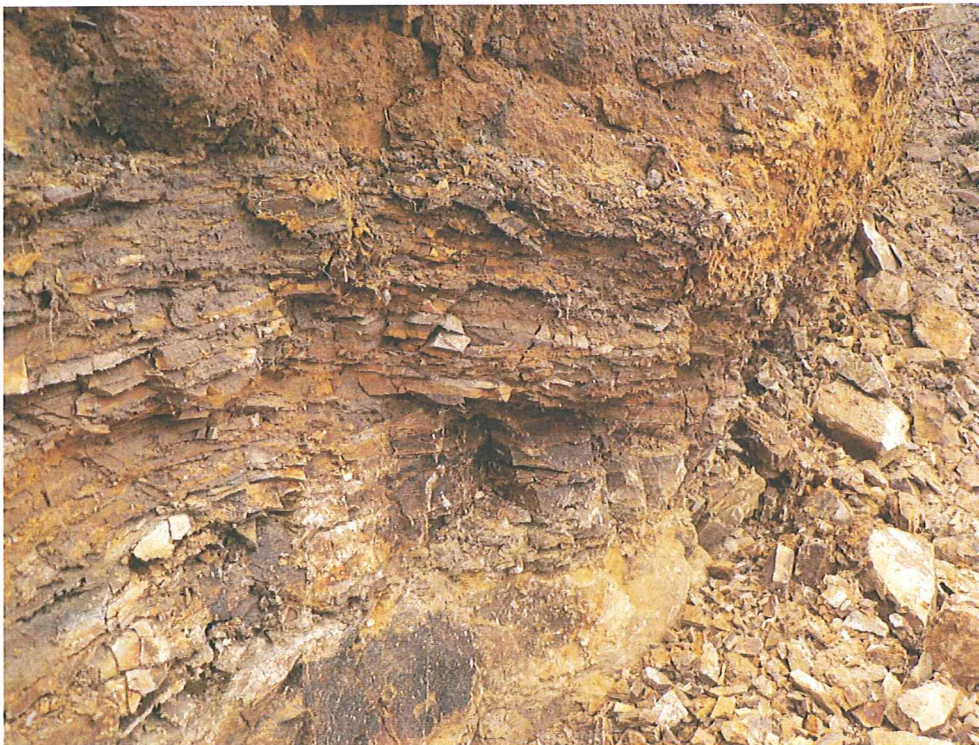
**Plate T1B.** Chn.9m. Contact between meta-shale and underlying tuffaceous sandstone.

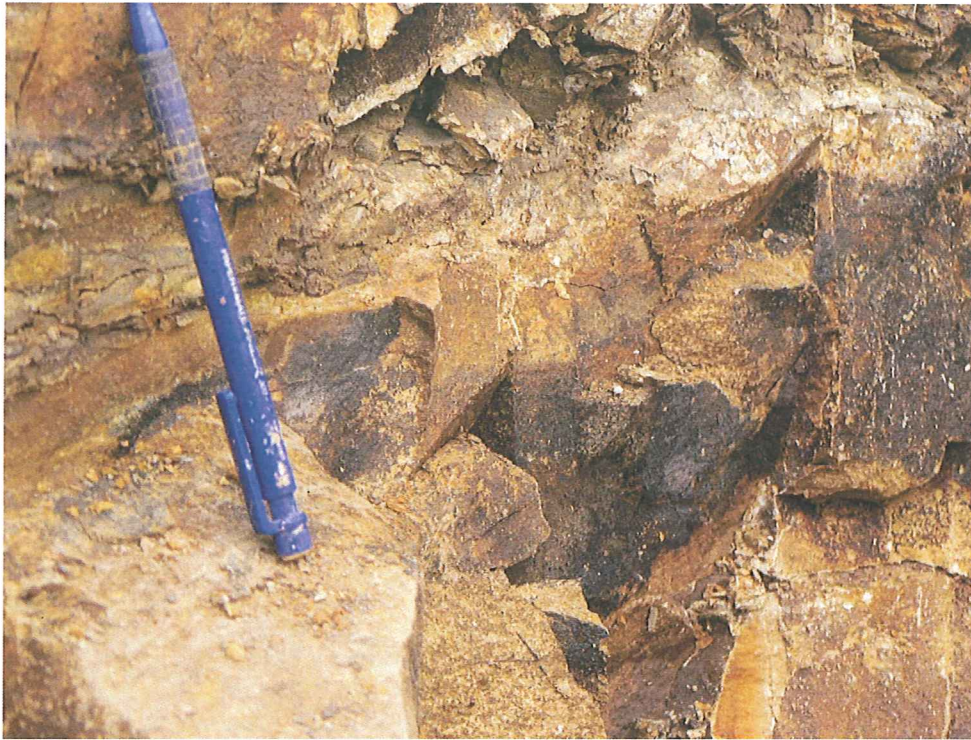
**Plate T1C.** Chn.9m. Contact between meta-shale and underlying tuffaceous sandstone.

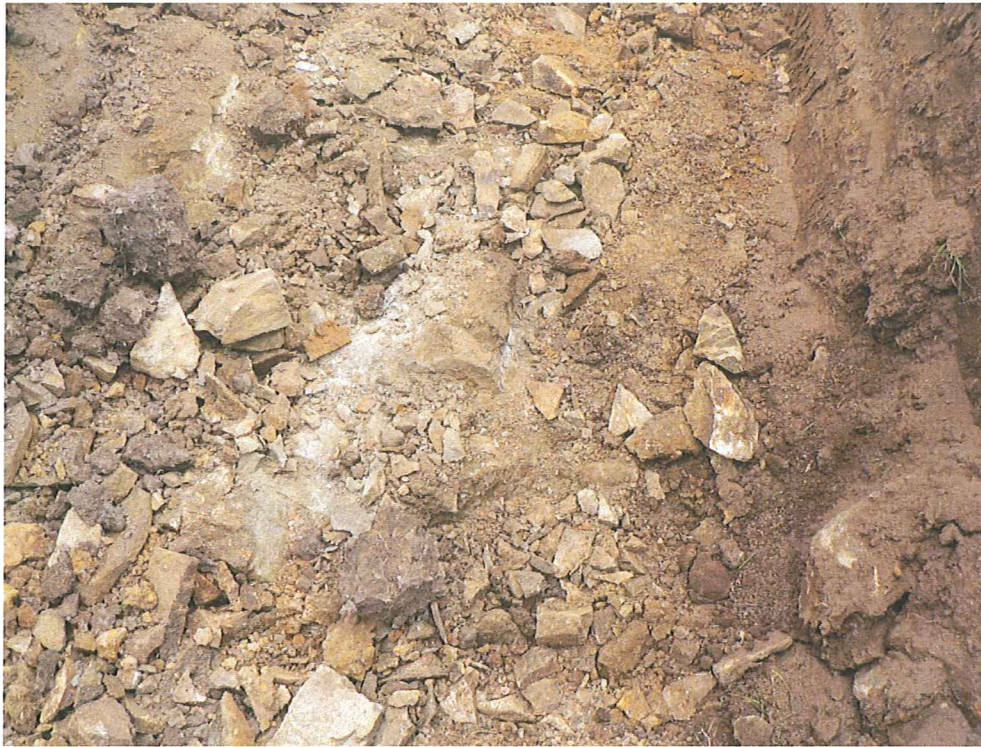
**Plate T2A.** Chn.6.5m. Refusal on slightly weathered tuffaceous sandstone.

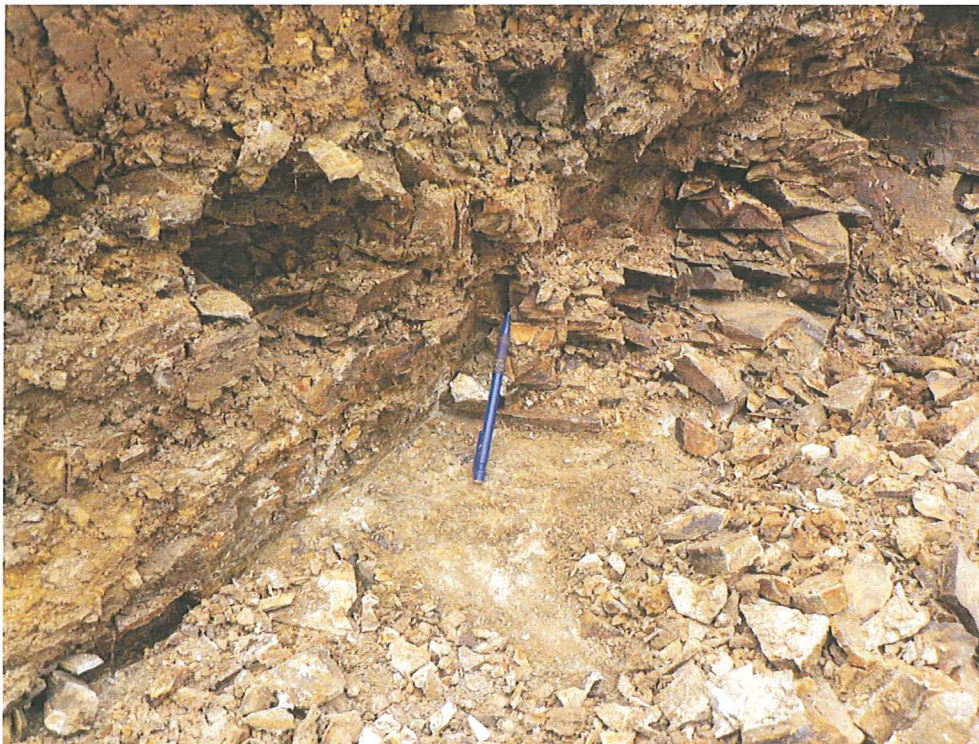
**Plate T2B.** Chn.9.5m. Contact between meta-shale and underlying tuffaceous sandstone.

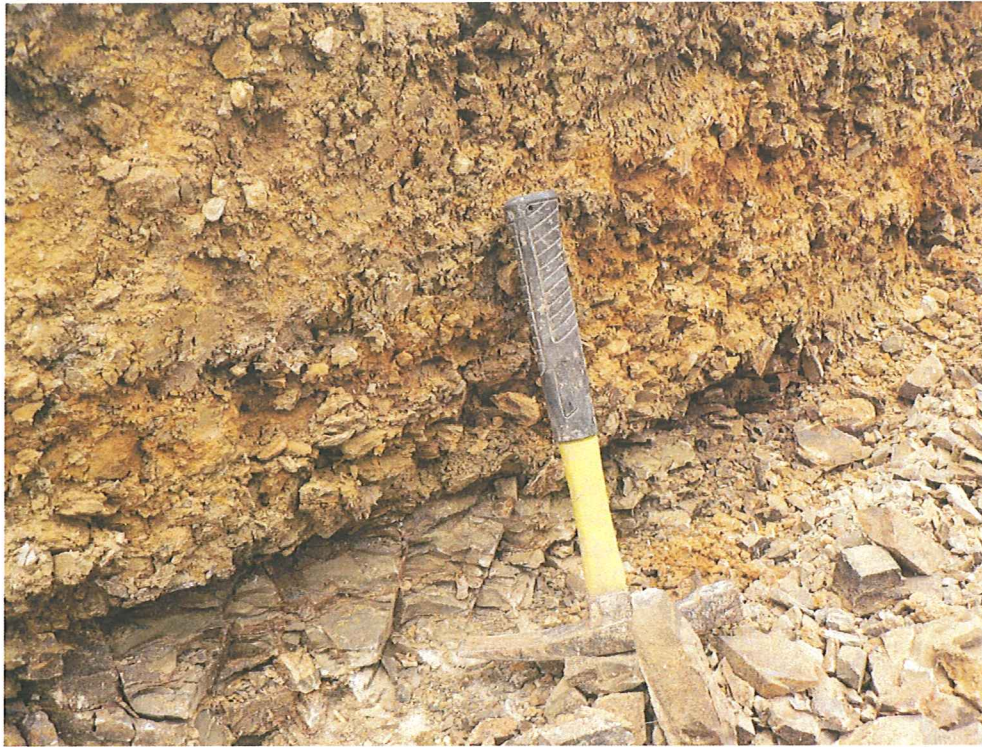
**Plate T2C.** Chn.10.7m. Gravelly silty clay overlying meta-shale.

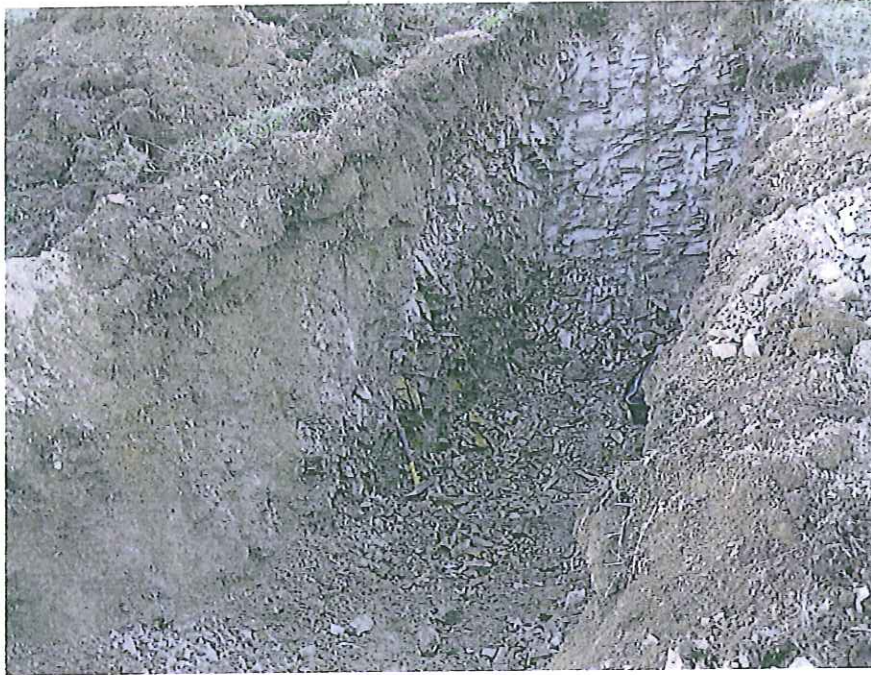
**Plate TP137A.** General view of the test pit looking from west to east (up the slope).

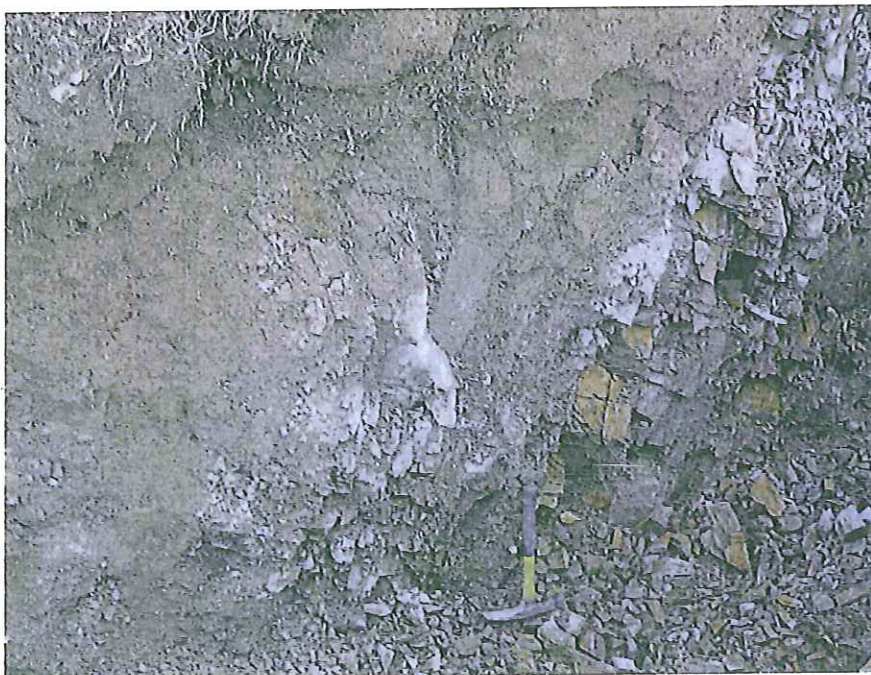
**Plate TP137B.** Highly weathered, crushed meta-shale in eastern half of test pit. Geological hammer marks clayey zone.

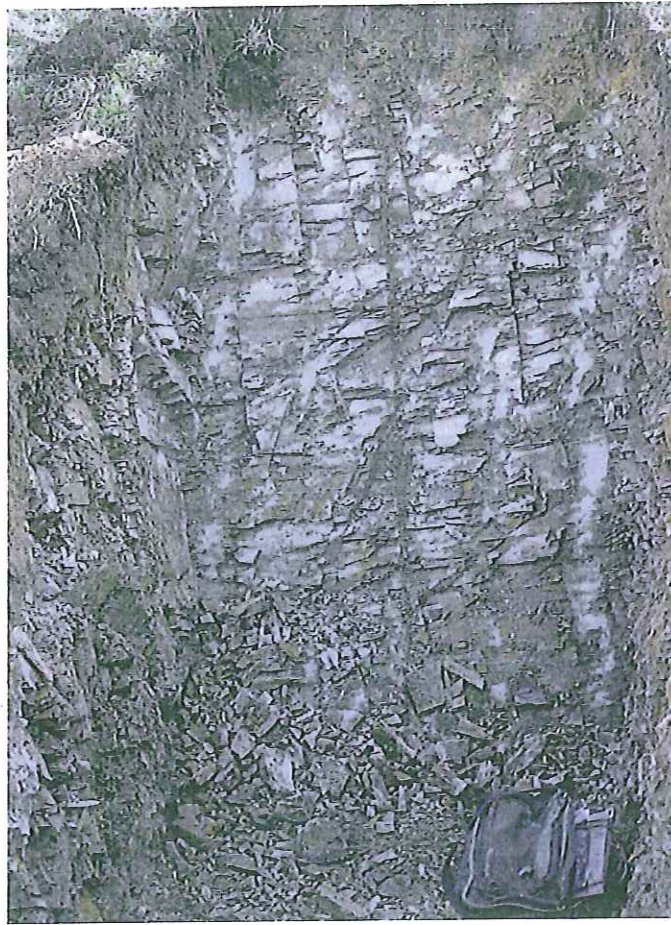
**Plate TP137C.** Probable bedding dipping into the western end of the test pit.

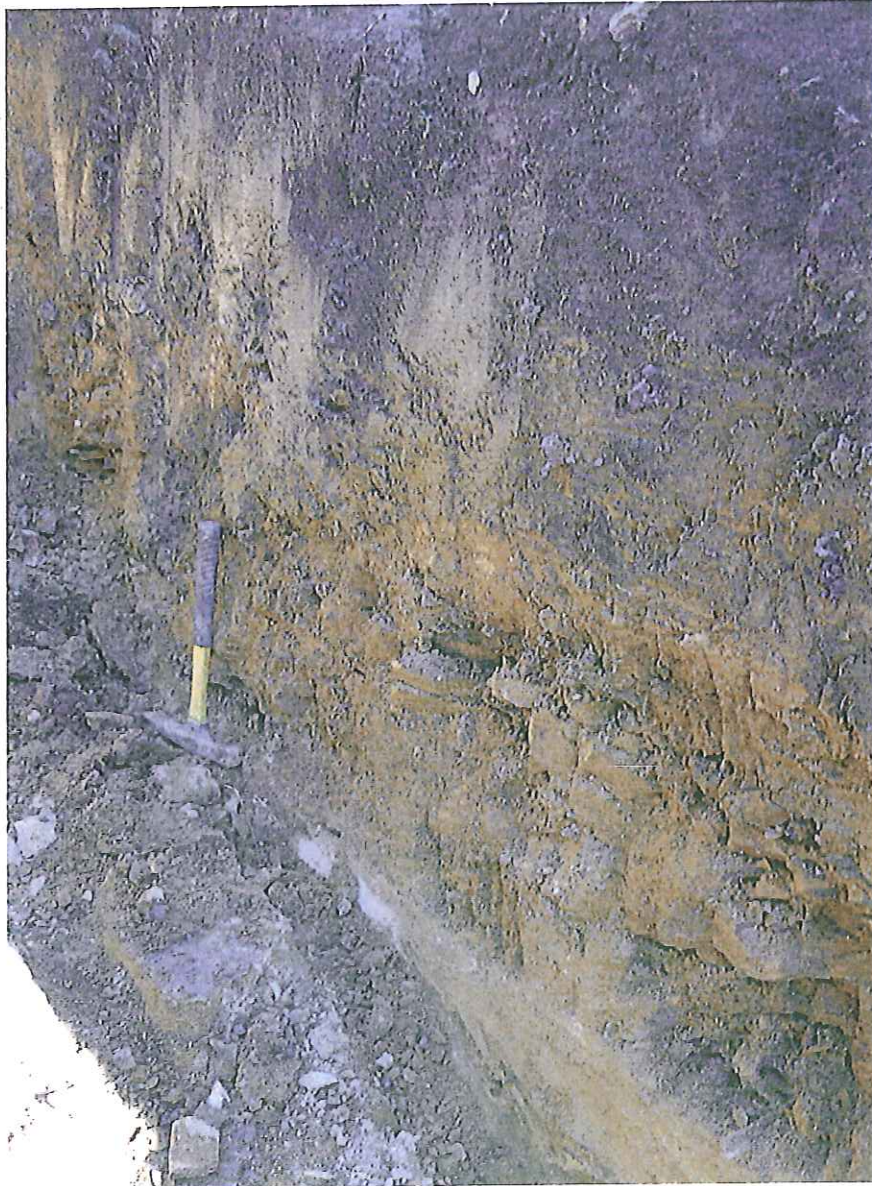
**Test Pit TP147.** Crushed sandstone layer, 1.05m to 1.20m depth.
