## Bayswater B Power Station

### Final Part 3A Bushfire Risk Assessment

## Final Bushfire Risk Assessment

ITEM	DETAIL
Project Name	Bayswater Liddell Power Generation Complex - Bushfire Risk Assessment
Project Number	09NEWECO-0014
Prepared by	Steven House
Approved by

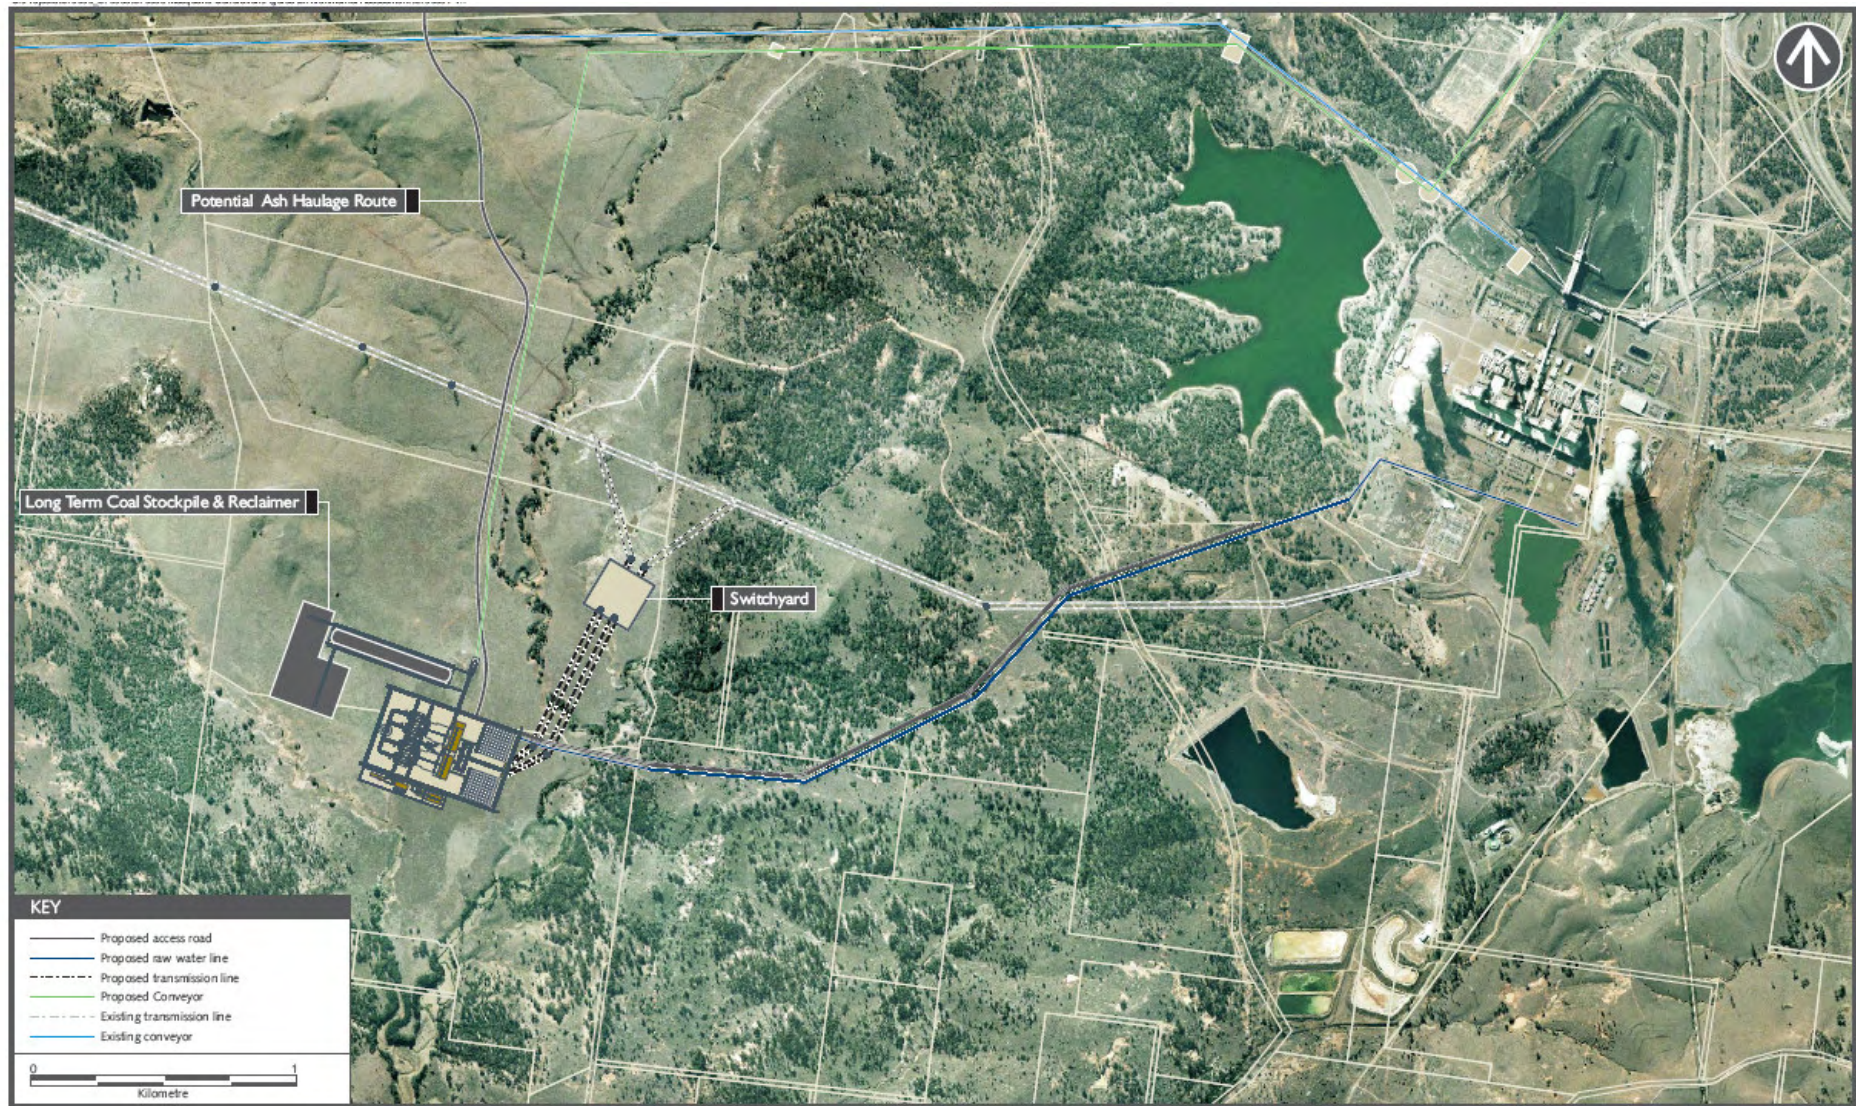
Figure 1: Concept Plan design of the proposed Coal Fired Plant, Bayswater B (supplied by AECOM).

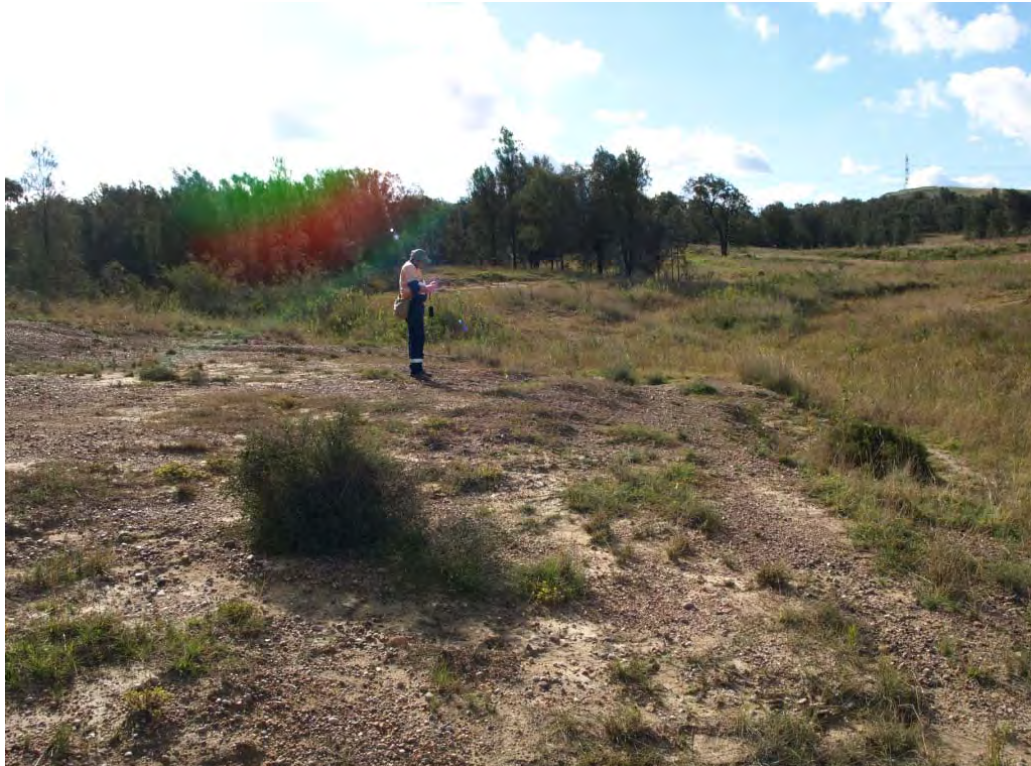
**Plate P3: View north showing area of exposure**

Small ground surface exposures (1 m<sup>2</sup> to 10 m<sup>2</sup>) occur sporadically throughout the study area, particularly in close proximity to the western tributary creek. Several larger exposures also occur (**Plate P3**), particularly as water erosion at the top of high creek banks or on slopes (**Plate P4**). These exposures are most prevalent along the banks of creeks and occur randomly on some slopes. High salt levels in the soil may be one cause of many exposures.

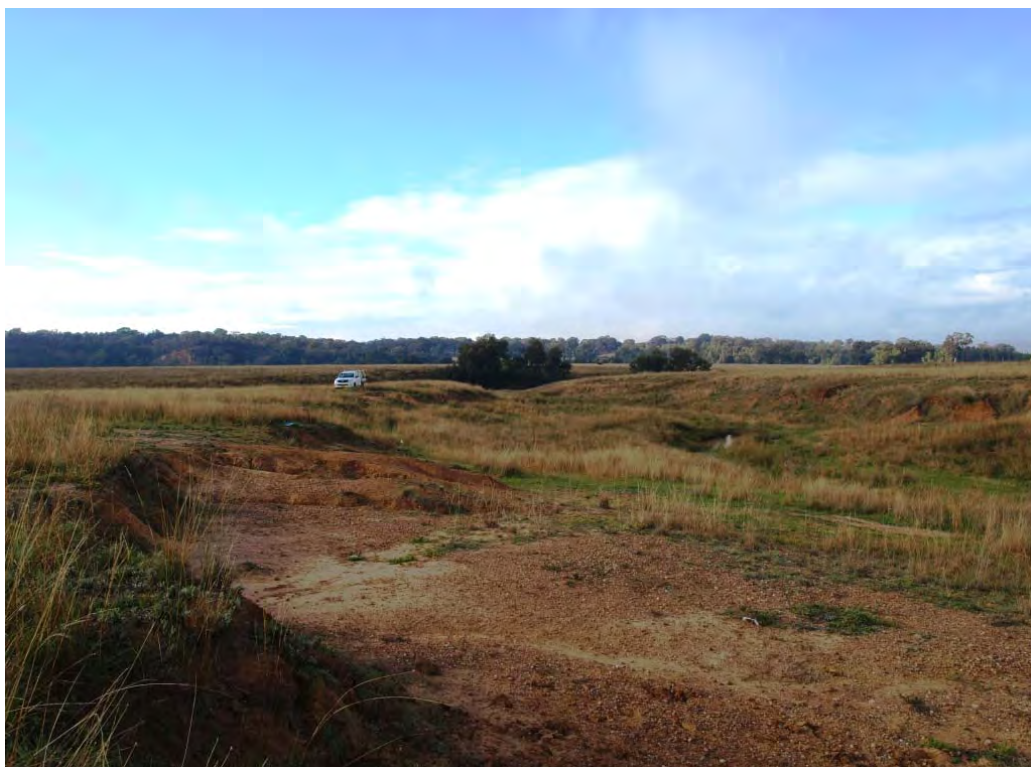
**Plate P4: View east showing exposure along western tributary creek bank**
