Final Report

Preliminary Geotechnical Site Assessment:
17-21 Parramatta Road, Lidcombe

Prepared for
Costco Wholesale Australia Pty Ltd
Ground Floor
82 Waterloo Road
North Ryde NSW 2113
43217997

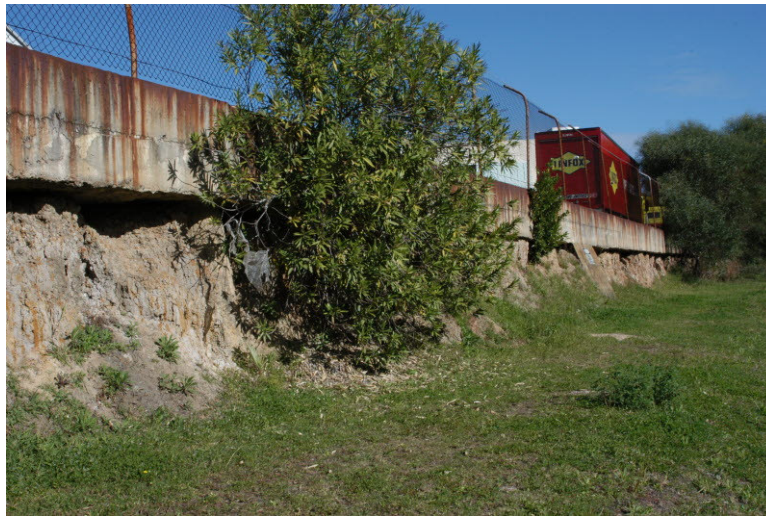
Figure 4-1 Contiguous Pile Wall along Haslam's Creek

Contiguous pile wall connected with a capping concrete beam is present at the northern site property boundary with Haslam's Creek's bank (refer to Figure 4-1). The condition of this wall is generally in a fair condition with slightly exposed spalling concrete under the capping beam. However, no design details are available and further investigations are required to determine the As-Built details of the wall.

The minimum distance of this wall to the proposed excavation area is approximately 8 m at the most northern corner of the proposed building. Considering this distance and the maximum excavation depth of 3.5 m below the existing ground surface for Option 1, excavation works with a slope of 2(H):1(V) will be unlikely to result in ground movement to the existing wall.
