Bore No: MW3D
Client: Costco Wholesale (Australia) Pty Ltd
Project: Phase I and II Site Investigations
Box 1 of 2
Depth: 5.6 - 9.0 m
Date: 1 August 2009

BOREHOLE MW3D

URS Australia PTY LTD	Phone:	Project Reference:	Client:
	Fax:	Preliminary Geotechnical Assessment	Costco Wholesale (Australia) Pty Ltd
Drilling Contractor:	Terratest Pty Ltd	Project No.: 43217997	Location: 17-21 Parramatta Road, Lidcombe
Logged By: J Kor	Bore Size: 100mm mm	Relative Level: mRL	Drill Type: HQ triple tube, wire line coring
Checked By: V Tandjiria	Casing Size: mm	Coordinates: 6252885.00 mN	Drill Model: EDSON 3000
Date Started: 1-8-09	Total Depth: 13.00 m	319631.00 mE	Drill Fluid: Water
Date Finished: 1-8-09	Borehole Inclination and Bearing: 90° from horizontal at ° True North	Permit No:

BOREHOLE MW4D

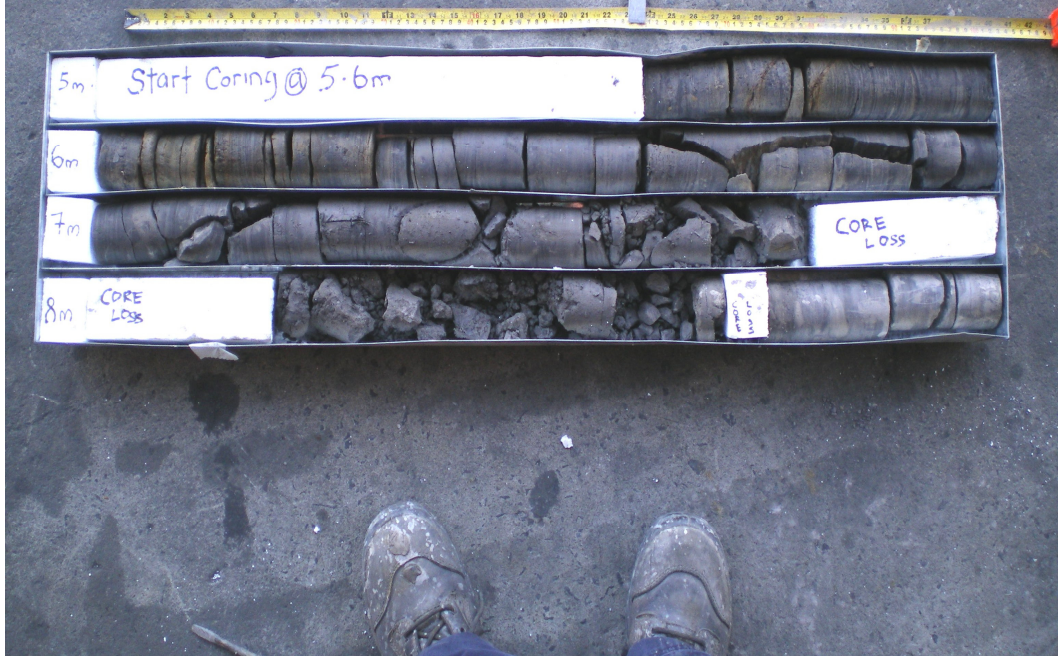
5.6			Start coring at 5.6m			5.6			
			100%			SHALE, very low to low strength, extremely weathered, brownish grey, thinly laminated, iron staining, fractured to slightly fractured Ironstone band Ironstone band Point Load Test (Is50) at 5.83m A=0.09, D=0.03	XW		73			BG, 5°-10°, Pl, S, iron staining BG, 5°-10°, Pl, S, iron staining BG, 5°-10°, St, S, KL BG, 5°-10°, Pl, S, iron staining BG, 5°-10°, Pl, S, KL

6.38						6.38			BG, 5°-10°, Pl, S, iron staining BG, 5°-10°, Pl, S, KL
												BG, 5°-10°, Pl, S, iron staining JN, 75°-80°, Ir, S, KL JN, 75°-85°, Wa, S, KL
												JN, 10°-15°, Pl, S, KL JN, 85°-90°, Wa, S, KL
												Highly fractured zone (7.3m to 8.7m)
				6

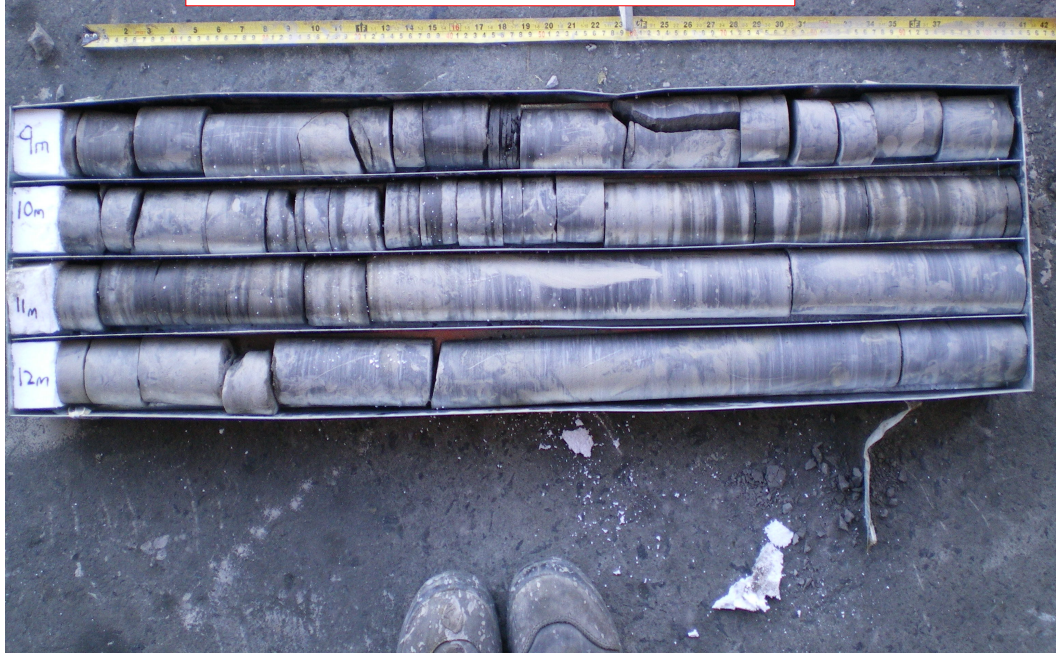
Bore No: MW3D
Client: Costco Wholesale (Australia) Pty Ltd
Project: Phase I and II Site Investigations
Box 2 of 2
Depth: 9.0 - 13.0 m
Date: 1 August 2009

Point Load Test (Is50) at 11.34m A=0.67, D=0.29

BG, 5°-10°, St, S, KL JN, 25°-30°, Pl, S, KL BG, 5°-10°, Pl, S, KL BG, 0°-5°, Pl, S, KL
			11									
		12.3	12									
		100%	13									
				13	Coring ended at 13.0m, target depth reached							
				14								
				15
