Bore No: MW4D  
Client: Costco Wholesale (Australia) Pty Ltd  
Project: Phase I and II Site Investigations  
Box 1 of 2  
Depth: 6.34 - 10.0 m  
Date: 1-2 August 2009

# **Appendix C**

## **Logs and Well Construction Details**

### **C2. Monitoring Well Construction Details**

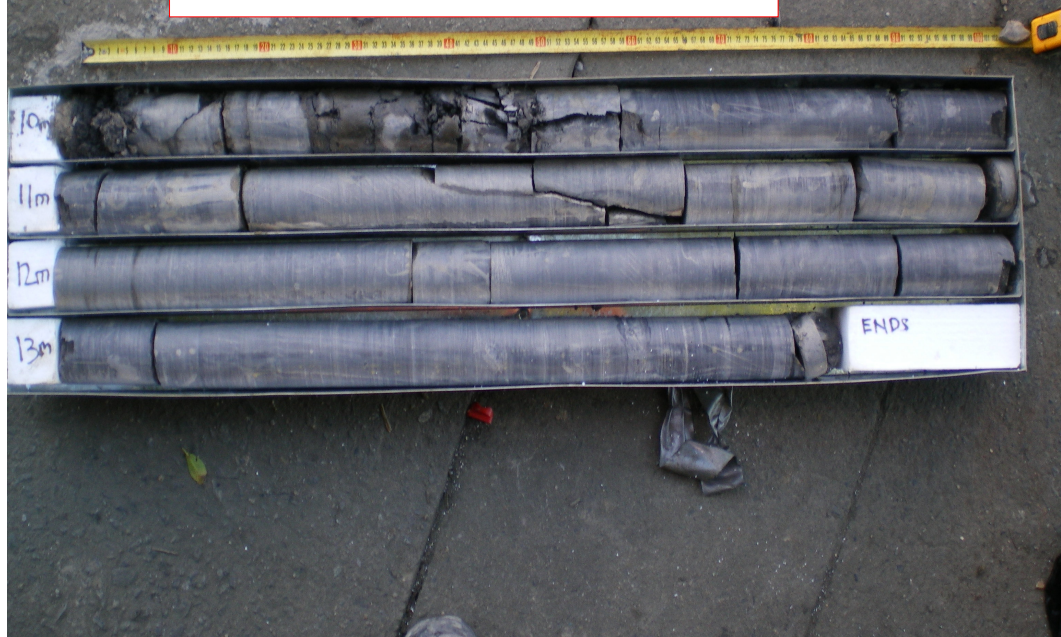
Bore No: MW4D  
Client: Costco Wholesale (Australia) Pty Ltd  
Project: Phase I and II Site Investigations  
Box 2 of 2  
Depth: 10.0 - 13.8 m  
Date: 1-2 August 2009

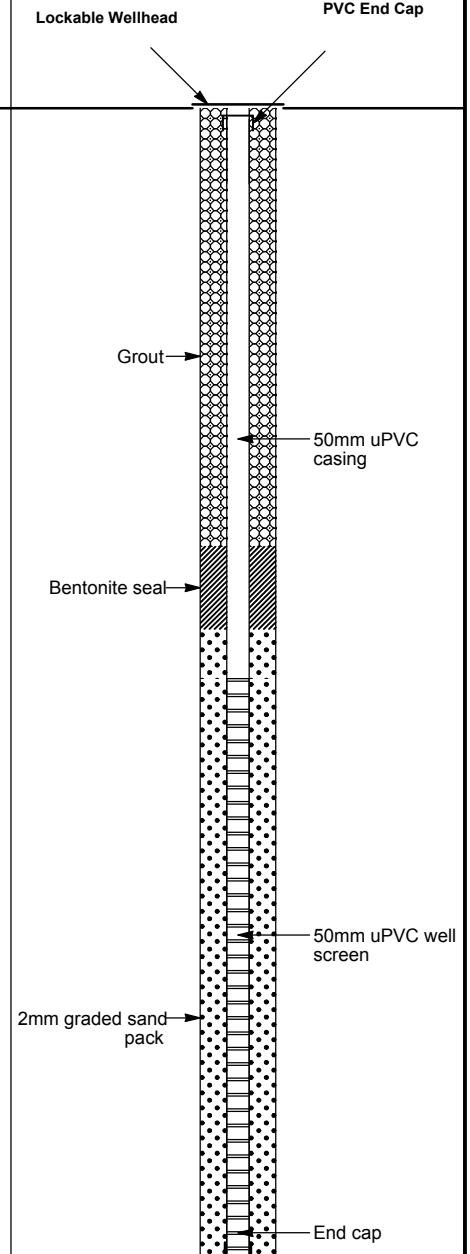
## MONITORING WELL MW04D

Sample Interval PID (ppm)	Sample ID	Legend	USC DESCRIPTION OF STRATA Type, plasticity / particle size, colour, secondary / minor components (e.g., "trace"), moisture content, consistency / density, and additional observations	Classification	Depth (m)	Moisture Condition	WELL CONSTRUCTION DETAILS
			CONCRETE (140mm)		0	D/M	Lockable Wellhead
			FILL: Clayey sand, fine grained, dark brown, with a trace of glass, dry to moist		1	D/M	PVC End Cap
			CLAY: Medium to high plasticity, dark brown, with a trace of sand, dry to moist, soft		2		
			Becoming reddish brown at 1.5m		3		
			Very stiff, with iron staining, becoming mottled reddish brown, and dry at 2m		4		
			Hard, shaley, brownish grey, and with some ironstone fragments at 3m		5		
			Hard and shaley at 4m		6		
			SHALE: Weathered, grey, with iron staining		7		
			V Bit refusal at 6.45m, continues with coring		8		
			SHALE: Weathered, brownish grey, thinly laminated, highly fractured to fractured		9

10		
			SHALE: slightly weathered to fresh, grey, thinly laminated, slightly fractured		11		
					12		
					13		
			Coring ended at 13.9m (targeted depth)		14		
					15

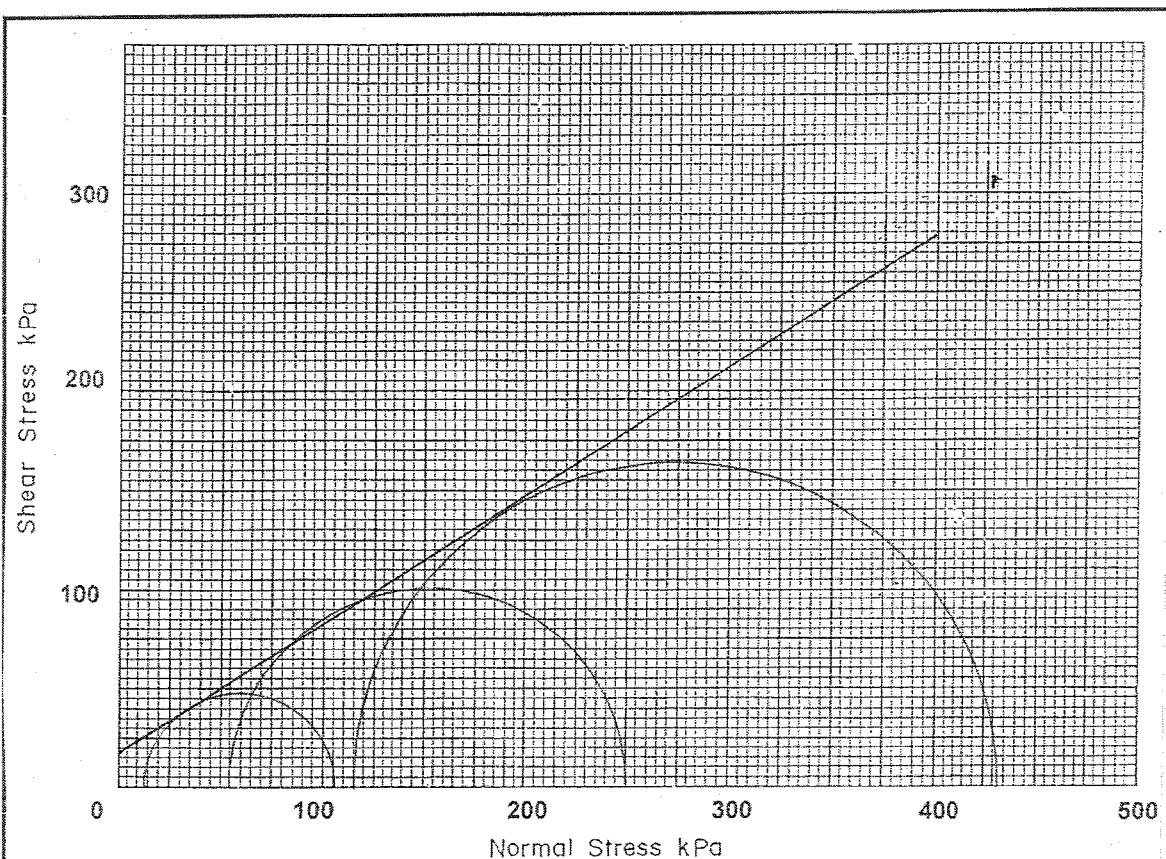
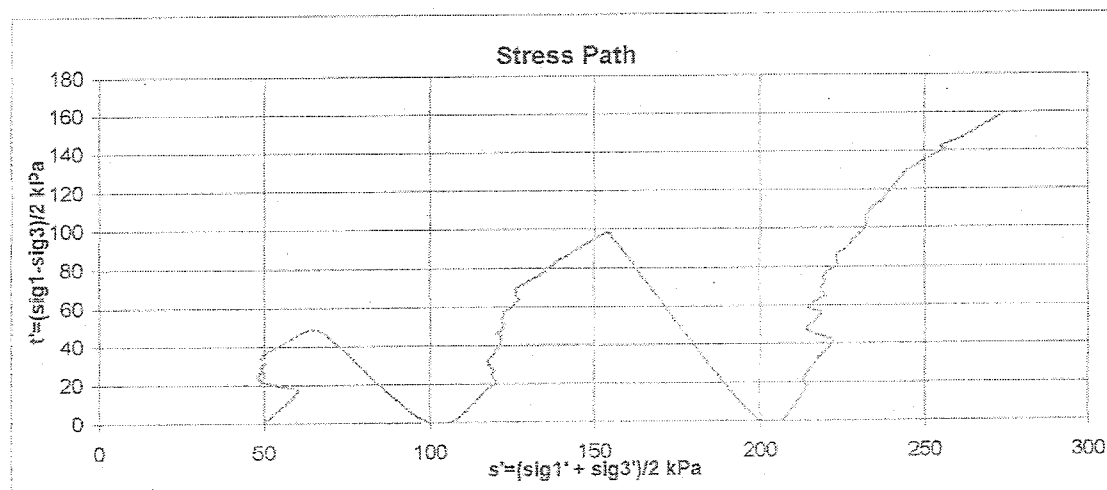
Test procedure: AS 1289 6.4.2 Determination of compressive strength of soil - Compressive strength of a saturated specimen tested in undrained triaxial compression with measurement of pore water pressure.

**Effective Cohesion (kPa):** 32

**Effective Angle Of Friction (degrees):** 18.0

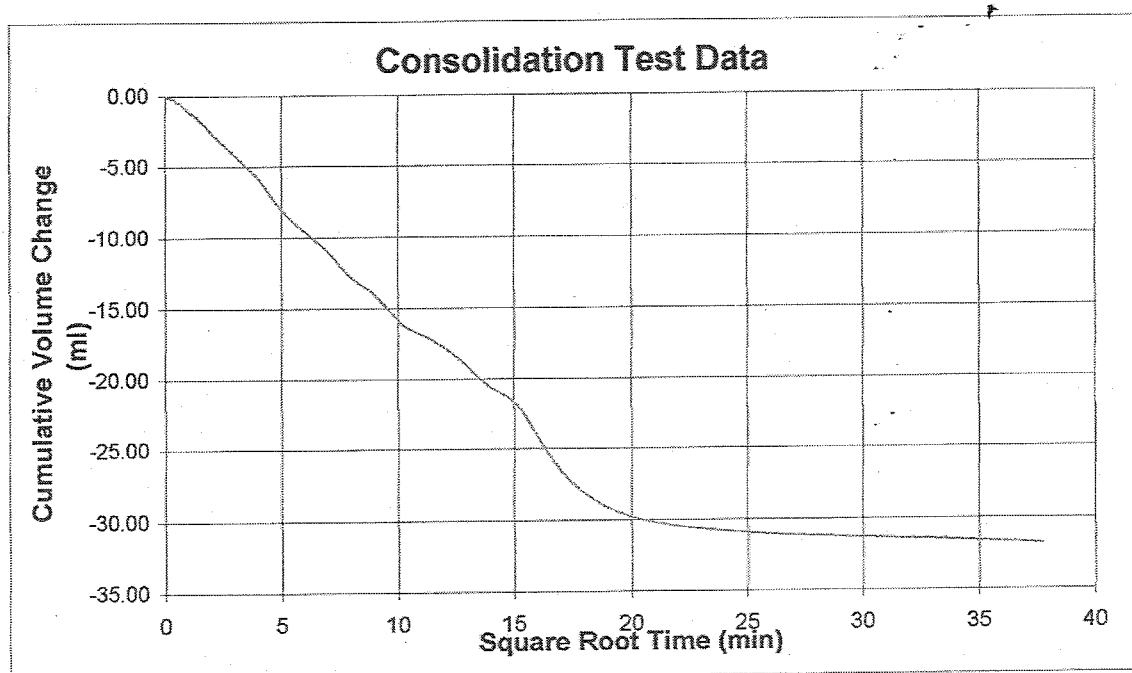
Drainage Conditions: Bottom, Side  
Stage 1

Net Cell Pressure (kPa): 50

Time for 100% Consolidation (min): 324

Coefficient of Consolidation ( $\text{m}^2/\text{yr}$ ): 0.29

B Bar Response: 1.00      Rate Of Strain (mm/min): 0.001
