# Final Report

Phase 1 and Preliminary Phase 2 ESA:

17 - 21 Parramatta Road, Lidcombe, NSW 2141

7 SEPTEMBER 2009

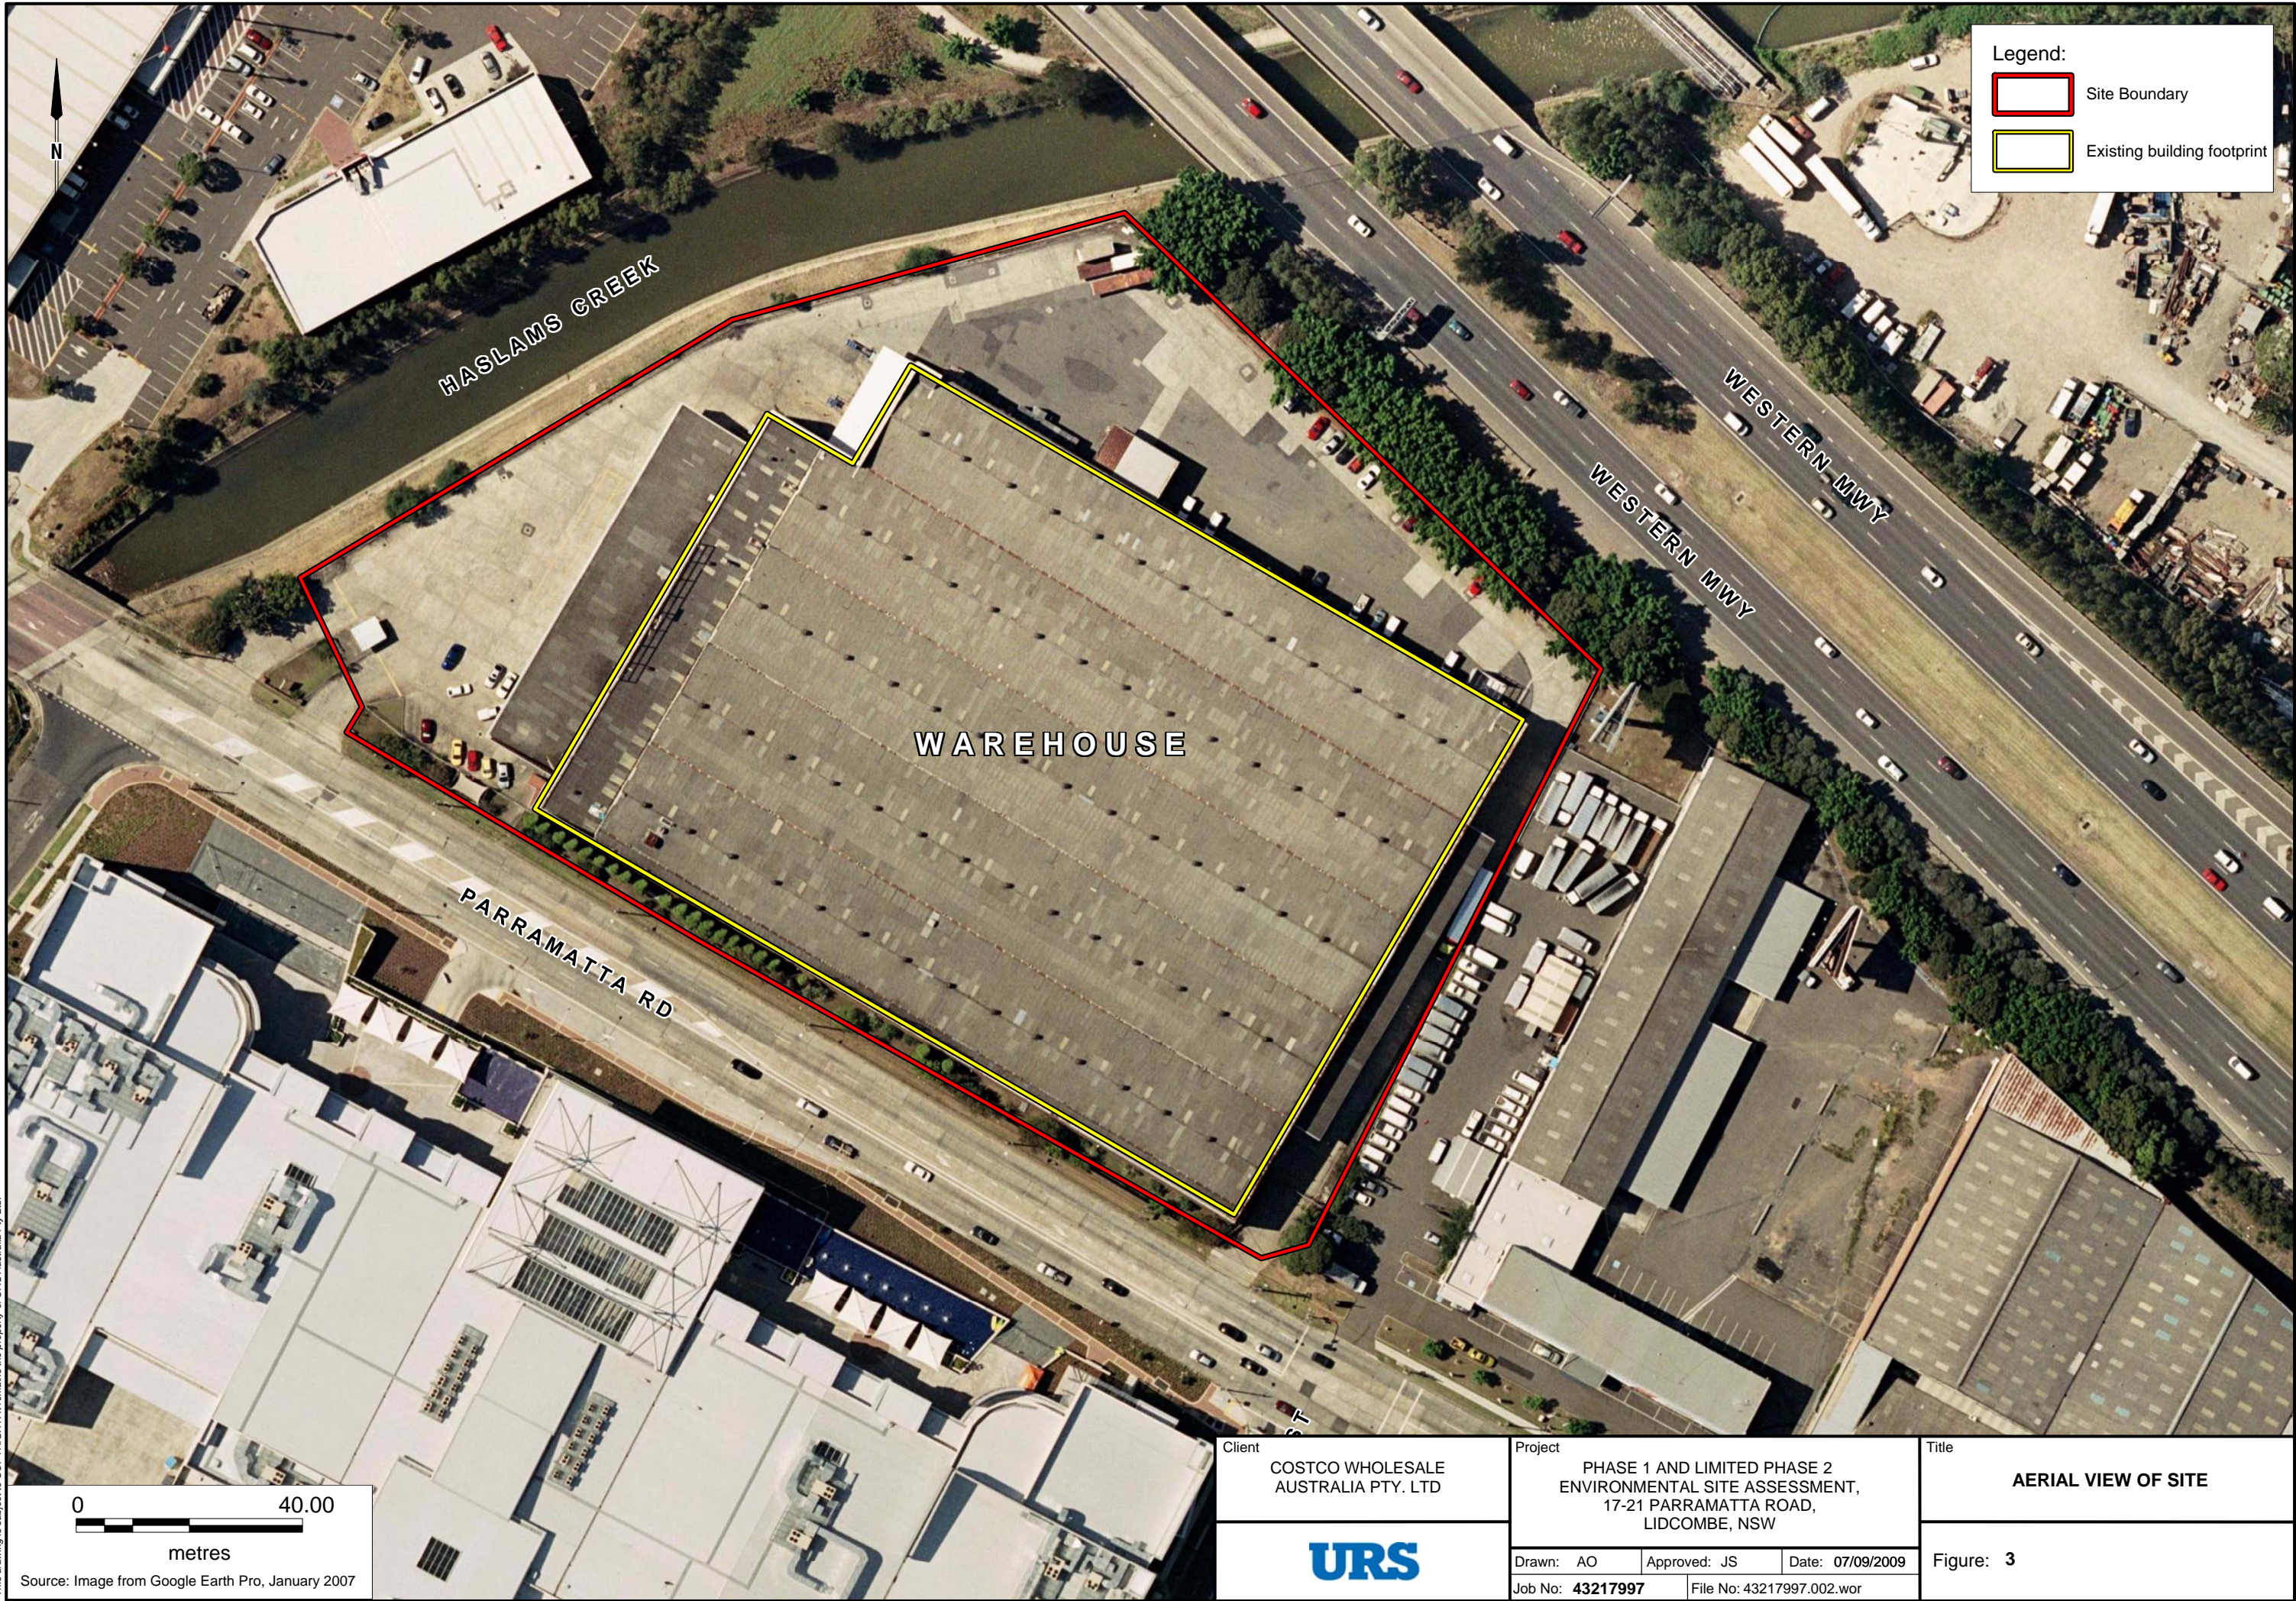
- Site Boundary
- Existing building footprint

The site is located at 17-21 Parramatta Road, Lidcombe, NSW and occupies an area of approximately 2.5 hectares. The property is described as Lot 1 in Deposited Plan (DP) 522225 and Lot 1 in DP 214452 as shown in site location plan presented on Figure 2.
