PHASE 2 CONTAMINATION ASSESSMENT

BELMORE PARK

CORNER OF HAY AND PITT STREETS

Project 36569.03

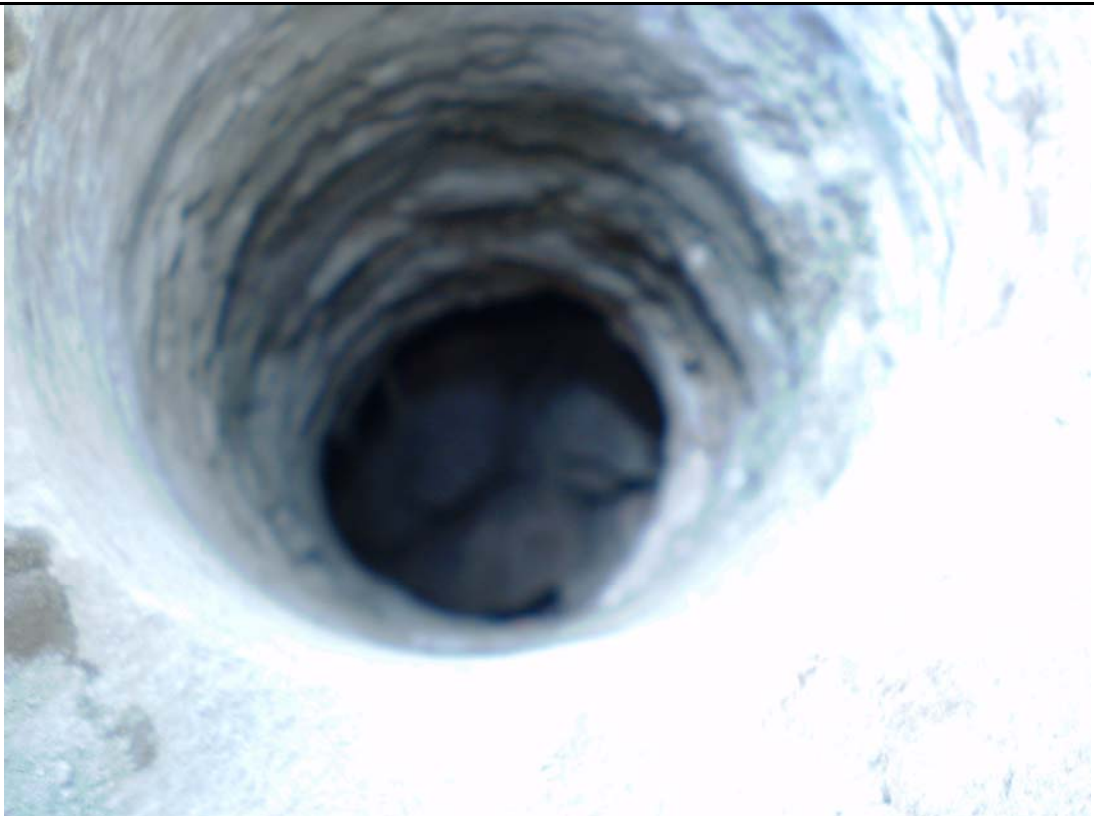
PHOTO 4: Conditions encountered in Bore 106. Large boulders were visible within a void at approximately 1.5 m bgl

Test bore 106 encountered filling comprised of large boulders and brick fragments that appeared to be within a large void between 1.5 and 2.0 m bgl, where the test bore was discontinued due to the conditions. Refer to Photograph 4, Appendix B.
