Table T1: Transects Sampled and Effective Coverage

TableT2: Aboriginal Sites Identified During the Field Survey

TableT3: Potential Archaeological Deposits Identified During the Field Survey

Table T4: Historic Heritage Items Identified During the Field Survey

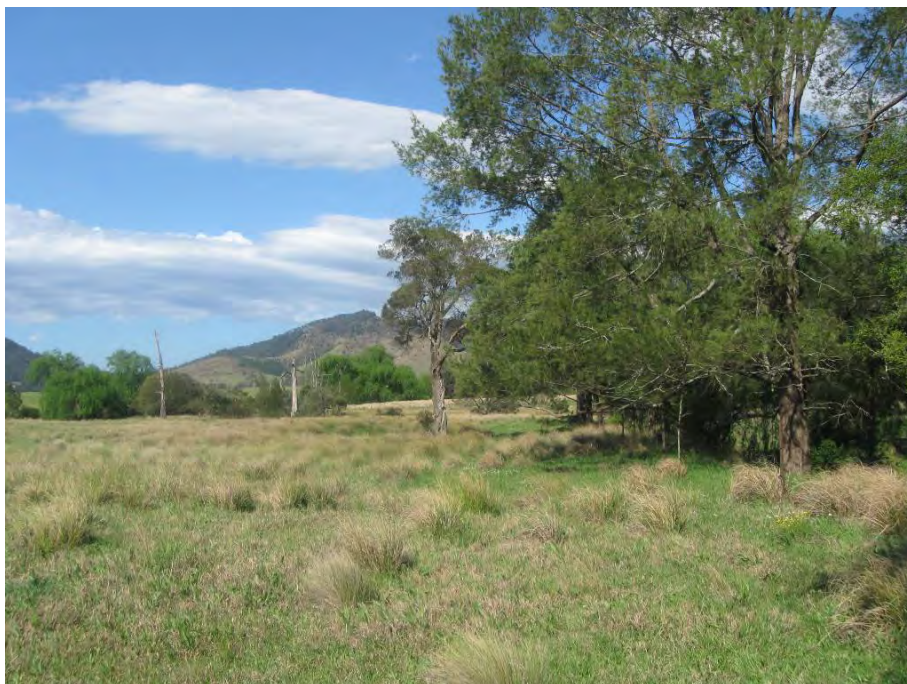
Plate P1: Example of typical (0%) ground surface visibility (Transect 3 on Avon River)

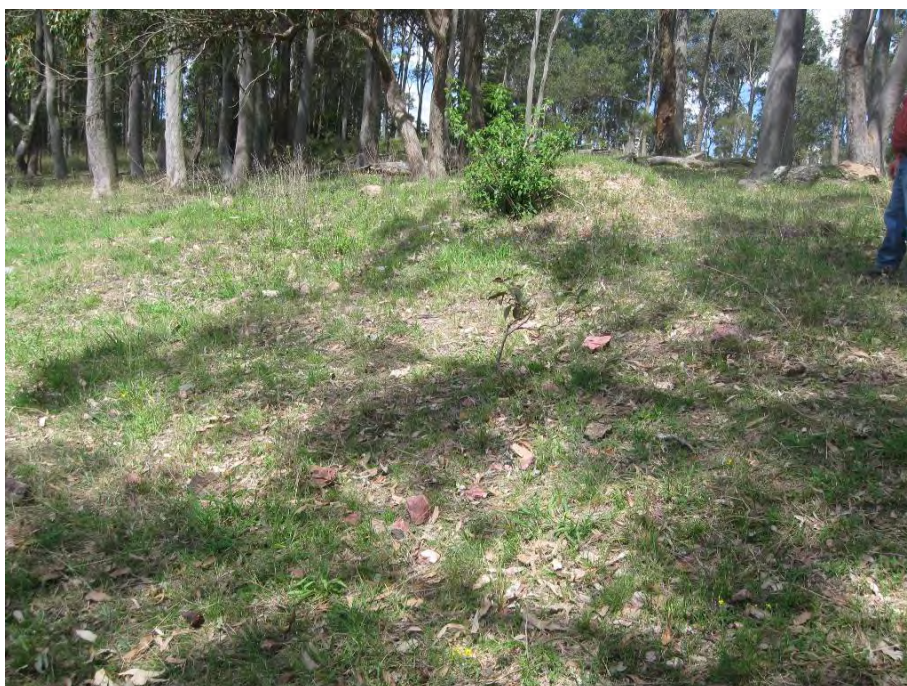
Plate P2: Example of transect where ground surface visibility was <10%
This image is of PAD13 on Transect 46 where silcrete cobbles were found

PAD13	Centroid	382073	6388896	O'Keefe's property (151DP1067987), off Holmwood Road. It is located on the northern side of a west-facing spur line, approximately 30 m west of the eastern boundary fence in a relatively cleared corridor through the woodland.	PAD	Low ridge crest	This location appears to be a source of raw material (red silcrete) that is commonly used in the manufacture of stone tools. The site consists of a 5 x 5 m surface scatter of silcrete cobbles and at least one large rock that is mostly buried, indicating the material is <i>in situ</i> and suggests that a seam runs through this location. As such there is the potential that sub-surface indications exist of Aboriginal usage. Due to the cleared corridor, this area was considered by the proponent as an alternative route for the pipeline. However, the original alignment has been retained, thus avoiding this PAD.	Original corridor alignment to be retained along boundary fence. Provisions of AHMP apply.

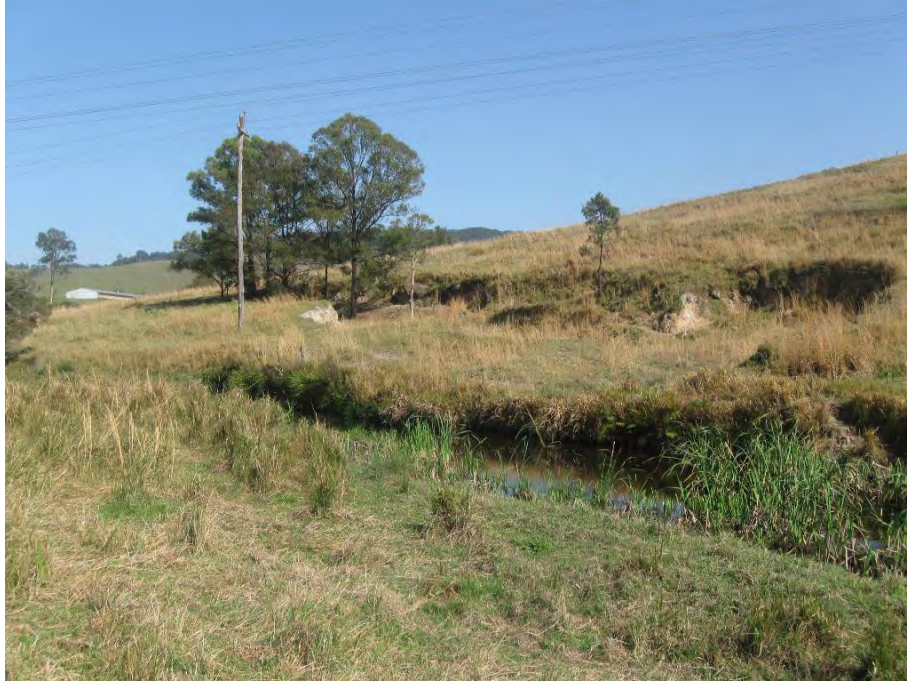
Plate P3: Example of a large eroded exposure on the banks of a second order creek in Transect 21

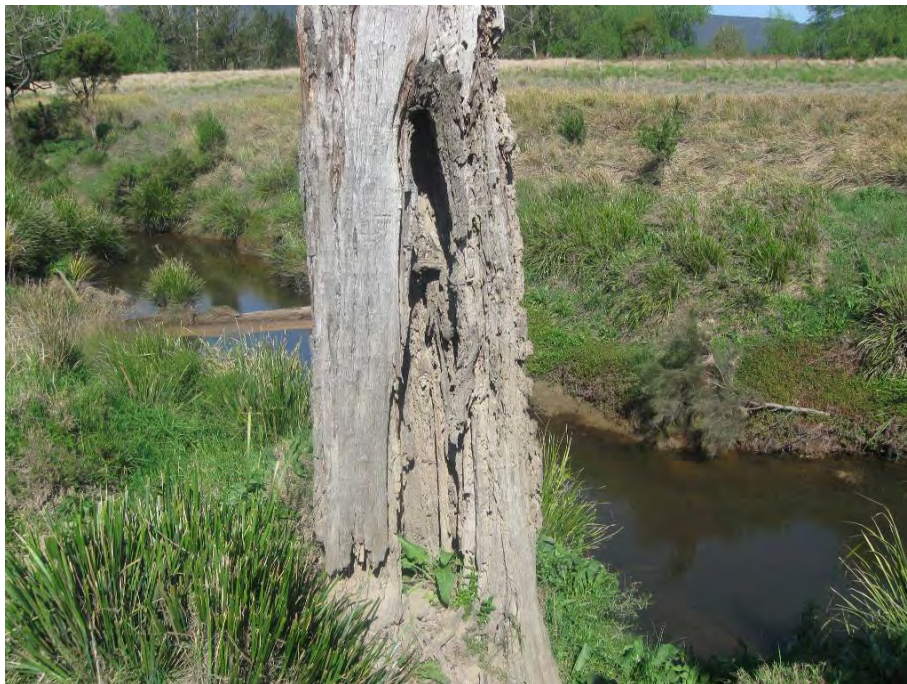
Plate P4: The highly damaged scar on the trunk of a dead eucalypt at LEA1

Site No.	Point	MGA Easting	MGA Northing	Location	Site Type	Landform	Description	Mitigation
LEA1	Object	0402611	6452503	Mitchell's property on western bank of the Avon River, approximately 400 m west of its confluence with Waukivory Creek. (Approximately 300 m NE of the Fairbairn Rd bridge over the Avon.)	Scarred tree	River bank	This site is a dead eucalypt (species unknown) with a scar on the western side. The scar is approximately 400 mm wide at its widest point, and tapers to a uniform point at the top and extends to a flat bottom, 400 mm from the ground. It is approximately 2.2 m long. The scar is in extremely poor condition with the surface completely decayed and the tree hollowed out within. The scar is not uniform in shape (ovoid at the top but straight horizontal at the base). Its shape suggests that this site is NOT an Aboriginal site, but its poor condition makes conclusive identification unreliable.	Nil required. This site is considered to be too close to the creek bank to be affected.

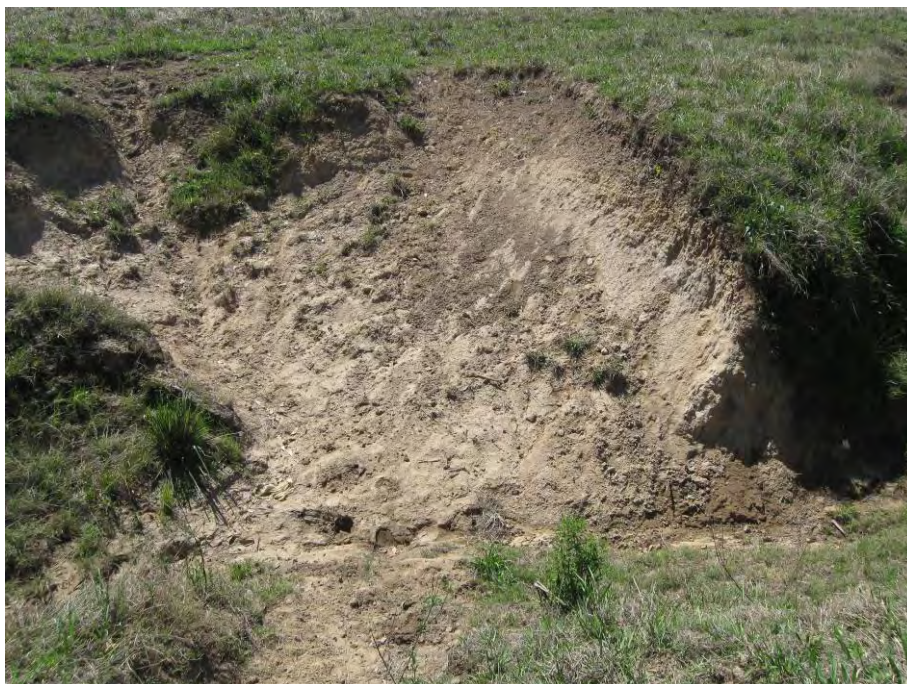
Plate P5: Site view of LEA2. Artefacts are in the eroding bank of a gully draining into the Avon River. Looking NE

LEA2	Object	0402096	6449859	Tiedman's Block (Lucas Energy). Located approx 200 m NE of the ford over the Avon River (just north of its confluence with Dog Trap Creek).	Isolated find	Lower slope, re-entrant	This site consists of a single small silcrete multi-platform core (unifacial). L: 24 mm; W: 7 mm. The site lies within a small re-entrant in the low ridge that runs along the eastern bank of the Avon at this point. Within the re-entrant there is an extensive "L-shaped" contour bank that has been excavated around the eastern and northern sides. Running parallel to, and on the northern side of the contour bank, is an extensive exposure (~5 m wide by 30 m long) where the fill for the bank has been excavated. There is also a small exposure 2 m south and 4 m west of the NE corner of the bank. This is where the artefacts is located. Veg cover is 60% in the exposures; 100% elsewhere. The site is approximately 100 m east of the river bank.	Avoid any ground-breaking activities within a 100 m of this location. It is understood that the proponent is not considering any further development in this area.

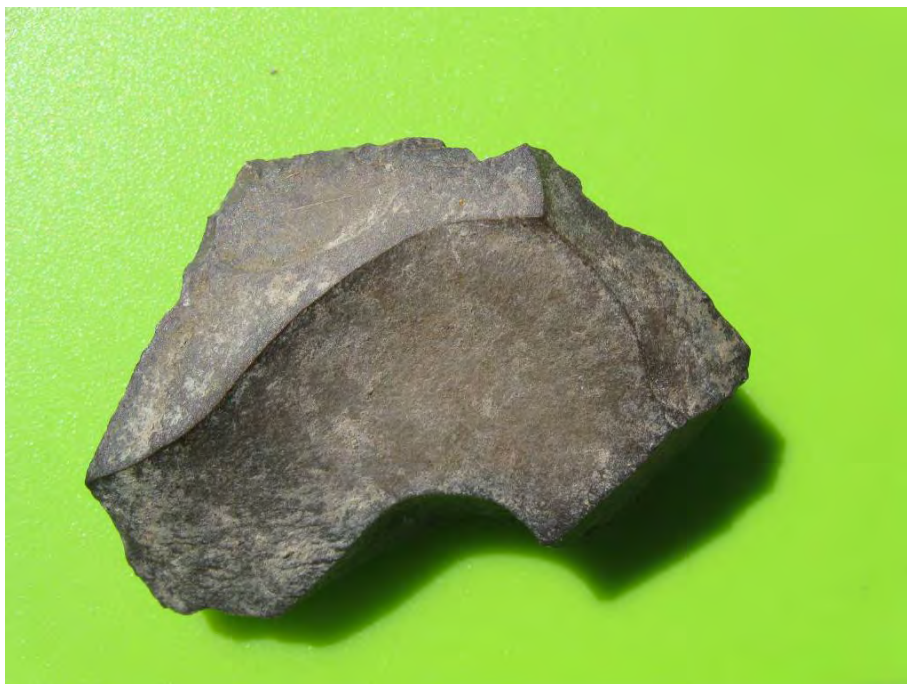
Plate P6: One of the grey mudstone flakes found at LEA2

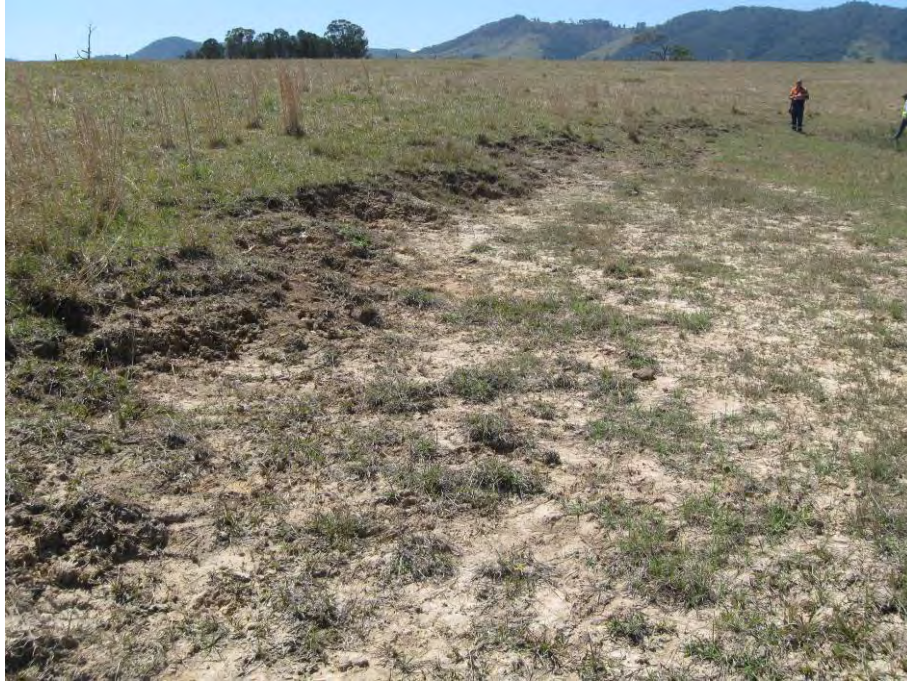
**Plate P7: Site view of LEA3. Artefact is on the downhill side of a long contour bank.
Looking ENE**

Site No.	Point	MGA Easting	MGA Northing	Location	Site Type	Landform	Description	Mitigation
							Other lithic material in the exposures consists mainly of ironstone.	
LEA3	Centroid	0402011	6449027	Tiedman's Block (Lucas Energy). Located on the eastern side of Dog Trap Creek, approx 200 m SE of its confluence with the Avon River.	Artefact scatter	River flat	This site consists of two mudstone (gray) flakes. The site lies approximately 10 m east of the creek bank in a small dry tributary that comes of the eastern side of the creek and then turns SE. The site is located in a very short eroded section out of the tributary's northern bank. Given their location, it is considered that the area overlying this tributary, up to the bank of Dog Trap Creek, is a PAD measuring 20 m E-W and 10 m N-S.	Nil required. This site is considered to be too close to the creek bank to be affected. It is understood that the proponent is not considering any further development in this area.

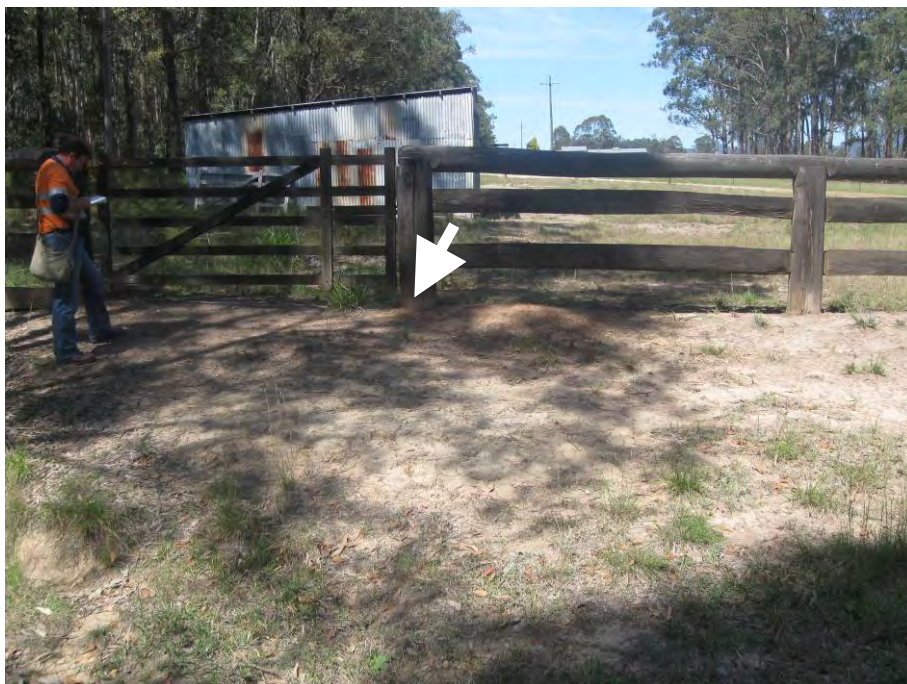
Plate P9: Site view of LEA4. The artefact is (was) laying beside the gate post. Looking south

LEA4	Object	0398996	6442117	Yates' property (1DP1003762); southern side of Woods Road. The artefact is situated on the road verge next to the western-most fence post next to a timber stock gate at the front of the property.	Isolated find	Gentle lower slope	This site is an isolated find of a core, measuring 32 mm long by 23 mm wide by 10 mm thick. The platform shows a minor amount of cortex, there is a negative flake scar with two scar ridges, a bulb of percussion, and possible usewear on one of the lateral margins. The artefact is formed from a coarse-grained siliceous material that may be silcrete, although it is of a darker, greyish-red than the material seen elsewhere in the Gloucester region. There is very little exposure here except around the fence posts. However, there is extensive ground surface exposure around the shed behind the gate and extending some 20-30 m southwards to where the property's driveway comes close to the eastern boundary fence. It is estimated that the total exposure in this area 50 m2. Ground surface visibility is	This site was originally identified on 2 October 2008. A subsequent inspection of the site on 10 October 2008 failed to relocate the object, despite it being located in a prominent position.

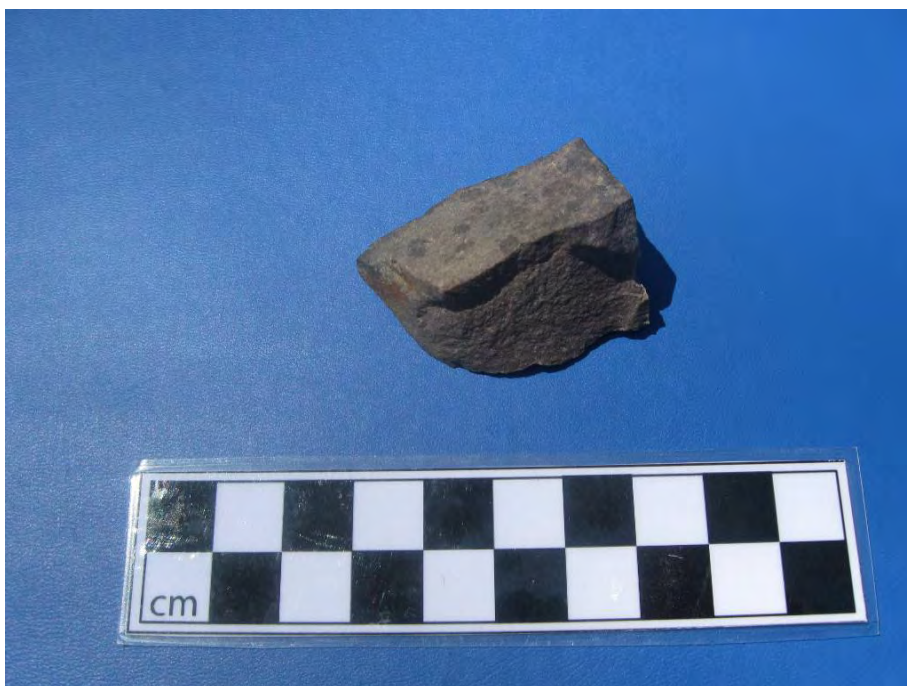
Plate P10: A red fine-grained siliceous core found at LEA4

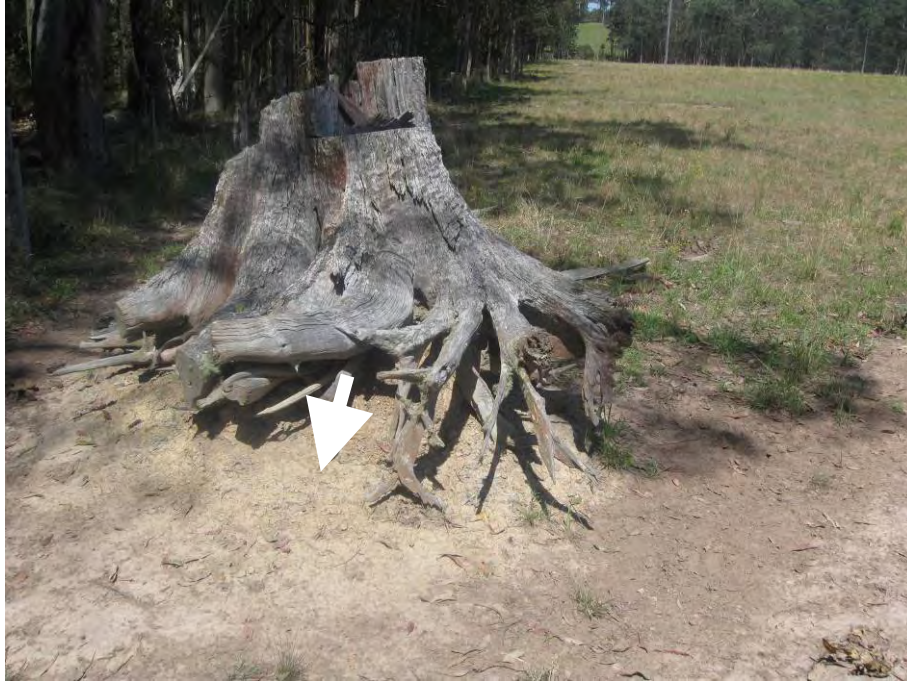
Plate P11: Site view of LEA5. The artefact is lying on the northern (uphill) side of this stump

Site No.	Point	MGA Easting	MGA Northing	Location	Site Type	Landform	Description	Mitigation
							estimated to be about 60% in the exposure but 0% elsewhere due to thick pasture cover.	
LEA5	Object	0398904	6440693	Bosma's property (2DP1003762); on the rising gentle slope approximately 200 m north of Coal Creek. The site is located on an exposure on the northern side of a large tree stump that has been left on a pedestal of eroded soil, 2 m west of the property's eastern boundary fence (adjacent to a large wooded block to the east) and 30 m south of an east-west fence and gate.	Isolated find	Gentle mid-slope	The site is an isolated find consisting of a single single-platform, multi-facial core, measuring 34 mm long by 26 mm wide by 7 mm thick. There is a single negative flake scar and a possible bulb of percussion. Other scars do not show diagnostic features. The site is located on a 4 x 3.5 m (14 m ²) exposure that has a total surface lithic density of approximately 5 lithics/m ² . Other nearby exposures have 20+ lithics/m ² . Ground surface visibility in the exposures is estimated to be about 80%, and only 10% elsewhere due to thick pasture ground cover.	It is understood that the pipeline route is situated approx 10 m west of the fence line. It is recommended that the pipeline route be detoured approximately 20 m further west (around the site) to avoid impacts from trenching and spoil deposition. Should realignment be unfeasible and damage to the site unavoidable, it is considered that collection of the artefact under a s.90 permit is not necessary.

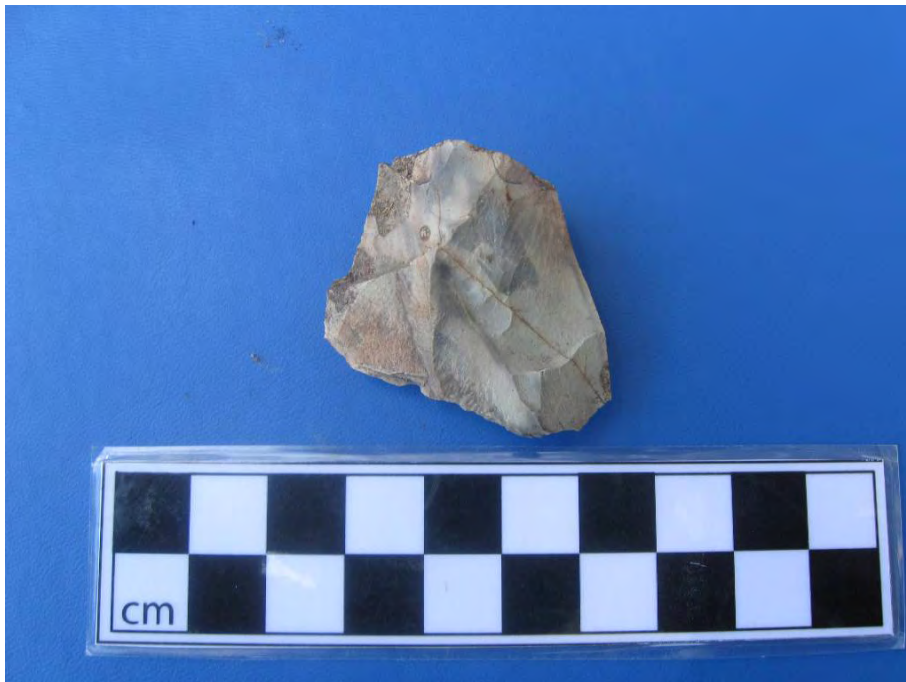
Plate P12: Core found at LEA5

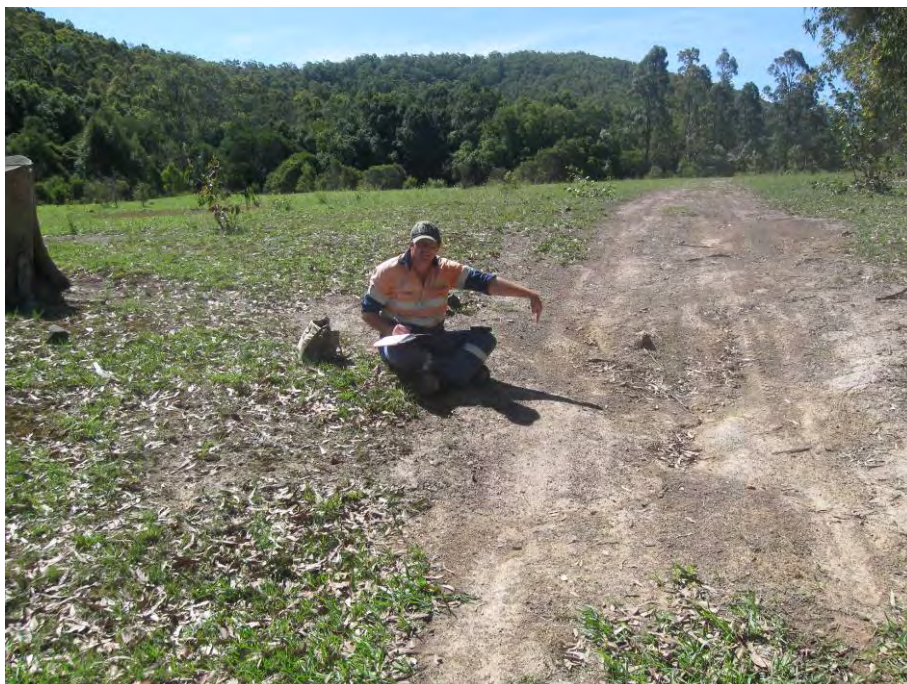
Plate P13: Location of LEA6. The two artefacts are located on either side of the small drainage line. Exposure is along a vehicle track fording the drainage line.

LEA6	Object	0394945	6410460	Black Camp Road; Farrell's property (35DP95407). On eastern boundary of property adjacent to road reserve.	Artefact Scatter	First order creek, lower foot slope	The site is an artefact scatter consisting of two stone artefacts: a thin mudstone core, measuring 44 mm long by 32 mm wide by 10 mm thick (Plate P10), and an indurated mudstone flake, measuring 24 mm long by 17 mm wide by 8 mm thick. The core has four ridge scars, ripple marks and possible usewear on the right lateral margin. Its platform has been reduced to about 5 mm ² and there is no indication of any bulb of percussion. It retains about 50% cortex. Both artefacts lie on an exposure measuring 10 x 2 m (20 m ²) and there is a fairly dense scatter of surface lithics (50-100/m ²) within the	This site is in the general vicinity of sites LEA7, PAD8, LEH6 and LEH7. It is recommended that the pipeline route avoid this property completely and follow the road easement only.

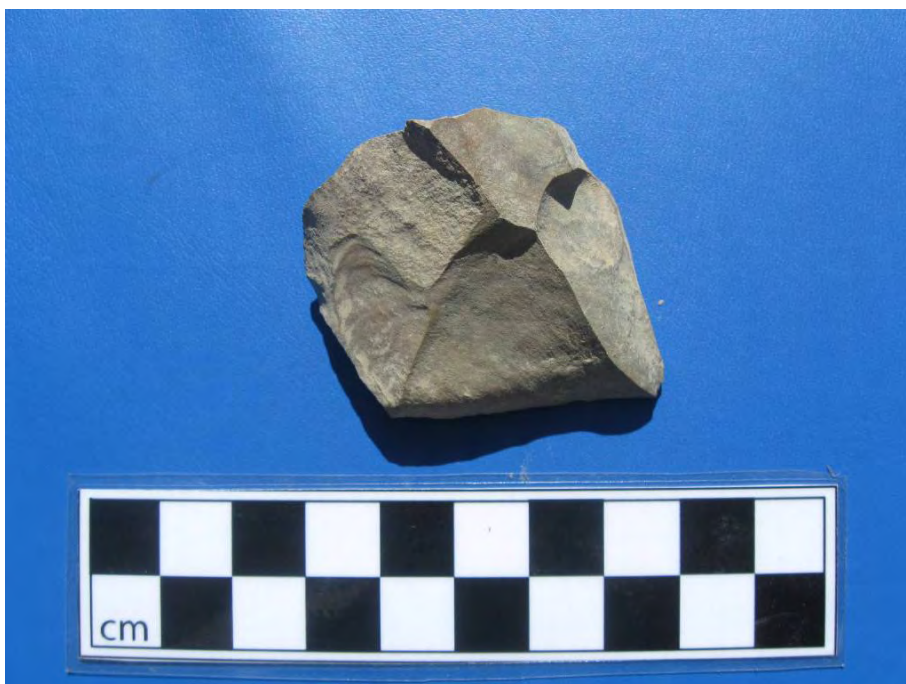
Plate P14: A white mudstone core found at LEA6

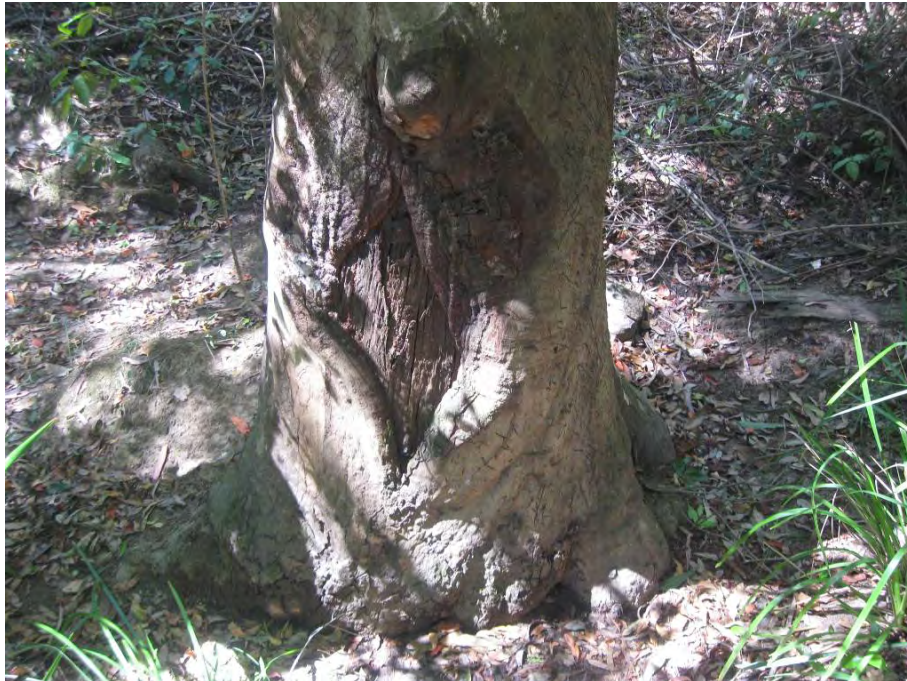
Plate P15: The unusual-shaped scar on a eucalypt tree beside Bottle Corner Gully at LEA7

Site No.	Point	MGA Easting	MGA Northing	Location	Site Type	Landform	Description	Mitigation
							exposure, but no other artefacts were found. The artefacts lie about 15 m apart.	
LEA7	Object	0394770	6410201	Bottle Corner Gully, Black Camp Road; James and Hull's property (122DP526671). It lies about 30 m west of the road's creek crossing and about 2m from the northern creek bank.	Scarred tree	2nd order creek	The site is a scarred tree that may be of Aboriginal cultural origin. The scar is elliptical or diamond-shaped and non-uniform in shape, and measures 650 mm long by 280 mm wide by 70 mm deep, and the base 480 mm above the ground surface. The surface of the scar is fairly rough and is deteriorating; however it is till intact and there is what appears to be hand-axe cut near the apex. The scar is on the southern side of a large smooth-barked eucalypt (blue gum?). The tree is located on a second order creek that crosses Black Camp Road, running east to west, draining into Black Camp Creek.	This site is in the general vicinity of sites LEA6, PAD8, LEH6 and LEH7. It is recommended that the pipeline route avoid this property completely and follow the road easement only.

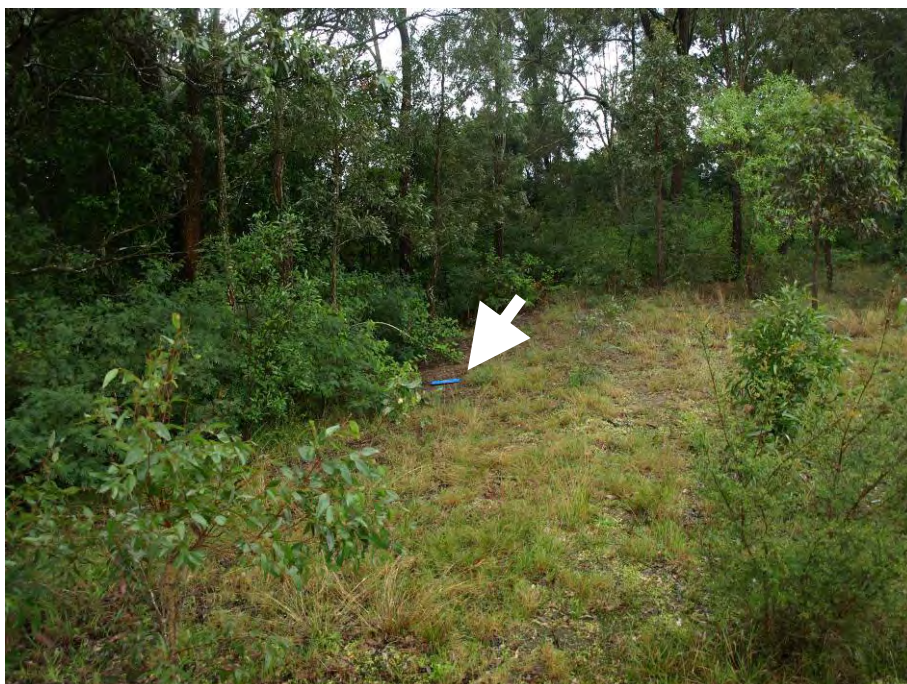
Plate P16: Site view of LEA8 looking south east. Artefacts are located where the blue folder is lying.

LEA8	Objects	0378005	6384593	Clarence Town Road; Dead Man's Creek crossing. It lies about 140 m north of the road on the west bank of the creek (about 4 m back from the bank edge).	Artefact Scatter	Creek flat	The site is an artefact scatter consisting of two stone artefacts: a white silcrete medial flake, measuring 36 mm long by 14 mm wide by 9 mm thick, and red silcrete flaked piece, measuring 12 mm long by 12 mm wide by 6 mm thick. The only diagnostic features on these objects are flake scar ridges, offering some doubt as to the identification of these objects as artefacts. Both artefacts lie on an exposure measuring 1 x 2 m (2 m ²). No other lithic material was observed. The artefacts lie about 0.5 m apart. The site is considered to be part of a continuous subsurface deposit incorporating LEA9 (130 m south east).	Recommend test excavation along the western bank of Deadmans Creek and collection of surface artefacts.

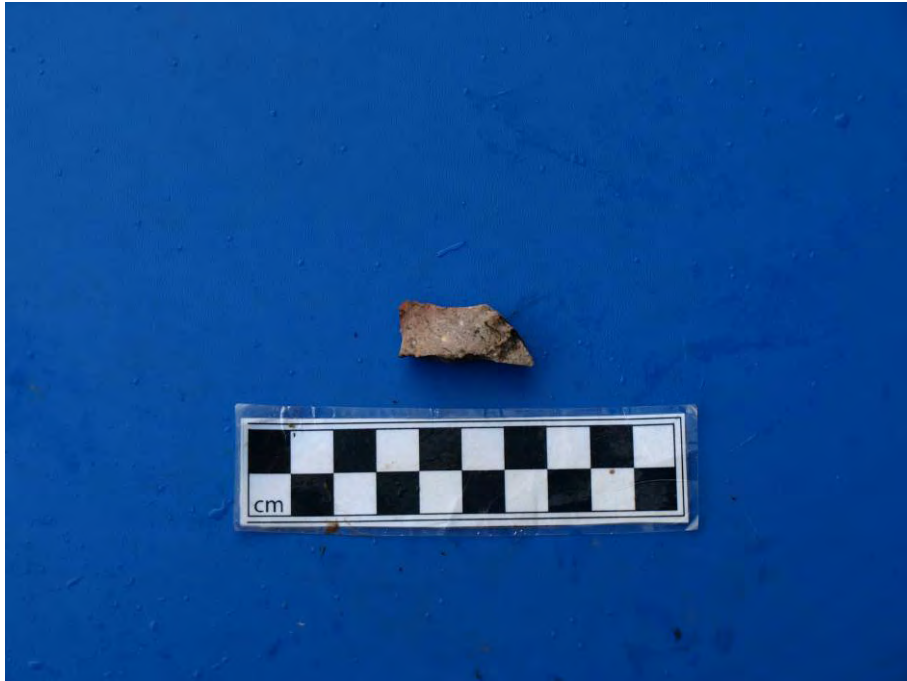
Plate P17: Silcrete artefact found at LEA8

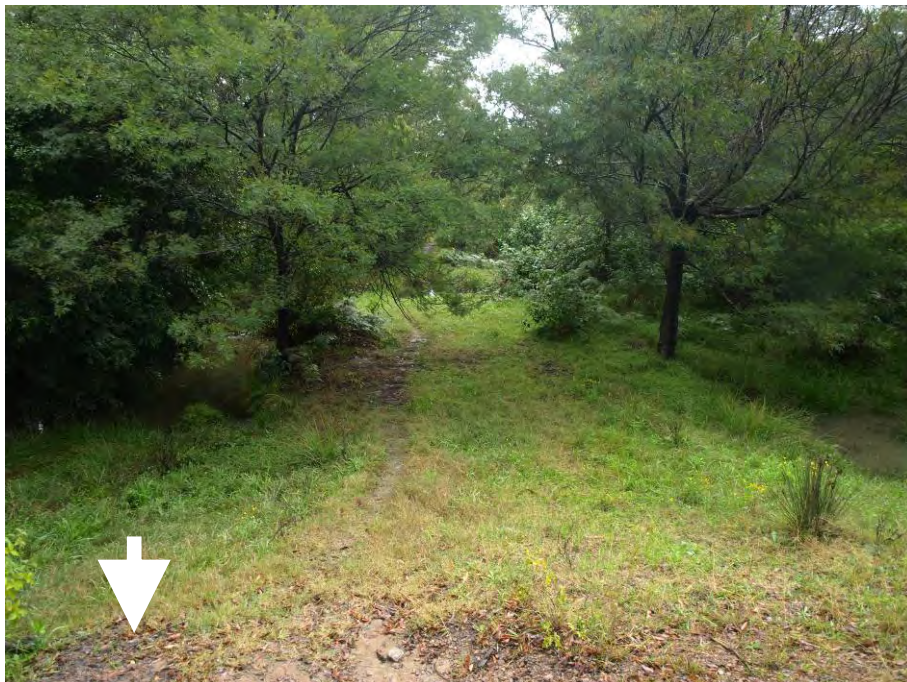
Plate P18: Site view of LEA9. Artefacts are on exposure in bottom left of picture. Looking NNE across ford over Deadmans Creek, next to Clarence Town Road.

Site No.	Point	MGA Easting	MGA Northing	Location	Site Type	Landform	Description	Mitigation
LEA9	Objects	0378093	6384498	Clarence Town Road; Dead Man's Creek crossing. It lies about 10 m north of the road on the west bank of the creek (about 4 m back from the bank edge).	Artefact Scatter	Creek flat	The site is an artefact scatter consisting of two white silcrete broken flakes, measuring 13 x 21 x 6 mm and 18 x 15 x 3 mm respectively. The only diagnostic features on these objects are flake scar ridges, offering some doubt as to the identification of these objects as artefacts. Both artefacts lie on an exposure measuring 6 x 4 m (24 m ²) about 4 m north of the roadside fence. Visibility within the exposure is about 70-80%. The artefacts lie about 0.2 m apart. The site is considered to be part of a continuous subsurface deposit incorporating LEA8 (130 m north west).	Recommend test excavation along the western bank of Deadmans Creek and collection of surface artefacts.

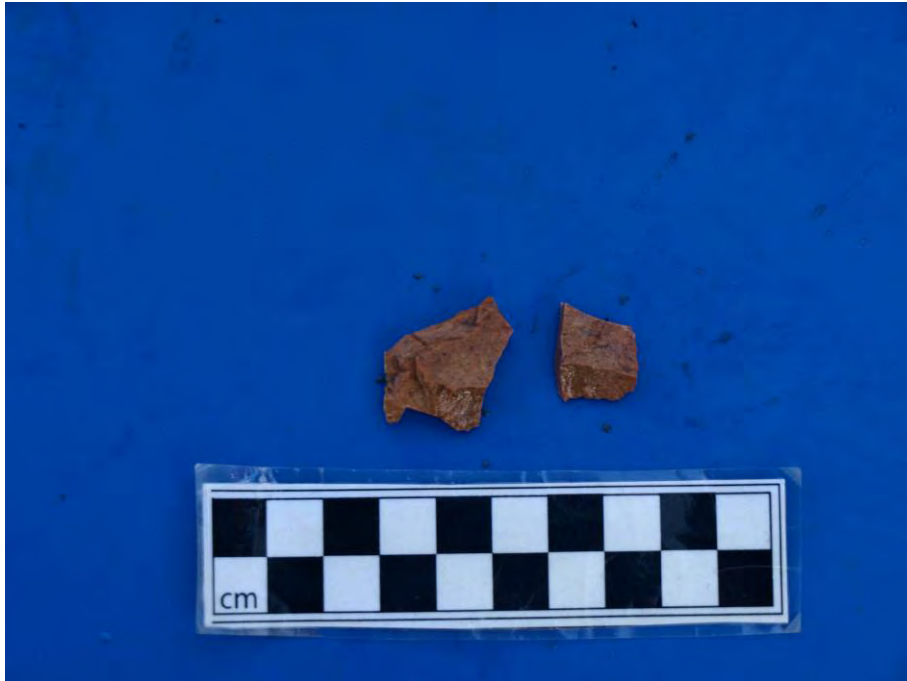
Plate P19: Silcrete artefacts found at LEA9

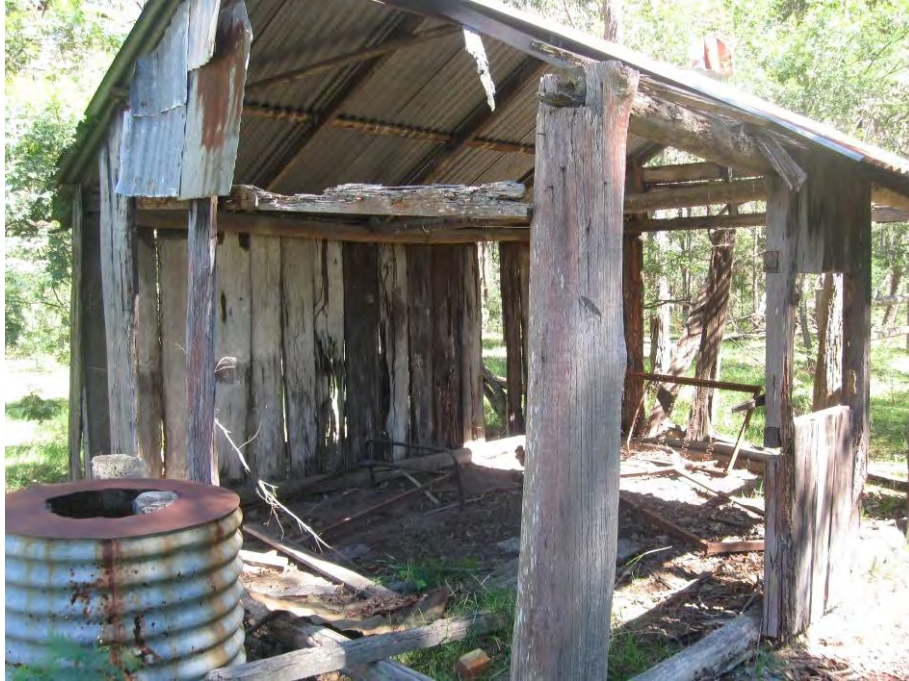
LEH3	Object	396564	6416168	Gorton's property, off the western side of Black Camp	Hut and Stockyards	Creek flats	The hut is an end-gabled, rectangular timber hut. The walls are framed with round-log	Nil required under current alignment. This item is located

Plate P21: Hut and Stockyards at LEH3

Site No.	Point	Easting	Northing	Location	Site Type	Landform	Description	Mitigation
				Road, west of Stroud (3DP744888). It is situated about 20 m from the road edge.			corner posts with top and bottom beams. They are clad with vertical timber slabs (most are missing off the front and side walls, but mostly intact on the rear wall). The roof is clad with corrugated iron and the gables are also clad with several small sheets of corrugated iron. The roof appears to be newer than the rest of the hut since it is framed with sawn timber joists and rafters. There is a single door and window at the front. There is no glass in the window but there is a leaf hinge attached to the frame indicating a timber shutter. There is also the remains of a very small CI water tank and stand at the southern end. About 20 m south of the hut is an old stockyard with newer extensions that may still be in use. Several sections of old timber fence lie around the hut consisting of timber posts with rebates for two rails. A small refuse scatter is located about 5 m south of the hut.	more than 100 m west of the proposed alignment and is not considered to be under any threat from the development. Should realignment be considered in the vicinity of this site any ground-breaking activities should not be conducted within 50 m of the building with preference given to the eastern side of Black Camp Road or within the road easement.

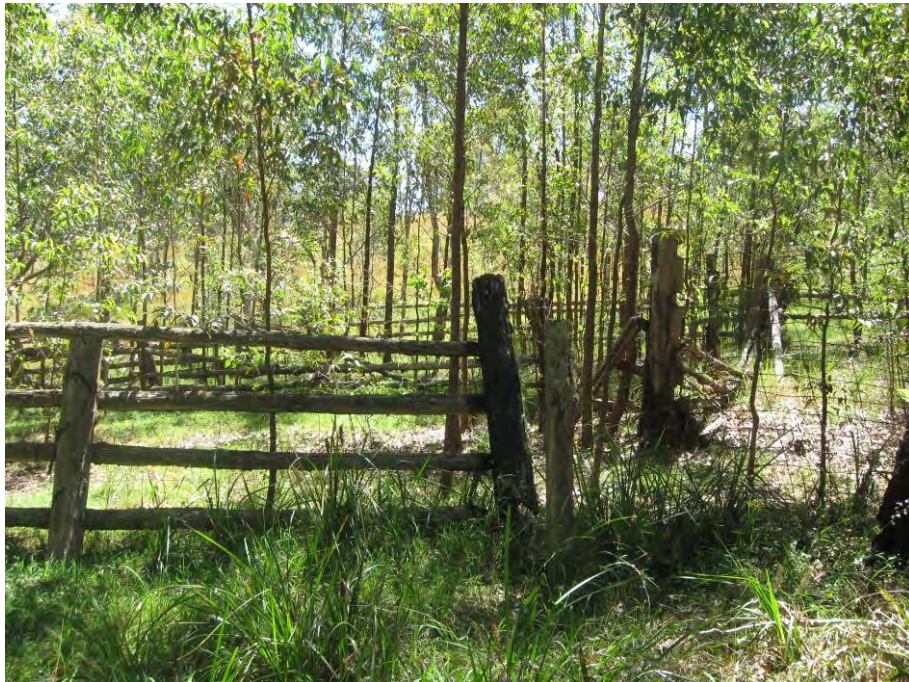
LEH4	Object	395584	6411836	Fearon and Nosworthy's property on Black Camp Road (103DP570275)	Stockyard	Upper slope	The site consists of a small stockyard measuring about 20 x 10 m with a stock ramp and chute at the southern end. It appears to have had three pens, but many of the fences have fallen down leaving gaps in the structure. It is constructed of 1.5 m high round-log posts (at ~3 m centres) with three split-log rails and a top-rail. All rails are wired to the posts. The stock ramp has a base of coarse rock that was probably covered in loose gravel that has since been washed away. The rock fill is between vertical round log sides.	All care should be taken for construction to avoid impact to this site, which is located within 2 m of the edge of the road. The pipeline may remain within the road easement (on the eastern side of the road) or may detour approx 50 m west of the item to cut the road corner.

Plate P22: Stockyard at LEH4

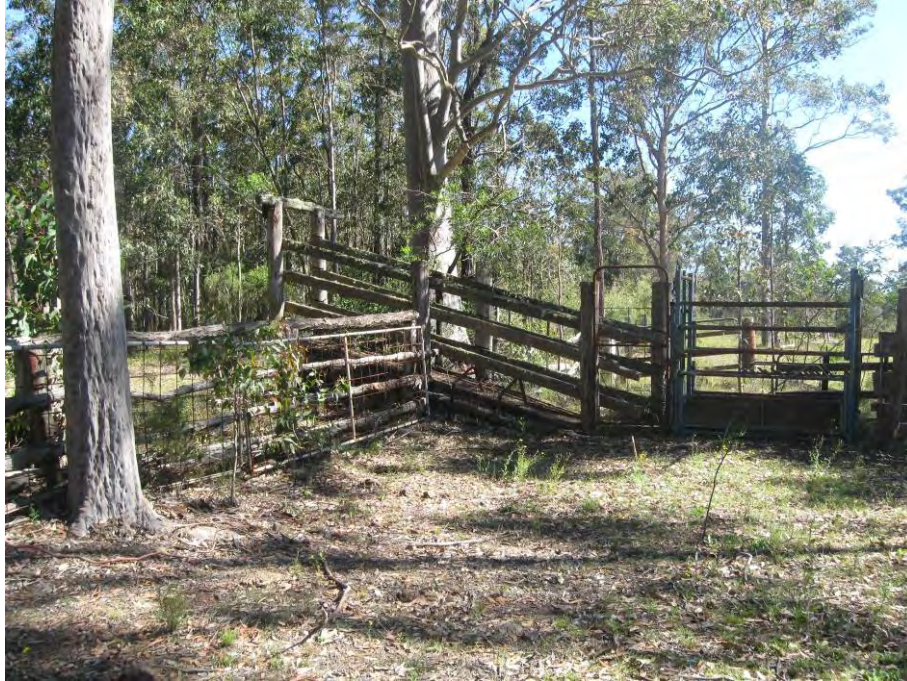
LEH7	Object	394609	6410020	Black Camp Road. Just off roadside and just south of entry gate into James & Hull's property (122DP526671)	Stockyard	On crest of northerly-facing spur	The stockyard was originally constructed of round log posts with round log rails wired to the posts. Several sections appear to have been either repaired or extended using round log posts with sawn timber rails (also attached by wire). The interior of the yards have been reinforced by wire mesh; the yard appears to be in useable condition though modifications mean that it has only moderate integrity.	This site is in the general vicinity of sites LEA6, LEA7, PAD8 and LEH6. It is recommended that the pipeline route avoid this property completely and follow the road easement only. On the southern side of the un-named creek where LEA7 is located, the route then deviate back into

Plate P25: Stockyards at LEH7
