IDENTIFIED SITES AND HERITAGE SURVEY TRANSECTS - KILOMETRE POINT 82 - 88km
SHEET 13 OF 14

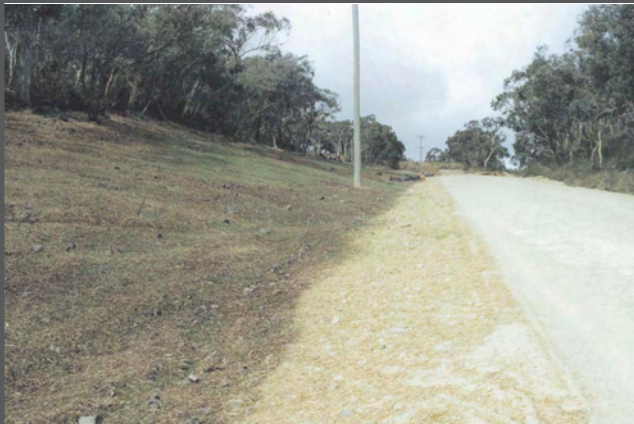
Photograph 1
Early regeneration of ground cover following hydro mulching along the roadside corridor.

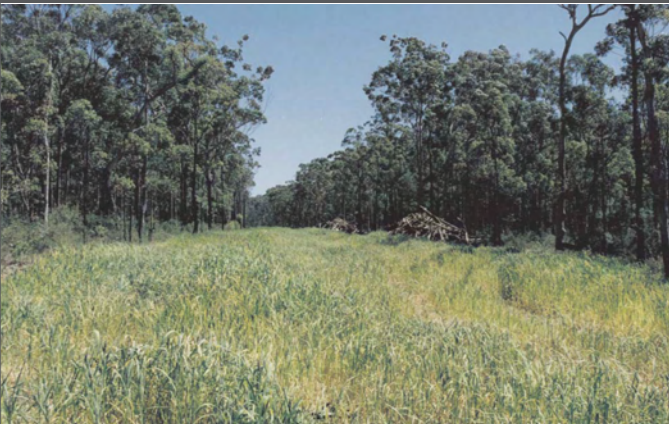
Photograph 2
Early crop cover establishment along a pipeline easement.

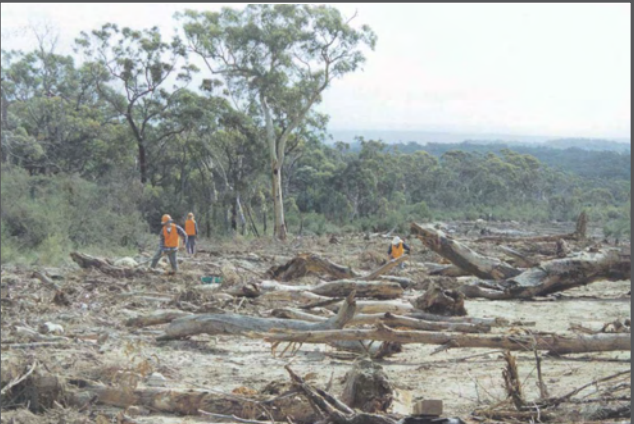
Photograph 3
Re-spreading of vegetation over easement through Moreton National Park, NSW.

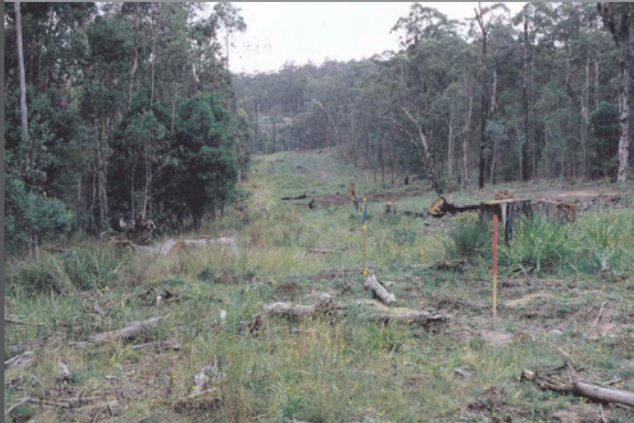
Photograph 4
Early establishment of revegetation through heavily vegetated area. Re-spreading of vegetation across easement evident.

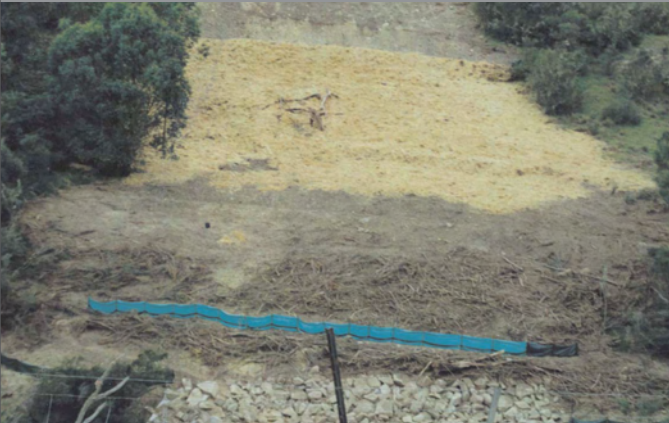
Photograph 5
Rehabilitation of an open trenched creek crossing. Hydro mulching, rip rap and sediment and erosion control fencing present along creek line.

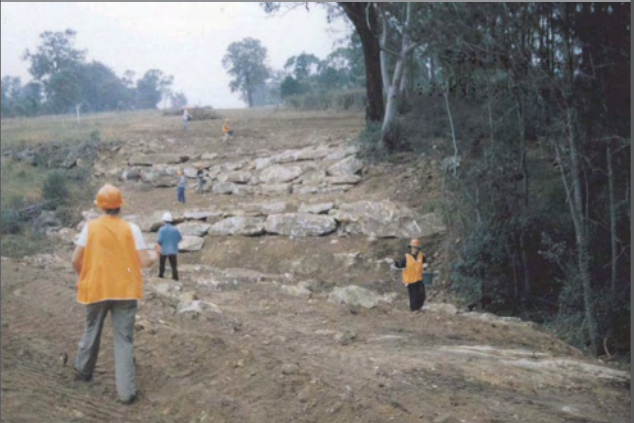
Photograph 6
Hand-broadcasting of seed along drainage line. Rock walls placed to assist with bank stability.

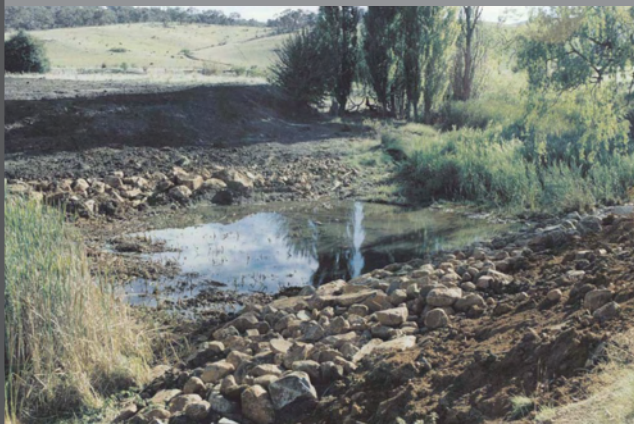
Photograph 7
Rehabilitation of open trenched creek crossing. Natural contours have been restored and rip rap placed to assist bank stability.

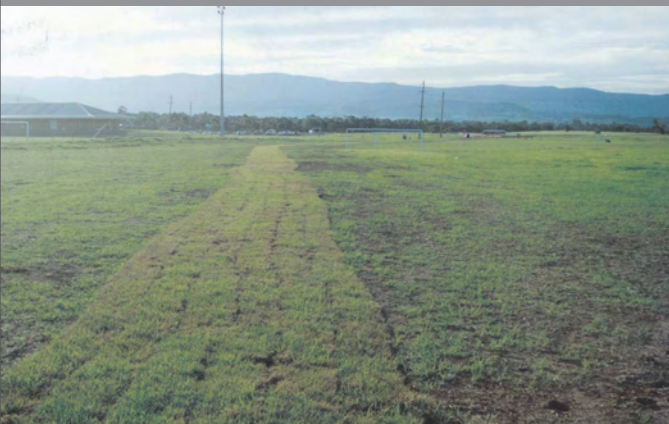
Photograph 8
Turf laid over easement through sporting field.

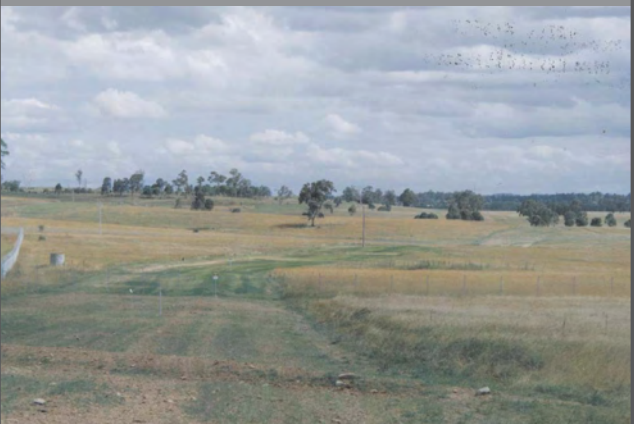
Photograph 9
Predominantly rehabilitated pipeline corridor through rural land.

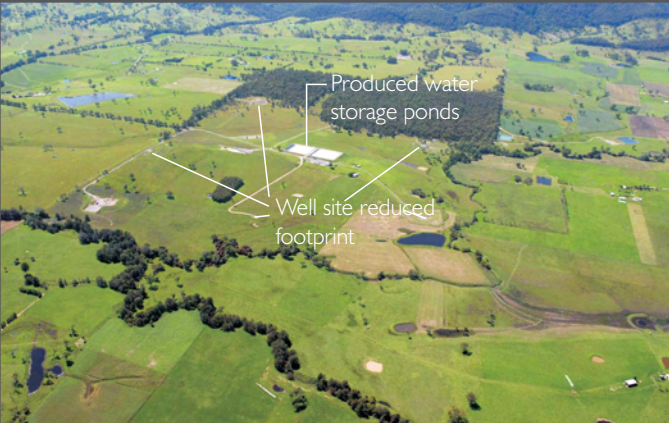
Photograph 11
Aerial photograph of the reduced and rehabilitated footprint (15x15m) for each well site at the Stratford Pilot
