**APPENDIX B10. JUNE 1991 FLOOD PHOTOGRAPHY (E Rigby) (ctd)**

## APPENDIX B11. JUNE 1991 RECORDED FLOOD LEVELS

# **HYDROLOGIC MODEL ESTABLISHMENT**

# **HYDRODYNAMIC MODEL ESTABLISHMENT**

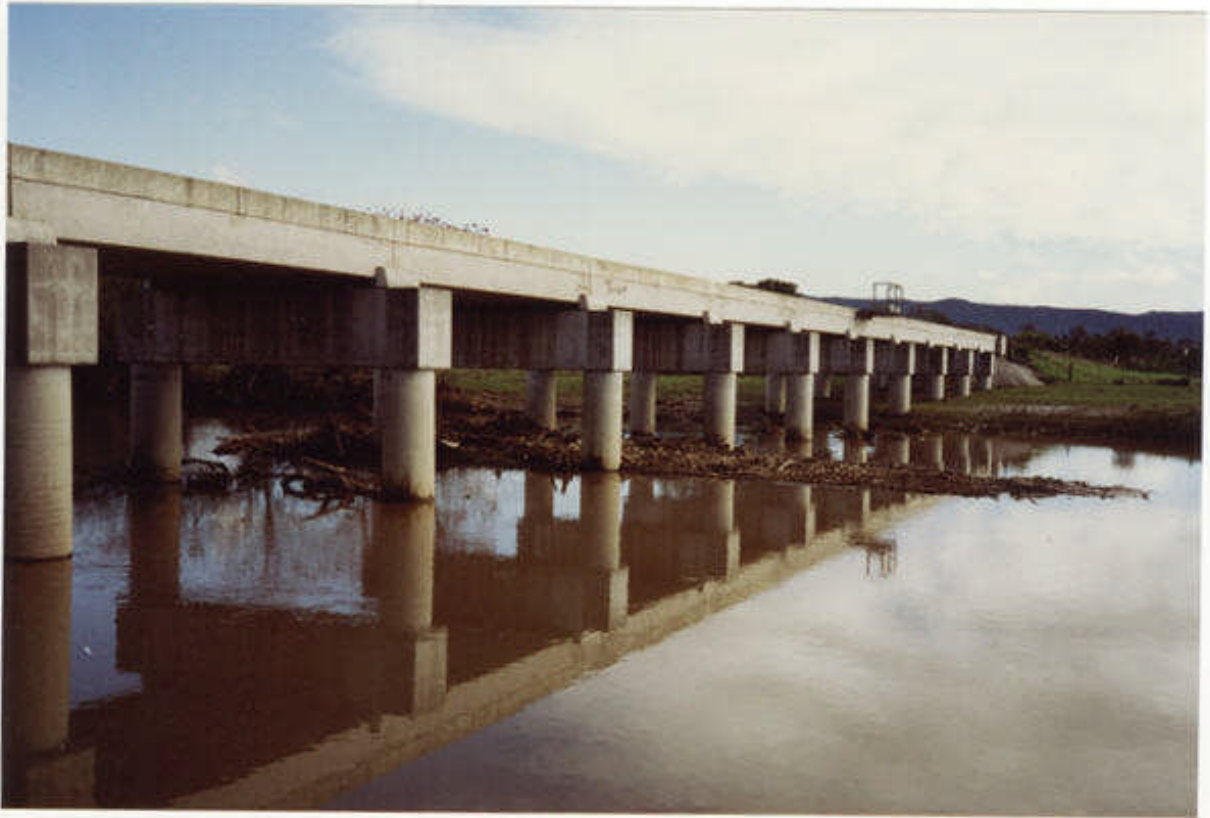
**Rail Bridge - Accumulated Debris After Event From DS South Bank**

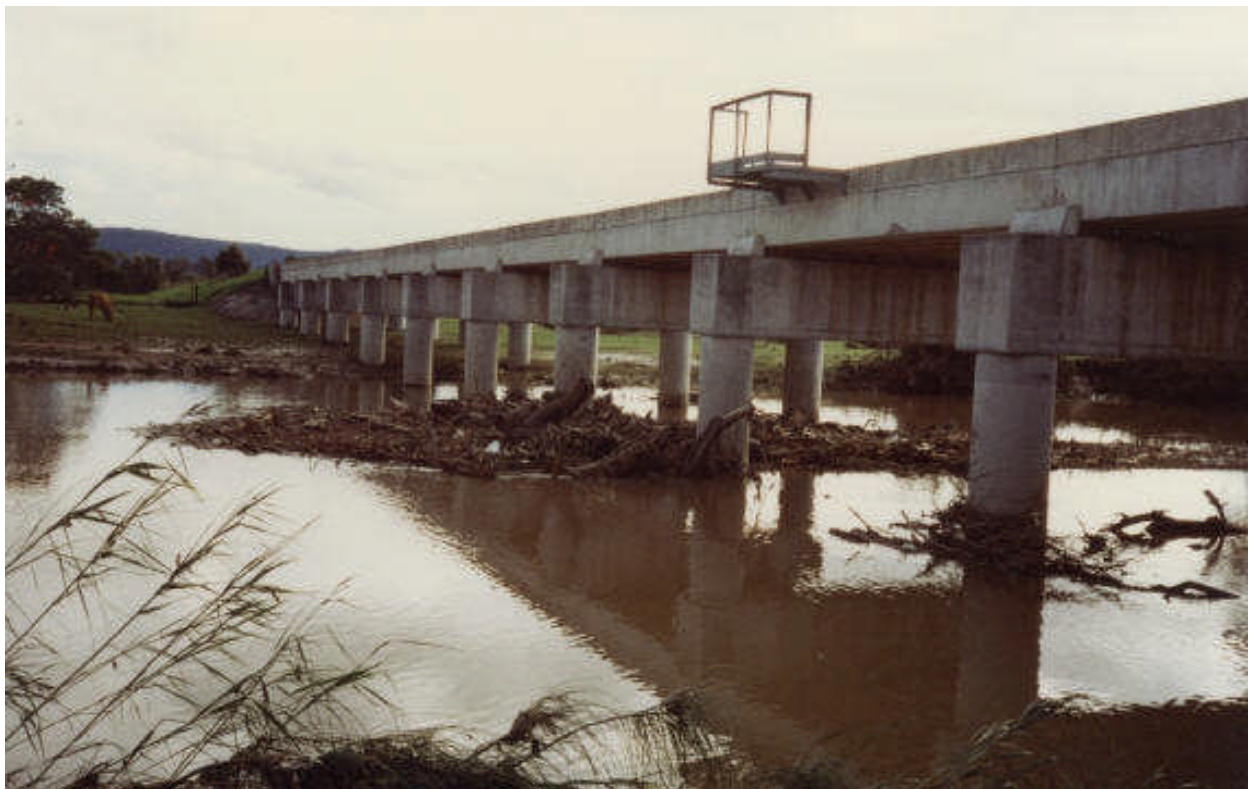
**Rail Bridge - Accumulated Debris After Event From US South Bank**

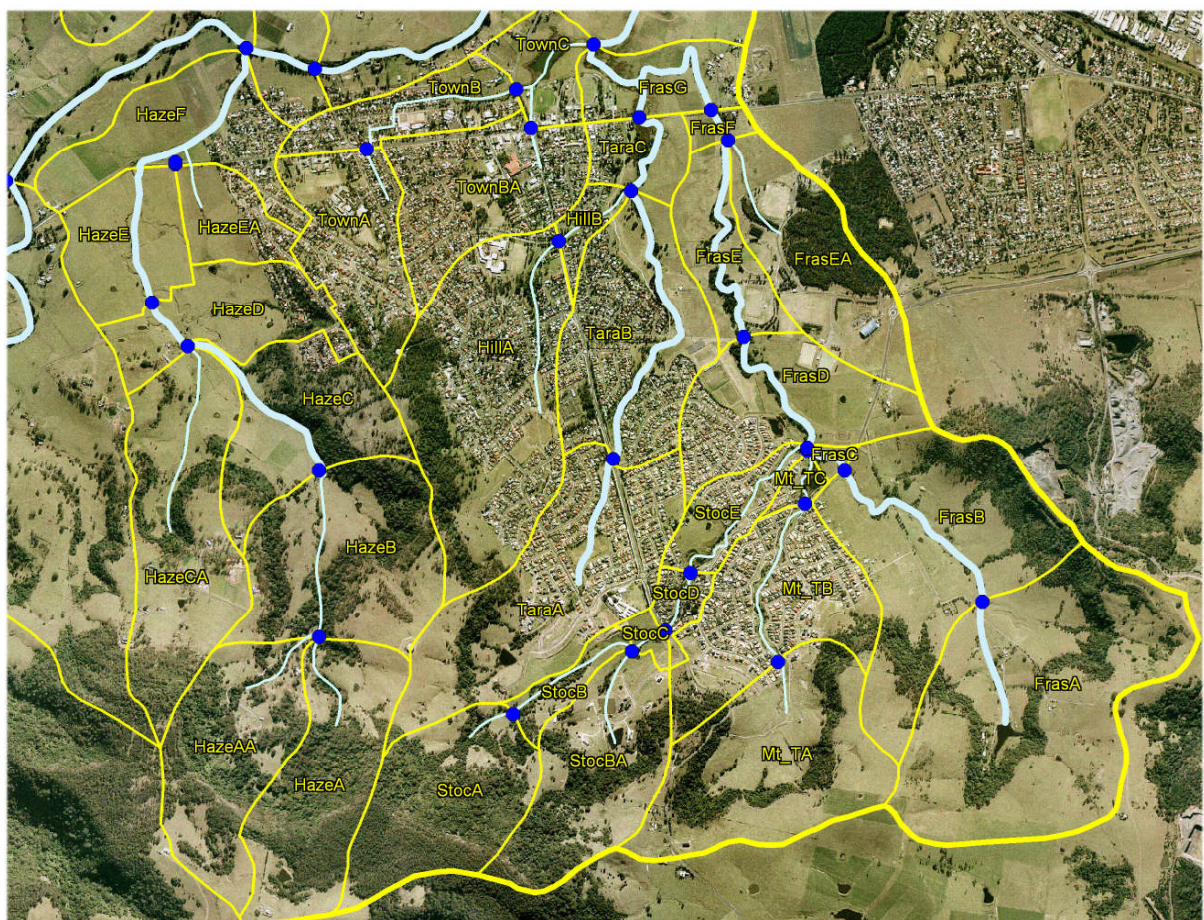
# ALBION PARK ENLARGEMENT

## APPENDIX C1 HYDROLOGIC MODEL LAYOUT

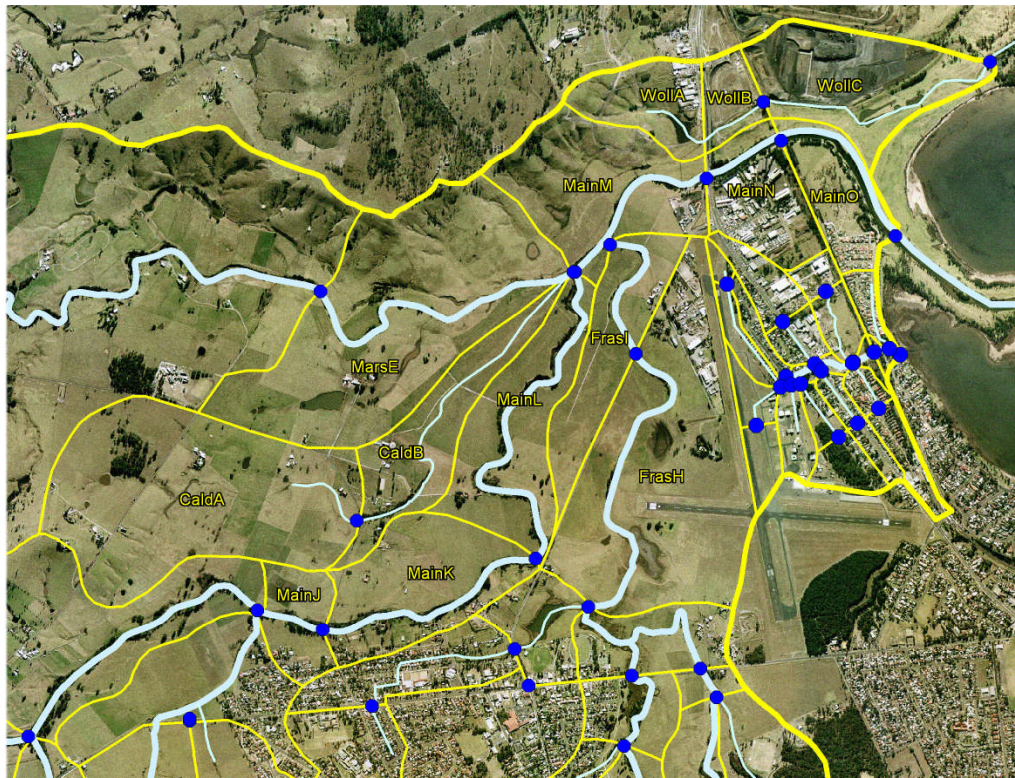
**ENLARGEMENT AT OUTLET**

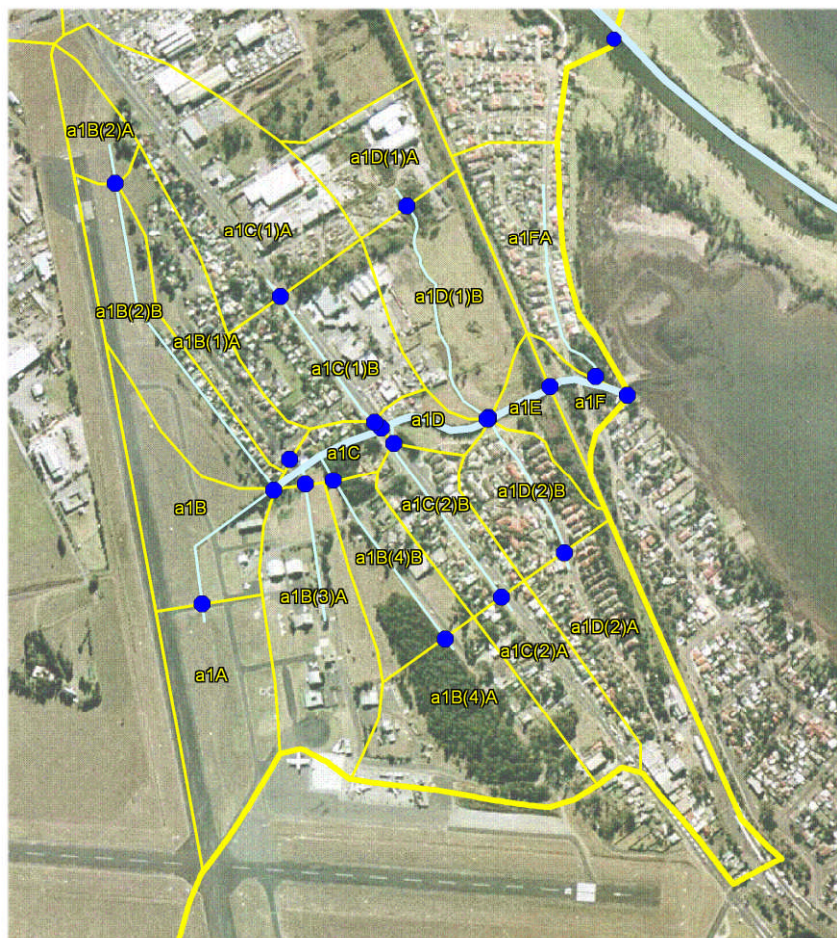
**ENLARGEMENT AT ALBION CREEK**

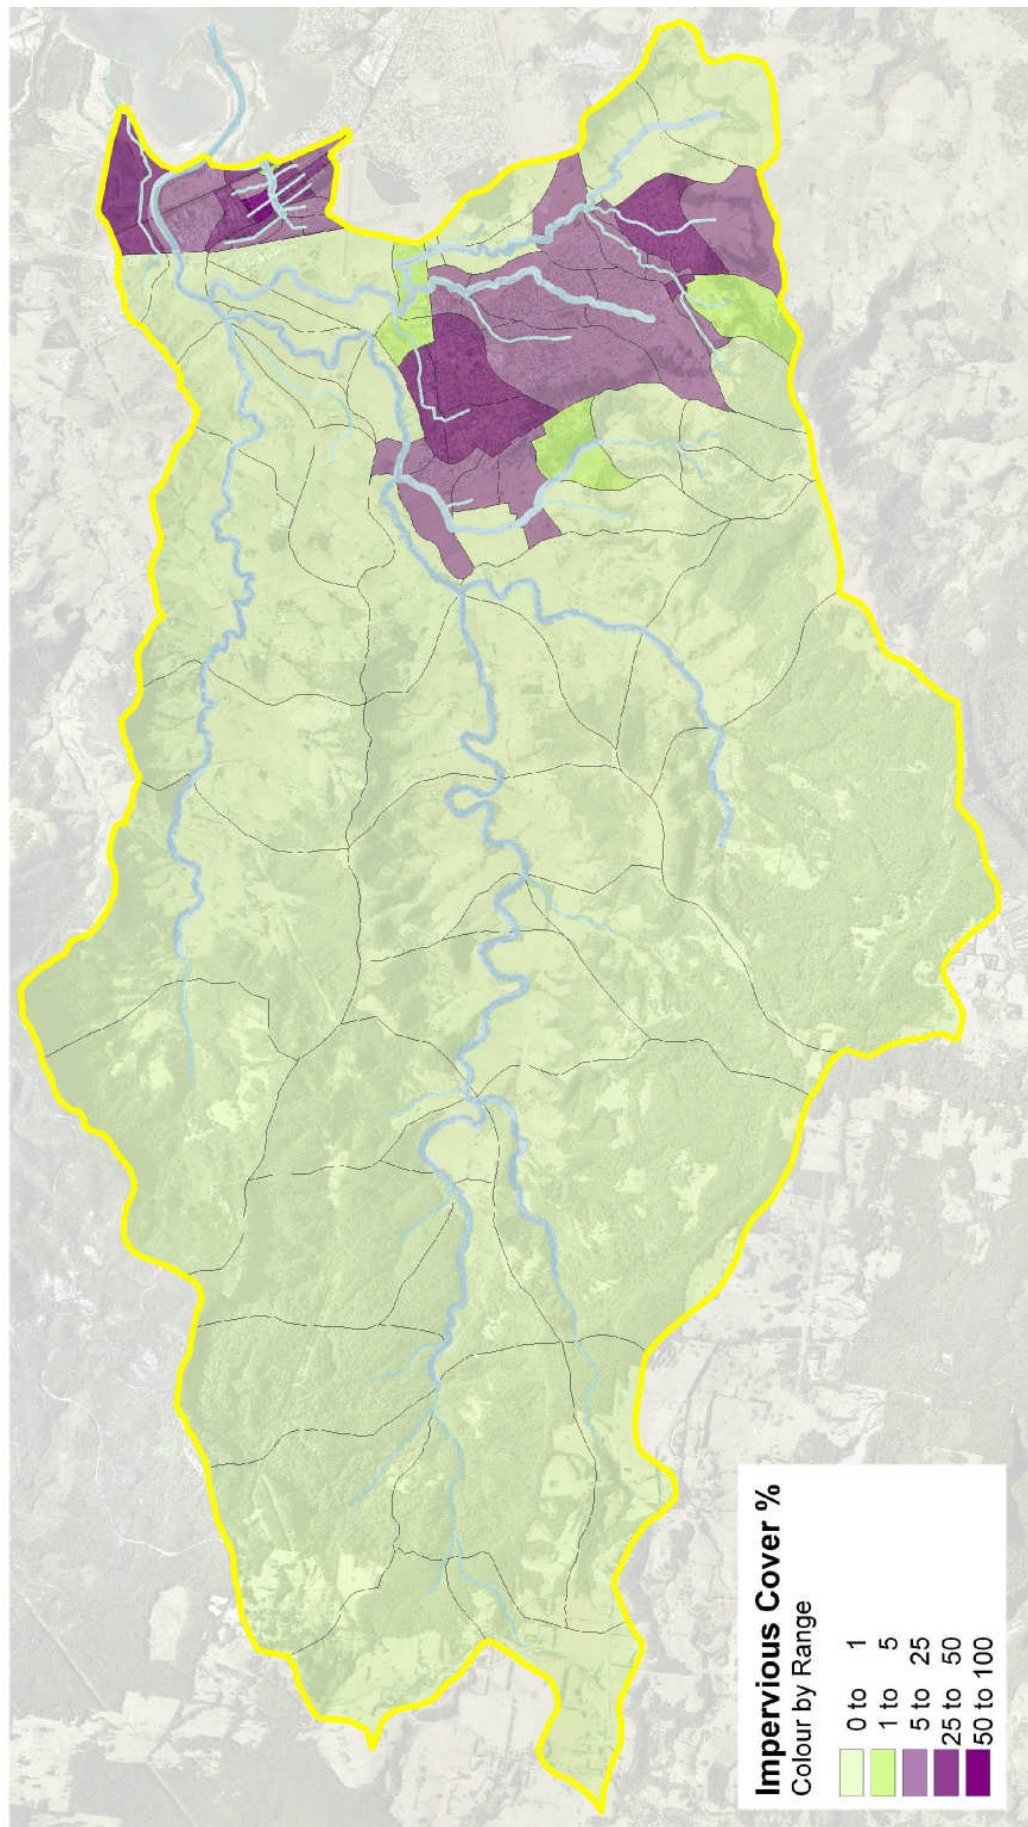
APPENDIX C2, HYDROLOGIC MODEL IMPERVIOUS COVER
