## 9.1 Introduction

This assessment considers the flora and fauna impacts of the proposed Biomass Power Plant Project with regard to Commonwealth and NSW planning and environmental legislation, including the *Environment Protection and Biodiversity Conservation Act 1999* (EPBC Act), *Environmental Planning and Assessment Act 1979* (EP&A Act), *Threatened Species Conservation Act 1995* (TSC Act), *Native Vegetation Act 2003* (NV Act), State Environmental Planning Policy (SEPP) 44 and the *Noxious Weeds Act 1993*. The full Terrestrial Ecology Assessment is presented in **Appendix D**.

## Terrestrial Ecology

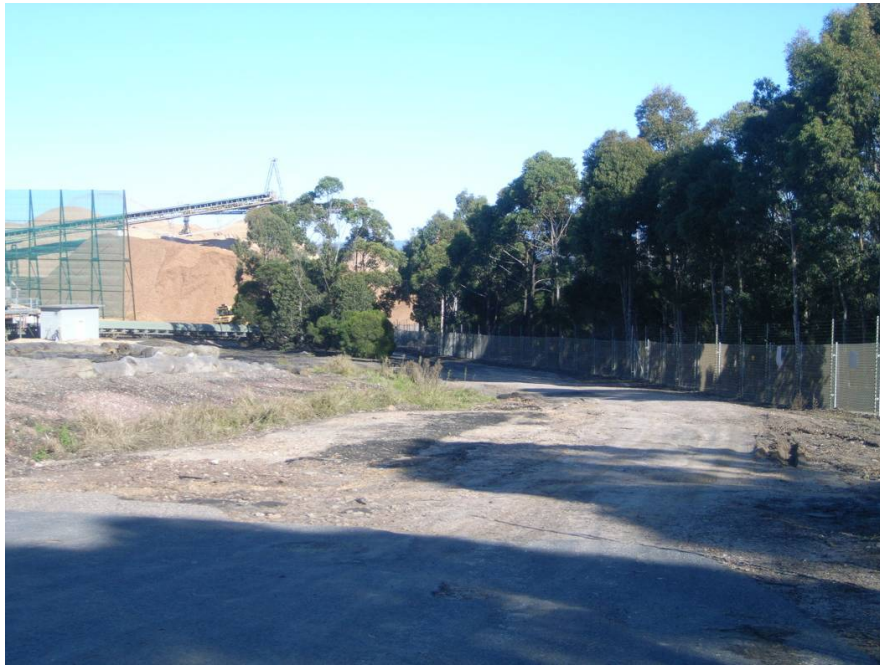
**Plate 9-1**      **Vegetation adjacent to the internal site road**

Vegetation in proximity to the proposed Power Plant includes some small areas of vegetation, generally very patchy and highly disturbed regrowth, typically alongside roadways and fence lines. There are no large continuous patches of vegetation, however there are extensive vegetated areas outside of the Site boundary. Some of the areas of vegetation within the Site, and specifically, within the area of anticipated impact, appear to have been planted with native (but not necessarily endemic) vegetation for landscaping and screening purposes. Most of the areas of vegetation within the Site are highly fragmented, with numerous tracks, walkways and roads throughout.

Many of the vegetated areas of the Site comprise a range of Eucalypt and exotic pine species in the canopy, which is generally patchy and disturbed, with various *Acacia* species in the midstorey. Much of the Site lacks any understorey vegetation, however some areas do have a disturbed understorey primarily of exotic grass (typically mowed lawns) and annual species such as Fleabane *Conyza bonariensis* and Cobblers Pegs *Bidens pilosa*.

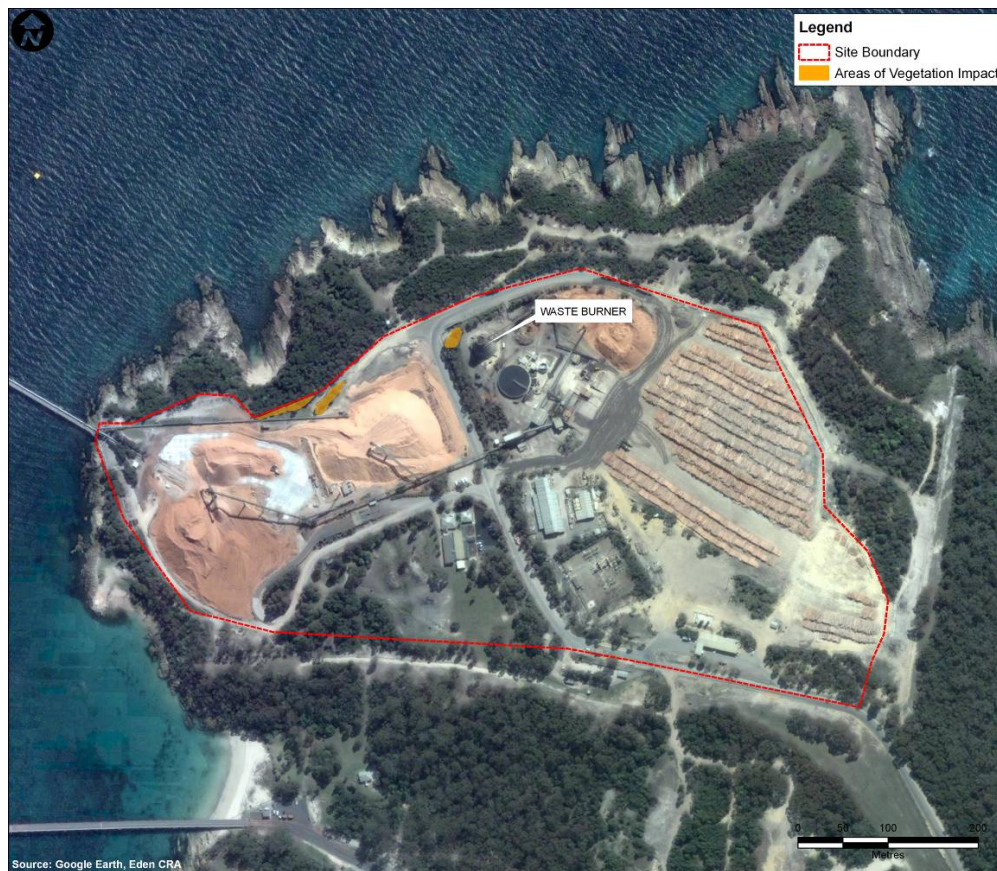
**Figure 9-3 Areas of Potential Vegetation Clearance**

The KTP relevant to the proposal is 'clearing of native vegetation'. The proposal will involve the clearing of 0.09 ha of vegetation (**Figure 9-3**). The vegetation within the area of anticipated impact is highly degraded and modified, hence the proposed action would not result in an increase to this KTP.

The proposed works will require clearing of 0.09 ha of vegetation, comprised of highly degraded and modified native and exotic species, of no particular discernable vegetation community (**Figure 9-3**).
