## **TARGETED PHASE 2 CONTAMINATION ASSESSMENT**

**INDUSTRIAL PORTION  
HOXTON PARK AIRPORT  
WEST HOXTON**

**Prepared for  
MIRVAC PROJECTS PTY LTD  
AND WOOLWORTHS LIMITED**

**Project 71500 – Revision 1  
February 2010**

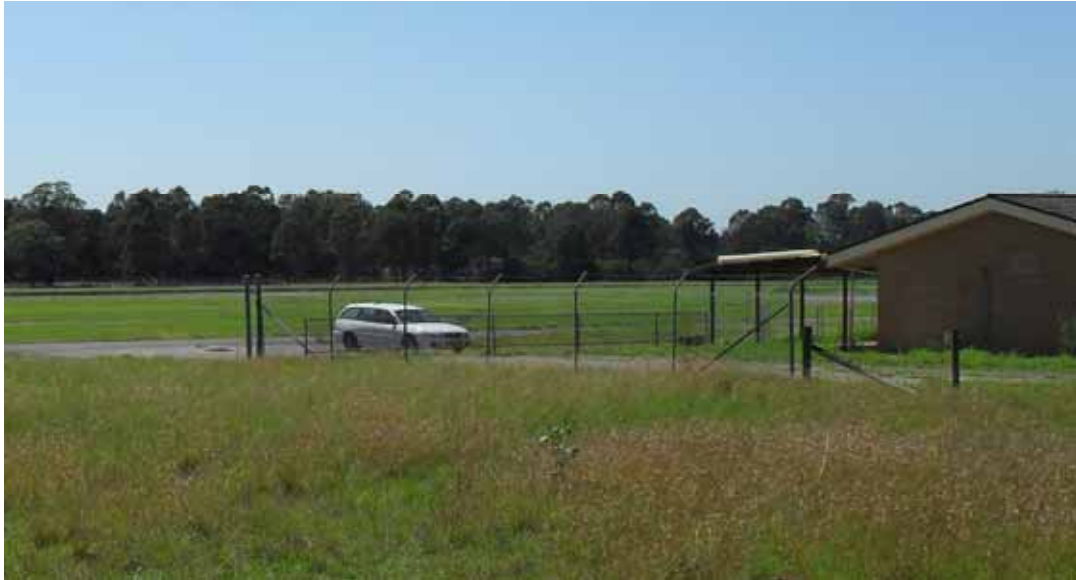
Photo 3: Location of former UST/BP refueling area

At the time of the 2009 tank pit characterization and GME, ENSR reported that the UST has been removed by Dermont Fuelling Systems. The removed UST was noted to be in good condition with no observable cracks. Approximately 300 L of water was pumped out from the tank pit excavation by the contractor. No sheen or odours were noted by ENSR.

Discoloration and hydrocarbon odours were noted in the soils in the former bowser/fuel line excavation. The noted impacted soils were chased out and removed. In summary about 80 m<sup>3</sup> of soil was removed from the tank pit excavation. About 40 m<sup>3</sup> of the excavated soil was validated and found to be not impacted and not odorous. These were returned to the tank pit. It is noted that two samples were collected from the spoil excavated from the tank pit. From ENSR’s discussions, it appeared that the contaminant levels in these two “tankpit excavation spoil samples were low” (as the only sample with reported elevated levels of TPH and benzo(a)pyrene was SP5 which was collected from the bowser/fuel line area (all material from the bowser/fuel line was disposed offsite – see below).

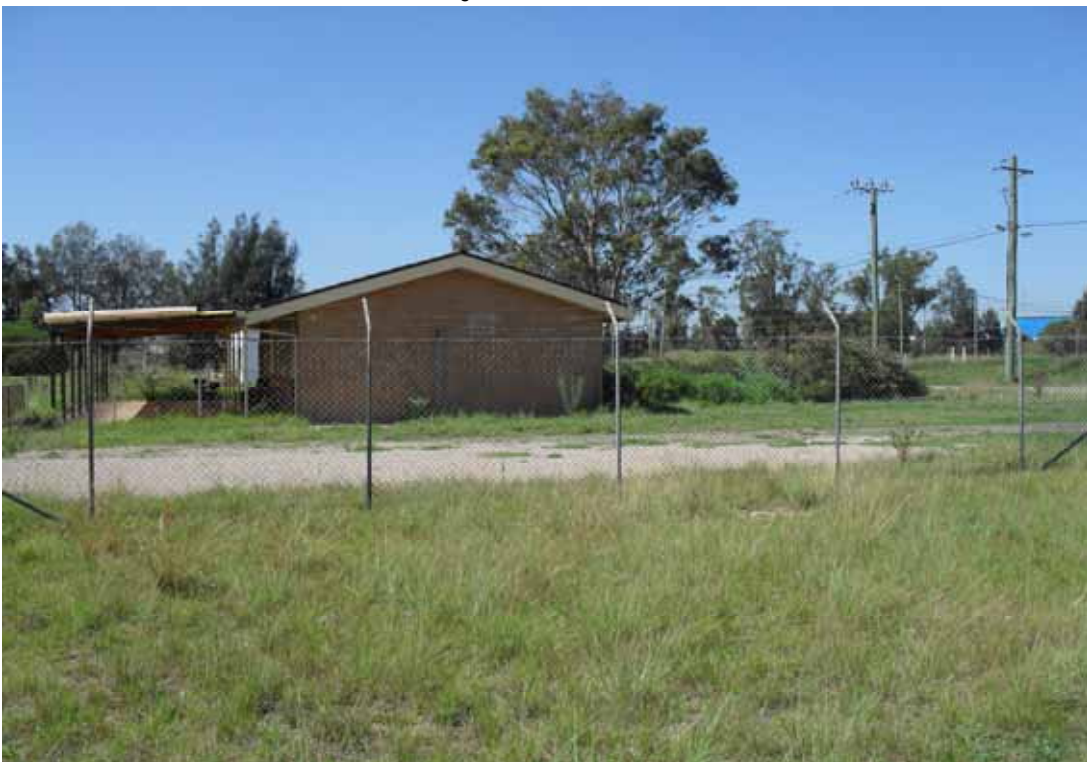
Photo 4: Location of former UST/BP refueling area

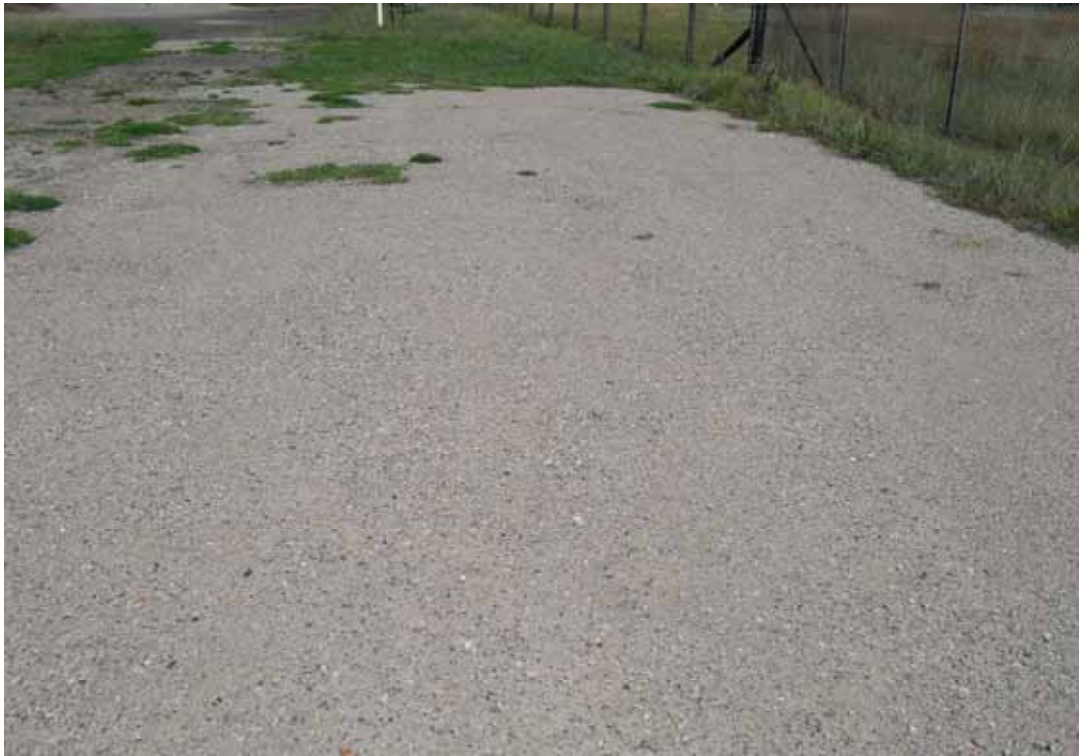
Photo 5: Recycled concrete backfill in former UST pit

It was reported that approximately 40 m<sup>3</sup> of imported recycled concrete and road base were placed in the excavation. It is noted that ENSR did not test for asbestos. Levels of chemical contaminants in the imported fill were found to be acceptable.

DP generally agreed with ENSR’s assessment, but noted that there were data gaps in their validation sampling plan (some samples not analysed without adequate justifications). Also the imported fill material used to backfill the tank pit excavation comprised recycled concrete and road base material, instead of VENM. It is recognized that recycled concrete may be cross contaminated with asbestos containing material. In this regard, ENSR has not tested for asbestos. Having said this, the potential area of backfill is only limited in extent (within the tank pit excavation), and the health impacts associated with the backfill material is envisaged to be minimal, and can be managed in a simple and straightforward manner.

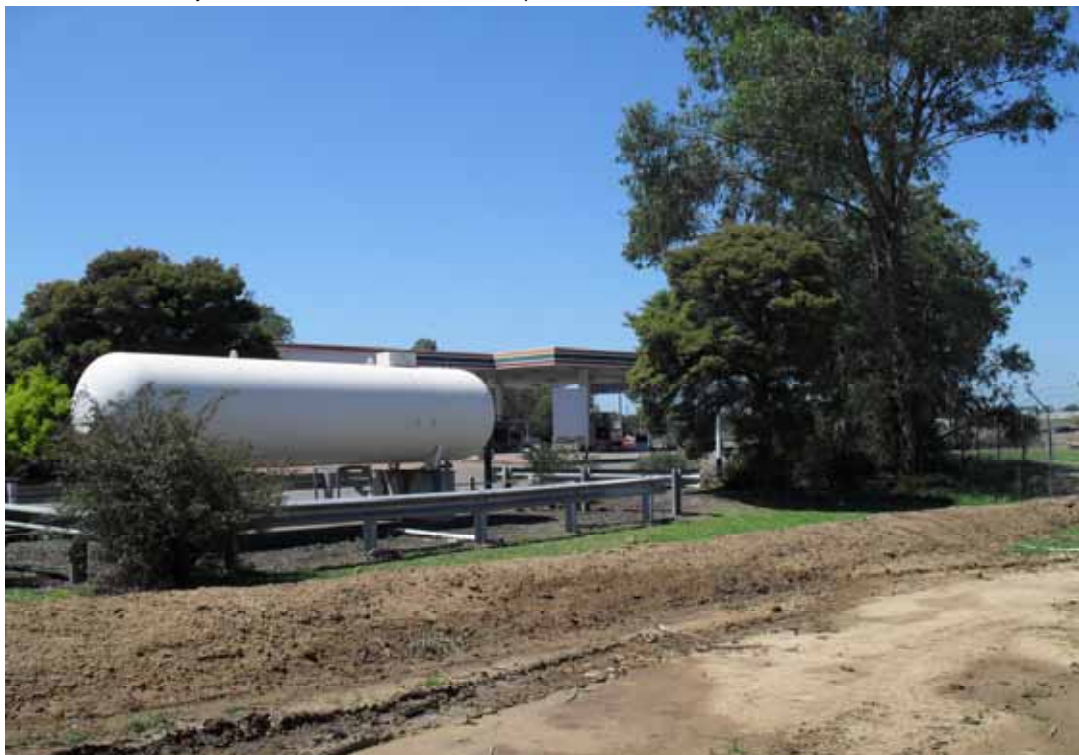
Photo 6: Service Station outside south east boundary of site

Of the above-mentioned nearby landuses, the one with the highest potential for causing impacts on the site is the service station located to the south east. Given the noted topography and geographical setting, it is envisaged that the general gradient of groundwater (and hence the direction of groundwater migration) would be in a north easterly to easterly direction, towards Hinchinbrook Creek. In this light, the potential for contamination impacts from this service station on the Site is envisaged to be relatively low. One groundwater well was installed near the section of site boundary to the north of the service station to assessment the potential impacts from the service station.

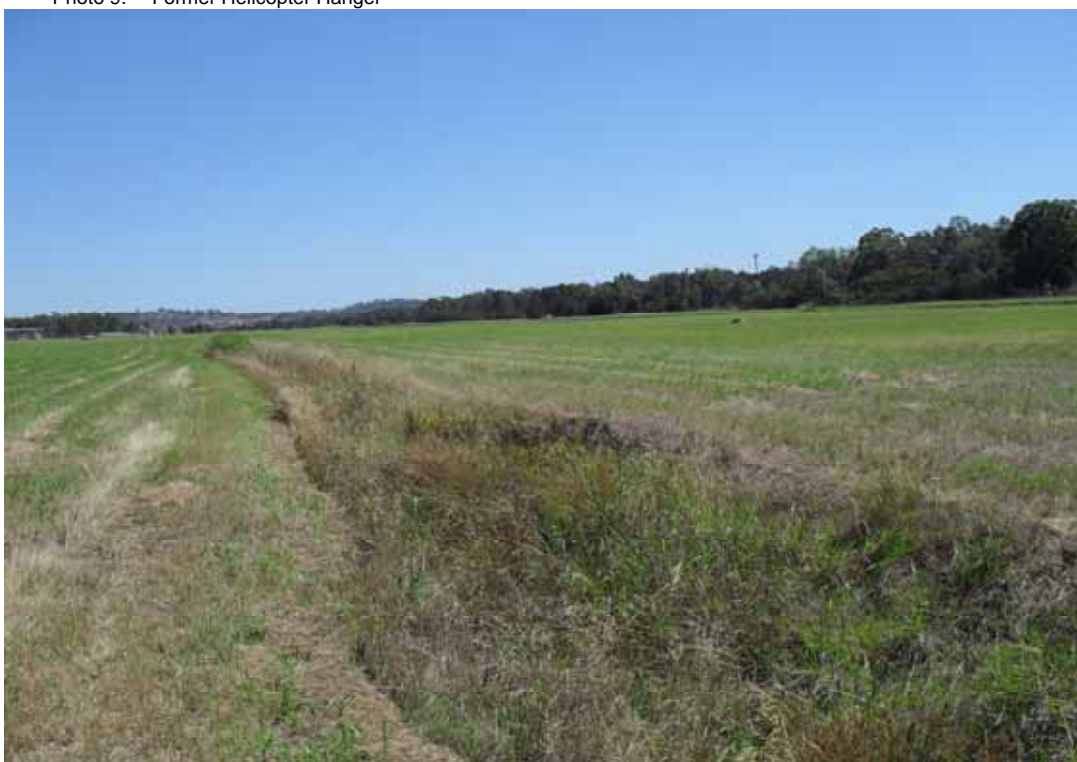
Photo 10: Drainage Trench in running north to south in southern half in between runway and taxiway

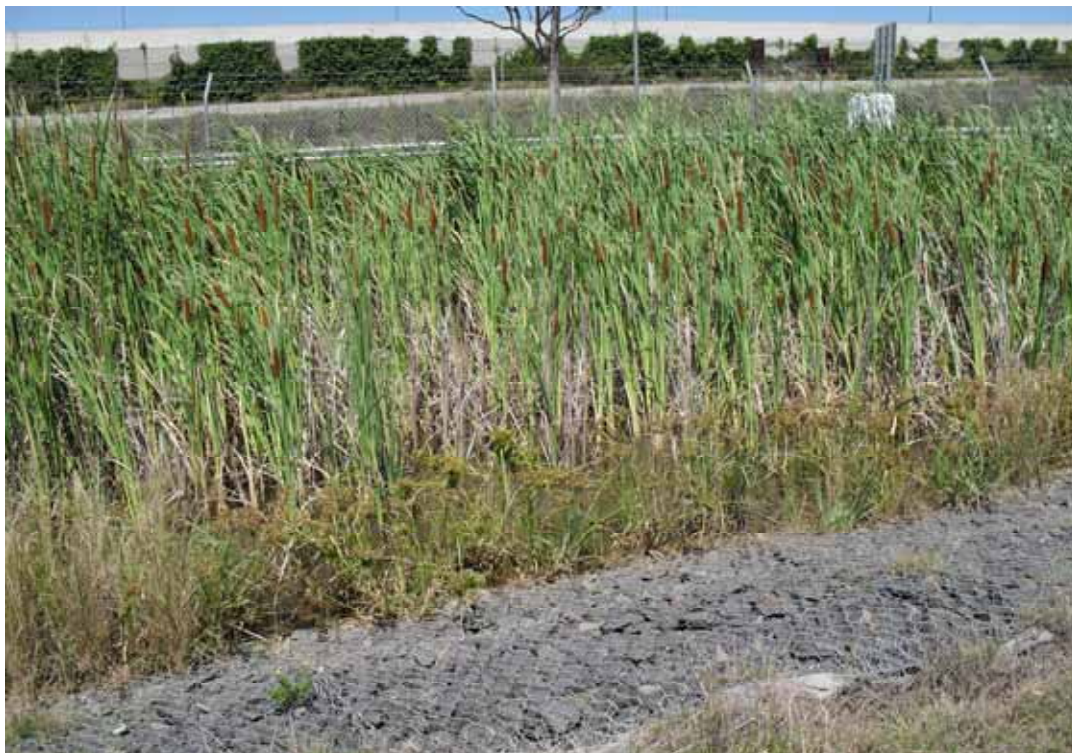
Photo 11: Drainage Trench in south west corner of site

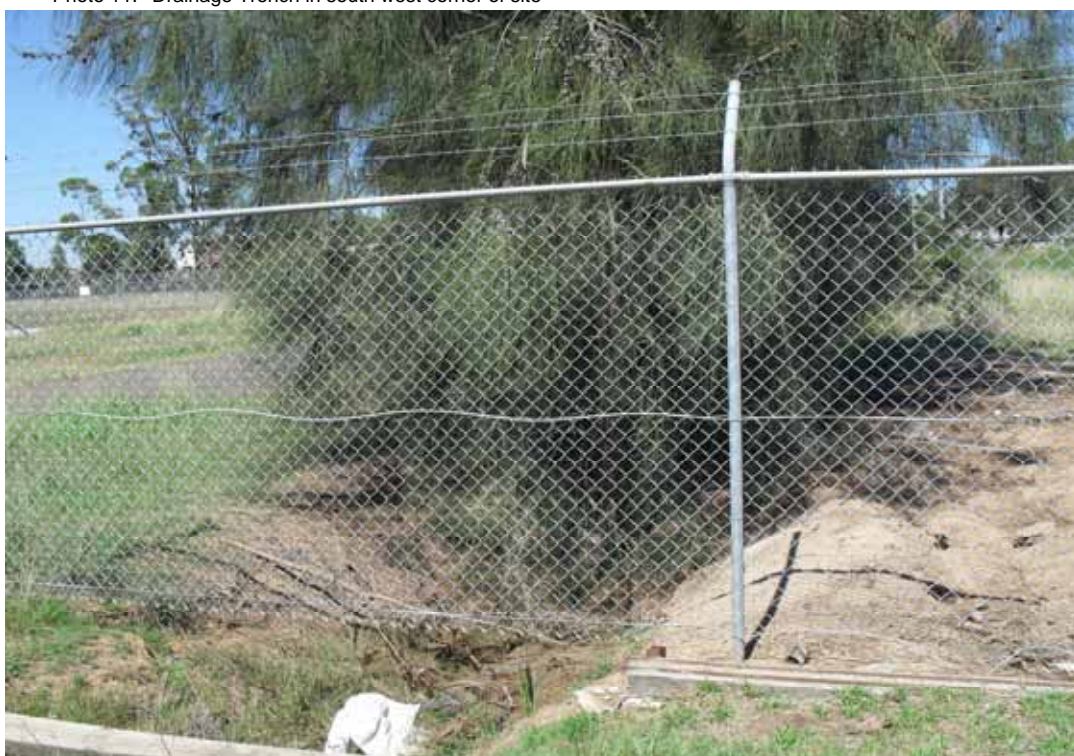
Photo 12: Drainage trench near former helicopter bay

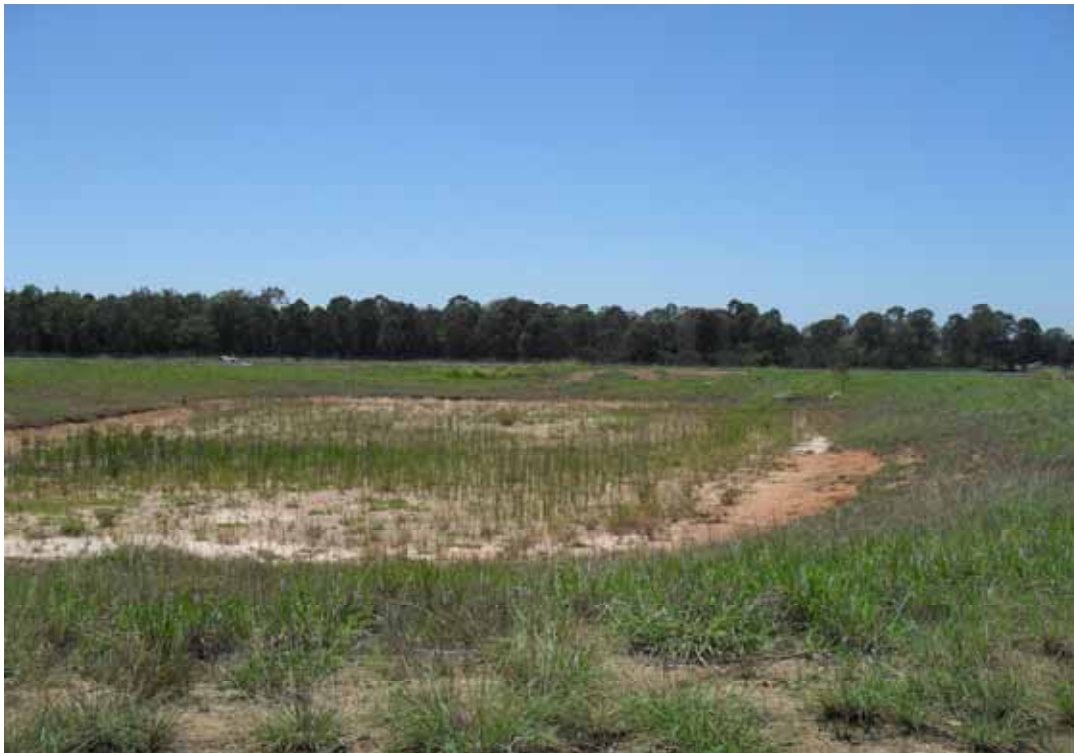
Photo 13: Stormwater retention basin outside south western side of site

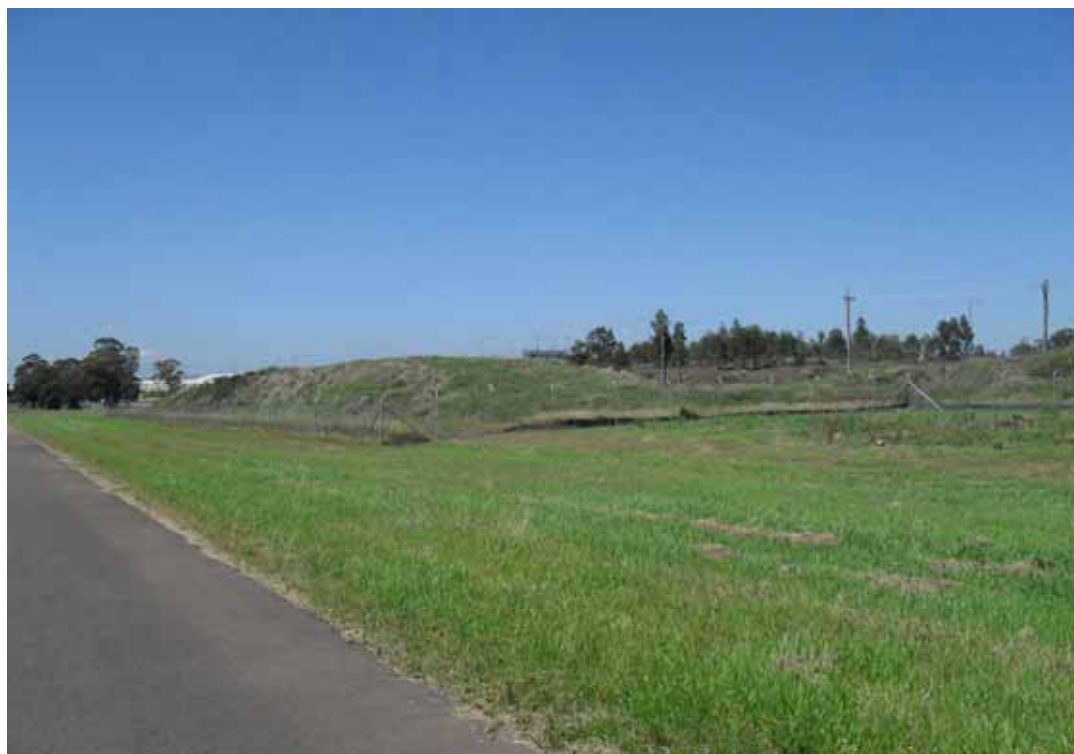
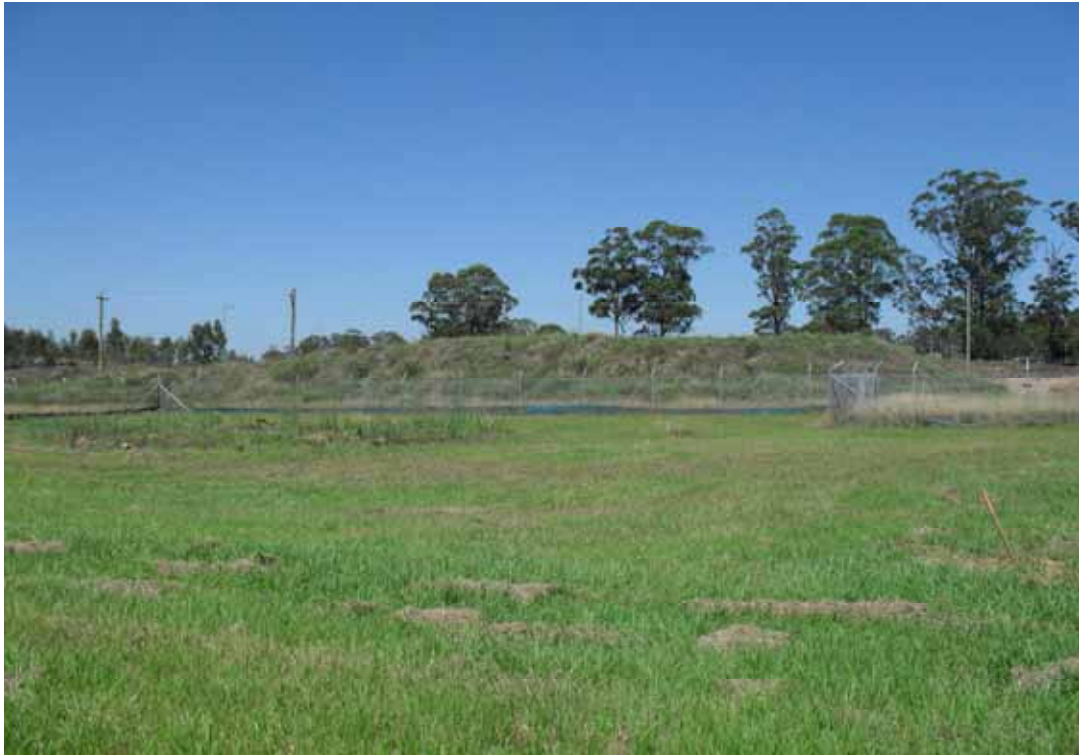
Photo 14: Soil Stockpiles outside site boundary (western side)

Photo 15: Soil Stockpiles outside site boundary (western side)

In 2005, the land parallel to the Westlink M7 was cleared in the western portion of the site. A small M7 construction compound was located in the southern section of the cleared area. [Note: DP noted a stockpile of fill material placed outside the boundary fence of the site, near the site entrance.]
