REPORT
on
PRELIMINARY GEOTECHNICAL INVESTIGATION

PROPOSED INDUSTRIAL DEVELOPMENT HOXTON PARK AIRPORT

Prepared for MIRVAC GROUP

Project 71500.01 January 2010

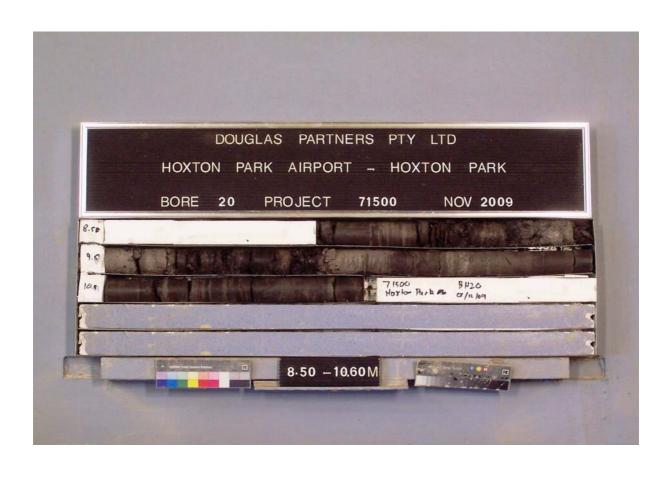
CLIENT: Mirvac Group
PROJECT: Hoxton Park Airport

LOCATION: Cowpasture Road, Hoxton Park

1	Description	Degree of	ပ	Rock Strength	Fracture	Discontinuities				n Situ Testing
뒫	Depth (m)	of	Weathering	raph	Ex Low Very Low Nedium Medium Water Water Water	Spacing (m)	B - Bedding J - Joint	Туре	ore c. %	RQD %	Test Results &
		Strata	EW HW EW	O	Pickled Medical Control		S - Shear D - Drill Break	ı-	σæ	شّ	Comments

0.05	TOPSOIL - grey brown, silty clay topsoil with some fine gravel and grass rootlets, moist						A/E			PID<1ppm PID<1ppm
43		SILTY CLAY - stiff, brown, silty clay, damp to moist						AVE.			1 10 - 1ppiii

-	1 1.0	CLAY - stiff, orange brown and light grey, clay with trace of silt, moist	-	//				A/E			PID<1ppm 4,6,8
42		SILTY CLAY - stiff to very stiff, mottled orange light grey, silty clay, moist						S			N = 14
	2 20	CLAY - very stiff, mottled orange light grey clay, moist	-								
41	3							s			6,11,13 N = 24
40						 					
39	4 4.0	SILTY CLAY - very stiff, light grey and orange brown, silty clay with trace of fine grained sand and ironstone gravel	- 1 1 1 1 1 1 1 1 1 1 1 1 1 1 1 1 1 1 1					s			7,9,12 <b>N</b> = 21
38	5 5.5 6	GRAVELLY SILTY CLAY - stiff to very stiff, brown, gravelly (ironstone) silty clay, wet	- 1 1 1 1 1 1 1 1 1 1 1 1 1 1 1 1 1 1 1					s			5,8,12 N = 20
37	7	- becoming stiff at 7.0m							-		
		g can at man	11111					S			6,6,9 <b>N</b> = 15
36	8						Note: Unless otherwise stated, rock is fractured along rough planar bedding dipping at 0°- 10° or joints				
35		SILTSTONE - very low and low strength, grey brown siltstone SILTSTONE - medium strength, slightly weathered, fragmented to		=======================================			8,6m: B0°, 2mm clay 8,6-8,75m: fragmented				PL(A) = 0.8MP

9	fractured, grey siltstone  CARBONACEOUS SHALE - extremely low and low to medium strength, highly and slightly					8.9m: B0°, clay band 9m: B0°, clay band 9.13-9.43m: fragmented	С	100	65	PL(A) = 0,3MP
34	9.57	weathered, fragmented to fractured, dark grey to black, carbonaceous shale, some very					9.7m: B0°, 5mm clay				PL(A) = 0.4MP

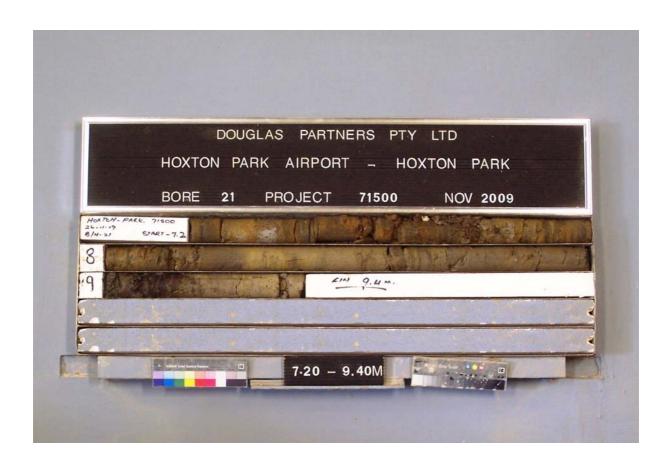
CLIENT: Mirvac Group

PROJECT: Hoxton Park Airport

Description	Degree of Weathering	i c	Rock Strength	_	Fracture	Discontinuities			_	n Situ Testing
Dept (m)		of		raph	Strength Nedical Nedical Nedical Nedical Nedical Nedical Nedical	Vate	Spacing (m)	B - Bedding J - Joint	Туре	Core Rec. %	g %	Test Results &
(,		Strata	M M M M M M M M M M M M M M M M M M M	O	Medic Very	> 0	0 00 0 10 0 50 1 00	S - Shear D - Drill Break	Ę,	ပ္သစ္တ	٣ "	Comments

0.2	FILLING - red brown, crushed sandstone filling	-	X					E/A			PID<1ppm
		FILLING - grey brown, sandy clay filling with some silt and concrete gravel, moist		$\otimes$		i			E/A			PID<1ppm
-1	0.8	CLAY - stiff, brown clay with some silt and trace of ironstone gravel, moist to wet							E/A E/A S			PID<1ppm PID<1ppm 4,5,7 N = 12
3-									S			3,6,6 N = 12
-4	3.8-	GRAVELLY CLAY - very stiff, brown, gravelly (ironstone) clay, wet				Ţ			s			3,8,8 N = 16
5	4.7	SHALY CLAY - hard, orange/yellow brown, shaly clay with ironstone bands		9////								
-6								Note: Unless otherwise stated, rock is fractured along rough planar	S			8,15,21 N = 36
<b>X</b>	6.8	SHALE/SILTSTONE - very low strength, grey brown shale/siltstone						bedding, dipping at 0°- 10° or joints				22,25/50mm
33	7.2							7.27-7.42m: (x2) B0°, ironstained 7.55m: J85°, ironstained 7.63m: B0°, 2mm clay	S			refusal PL(A) = 0.3MP
32								8.4m: J80°, ironstained	С	100	0

TYPE OF BORING: Solid flight auger to 4.0m; Rotary to 7.2m; NMLC-Coring to 9.4m WATER OBSERVATIONS: Free groundwater observed at 3.8m whilst augering **REMARKS:** E = Environmental sample, *Level relative to AHD, SSM167133

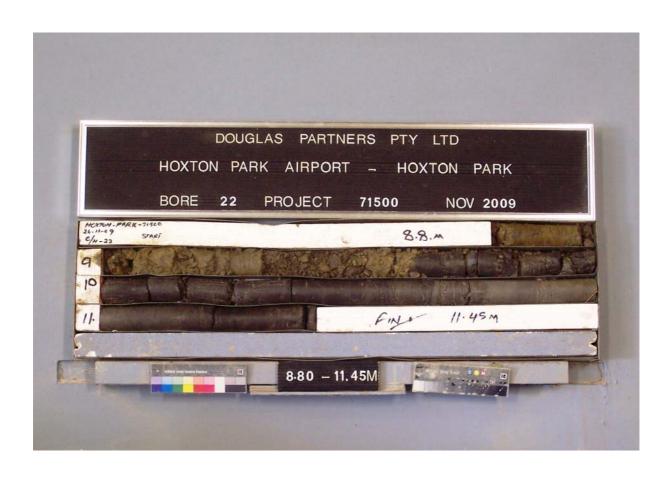
**CLIENT:** Mirvac Group

PROJECT: Hoxton Park Airport

FILLING - brown, fine grained, sand filling with some roadbase gravel, humid	11111				11 11 11 11 11 11 11 11		A			PID<1ppm
0.7	SILTY CLAY - stiff, orange brown, silty clay with trace of fine grained sand, moist							A ,			3,4,8 N = 12 PID<1ppm
2 2.4	SANDY CLAY - very stiff, brown, fine grained, sandy clay, moist	- 1   1   1   1   1   1   1   1   1   1				11   11   11   11   11   11   11   11		s			3,7,9 N = 16
-3 3.5 -4	SANDY SILTY CLAY - very stiff then hard, mottled orange brown and light grey, fine grained, sandy silty clay, moist				<u> </u>			S			4,10,16 N = 26
-5	5.5m: becoming hard							S			6,14,23 N = 37
-7 7.0	GRAVELLY CLAY - hard, brown, gravelly (ironstone) clay, moist		\$ \$ \$ \$ \$ \$ \$ \$ \$ \$ \$ \$ \$ \$ \$ \$ \$ \$ \$					s			11,20,28 N = 48
-8 8.4	4					11 11 11 11 11 11 11 11	Note: Unless otherwise stated, rock is fractured along rough planar bedding, dipping at 0°- 10° or joints

9.0	SHALE - medium strength, fresh, slightly fractured, grey shale		崖		1		9,69m: J55°, clay smear 9,78m: J, subvertical, rough		100		PL(A) = 0.4N

TYPE OF BORING: Solid flight auger to 4.0m; Rotary to 8,8m; NMLC-Coring to 11.45m WATER OBSERVATIONS: Free groundwater observed at 4.0m whilst augering

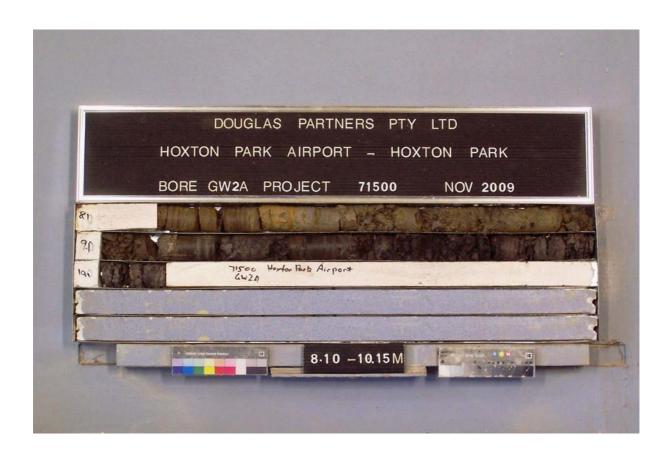
**CLIENT:** Mirvac Group PROJECT: Hoxton Park Airport

LOCATION: Cowpasture Road, Hoxton Park

0	0.6	topsoil with trace of fine grained sand and grass rootlets (possible topsoil)  FILLING - grey brown, silty clay		×				Α			PID<1ppm PID<1ppm
39	1		filling with some gravel, humid SILTY CLAY - stiff, light brown to red brown, silty clay with some ironstone gravel, damp to moist 1.0-1.5m: gravelly (ironstone) silty clay						S			PID<1ppm 6,6,7 N = 13 PID<1ppm
38		2,1	SILTY CLAY - stiff, light grey, silty clay, moist						S			3,7,7 N = 14 PID<1ppm
36	4	3.5	GRAVELLY SILTY CLAY - very stiff, brown, gravelly (ironstone) silty clay, moist to wet						s			5,8,11 N = 19 PID<1ppm
34 35	6	5.4	SILTY CLAY - very stiff, brown, silty clay with trace of fine grained sand and ironstone gravel, wet		2000				s			6,9,9 N = 18 PID<1ppm
33	7								s			7,8,10 N = 18 PID<1ppm
32	8	8.0 8.1 8.3	strength brown fine grained		\(\frac{1}{2} \\ \frac{1}{2} \\ \fra			8.16-8.23m: (x3) B0°- 10°, ironstained 8.3m: B10°, ironstained 8.3-9.15m: numerous drilling breaks				PL(A) = 0.8MPa

31	9		SILTSTONE - extremely low to very low strength, extremely to highly then slightly weathered, grey siltstone. Some low to medium strength bands  9.5-9.8m; carbonaceous shale					Note: Unless otherwise stated, rock is fractured along planar bedding planes dipping at 0°- 10° or joints	С	100	0	PL(A) = 0.3MPa PL(A) = 0.1MPa

TYPE OF BORING: Solid flight auger to 8.1m; NMLC-Coring to 10.15m WATER OBSERVATIONS: Free groundwater observed at 4.5m whilst augering

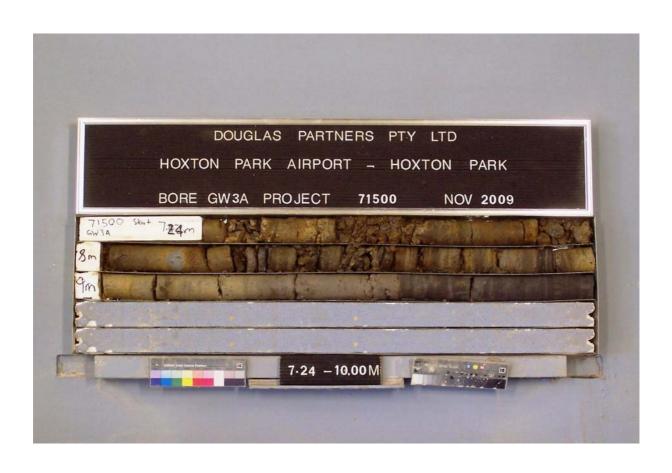
CLIENT: Mirvac Group PROJECT: Hoxton Park Airport

LOCATION: Cowpasture Road, Hoxton Park

D	Description	Deg	gree of	2	Rock Strength	Fracture	Discontinuities		_	_	In Situ Testing
Depth (m)	of		athering ≥ ≥ ∞ α	Log	Vate 19 19 A	Spacing (m)	B - Bedding J - Joint	Туре	ore c. %	RQD %	Test Results &
4	Strata	Ĭ ¥	M S S S	٤ ا	F Key Hald	0.05 0.10 1.00	S - Shear D - Drill Break	Ę	O &	άľ	Comments

0.05	BITUMINOUS CONCRETE	A ! !		77				Α			PID<1ppm
	ROADBASE GRAVEL	l i i	iii	1//	i i i i i i i i i i i i	ii ii					
	SILTY CLAY - stiff, brown silty clay moist	111	111	1/	[						
		l i i	iii	1/2	iiiiiii li	ii ii		Δ.			
F-1		1!!	111	1/		11 11	_	Α			5,6,9
		Hii	111	1/				s			N = 15

1.5	ODANELLY OUTVOLAN (III)	11	111	14	1111111	11 11					PID<1ppm
	GRAVELLY SILTY CLAY - stiff to very stiff, brown, gravelly	111	111	3							
2	(ironstone) silty clay with some fine	11 2 2	iii	Pare	: i i i i i i    i	ii ii					
	grained sand, moist	111	111	PX		11 11					
		1ii	iii	52	iiiiiii    i	ii ii

2.5	SILTY CLAY - very stiff, light grey	111	111	17			=				6,7,10
	and orange brown, silty clay with some fine grained sand and	lii	iii	1/	1 i i i i i i    i	ii ii		S			N = 17 PID<1ppm
3	ironstone gravel, moist	111	111	X		- !! !!					
		lii	iii	1/		ii ii					
		111	!!!	1/		11 11					
		H		1/							
8-4		l i i	111	1/		ii ii					
T"			111	1//		11 11		s			7,9,11 N = 20
<u> </u>		l i i	iii	1/	{	ii ii		3			PID<1ppm
ļ .		11	111	1/	1	11 11					
		1 i i	iii	W		ii ii					
5		111	111	1/		-					
		111	111	1/		ii ii					
		11	111	W		11 11					
		Hii	111	1/		11 11		s			6,9,11 N = 20
g-6		l i i	iii	1/	iiiiii 🔻	11 11					PID<1ppm
				1/		11 11					
		li i	iii	W		ii ii	Note: Unless otherwise				
		111	111	W	{		stated, rock is fractured along rough planar

7.24	strength, grey siltstone	ننه		+=	<u>                                   </u>	4	7 29m; DO ^o ironotoined				PID<1ppm PL(A) = 0.4MP
	SILTSTONE - low to medium strength, highly and highly to	4	1 1 1	_		11 11	7,28m: B0°, ironstained, 10mm clay				Invared to Secondaria
	moderately weathered, fractured to	111	111	-		11 (11)	7.28-7.64m: fragmented (D) in 0.01-0.05mm				
8	slightly fractured, grey brown siltstone. Some extremely low	HÌ	1.1.1			<u>-</u> ₩11	17.64m: J, subvertical	С	100	38	
	strength bands						7.9m: B0°, fragmented 8m: J50°, rough				
		П	i i i	-		l ii	8.21m: B20°, ironstained 8.21-8.73m: D,				PL(A) = 0.3MF

TYPE OF BORING: Solid flight auger to 7,24m; NMLC-Coring to 10.0m WATER OBSERVATIONS: Free groundwater observed at 6.0m

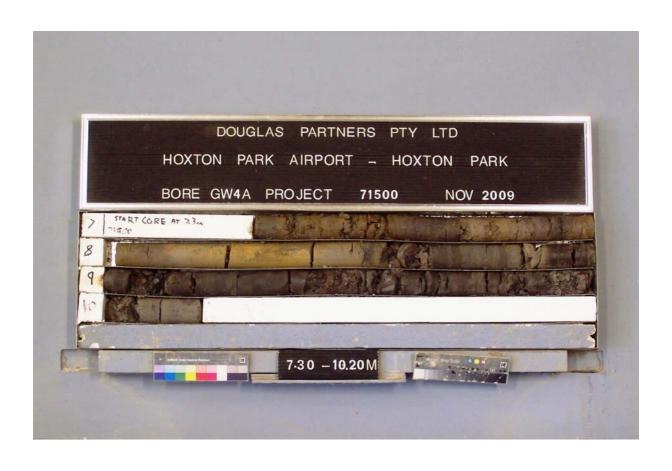
CLIENT: Mirvac Group

PROJECT: Hoxton Park Airport

Description	Degree of Weathering	ျို့	Rock Strength	Fracture	Discontinuities	_		_	In Situ Testing
Dep (m		of Strata	Weathering	Graph	Ex Low Very Low Medium Medium High Very High Ex High Ex High Ex High Obst	Spacing (m) 82 88	B - Bedding J - Joint S - Shear D - Drill Break	Туре	Core Rec. %	RQD %	Test Results & Comments
		FILLING - grey brown, silty clay topsoil with trace of gravel and grass rootlets, humid (possible topsoil)				11 11		A			PID<1ppm PID<1ppm
1	0.7-	FILLING - grey brown, silty clay and shale fragments filling, humid / SILTY CLAY - very stiff, mottled orange, grey and brown, silty clay with trace of ironstone gravel, moist		X / / / / / / / / / / / / / / / / / / /				S			PID<1ppm 8,8,10 N = 18 PID<1ppm
_3								s			5,8,10 N = 18 PID<1ppm
4	3,5-	SANDY CLAY - stiff to very stiff, light grey and orange brown, fine grained sandy clay, moist to wet				11 11 11 11 11 11 11 11 11 11 11 11		S			5,7,8 N = 15 PID<1ppm

-5								S			5,8,11 N = 19 PID<1ppm
	6.3	SHALE/SILTSTONE - extremely low to very low strength, grey shale/siltstone					Note: Unless otherwise stated, rock is fractured along rough planar bedding dipping at 0°- 10° or joints				12,20/80mm
8	7.3	SHALE/SILTSTONE - extremely low to very low strength, extremely to highly weathered, light grey brown, shale/siltstone					7.5m: J85°, smooth 7.5-7.57m: fragmented in 0.01mm intervals 7.73m: B0°, clay band	C	100	0	refusal — PID<1ppm
9	8,53	SHALE - low to medium and medium strength, slightly weathered, slightly fractured, grey shale with extremely low strength bands					8.65m: B0°, 10mm clay 8.9m: B0°, 20mm clay & \J70° smooth 9.05m: B0°, 50mm crushed rock	С	100	90	PL(A) = 0.3MF
	9,8	9.55-9.60m: very high strength siltstone band					9.41m: B5°, 120mm crushed rock 9.65m: B0°, 5mm clay 9.83m: B0°, clay smear	С	100	43	PL(A) = 0.4MF

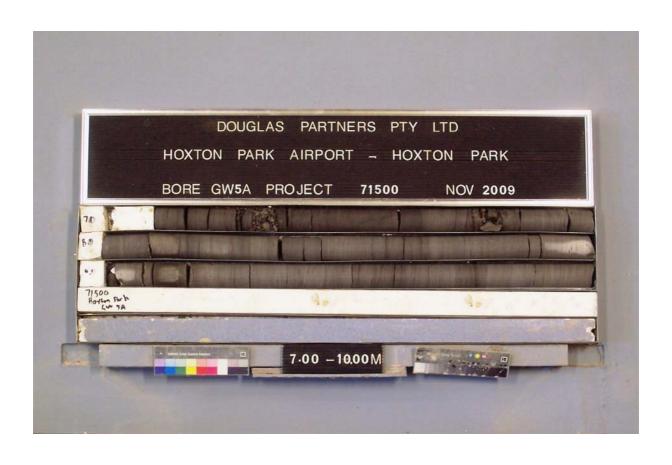
CLIENT: Mirvac Group

PROJECT: Hoxton Park Airport

-							
	Description	Degree of Weathering	ပ	Rock Strength		Fracture	Discontinuities	Sa	mpling &	In Situ Testing
Depth (m)	of	l rounioning	aph		ate	Spacing (m)	B - Bedding J - Joint	e e	e % □ °	Test Results
(,	Strata	TR SW HW	Ō	Strength  Strength  Wedigin  Wedigin  Wedy High  Kery High  Kery High  Kery High  Kery High  Kery High  Kery High  Kery High  Kery High  Kery High  Kery High  Kery High  Kery High  Kery High  Kery High  Kery High  Kery High  Kery High  Kery High  Kery High  Kery High  Kery High  Kery High  Kery High  Kery High  Kery High  Kery High  Kery High  Kery High  Kery High  Kery High  Kery High  Kery High  Kery High  Kery High  Kery High  Kery High  Kery High  Kery High  Kery High  Kery High  Kery High  Kery High  Kery High  Kery High  Kery High  Kery High  Kery High  Kery High  Kery High  Kery High  Kery High  Kery High  Kery High  Kery High  Kery High  Kery High  Kery High  Kery High  Kery High  Kery High  Kery High  Kery High  Kery High  Kery High  Kery High  Kery High  Kery High  Kery High  Kery High  Kery High  Kery High  Kery High  Kery High  Kery High  Kery High  Kery High  Kery High  Kery High  Kery High  Kery High  Kery High  Kery High  Kery High  Kery High  Kery High  Kery High  Kery High  Kery High  Kery High  Kery High  Kery High  Kery High  Kery High  Kery High  Kery High  Kery High  Kery High  Kery High  Kery High  Kery High  Kery High  Kery High  Kery High  Kery High  Kery High  Kery High  Kery High  Kery High  Kery High  Kery High  Kery High  Kery High  Kery High  Kery High  Kery High  Kery High  Kery High  Kery High  Kery High  Kery High  Kery High  Kery High  Kery High  Kery High  Kery High  Kery High  Kery High  Kery High  Kery High  Kery High  Kery High  Kery High  Kery High  Kery High  Kery High  Kery High  Kery High  Kery High  Kery High  Kery High  Kery High  Kery High  Kery High  Kery High  Kery High  Kery High  Kery High  Kery High  Kery High  Kery High  Kery High  Kery High  Kery High  Kery High  Kery High  Kery High  Kery High  Kery High  Kery High  Kery High  Kery High  Kery High  Kery High  Kery High  Kery High  Kery High  Kery High  Kery High  Kery High  Kery High  Kery High  Kery High  Kery High  Kery High  Kery High  Kery High  Kery High  Kery High  Kery High  Kery High  Kery High  Kery H	5		S - Shear D - Drill Break	Туре	Core Rec. % RQD %	& Comments

0.3	FILLING - grey brown, silty clay and shale fragments filling, with \some grass rootlets		$\bigotimes$					Α		PID<1ppm
	SILTY CLAY - stiff, brown to red brown, silty clay with trace of fine							Α		PID<1ppm
-1	grained sand, moist							Α		PID<1ppm
								S		4,5,7 N = 12 PID<1ppm
2 2.0	SILTY CLAY - stiff, grey silty clay, moist to wet									
		11111						S		5,6,6 N = 12
3										PID<1ppm

3.7	CLAYEY SAND - loose, brown, fine grained, clayey sand, wet						6			
-4								s		2,3,4 N = 7 PID<1ppm
-5 5.0	SILTSTONE - extremely low to	11111			¥					
	very low strength, grey brown siltstone		=							
6								S		12,17,26 N = 43 PID<1ppm
0						N 115050 11111 1	Note: Unless otherwise stated, rock is fractured along rough planar bedding dipping at 0°- 10° or joints			
7 74							ro or joints	S		30/100mm refusal

7.1	SANDSTONE - high then high to very high strength, fresh, slightly fractured and unbroken, light grey, fine grained sandstone with some siltstone laminations and bands						7.27m: B0°, 10mm crushed rock 7.3m: B0°, 50mm crushed rock			PID<1ppm PL(A) = 2.5MF
8	Sustaine laminations and ballus						7.76m: B0°, clay veneer 7.78m: J, subvertical			PL(A) = 3.2MF
								С		
9							9,08m; B0°, 10mm clay 9,18m; B0°, clay veneer			PL(A) = 5.5MI

TYPE OF BORING: Solid flight auger to 7.1m; NMLC-Coring to 10.0m WATER OBSERVATIONS: Free groundwater observed at 4.5m whilst augering

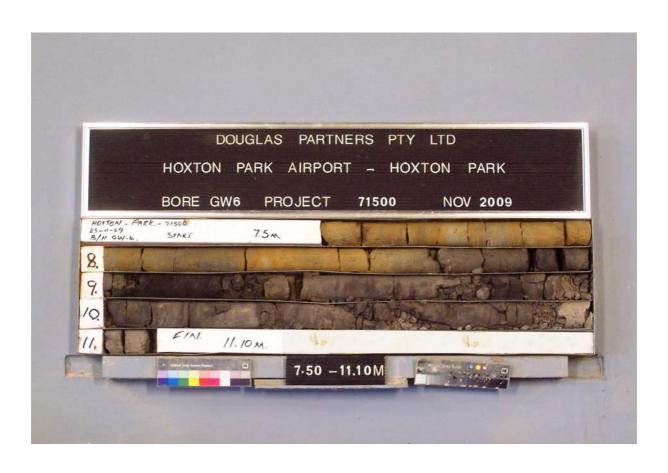
CLIENT: Mirvac Group PROJECT: Hoxton Park Airport

N:	Cowpasture Road, Hoxto	on Park		DIP/AZIMUTH	6245350 : 90°/	SHEET 1 OF 2	
	Description	Degree of	Rock	Fracture	Discontinuities	Sampling & In Situ	T

Dept	, l	Description	Degree of Weathering	Dic -	Rock Strength	5	Fracture Spacing	Discontinuities	Sa	-		In Situ Testin
(m)		of Strata	Degree of Weathering	Graph	Ex Low Very Low Medium High Ex High	Water	(m)	B - Bedding J - Joint S - Shear D - Drill Break	Туре	Core	RQD %	Test Result & Comments
0	.02	ROADBASE GRAVEL - with some	111111	X	111111	1	11 11		E/A			PID<1ppm
		sand and clay  FILLING - brown and red brown, silty clay filling, humid to damp		$\bigotimes$		i			E/A			PID<1ppm
1	0.9	SILTY CLAY - stiff, grey brown and brown, silty clay, damp to moist				111111111111111111111111111111111111111	11 11 11 11 11 11 11 11 11 11		E/A S			PID<1ppm 3,4,6 N = 10 PID<1ppm
2	2.1	CLAY - firm, brown clay, wet							E			PID<1ppm 2,2,2
3	3,1	CLAY - very stiff, light brown clay with some ironstone gravel, wet				Ţ			S	-		N = 4 PID<1ppm
4									S			2,9,16 N = 25
5	4.7	GRAVELLY CLAY - very stiff to hard, red brown, gravelly (ironstone) clay, moist		2000					s			9,13,17

6								Note: Unless otherwise stated, rock is fractured	5			N = 30
7	7.5					i		along rough planar bedding dipping at 0°- 10° or joints				
8	7.5	SILTSTONE - extremely low to very low strength, extremely to highly weathered, light grey, orange brown siltstone with a low to medium strength band at 7.85 to 8.0m						7,75m: B0°, ironstained	С	100	0	PL(A) = 0.3M
9	3.7	SHALE - very low strength, highly weathered, grey to dark grey, shale with a carbonaceous shale band from 9.02m to 9.3m						9.02m: J75°, rough				PL(A) = 0.1M
9	9.7	SHALE - description next page				1		9.3m: J, subvertical 9.7-10.10m: J85°, rough	С	100	66

WATER OBSERVATIONS: Free groundwater observed at 3.1m whilst augering

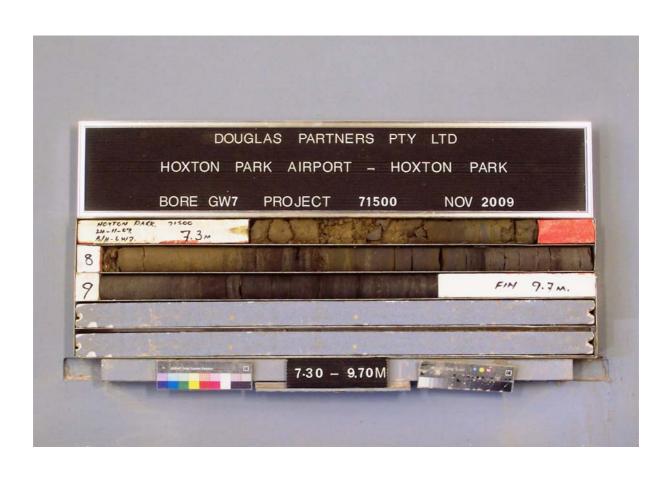
CLIENT: Mirvac Group

PROJECT: Hoxton Park Airport

l D	onth	Description	Degree of Weathering 을	Rock Strength	Fracture Spacing	Discontinuities	Sa			In Situ Testing
	epth (m)	of Strata	Degree of Weathering Order	Ex Low Low Strength Medium High Sx High Sx High Water	(m)	B - Bedding J - Joint S - Shear D - Drill Break	Type	Core	Rab %	Test Results
ě	0.3-	FILLING - light brown, gravelly clay filling with trace of grass rootlets CLAY - firm to stiff, light grey clay, humid	m T T O T T				A/E			PID<1ppm PID<1ppm
1	4.5						A/E S			PID<1ppm 3,5,4 N = 9
-2	1.5	CLAY - very stiff, red brown then light grey brown, clay with some fine ironstone gravel, wet		¥						
-3							S			PID<1ppm 4,8,11 N = 19
4	3.8-	GRAVELLY CLAY - hard, red brown and brown, gravelly (ironstone) clay, wet					s			8,12,20
-5										N = 32
6			6			Note: Unless otherwise stated, rock is fractured	S			15,17,20 N = 37
7	6.8	SILTSTONE - extremely low strength, light grey brown siltstone	.           <u>                           </u>			along rough planar bedding dipping at 0°- 10° or joints

-8	7.3	SILTSTONE - extremely low to very low strength, highly to moderately weathered, light grey, yellow brown, siltstone with a low strength band from 7.6m to 7.9m				7.6m: B0°, ironstained 7.6-7.9m: (x3) B0°- 10°, ironstained 7.9m: CORE LOSS:				PL(A) = 0.2MF
-9		SHALE - low to medium then medium strength, slightly weathered, slightly fractured, light grey to dark grey shale				100mm 8.31-8.44m: (x2) B0°, clay smear 8.66m: J45°, smooth	С	96	71	PL(A) = 0.3MI PL(A) = 0.3MI

TYPE OF BORING: Solid flight auger to 4.0m; Rotary to 7.3m; NMLC-Coring to 9.7m WATER OBSERVATIONS: Free groundwater observed at 2.0m whilst augering

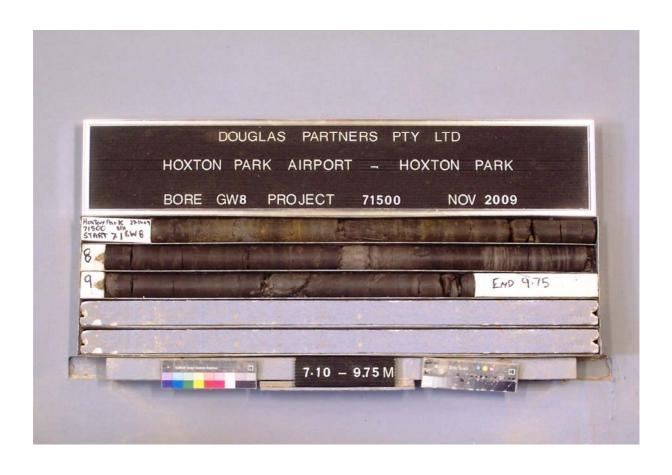
CLIENT: Mirvac Group PROJECT: Hoxton Park Airport

LOCATION: Cowpasture Road, Hoxton Park

Description	Degree of	္ပ	Rock Strength	Fracture	Discontinuities	Sa	mpli	ng &	In Situ Testing
R		epth (m)	of	Weathering	raph	Strength Strength Nate Nate Nate Nate Nate Nate Nate Nate	Spacing (m)	B - Bedding J - Joint	e e	و م %	٥.	Test Results
		` .	Strata	WH W W W W W	Ō	Medicine New Long Long Long Long Long Long Long Long		S - Shear D - Drill Break	Type	လို လိ	RQD %	& Comments
43		8.0	SILTY CLAY - grey brown, silty clay with some gravel and trace of grass rootlets, humid (possible topsoil)  SILTY CLAY - stiff to very stiff,				11 11 11 11 11 11 11 11 11 11		A A*			PID<1ppm PID<1ppm
42	-1		mottled orange, light grey, silty clay with some ironstone gravel, moist						s			
41	-3	2,5	SANDY CLAY - firm to stiff, orange brown and light grey, fine grained sandy clay with trace of silt and ironstone gravel, wet						s			
39 40	-4	4.5	brown, gravelly (ironstone) silty			▼			s			
38	-5		clay, wet						A S			PID<1ppm

37	7	7.0	¬ SHALE - very low strength, grey					Note: Unless otherwise stated, rock is fractured along rough planar bedding dipping 0°- 10° or joints	•			
36			\shale SHALE - low strength, moderately to slightly weathered, slightly fractured, grey brown shale				11 11	7.48m: B0°, clay smear	(8)			PL(A) = 0.2MPa
	-8	7,85	SILTSTONE - medium strength, slightly weathered and fresh, fractured to slightly fractured, grey siltstone					8.05m: B0°, slightly ironstained 8.29m: B0°, 2mm carbonaceous laminations	С	100	81	PL(A) = 0.5MPa PL(A) = 0.6MPa
34 35	9	0.75	8.75-9.0m: low strength band					8.48m: B0°- 5°, 50mm clay band 8.55m: J70°, smooth 8.7m: B0°, clay smear 8.76-9.0m: B (numerous) 0°, clay smear 9.33m: B0°, clayey				PL(A) = 0.4MPa
E		9.75	Bore discontinued at 9.75m	11111		TIT'III	Tii	9.4-9.55m: (x2) J25°- 30°. rough

TYPE OF BORING: Solid flight auger to 7.1m; NMLC-Coring to 9.75m WATER OBSERVATIONS: Free groundwater observed at 4.0m whilst augering
