APPENDIX B

Notes Relating to this Report
Test Pit Logs (TP 1-89)
Borehole Logs (BH 101-112)

NOTES RELATING TO THIS REPORT

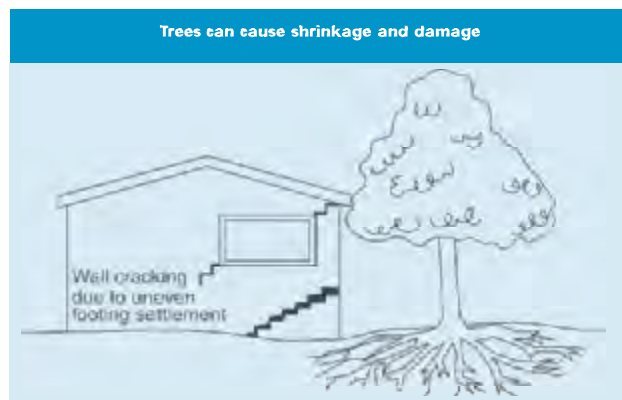
As the moisture absorption process completes its journey to the innermost areas of the building, the internal footings will rise. If the spread of moisture is roughly even, it may be that the symptoms will temporarily disappear, but it is more likely that swelling will be uneven, creating a difference rather than a disappearance in symptoms. In buildings with timber flooring supported by bearers and joists, the isolated piers will rise more easily than the strip footings or piers under walls, creating noticeable doming of flooring.

As the weather pattern changes and the soil begins to dry out, the external footings will be first affected, beginning with the locations where the sun's effect is strongest. This has the effect of lowering the external footings. The doming is accentuated and cracking reduces or disappears where it occurred because of dishing, but other cracks open up. The roof lines may become convex.

The first noticeable symptom may be that the floor appears slightly dished. This is often accompanied by some doors binding on the floor or the door head, together with some cracking of cornice mitres. In buildings with timber flooring supported by bearers and joists, the floor can be bouncy. Externally there may be visible dishing of the hip or ridge lines.

Doming and dishing are also affected by weather in other ways. In areas where warm, wet summers and cooler dry winters prevail, water migration tends to be toward the interior and doming will be accentuated, whereas where summers are dry and winters are cold and wet, migration tends to be toward the exterior and the underlying propensity is toward dishing.
