2.5 Site History and Elements

2.5.3 History of Construction

## 2.5.5 History of Setting

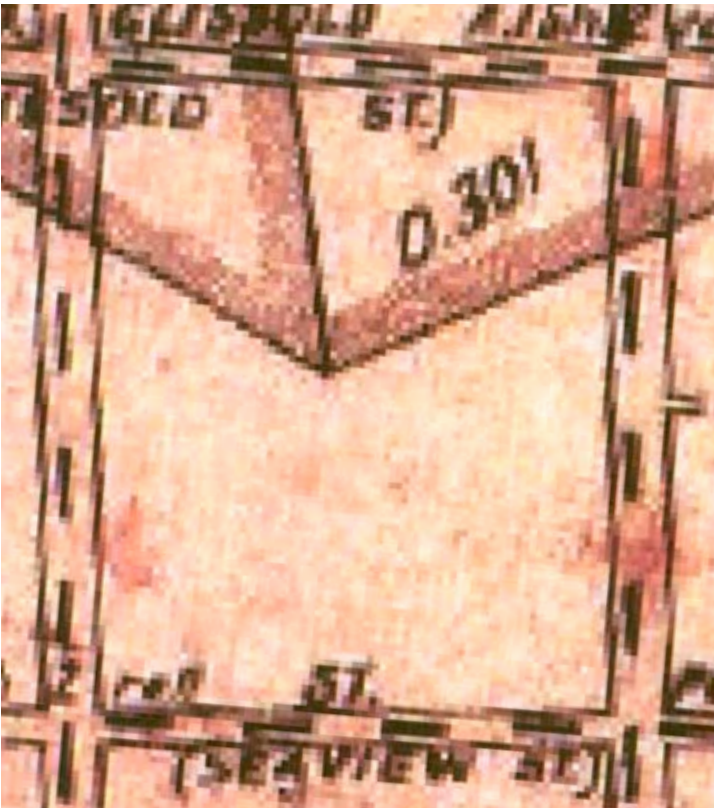
**Figure 2.5.1a**  
C1800s Streets laid out over existing subdivisions. Note the irregular lot lines that are likely to have followed the natural topography of the ridge (east-west) and creek line/natural shallow gully (north-south).

By 1894, the site was located within the crown grant areas of three separate owners (Patterson, Miller and Clepham) (Figure 2.5.1a).

It is likely that this grant pattern was consistent with the topography following a line of contours and a possible water course that may have run (intermittantly) through the centre of the site.

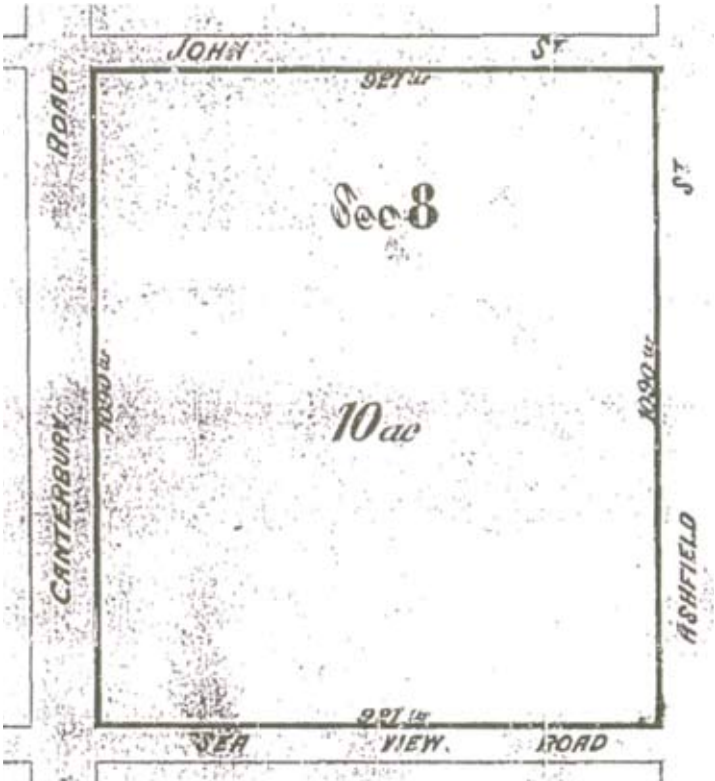
**Figure 2.5.1b**  
C 1860s Previous lots were amalgamated by the Cambell family. The original 10 acre subdivision has now occurred. Clissold Street appears to have had a name change during this time to be John Street.

By 1860, the site formed part of an amalgamation of land by a single owner (Cambell) which enabled a regularised future lot subdivision (Figure 2.5.1b).

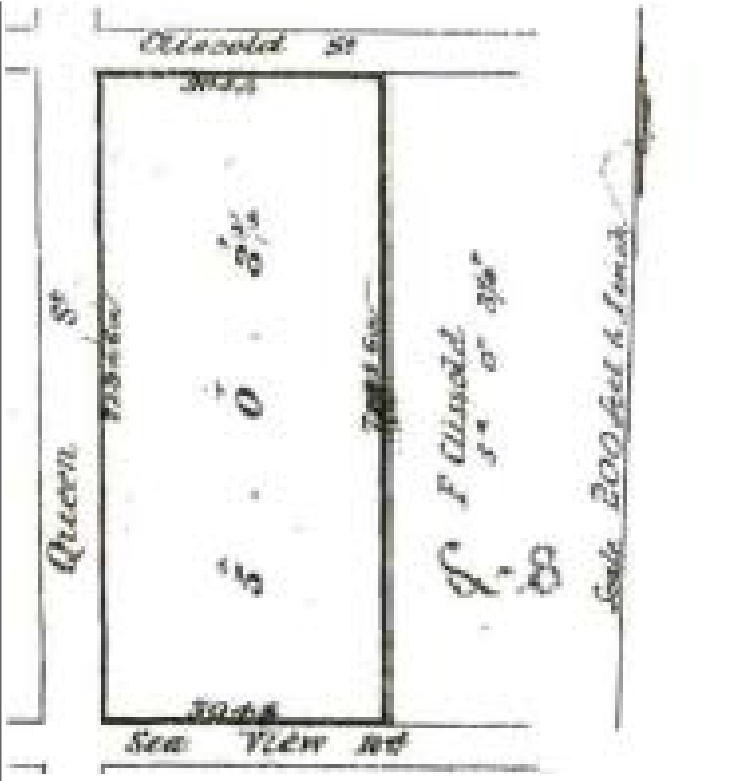
**Figure 2.5.1c**  
C1885 further subdivision of the Bellevue site (Queen Street) and Clissold Street retains its original name.

In 1880, the block was further subdivided into two 5 acre lots which eventually were owned by Clissold and Seaward (Figure 2.5.1c).

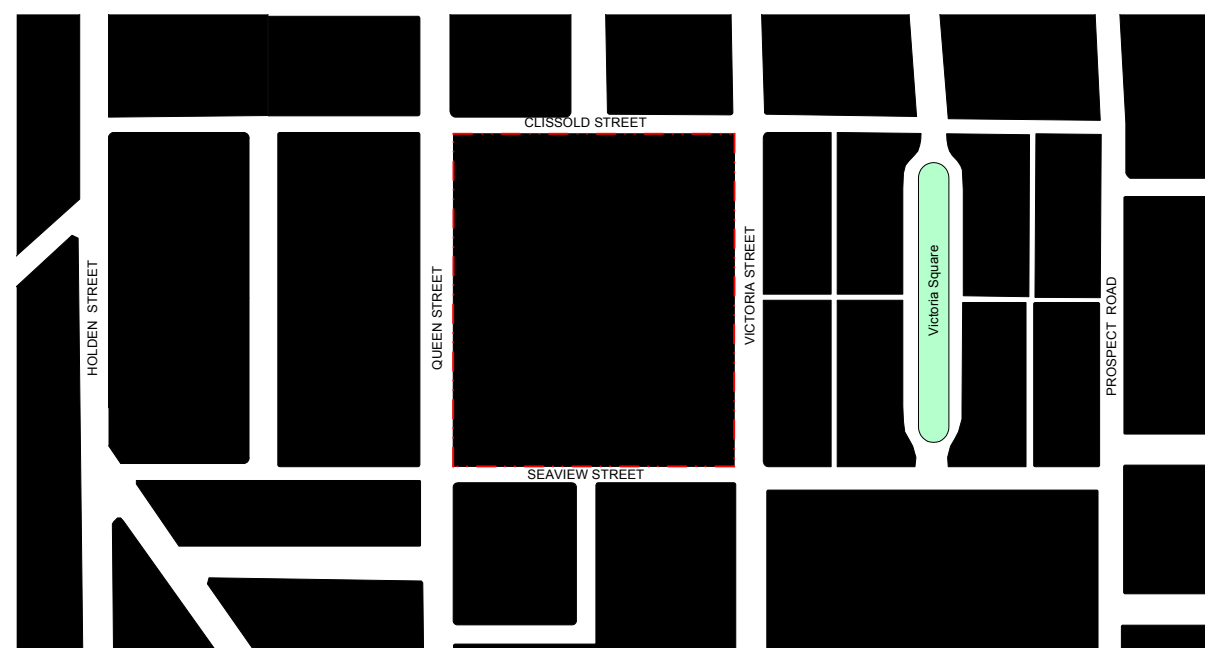
**Figure 2.5.2a**  
Block structure in the later 1800s showing the Cardinal Freeman Village site at the centre of a three-block group of blocks of equal size and varying permeability.

The Cardinal Freeman village block can be seen as the centre piece of a subdivision in the late 1800s that provided an urban structure of three distinct, square-shaped blocks each of approximately 4 hectares (10 acres) (Figure 2.5.2a).

Indeed this structure reflects the historic development of the site as can be seen in Figures 2.5.2a and Figures 2.5.4a to 2.5.4c (left) and has much in common with great urban traditions such as the Roman town or the Georgian square.

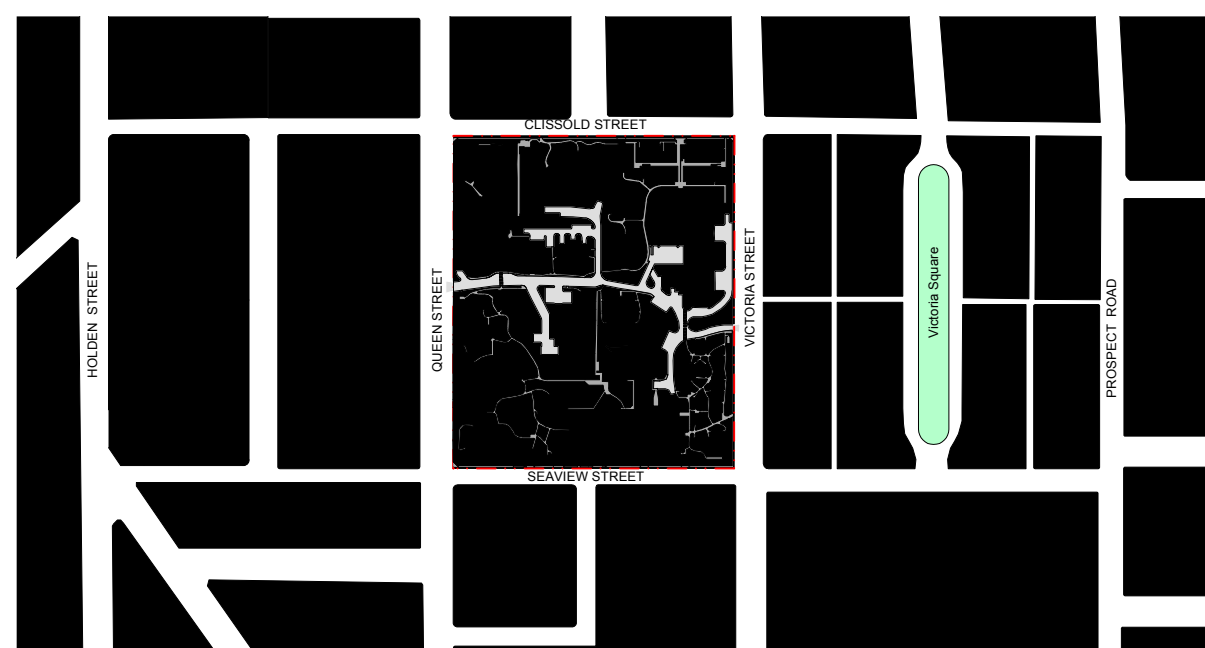
**Figure 2.5.2b**  
Block structure in the 1980s following the construction of the aged care villas and hostel. The meandering route does not encourage the public use of the connection.

In 1978, (Figure 2.5.2b) the Hibernian Society formalised an east-west through-block connection through the Cardinal Freeman site. It was a somewhat meandering route for vehicular traffic that extended the existing formal entry to Glentworth House on Victoria Street to connect with Queen Street. While accessible to the public, it is an internal, private road and its poor sightlines do not invite public access.

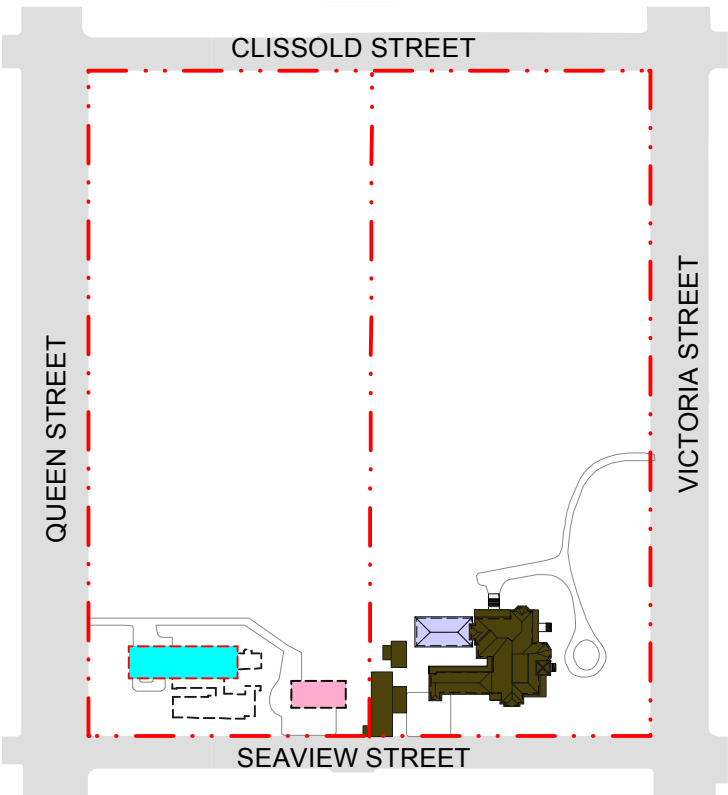
Figure 2.5.3d  
1919 The first Chapel. Lightweight construction and directly abutting Glentworth House.

In 1919, the Sisters embarked on another building project. This time to construct a new chapel with sufficient space to house both the nuns and the girls.

This was located immediately to the west of Glentworth House and appears to have directly abutted the original house. This began a pattern of alteration and addition to Glentworth House which kept the original house intact while make significant changes to the functioning and facilities on the site.

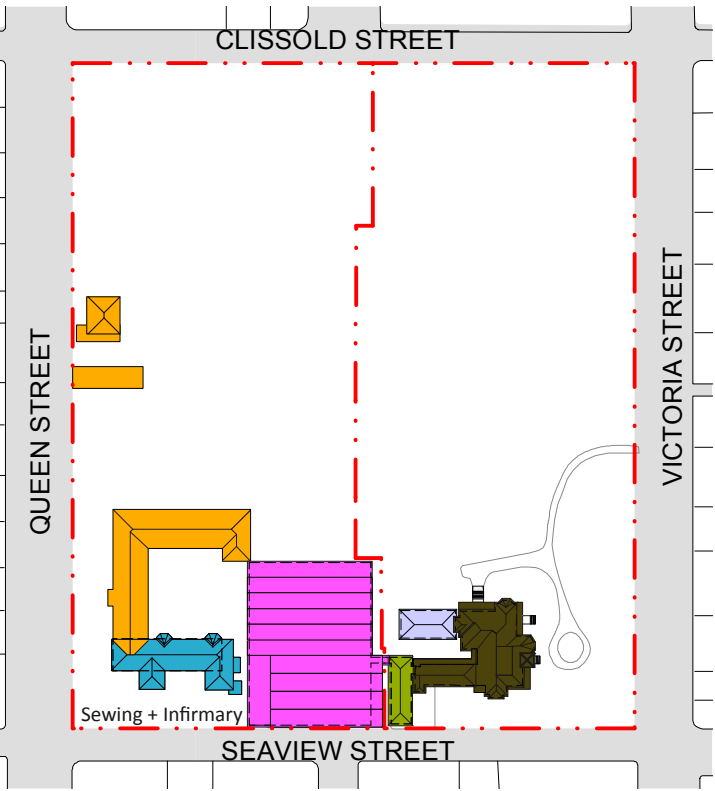
Figure 2.5.3h  
1937 The Infirmary and Sewing wing replace the original dormitory wing.

The original dormitory was demolished to make way for a new sewing and infirmary wing.

This was to be located on the site of the original Bellevue home and directly abutted the College building.

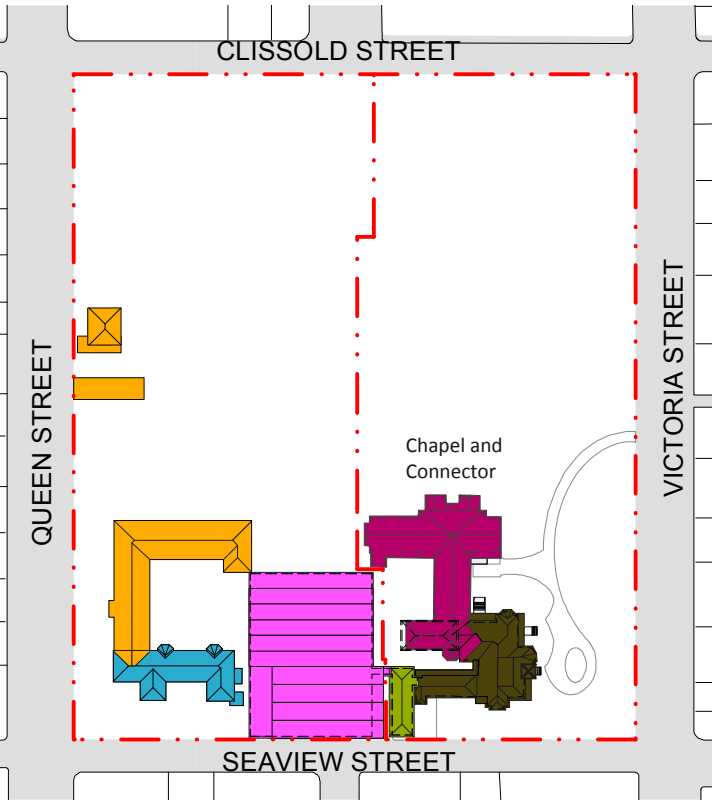
Figure 2.5.3i  
1941 the new Chapel and connector building abut Glentworth House.

The Chapel and Connector building were constructed from 1941 to 1943. The original Chapel was demolished and the masonry Connector built in its place directly abutting Glentworth House.

The Chapel abutted both the Connector piece and Glentworth House at its north west corner providing a magestic scale along the northern facade.

The importance of the alignment of the northern facade is clearly evident in the design of the Chapel. Glentworth House provided the driving architectural principles with the height datum of its eaves and its cornice detail that was continued around the Chapel. The resolution of disparate architectural styles, function and massing demonstrates a high level of skill.

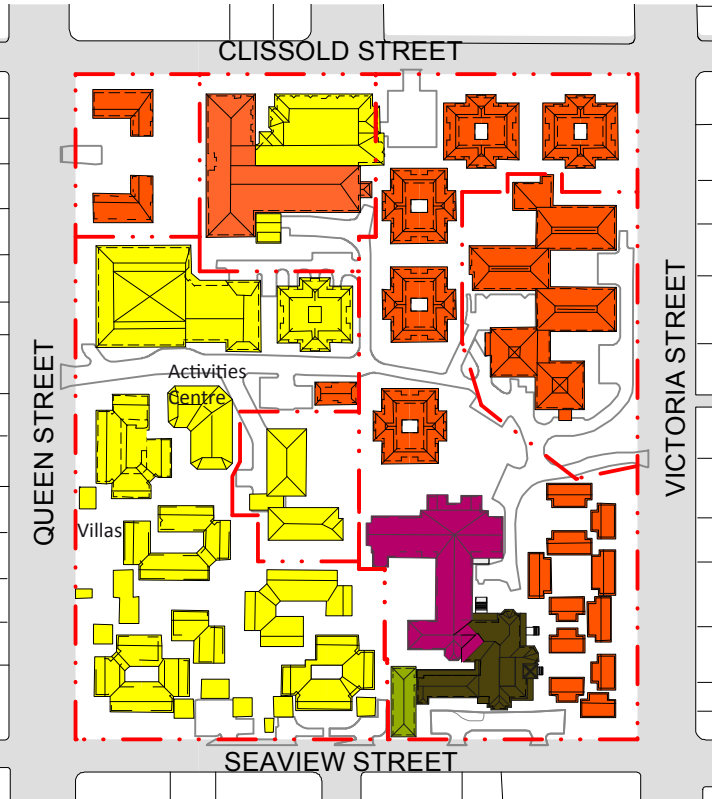
**Figure 2.5.3k**  
1990s completion of the Villa and Hostel development results in the urban, architectural and spatial isolation of Glentworth House and the Chapel.

Stage 2 of the Villa construction occurred during the late 1980s and early 1990s. Again this further destroyed the character of the site. These building footprints now form the current site lay-out.

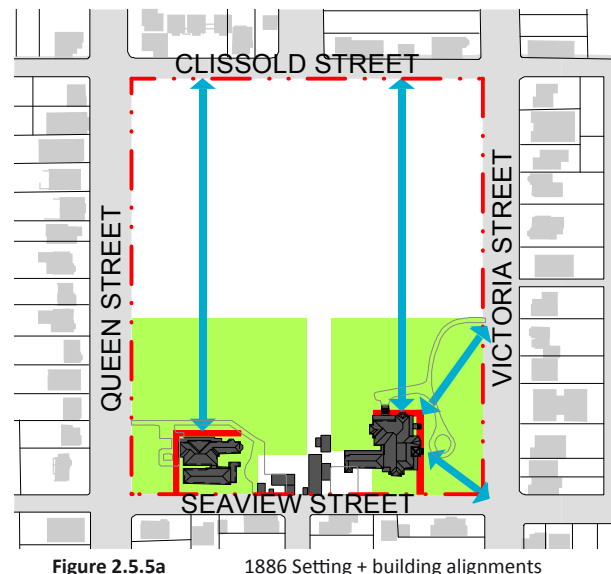
Figure 2.5.5a 1886 Setting + building alignments

In 1886, the original buildings, Bellevue and Glentworth House, were located within extensive domestic gardens and would have been clearly visible from Victoria Street, Queen Street, Seaview Street and Clissold Street because of their location on the highest points of the site.

Also important were the building alignments in relation to the setting. The dominant elevations were to the north and to their respective street addresses - Queen Street to the west for Bellevue and Victoria Street to the east of Glentworth House.

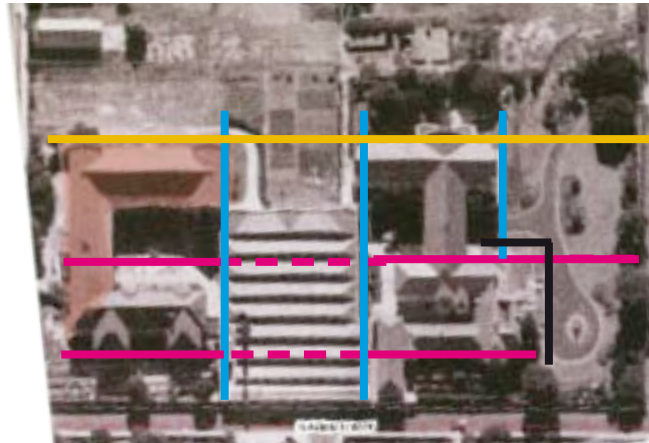
**Figure 2.5.6a**  
1940s aerial view of the site. The common datum of building lines demonstrates the emphasis of the northern facades in their relationship to the setting.

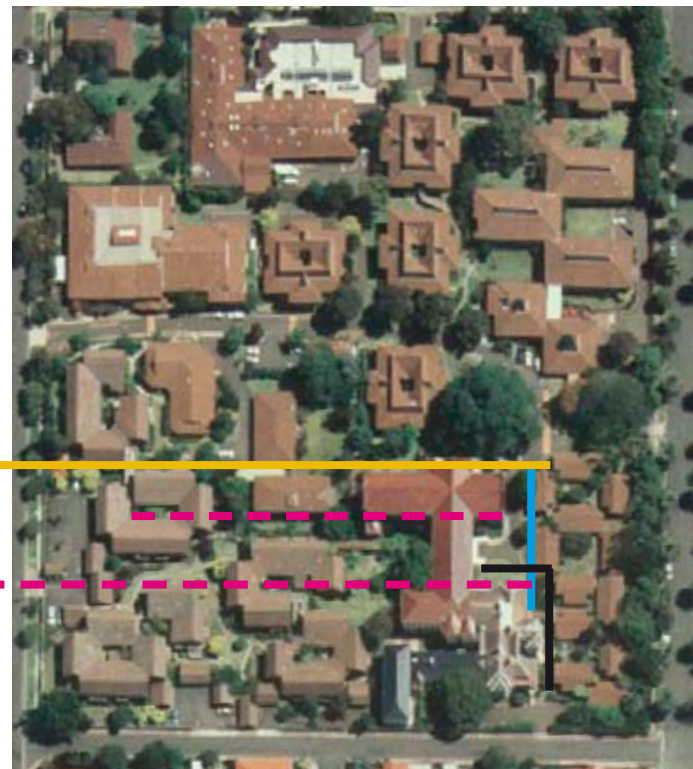
**Figure 2.5.6b**  
2008 aerial view of the site. Although the placement of buildings appears somewhat random, there is still a clear datum of the northern building line of the chapel that is used as a reference point.

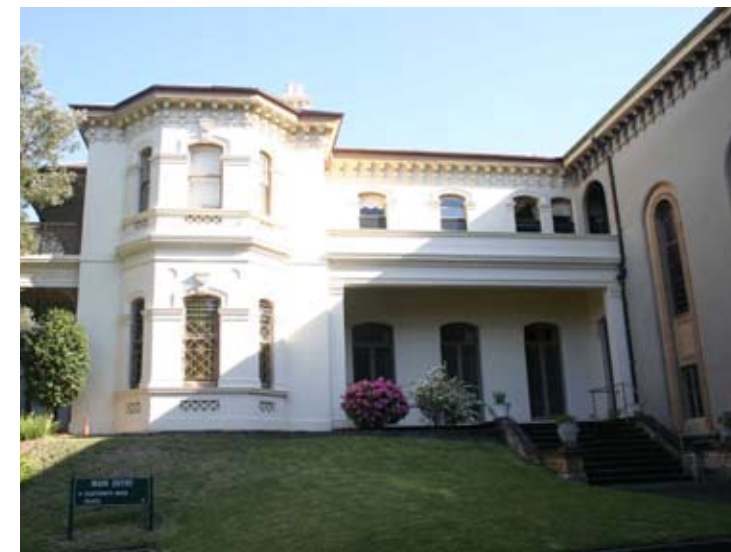
**Figure 2.5.6c**  
View of Glentworth House at the junction of the Chapel addition. Note the height datum of eaves and eaves detail of Glentworth House has been continued around the Chapel. There has been no attempt to disengage the Chapel from the building fabric of the House. Quite the contrary, where distinct architectural styles communicate a meaningful and clear connection between the two.

The original embankment which has the effect of siting the house on a podium remains substantially intact.
