## **2.8 Layout of Grounds, Carriageways, Paths, Fencing, Perimeter Walls & Ancillary Buildings**

## 2.9 Summary Overview of Site Development and of Documented Changes

### 3.6 Condition and Integrity of Heritage Buildings

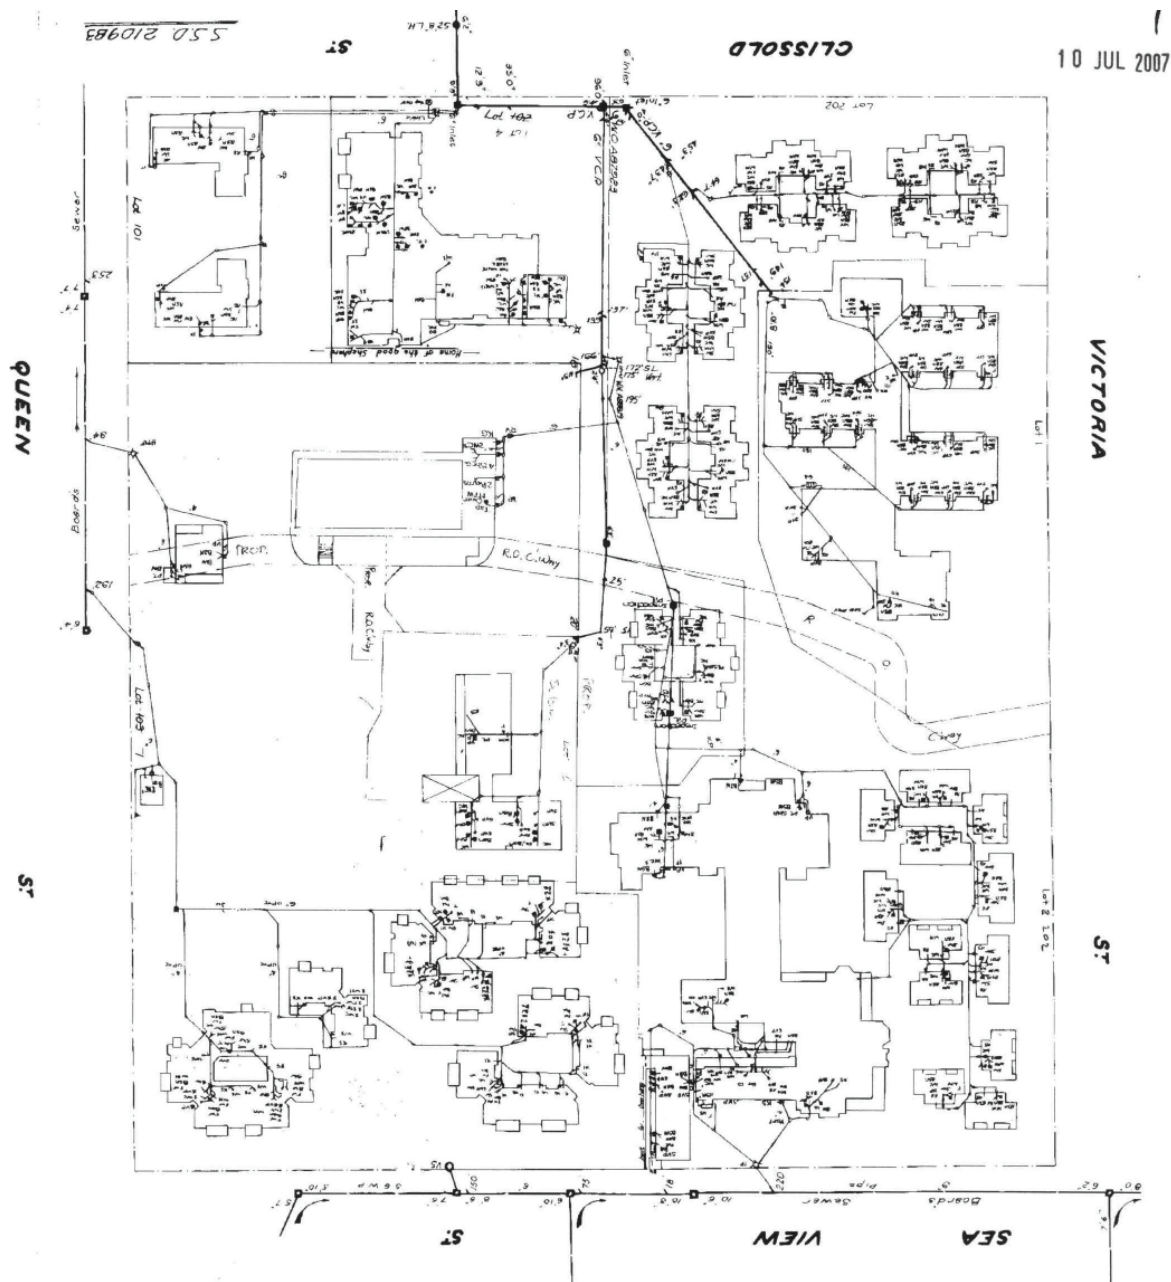
Figure 2.7.6  
Water Board survey of the Cardinal Freeman Village site in 1985, showing the extent of new development across the property for the retirement village  
(Sydney Water Board SRS 28, 1985)

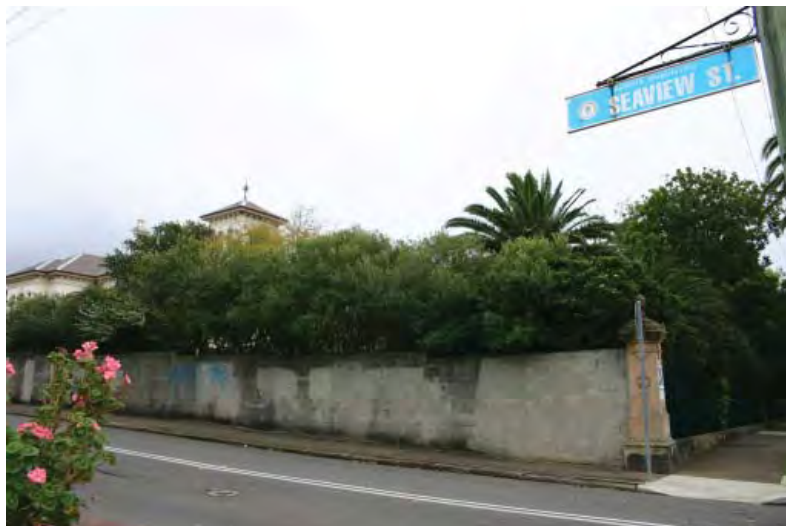
Figure 3.3.4  
View at the corner of Victoria and Seaview Streets, where the palisade fencing meets the solid masonry wall. It is likely that this solid wall was introduced after 1913 as a cloister wall for the Convent, and it is likely that prior to that time the palisade fencing continued along this Seaview Road aspect.

After 1913 that part of the property became a convent enclosure for a semi-enclosed religious order. It is speculative, but reasonable to propose that the high masonry wall along Seaview Street at this southeast corner of the property may therefore be a replacement for earlier palisade fencing.

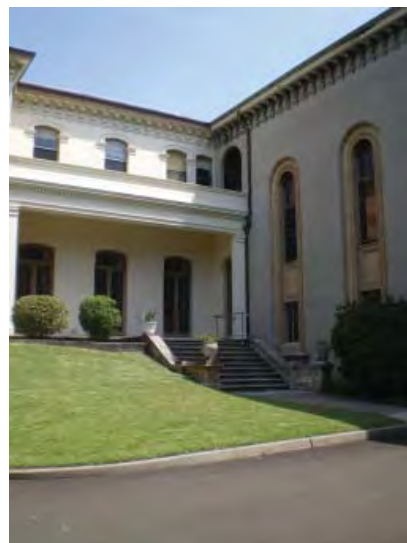
Figure 3.4.1  
Typical example of the manner in which various components of the buildings meet in a relatively seamless manner. Note especially the eaves lines and detail replication, and understated Chapel fenestration

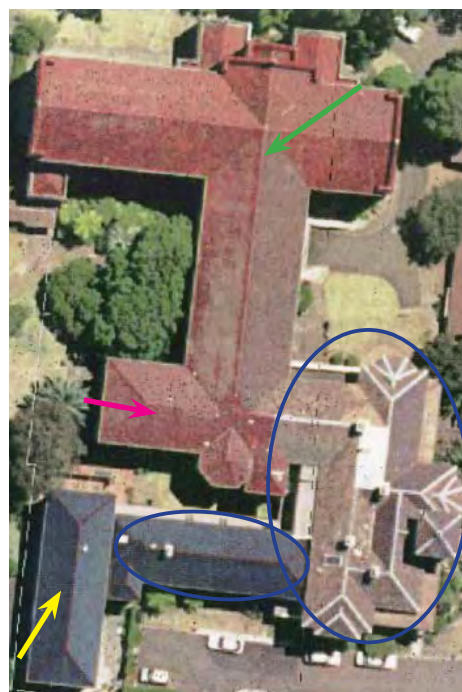
Figure 3.4.2  
Aerial view of the heritage footprint showing:  
The original components of *Glentworth House* as circled with the blue ovals; the 1935 extension, as indicated by the yellow arrow; the 1941 Convent extension, as indicated by the red arrow; and the 1941 Chapel, as indicated by the green arrow  
(Source: NSW Department of Lands SIX Viewer 2008)

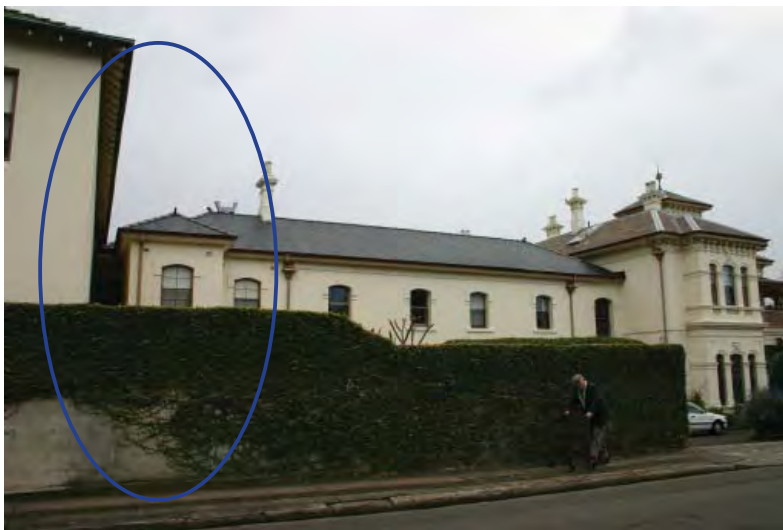
Figure 3.4.4  
The original *Glentworth House* had a number of relatively seamless additions as well as a re-slating of the west wing. The nibbed section of the building indicated within the blue oval, the annexed Parlours building to the left and the stairway section between the two buildings were all built between 1935 and 1943. It seems apparent that the upper floor of the west wing was until that time slightly shorter.

*Glentworth House* itself evidences slate tiling that is consistent with its age, except for its rear wing, extending to the west. This wing had some modification at its far west end between 1935 and 1943. It is likely that it was re-clad, consistent with the construction of the additional north-south wing (1935), to which it was subsequently attached. The slate tiling and the ridge capping over this now 'L' shaped component of the building presents as consistent. The eaves treatment generally presents as being highly detailed and with high quality componentry in the guttering and downpipes. As can be noted from the accompanying image, the entire presentation is harmonised by an interesting use of articulations and hipped formations. The most prominent feature of the early residence is the tower, with spire at the top, which can be viewed from various points in the local area and which in turn commands extensive views over the greater city. The roof line is also characterised by well profiled chimney stands and pots.

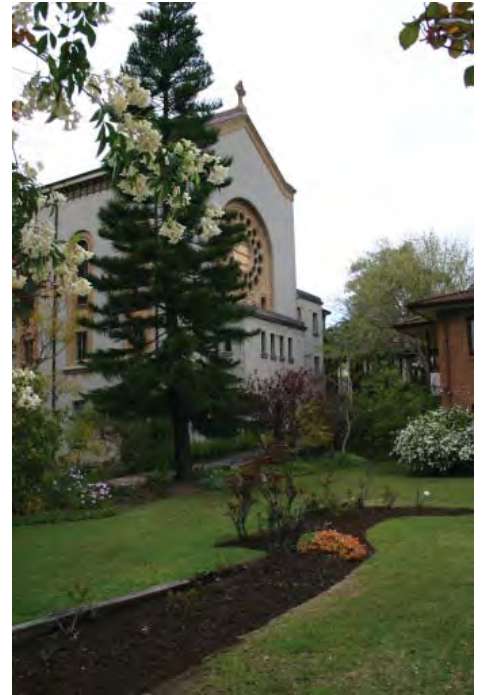
Figure 3.4.3  
The Chapel is gabled with parapets formed with synthetic stone. The wheel windows and enframing of the tall round-headed windows are also formed of moulded synthetic stone

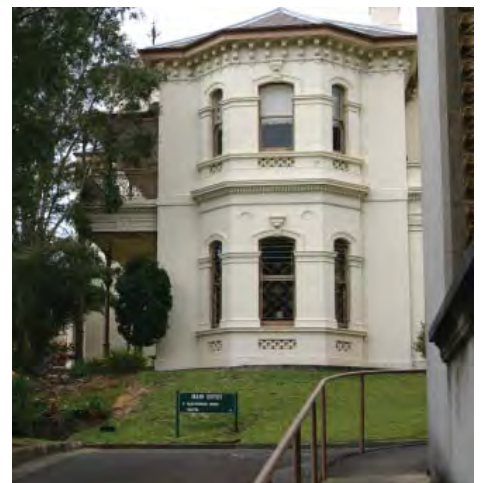
Figure 3.4.5  
The principal formal areas of *Glentworth House* present with faceted bays bracketed eaves robust stucco and delicate iron lacework. The dwelling is set proud on mounded earthworks that facilitate the use of formal stairway entrances

The earliest component (*Glentworth House*) is characterised by its double storey verandahs, with their restrained lace friezes and columns-work. There are ample but restrained stucco mouldings variously featured, and especially on the portico under the tower. Massive capitals present above the double pilaster columns leading to the dentils of the entablature. The fenestration is generous, of quality construction, and geometrically proportioned in the classic Georgian manner, and this is the template for the whole built composition over the 60 years of evolution. There is a fine classical entrance with a Georgian circular fanlight and the name 'Glentworth' is etched in the glass. The side-lights are also glass etched. This exterior presentation is complemented by garden spaces in undulating levels.

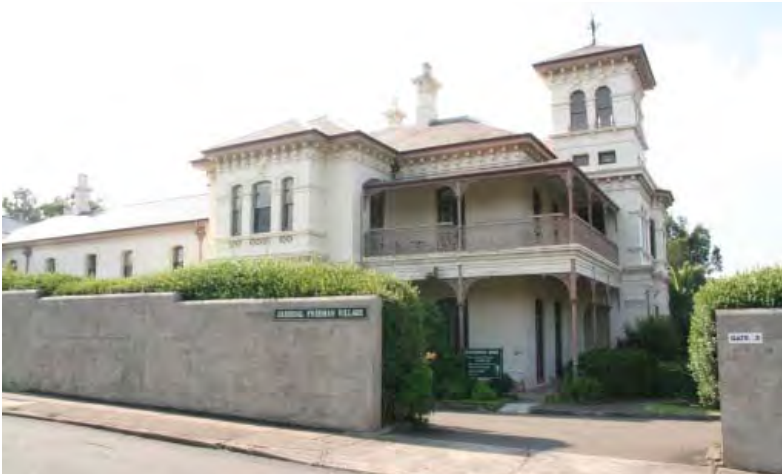
Figure 3.4.6  
View at the south east corner of *Glentworth House* displaying the multiple features of the Victorian *Italianate* style, including the tower. The masonry wall in the foreground was likely built after 1913 for the cloistered area of the Convent

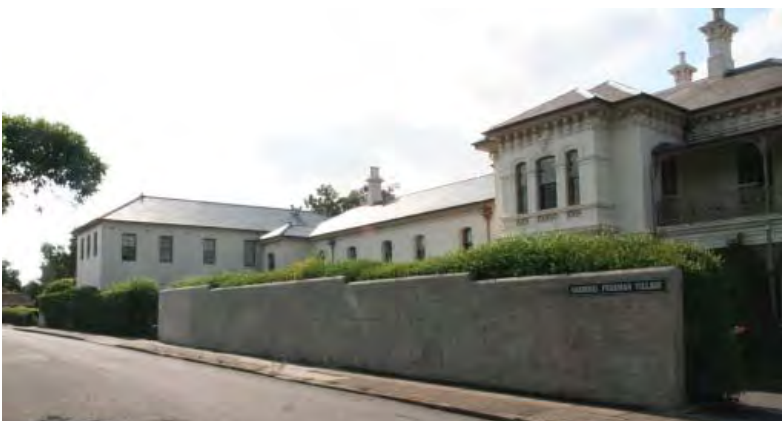
Figure 3.4.9  
View along Seaview Street and showing the masonry wall probably introduced after 1913 as a cloister wall

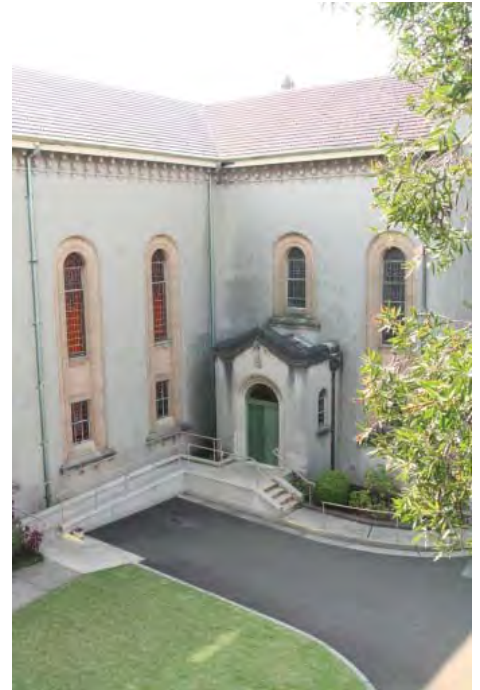
Figure 3.4.7  
The Chapel continues the detail of the Victorian eaves treatment but combines it with tall round headed windows formed with synthetic stone. The original plans specified slate tiling and a colouration to match the residence

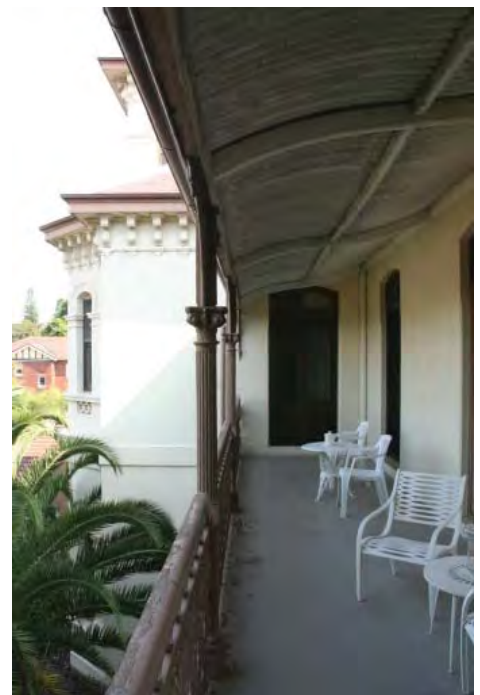
Figure 3.4.10  
The generous usable verandah spaces reveal the detail of delicate ironwork, columns and framing as well as iron roofing featuring joinery curvature

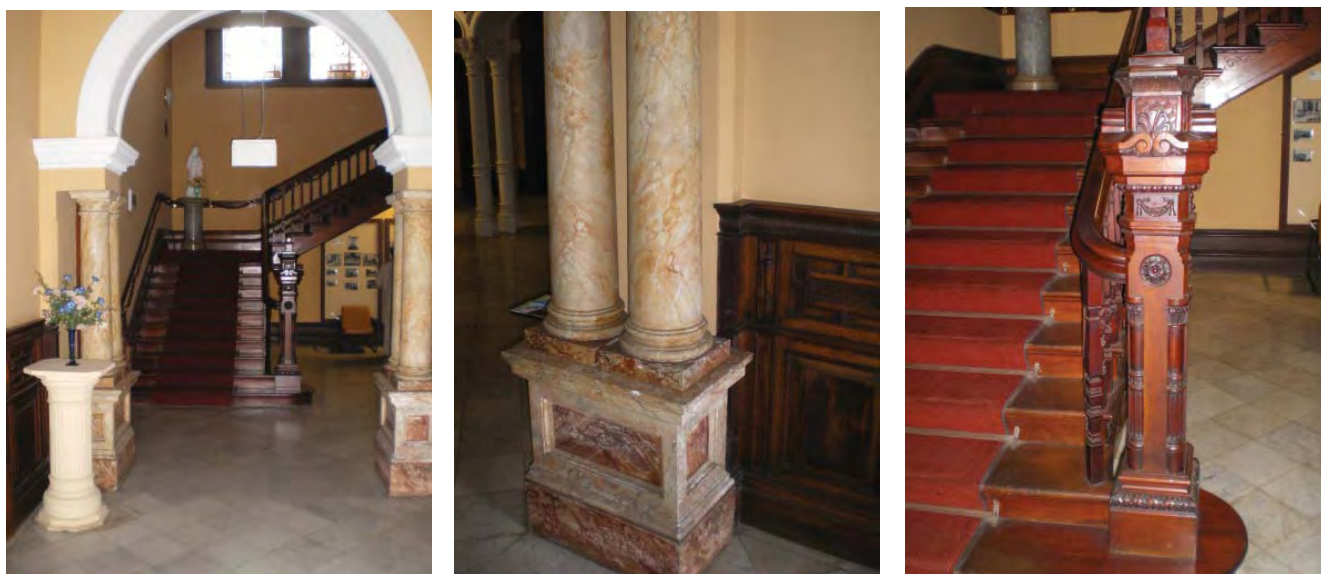
Figure 3.5.1

The main front entrance vestibule showing much high quality original fabric and workmanship, evidenced in the marble (tiling, columns and plinths), the detailed plasterwork, the high quality, highly detailed timber joinery (some elements of which are of massive proportion) and showing a generosity of space and volume. This grand stairway featured, in timber carving, the name of the carpenter and the date of construction.

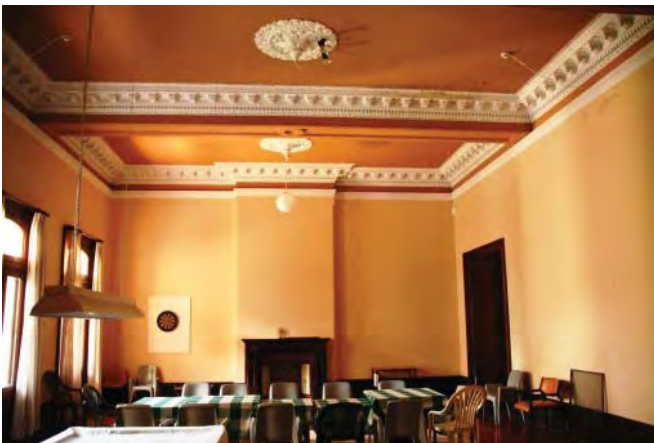
Figure 3.5.4  
View of the original ballroom looking to the east. It features an exaggerated ceiling height, with two clearspan joists and detailed cornice work, as well as doors of exaggerated height

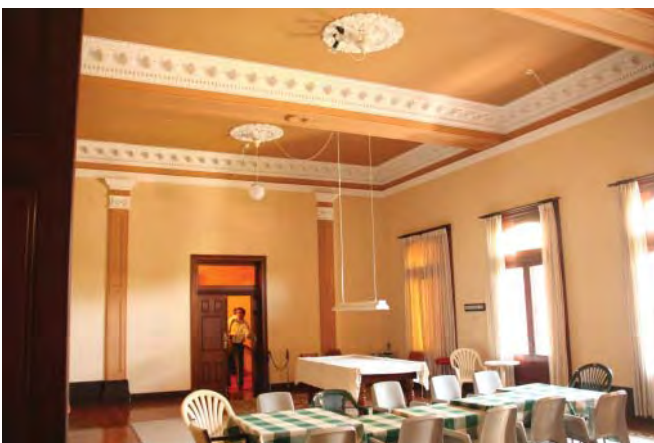
Figure 3.5.5  
View of the original ballroom looking to the west. The two pilasters and the deep skirtings show the position and width of the original bay window, which was removed for extension into the 1919 Chapel

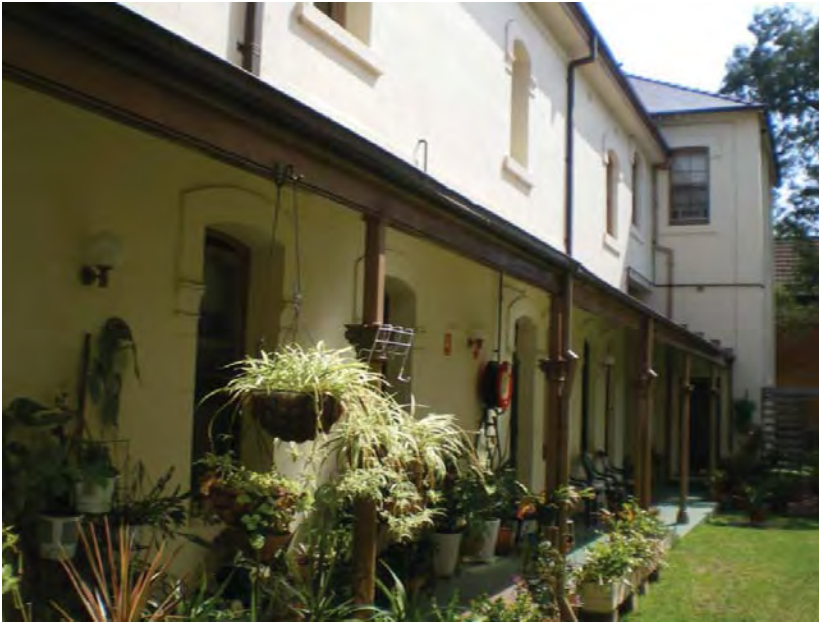
Figure 3.5.15  
View looking west along the interior facade of the west wing. This view show what was substantially an original verandah feature of the residence, however it was most likely of timber flooring. Foundations and formwork, as well as a sealed-in stairway beneath indicate concrete works some time after the 1950s. Lawn and garden spaces may contribute to some damp problems beneath

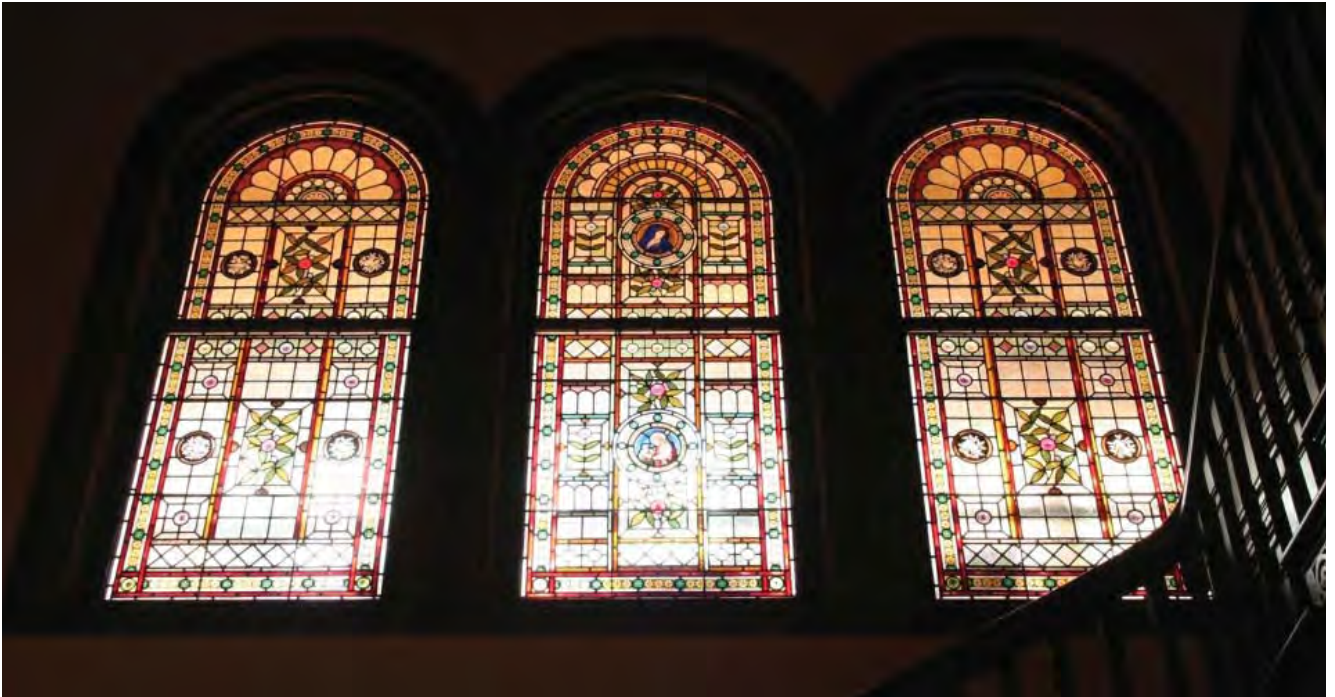
Figure 3.5.33

The elaborate stained and leadlight glass on the grand stairway at the entrance Vestibule, showing very fine work. Some smaller panes have been replaced with religious motifs as shown below. Most panes however exemplify typical Victoriana motifs, especially birds, fruit and leaves

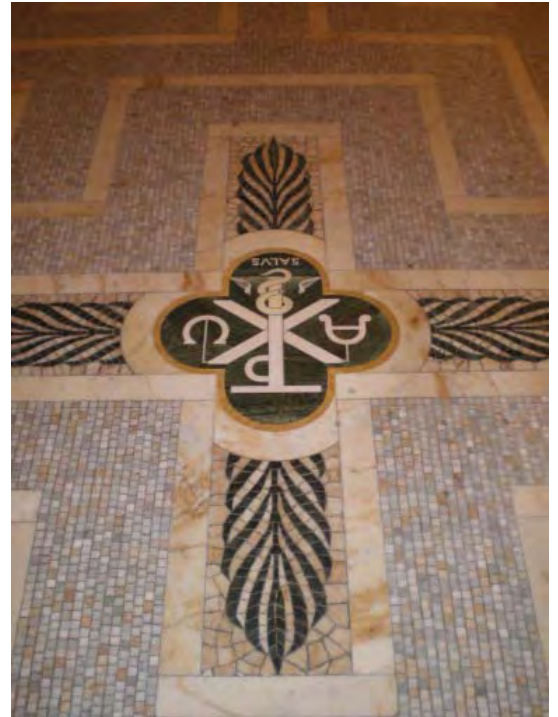
Figure 3.5.42  
The sanctuary flooring is highly detailed in inlaid marble chip mosaic showing classic motifs

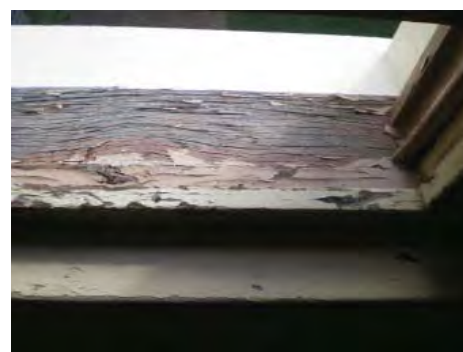
Figure 3.6.3  
Typical deterioration of window joinery west wing, *Glentworth House*

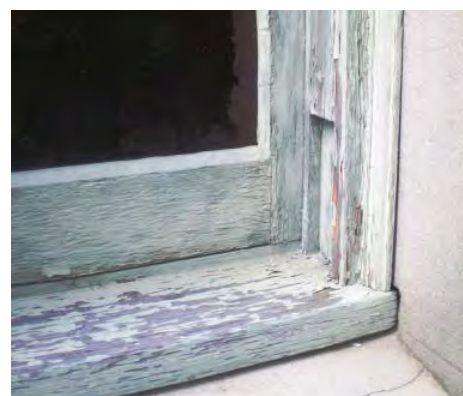
Figure 3.6.4  
Typical deterioration of window joinery, Chapel

The most substantial addition to the original built fabric was the Chapel, which is now an established part of the heritage footprint. Again, while the Chapel presents with an overall integrity of form, fabric and finish, maintenance problems are apparent upon closer inspection. There is some deterioration around external window joinery and there is evidence of water penetration in the smaller alcoved areas, most likely from roofing and guttering breakdown. The Chapel is a space for liturgy and reflection. For the first 35 years of its life it was in intensive daily use, and a highly maintained space, with a full compliment of movable patrimony. As it currently presents, it is a more or less neutral space that is substantially under-utilised. There is reservation of the Blessed Sacrament for personal devotion and a mass for a small congregation on some days of the week, with occasional (monthly) sung Office of the Church by outside groups.

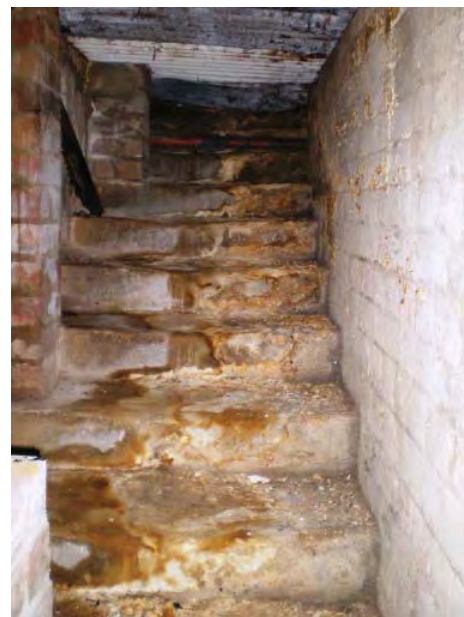
Figure 3.6.5  
Sealed up stairway to original kitchen and showing much water penetration from concrete verandahs and garden spaces above

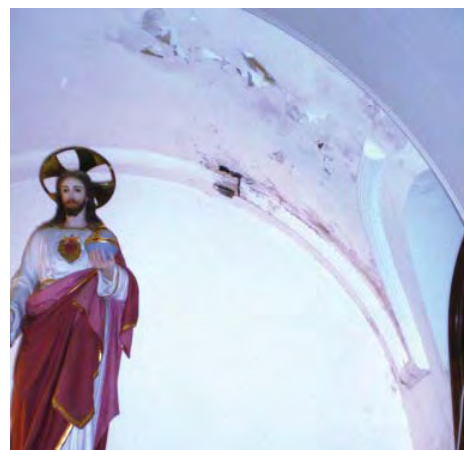
Figure 3.6.6  
Evidence of water penetration in alcove area of the Chapel

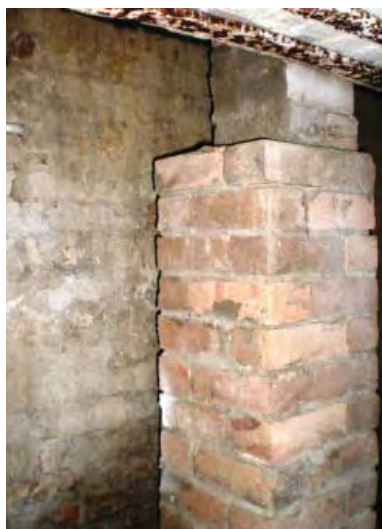
Figure 3.6.7  
Introduced foundations under *Glentworth House* (rear) and evidencing water penetration

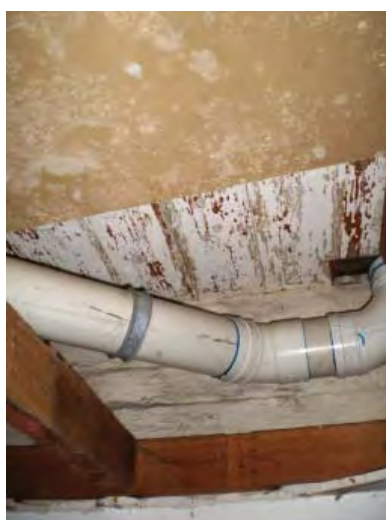
Figure 3.6.8  
Typical example of introduced PVC plumbing arrangements

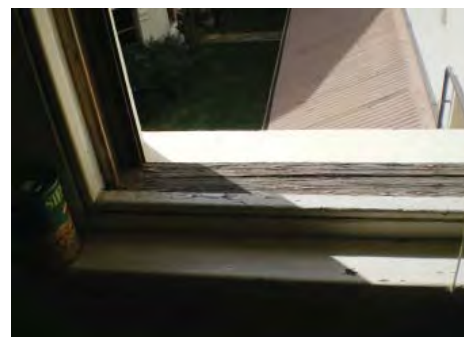
Figure 3.6.9  
Deterioration of window joinery, first floor Parlours building (annex)
