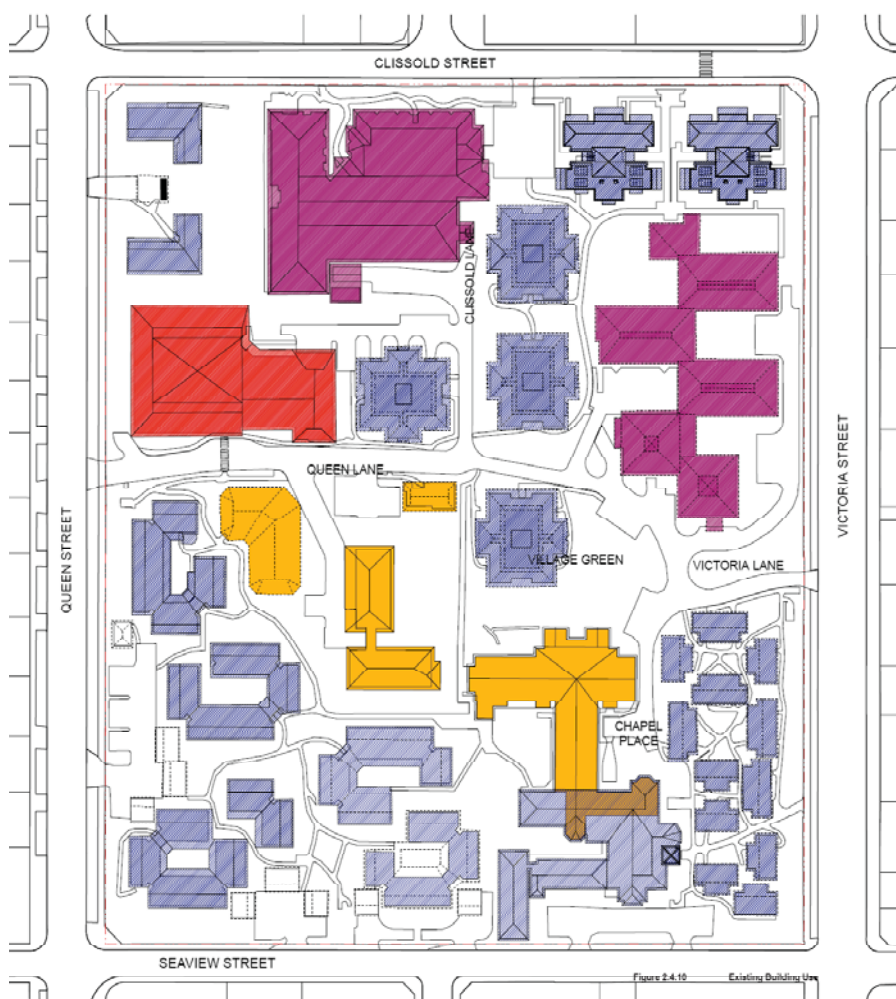
Figure 2.8.13
A diagram showing the existing site structure and buildings usage. Communal activities generally occur in the centre of the site. Serviced care and hostel care are in two areas, raising some logistics issues. . Independent units are variously scattered throughout the site but with some concentration along the south side
(Source: Hill Thalys Architecture & Urban projects, 2009)

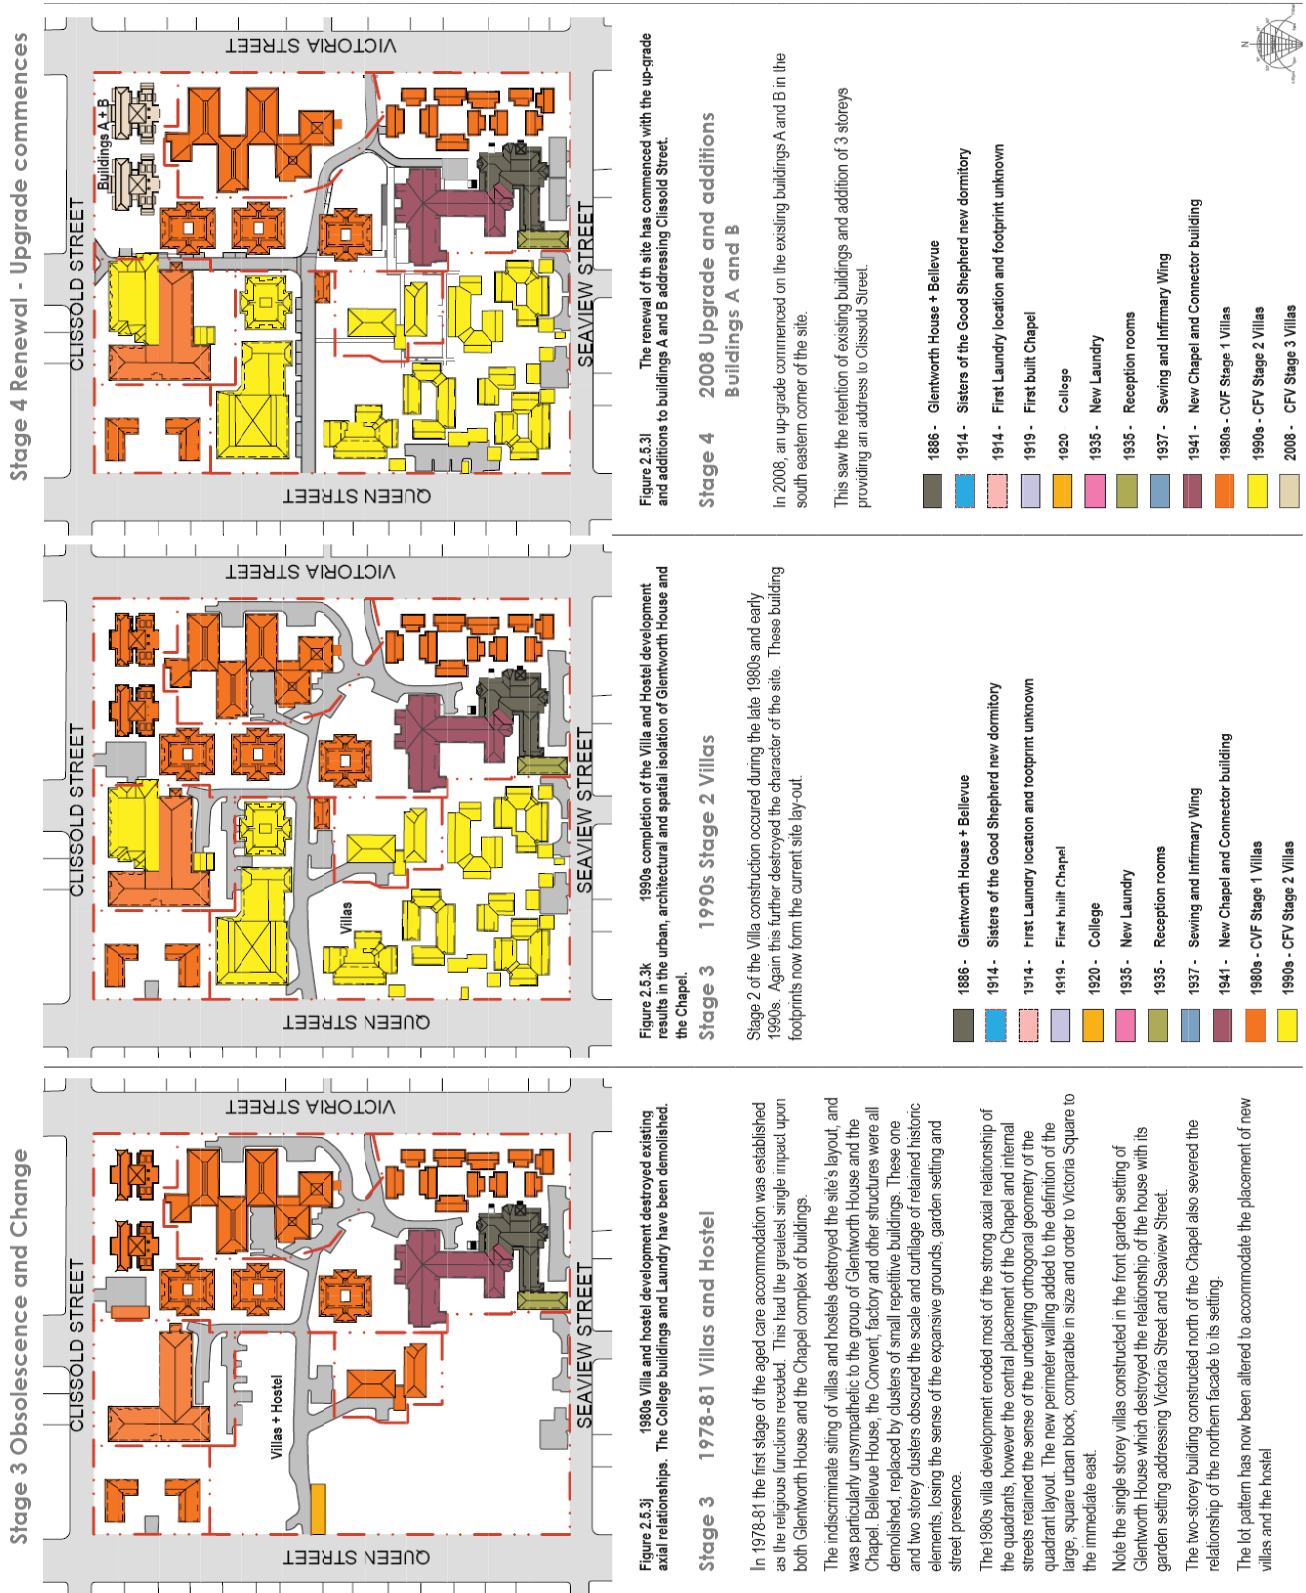
Figure 2.8.14

A diagram showing the staged development of the Cardinal Freeman Village between 1978 and 2008, development which has progressed substantially to the north and the west

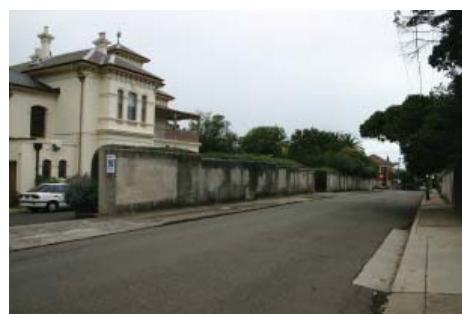
Figure 3.2.5
View along Seaview Street looking east, and showing the presumed introduced cloister wall, with current driveway openings

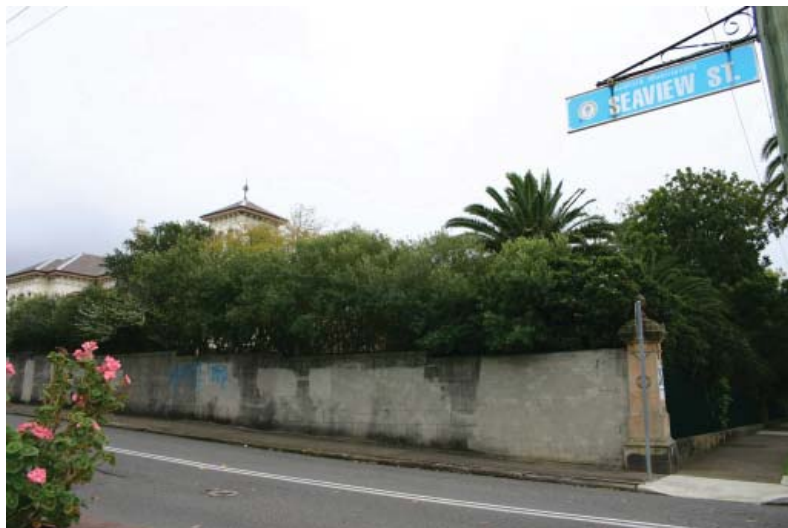
Figure 3.3.4
View at the corner of Victoria and Seaview Streets, where the palisade fencing meets the solid masonry wall. It is likely that this solid wall was introduced after 1913 as a cloister wall for the Convent, and it is likely that prior to that time the palisade fencing continued along this Seaview Road aspect

(This involves the re-establishment of the presumed palisade fencing and pilasters at the corner of Seaview and Victoria streets which seems to have been replaced by the cloister fencing some time after 1913. This strategy would impart a more open visual appreciation.)

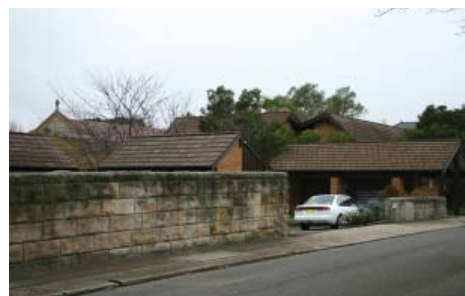
Figure 3.3.5
Typical stone wall fencing along Seaview Street at the frontage of the former laundry

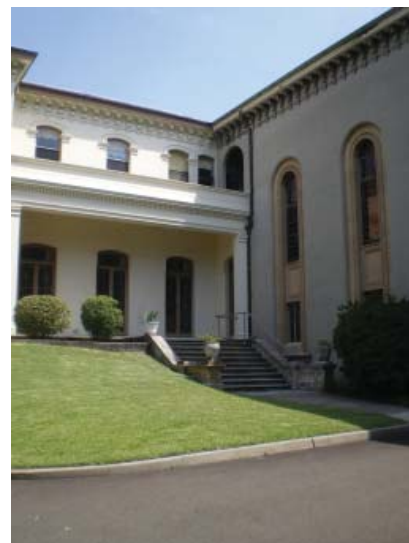
Figure 3.4.1
Typical example of the manner in which various components of the buildings meet in a relatively seamless manner. Note especially the eaves lines and detail replication, and understated Chapel fenestration

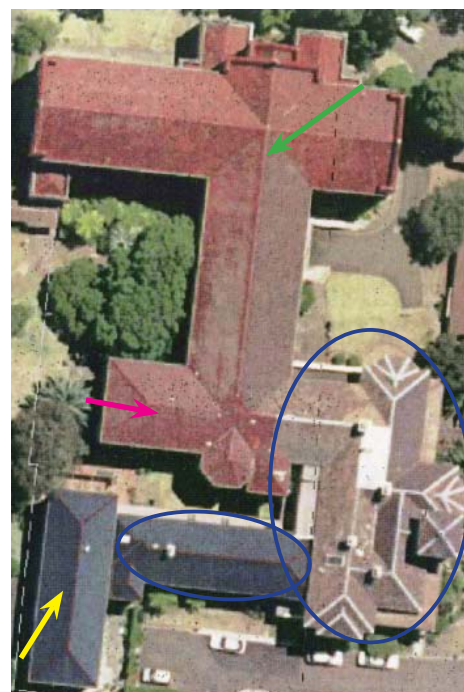
Figure 3.4.2
Aerial view of the heritage footprint showing:
The original components of *Glentworth House* as circled with the blue ovals; the 1935 extension, as indicated by the yellow arrow; the 1941 Convent extension, as indicated by the red arrow; and the 1941 Chapel, as indicated by the green arrow
(Source: NSW Department of Lands SIX Viewer 2008)

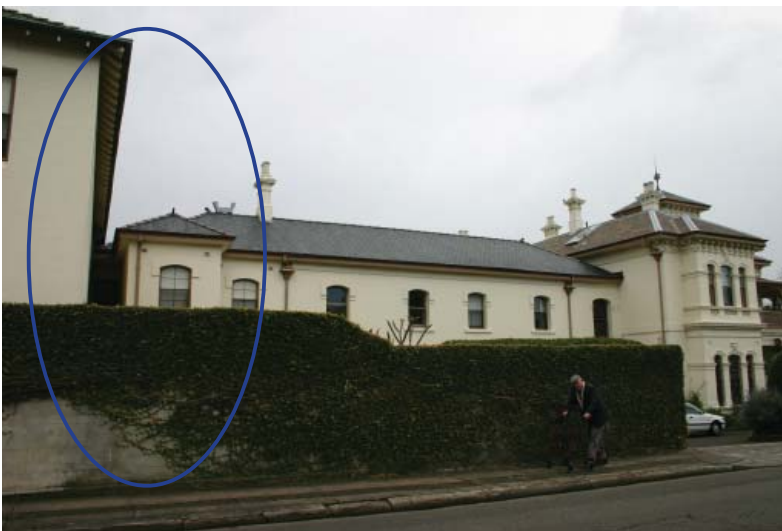
Figure 3.4.4

The original *Glentworth House* had a number of relatively seamless additions as well as a re-slating of the west wing. The nibbed section of the building indicated within the blue oval, the annexed Parlours building to the left and the stairway section between the two buildings were all built between 1935 and 1943. It seems apparent that the upper floor of the west wing was until that time slightly shorter. The building seems to have ended with a one storey laundry and small verandah return.

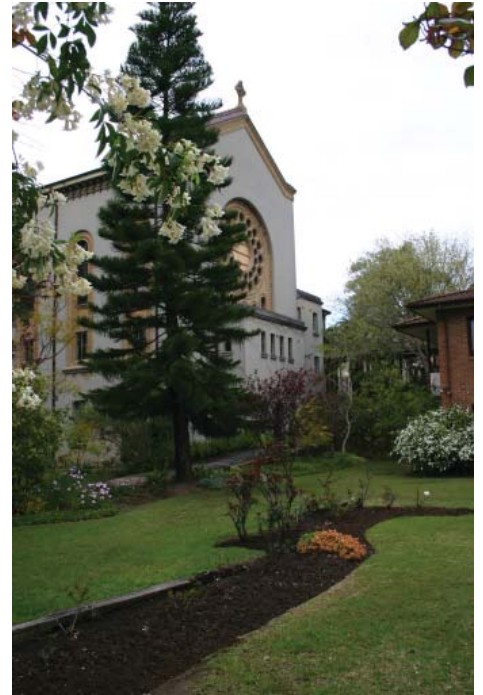
Figure 3.4.3

The Chapel is gabled with parapets formed with synthetic stone. The wheel windows and enframings of the tall round-headed windows are also formed of moulded synthetic stone

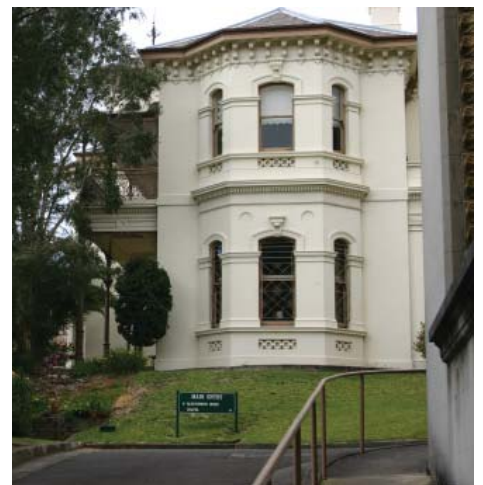
Figure 3.4.5

The principal formal areas of *Glentworth House* present with faceted bays bracketed eaves robust stucco and delicate iron lacework. The dwelling is set proud on mounded earthworks that facilitate the use of formal stairway entrances

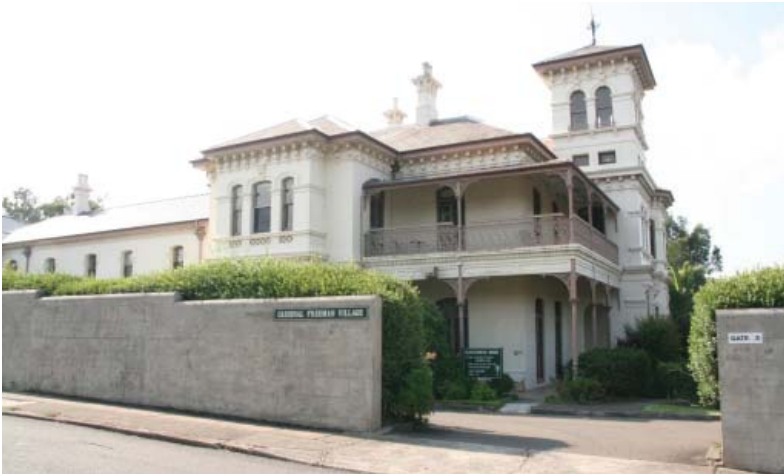
Figure 3.4.7
View at the south east corner of *Glentworth House* displaying the multiple features of the Victorian *Italianate* style, including the tower. The masonry wall in the foreground was likely built after 1913 for the cloistered area of the Convent

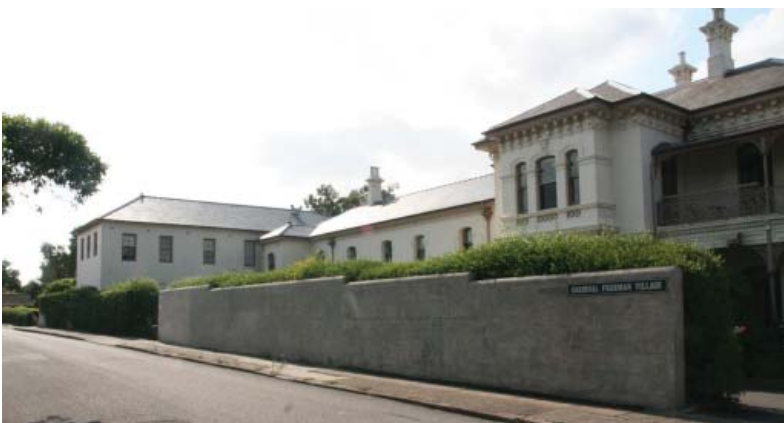
Figure 3.4.10
View along Seaview Street and showing the masonry wall probably introduced after 1913 as a cloister wall

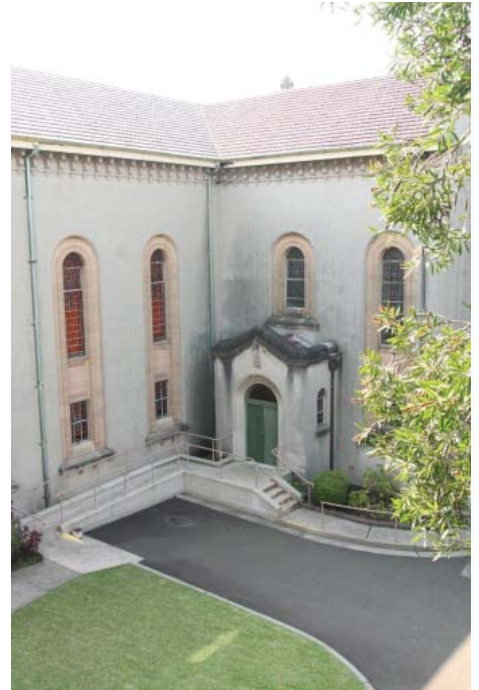
Figure 3.4.8
The Chapel continues the detail of the Victorian eaves treatment but combines it with tall round headed windows formed with synthetic stone. The original plans specified slate tiling and a colouration to match the residence

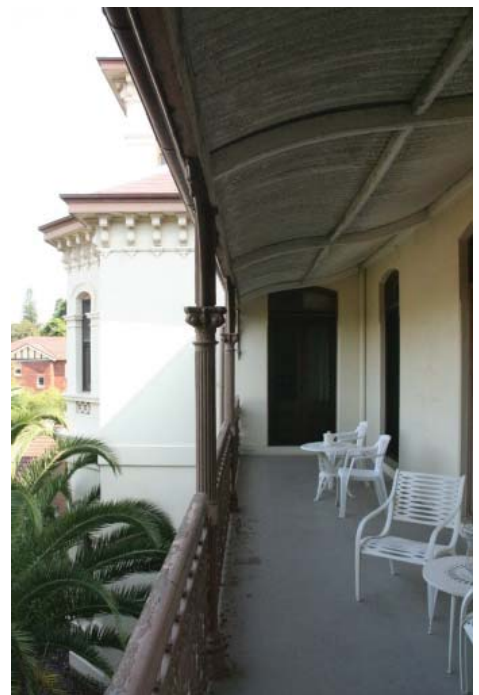
Figure 3.4.11
The generous usable verandah spaces reveal the detail of delicate ironwork, columns and framing as well as iron roofing featuring joinery curvature

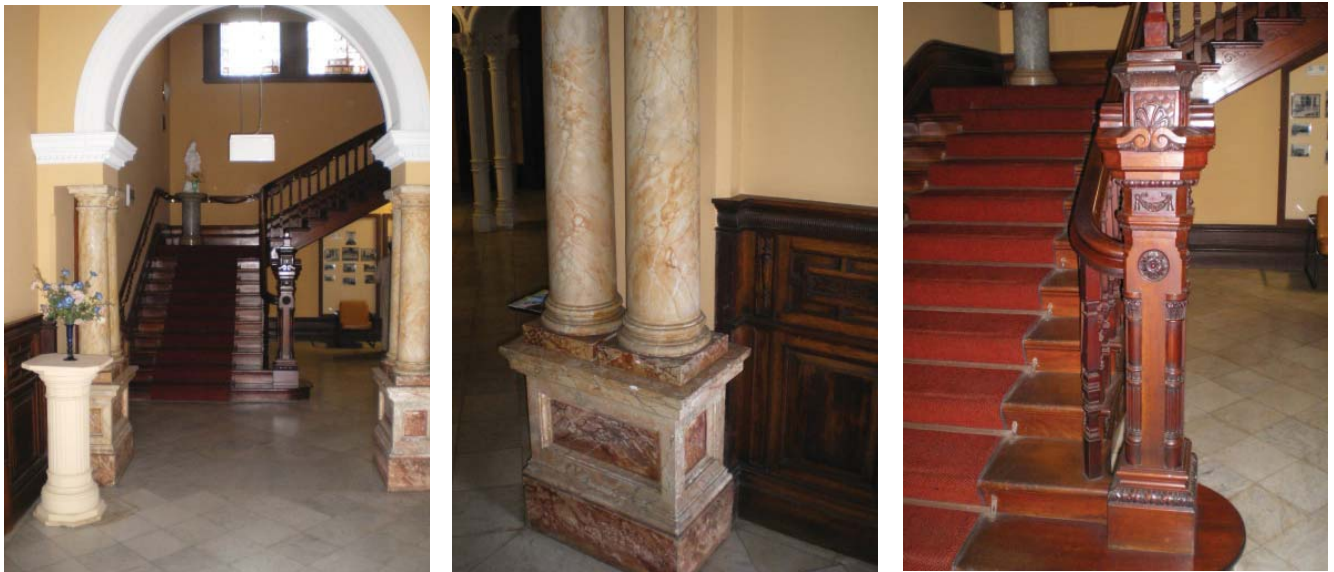
Figure 3.5.1

The main front entrance vestibule showing much high quality original fabric and workmanship, evidenced in the marble (tiling, columns and plinths), the detailed plasterwork, the high quality, highly detailed timber joinery (some elements of which are of massive proportion) and showing a generosity of space and volume. This grand stairway featured, in timber carving, the name of the carpenter and the date of construction.

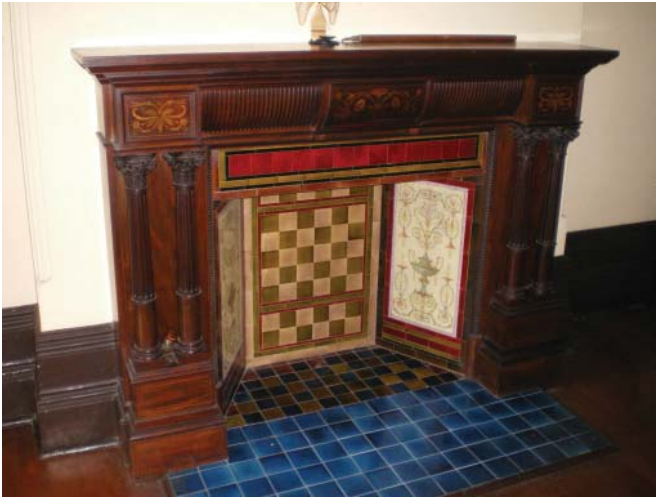
Figure 3.5.2
The fireplace in the ballroom is typical of those in the principal rooms of the house, featuring tiling, carved and inlaid timber

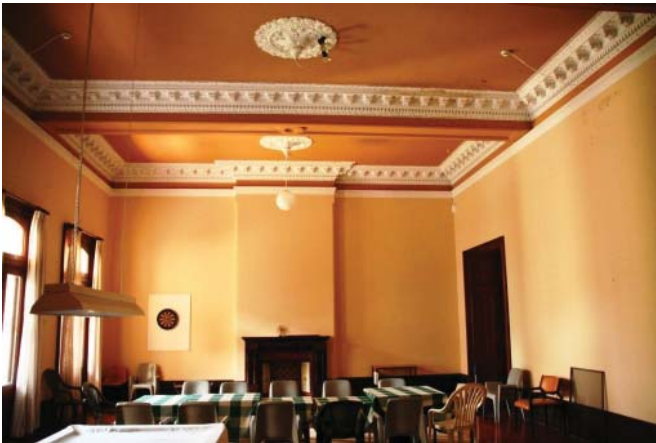
Figure 3.5.4
View of the original ballroom looking to the east. It features an exaggerated ceiling height, with two clearspan joists and detailed cornice work, as well as doors of exaggerated height

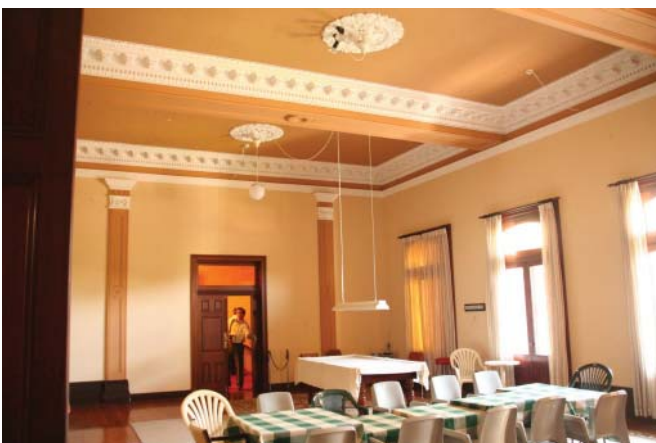
Figure 3.5.5
View of the original ballroom looking to the west. The two pilasters and the deep skirtings show the position and width of the original bay window, which was removed for extension into the 1919 Chapel

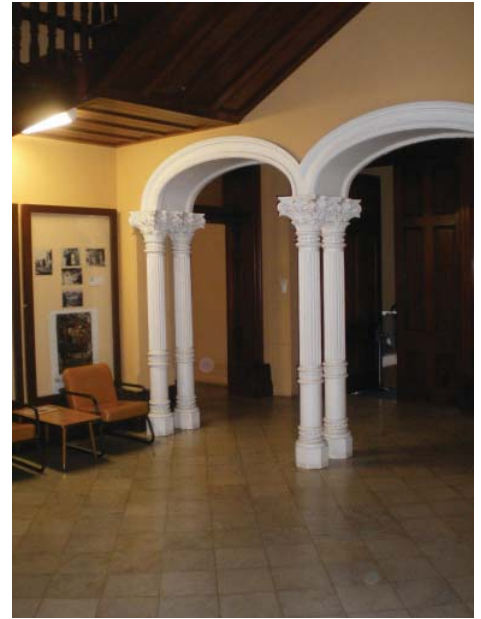
Figure 3.5.3
The formal walkway from the entrance vestibule to the ballroom (right) with marble tiles beneath detailed masonry and plasterwork. The area is presently compromised a little by a utilitarian fit-out and basic interpretation strategy

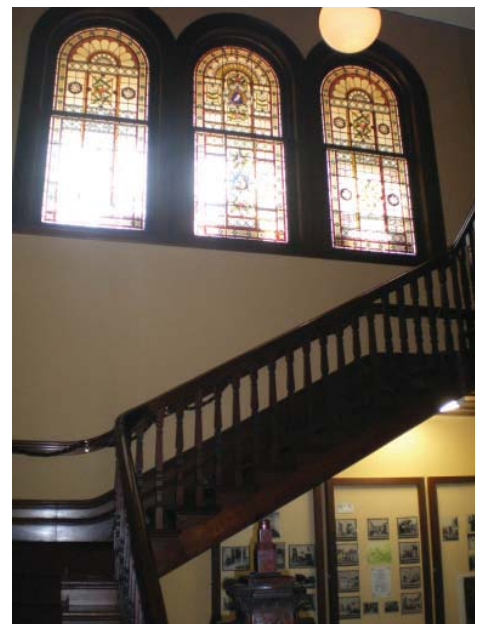
Figure 3.5.6
The imposing grand stairway from the entrance vestibule to the first floor of *Glentworth House* and showing the stained and leadlighted windows, substantially original, though some panes were later replaced with religious motifs

The elaborate stained and leadlight glass on the grand stairway at the entrance Vestibule, showing very fine work. Some smaller panes have been replaced with religious motifs as shown below. Most panes however exemplify typical Victoriana motifs, especially birds, fruit and leaves

Some panes in the grand stairway central window were replaced by religious motifs. The window shown here in the centre is an excellent and simple example of Victorian glass, located on the main service stairway

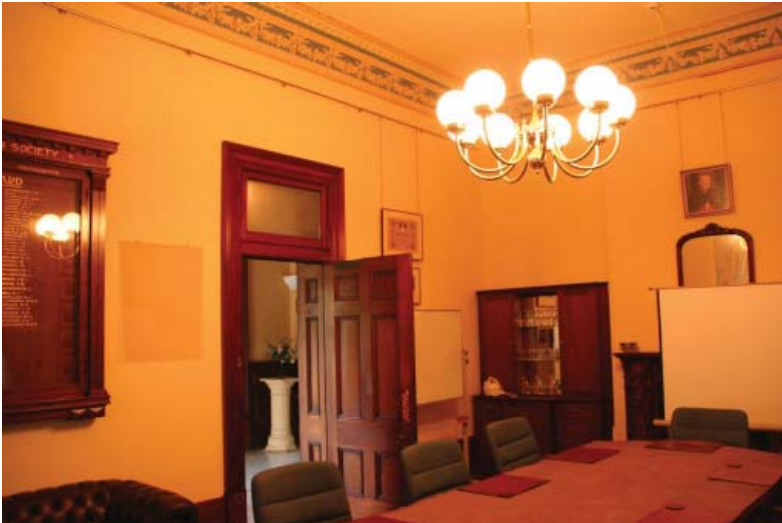
Figure 3.5.7

View of the principal formal reception room, now known as the boardroom. It opens from the entrance vestibule (left) and into the hall by the formal dining room (right). It is of extremely generous proportion, featuring very fine joinery and inlaid work, highly detailed plaster cornices, elegant formal fireplace

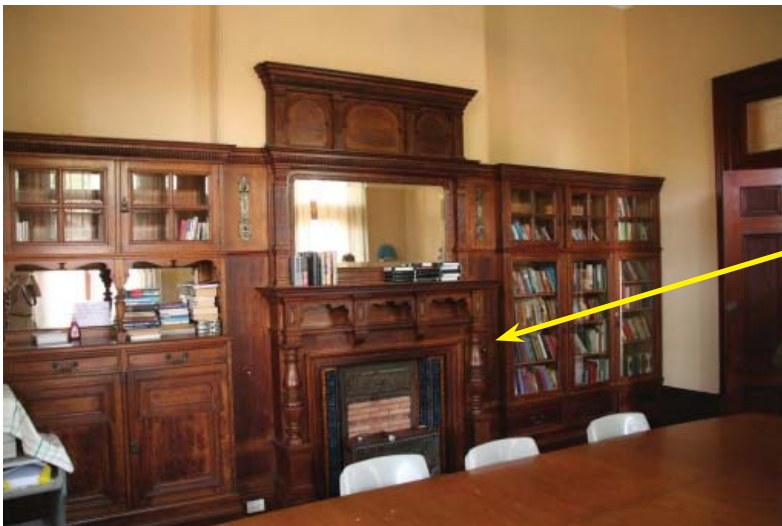
Figure 3.5.8 (a) and (b)

The original library, and still known as a library opens from the entrance vestibule (door at right). While it is compromised by some minor fireplace modifications and movables, it still retains much original features, including a servants call bell at the left of the fireplace (see above)

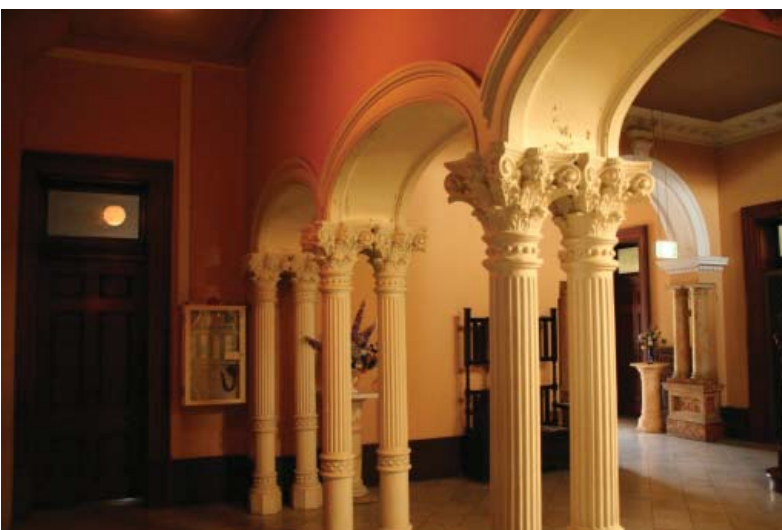
Figure 3.5.9

The formal entrance vestibule looking from the Ballroom back towards the front entrance, with the door to the principal reception room at the left. The ornate plasterwork in cornices and columns is well observed

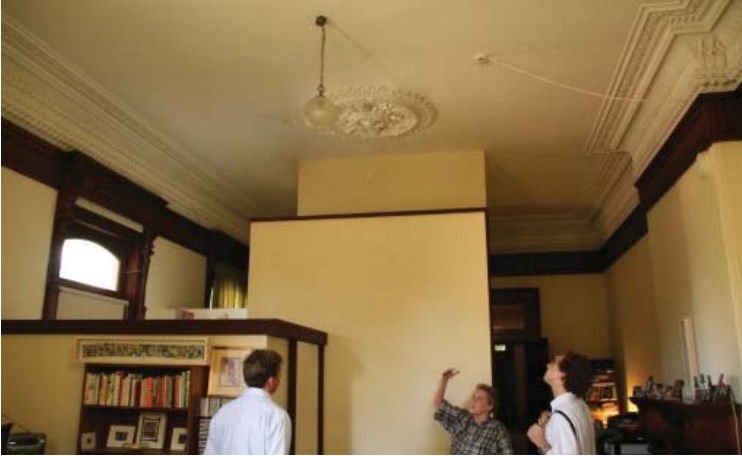
Figure 3.5.10
The former grand dining room is now converted as a single dwelling flat, with introduced (reversible) dividing partitions and some plumbing interventions. Much of the original presentation is still evident

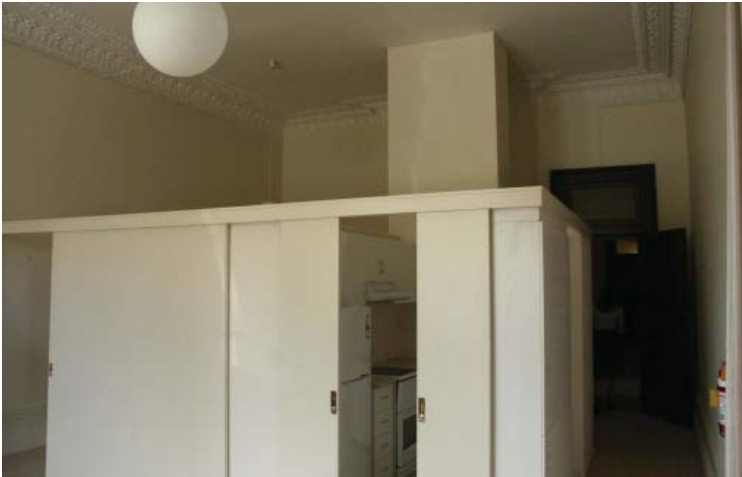
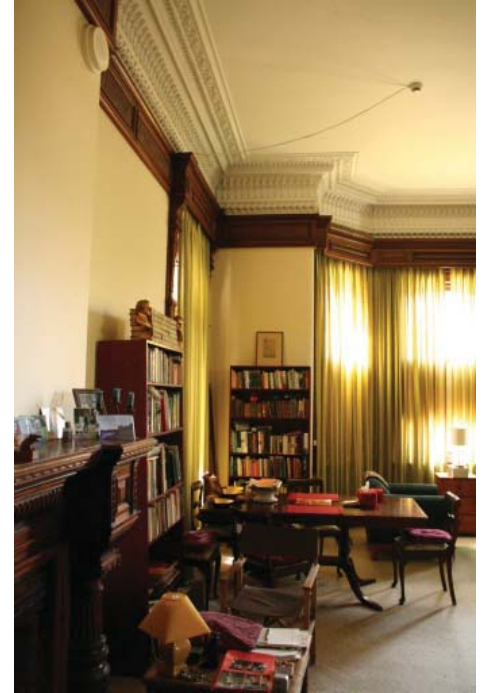
Figure 3.5.11
The former dining room, now a self-contained flat, and showing such original features as the fireplace and the elaborate plaster cornicework

Figure 3.5.12
The original billiard room (see image p.14) is also now a single dwelling flat with introduced (reversible) dividing partitions. The services column is evident

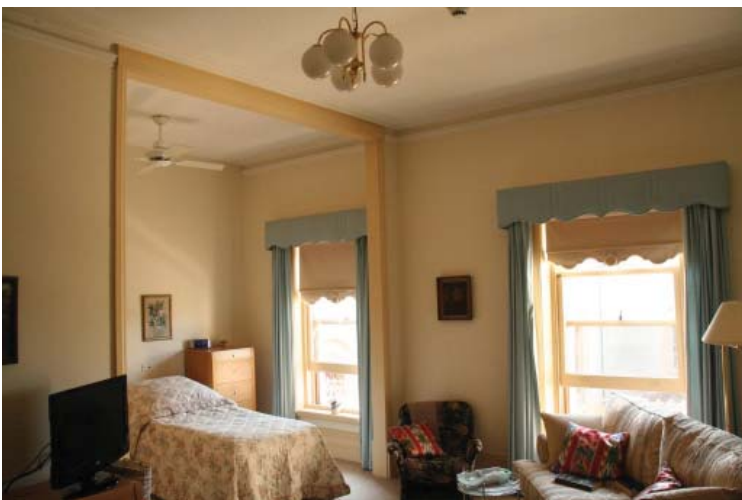
Figure 3.5.14
A self contained flat above the original ballroom. Note the relative height of windows to floor; an unusual feature

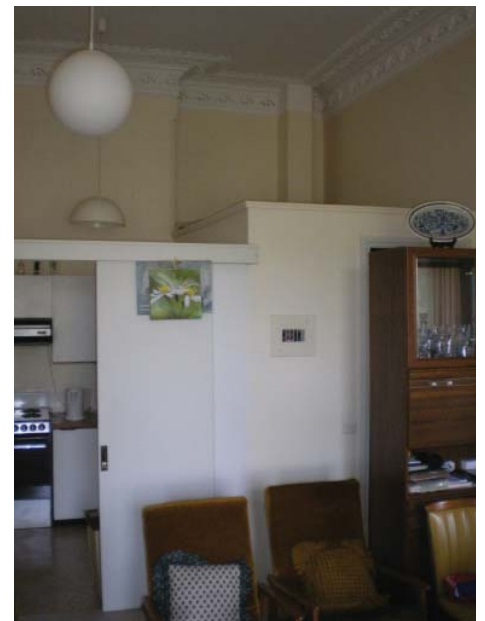
Figure 3.5.13
Image of a flat above the principal reception-room and typical of the lightweight partition divisions and generally the 'over-divided' spaces

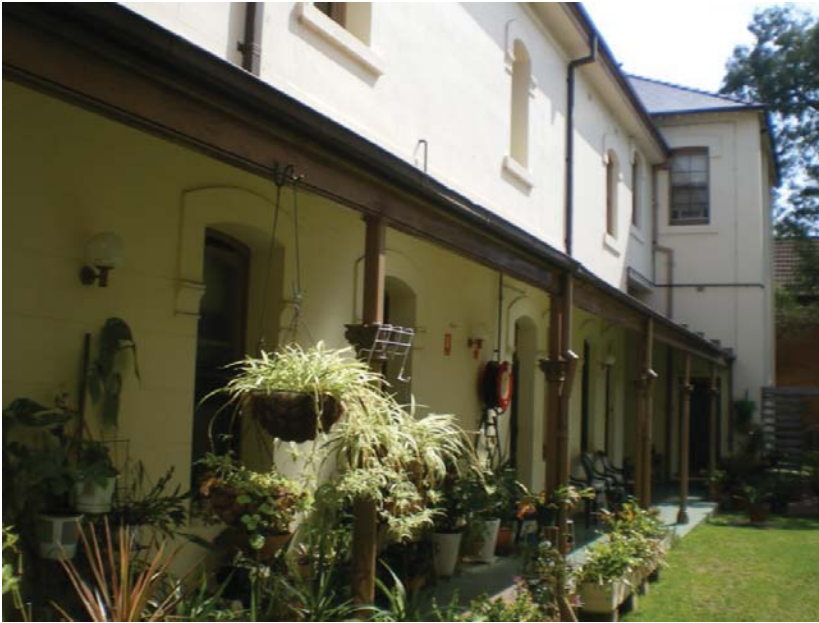
Figure 3.5.15
View looking west along the interior facade of the west wing. This view shows what was substantially an original verandah feature of the residence, however it was most likely of timber flooring. Foundations and formwork, as well as a sealed-in stairway beneath indicate concrete works some time after the 1950s. Lawn and garden spaces may contribute to some damp problems beneath

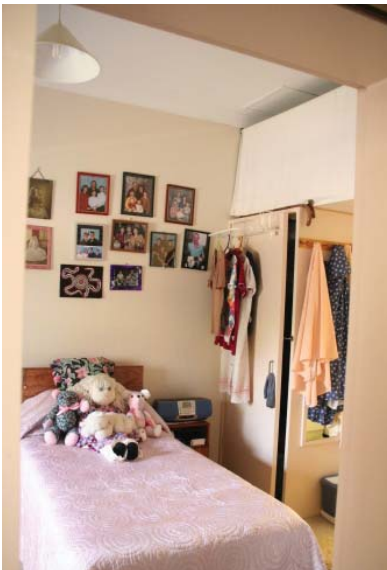
Figure 3.5.17
Typical divisions introduced into small spaces to create a bedroom area

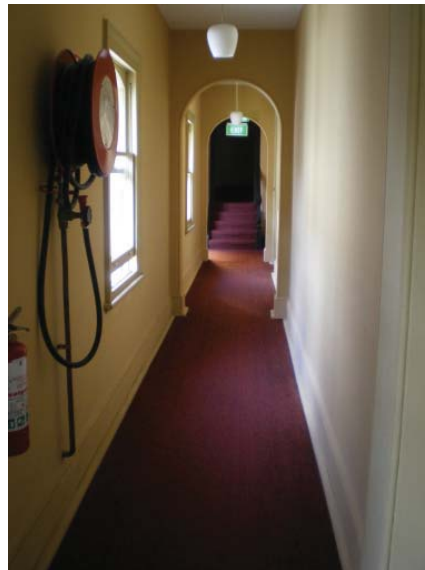
Figure 3.5.18
View of the upstairs hallway along the west wing, showing a relatively narrow space, and off this hallway relatively small rooms converted into bed-sitter flats

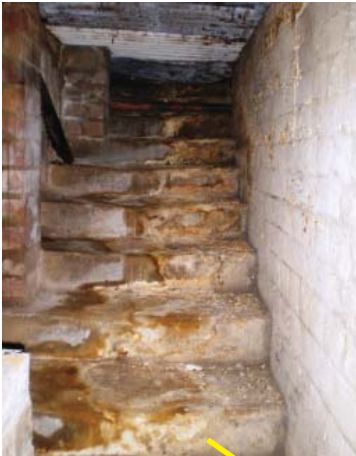
Figure 3.5.20
The sealed-in service stairway on the north side of the kitchen

Figure 3.6.5
Sealed up stairway to original kitchen and showing much water penetration from concrete verandahs and garden spaces above

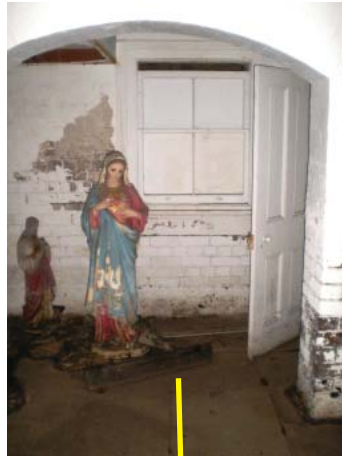
Figure 3.5.21
A probable original scullery area

- The original ceiling height on the ground and first floors of *Glentworth House* should be maintained as existing.
- The remnant *Glentworth House* basement kitchen, scullery and pantry spaces, together with the stairway access, should be conserved and waterproofed, with the stairs repaired. The space should be interpreted and if possible based on the proviso that there is no impact to the original elements.

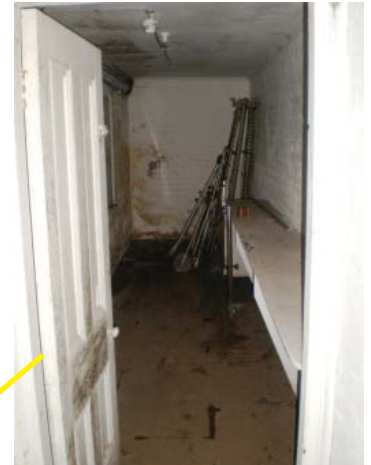
Figure 3.5.22
The probable original larder

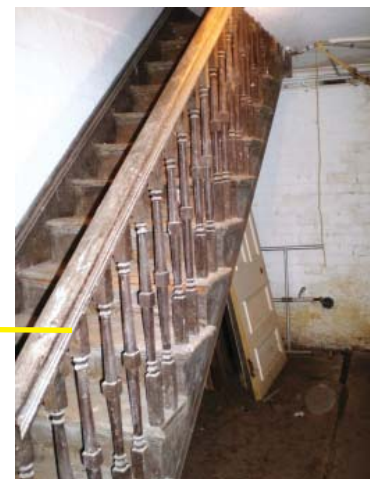
Figure 3.5.24
The service stairway

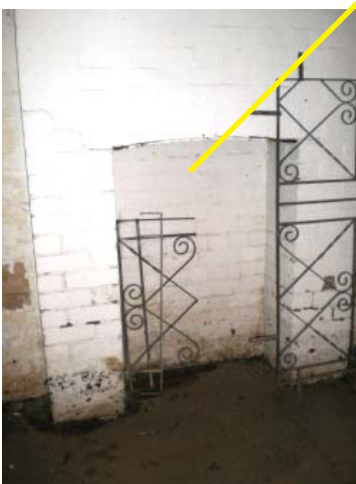
Figure 3.5.25
The original kitchen fireplace

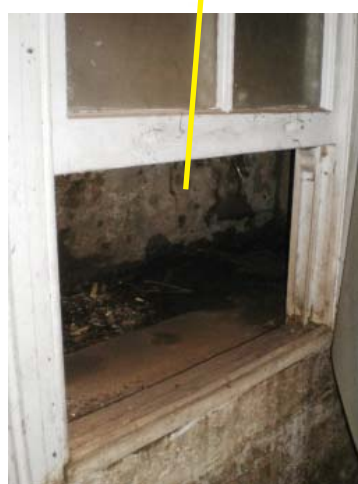
Figure 3.5.26
Window at the south side of the kitchen, with a now tight light shaft

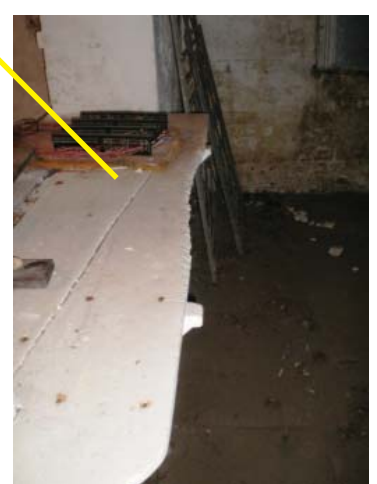
Figure 3.5.27
An original serving bench with interesting blade markings

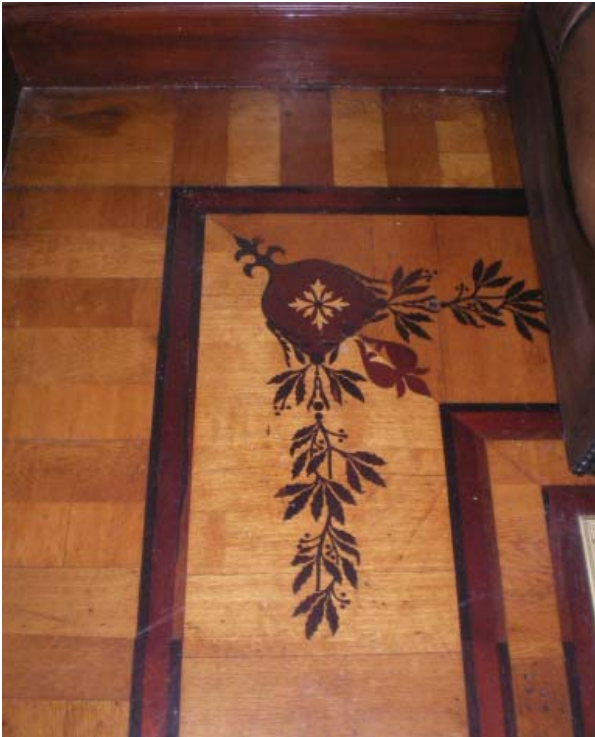
Figure 3.5.29
Highly detailed original inlaid flooring in the principal reception room (now Board-room)

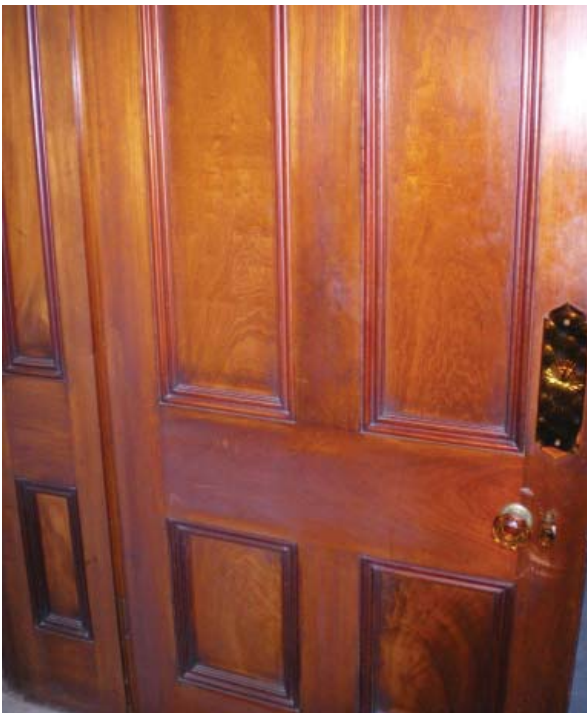
Figure 3.5.31
Typical door joinery of very high quality. Some doors present with an exaggerated height

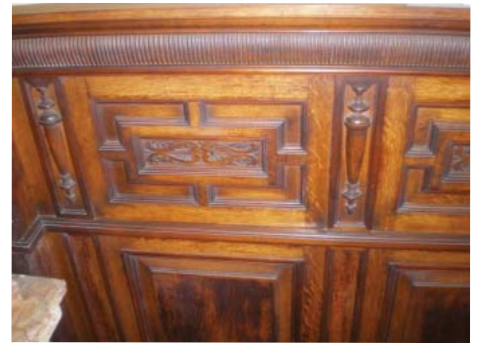
Figure 3.5.28
Detail of typical fine wood carving in the entrance Vestibule

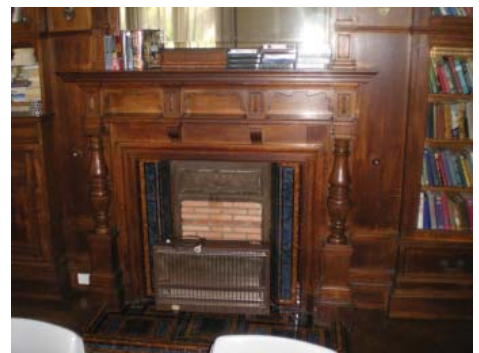
Figure 3.5.30
Detail of timber panelling in the Library, and showing the now compromised heating arrangement

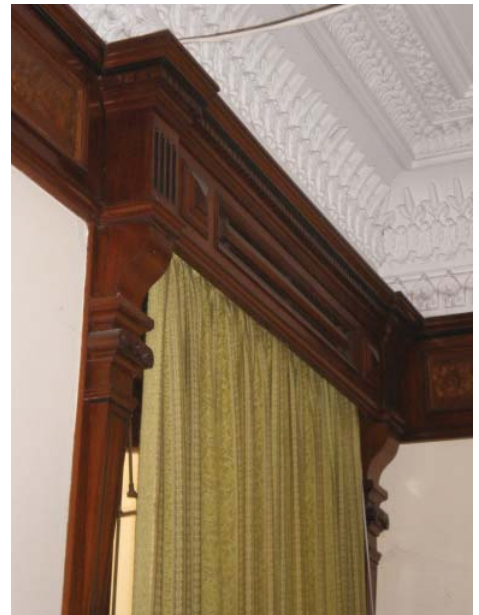
Figure 3.5.32
Combination of typical design features, including the elaborate plaster cornice work and finely detailed timber carving

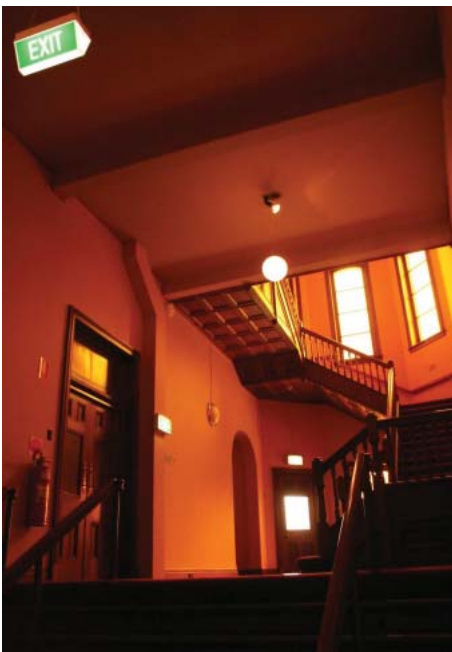
Figure 3.5.37
The 1941 connector section stairway, at a point of several levels changes

This generosity of interior dimension and quality of overall finish is however continued through the various extensions of principal spaces in the whole set of buildings. This the 1941 Convent extension comprises offices and surgery on the ground floor, with five bedrooms and bathrooms on the first floor (mainly for use by sick sisters), as well as the connector section comprising and hallway and grand stairway spaces presents in an almost seamless fashion, evidencing generous spaces, especially at the public stairways, high quality detailed joinery, articulated and bayed window spaces, lead-lighting and so forth. An elevator has been introduced to this space.

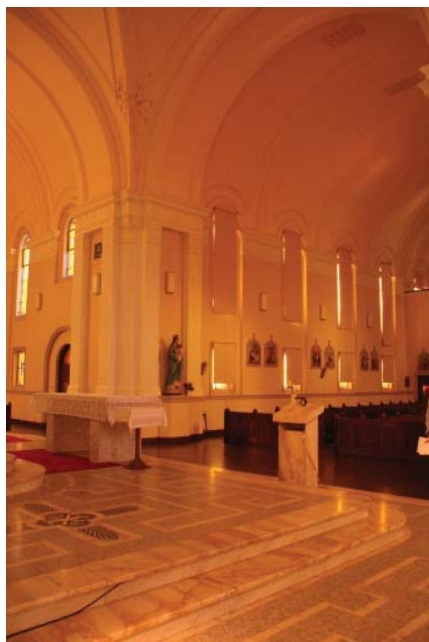
Figure 3.5.39
View across the Melocco sanctuary work towards the former sisters chapel (right) and public chapel (left). The smaller altar and ambo would have been circa 1970 additions

The Chapel spaces and volumes are particularly generous with a highly detailed level of quality finish in the timber and marble. This achieves an especially fine standard in the especially in the *Melocco Bros* sanctuary work. The large altar and reredos in renaissance detail, the inlaid marble-chip mosaic flooring, the treads and risers are in subtle harmonised Wombeyan marble.¹ The interior is beautifully scaled and detailed. The gallery columns are of synthetic stone and the walls are solid plastered with coffered ceilings of fibrous plaster. Over the projecting sanctuary area (12m x 9m) is a semi-apsidal ceiling, richly coffered, the flat portion of which is arched and opens to a naturally lit shrine of the Good Shepherd with full relief figures. The ceiling of the sanctuary is the intersection of the nave and the transepts, and is divided from them by arches of more than 2m width, which spring off the four fluted pilasters and entablature at each corner. At each of the four corners there are niche/pedestals for statues. The general form of the whole ceiling is semi circular with beautifully modelled pilasters and entablature, and at a length 33m, with a 12 m height. The whole interior is enriched with model mouldings. There are synthetic stone windows, with glazing in stained glass and amber coloured leadlights. There is high quality parquetry flooring in combinations of tallowood and jarrah, with the remainder of the joinery in silky oak, including the pews. This quality finish and joinery is carried into the sacristy areas. There is a connecting stairway between this sacristy section, the undercroft and the choir gallery above. A notable feature is the rose windows of synthetic stone and stained glass, designed by Arthur G Benfield, and constructed in the Waterloo studios of F. G. O'Brien. At the western end of the undercroft is a small chaplain's residential 'studio' flat with bedroom and kitchen.

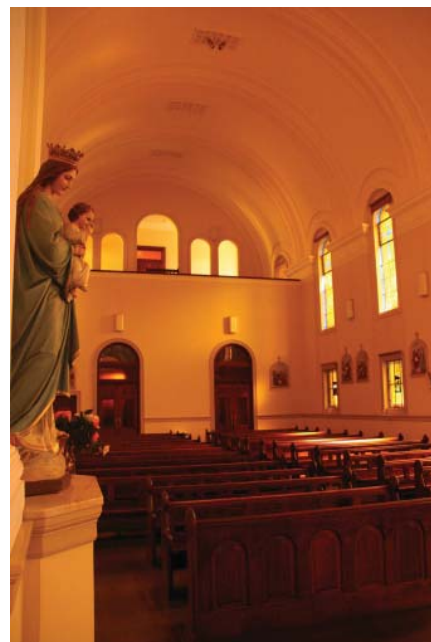
Figure 3.5.40
View into the sisters chapel, showing the infirmarium gallery above. These pews have been moved from the girls and public sections

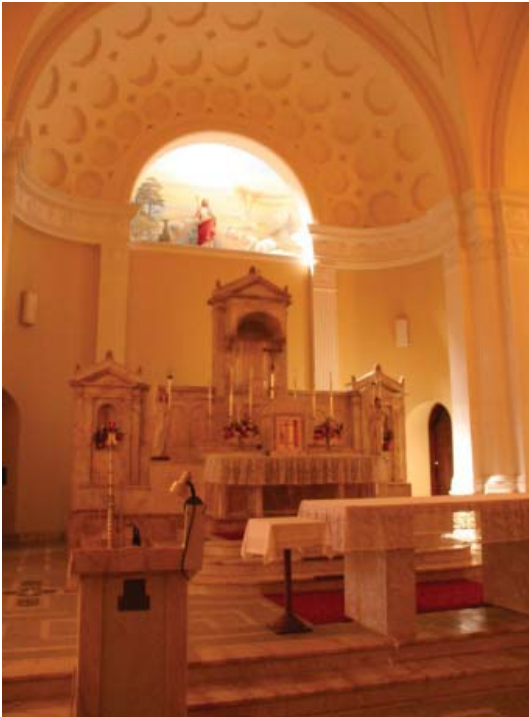
Figure 3.5.41
View of the much-lauded Glancey design and Melocco construction of the original sanctuary area with its naturally lighted Good Shepherd motif, high altar and reredos. Forward altar and ambo are later additions

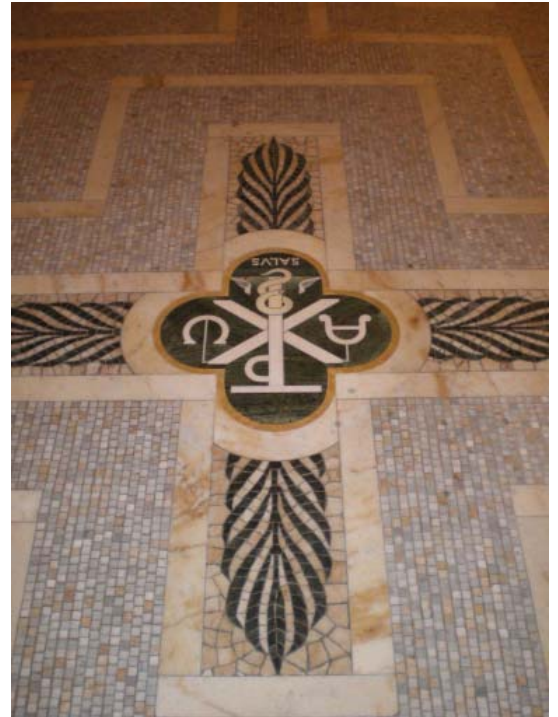
Figure 3.5.42
The sanctuary flooring is highly detailed in inlaid marble chip mosaic showing classic motifs

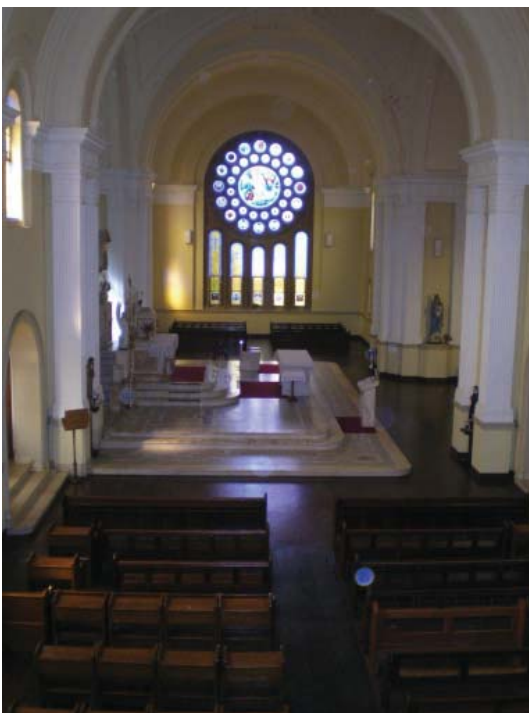
Figure 3.5.43
View from the choir loft of the girls section of the chapel showing imposing volume. This sideways view to the altar would have been a novel and perhaps controversial arrangement in 1940

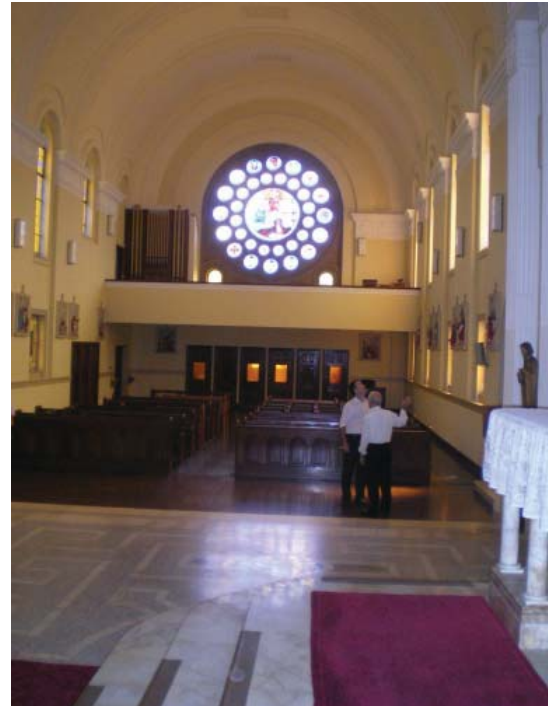
Figure 3.5.44
The view from the sanctuary and back into the girls section of the chapel, showing the great wheel window, the choir gallery and pipe organ. The current *pre-Dieu* seats have been moved from the sisters chapel

- Any conservation work for the Chapel should include maintenance, retention and preservation of the principal spaces and volumes, floors, windows, stained glass, choir loft, pipe organ and fittings.

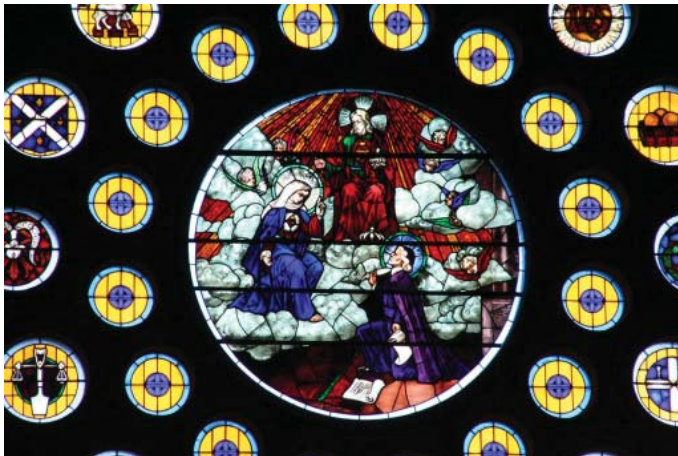
Figure 3.5.45
Detail from the great stained glass wheel window

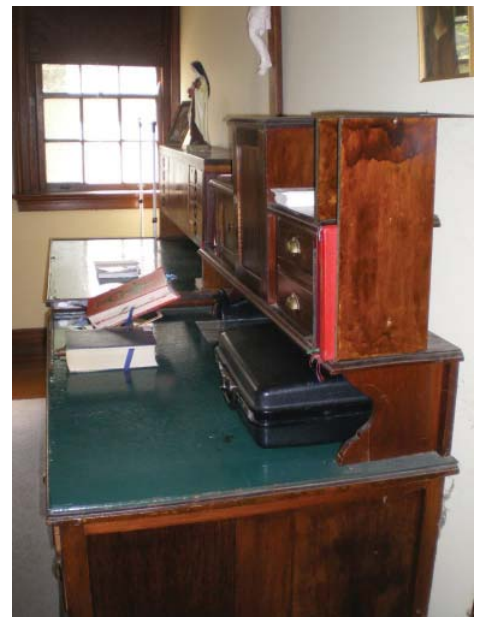
Figure 3.5.48
The priest's sacristy adjacent to a work sacristy. Both present with quality joinery. The record of contents were not examined for this Report. It is presumed that the movable patrimony, which is likely to be of considerable value is located either on site or in the care of the Good Shepherd Sisters, the original owners. It was not examined for this Report

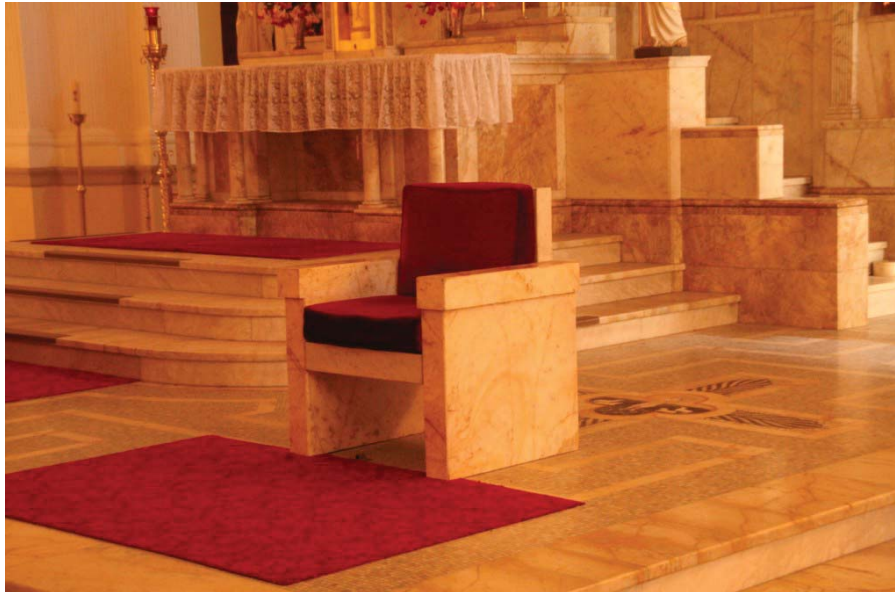
Figure 3.5.49
The sanctuary showing high quality marble work
