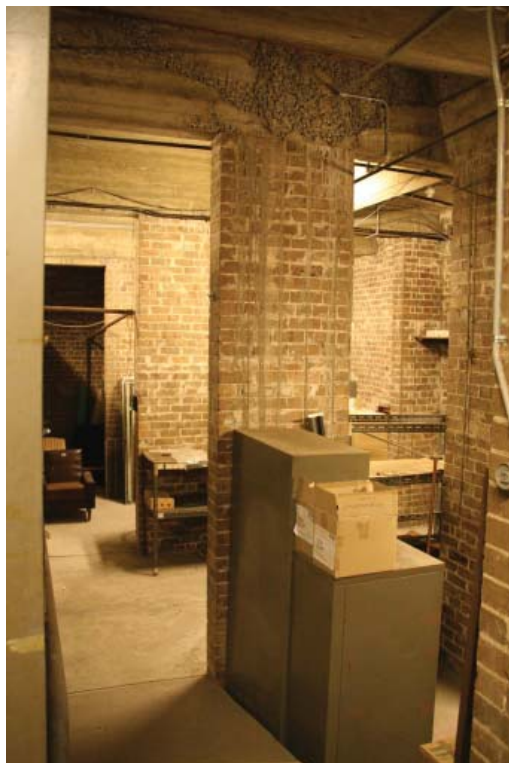
Figure 3.5.50
View showing the Chapel undercroft

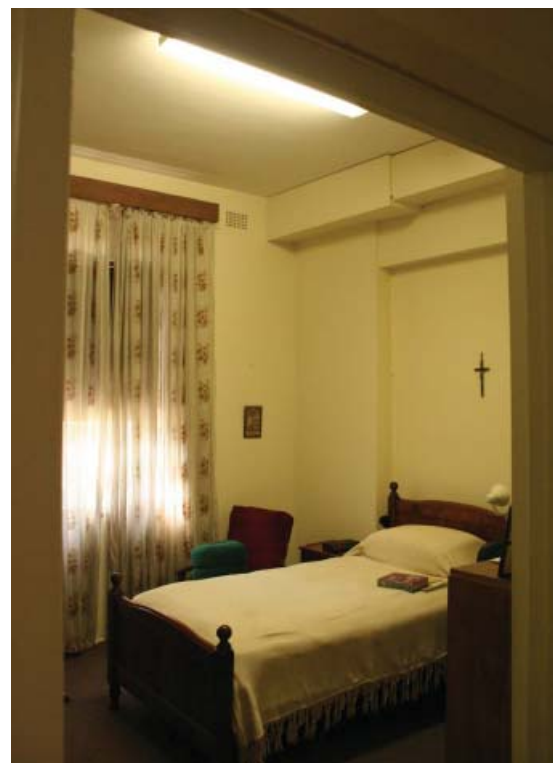
Figure 3.5.51
The bedroom in the chaplain's flat, on the western end of the Chapel undercroft.

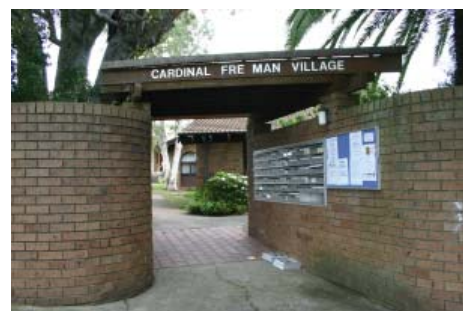
Figure 3.6.1
The front entrance introduced in the 1980s

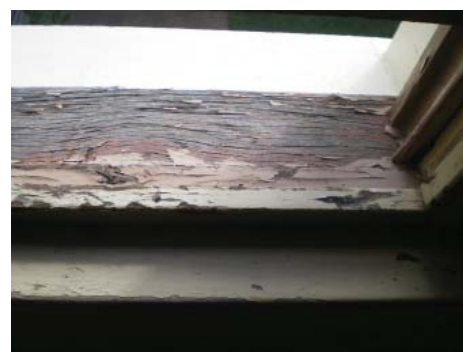
Figure 3.6.3
Typical deterioration of window joinery west wing, *Glentworth House*

- Damaged joinery members are to be repaired to match existing.

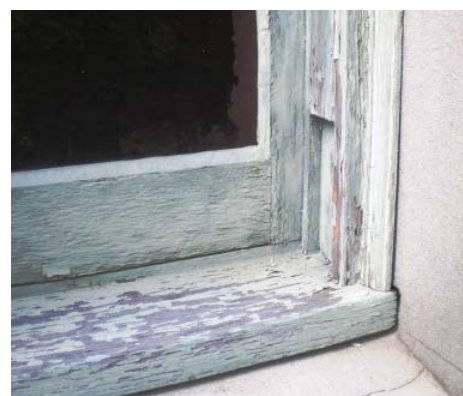
Figure 3.6.4
Typical deterioration of window joinery, Chapel

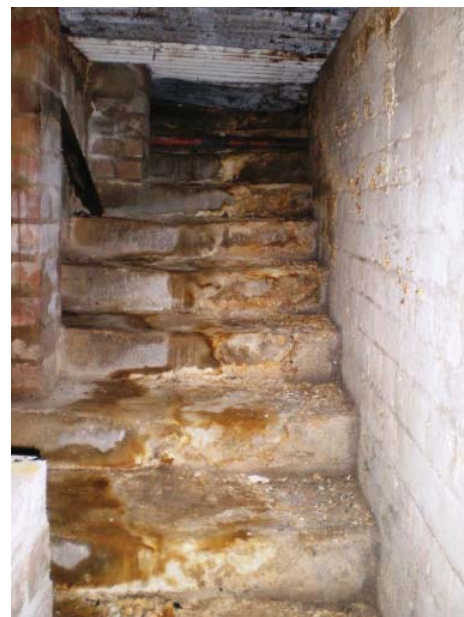
Figure 3.6.5
Sealed up stairway to original kitchen and showing much water penetration from concrete verandahs and garden spaces above

- The original ceiling height on the ground and first floors of *Glentworth House* should be maintained as existing.
- The remnant *Glentworth House* basement kitchen, scullery and pantry spaces, together with the stairway access, should be conserved and waterproofed, with the stairs repaired. The space should be interpreted and if possible based on the proviso that there is no impact to the original elements.

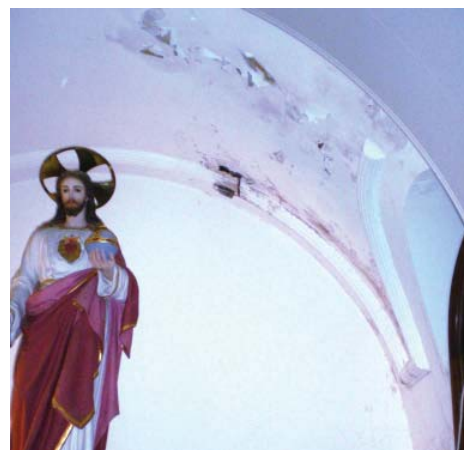
Figure 3.6.6
Evidence of water penetration in alcove area of the Chapel

The most substantial addition to the original built fabric was the Chapel, which is now an established part of the heritage footprint. Again, while the Chapel presents with an overall integrity of form, fabric and finish, maintenance problems are apparent upon closer inspection. There is some deterioration around external window joinery and there is evidence of water penetration in the smaller alcoved areas, most likely from roofing and guttering breakdown. The Chapel is a space for liturgy and reflection. For the first 35 years of its life it was in intensive daily use, and a highly maintained space, with a full compliment of movable patrimony. As it currently presents, it is a more or less neutral space that is substantially under-utilised. There is reservation of the Blessed Sacrament for personal devotion and a mass for a small congregation on some days of the week, with occasional (monthly) sung Office of the Church by outside groups.

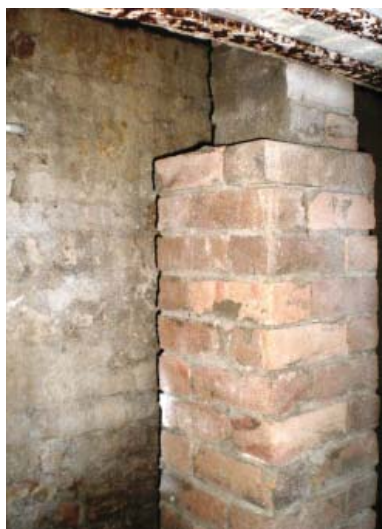
Figure 3.6.7
Introduced foundations under *Glentworth House* (rear) and evidencing water penetration

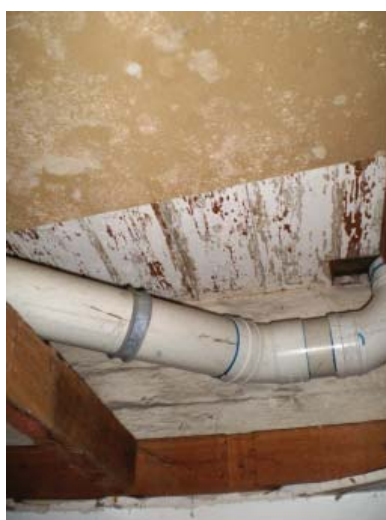
Figure 3.6.8
Typical example of introduced PVC plumbing arrangements

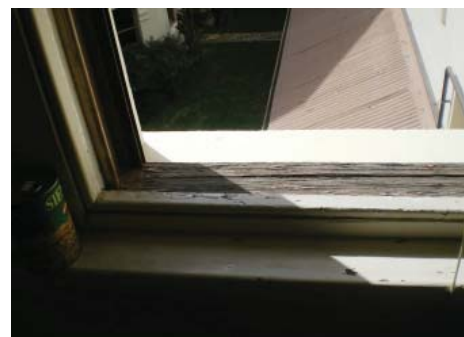
Figure 3.6.9
Deterioration of window joinery, first floor Parlours building (annex)

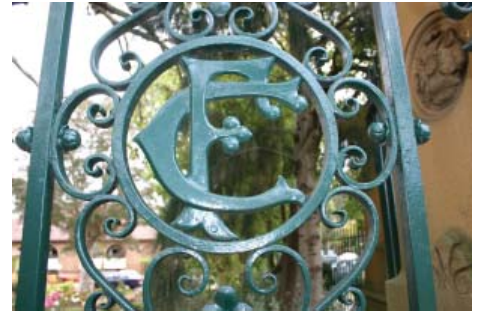
Figure 4.1
The large stone pilasters that frame the entrance gate, replete with the Frederick Clissold initials provide a strong ritual entrance

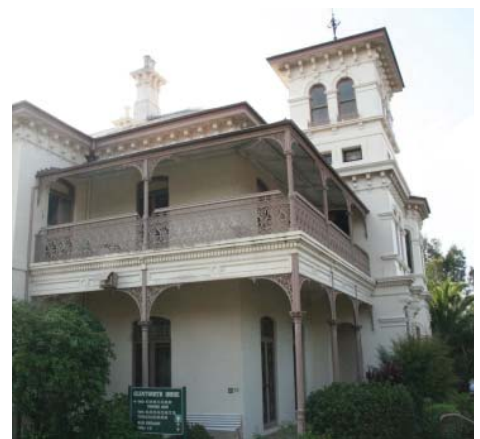
Figure 4.2.
Glentworth House with iron lacework and imposing tower provide good example of *Italianate* grandeur

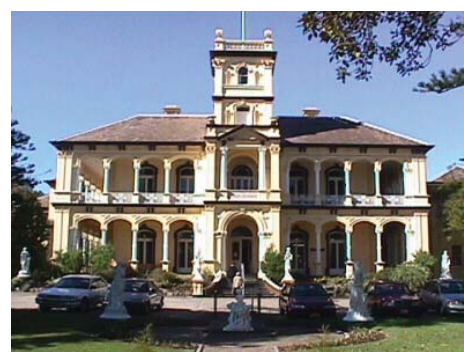
Figure 4.8
Image, War Memorial Hospital, Birrell Street Waverly, a grand *Italianate* residence with typical tower, and set in landscaped gardens
(Source: <http://www.heritage.nsw.gov.au>)

The War Memorial Hospital Group comprises a very fine collection of high Victorian buildings. All the Victorian buildings in this group form a coherent unit of historical interest which, by virtue of the continued connection of the Vickery family, and also with the hospital, is carried on to the later buildings which are well placed in relation to the earlier buildings. Ebenezer Vickery was a prominent and influential Methodist layman. The centrepiece, *Edina*, is the most elaborate house in the area, very well preserved and maintained with good examples of all types of applied ornament. *Edina* is a large two storey house with tower built c 1880-90. The exterior is a good example of coarse iron and tiling on verandahs. Fine cedar joinery inside and house is complemented by two other buildings, *Banksia* and *Witchagil*, two semi-detached and one detached identical two storey Victorian villas, c 1880-90. The gates, detached from main part hospital grounds, are elaborate cast iron with iron gate posts.

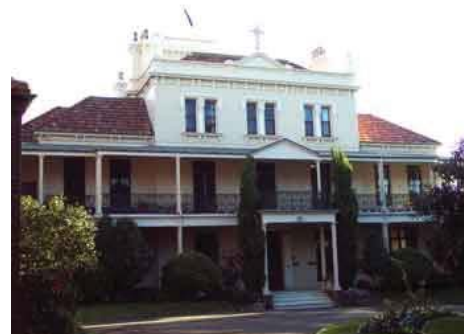
Figure 4.9
Front entry to St Scholastica's Convent Glebe, formerly Toxteth Park, and showing the 1880 third storey additions with tower, in the *Italianate* style, and presenting in established gardens
(Source: <http://www.sydneymarchitecture.com>)

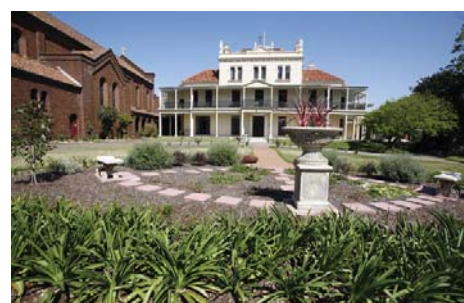
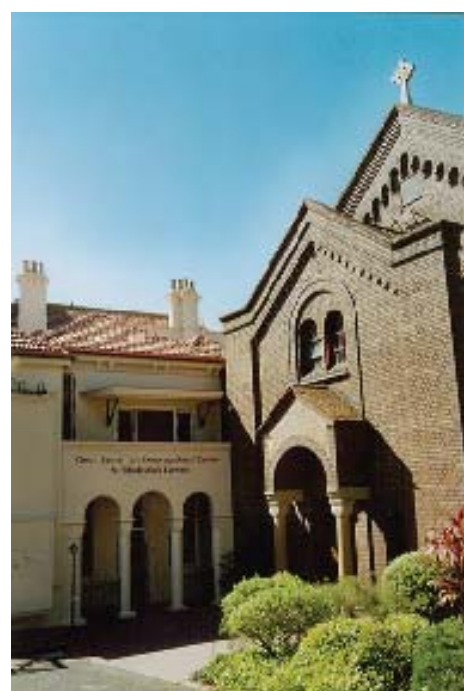
Figure 4.10 (a) and (b)
Two images of St Scholastica's Glebe, showing the relationship between the original residence and the later Chapel addition
(Source: <http://www.cityofsydney.nsw.gov.au>)

extensions to the main residence that took place in unison with the Chapel construction. The eaves lines are also in keeping with the line established by the old house, and though the Chapel is large is maintains a relative overall seamlessness.

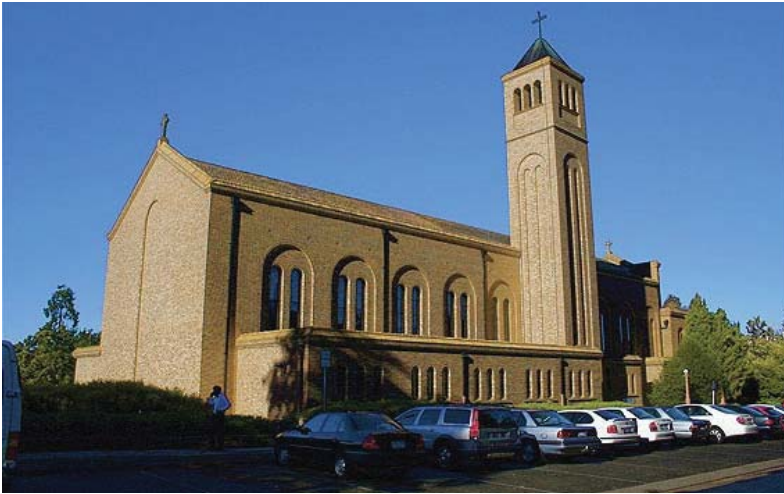
Figure 4.11
Image, St Christopher's Catholic Cathedral, Canberra, designed by Glancey and probably Rosetta Edmunds. It was constructed in the late 1930s and bears many similarities to the subject Chapel in Ashfield
(Source: www.ohta.org.au)

The subject Chapel on this site is a work by Clement Glancy. It is possible that Rosette Edmunds had some part in the design, with certain likenesses to other ecclesiastical works in which she had a hand, such as St Christopher's Cathedral Canberra. In this case the building is rendered in a light colouration to harmonise with the older main residence (the Convent) as well as the residential

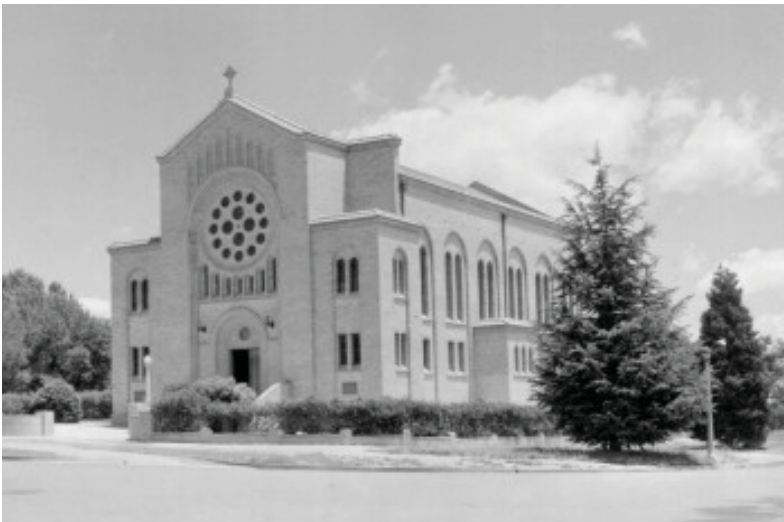
Figure 4.12
Historic image of St Christopher's Catholic Cathedral, Canberra (Clement Glancey and probably Rosetta Edmunds). It bears many similarities to the subject Chapel in Ashfield
(Source: www.images.act.gov.au/duslibrary/imagesact)

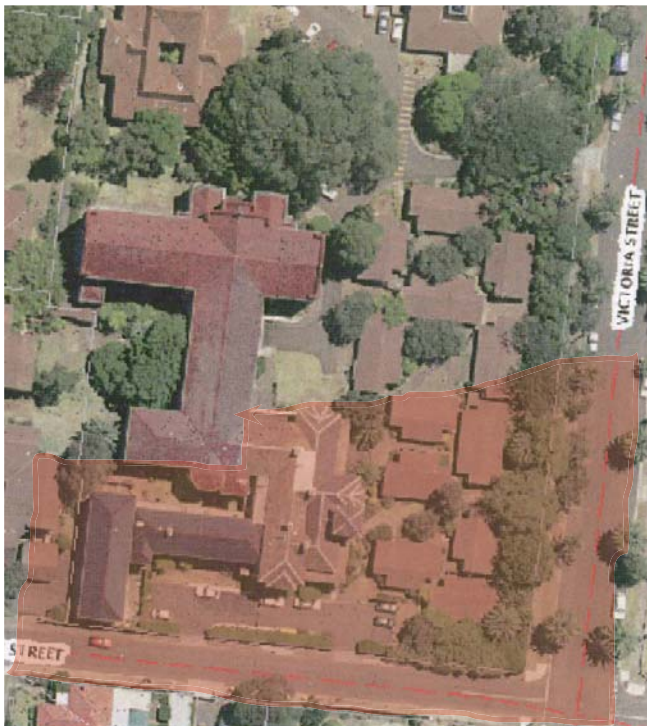
Figure 4.14
The determined curtilage of *Glentworth House* (as shaded) is to be best appreciated from its south-east visual arc, which extends across Victoria and Seaview Streets and north to the original main entrance (Source: NSW Department of Lands SIXViewer)
