SUPPORTING DATA

- B.1 Aerial Photography
- B.2 ALS Survey Data
- B.3 Stream Photography
- B.4 Structure Survey & Photography
- B.5 June 1991 Rainfall Hyetographs
- B.6 June 1991 Albion Park Stage Record
- B.7 June 1991 Princes Highway Stage Record
- B.8 Albion Park(Sunnybank) Rating Curve
- B.9 Princes Highway Rating Curve
- B.10 June 1991 Flood Photography
- B.11 June 1991 Recorded Flood Levels

CALDERWOOD
URBAN DEVELOPMENT PROJECT

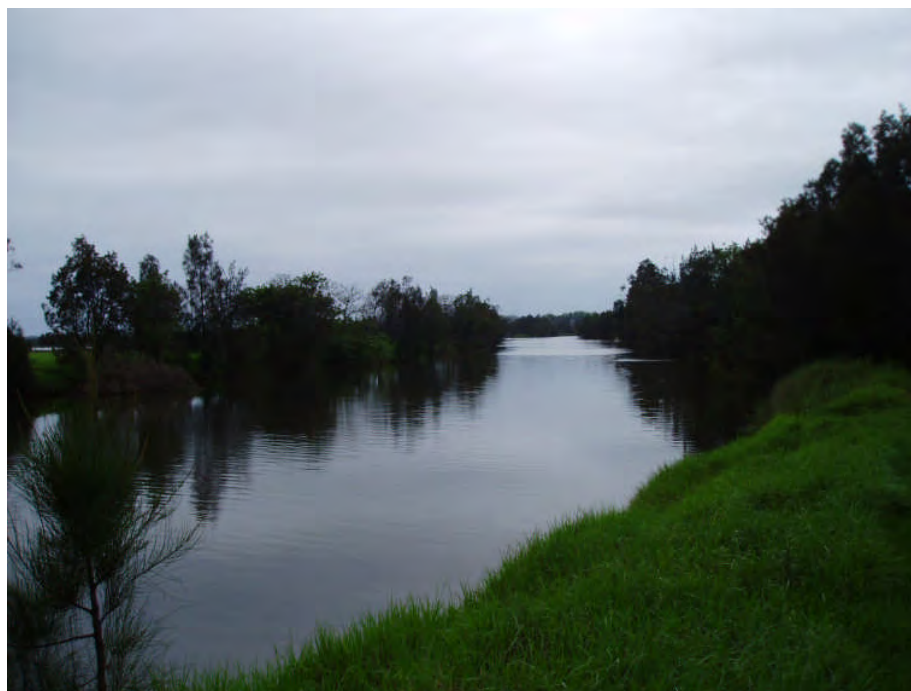
Macquarie Rivulet D/S Illawarra Rail Bridge (Feb 2007)

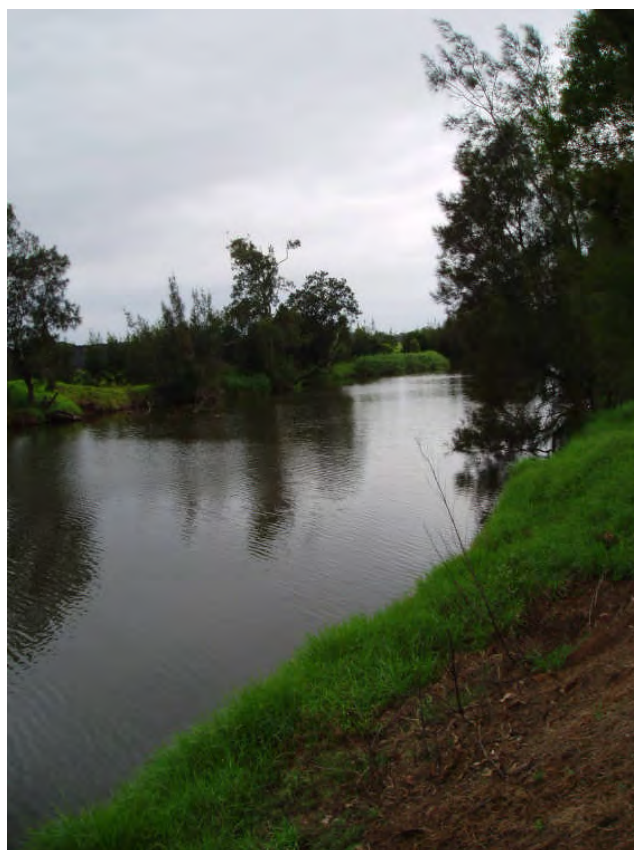
Macquarie Rivulet D/S Princes Highway Road Bridge (Feb 2007)

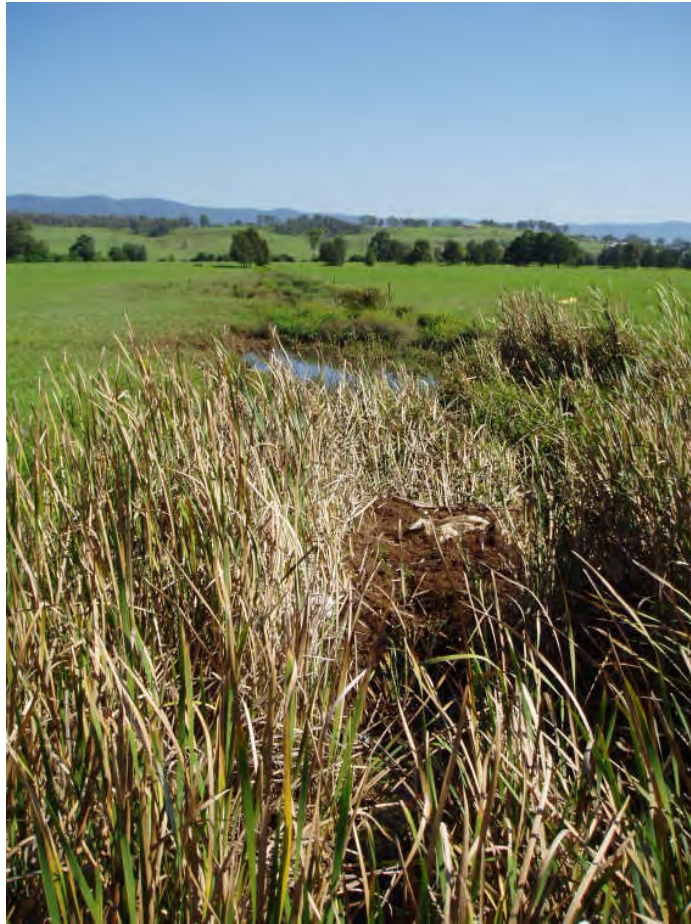
Frazers Creek D/S Illawarra Highway (Feb 2007)

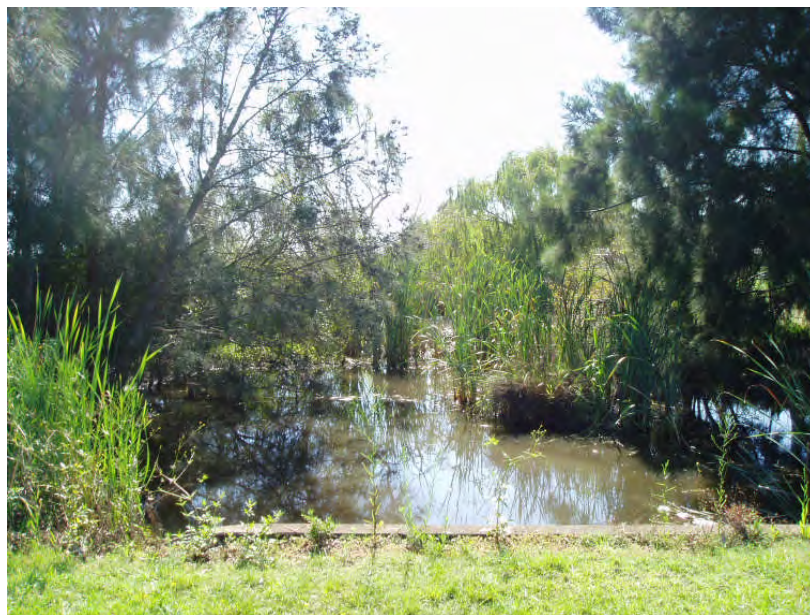
Town Creek D/S Illawarra Highway (Feb 2007)

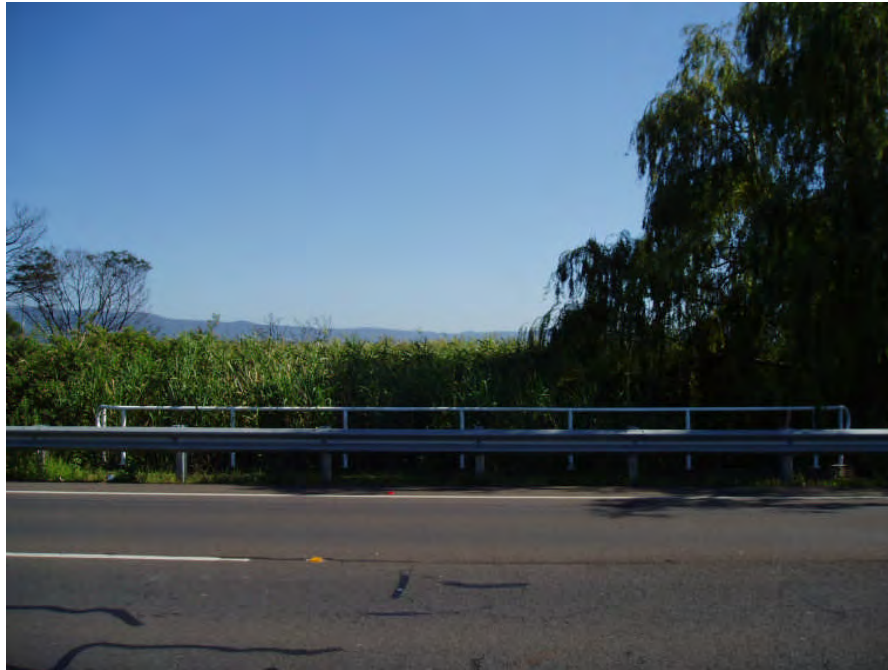
Frazers Creek West D/S Tongarra Rd (Feb 2007)

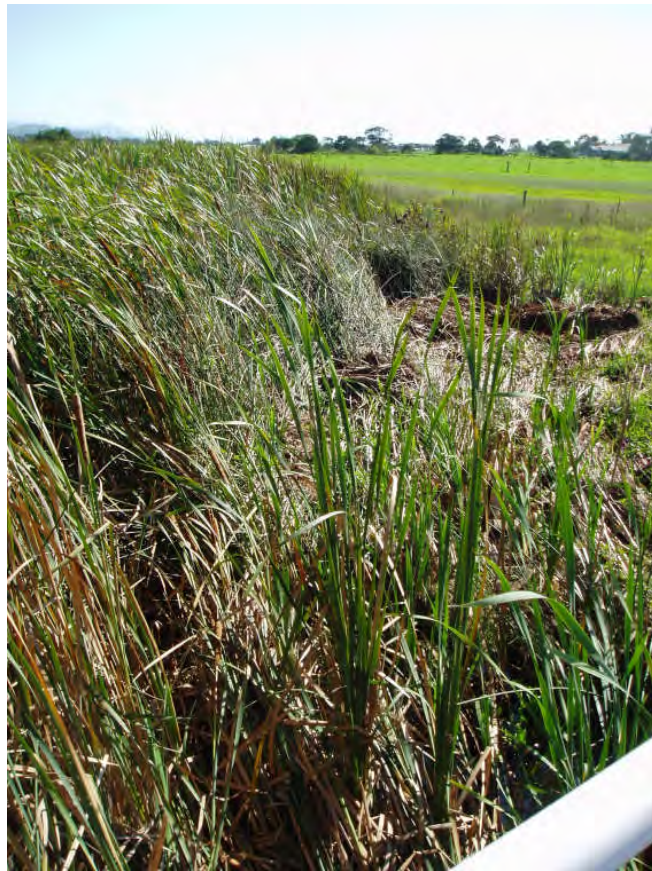
Frazers Creek Central D/S Tongarra Rd (Feb 2007)

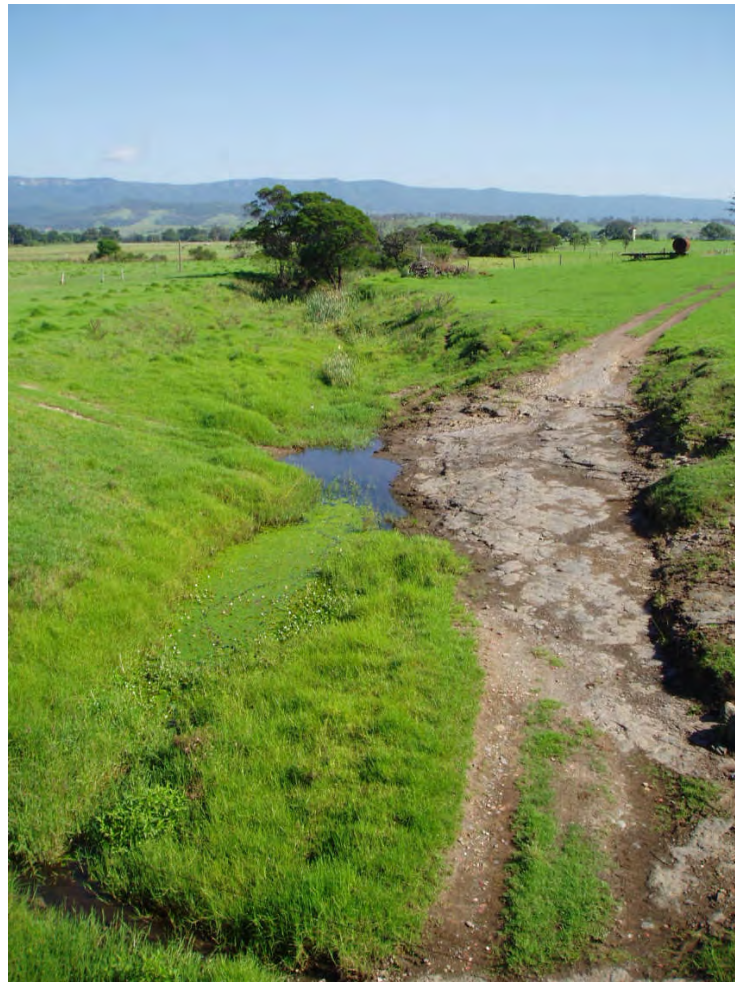
Frazers Creek East D/S Tongarra Rd (Feb 2007)

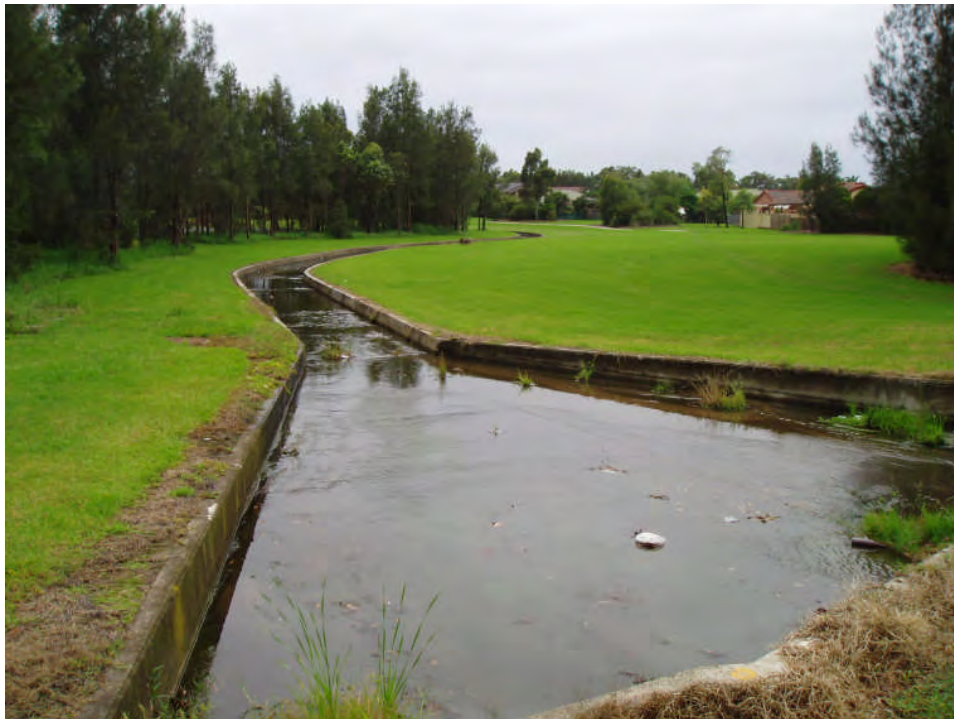
Albion Creek D/S Princes Highway (Feb 2007)

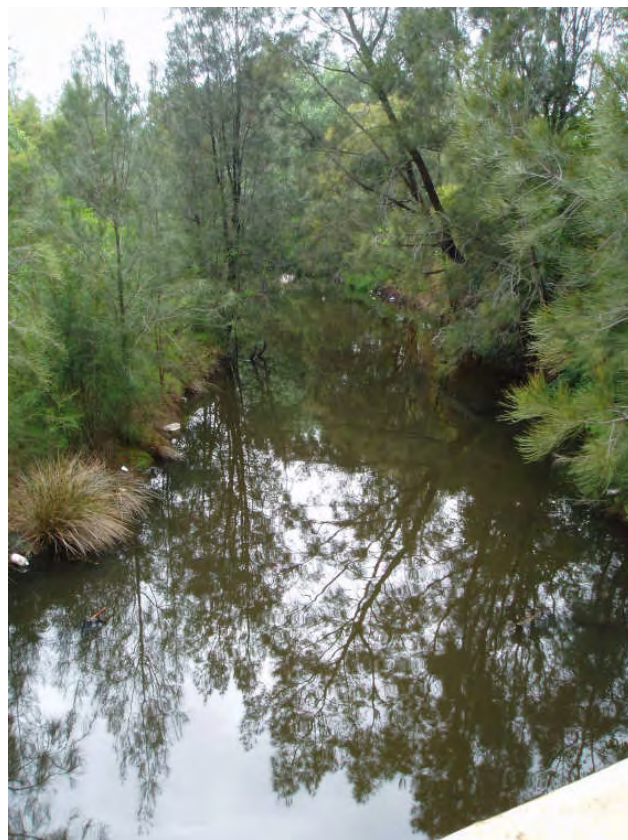
Albion Creek D/S Shearwater Drive (Feb 2007)

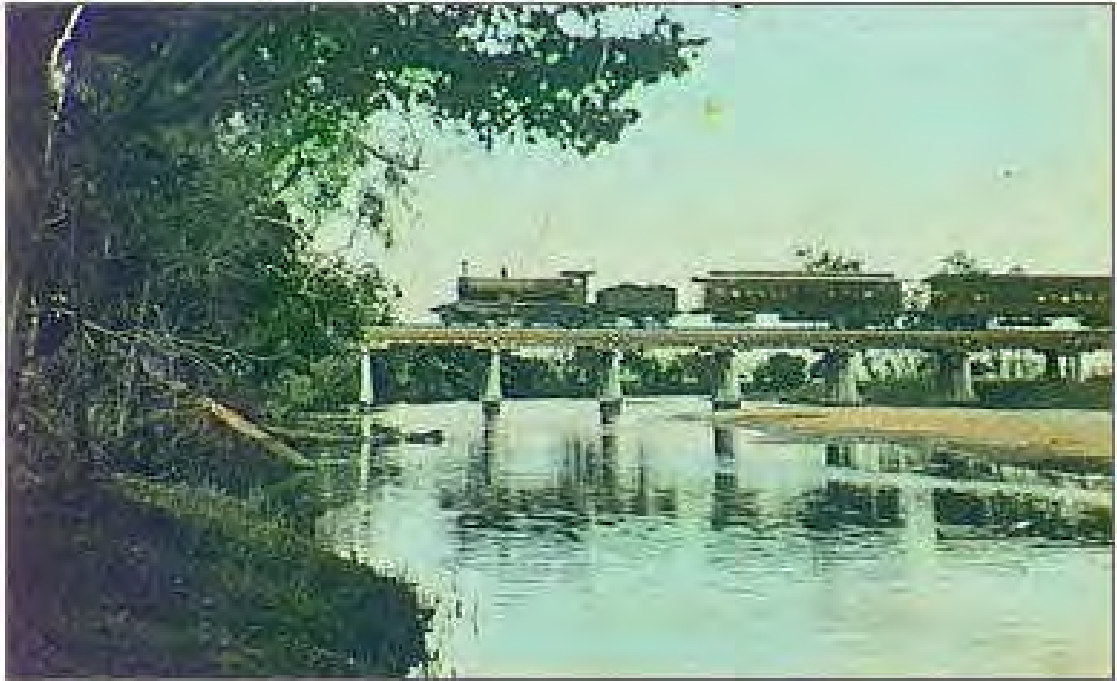
Original Illawarra Rail Bridge over Macquarie Rivulet circa 1908

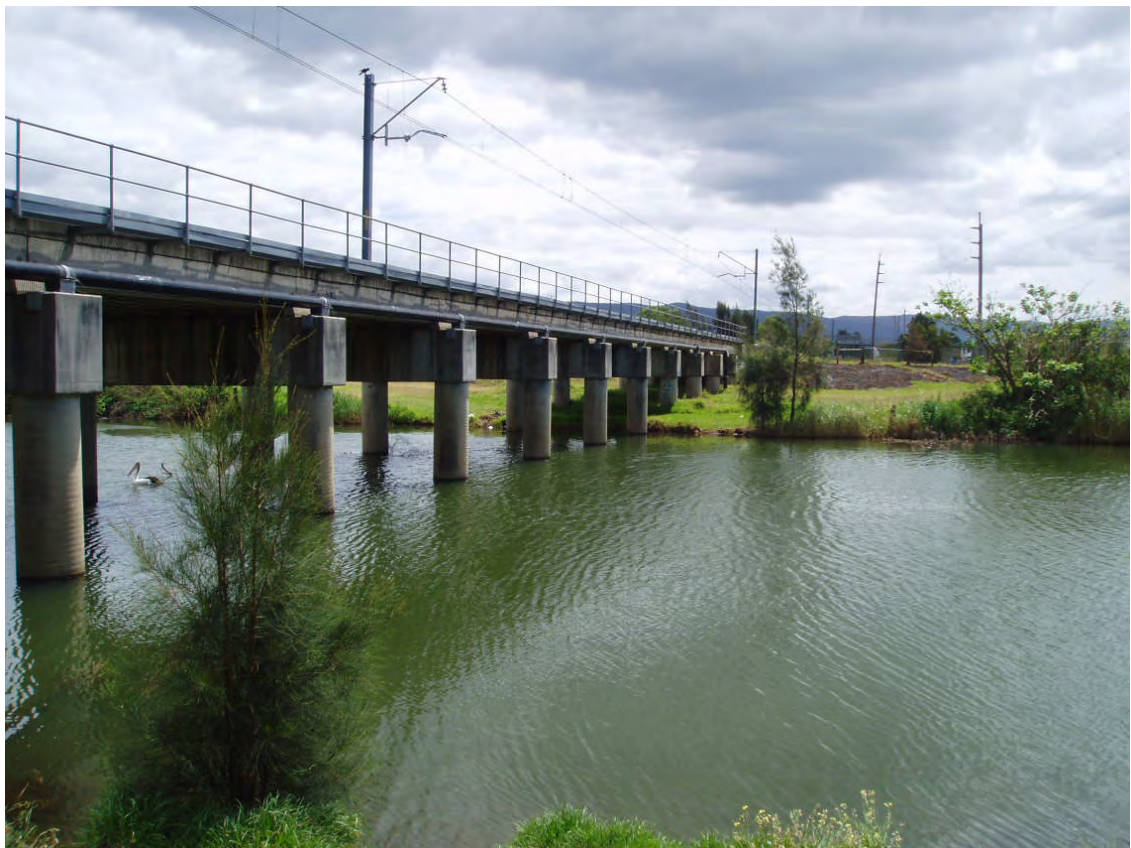
Present Illawarra Rail Bridge over Macquarie Rivulet

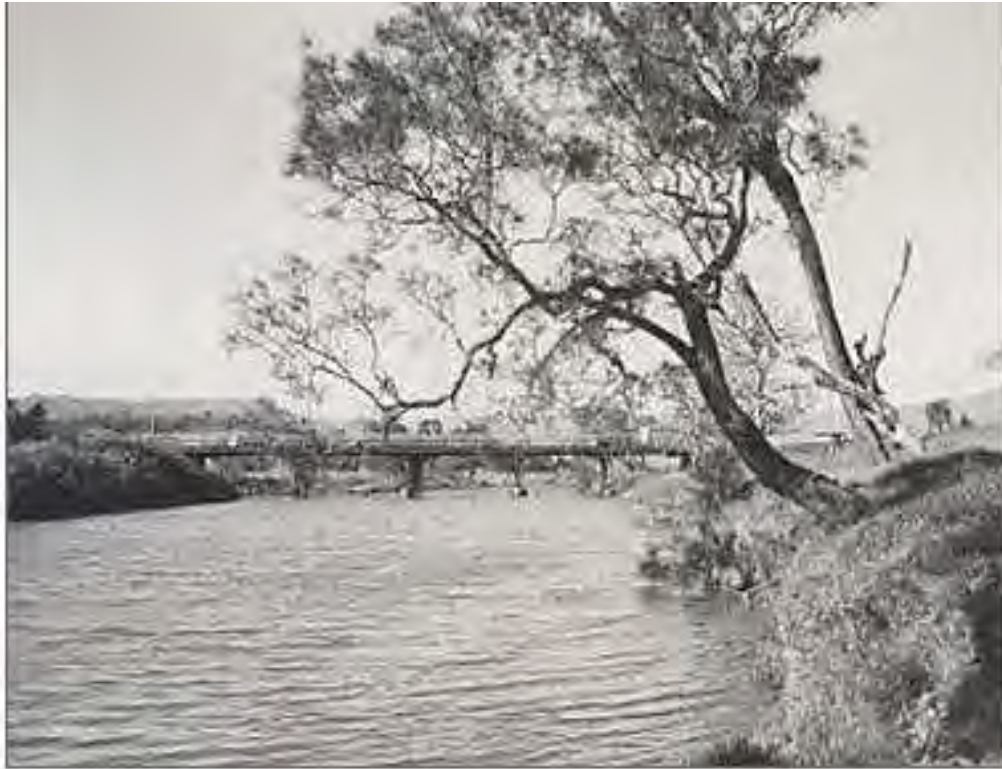
Early Princes Highway Road Bridge over Macquarie Rivulet circa 1950

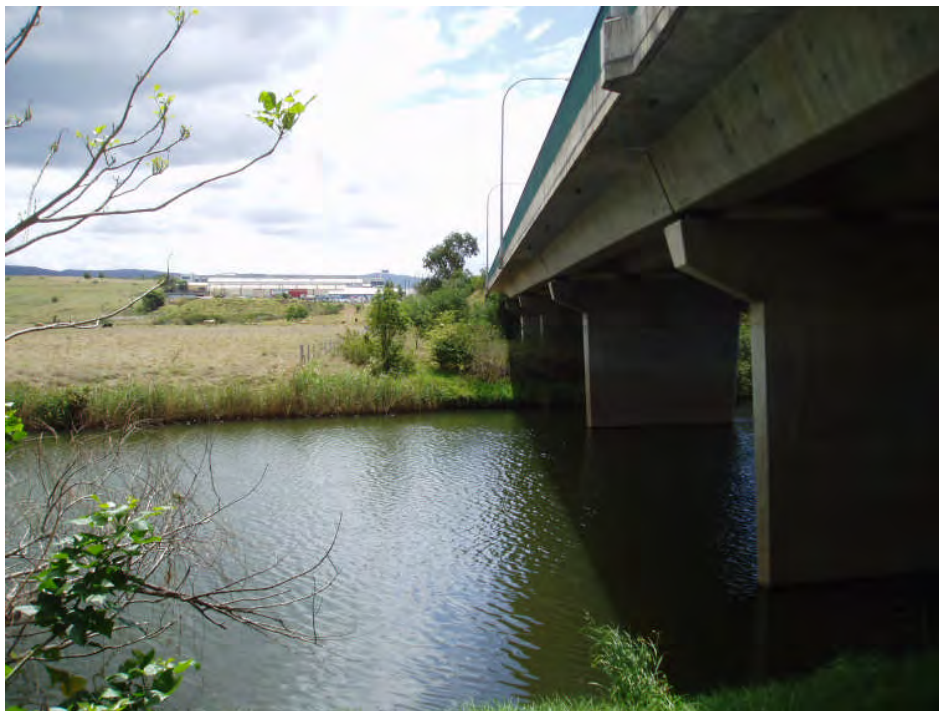
Present Macquarie Rivulet Road Bridge over Macquarie Rivulet

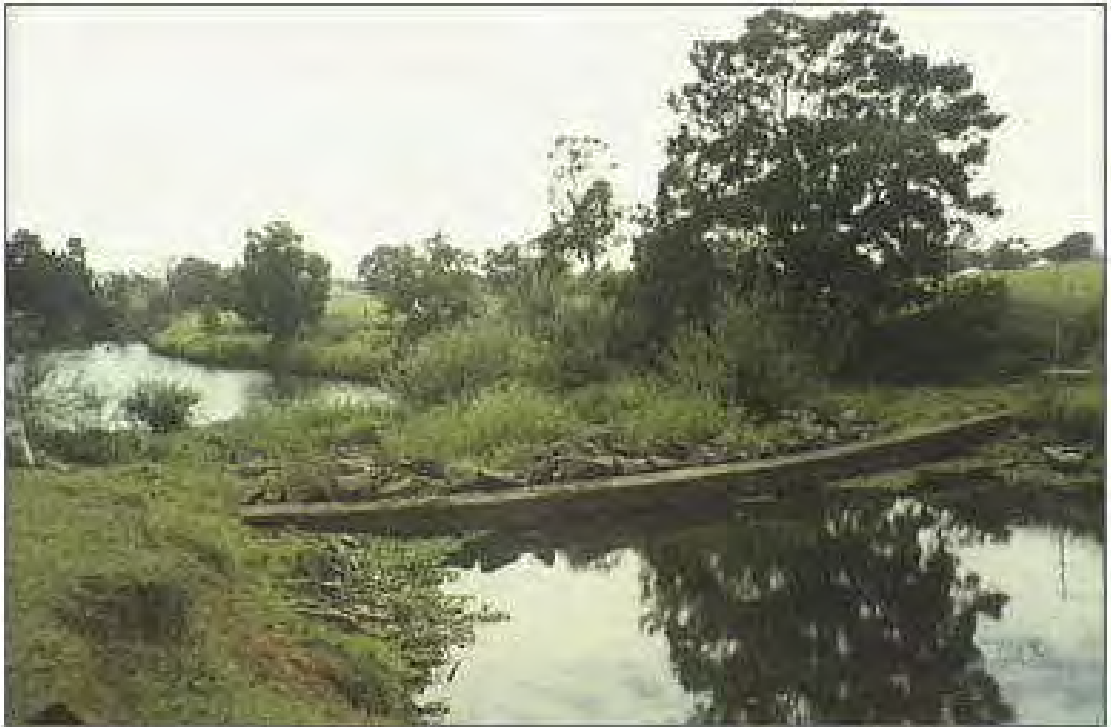
Weir in Macquarie Rivulet near Meadow View

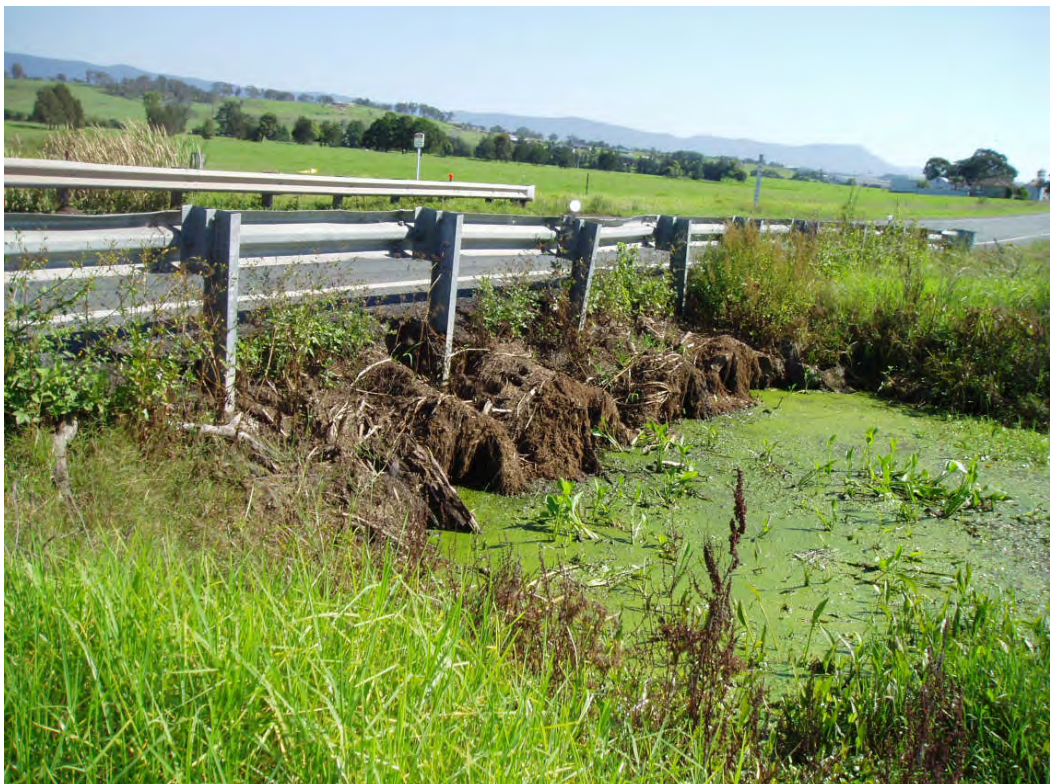
Illawarra Highway Road Culvert @ Frazers Ck

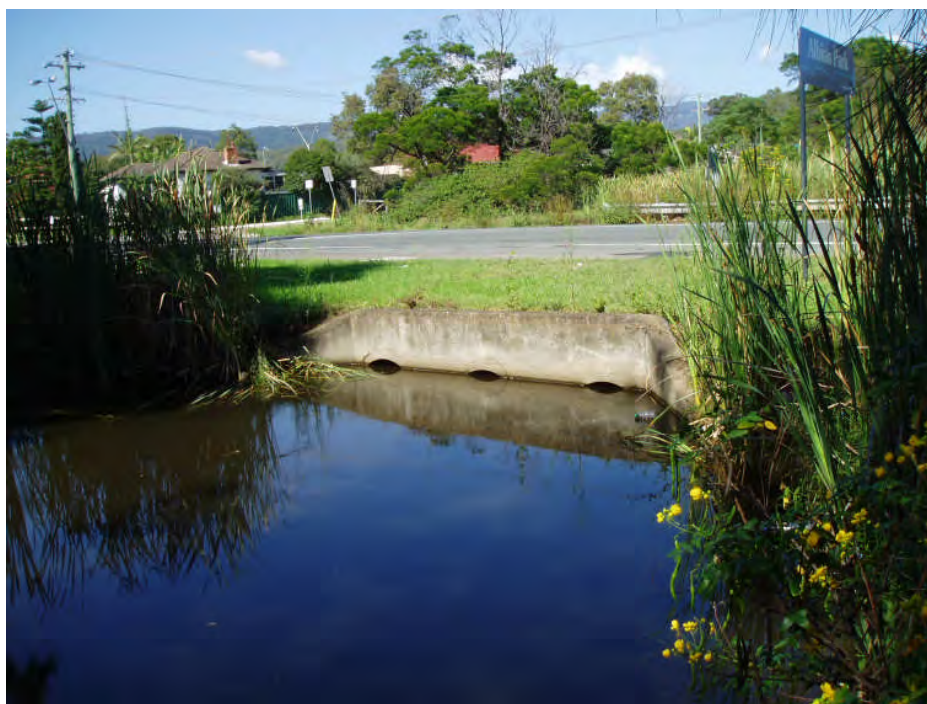
Illawarra Highway Culvert @ Town Creek

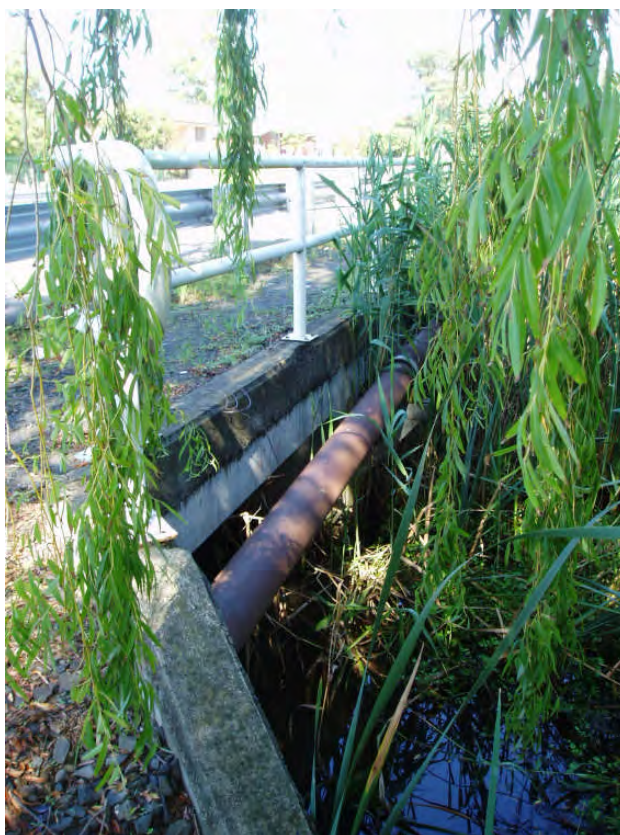
Tongarra Rd Culvert @ Frazers Ck (West)

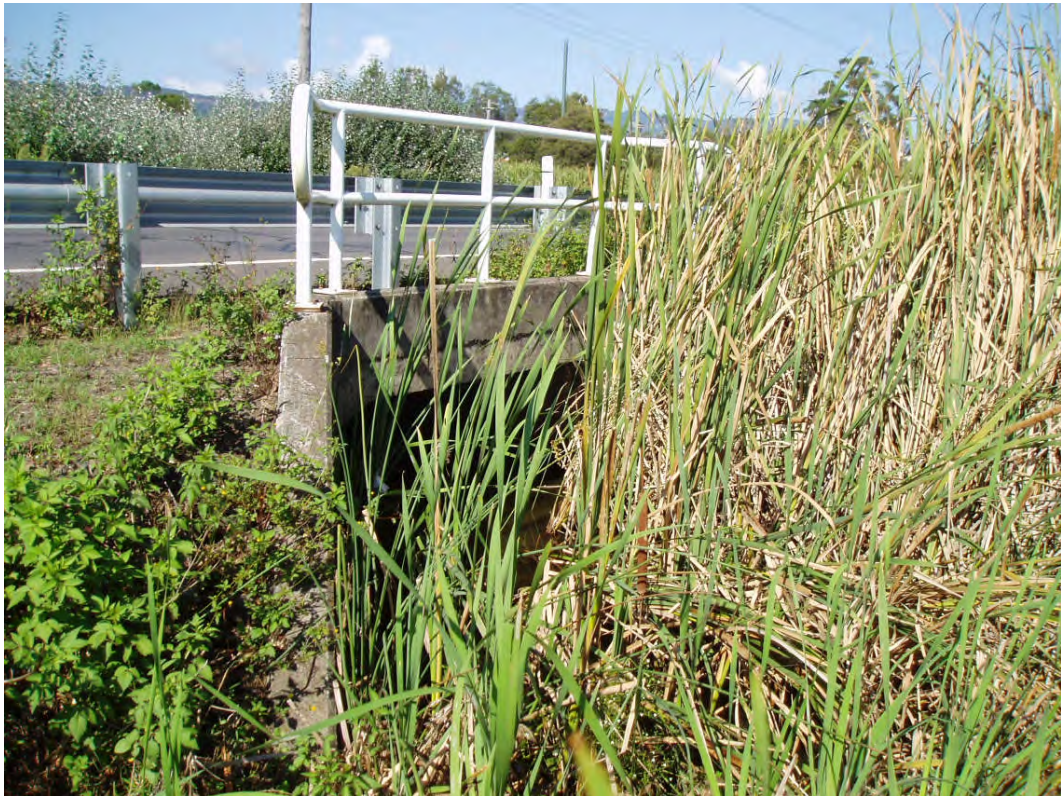
Tongarra Rd Culvert @ Frazers Ck (Central)

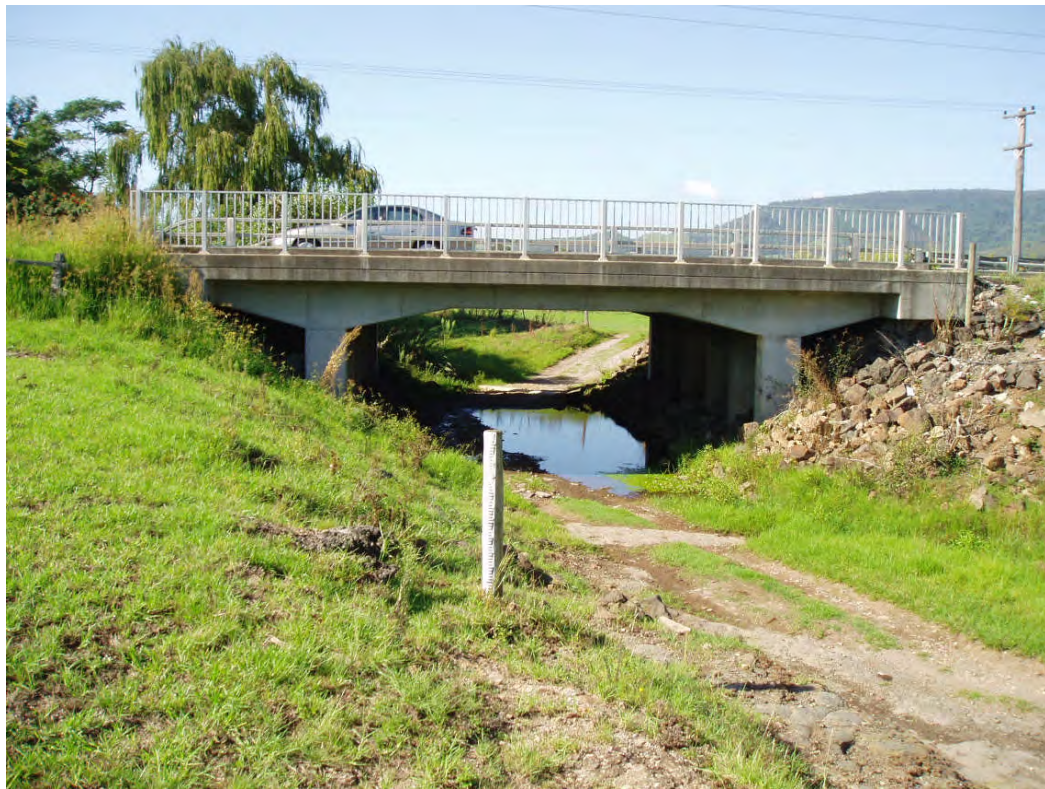
Tongarra Rd Bridge @ Frazers Ck (East)

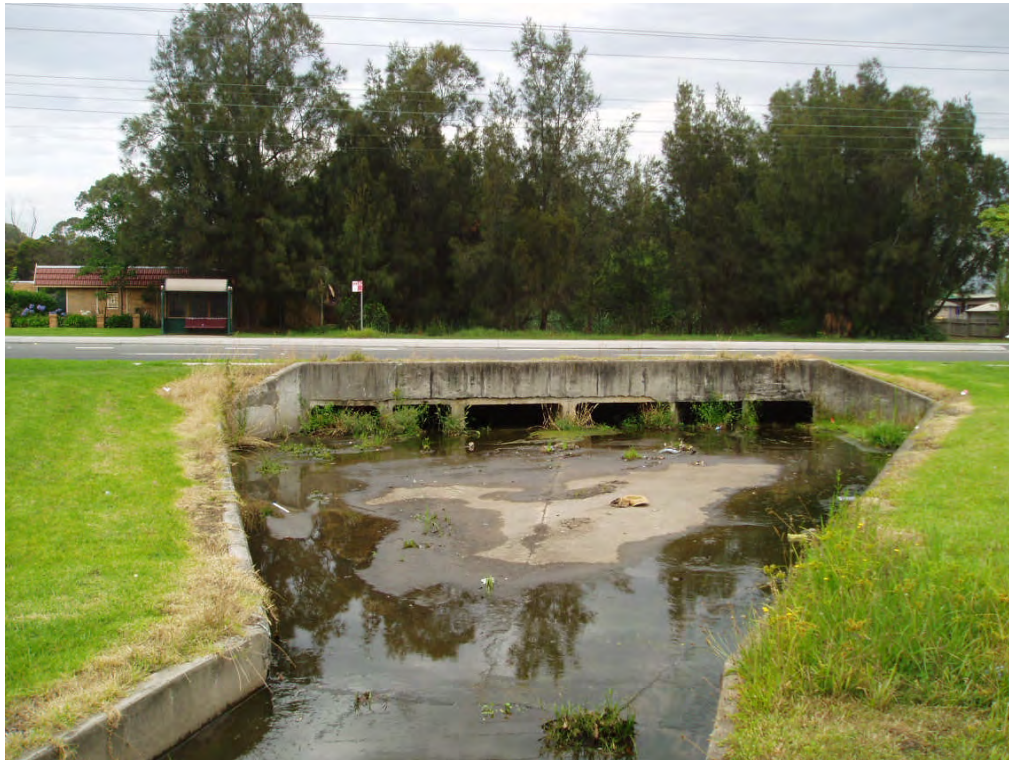
Albion Ck Culvert @ Princes Highway

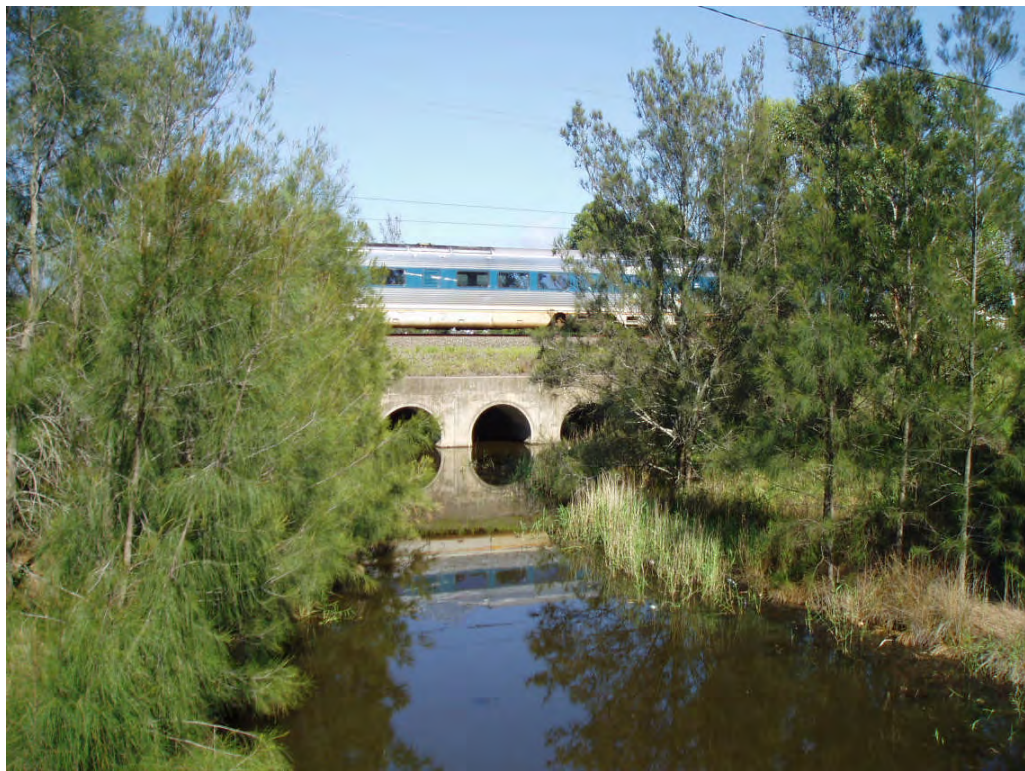
Albion Ck Culvert @ Illawarra Rail

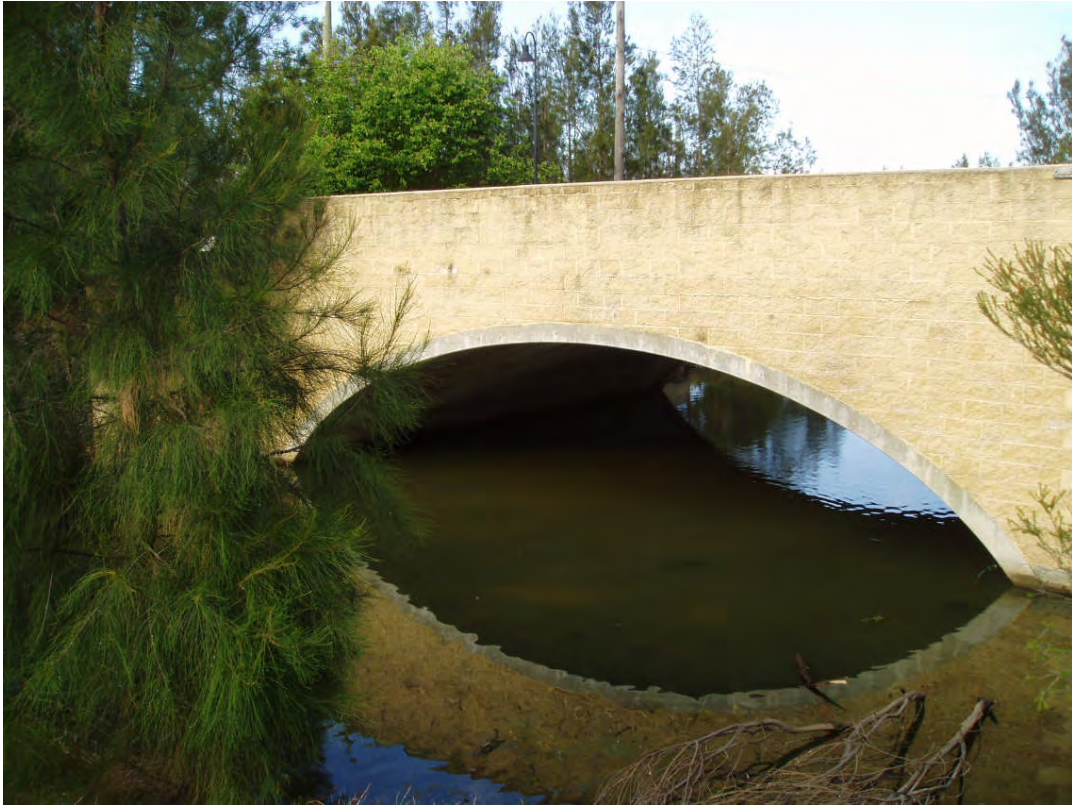
Albion Ck Culvert @ Shearwater Dr

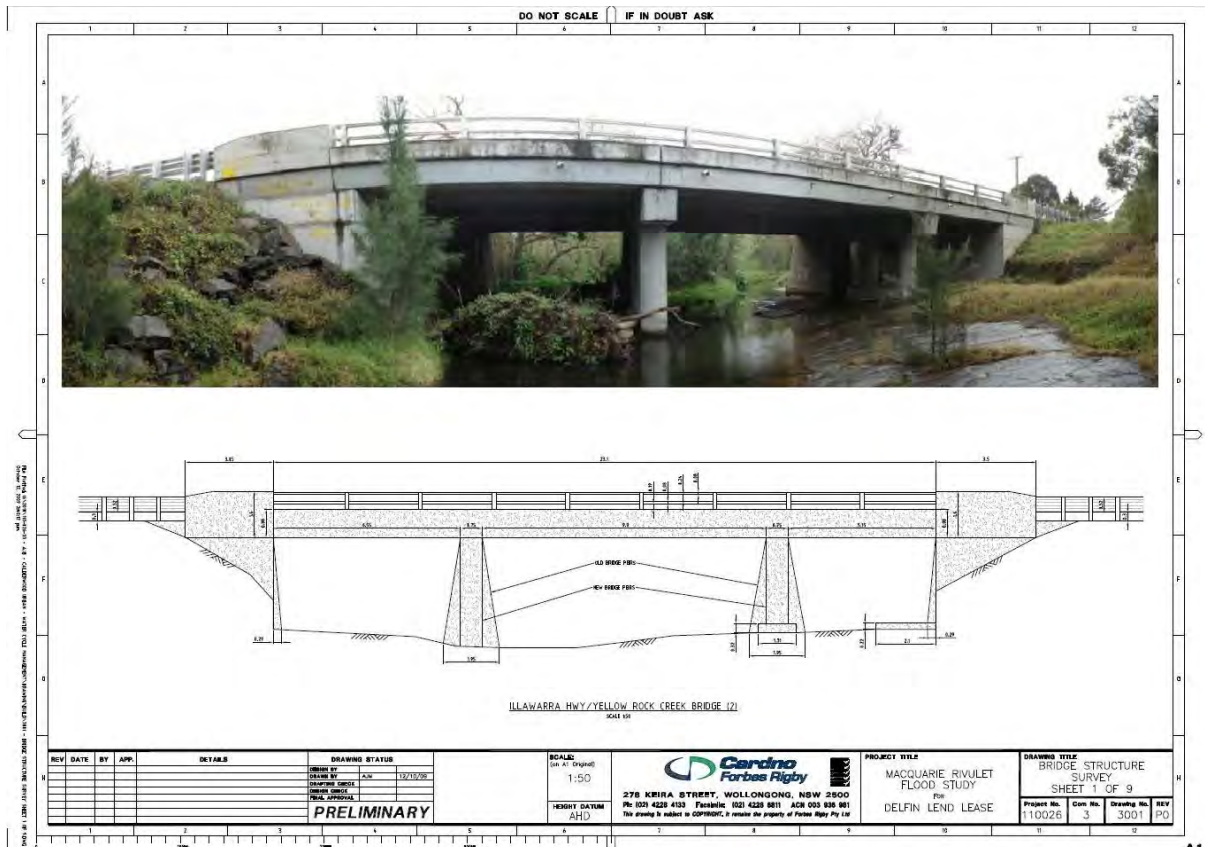
BRIDGE OVER YELLOW ROCK CK – ILLAWARRA HWAY

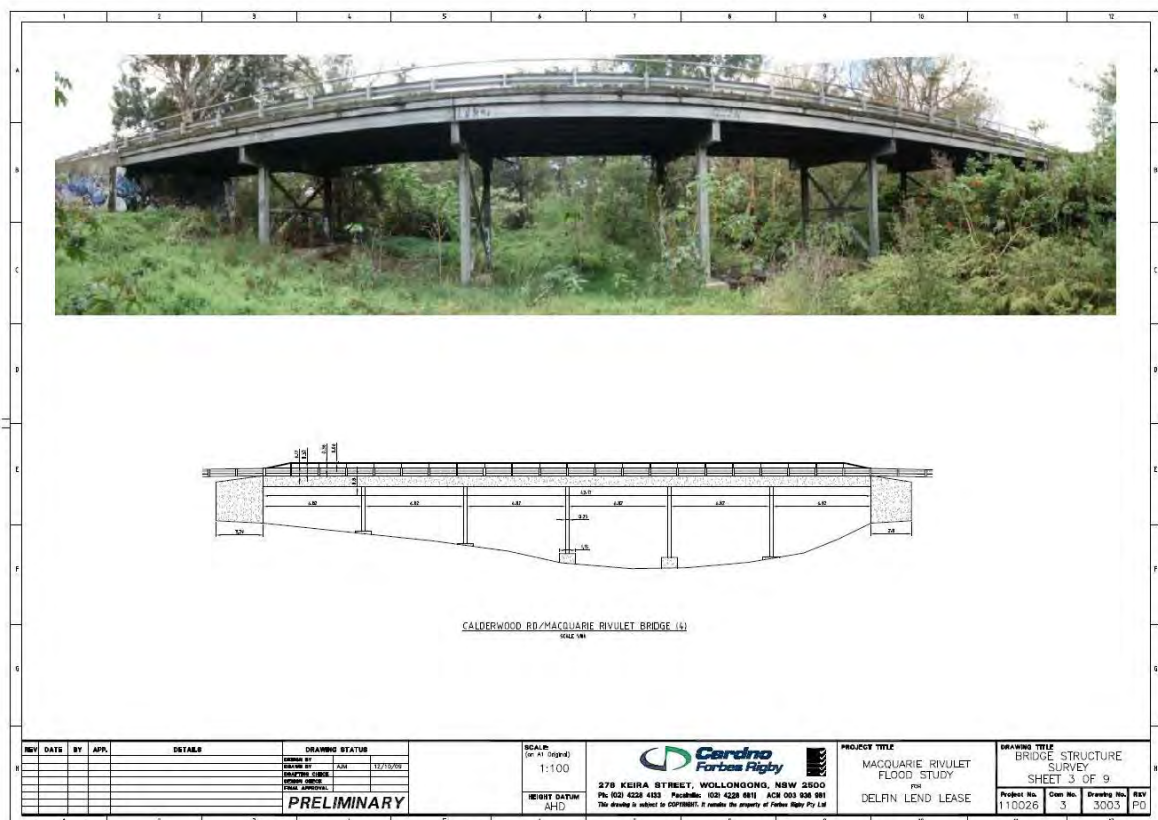
MANSONS BRIDGE – CALDERWOOD RD

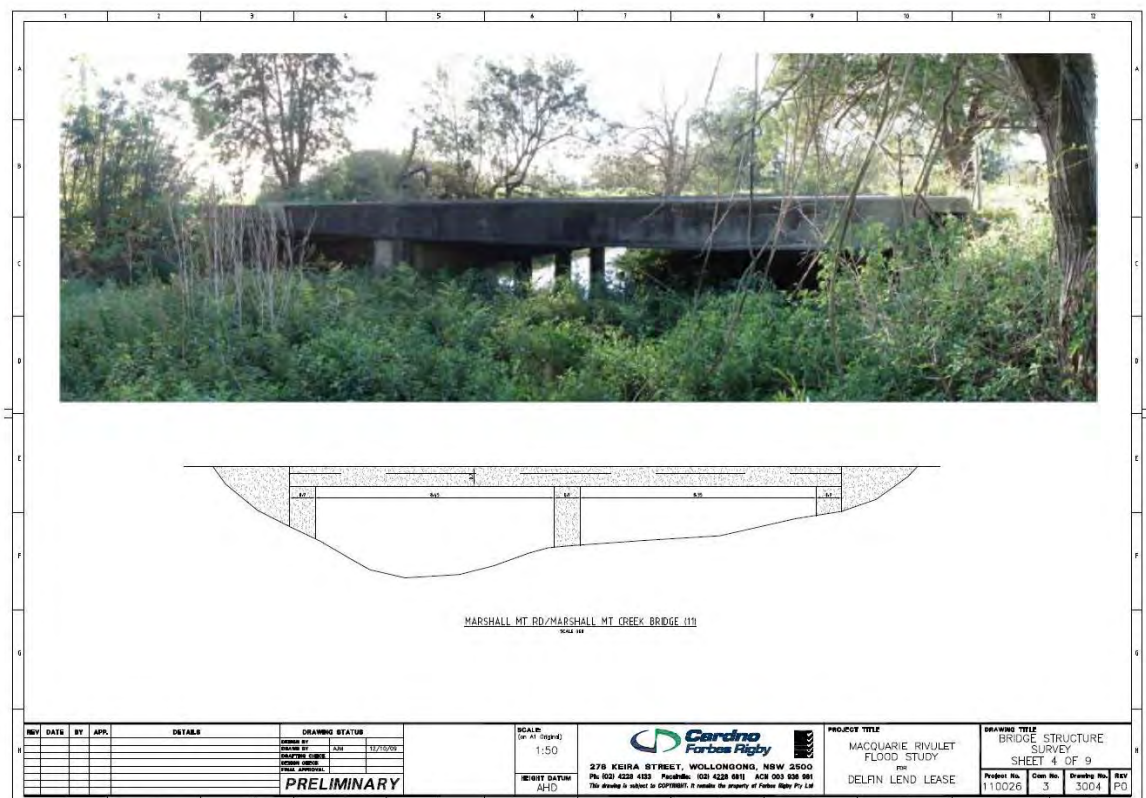
BRIDGE OVER MARSHALL MT CK – MARSHALL MT RD

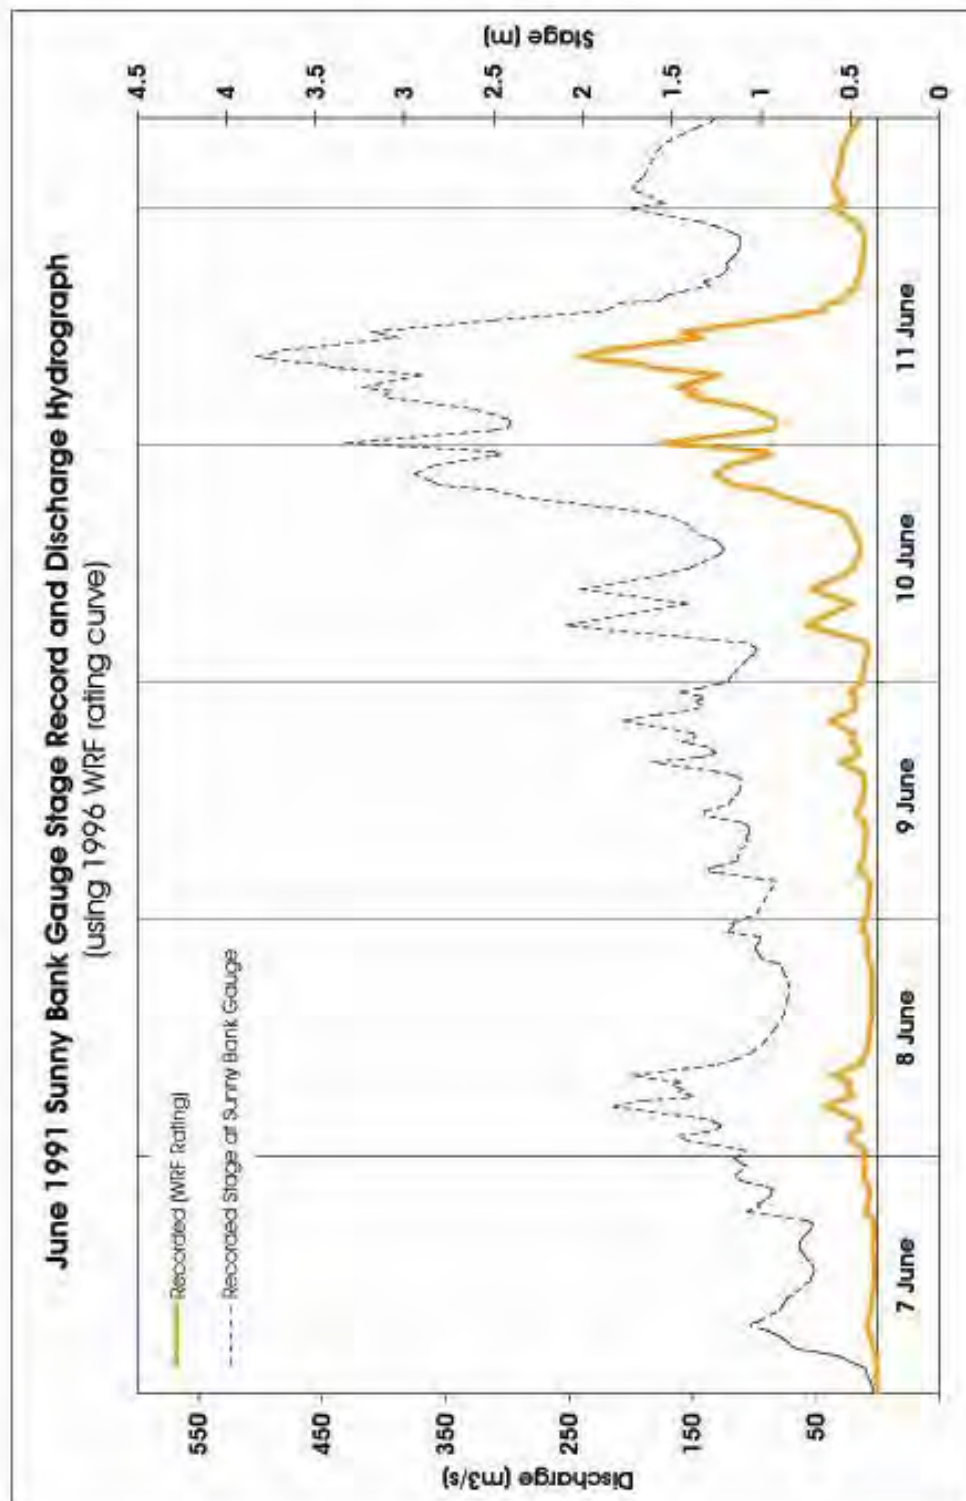
APPENDIX B6. JUNE 1991 ALBION PARK (SUNNYBANK) STAGE RECORD

The Department of Natural Resources (now DECC) operates a continuous stage recorder (CSR) immediately downstream of the Princes Highway road bridge. Tables A.-1 and A-2 provide a summary of the data recorded during the June 1991 flood event.(refer also stage hydrograph plot in Appendix B7)

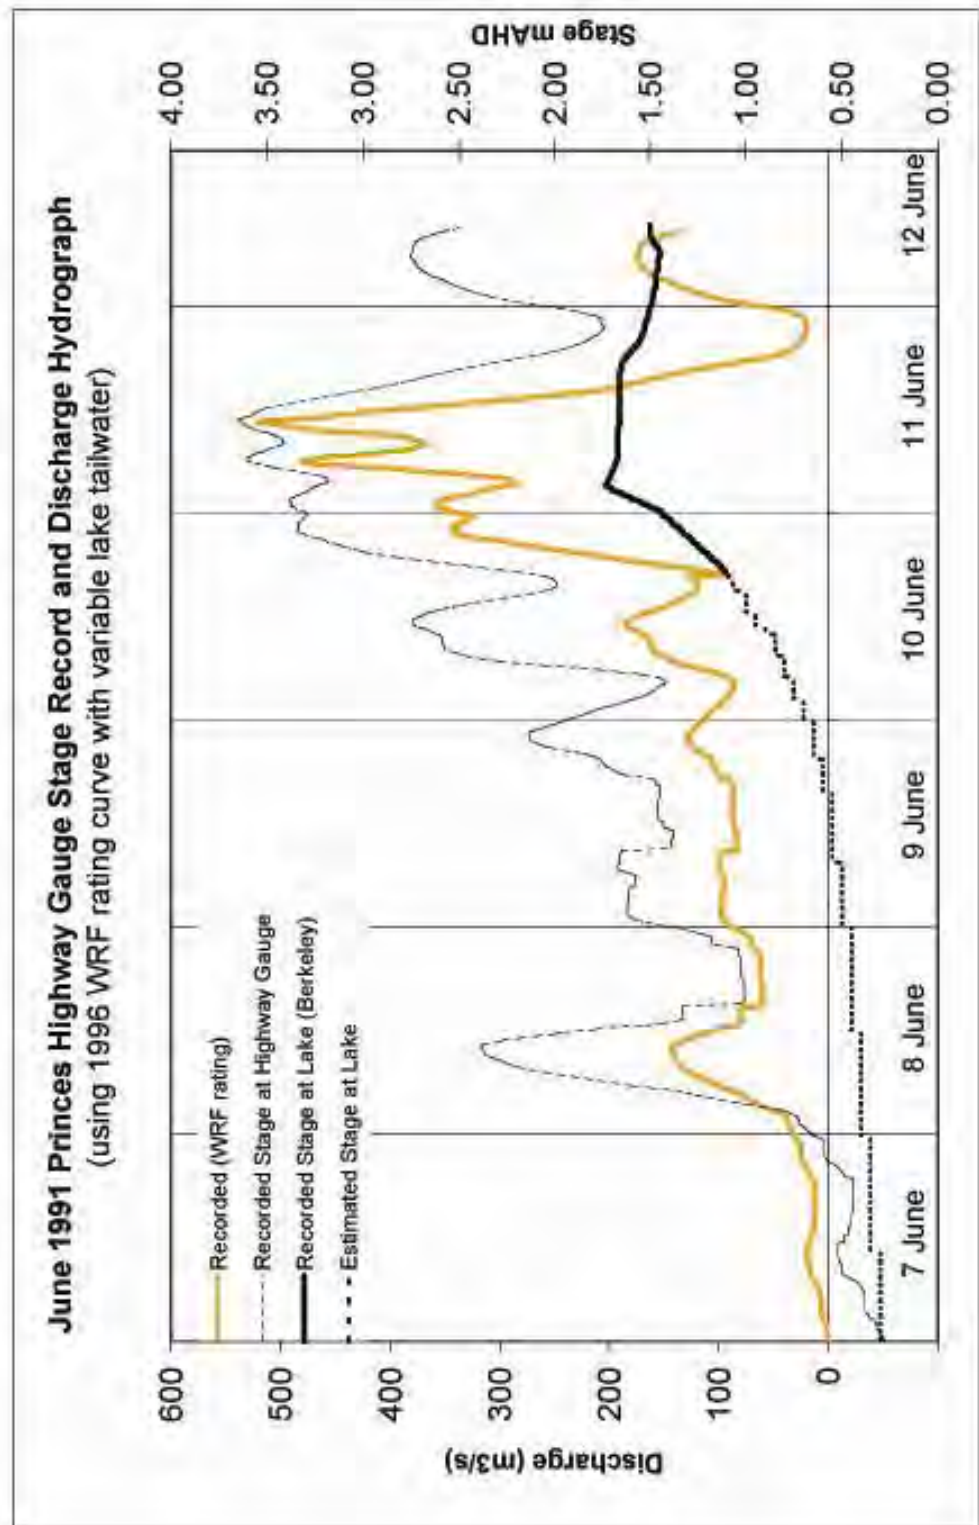
APPENDIX B7. JUNE 1991 PRINCES HIGHWAY STAGE RECORD

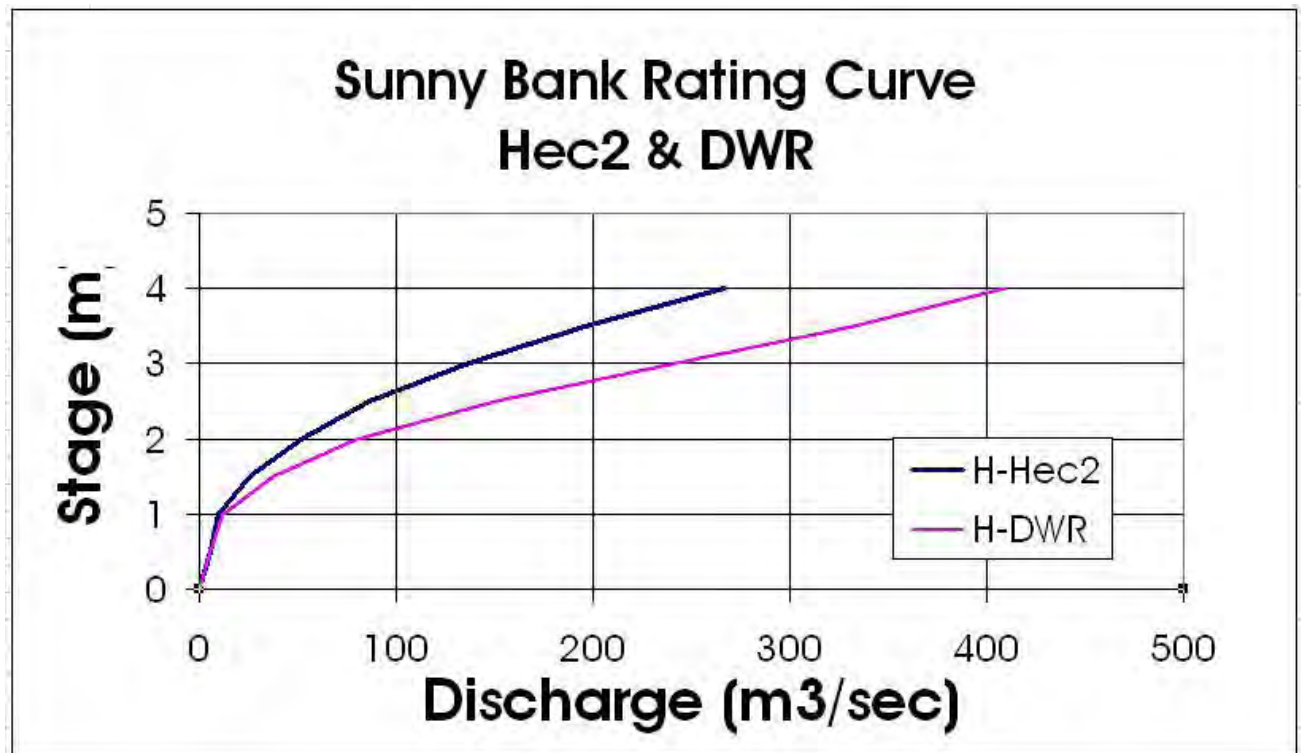
APPENDIX B8. ALBION PARK (SUNNYBANK) RATING CURVE
