SUPPORTING DATA

- B.1 Aerial Photography
- B.2 ALS Survey Data
- B.3 Stream Photography
- B.4 Structure Survey & Photography
- B.5 June 1991 Rainfall Hyetographs
- B.6 June 1991 Albion Park Stage Record
- B.7 June 1991 Princes Highway Stage Record
- B.8 Albion Park(Sunnybank) Rating Curve
- B.9 Princes Highway Rating Curve
- B.10 June 1991 Flood Photography
- B.11 June 1991 Recorded Flood Levels

CALDERWOOD
URBAN DEVELOPMENT PROJECT

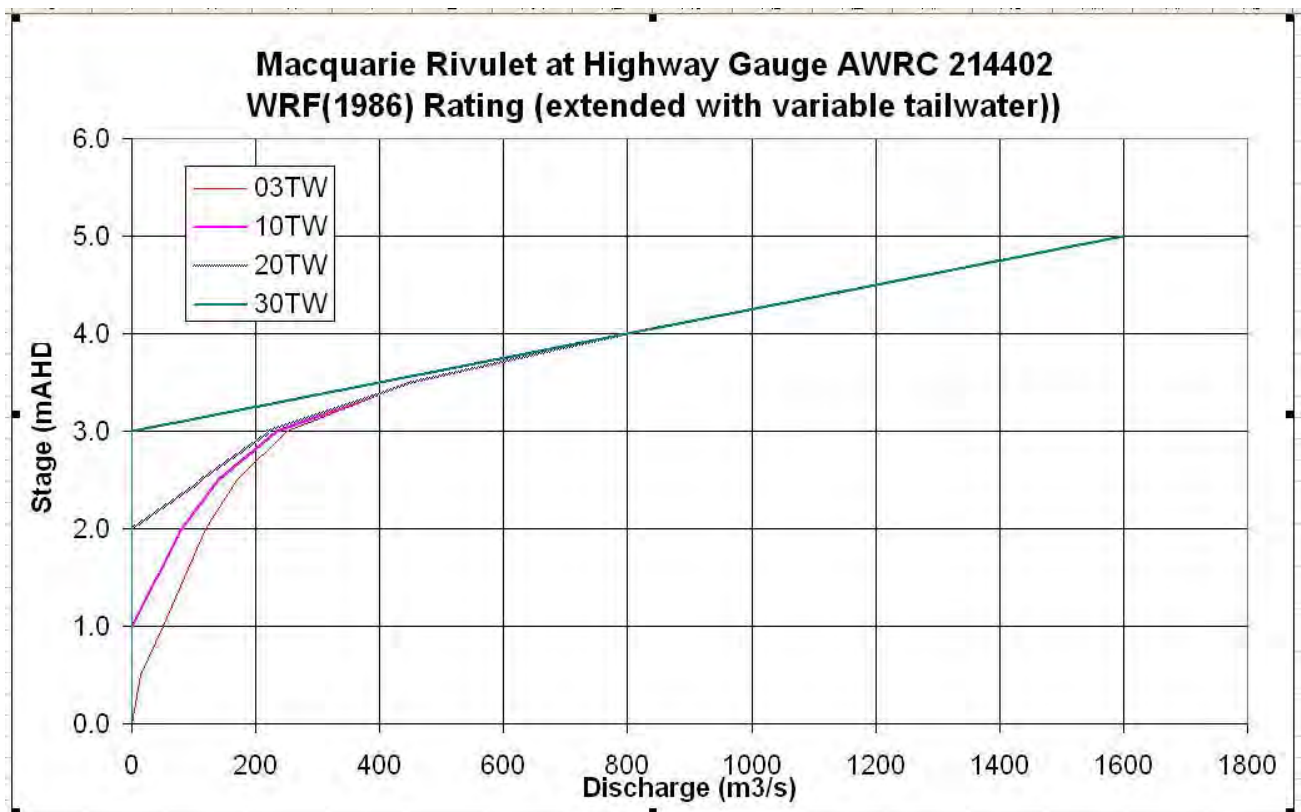
APPENDIX B9. PRINCES HIGHWAY RATING CURVE

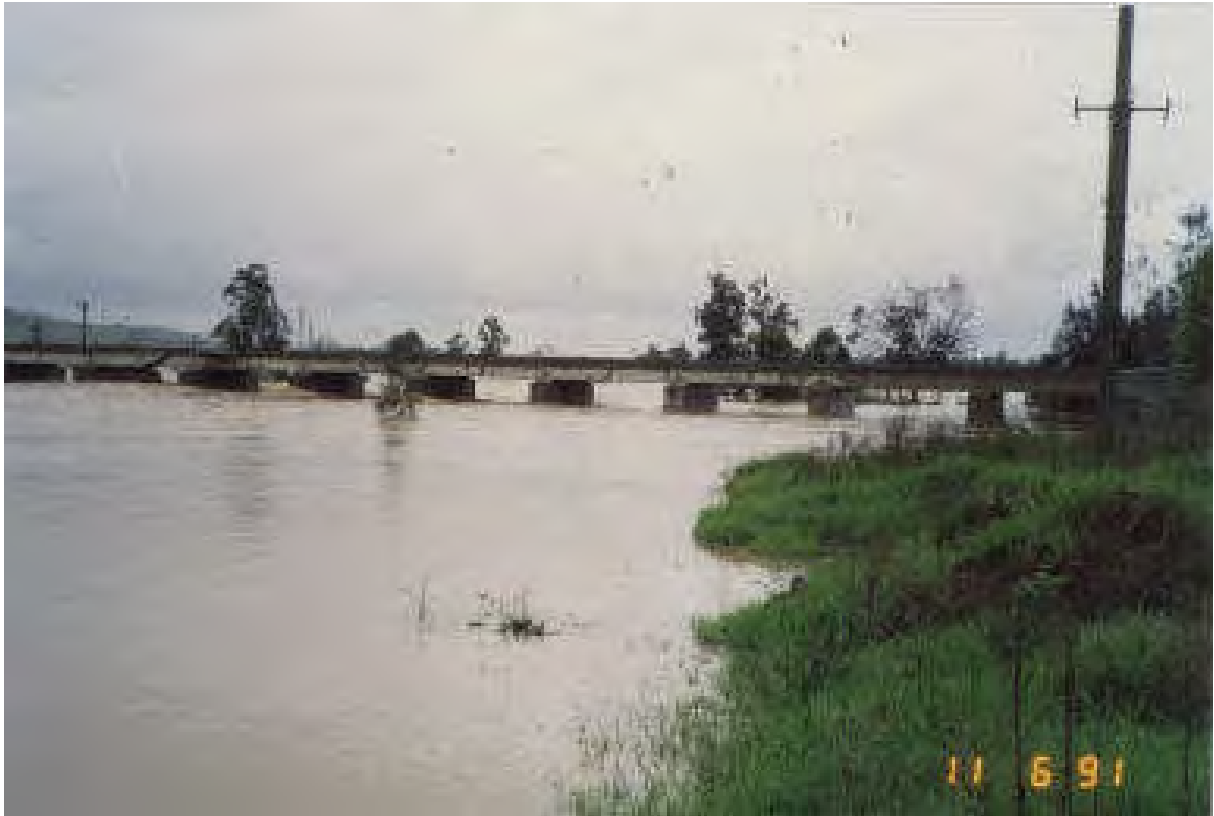
1..US RAIL BRIDGE (Note afflux above central spans

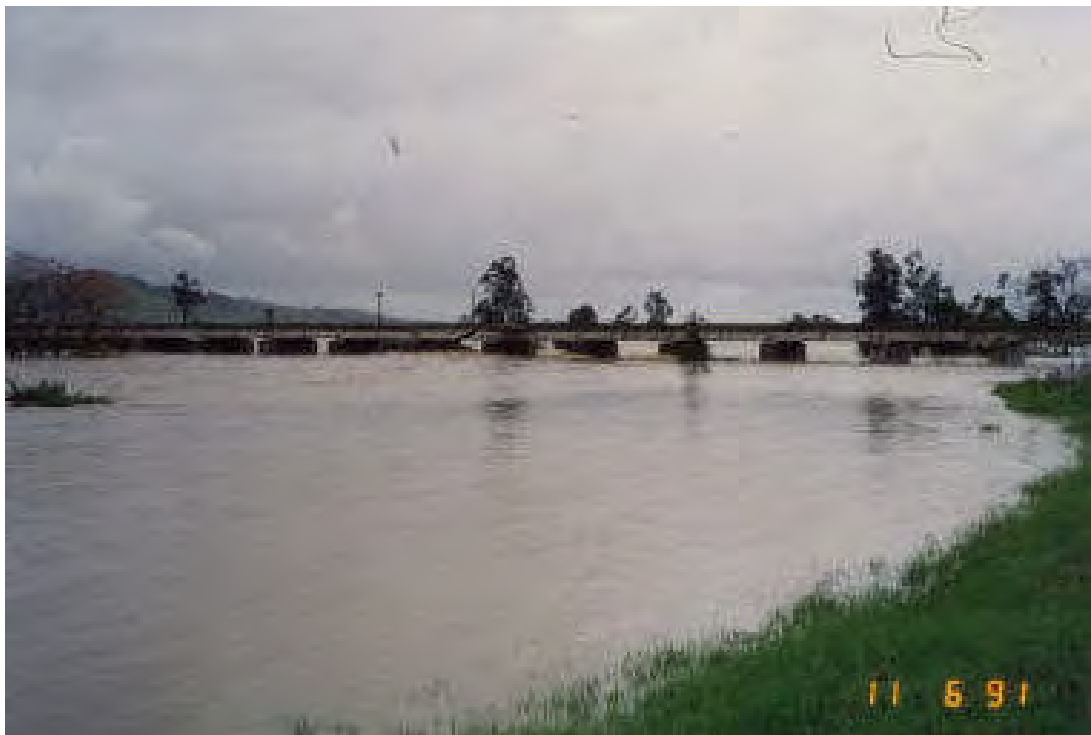
2..US RAIL BRIDGE (Note afflux above central spans

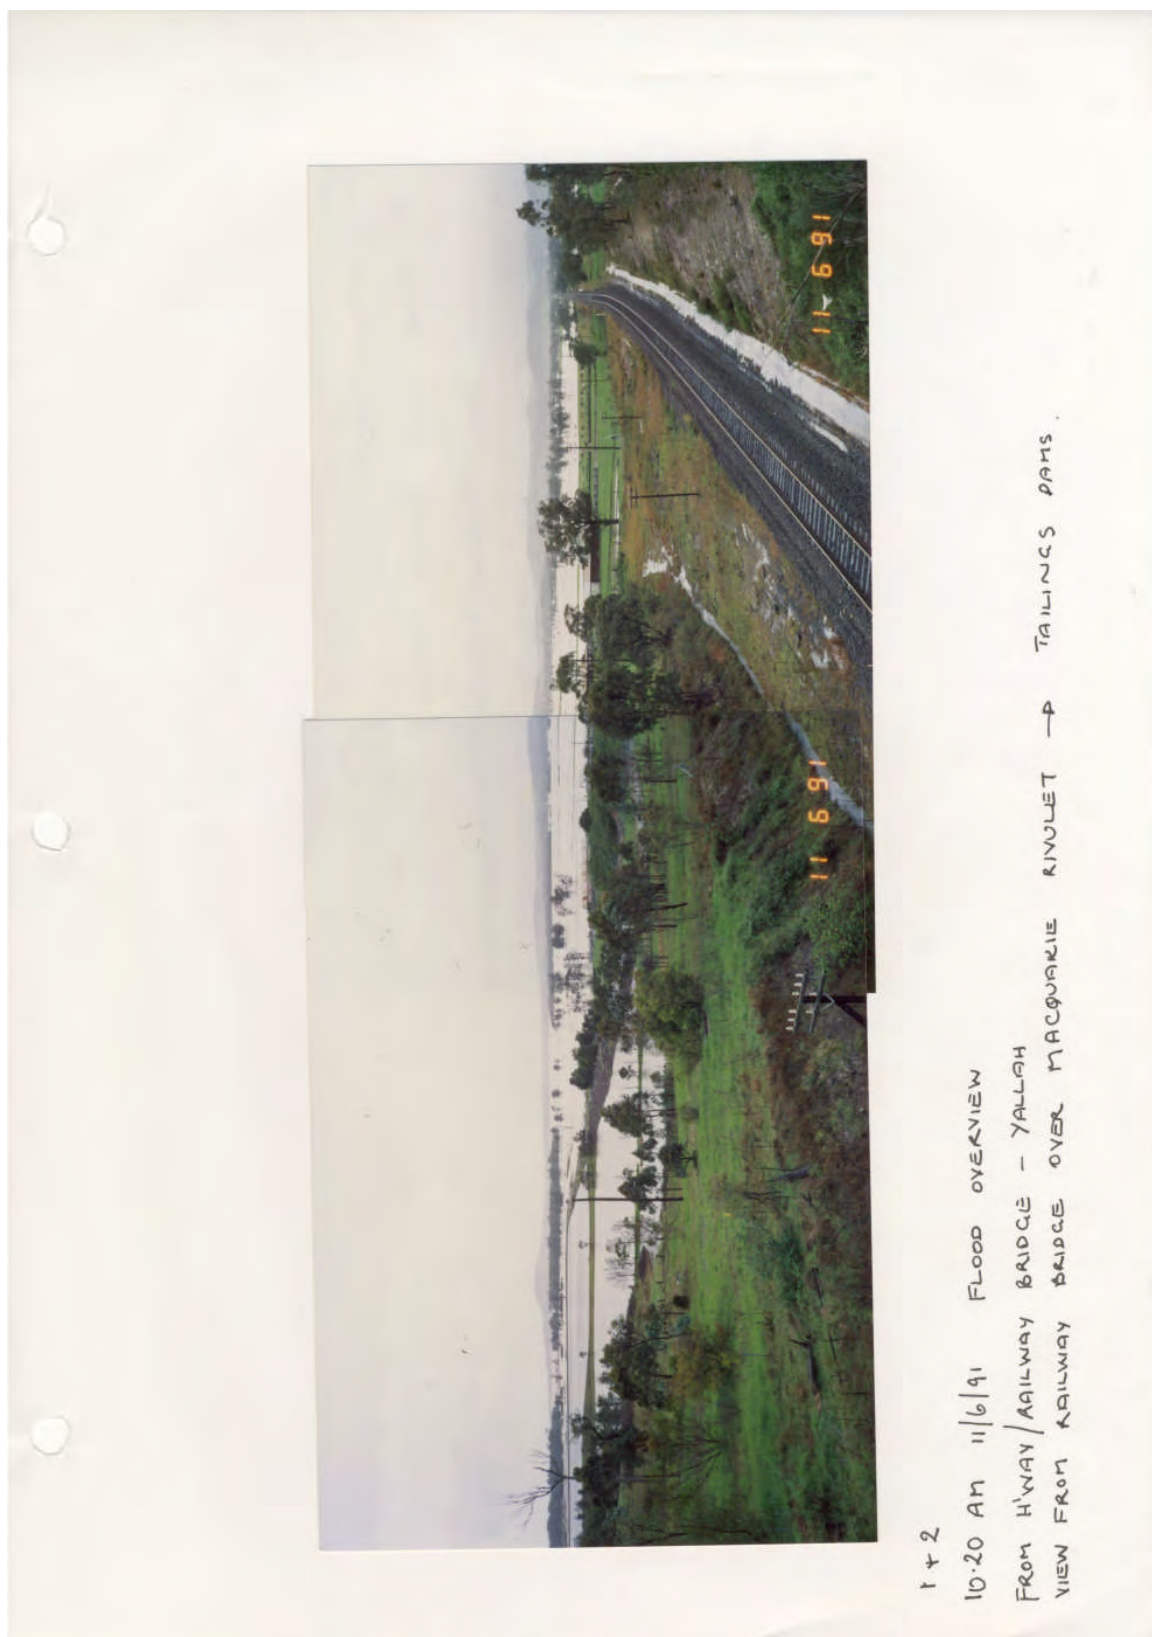
3..Floodplain DS Rail Bridge

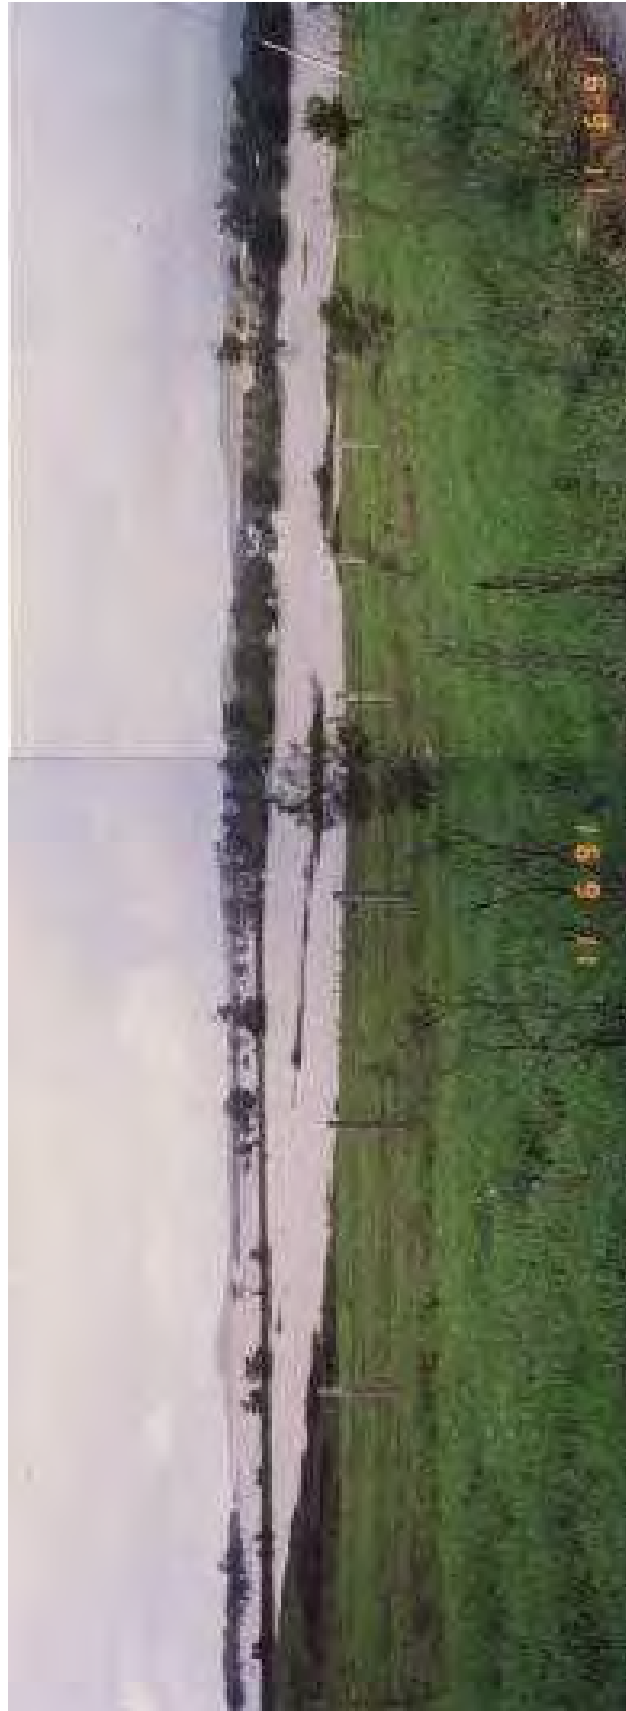
4.. Between Rail and Highway Bridges From North Bank

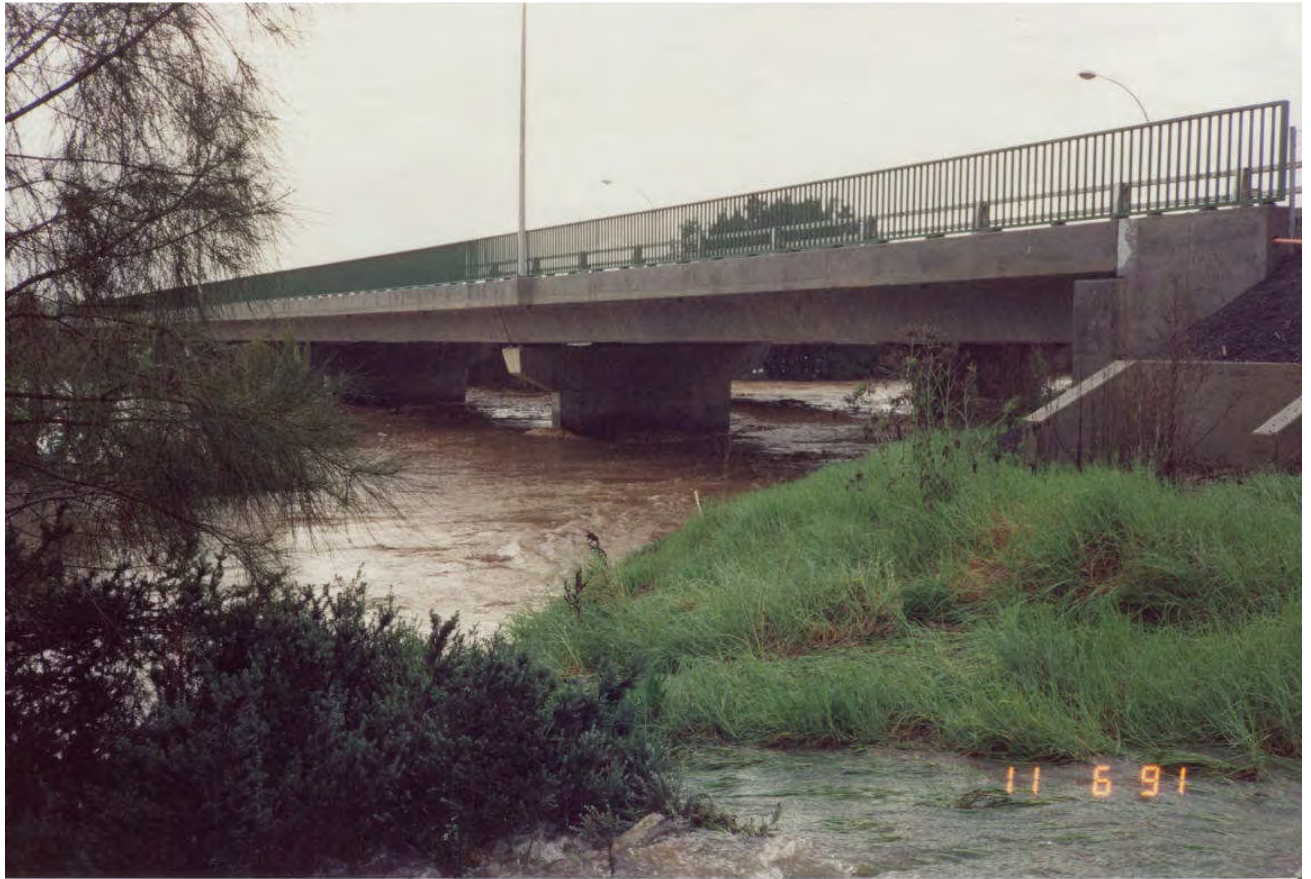
5.. US Princes Highway Bridge From South Bank

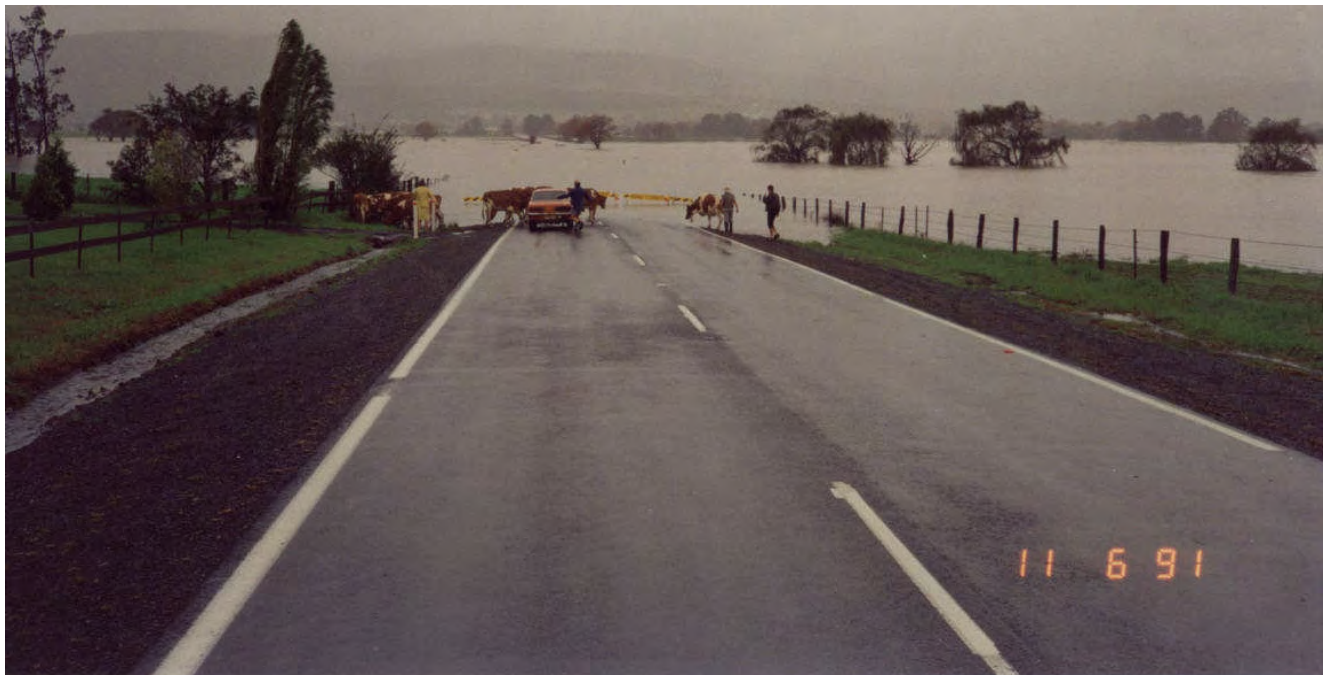
Illawarra Highway at Green Meadows

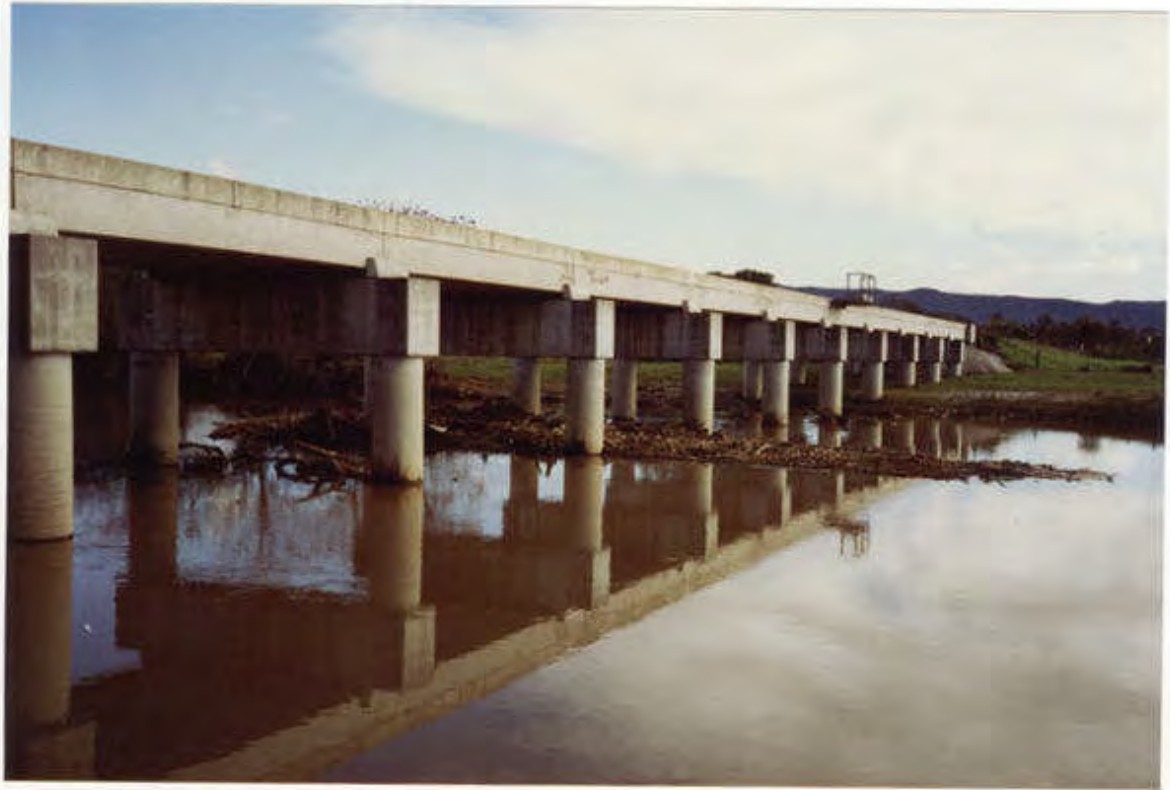
Rail Bridge - Accumulated Debris After Event From DS South Bank

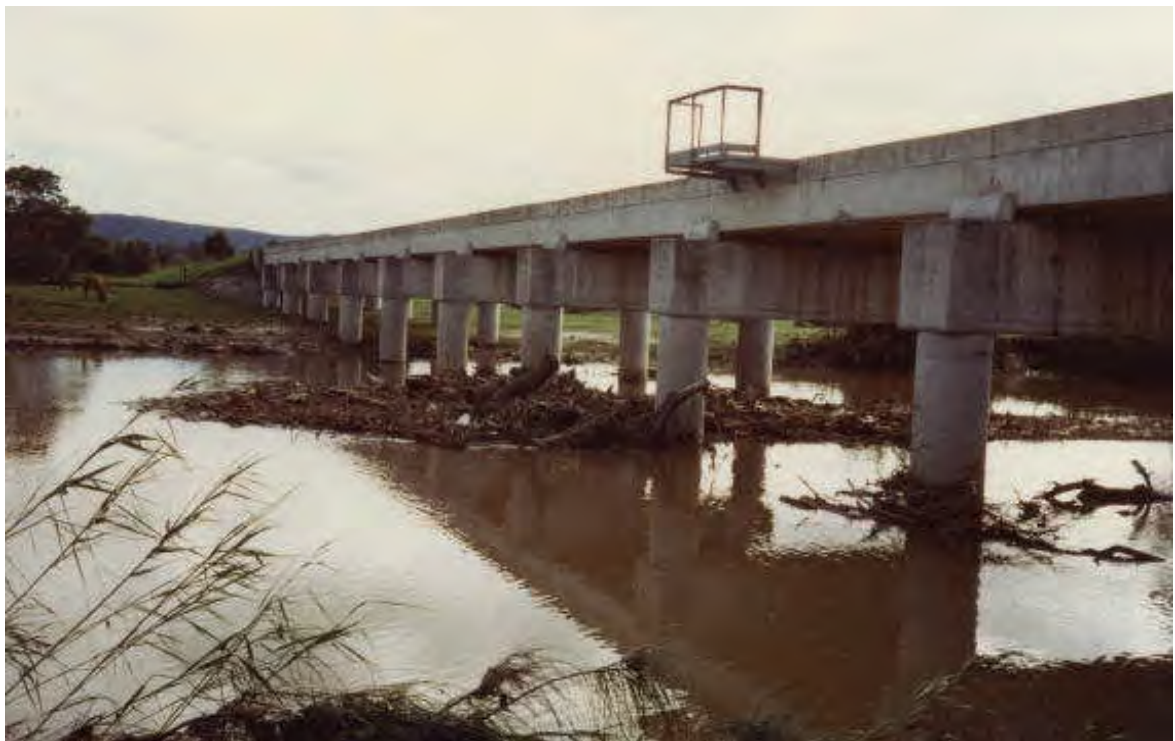
Rail Bridge - Accumulated Debris After Event From US South Bank
