# **St GEORGE MOTOR BOAT CLUB MARINA REDEVELOPMENT**

## **AQUATIC ECOLOGY IMPACT ASSESSMENT**

**Report Prepared for Planning Ingenuity Pty Ltd**

**Marine Pollution Research Pty Ltd**

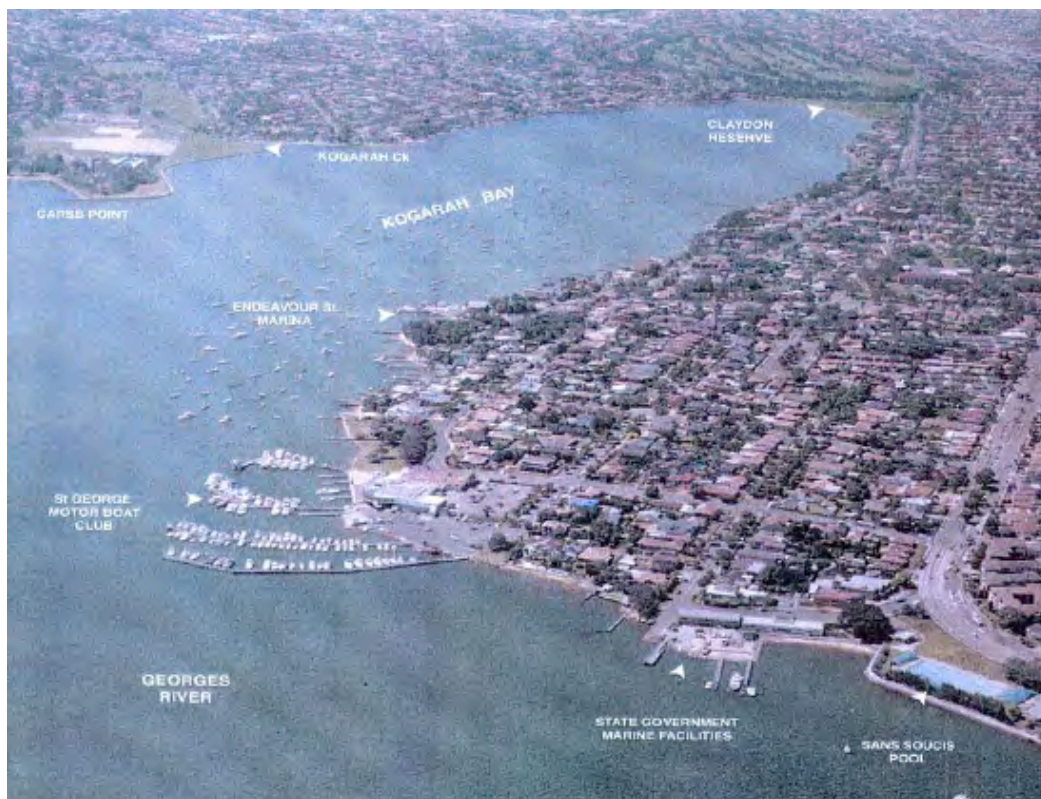
Kogarah Bay is located on the northern side of the Georges River just upstream from the confluence with Botany Bay (Figure 2). Kogarah Bay catchment is small (around 8 km<sup>2</sup>) and is approximately 0.9% of the total Georges River catchment area. The bay is about 2.3 km in length and varies in width from about 500m to 700m, with water depths generally less than 3m (JWP 2005). There are no extensive natural rocky shores or reefs in Kogarah Bay although there is a small intertidal to shallow sub-tidal rock shelf immediately east of the St George Motor Boat Club Marina (Figure 2). There are, however, extensive man-made rocky features (or other hard substrata) that support rocky shore or reef biota.

Figure 2 Oblique aerial view of Kogarah Bay looking north from Georges River.

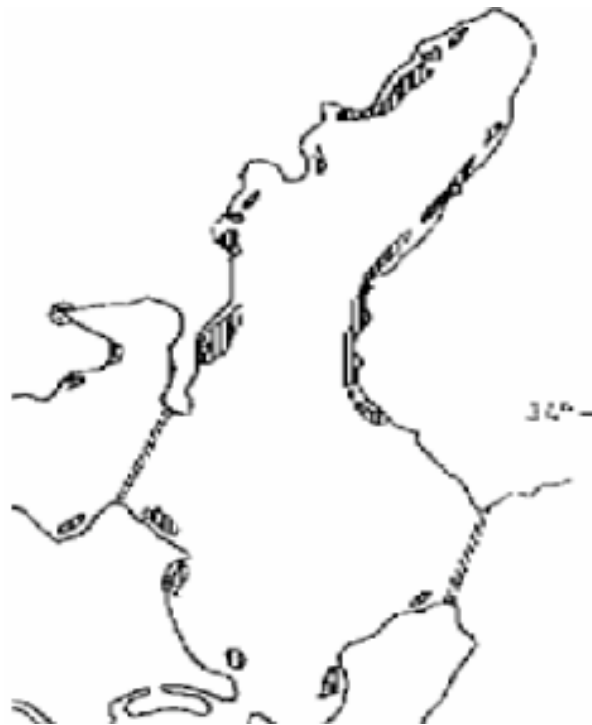
Figure 3 Mapping of *Zostera* beds in Kogarah Bay (West et al 1985)

The most recent mapping by Williams et al (2004) confirms the conclusion of earlier reports (West et al 1985 and MPR 2001) that there are no mangroves or saltmarsh resources in Kogarah Bay. Kogarah Bay does support seagrass beds. Figure 3 shows the West et al (1985) mapping of *Zostera* (eelgrass) beds in Kogarah Bay and Figure 4 shows the Williams et al (2004) mapping (based on 1998 photos).

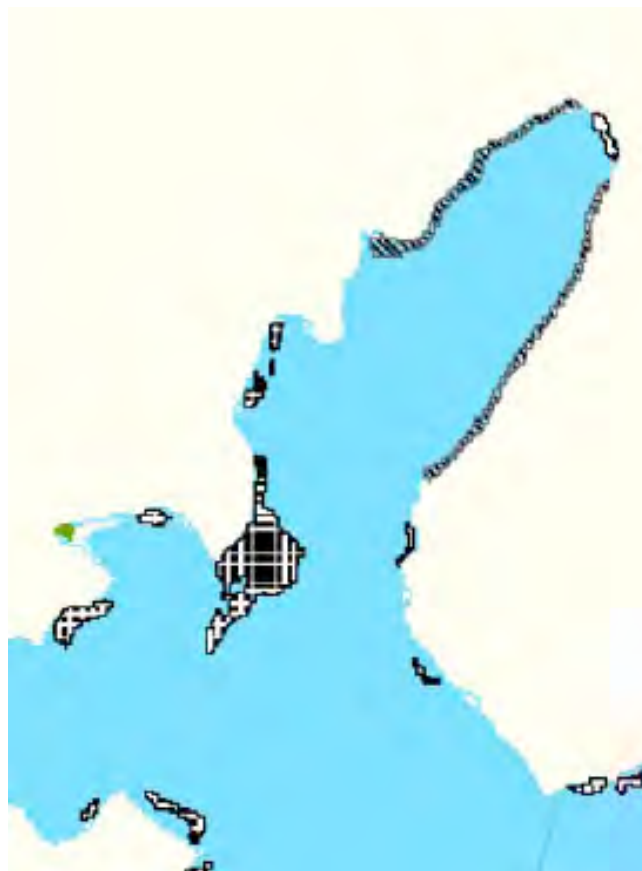
Figure 4 Mapping of *Zostera* beds in Kogarah Bay (Williams et al 2004).

Williams et al (2004) noted that whilst seagrass beds in Kogarah Bay had increased in size at some sites (most notably the bed off Tom Ugly's Point), others had decreased and/or become fragmented. In particular, the continuous narrow bed of *Zostera* that was mapped by West et al (1985) along the eastern shore had become fragmented at the southern end (as originally reported in MPR 2001) and less fragmented at the northern limits. Contrary to earlier studies, Williams et al (2004) also found small patches of strap weed (*Posidonia australis*) and mixed strap weed and eelgrass in the south eastern corner of the bay. This is currently the most upstream location of strap weed in the Georges River - Botany Bay estuarine system.

Off-shore from the sub-tidal fringing rock habitat south of the marina and along the rock boulder foreshore at the toe of the seawall of the marina to the north, the MPR (20010 study mapped a discontinuous strip of shallow water *Zostera* from around Harris Street (adjacent to the Government Marina Facilities) past the SGMBC to at least Nelson Street (the northern extent of the survey at that time). There were several linear patches of *Zostera* noted in the shallows fronting SGMBC. The patches were not uniform and density varied throughout the distribution. There were a few individual isolated shoots of *Zostera* also found outside the defined patch limits. The distribution of the strip of *Zostera* was in accord with the mapping presented in West et al (1985) but the width of the strip was less (i.e., a decrease in depth distribution and the strip was more fragmented (i.e., a distribution between that shown in Figures 4 and 5 above).

For the 2009 seagrass survey the distribution was similar to that shown in Figure 5 above, with the continuous bed south of the marina now located well south. However, whilst there was no seagrass bed located within the study area in 2009, eel grass was observed to be growing amongst the sediment and rock boulder habitat inshore (as noted in 2001). The eelgrass occurred as either as single shoots or clusters of a few individual plants, free of epiphytic growth with relatively long leaves (around 40cm in length) – also similar to that reported in 2001.

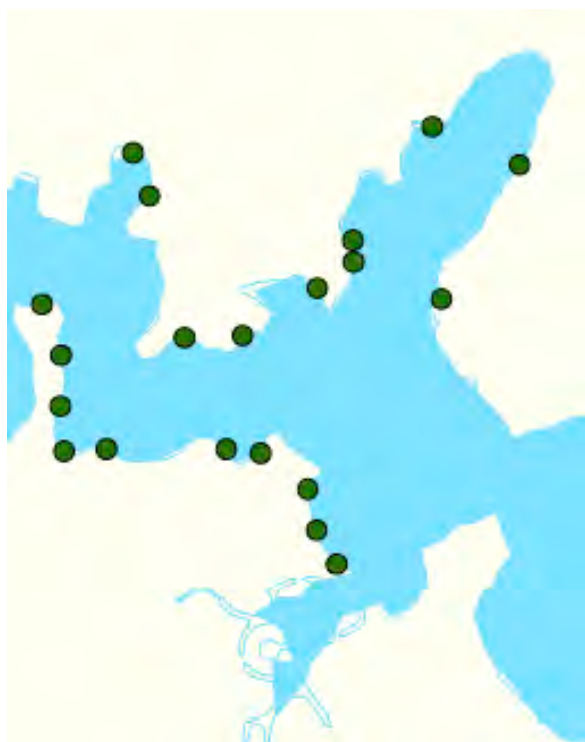
- There were 87 species of fish and decapod fauna found in the total study, of which 46 were reported from the Central Mud Basin (the 20 sites shown on Figure 5).
- Seagrass sites in the Georges River had a distinctly different suite of species compared to bare substrata sites and there were seven species reported from the two unvegetated (mud) sites in Kogarah Bay and 20 species from the three seagrass sites (*Zostera*).

Figure 5 Fish Sample Sites for the Central Mud Basin (from Williams et al 2005)

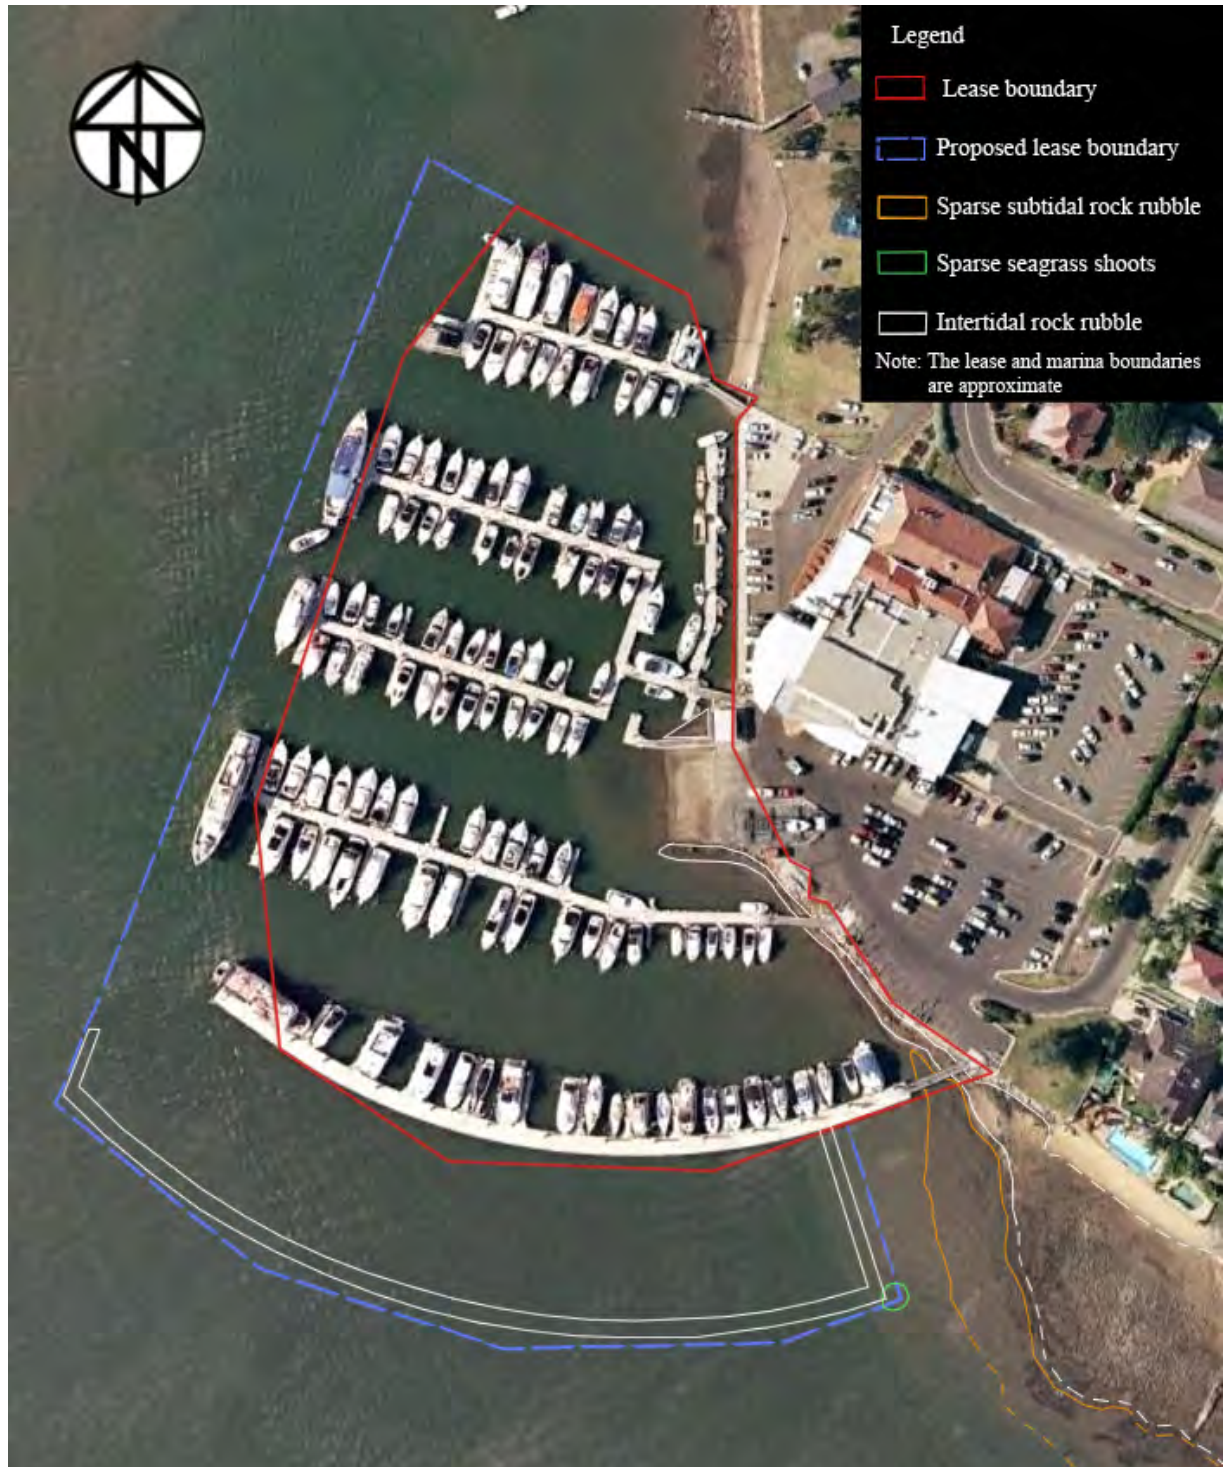
Figure 6 Location of Aquatic Ecological Habitats in October 2009.

Note that the seabed habitat seaward of the rock rubble habitats and seaward of the Marina seawalls and concrete ramps is all unvegetated soft sediment habitat.

MPR (2001) provided the results of a study of the aquatic ecology of the existing marina plus surrounds at that time, and the results of that study were used as base-line information for a further field study undertaken on 29 October 2009, to identify changes in the reported aquatic ecology of the locality since the 2001 study. Figure 6 (above) shows the current location of aquatic habitats at the site.

There was also a single patch of five shoots of eelgrass observed to be growing within or very close to the footprint of the inshore limits of the proposed arm F (see Figure 6 for location). Isolated sprigs of paddle weed were also observed growing in this location. There was no seagrass found within the marina lease area, underneath arm E or the access gangway or inshore along the carpark seawall.

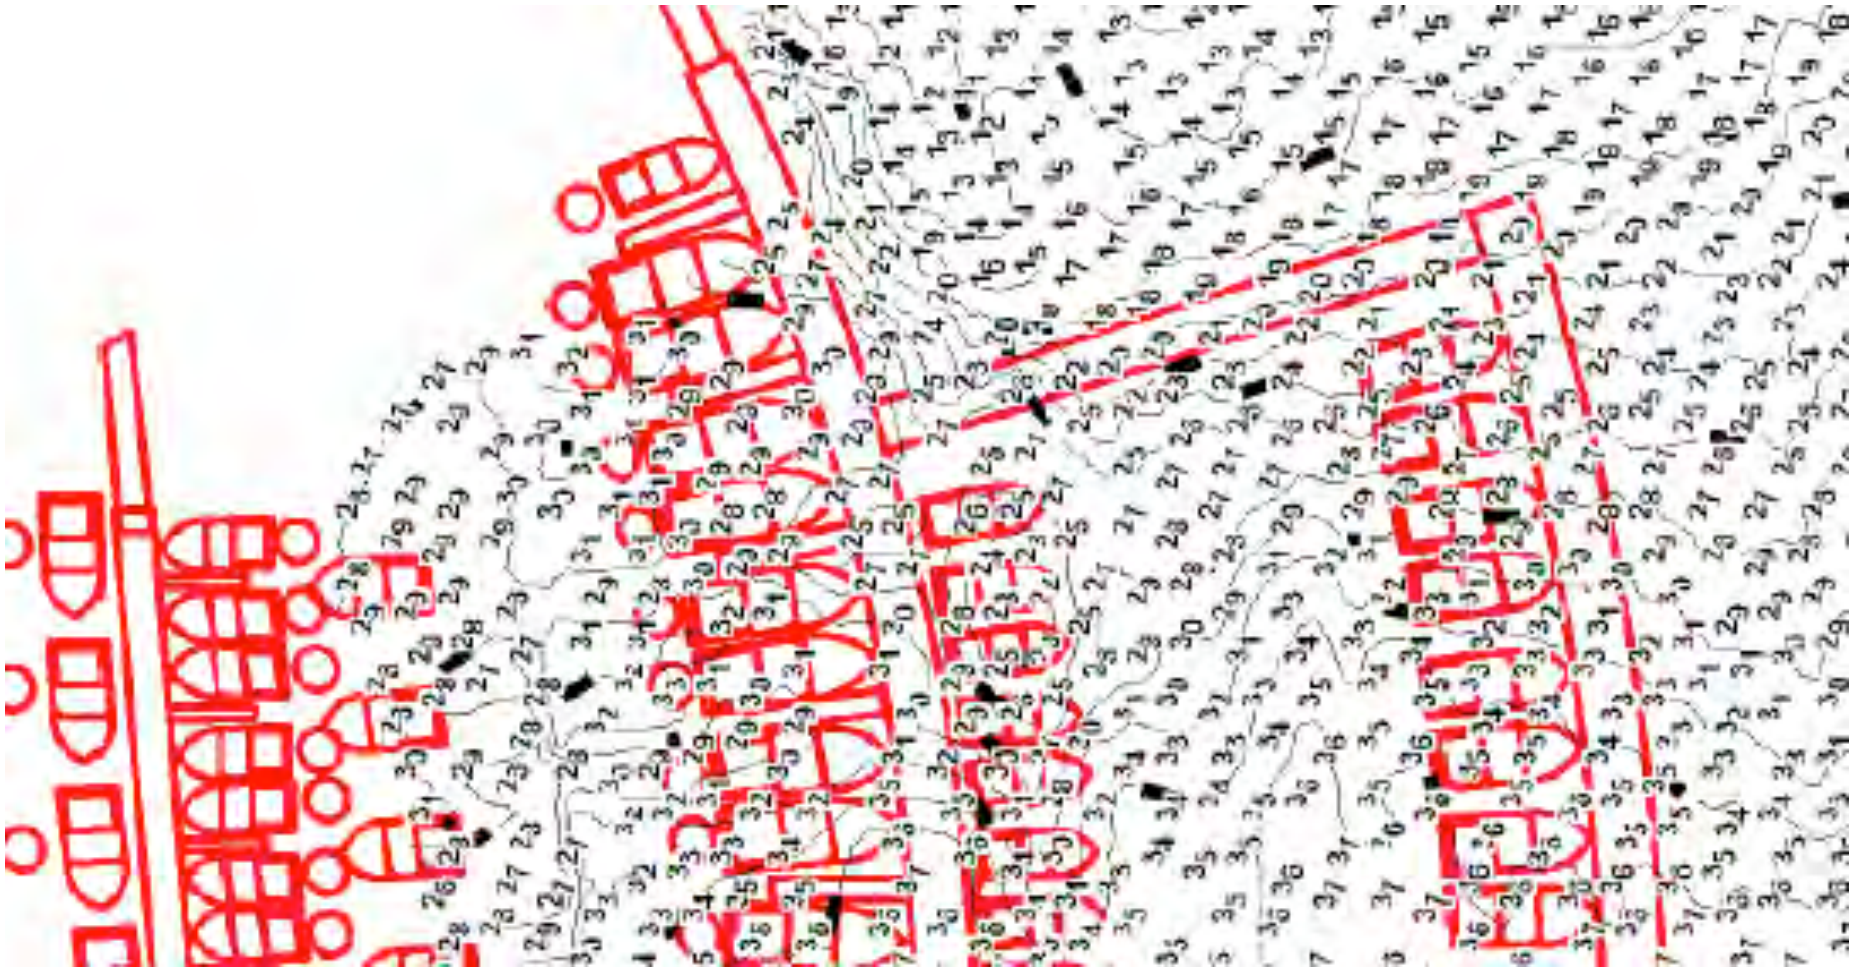
To the south of arm E, the decline is more gradual, reaching the same depth at a distance of 30 to 40m from the shoreline. This can be seen in Figure 7 (below), which provides a magnified view of portion of Cardno Lawson Treloar Figure D1- with the inner portions of marina arms D and E plus the proposed Arm F superimposed over the hydrographic survey.

Figure 7 Portion of Figure D1 from Cardno Lawson Treloar (2010) showing inshore parts of existing and proposed marina arms D to F superimposed over post-dredging hydrosurvey. Note depths are –m AHD.

In terms of changes from 2001 to 2009, the major alteration to aquatic habitats has been the dredging for the marina undertaken in 2002. As a result of the dredging, the shoreline now drops off fairly rapidly within the lease area to a depth of -2.5m to -3m (AHD), within 5 to 10m of the shoreline (see the post-dredging hydrographic survey - Figure D1 in the Cardno Lawson Treloar (2010) Coastal Processes report for the present EA).
