PHASE 1 CONTAMINATION ASSESSMENT WITH LIMITED INTRUSIVE SAMPLING

**MORLING COLLEGE
128 HERRING ROAD
MACQUARIE PARK**

Prepared for
LIPMAN PROPERTIES PTY LTD

Project No. 71476.01
December 2009

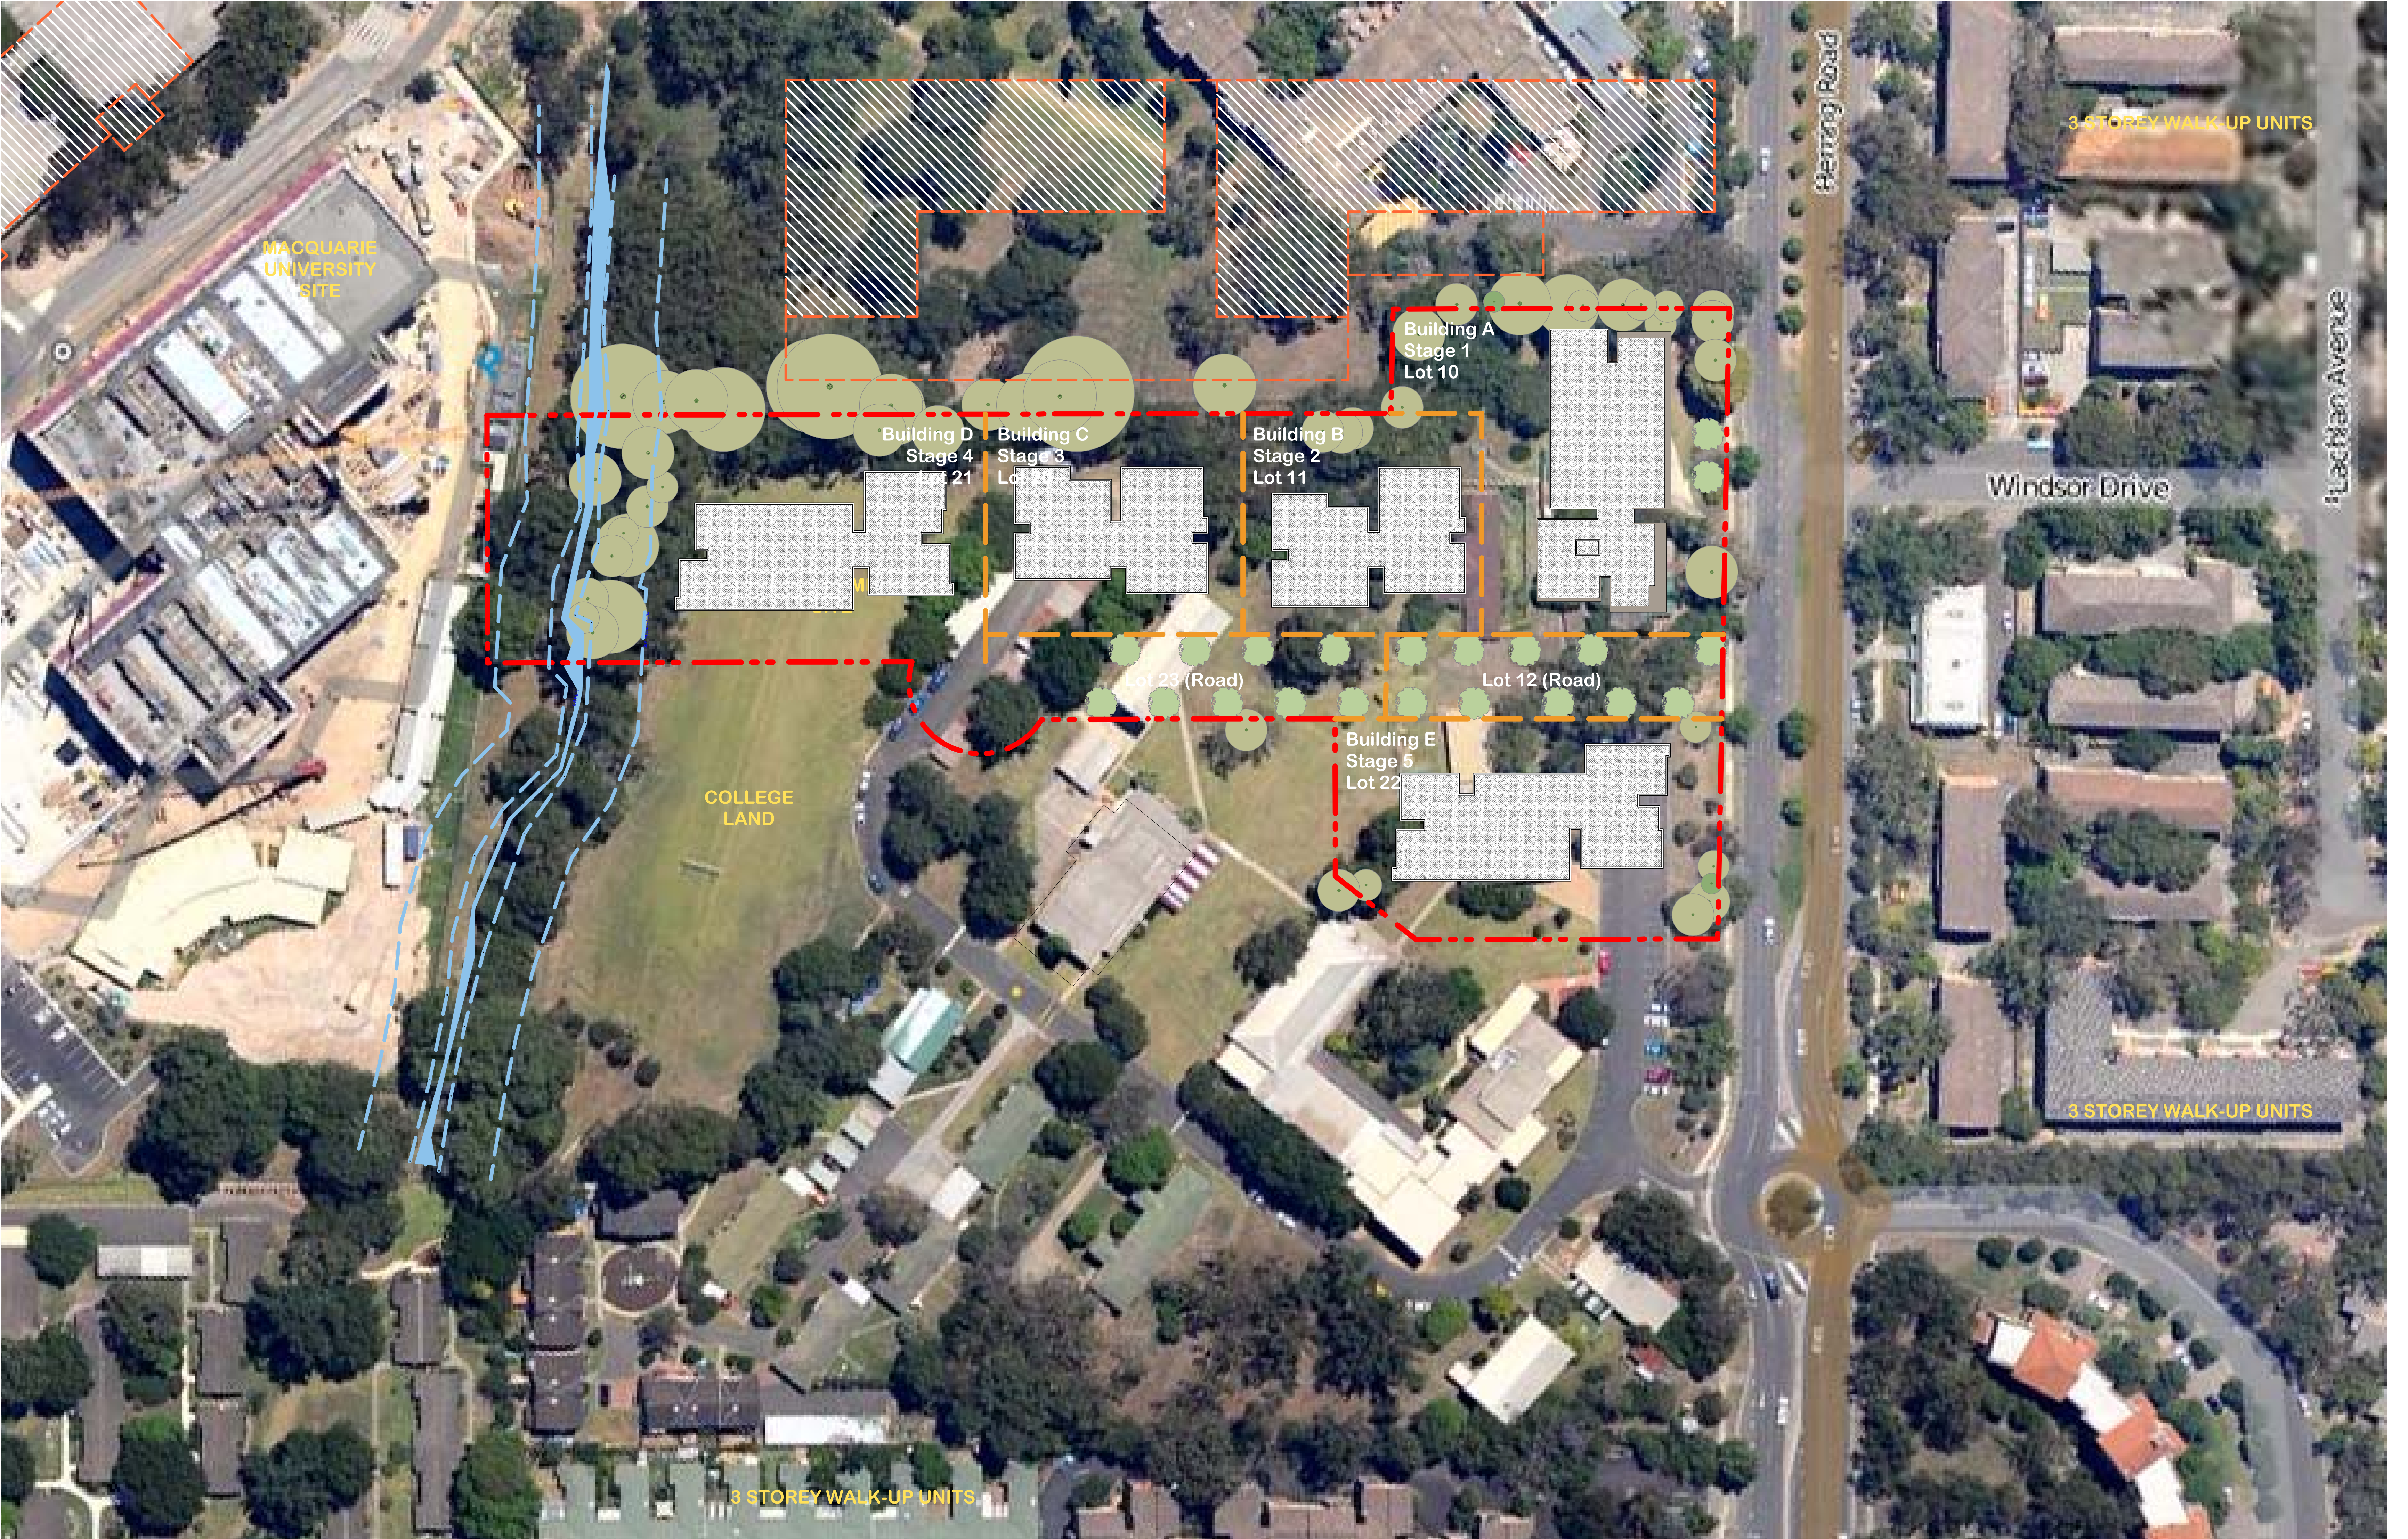
APPENDIX A
Concept Plan (A103)

--- LOT BOUNDARY --- SITE BOUNDARY --- REQUIRED CUL-DE-SAC --- ADDITIONAL LAND AREA REQUIRED --- UNIVERSITY CREEK --- RIPARIAN ZONE SETBACK: 20M

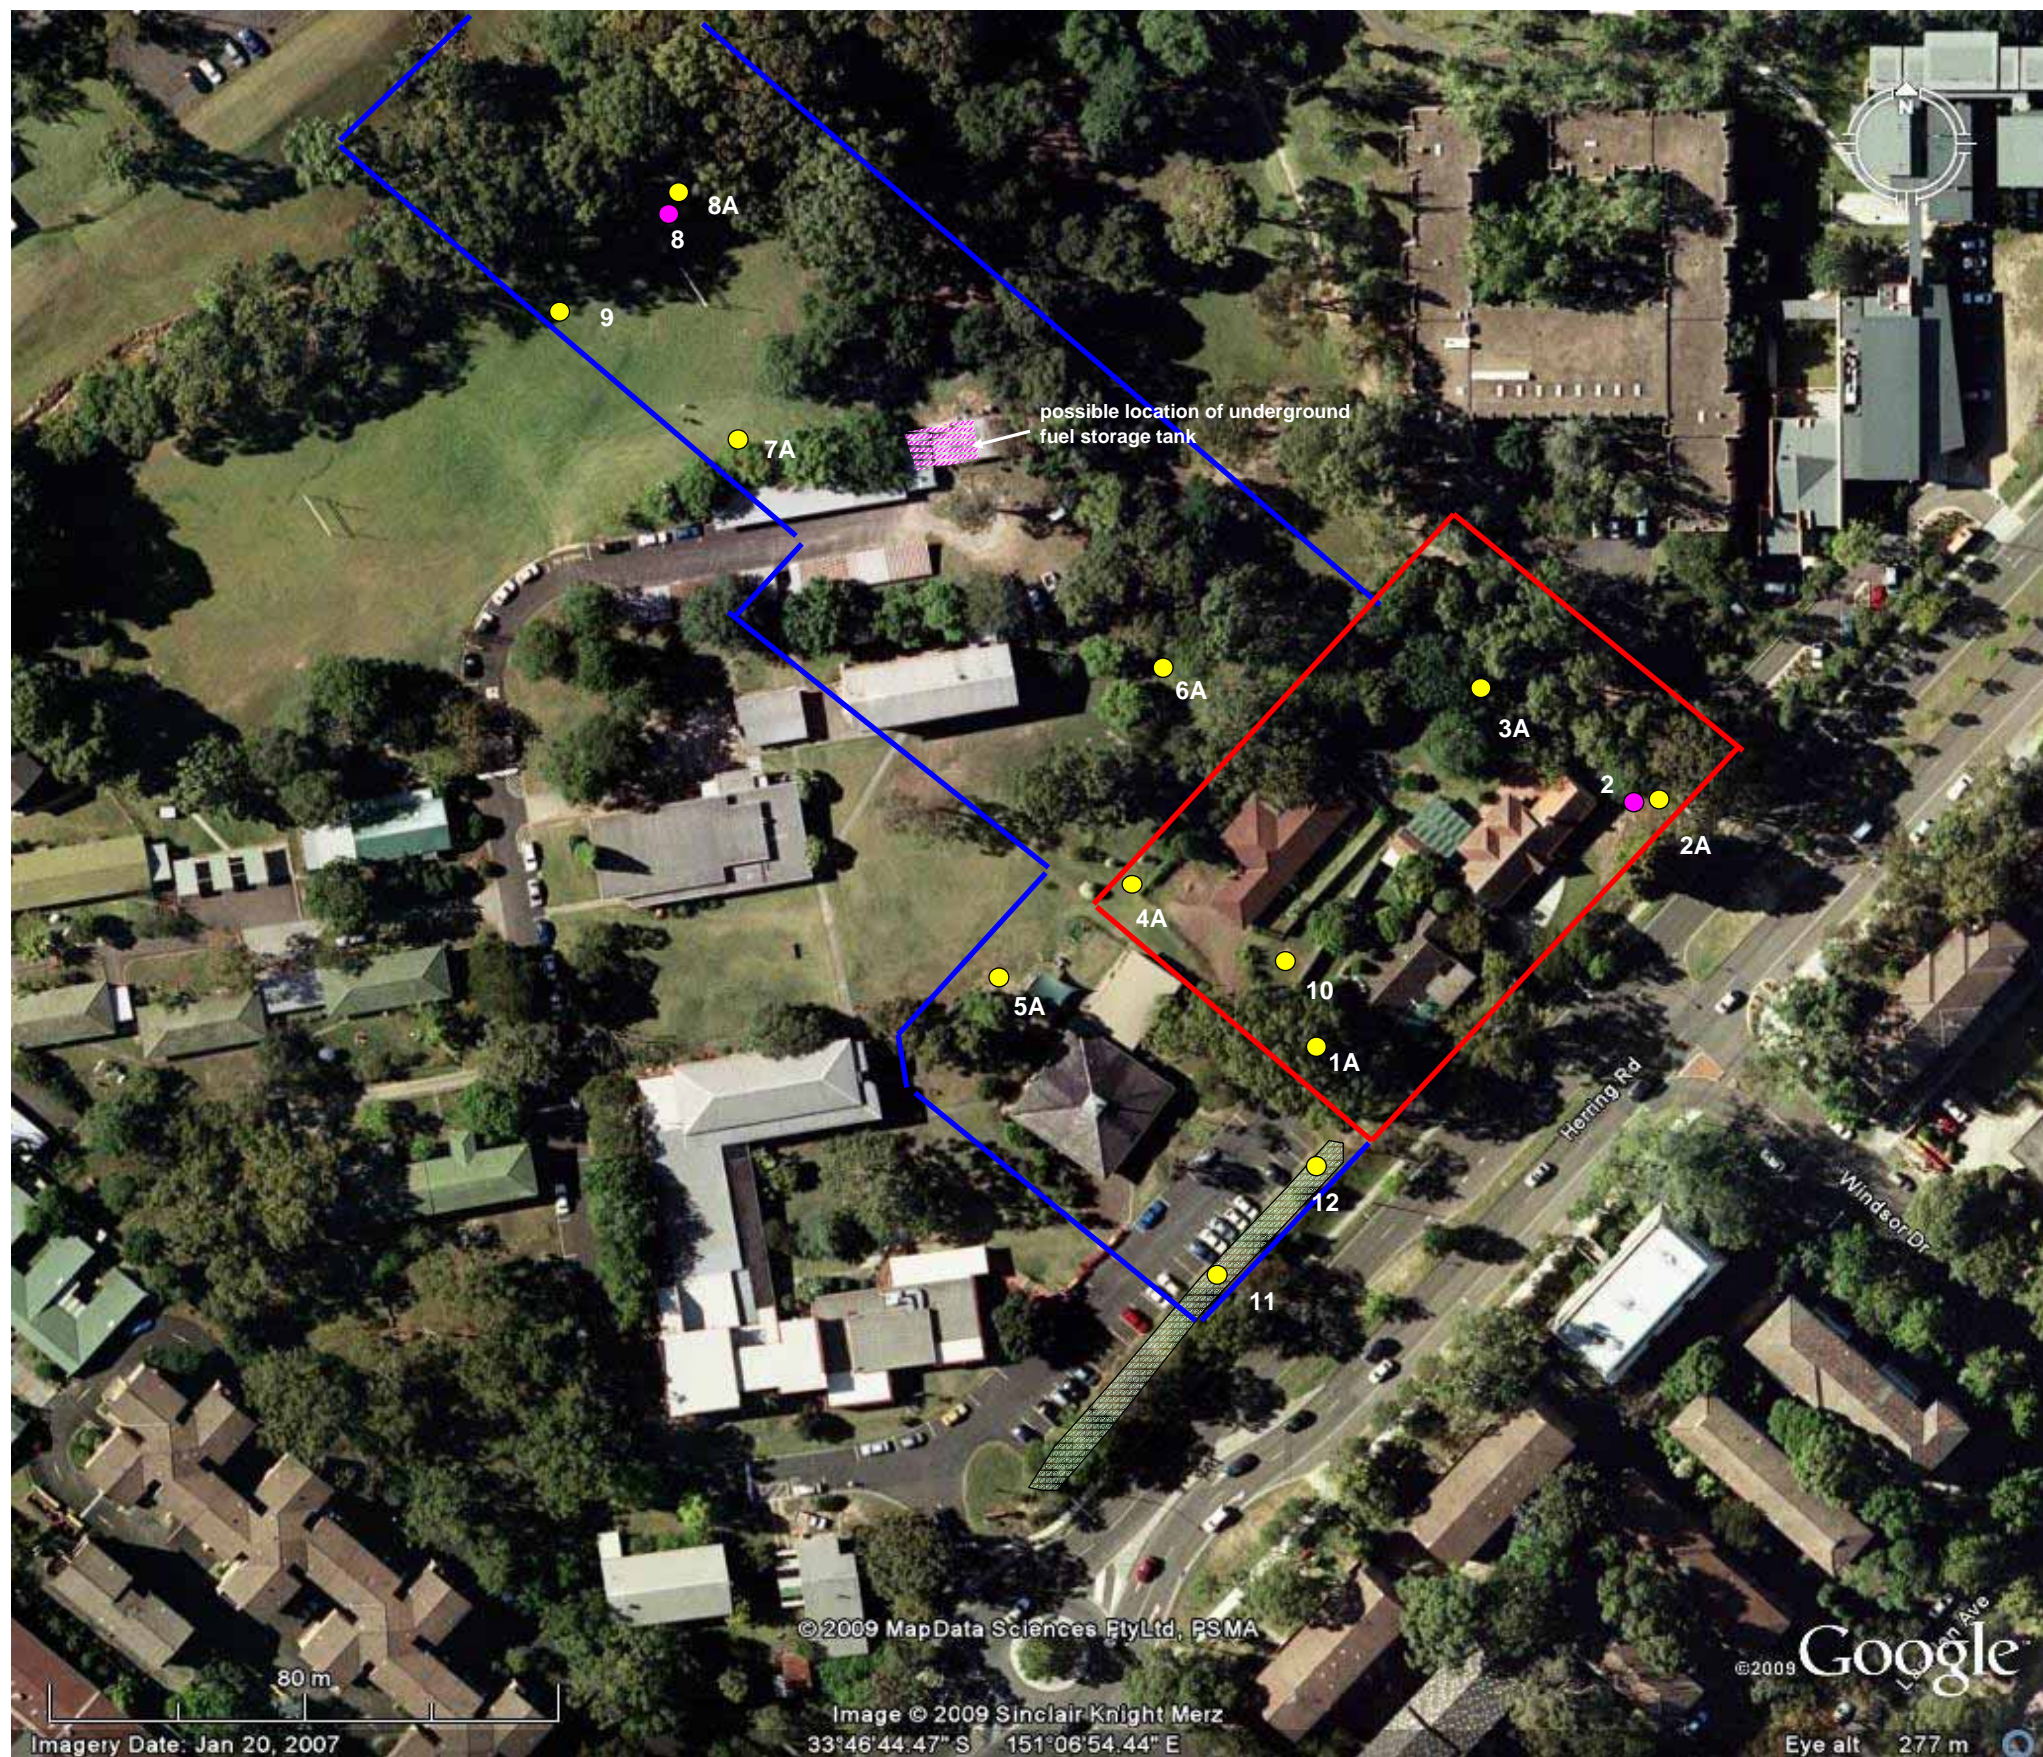
APPENDIX B
Drawing 1

At the time of conducting the assessment, the site was being utilised by the Morling College including administration, parking, accommodation, recreation and sporting uses. The site has a general fall towards the north-west and is predominantly grass covered and landscaped apart from a small number of dwellings, administration building, a mens accommodation building, car parking and a few sheds. Filling was noted in an earth mound at the Herring Road frontage and at the rear of the site forming a level playing field. The site location and general layout is presented in Drawing 1, Appendix B.

From the site history information obtained, it is apparent that the site was previously used for agricultural purposes including poultry farming and tea tree planting. An underground storage tank (UST) was also apparently installed (but never used) in the centre of the site, underneath

one of the existing sheds (see Drawing 1). It should be noted that there was no visual evidence of the UST on the ground surface.

- Further, more detailed investigations into soil contamination must be carried out in the vicinity of the UST location, as indicated on Drawing 1. The investigations should be aimed at assessing any soil contamination resulting from past leaks from the UST;

- Confirmation on the presence of a UST;
- Further, more detailed investigations into soil contamination must be carried out in the vicinity of the UST location, if present, as indicated on Drawing 1. The investigations should be aimed at assessing any soil contamination resulting from past leaks from the UST;

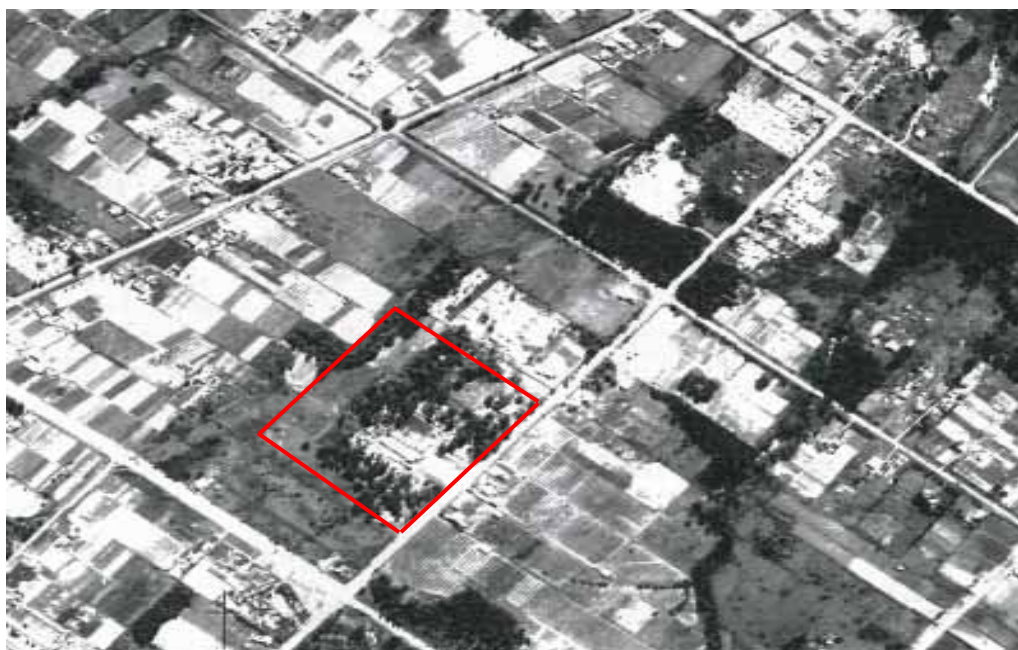
Photo 3: Aerial Photograph 1951

1951 – No significant change to the landuse or the surrounding area was observed since the 1943 photograph.

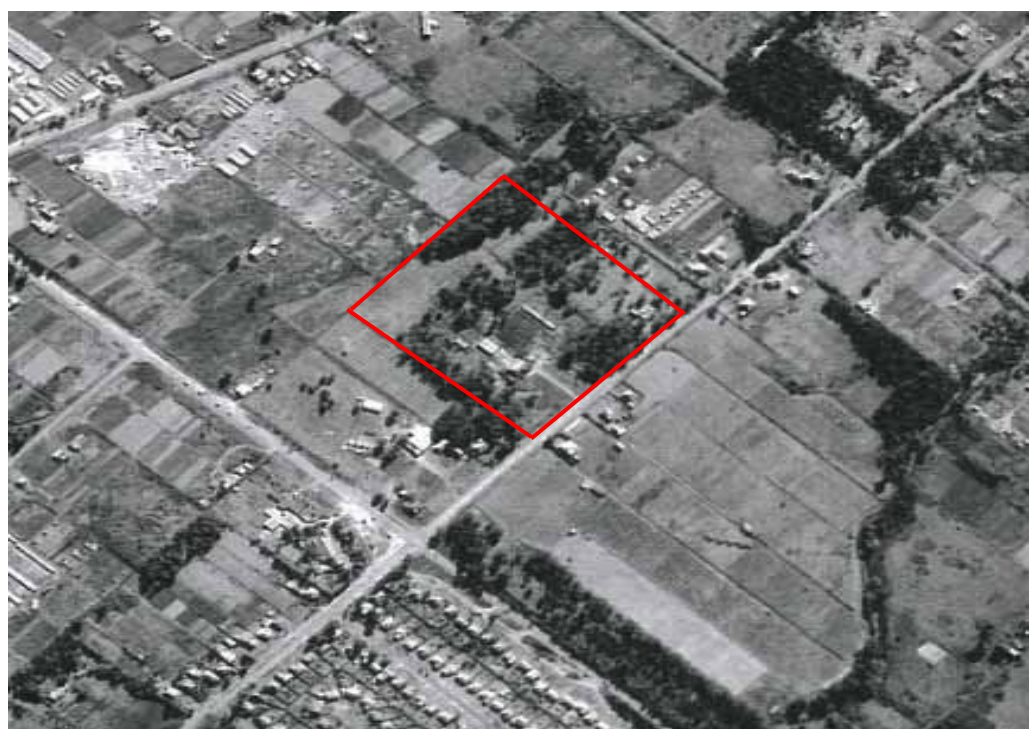
Photo 4: Aerial Photograph 1961

1961 – No significant change to the landuse or the surrounding area was observed since the 1951 photograph.

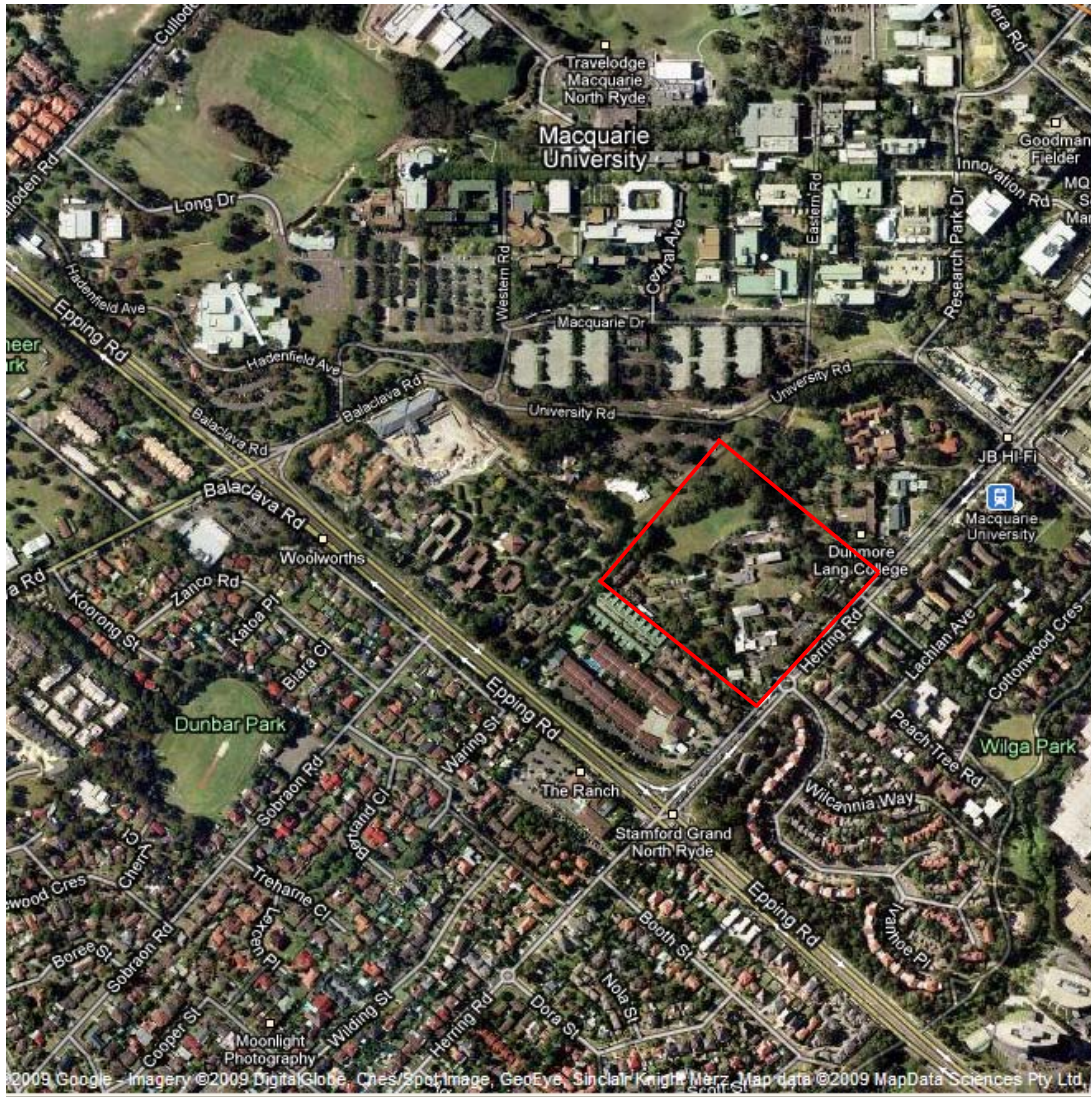
Photo 7: Aerial Photograph 2009

2009 – No significant change to the site landuse was observed from the 1986 photograph. The surrounding area landuse north and south-west of the site is dominated by Macquarie University buildings. The area south-east of the site has a residential use.
