**REPORT  
on  
GEOTECHNICAL INVESTIGATION**

**PROPOSED RESIDENTIAL DEVELOPMENT  
128 HERRING ROAD  
MACQUARIE PARK**

**Prepared for  
LIPMAN PROPERTIES PTY LTD**

**Project 71476.00  
December 2009**

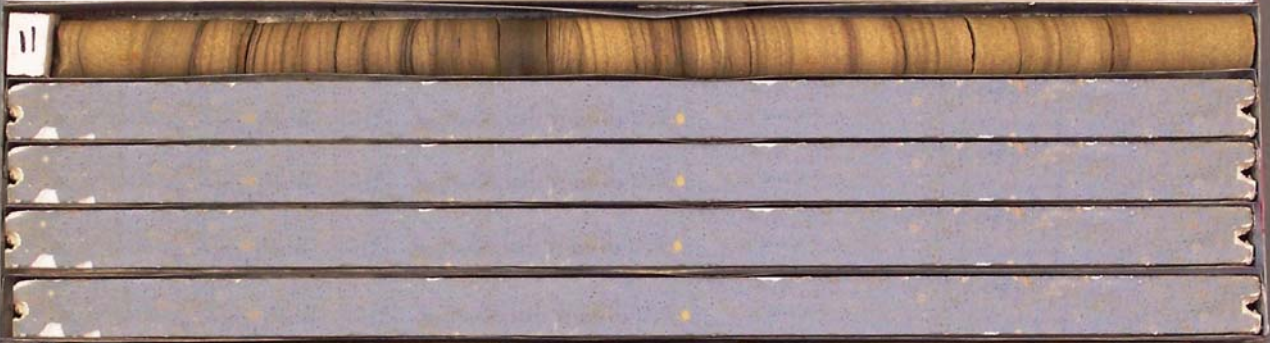
11.00 - 12.00M

DOUGLAS PARTNERS PTY LTD  
PROPOSED RESIDENTIAL DEVELOPMENT - MACQUARIE PARK  
BORE 1 PROJECT 71476 NOV 2009

Details of the subsurface conditions encountered are given in the borehole logs in Appendix B, together with colour photographs of the rock core samples and notes defining classification methods and descriptive terms.

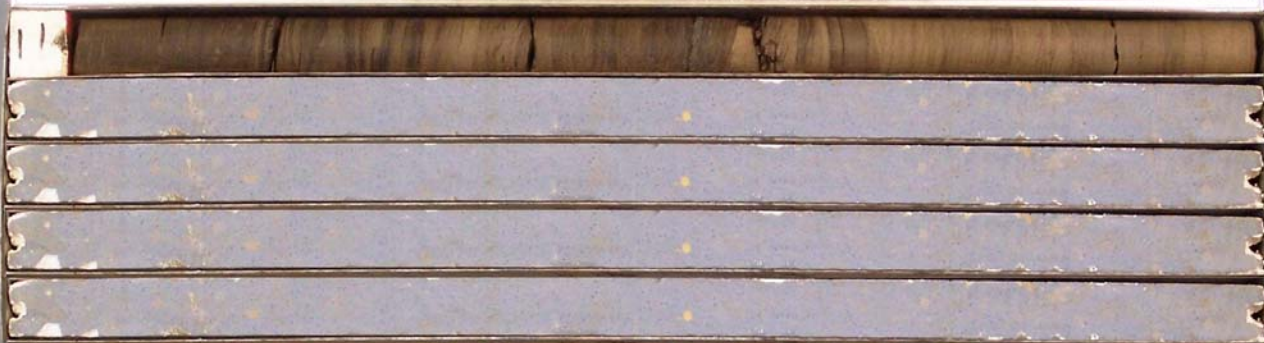
11.00 – 12.00M

DOUGLAS PARTNERS PTY LTD  
PROPOSED RESIDENTIAL DEVELOPMENT – MACQUARIE PARK  
BORE 2 PROJECT 71476 NOV 2009

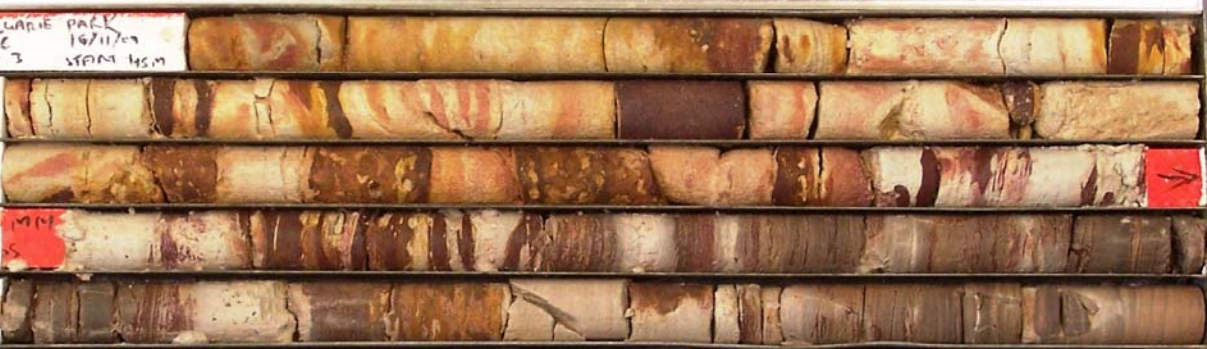
1.15 – 6.00M

MACQUARIE PARK  
71476  
B.H. 3  
16/11/09  
100MM 45M

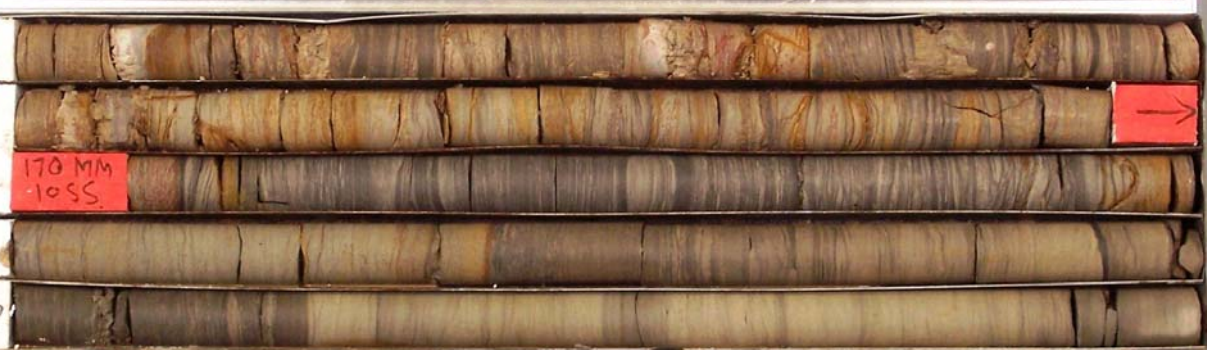
DOUGLAS PARTNERS PTY LTD  
PROPOSED RESIDENTIAL DEVELOPMENT – MACQUARIE PARK  
BORE 3 PROJECT 71476 NOV 2009

170 MM  
10SS

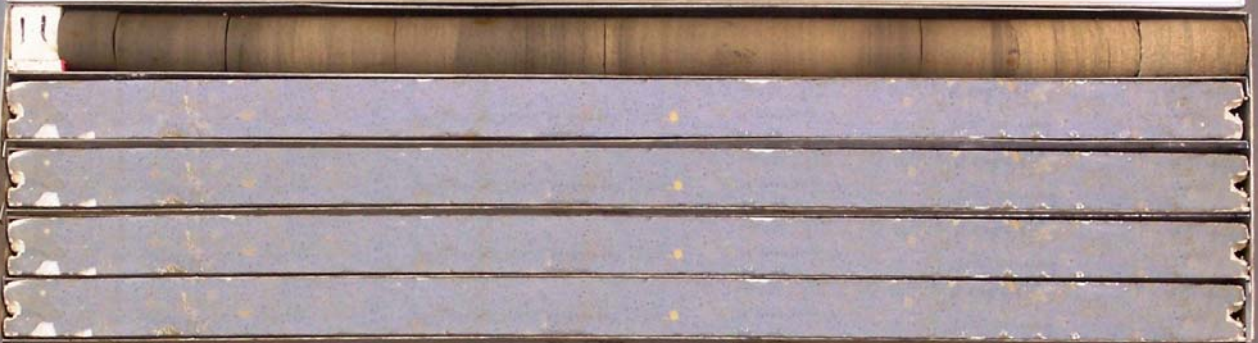
11.00 – 12.00M

DOUGLAS PARTNERS PTY LTD  
PROPOSED RESIDENTIAL DEVELOPMENT – MACQUARIE PARK  
BORE 3 PROJECT 71476 NOV 2009

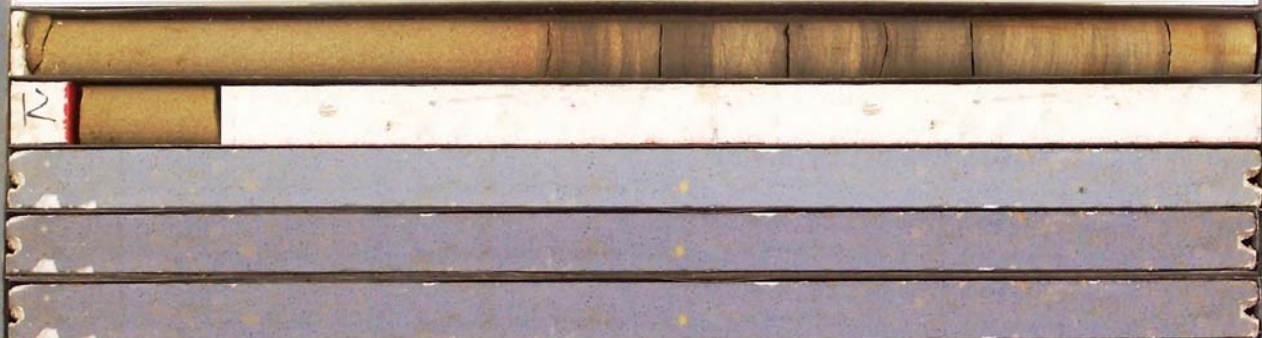
11.00 – 12.15 M

DOUGLAS PARTNERS PTY LTD  
PROPOSED RESIDENTIAL DEVELOPMENT – MACQUARIE PARK  
BORE 5 PROJECT 71476 NOV 2009

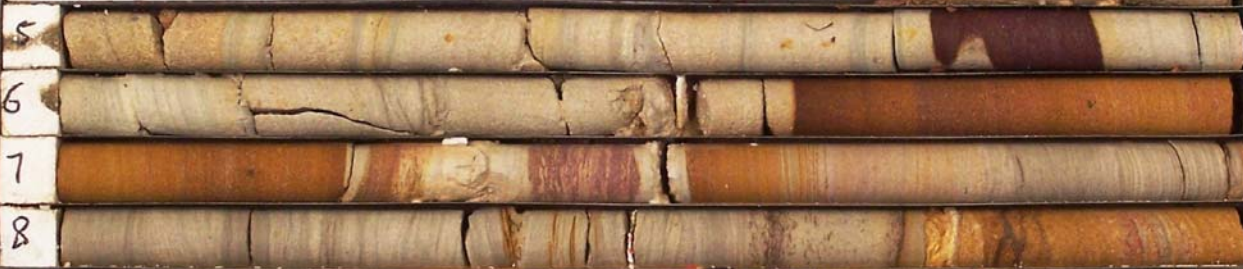
4.70 – 9.00M

MACQUARIE PARK 13/11/09  
71476 BH8 START 4.7M

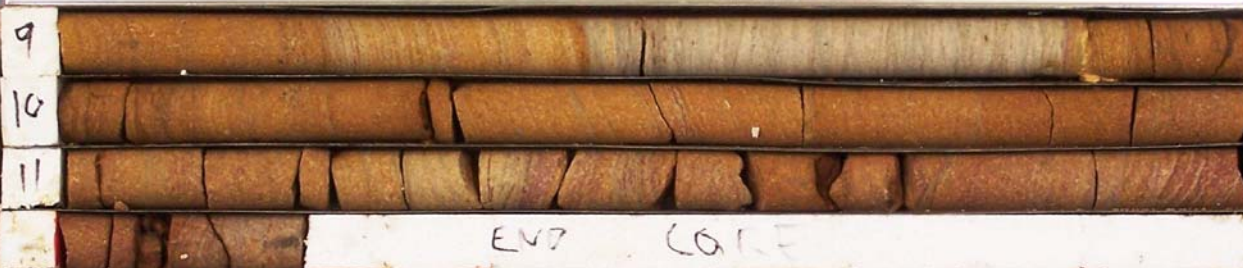
END CORE

DOUGLAS PARTNERS PTY LTD  
PROPOSED RESIDENTIAL DEVELOPMENT – MACQUARIE PARK  
BORE 8 PROJECT 71476 NOV 2009
