LIMITED STAGE 2 CONTAMINATION ASSESSMENT

**MARRICKVILLE METRO SHOPPING CENTRE
34 VICTORIA ROAD & 13-55 EDINBURGH ROAD
MARRICKVILLE**

**Prepared for
AMP CAPITAL INVESTORS LIMITED**

**Project 71645
May 2010**

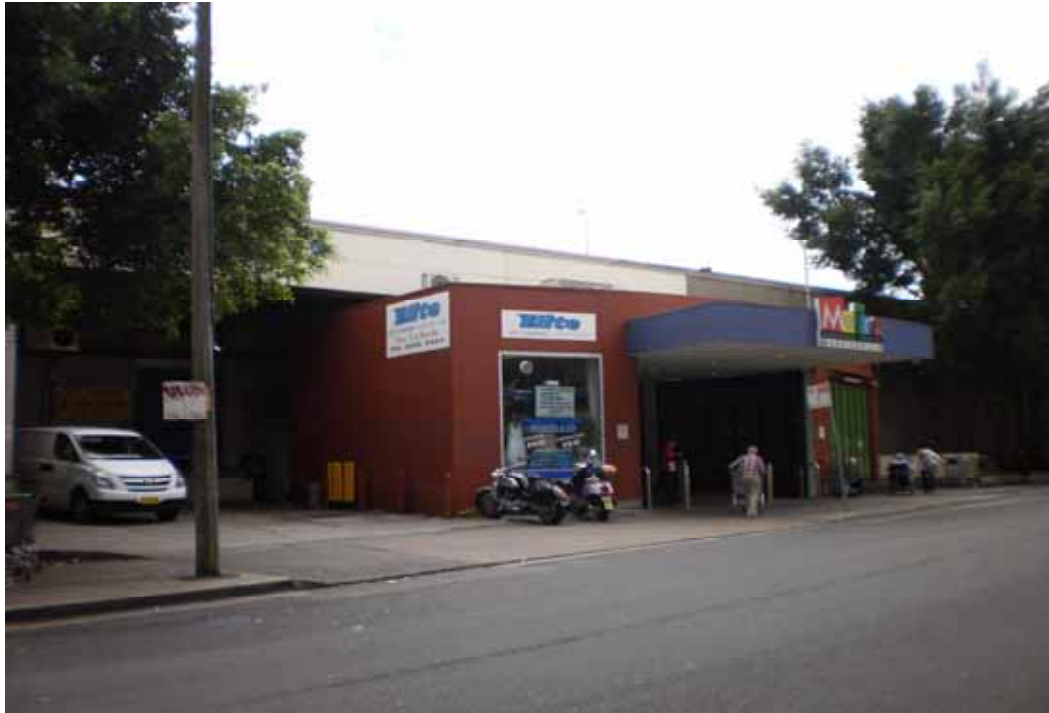
Photo 3: Drycleaner located adjacent to Smidmore Street Entrance

BH4 was located in the vicinity of the dry cleaning outlet. Potential contaminants associated with dry cleaning outlet include of cis-1,2-dichloroethene, trichloroethene and tetrachloroethene (DCE, TCE and PCE) which are known Dense Non-Aqueous Phase Liquid (DNAPL). DNAPLs are heavier than water and generally sink to the bottom of an impermeable geological stratum. It is understood that in the past some dry cleaning operators used to dispose the used solvents into sewers. As solvents are corrosive, cracks may appear over time and the solvents could then be leaking out of the sewer and entering into the groundwater system. It is not known whether such practice has been carried out at the site. Given the site is an operational shopping centre and surrounded by residential and commercial properties, additional boreholes could not be sunk in the vicinity of the sewerage system at the time of investigation.

Low level of cis-1,2-dichloroethene, trichloroethene and tetrachloroethene (DCE, TCE and PCE) were reported in groundwater sample collected from BH4. Although these concentrations do not exceed the GIL, it is notable that BH4 is located adjacent to the operational dry cleaners on Smidmore Street and that these chemicals are commonly used for dry cleaning. It is recommended that further groundwater investigation be carried out around the dry cleaner shop to obtain a better understanding of the presence of DCE and TCE in the underlying groundwater.

Low levels of PCE, TCE and DCE were detected in the groundwater sample collected from BH4 located adjacent to the dry cleaner. PCE is commonly associated with dry cleaning process and TCE and DCE are degradation by-products of PCE. Concentrations of PCE, TCE and DCE were not reported in the groundwater in the other two bores sampled in this round of investigation. It was common for waste PCE to have been disposed of via the sewer system and the sewer may be a migration pathway for this contaminant.

- Further groundwater investigation be undertaken to confirm or otherwise groundwater contamination associated with the dry cleaning operation and the possible historical leakage / spillage of petroleum products at the disused fuel point;

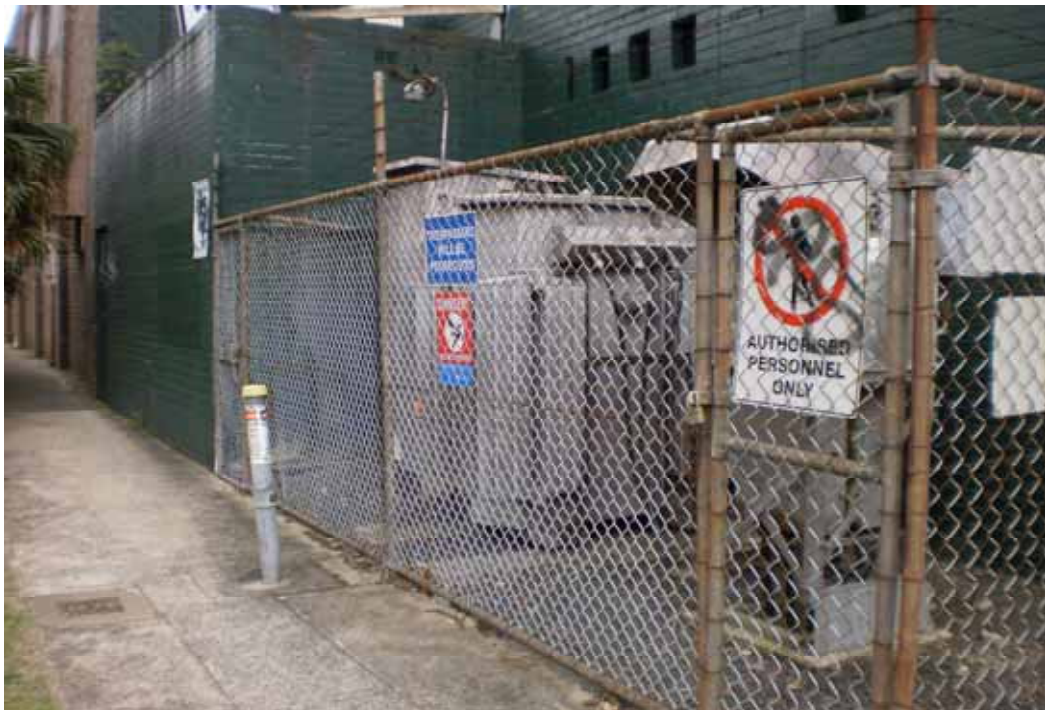
Photo 4: Electricity Sub-station located at the corner of Murray Street and Edinburgh Road

An electricity sub-station is located at the south-eastern corner of the shopping centre. An oil/water separator is located to the south of the Mill House which is used by Kmart Oil. Kmart Oil is currently trading as an auto and tyre repair facility. Grease traps were also noted at the loading docks.

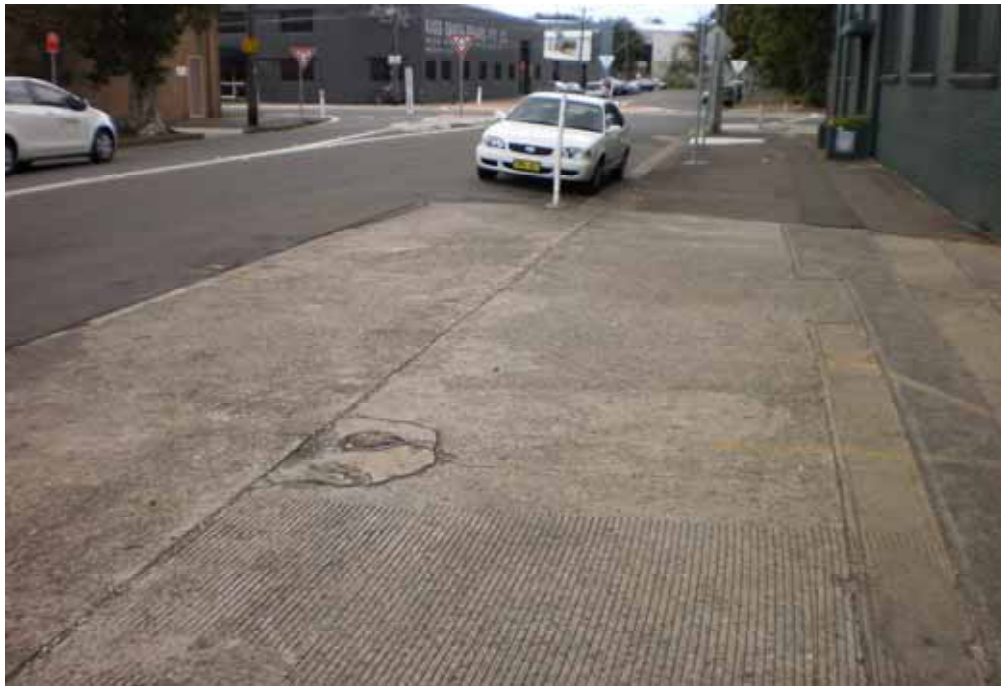
Photo 5: Old Fill Point located on Murray Street Footprint, adjacent to the Warehouse Building

An old underground storage tank (UST) fill point was noted on the footpath of Murray Street. The fill point was filled with concrete and it appears that the fuel point was connected to an UST located inside the warehouse. There were no signs of the presence of a UST located inside the warehouse. The tank is likely to be decommissioned and either buried beneath the existing concrete floor or has been removed off site.

Based on the findings from the previous DP validation assessment, it is known that there were formerly three USTs present at the southern portion of the site. A disused fuel point was noted on the footpath of Murray Street during site inspection which indicates that a fourth UST may be present in the eastern portion of the warehouse. An electricity sub-station was also noted at the corner of Smidmore Street and Murray Street which was constructed in 2006. This part of the site was previously owned by Energy Australia and may have been used as an electricity sub-station site prior to 2006. On this basis, residual PCBs may be potentially present in this part of the site.

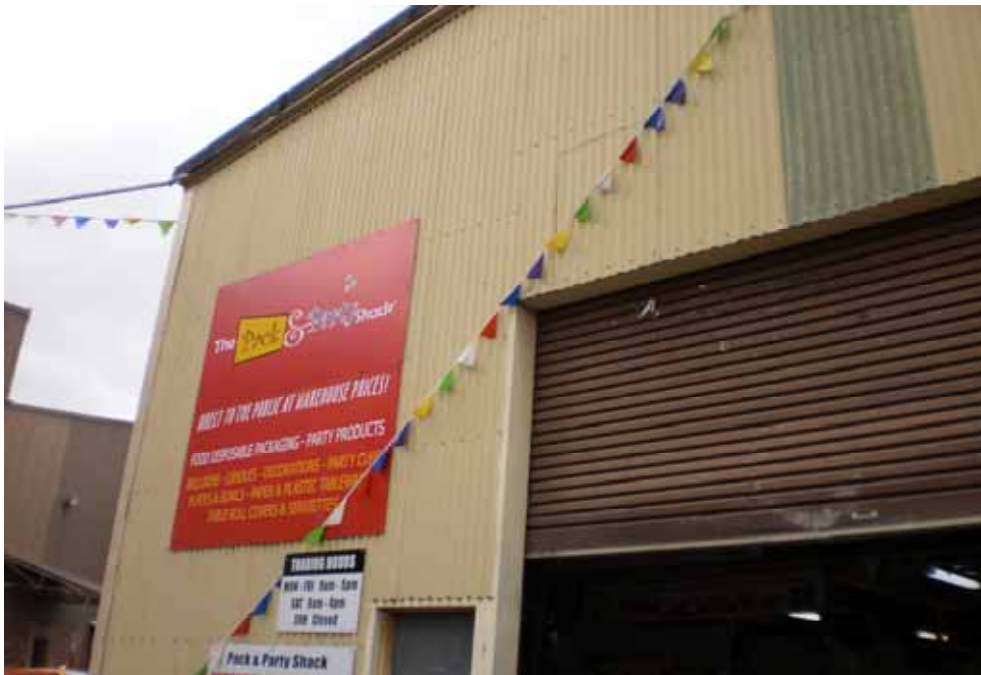
Photo 6: Warehouse Building located on the Southern Portion of the Site

The southern portion of the site comprises two warehouse buildings, currently occupied by a food packaging warehouse. The products stored at the site include disposable plates, cutlery, cups, etc. The main parking area is located to the west of the buildings. The surface cover consists of concrete paving and concrete building slabs with landscaping around the site boundary. The paving appears to be in a good condition at the time of the site visit.

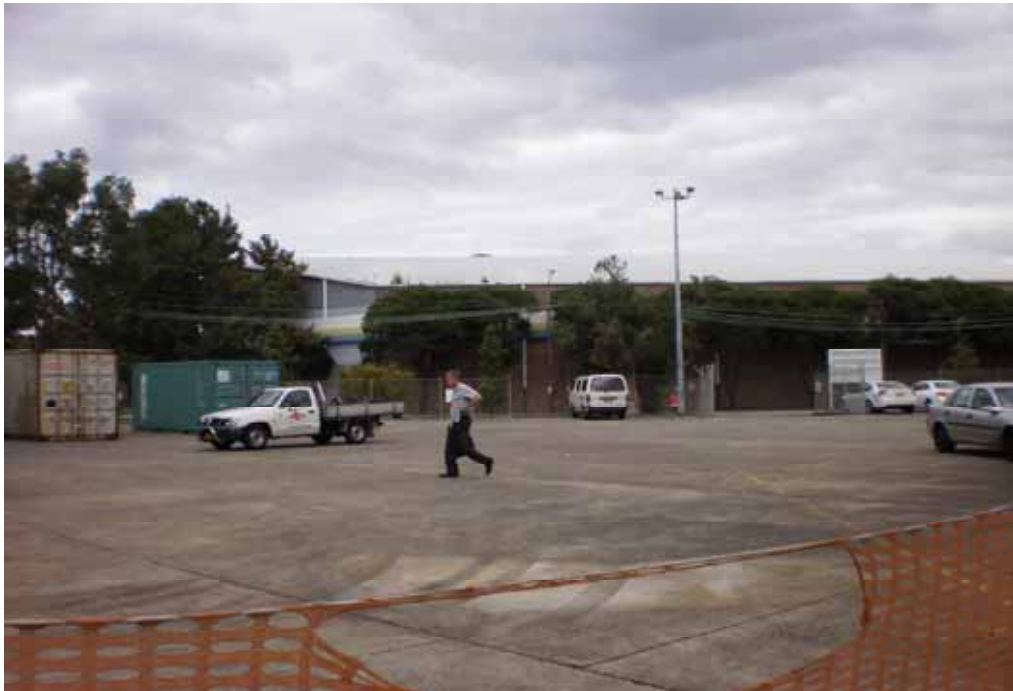
Photo 7: Car Parking Area for the Warehouse

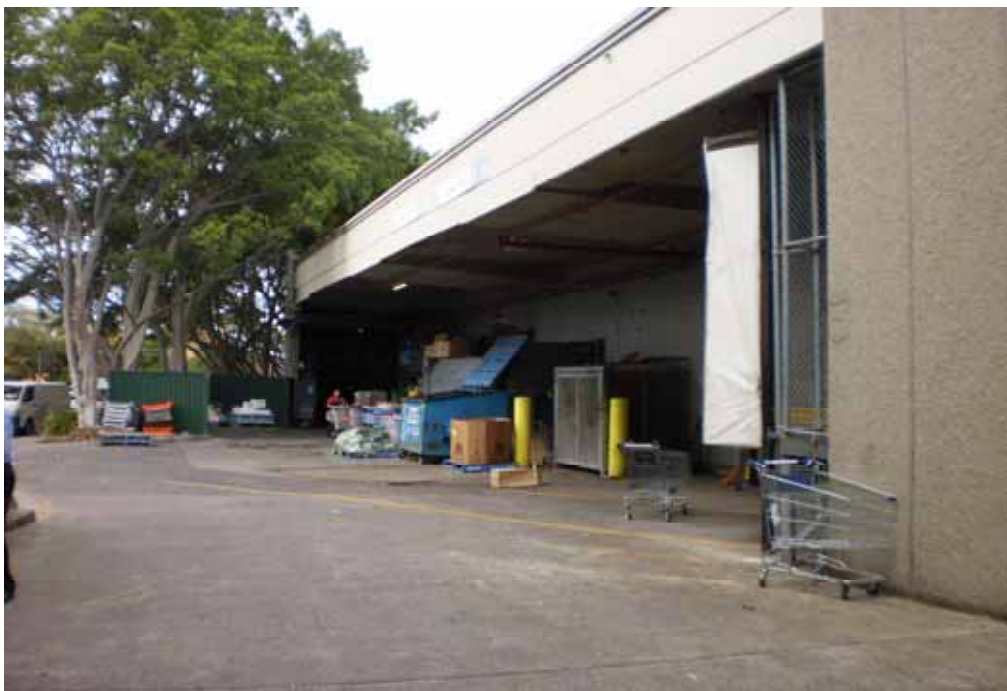
Phot 8: Loading Dock located adjacent to Smidmore Street Entrance
