WATERFRONT PRECINCT HERITAGE BUILDINGS,  
MAIN SITE BHP PORT WARATAH STEELWORKS, NEWCASTLE

### OPEN HEARTH CHANGE HOUSE

September 2000  
Our Ref: 3882-04-rec-007

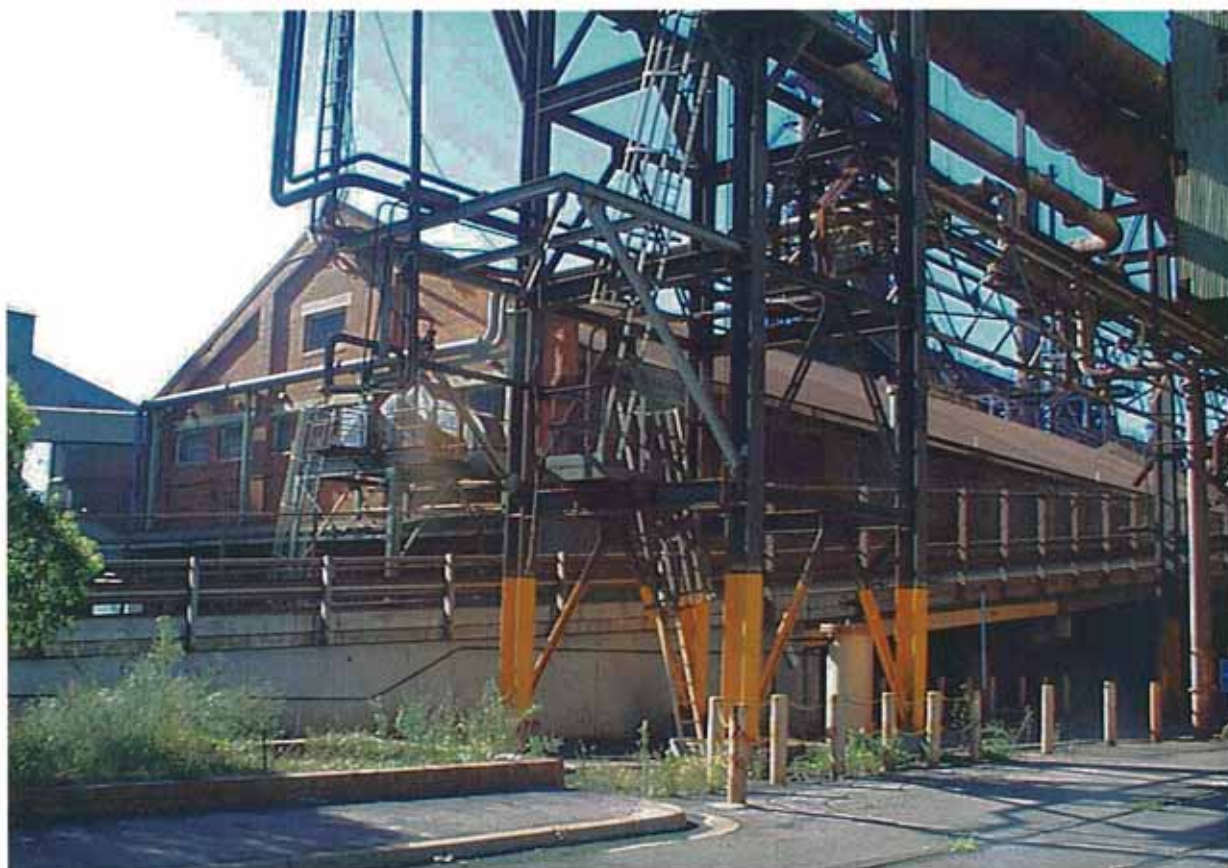
Figure 0.1 View North – East of Open Hearth Bath House showing West and South facades overlaid with the later added B.O.S. scrap feed ramp and pipe-work framing.

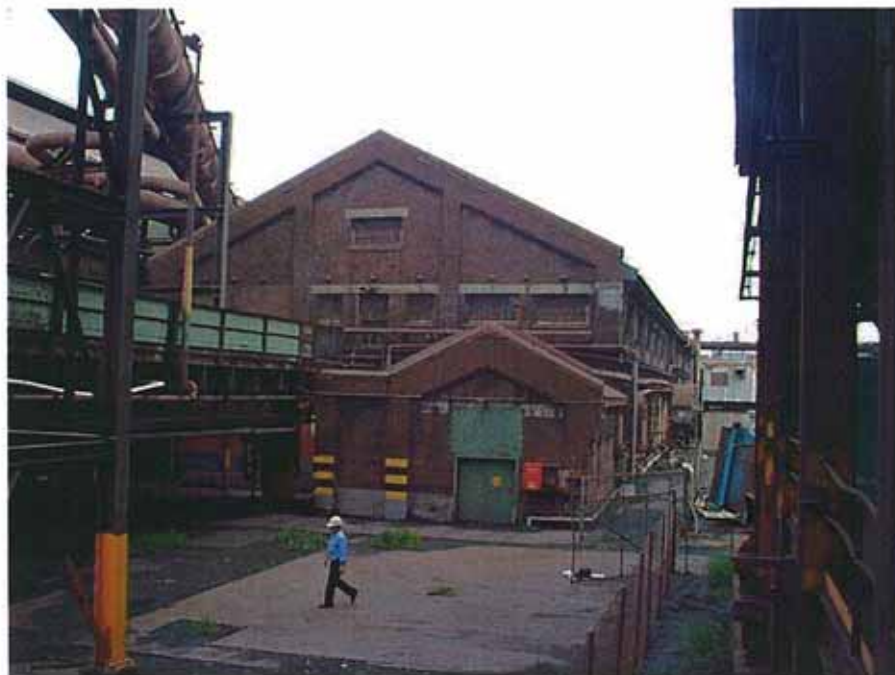
Figure 6.1 View West of Open Hearth Change House's Eastern facade. Shows Main 2 storey building with late single storey extension in foreground for tar fuel pump house.

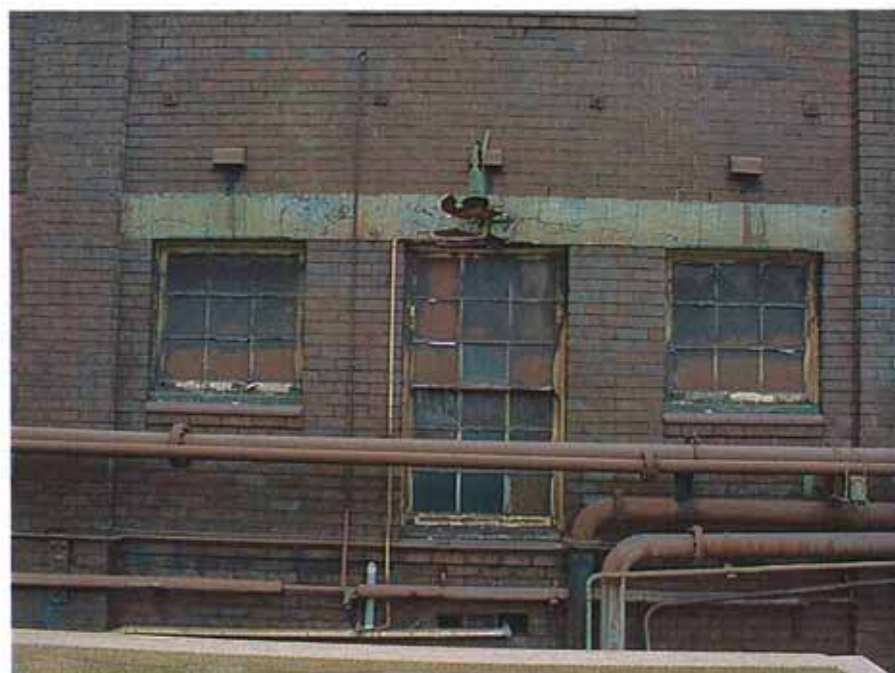
Figure 6.2 View West of upper level detail of original windows at Eastern façade.

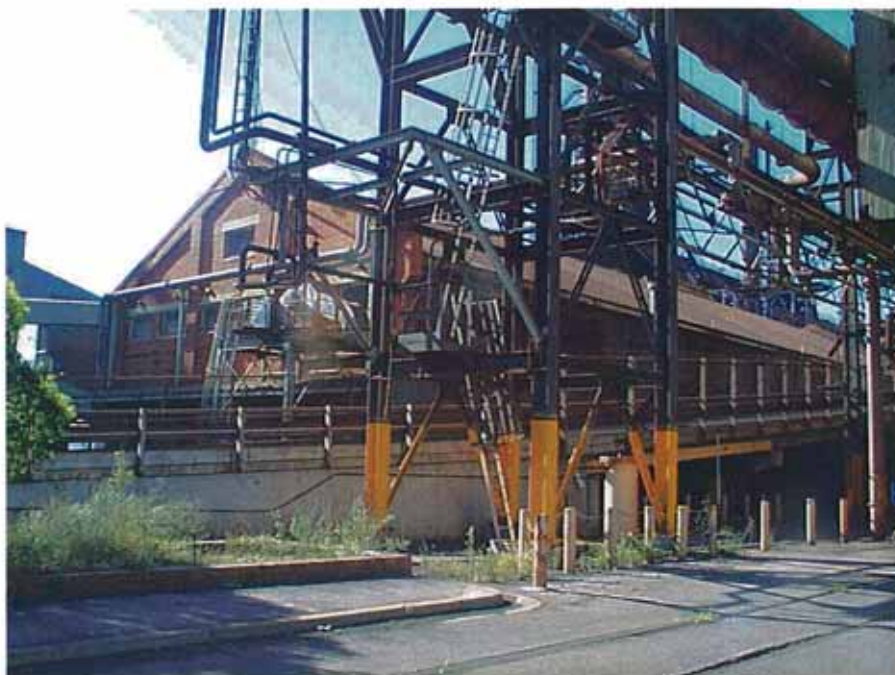
Figure 6.3 View North – East of Open Hearth Bath House showing West and South facades overlaid with the later added B.O.S. scrap feed ramp and pipe-work framing.

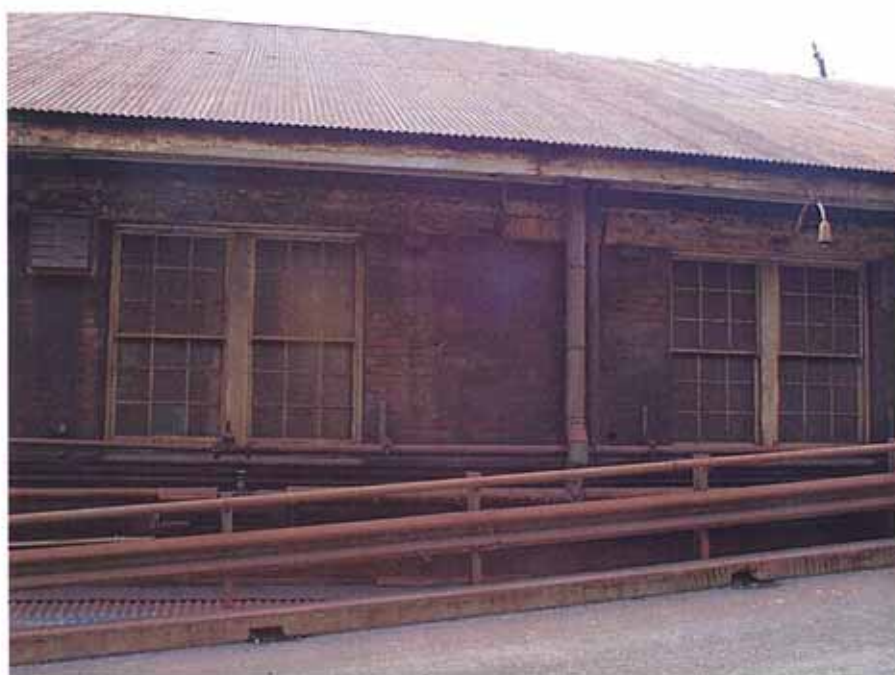
Figure 6.4 View North of Southern façade showing original windows. Taken from the B.O.S. scrap ramp.

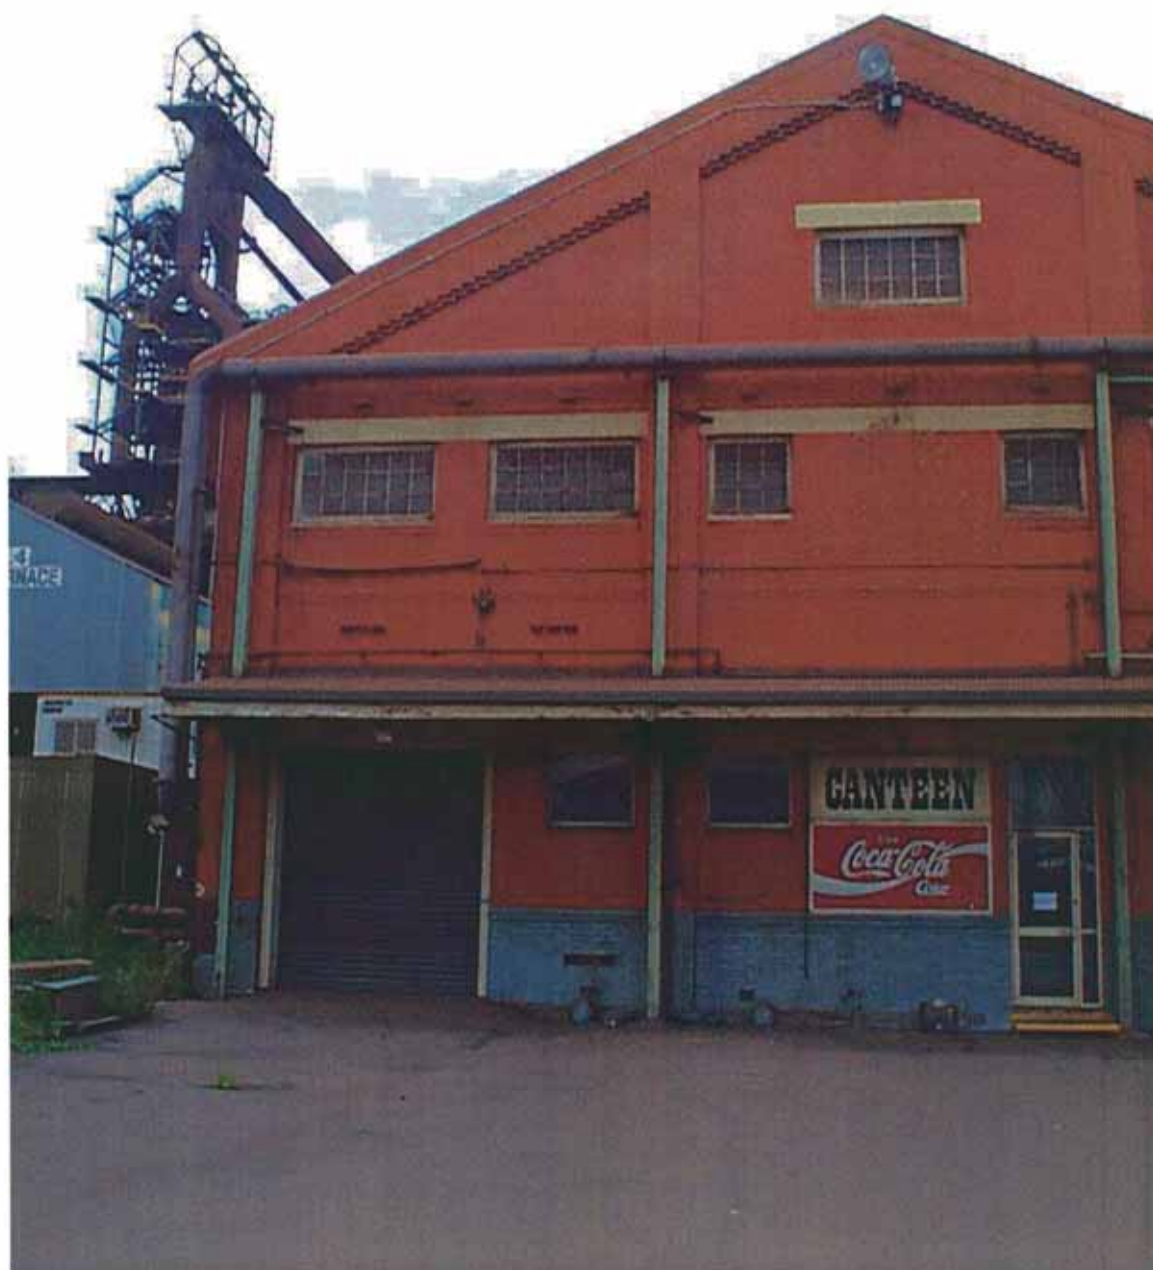
Figure 6.7 View East of Open Hearth Change House Western façade (left portion).

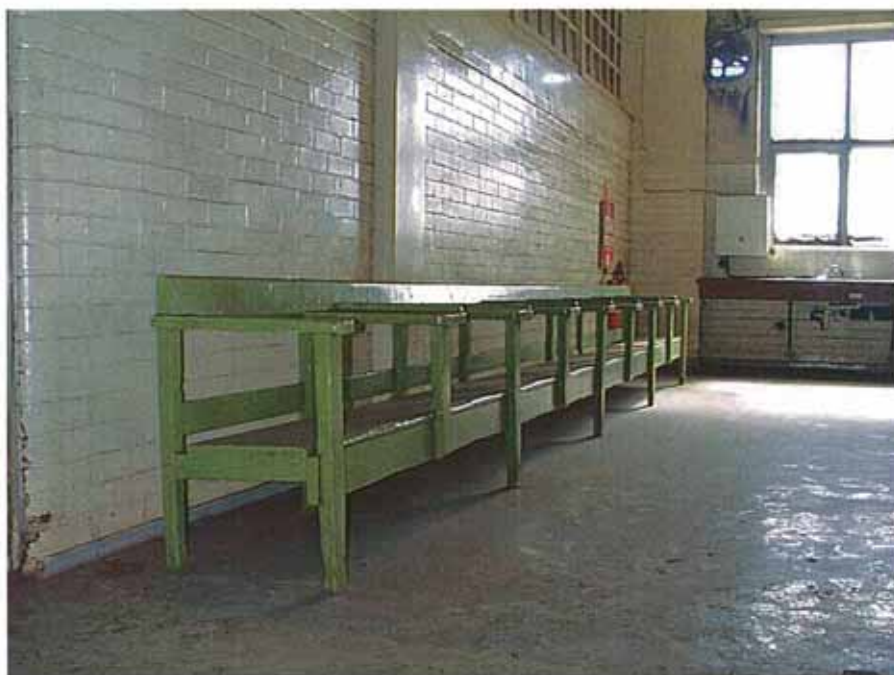
Figure 6.8 View of lunch area and bench within Open Hearth Bath House.

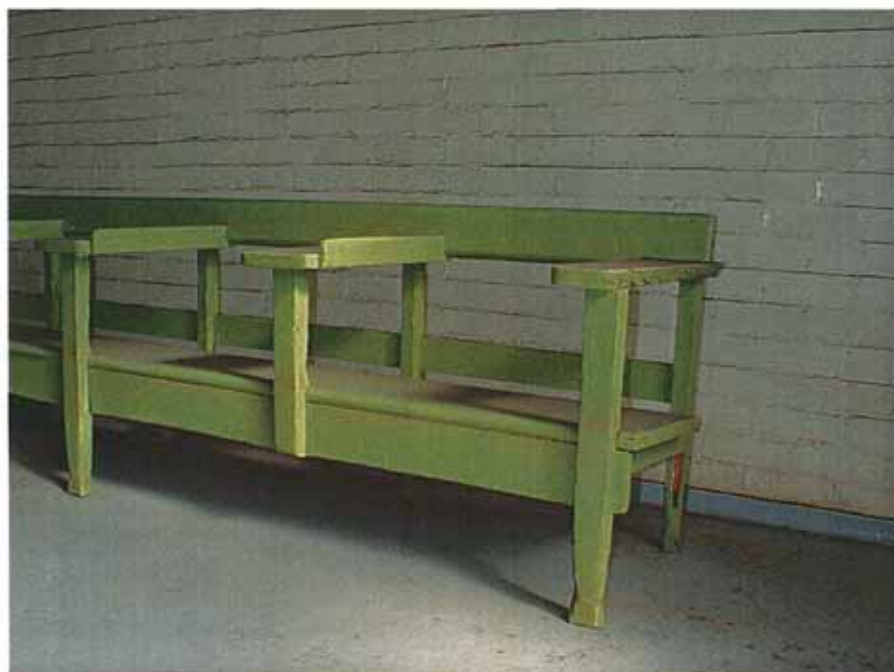
Figure 6.9 Close-up of "cedar" lunch room bench within Open Hearth Bath House. Note: Detail drawings of bench, differs from original detail drawings.

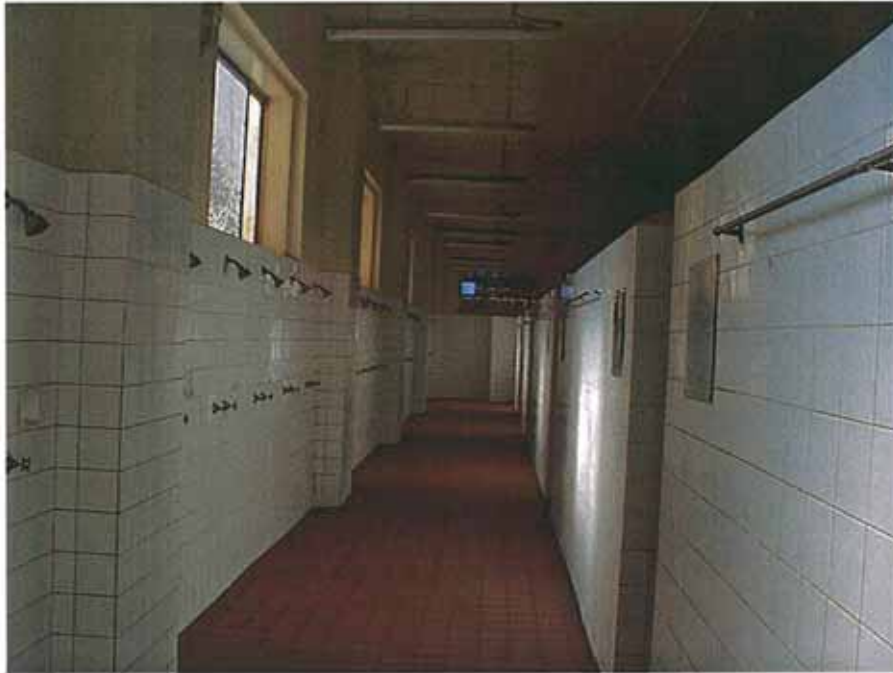
New plumbing was provided, floor levels adjusted to allow efficient drainage, exhaust fans installed and non-slip tiles laid on the floors. The new plumbing involved removing the overhead showers, which no longer conformed to government regulations, and installing them in rows along the walls. Pipes were bedded into the walls and covered with cement render. The walls were then tiled, providing a more hygienic surface than the original painted finish but also enabling easier removal of graffiti, which had been a long-time problem in change houses throughout the plant. The amount of graffiti was generally accepted as an indicator of the morale in the department and by this yardstick, morale was extremely low in the Open Hearth Department. When the upgrade was completed, there was a shower and toilet bowl for each 6 employees, surpassing the Department of Labour and Industry requirement of eight employees per facility.

Figure 6.10 View East along North side of showers to Open Hearth Bath House.  
Showers have been heavily modified to run East – West. Showers originally ran North – South with division wall at each. Wall panel at centre / external wall pier.

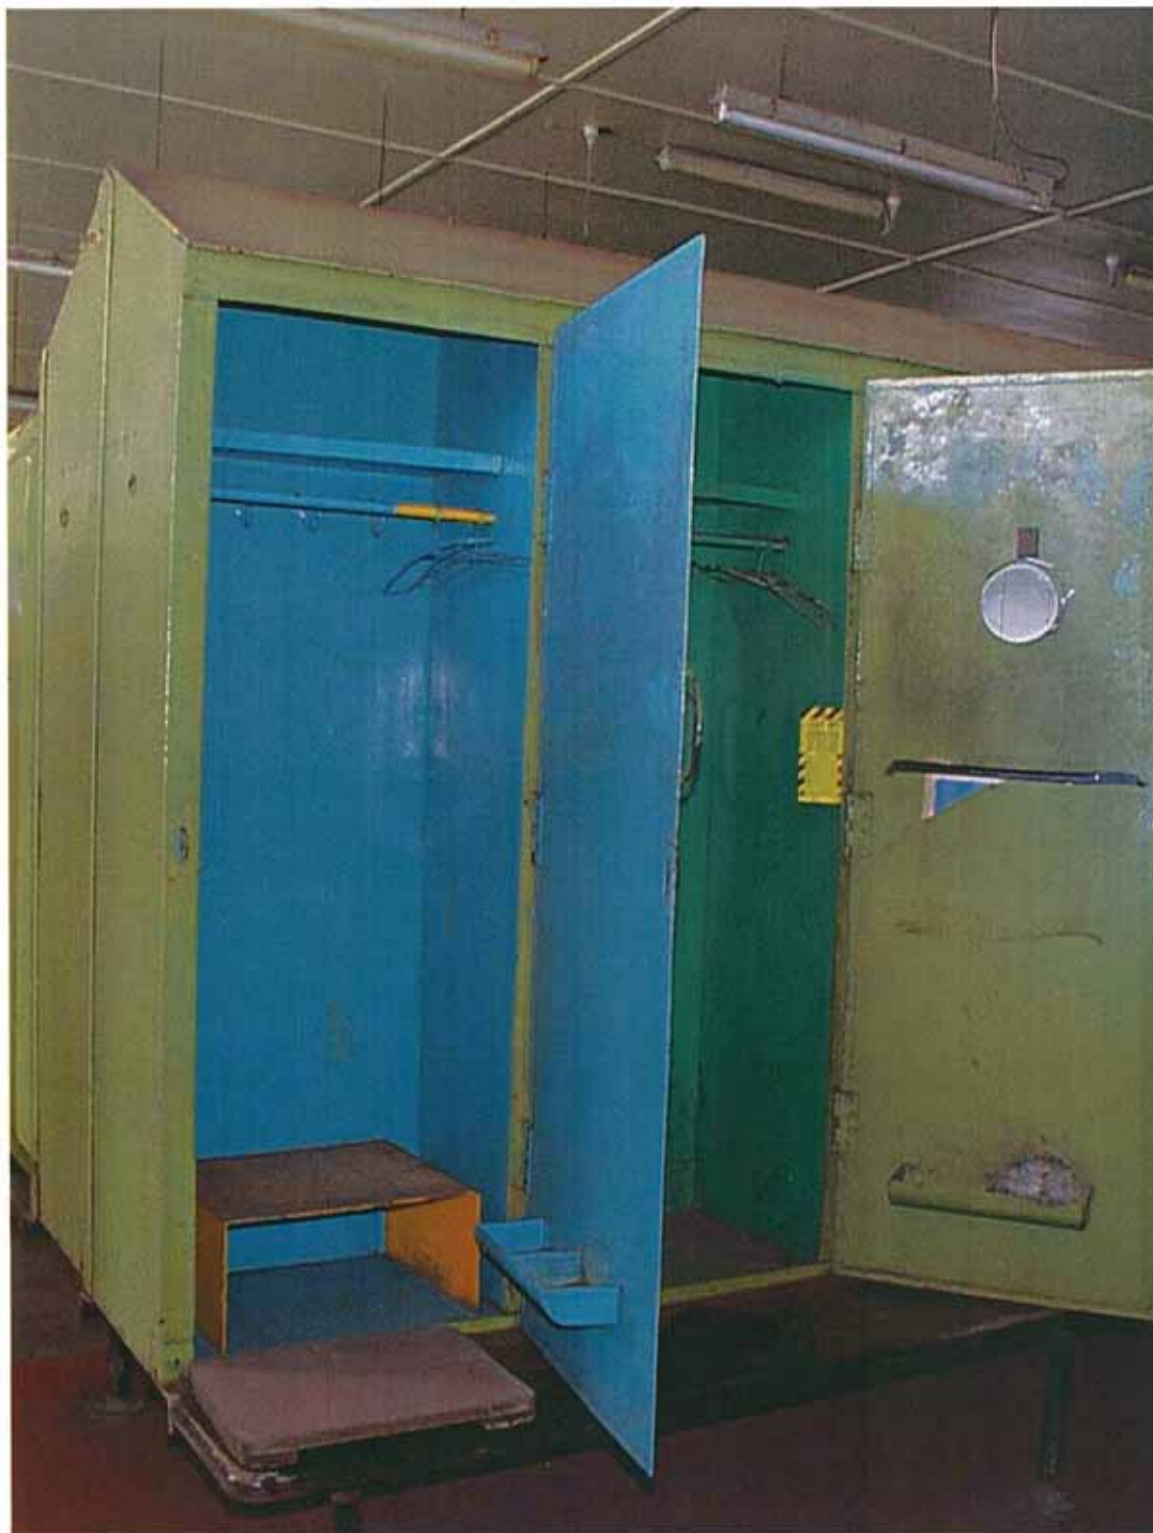
The original lockers were removed and their brick bases, which provided a harbour for rats, were demolished. These lockers were unusually large, being about 18" – 20" square and were made of heavy steel. Standard 12" wide lockers were erected in their place, prompting complaints from employees who resented the reduction in storage space. Fortunately, enough lockers were provided, and the workforce declined sufficiently, to allow two of the new lockers to be allocated to each employee.

Figure 6.11 Internal view of Open Hearth Bath House locker room. Shows original heavy plate steel lockers with original clothing hangers. Note foot board on bench seat and possible shoe box.
