ARCHIVAL RECORD

WATERFRONT PRECINCT HERITAGE BUILDINGS,
MAIN SITE BHP PORT WARATAH STEELWORKS, NEWCASTLE

MOULD CONDITIONING BUILDING

September 2000
Our Ref: 3882-04-rec-014

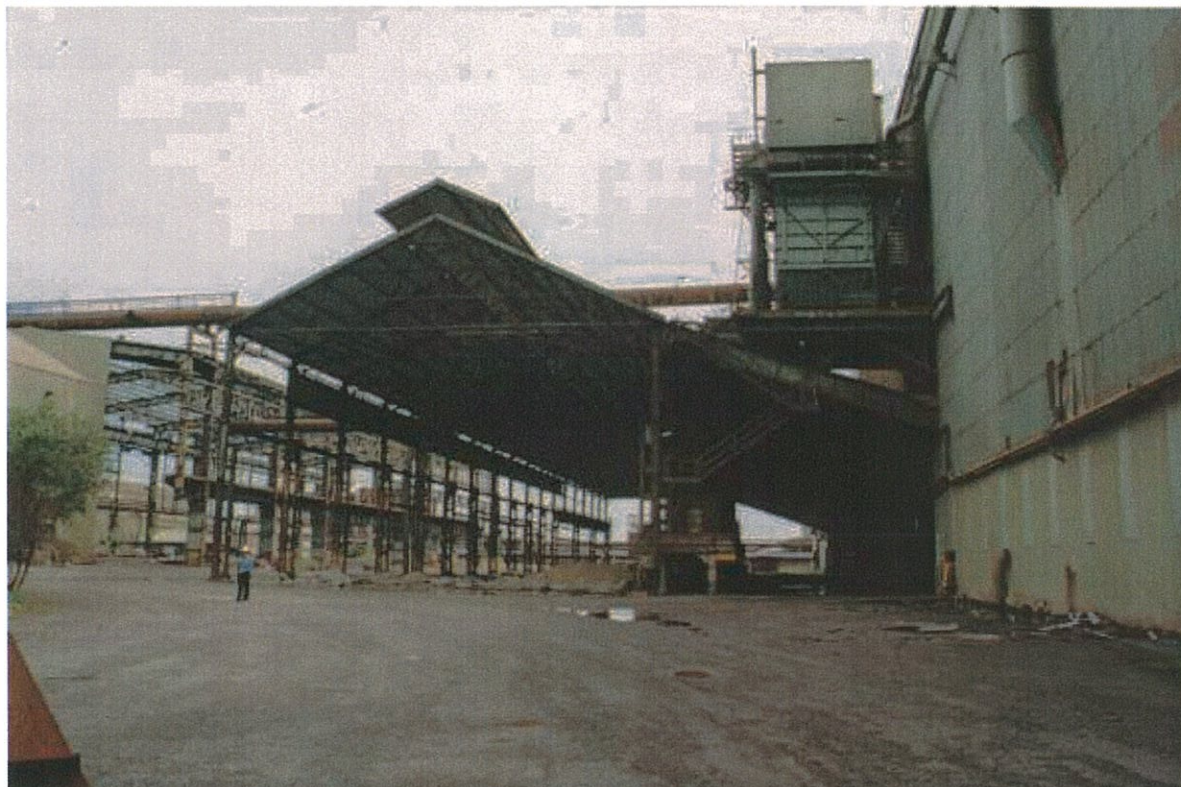
Figure 6.1 Mould Conditioning Building (item 20). Viewed from East looking West. Note deep steel beam skillion addition between mould conditioning building and open hearth building (item 3) at far right.

| Neg No. | Figure No. | Description |
|---|---|---|
| 2 | 6.1 | Mould Conditioning Building. Viewed from East looking West. Note deep steel beam skillion addition between mould conditioning building and open hearth building at far right. |

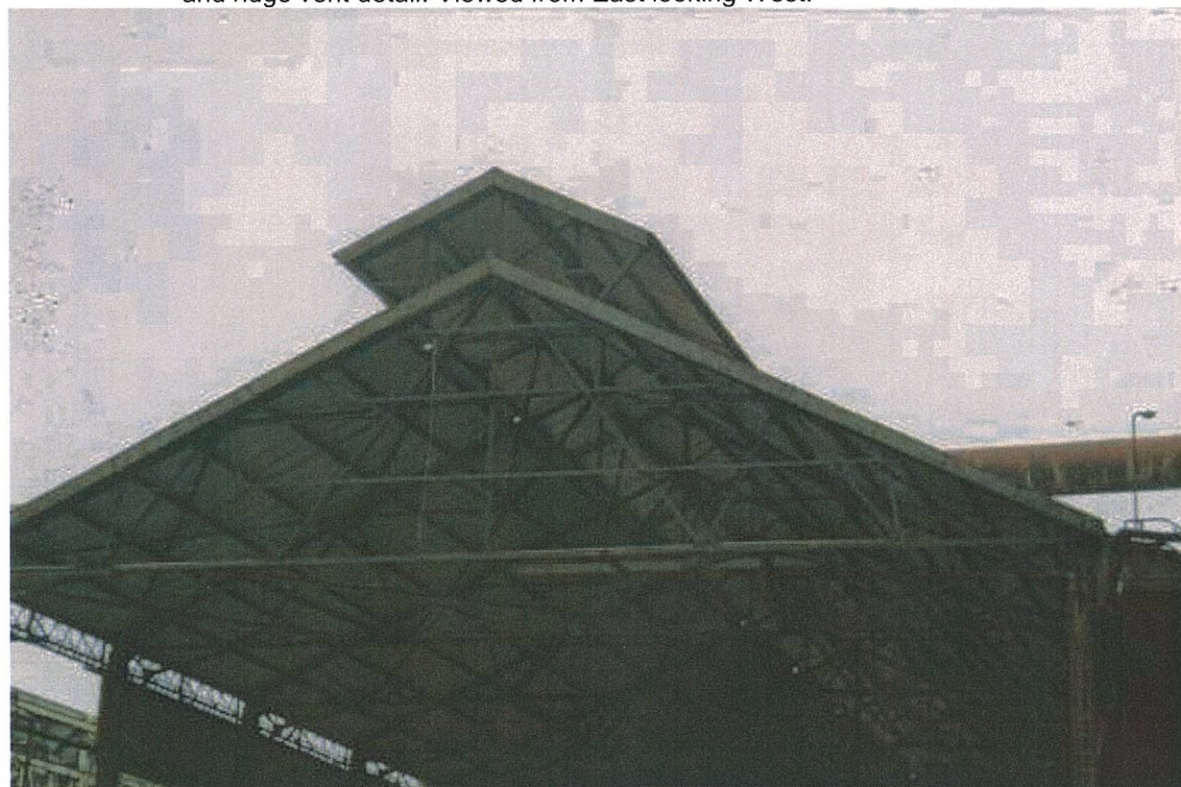
Figure 6.2 Mould Conditioning Building (item 20). Roof structure detail showing steel trusses and ridge vent detail. Viewed from East looking West.

| Neg No. | Figure No. | Description |
|---|---|---|
| 1 | 6.2 | Mould Conditioning Building. Roof structure detail showing steel trusses and ridge vent detail. Viewed from East looking West. |

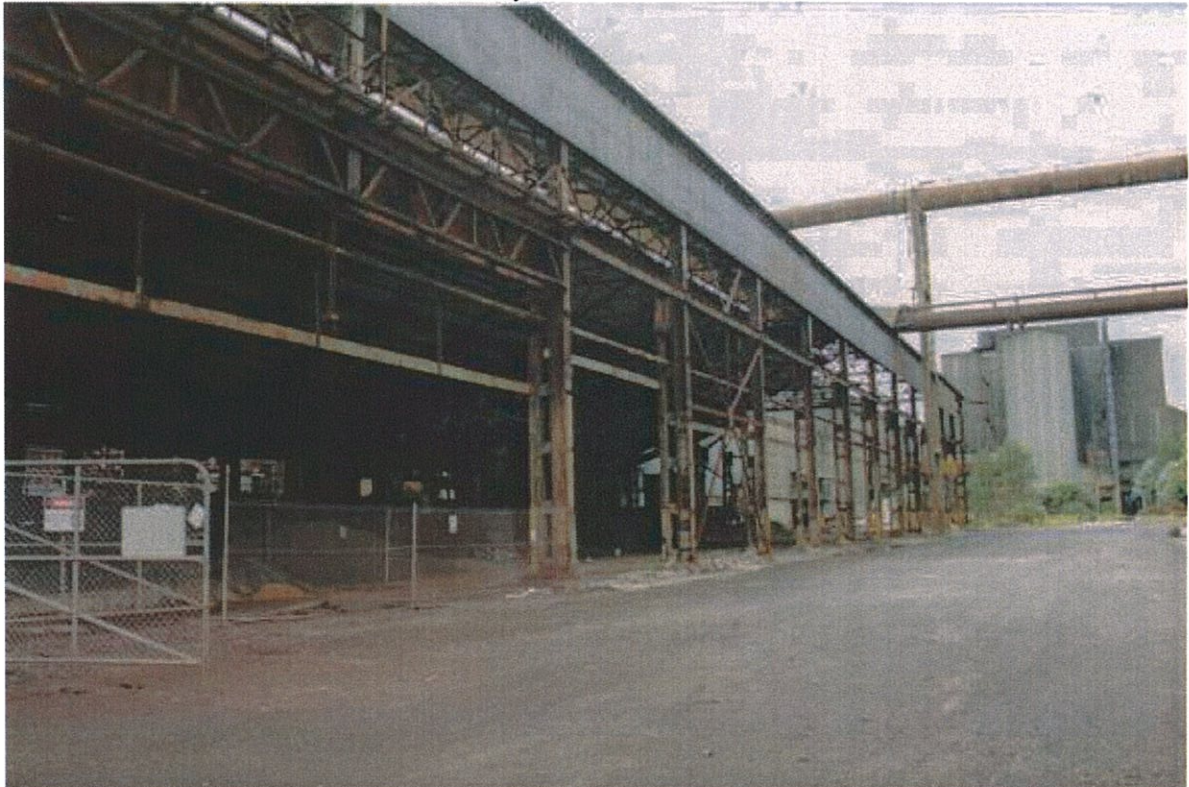
Figure 6.3 Mould Conditioning Building (item 20). Viewed from South looking East towards bloom caster in background beyond planting. Note riveted crane rail beam has been removed from last eleven bays.

| Neg No. | Figure No. | Description |
|---|---|---|
| 6 | 6.3 | Mould Conditioning Building. Viewed from South looking East towards bloom caster in background beyond planting. Note riveted crane rail beam has been removed from last eleven bays. |

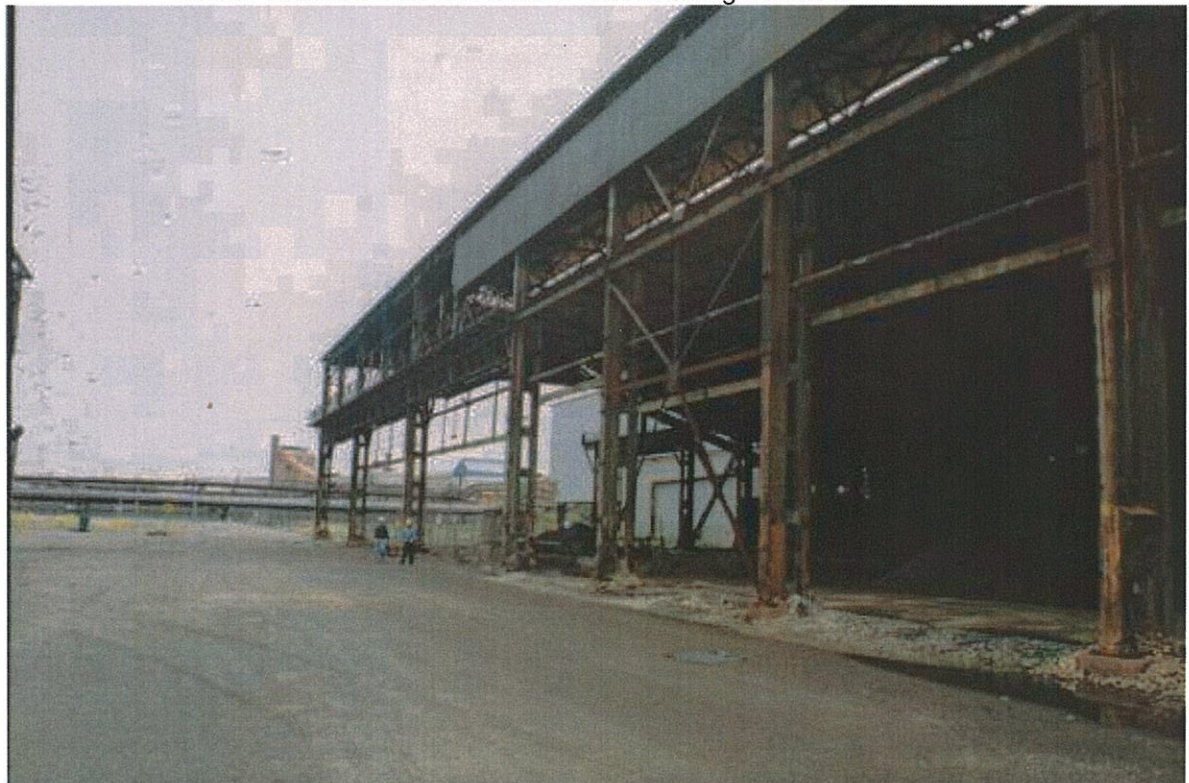
Figure 6.4 Mould Conditioning Building (item 20). View of southern wall Western end not riveted steel columns and exterior wall cladding removed.

| Neg No. | Figure No. | Description |
|---|---|---|
| 4 | 6.4 | Mould Conditioning Building. View of southern wall Western end not riveted steel columns and exterior wall cladding removed. |

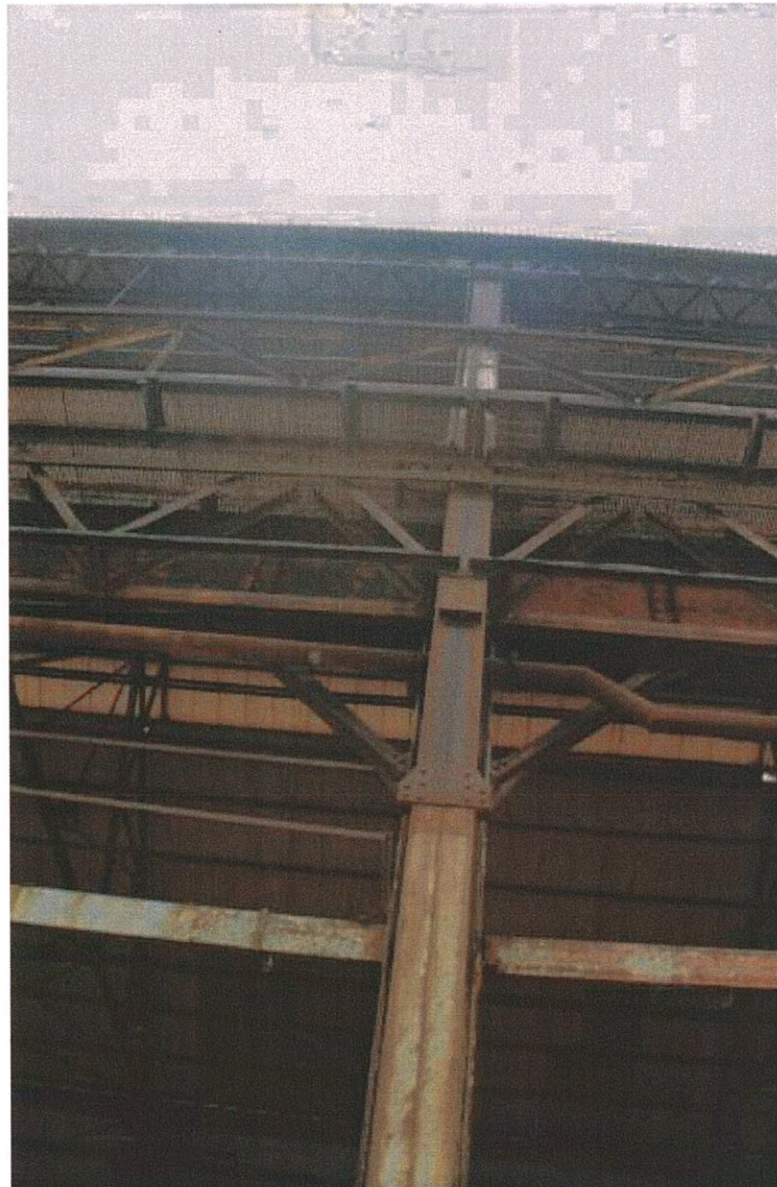
Figure 6.5 Mould Conditioning Building (item 20). Shows steel framing details of South wall. Note riveted crane rail beam painted red and parallel chord angle iron truss frames.

| Neg No. | Figure No. | Description |
|---|---|---|
| 5 | 6.5 | Mould Conditioning Building. Shows steel framing details of South wall. Note riveted crane rail beam painted red and parallel chord angle iron truss frames. |

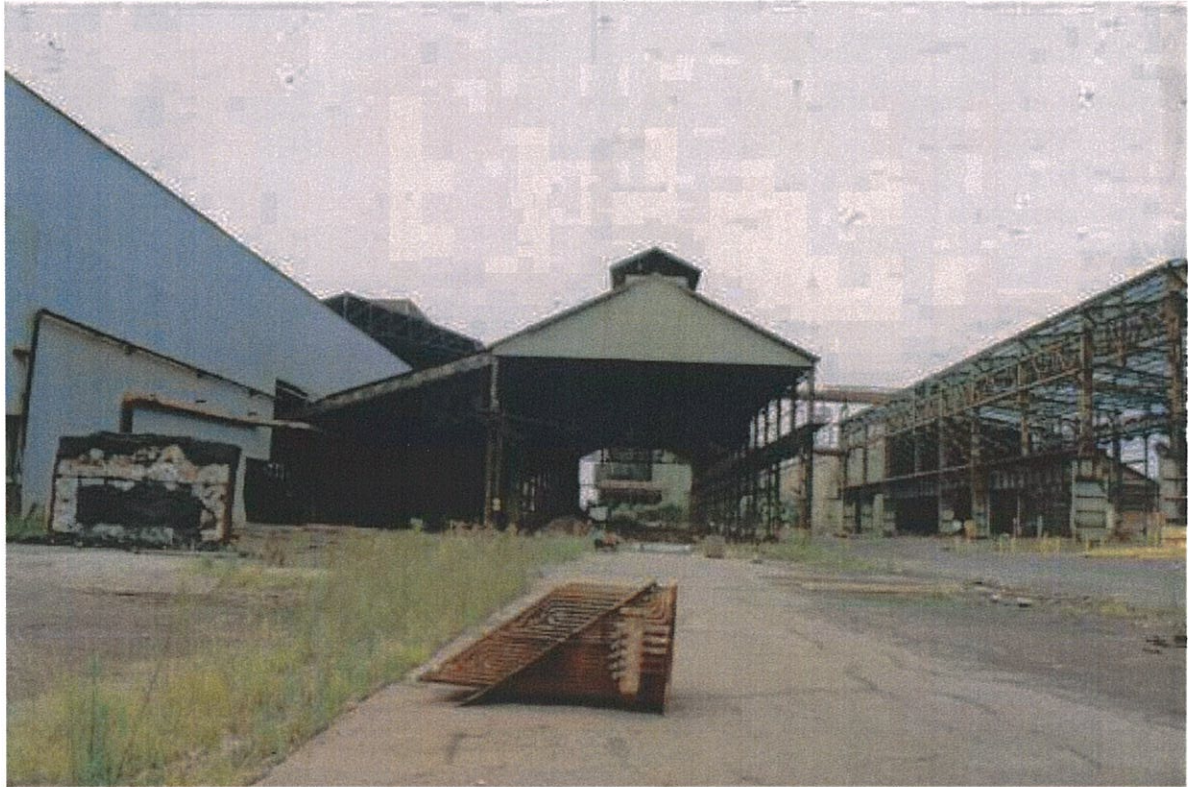
Figure 6.6 Mould Conditioning Building (item 20). Viewed from West looking East showing West elevation with North skillion addition to open hearth building (item 3) at far left. Frame of number 1 bloom mill (item 5) at far right.

| 18 | 6.6 | Mould Conditioning Building. Viewed from West looking East showing West elevation with North skillion addition to open hearth building at far left. Frame of number 1 bloom mill at far right. |

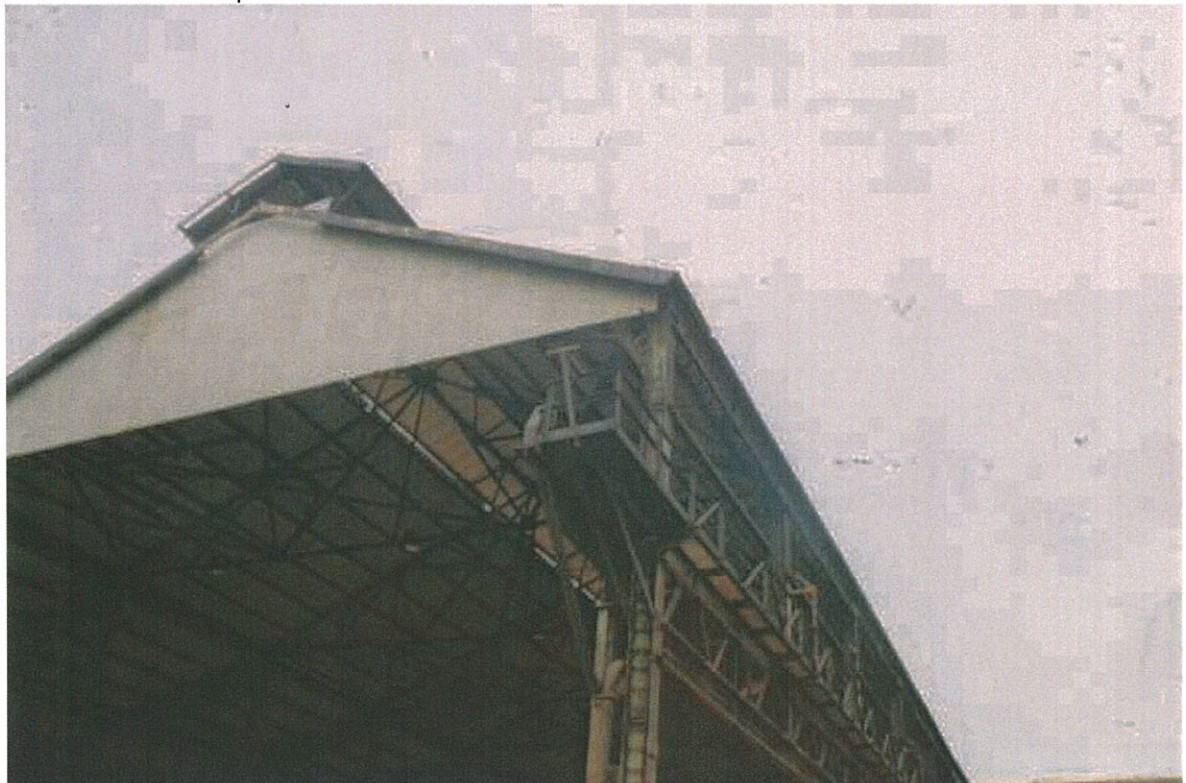
Figure 6.7 Mould Conditioning Building (item 20). View of West end wall showing roof and ridge vent profile.

| Neg No. | Figure No. | Description |
|---|---|---|
| 12 | 6.7 | Mould Conditioning Building. View of West end wall showing roof and ridge vent profile. |

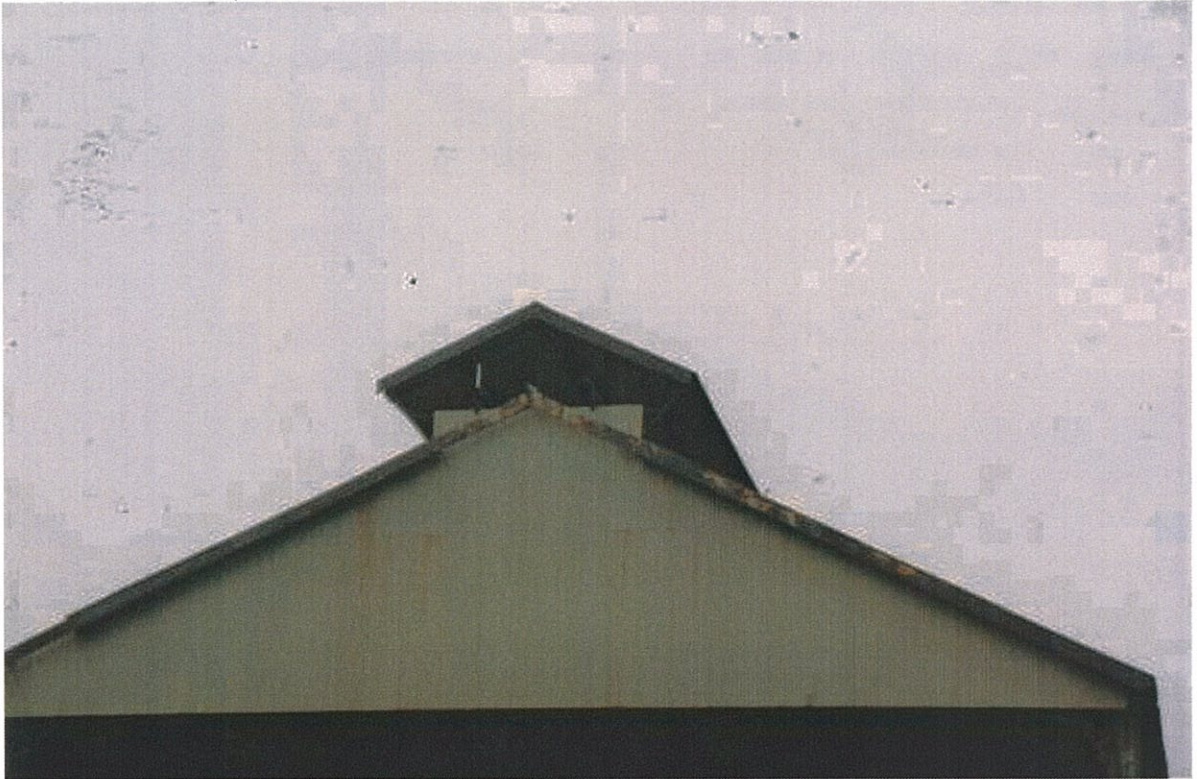
Figure 6.8 Mould Conditioning Building (item 20). View of west end wall showing roof and ridge vent profile.

| Neg No. | Figure No. | Description |
|---|---|---|
| 13 | 6.8 | Mould Conditioning Building. View of west end wall showing roof and ridge vent profile. |

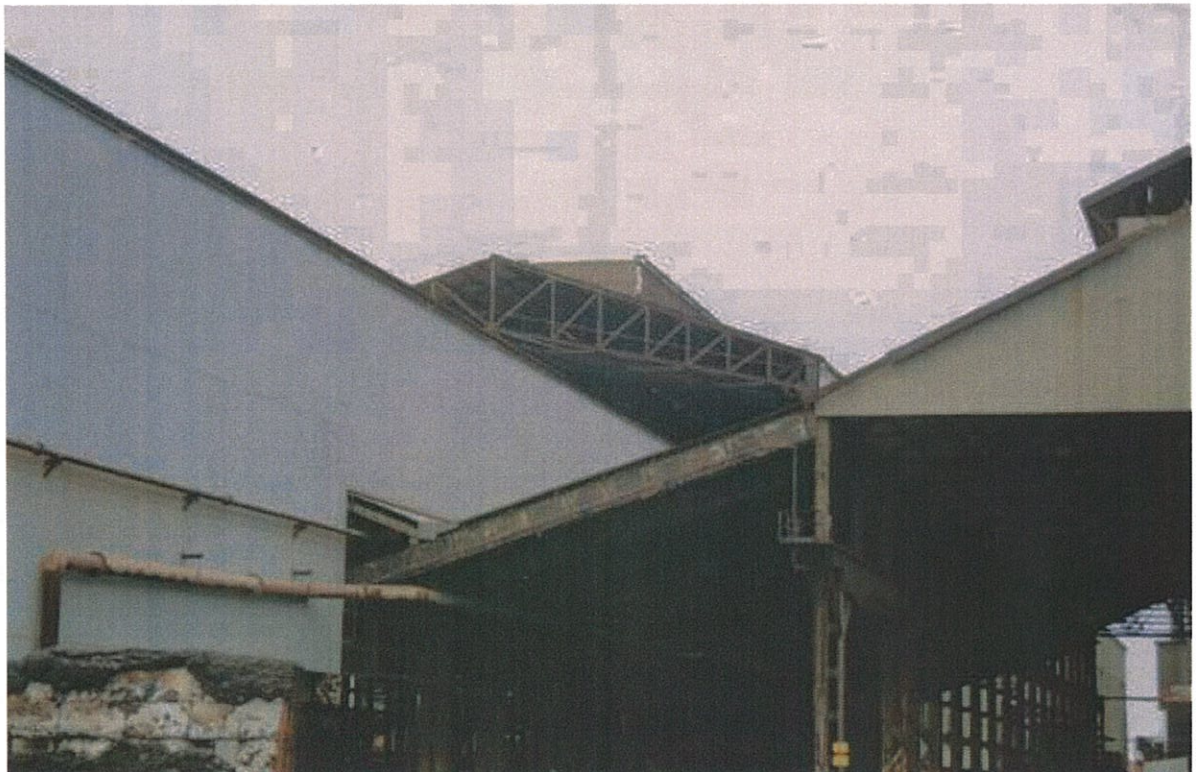
Figure 6.9 Mould Conditioning Building and addition (item 20) with open hearth building (item 3) at left. Note B.O.S. Building (item 21) overhead at rear.

| Neg No. | Figure No. | Description |
|---|---|---|
| 16 | 6.9 | Mould Conditioning Building and addition with open hearth building at left. Note B.O.S. Building overhead at rear. |

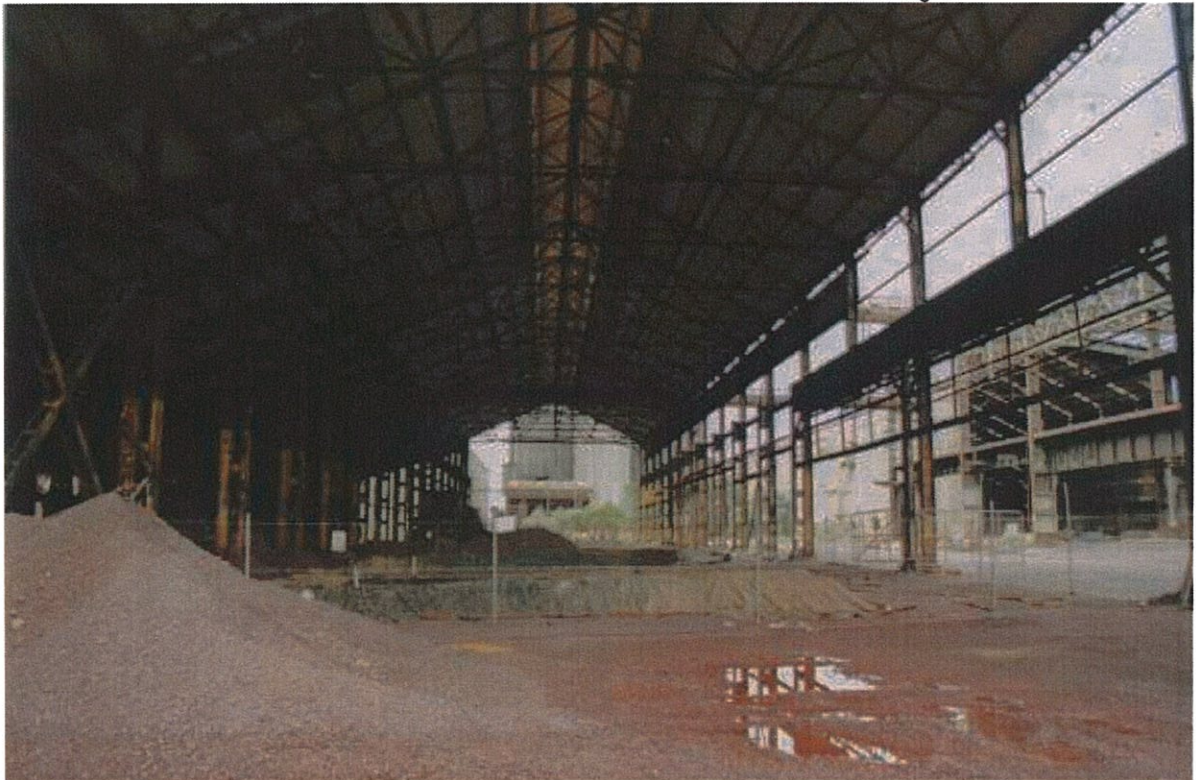
INTERNAL
Figure 6.10

Mould Conditioning Building (item 20). Interior view looking East towards bloom caster in far distance. Note former number 1 bloom mill at far right.

| Neg No. | Figure No. | Description |
|---|---|---|
| 9 | 6.10 | Mould Conditioning Building. Interior view looking East towards bloom caster in far distance. Note former number 1 bloom mill at far right. |

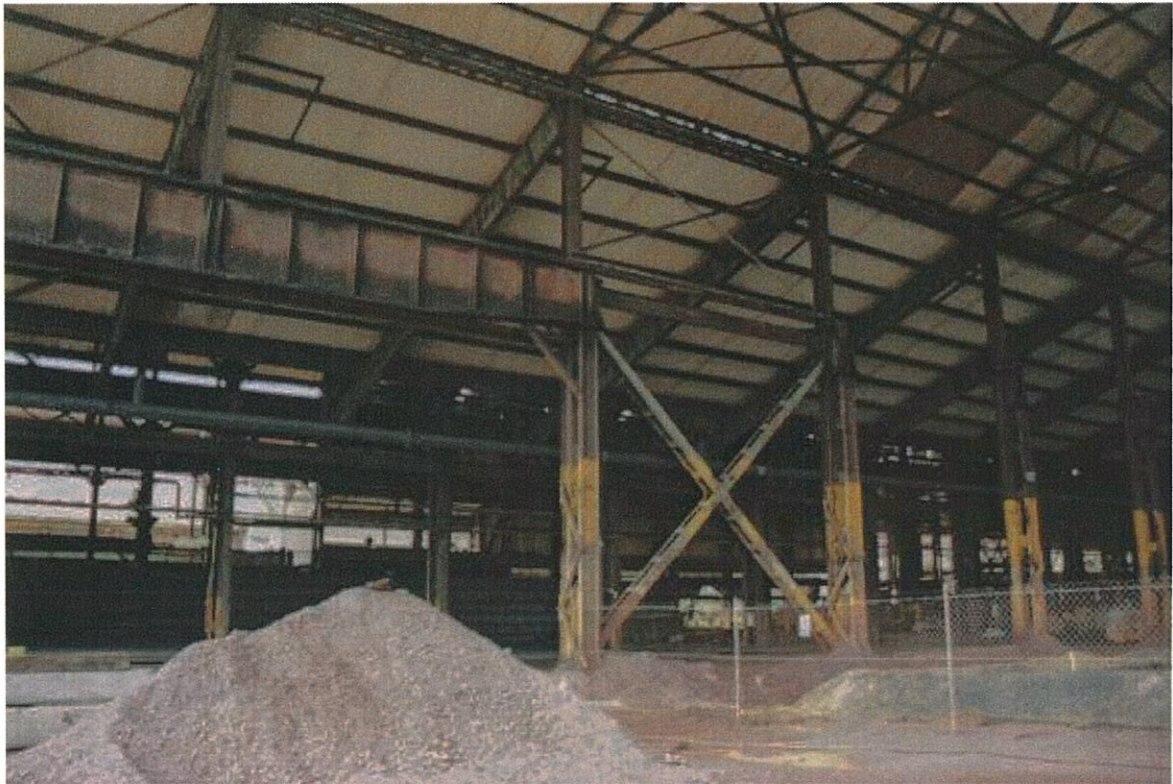
INTERNAL
Figure 6.12

Mould Conditioning Building (item 20). Interior view looking North to open hearth building (item 3). Note crane rail beam painted red and skillion addition between open hearth and mould conditioning buildings.

| Neg No. | Figure No. | Description |
|---|---|---|
| 7 | 6.12 | Mould Conditioning Building. Interior view looking North to open hearth building. Note crane rail beam painted red and skillion addition between open hearth and mould conditioning buildings. |

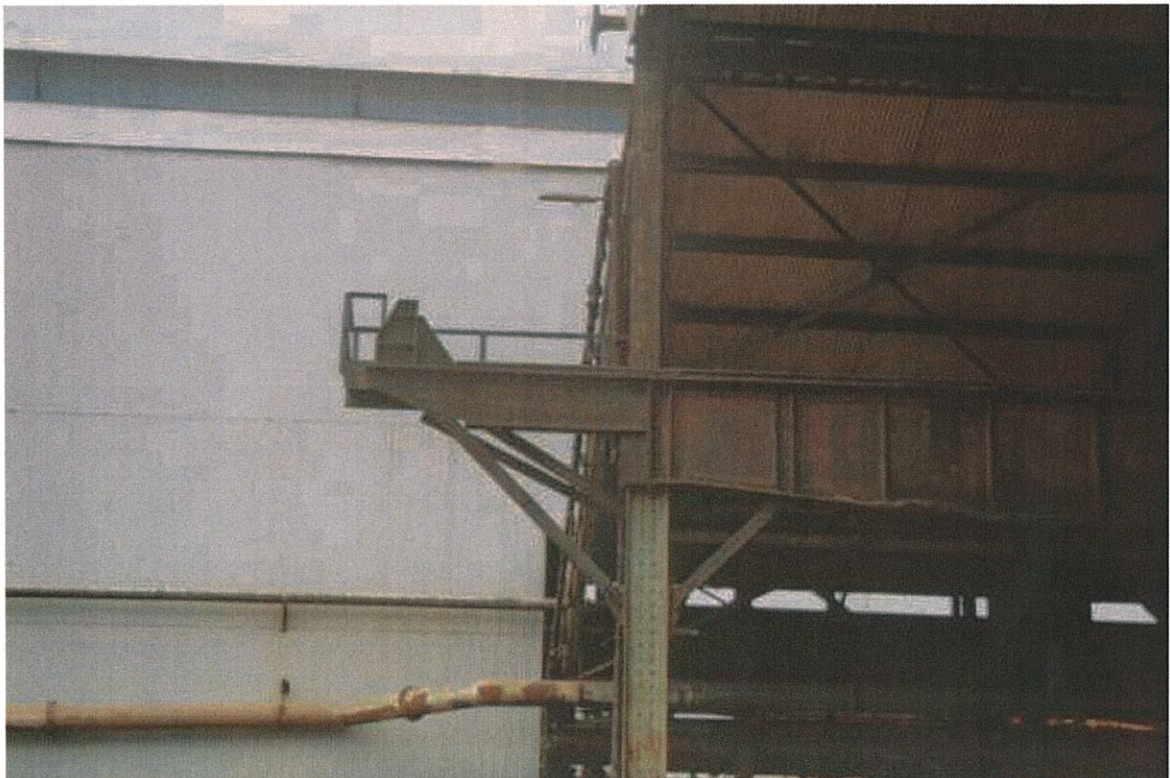
INTERNAL
Figure 6.13

Mould Conditioning Building (item 20). View of West end wall showing outrigger on North West column of West end wall. Open hearth building (item 3) in background.

| Neg No. | Figure No. | Description |
|---|---|---|
| 11 | 6.13 | Mould Conditioning Building. View of West end wall showing outrigger on North West column of West end wall. Open hearth building in background. |
