6.0 SELECTED PHOTOGRAPHS

7.0 NEGATIVE REFERENCE LIST

9.0 DIAGRAMMATIC RECORD AND DRAWINGS

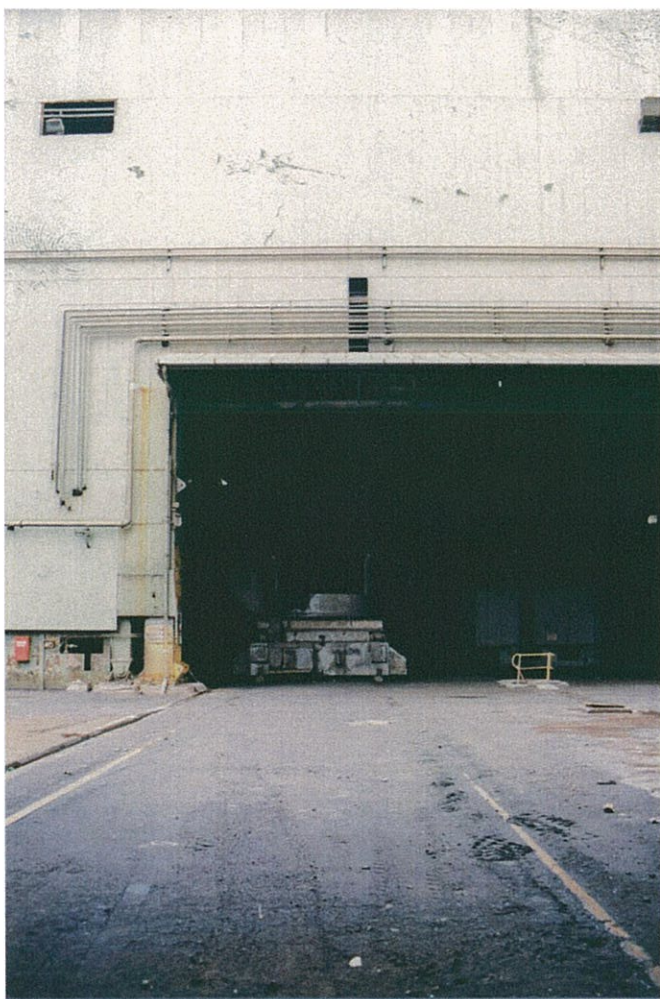
Figure 6.1 Opening to B.O.S. showing ladle car within.

Neg No.	Figure No.	Description
5A	6.5	Eastern facade of B.O.S. Plant showing teeming aisle (left) and hot metal charging aisle with rail tracks (right).
6A	6.6	Precipitators to Eastern side of B.O.S. Plant.
7A	6.7	View West of Southern side of B.O.S. Plant showing openings.
8A	6.1	Opening to B.O.S. showing ladle car within.
9A	6.8	View of North/West of B.O.S. (right) and junction with open hearth building mould conditioning building at left.
10A	6.3	View South/East of Western end of B.O.S. Plant showing overlap with old open hearth building.
11A	6.2	View East of overlap of B.O.S, with open hearth building. Mould condition building in centre of image.

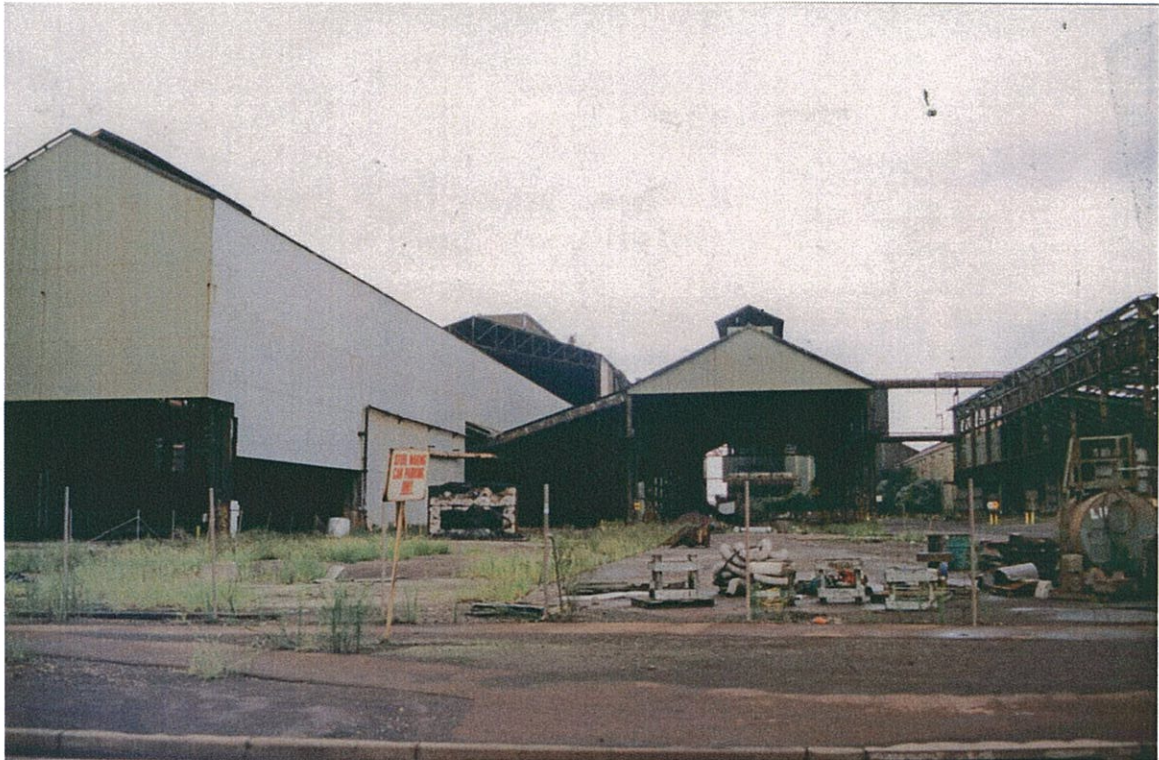
Figure 6.2 View East of overlap of B.O.S, with open hearth building at left. Open Hearth building in foreground and Mould condition building in centre of image.

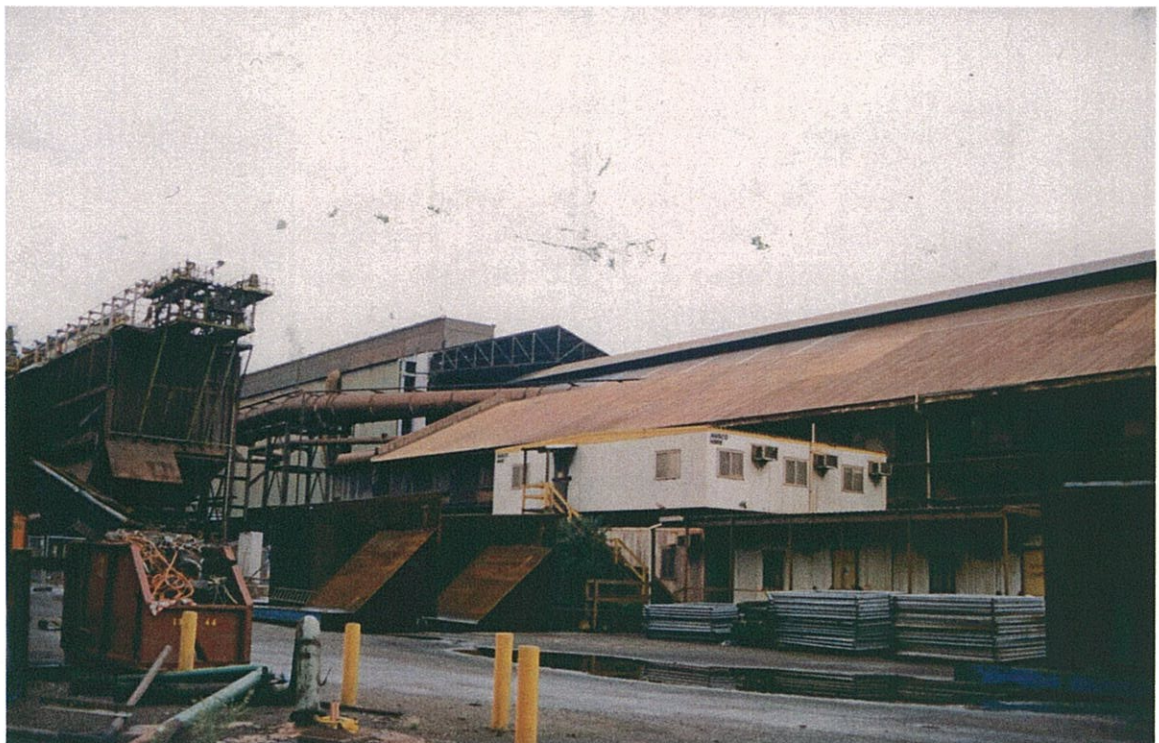
Figure 6.3 View South/East of Western end of B.O.S. Plant showing overlap with old open hearth building.

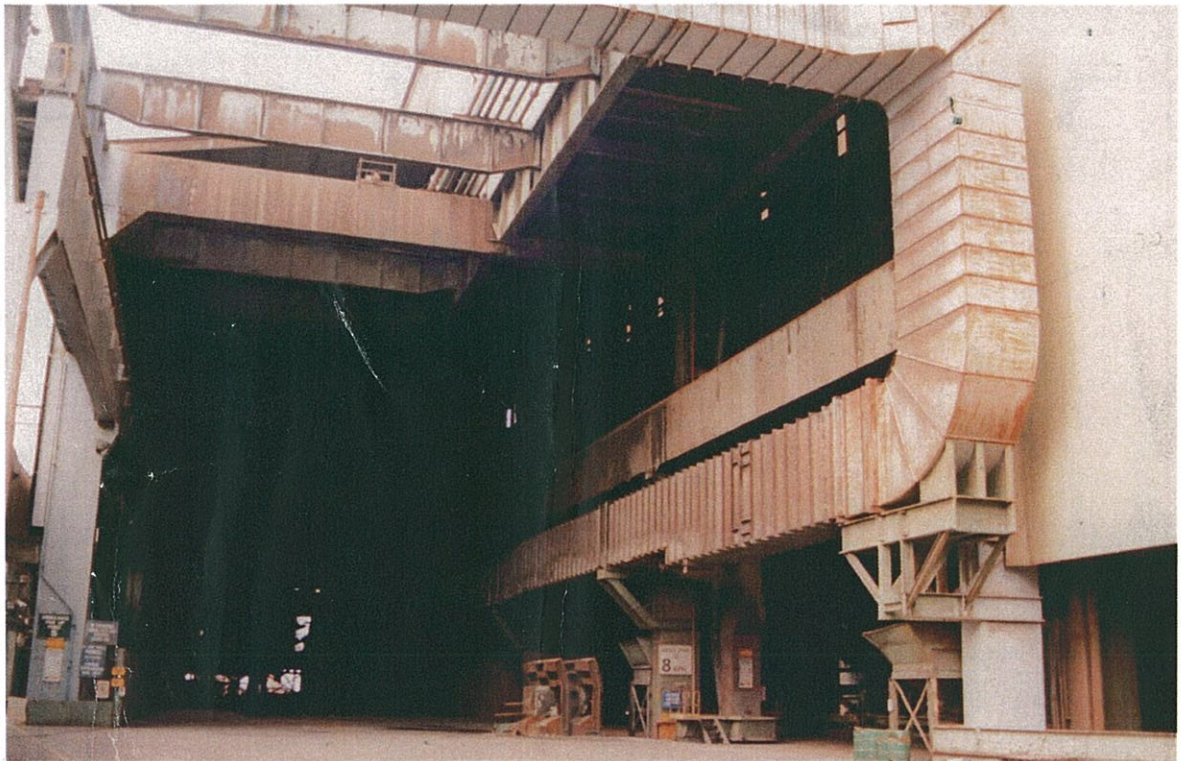
Figure 6.4 View East of entrance to scrap charging aisle.

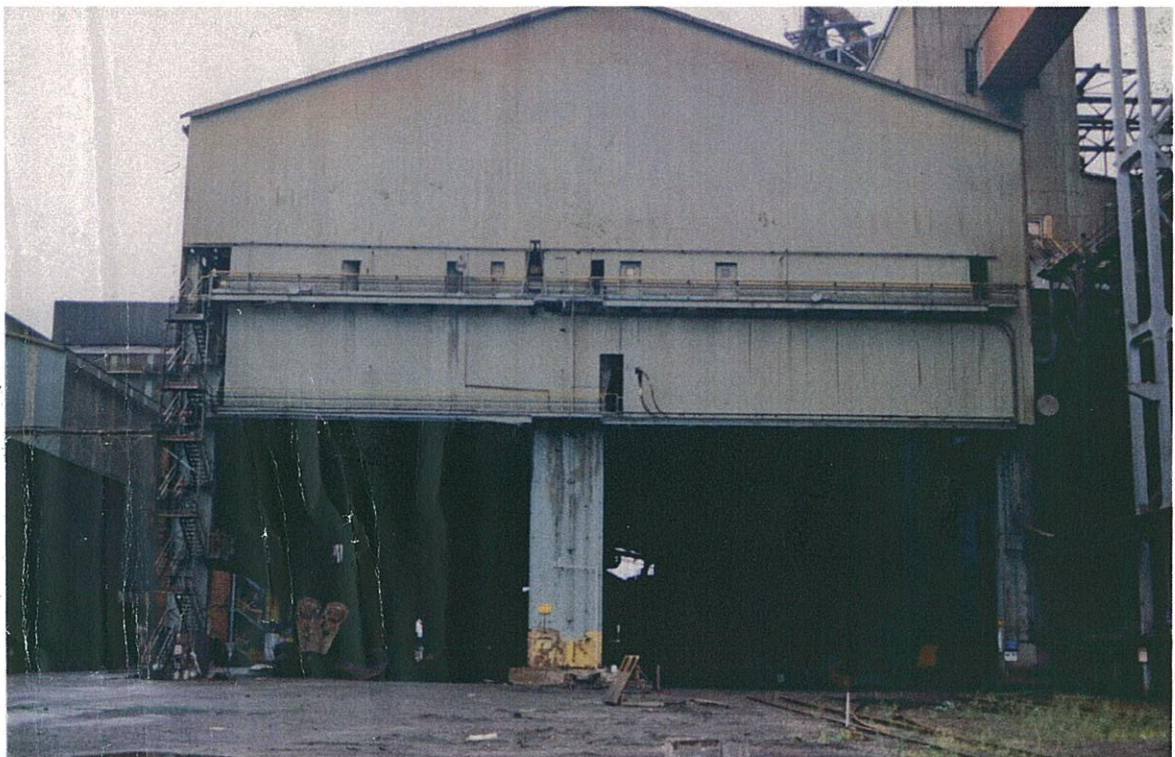
Figure 6.5 Eastern facade of B.O.S. Plant showing teeming aisle (left) and hot metal charging aisle with rail tracks (right).

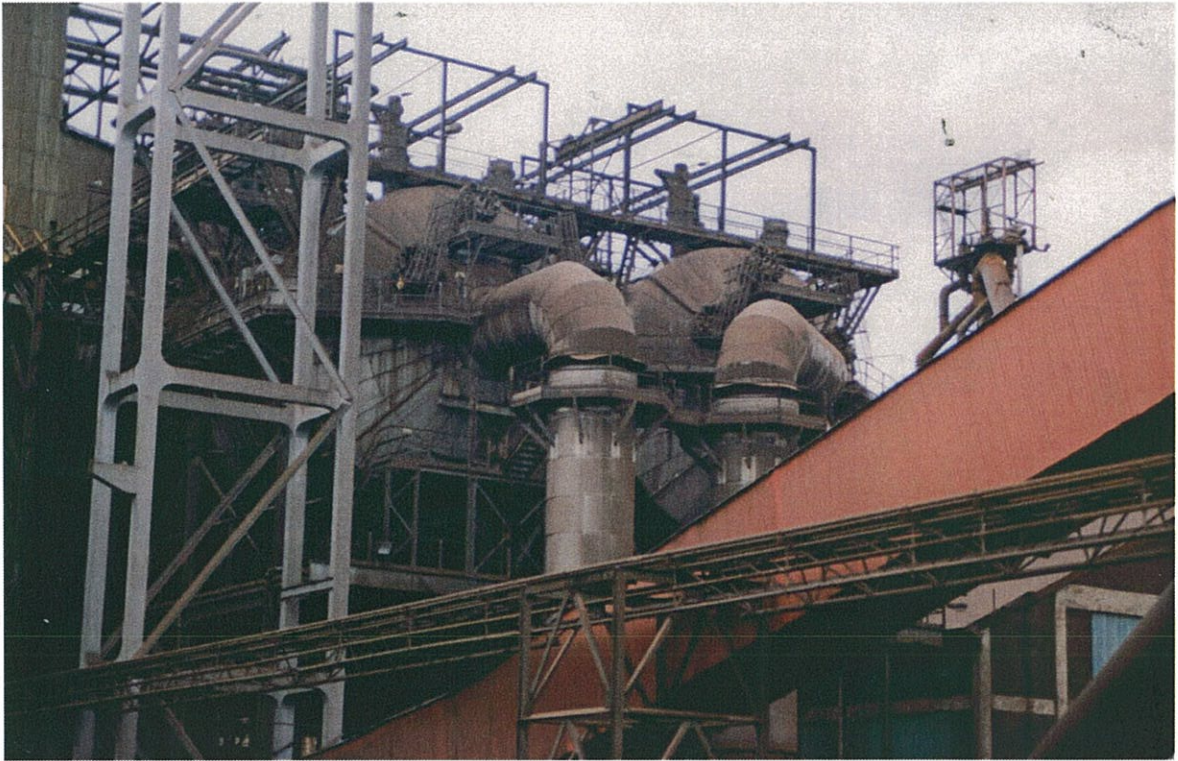
Figure 6.6 Precipitators to Eastern side of B.O.S. Plant.

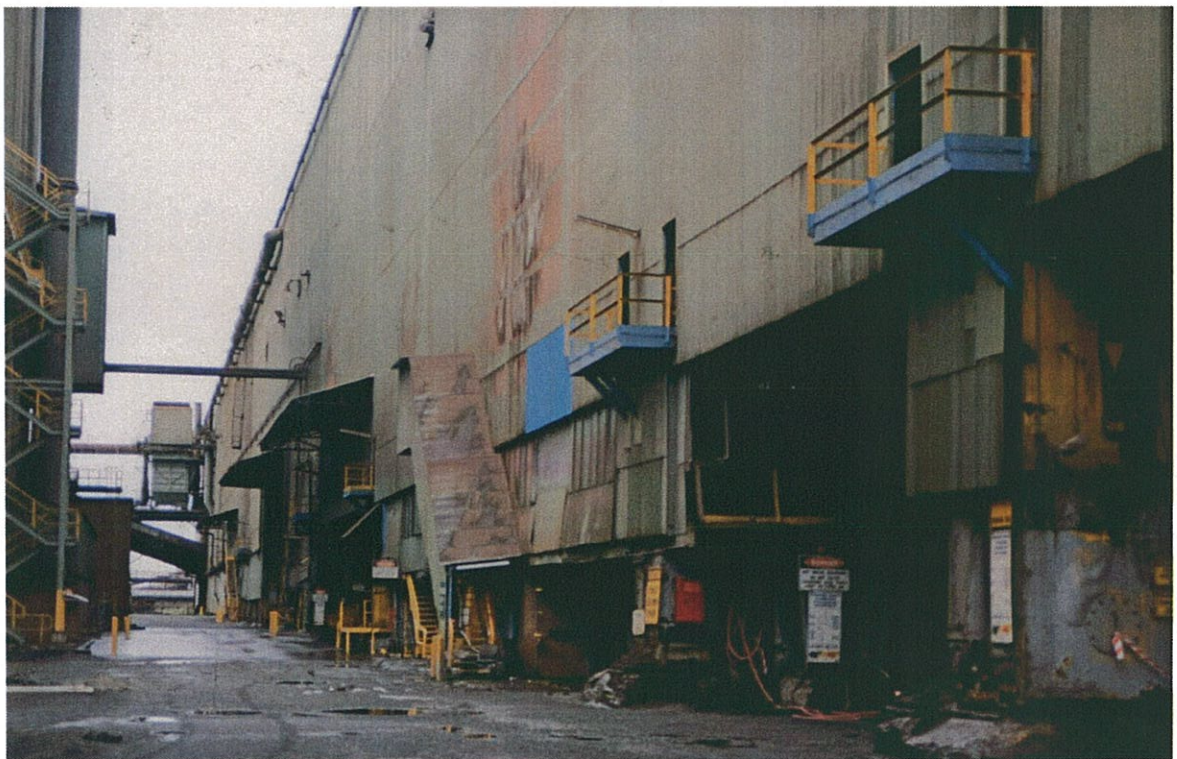
Figure 6.7 View West of Southern side of B.O.S. Plant showing openings.

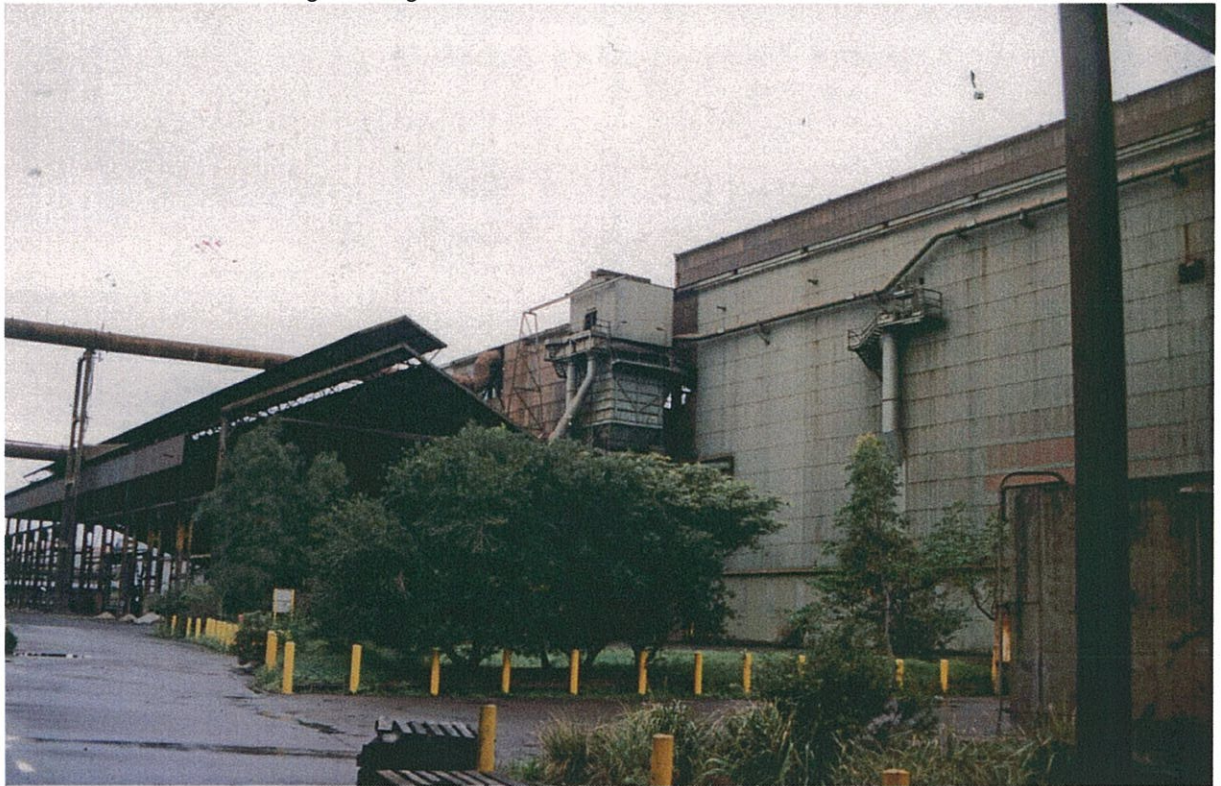
Figure 6.8 View of North/West of B.O.S. (right) and junction with open hearth building mould conditioning building at left.

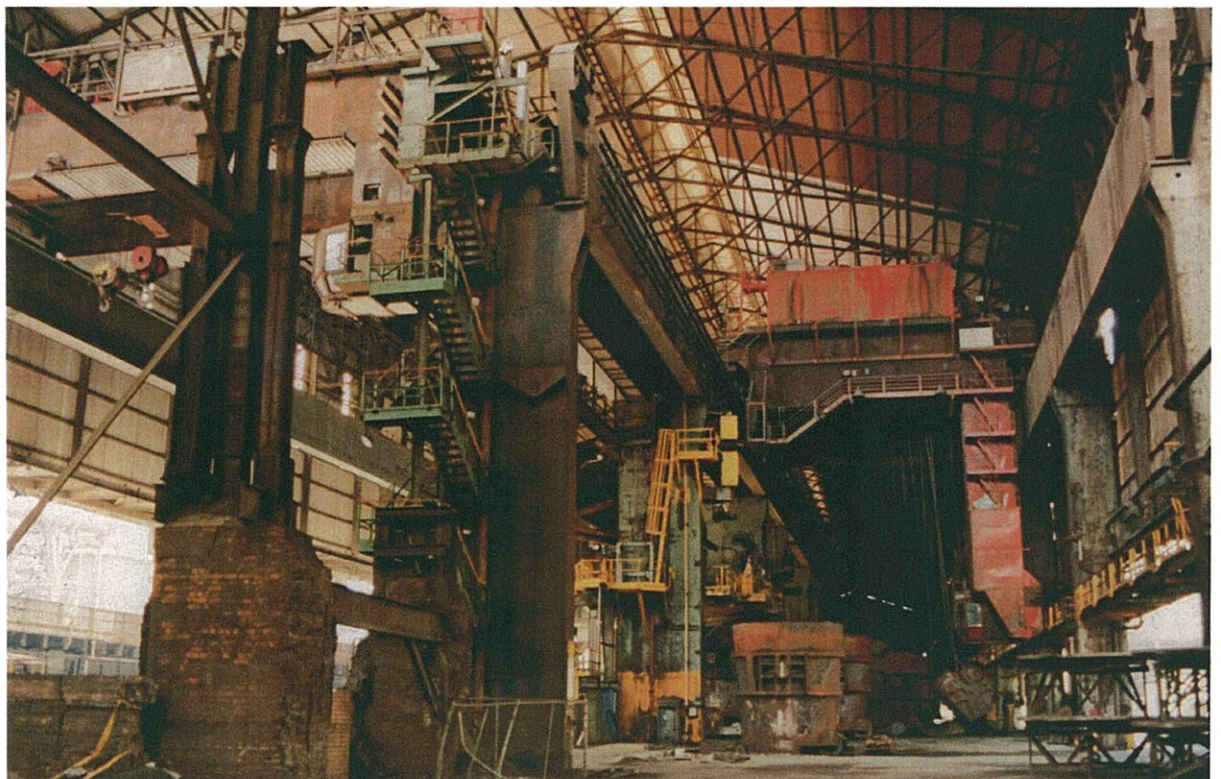
Figure 6.9 Interior - View East of B.O.S. Plant from under open Hearth building. Cranes over teeming aisle (right) and charging aisle. Note ends of runways and old open hearth columns.

Neg No.	Figure No.	Description
6	6.9	Interior - View East of B.O.S. Plant from under open Hearth building. Cranes over teeming aisle (right) and charging aisle. Note ends of runways and old open hearth columns.
7	6.10	Interior – View West of overlap between B.O.S. Building and open Hearth building. Open Hearth building at bottom of image.
8	6.11	Interior – View East towards teeming aisle showing crane and ladles.
9	-	Interior - Detail of crane (teeming aisle).
10	6.12	Interior – View South/East of ladle repair area.
11	-	Interior – View West of crane and rails in charging aisle. Open hearth trusses in background.
12	6.13	Interior – View South towards Lance holder.
13	-	Interior – Southern wall of B.O.S. (teeming aisle) and column support for dual crane runways.
14	6.4	View Eastern of entrance to scrap charging aisle.
15	-	Interior – View South of micro alloy pouring pit.
16	-	Interior – View South of Ladle Metallurgy Control booth.

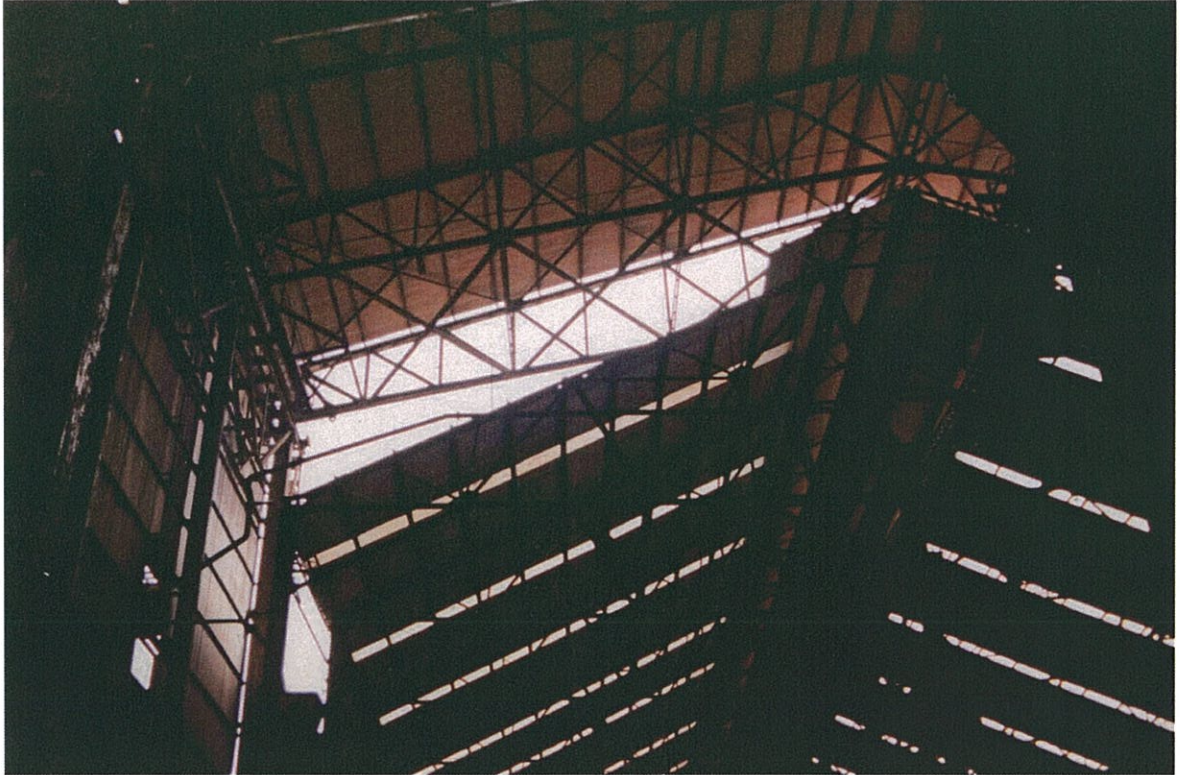
Figure 6.10 Interior view West of overlap between B.O.S. Building and open Hearth building. Open Hearth building at bottom of image.

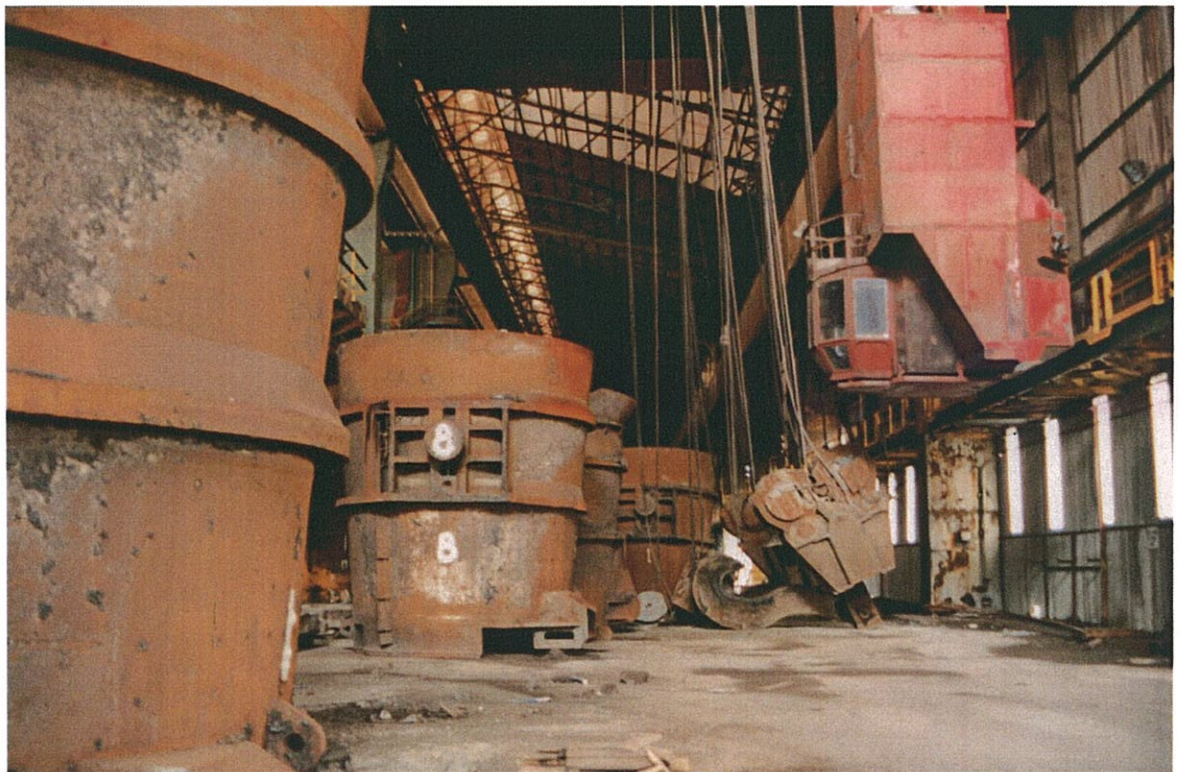
Figure 6.11 Interior – View East towards teeming aisle showing crane and ladles.

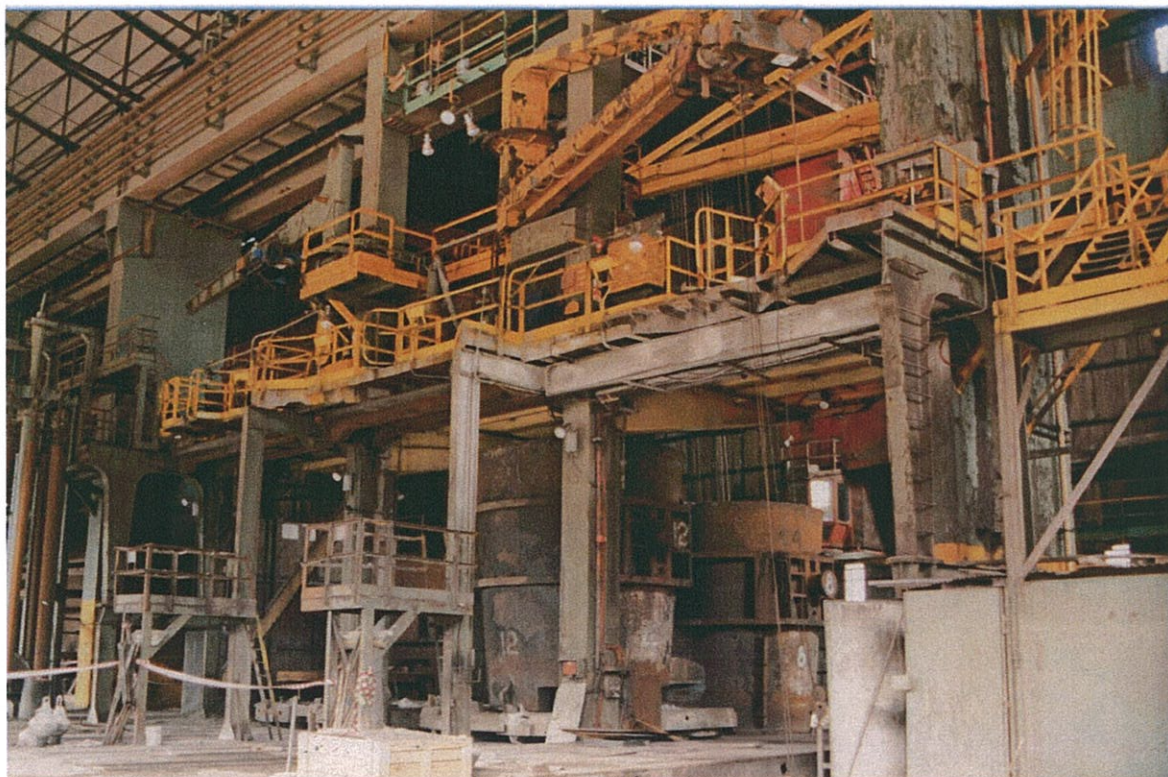
Figure 6.12 Interior – View South/East of ladle repair area.

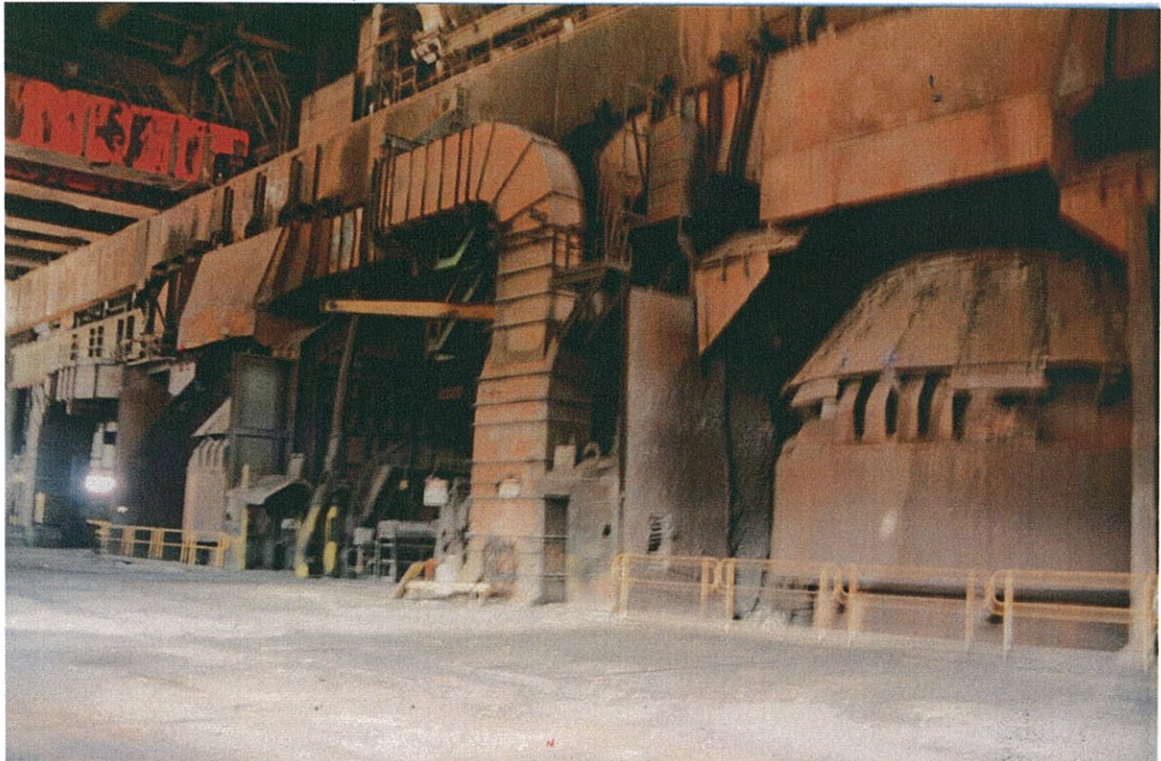
Figure 6.14 Interior – View South/East of B.O.S. Furnaces (number 2 on left), fume extraction ducts and scrap crane.

17	-	Interior – View South/East of storage area in scrap charging aisle.
18	6.14	Interior – View South/East of B.O.S. Furnaces (number 2 on left), fume extraction ducts and scrap crane.
19	-	Interior – View South of flue and ductwork over number 2 B.O.S. Furnace.
20	-	Interior – View South of number 2 B.O.S. Furnace.
21	6.15	Interior – View East of two cranes in scrap charging aisle. (cranes 59 and 36 [50/50/15T]).
22	6.16	Interior – View South of number 1 B.O.S. Furnace.

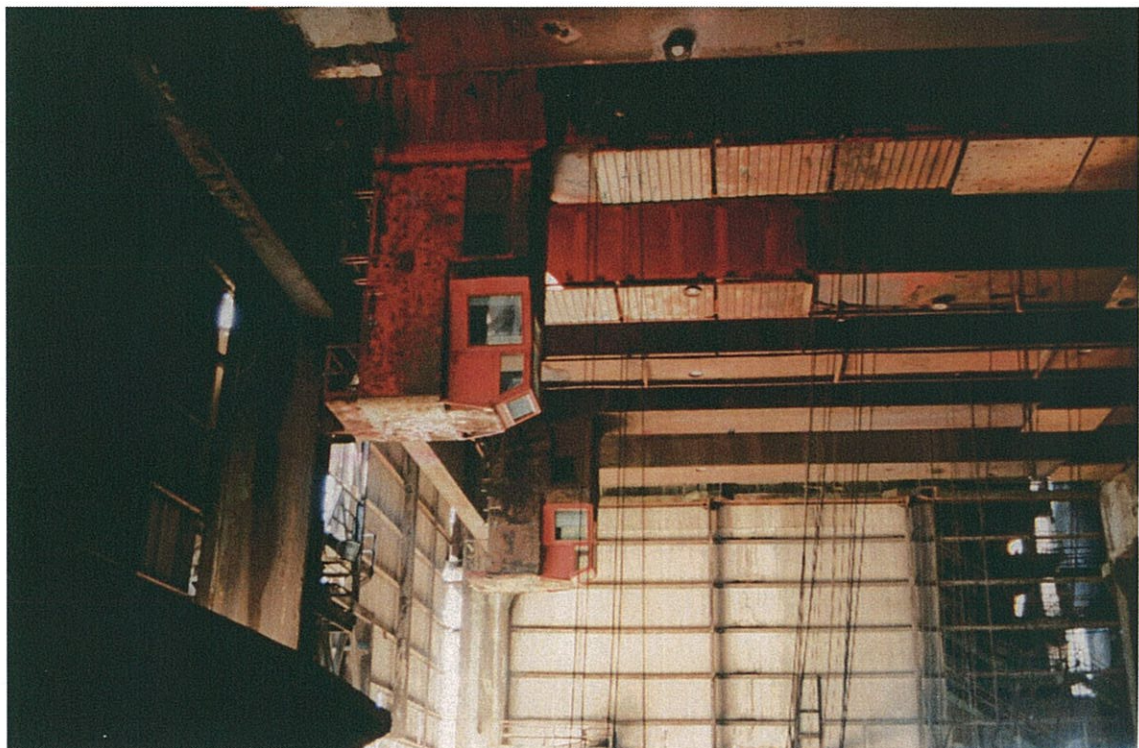
Figure 6.15 Interior – View East of two cranes in scrap charging aisle. (cranes 59 and 36 [50/50/15T]).

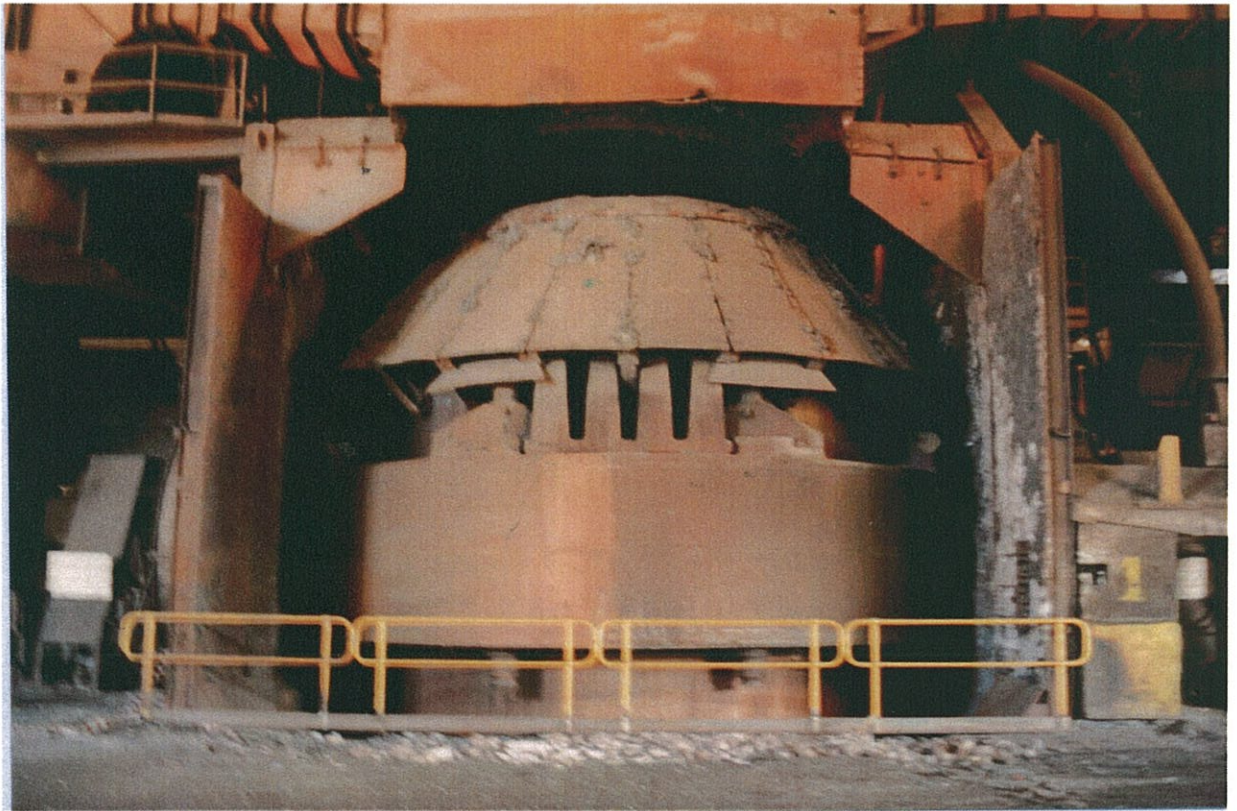
Figure 6.16 Interior – View South of number 1 B.O.S. Furnace.

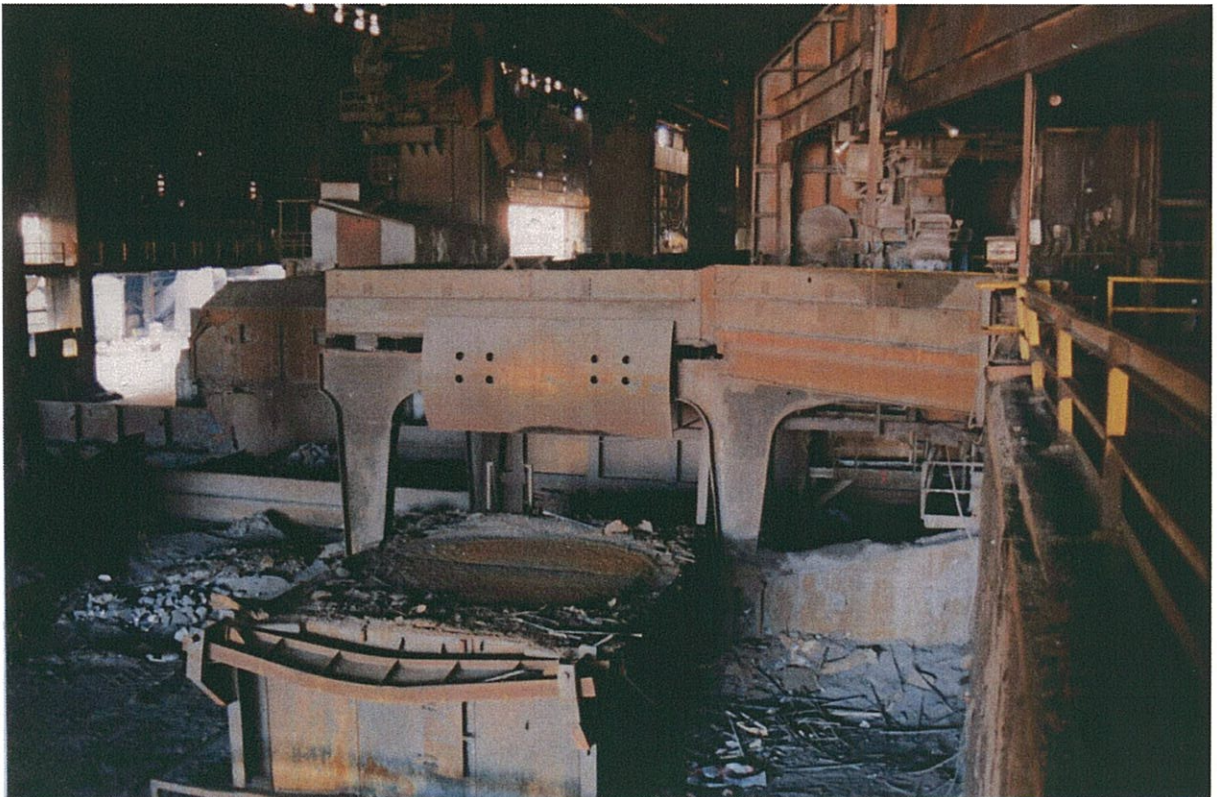
Figure 6.17 Interior – View west of ladle weighbridge.

Neg No.	Figure No.	Description
0	-	Interior – View South of Eastern side of B.O.S. Furnace number 1 showing south valve outlets and North valve inlets and Furnace trunnion.
01	-	Interior – View North/East view of crane hook scrap ramp and B.O.S. precipitators in background.
02	6.17	Interior – View west of ladle weighbridge.
03	-	Interior – Number 1 Furnace and slag taphole.
04	-	Interior – Number 1 ladle transfer pit and cars.
05	-	
06	-	
07	6.18	Interior – 300/75/15 T Charging Crane.
08	-	Interior – Hooks from Charging Crane.
09	-	Interior – view west of ladle treatment plant and opening in building to bloom caster (left).
10	-	
11	-	
12	-	
13	-	
14	-	
15	6.19	Interior – View North of ladle treatment plant (right) and ladle transfer car.
16	6.20	Interior – View North of ladle slag rake and ladle car in foreground.
17	6.21	Interior – View West of ladles and lids.
18	6.22	Interior – View North of slide gate nozzle platform.

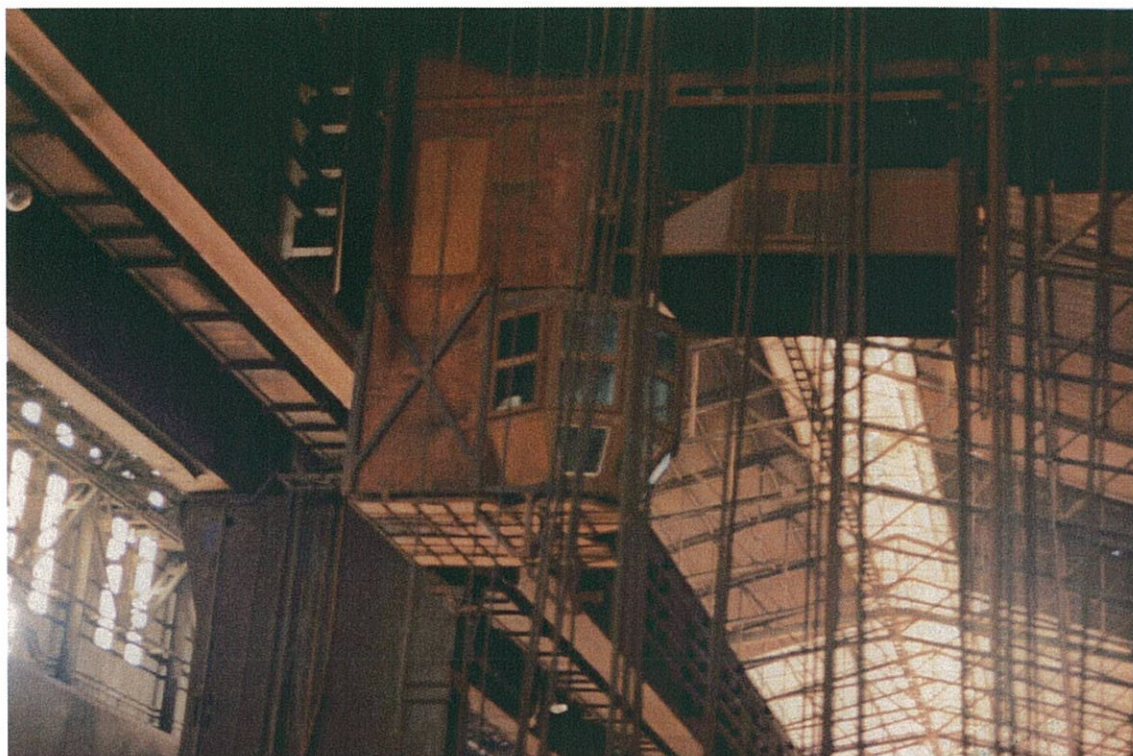
Figure 6.18 Interior – 300/75/15 T Charging Crane.

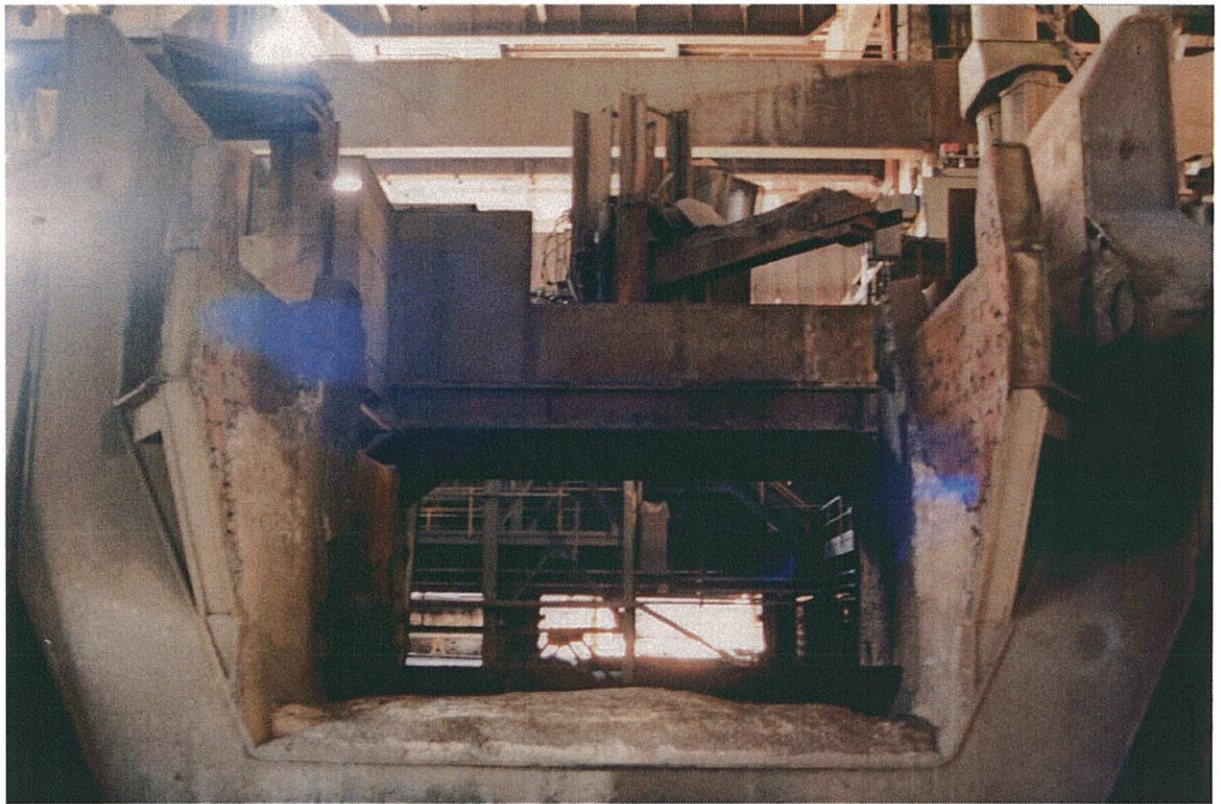
Figure 6.20 Interior – View North of ladle slag rake and ladle car in foreground.

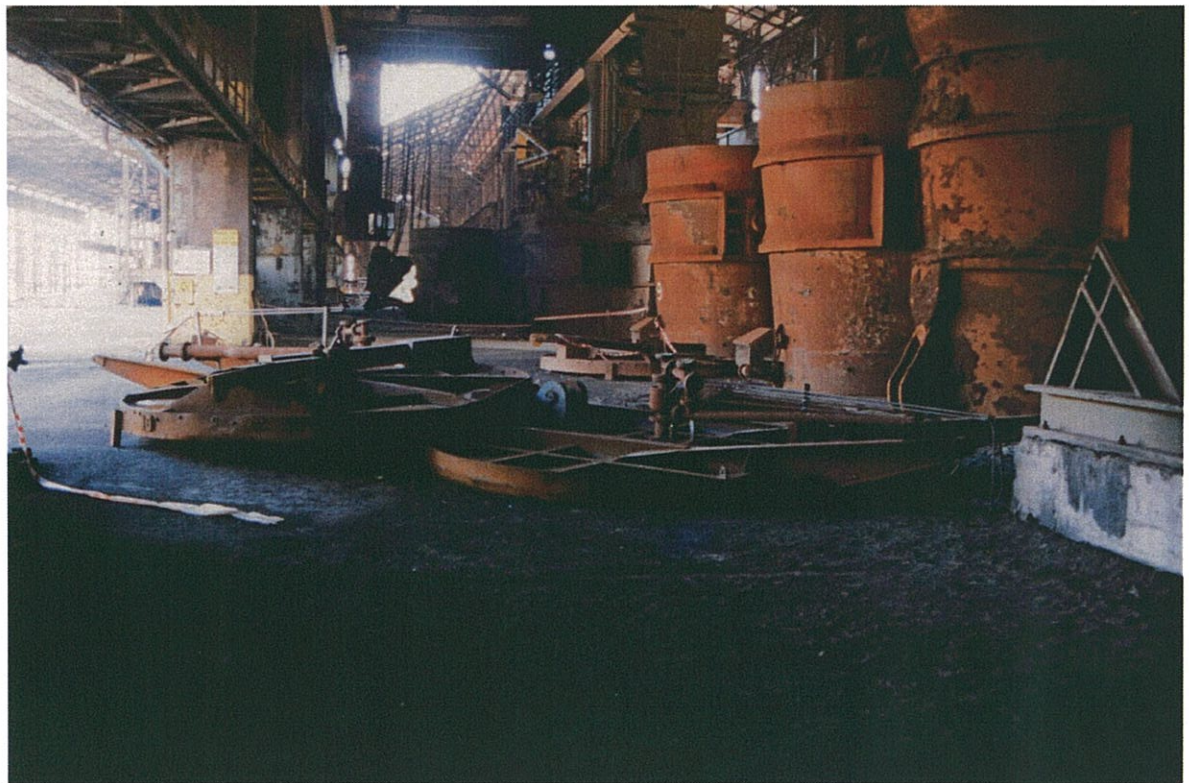
Figure 6.21 Interior – View West of ladles and lids.

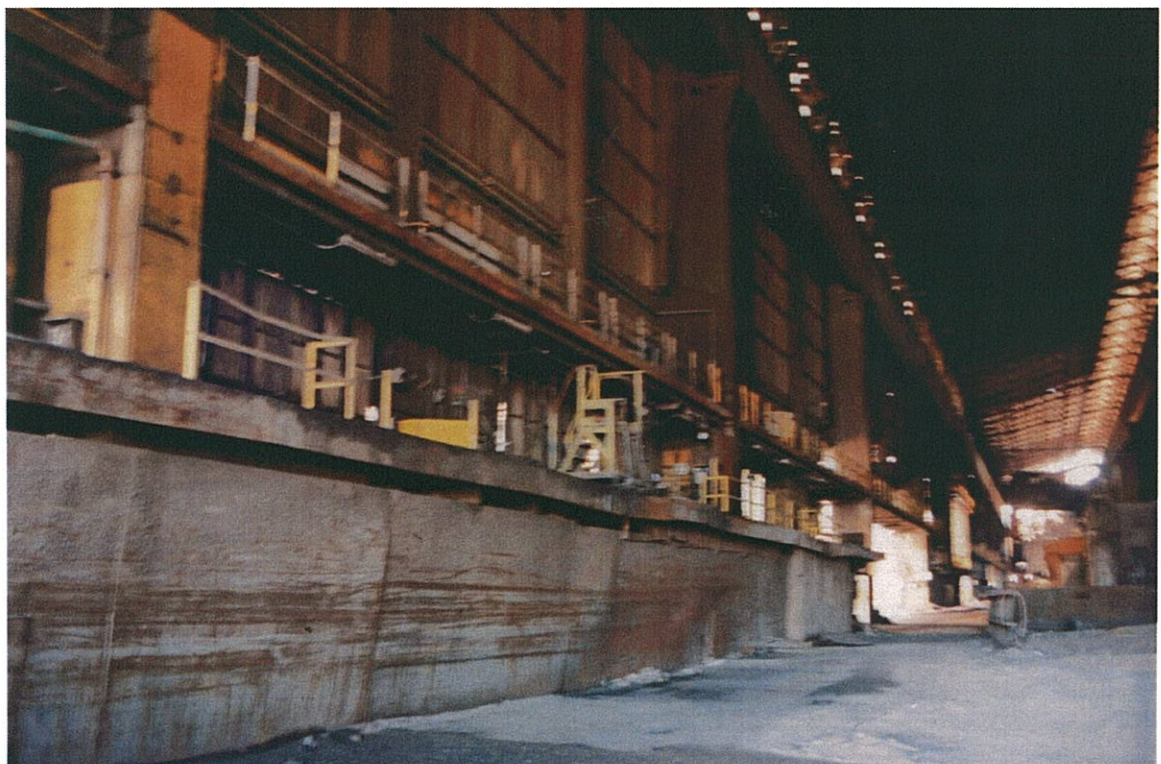
Figure 6.23 Interior – View West of teeming aisle.

19	-	Interior – View East along teeming aisle.
20	-	View East of opening in Southern facade (on left) and bloom caster mill to right.
21	6.23	Interior – View West of teeming aisle.
