Winten Property Group

Commercial Development, 88 Christie Street, St Leonards

Desktop Study Report - Geotechnical and Groundwater

Report No F0001-AA003230-NSR-01

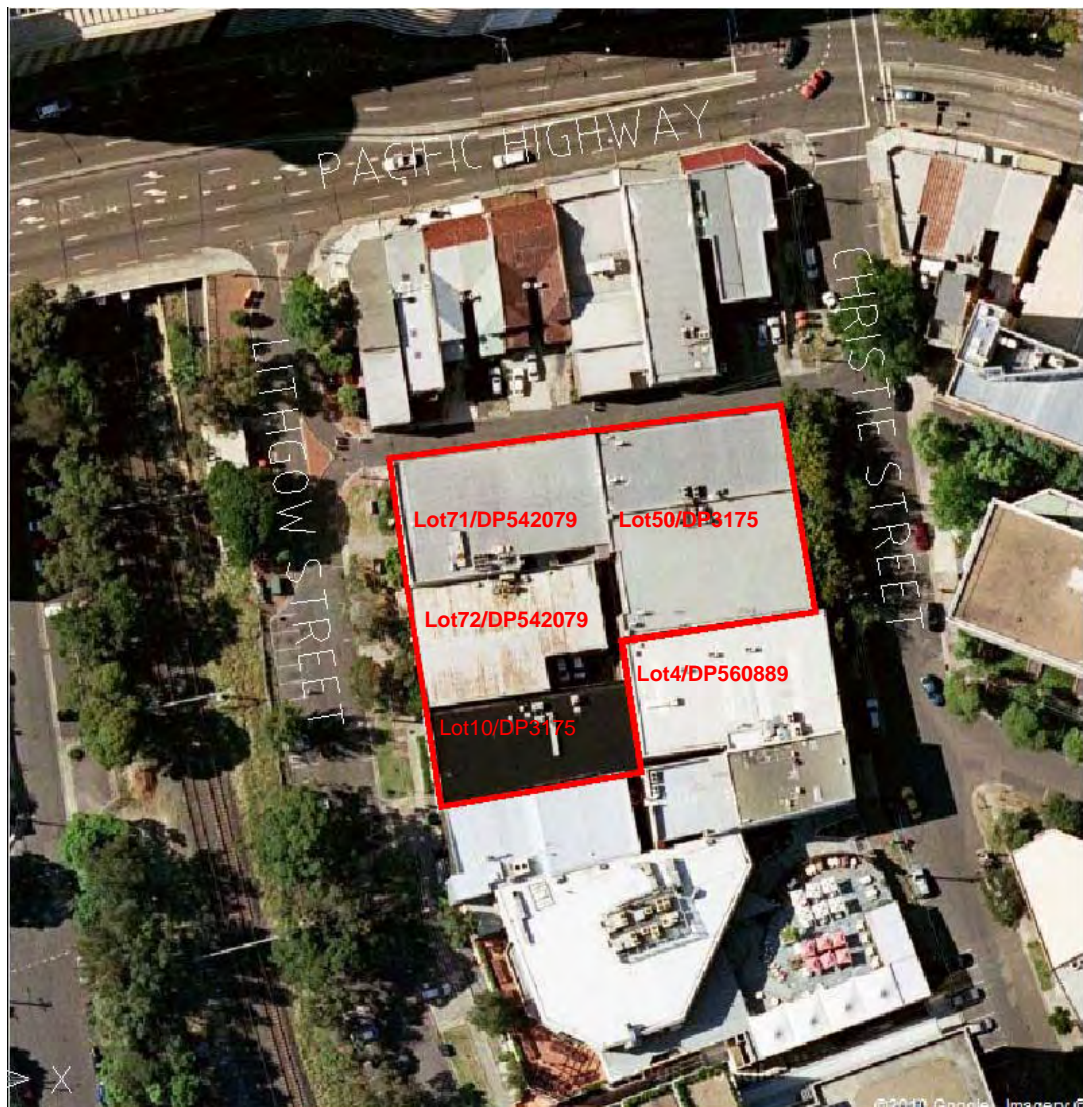
Figure 1: Existing Site Location ("AUSIMAGE © Sinclair Knight Merz Pty Ltd 2010")

The site is described as Lot50/DP3175, Lot4/DP560889, Lot71/DP542079, Lot72/DP542079, Lot10/DP3175, at Christie Street, St Leonards. The existing site is shown in Figure 1.

The North Shore Railway Line is close to the subject site to the west of the proposed development site as shown on Figure 1.

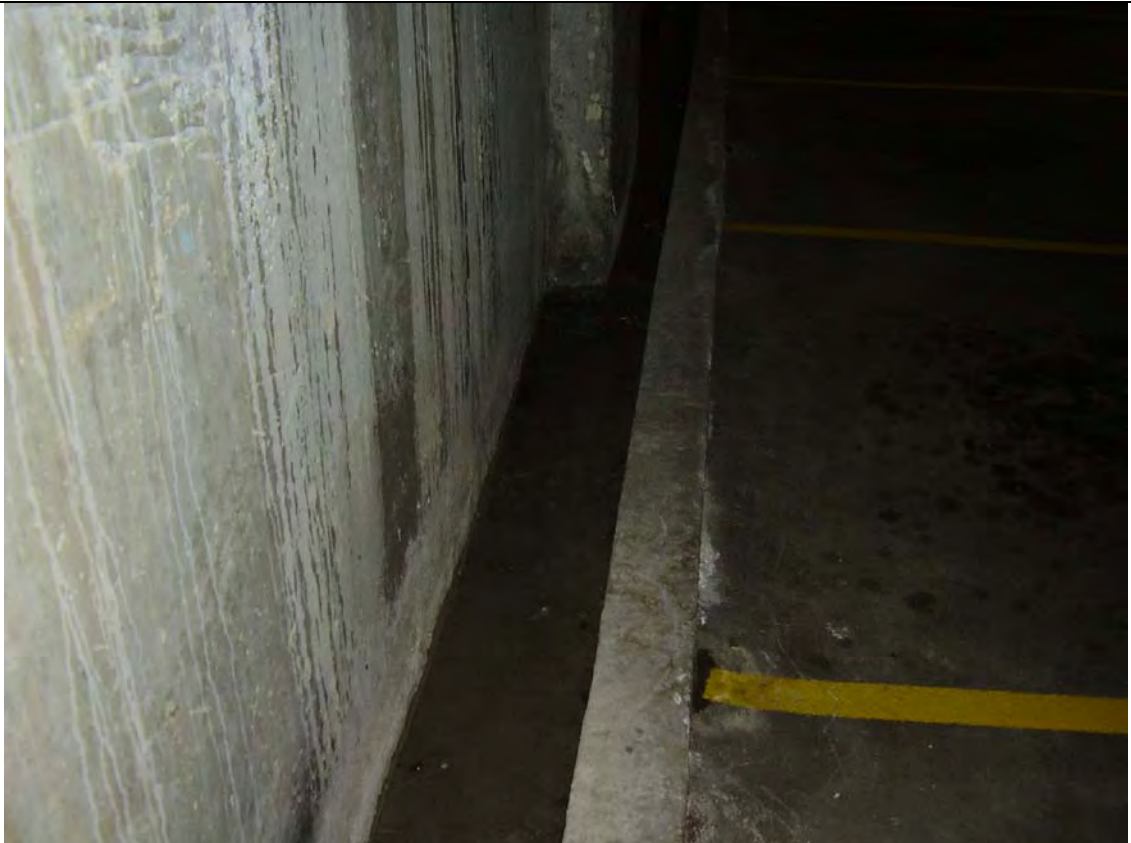
Figure 2: Observed groundwater seepage at the bottom of a retaining wall

- Retaining walls were seen from some of the side of carpark basement/space.
- No soil or rock was exposed at the time of site inspection.
- Some seepage was observed from the retaining walls at the time of inspection as shown on Figure 2 and Figure3.
- A drain at the bottom of the retaining wall was noted to divert the seepage to the pits.

- Groundwater table is likely to be at or below the existing basement level, possibly at a depth of 3 to 6m.
- “Shallow” seepage may originate from the perched water within the soils behind the retaining walls although the source of water is unknown.
- Groundwater is likely to be present predominantly within the rock defects in the rock mass.

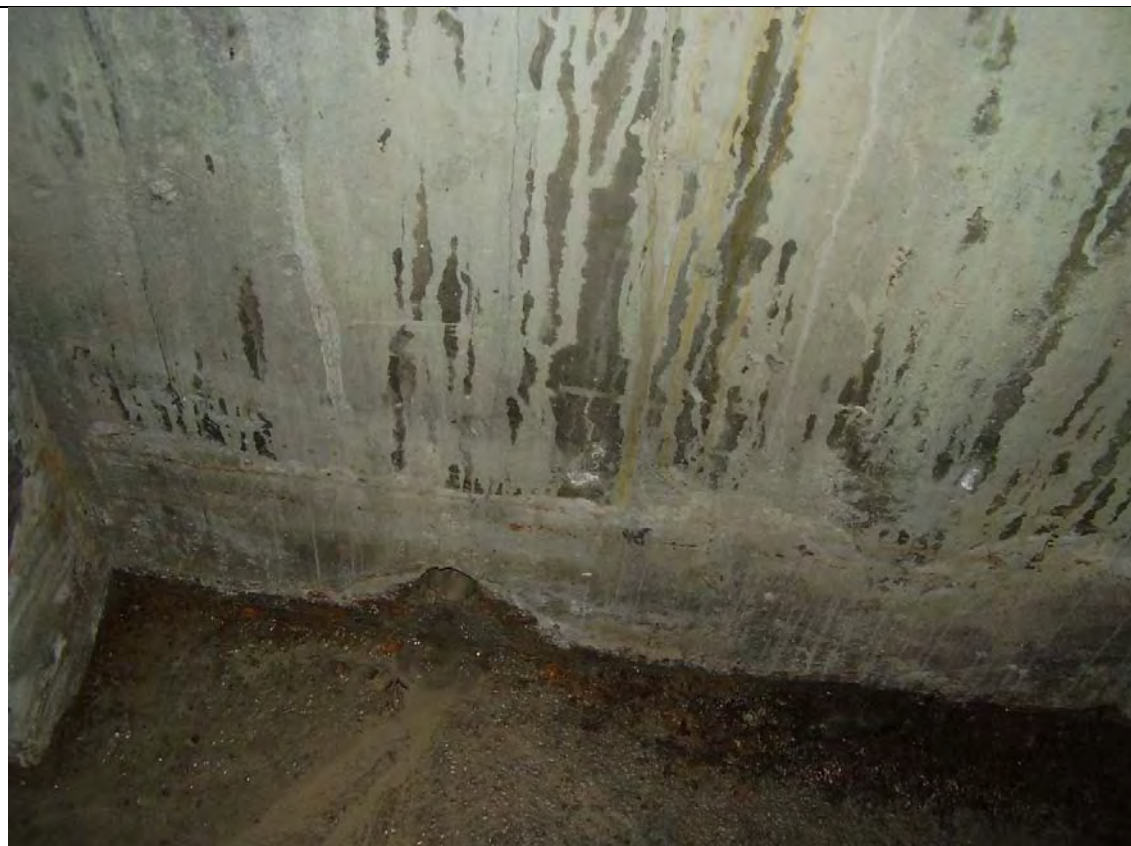
Figure 3: Observed groundwater seepage at the bottom of a retaining wall

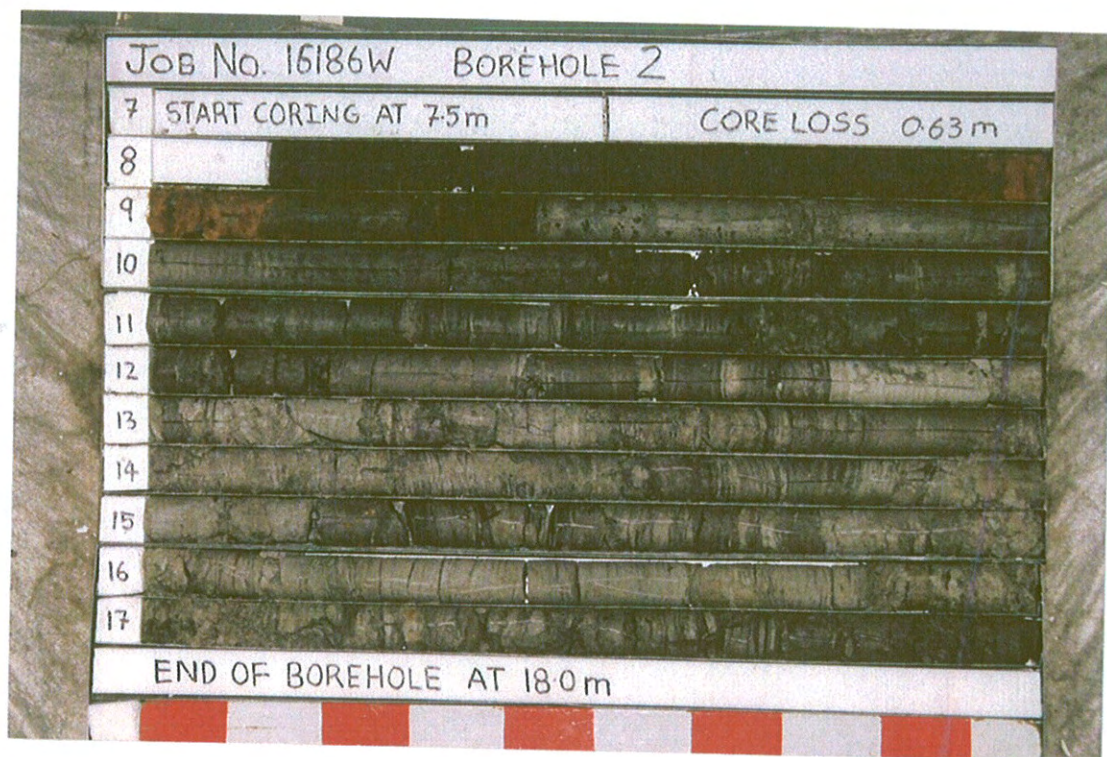
Client:												
Project: PROPOSED DEVELOPMENT												
Location: SITE 1												
Job No. 16186W			Method: SPIRAL AUGER JK250			R.L. Surface: \approx 85.0m						
Date: 29-7-02						Datum: AHD						
Logged/Checked by: A.M./ <i>APW</i>												
Groundwater Record	SAMPLES			Field Tests	Depth (m)	Graphic Log	Unified Classification	DESCRIPTION	Moisture Condition/ Weathering	Strength/ Rel. Density	Hand Penetrometer Readings (kPa.)	Remarks
	FS	US	DB									
								SHALE: dark grey.	DW	L-VL		VERY LOW TO LOW RESISTANCE
								REFER TO CORED BOREHOLE LOG				
					8							
					9							
					10							
					11							
					12							
					13							
					14

Two boreholes (BH1 and BH2) were drilled on this site to a maximum depth of 18m. BH2 was diamond cored from a depth of 7.5m and a copy of the borehole log is attached.

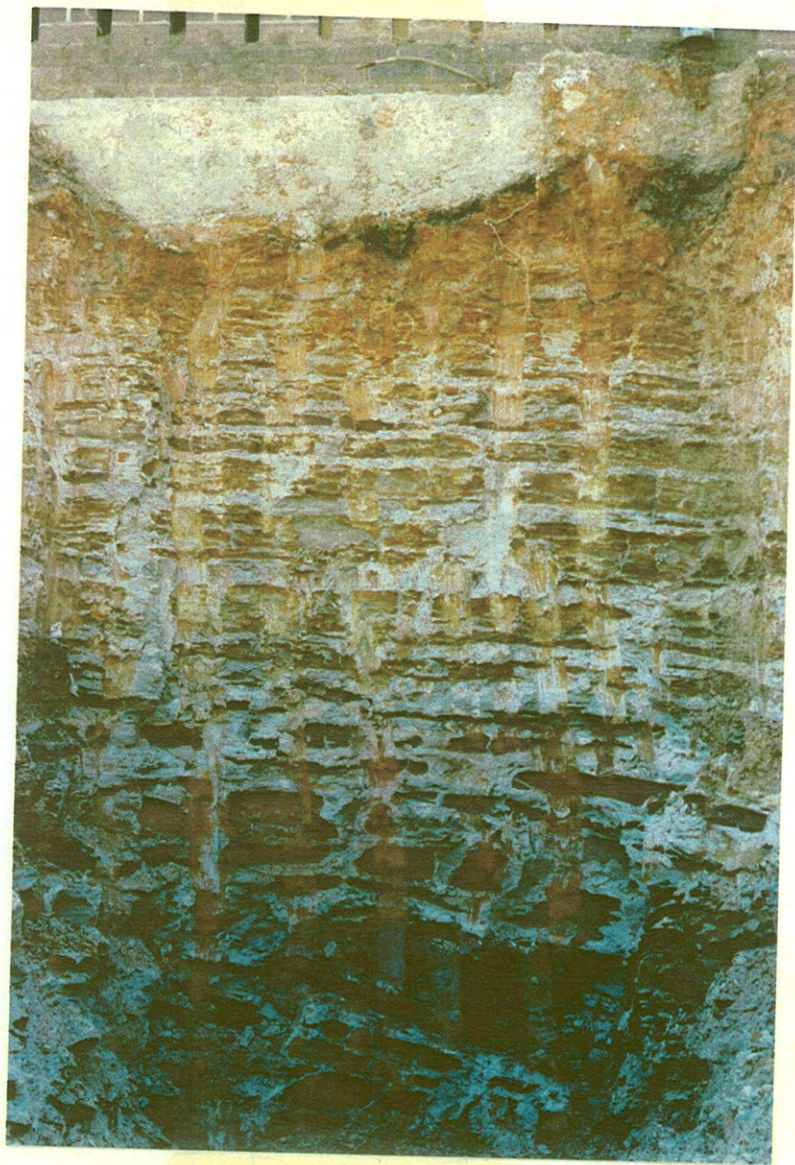
SITE 3
RECORD
PHOTOGRAPH 1

Initial Excav. for
underpinning new
corner

Inspections of the cut faces during excavation showed the subsurface profile to be highly variable, with numerous extremely weathered bands and clay bands within the sandstone bedrock strata. The cut faces required significant stabilisation treatment in some areas. Some record photographs of the excavation faces are attached.
