## Barangaroo Stage 1

Barangaroo Concept Plan Amendment (MP06\_0162 MOD4) - Marine Ecology, Water Quality and Contaminated Sediment Impact Assessment

301015-02234 24-MA-REP-0003

28 July 2010

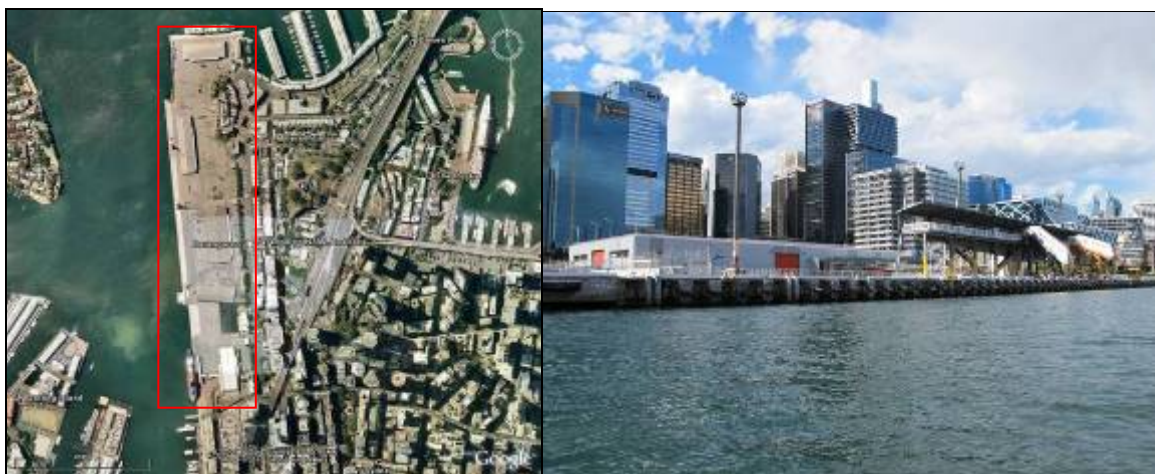
**Figure 1.3** The current Barangaroo site.

The Barangaroo site is currently largely vacant with the exception of the Wharf 8 cruise ship passenger terminal at the southern end of the site, which is currently being relocated to the north of Stage 1 for a temporary period of 2 years (refer **Figure 1.3**). Barangaroo and surrounding land at East Darling Harbour is owned by a variety public and private authorities and companies including Australand, Multiplex, Crown, Multiplex Funds Management Limited, NSW Land and Housing Corporation, GFC Trading Pty Ltd, Roads & Traffic Authority of NSW, Sydney Ports Corporation, Council, KSW Properties Pty Limited and the Barangaroo Delivery Authority.

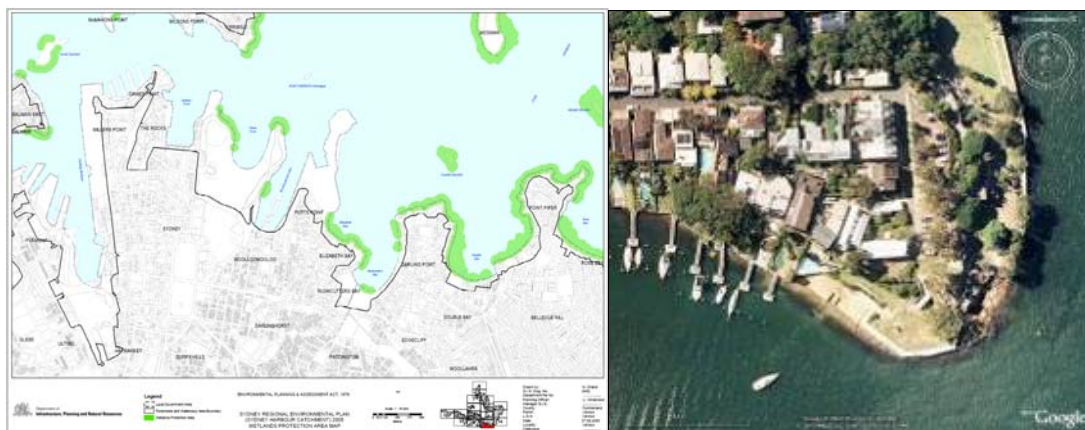
**Figure 4.2 Wetlands Protection Area mapped at Balmain East (opposite Barangaroo) (Harbour REP 2005).**

The *Sydney Harbour Regional Environmental Plan (Sydney Harbour Catchment) 2005 Wetlands Protection Area Map* indicates that the proposed Barangaroo Stage 1 development site is located opposite a Wetlands Protection Area at Balmain East (DIPNIR 2005) (refer **Figure 4.2**). Wetlands are described by NSW DPI (2005) as depressions that are inundated permanently or temporarily with water that is usually shallow, slow moving, or stationary. Wetlands include a wide range of habitats and in coastal areas and include:

*IMPACTS: No seagrass or other aquatic vegetation was observed in the footprint of the proposed development during the site inspections, by divers or on the underwater video. In addition, no aquatic vegetation has been mapped in the area by NSW DPI (2005). Further, the wetland area mapped at Balmain East was found to be dominated by seawalls and pontoons, rather than wetland vegetation. Due to the lack of aquatic vegetation in the vicinity of the proposed Lend Lease development, no impact on these sensitive habitats are expected.*
