LEND LEASE

BARANGAROO STAGE 1

BARANGAROO CONCEPT PLAN AMENDMENT (MP06_0162 MOD4) - MARINE ECOLOGY, WATER QUALITY AND CONTAMINATED SEDIMENT IMPACT ASSESSMENT

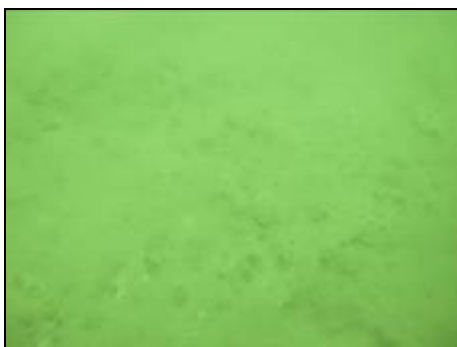
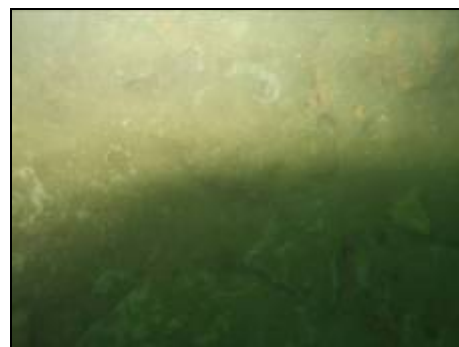
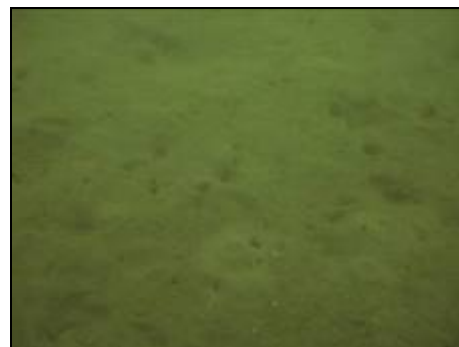
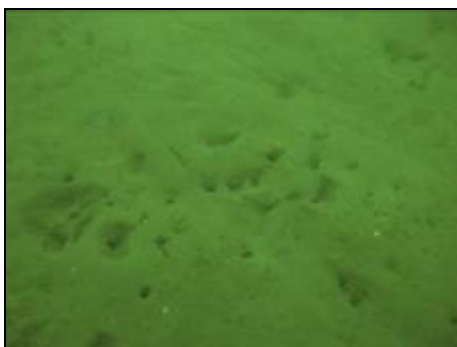
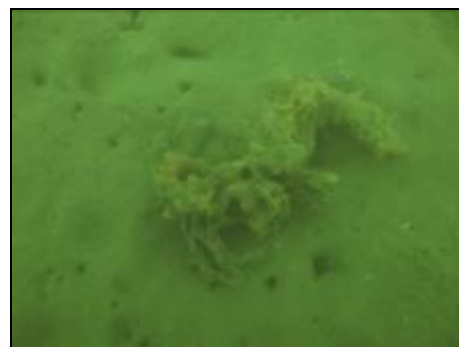
Figure 6.2 Benthic habitat at Barangaroo captured by diver photography.

The benthic habitat in Darling Harbour, adjacent to Barangaroo, consisted of clayey, silty, sandy sediments. Considerable bioturbation was evident across the entire site, presumably from burrowing organisms, such as polychaete worms and invertebrate crustaceans (see **Figures 6.2 and 6.3**). The substrate towards the southern end of the development contained a high proportion of clay and was relatively undisturbed. Much of the substrate here has a 'honeycomb' type appearance. The middle and northern sections of the site contained a higher percentage of silt than the southern area. The underwater terrain was relatively flat across the site, with little evidence of movement in the way of sand ripples. Video transects provided evidence of areas of dense shell rubble, possible organic materials (e.g. dark woody looking objects), occasional sponges and discarded anthropogenic objects on the seabed (**Figure 6.3**). No aquatic vegetation was observed by divers, or was reported on the underwater video transects.

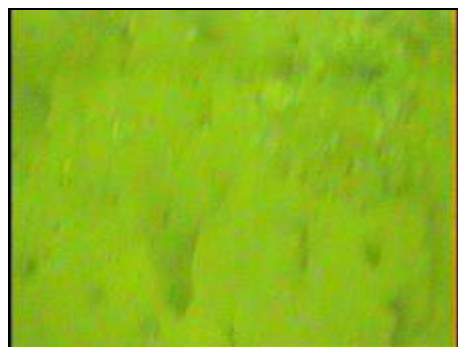
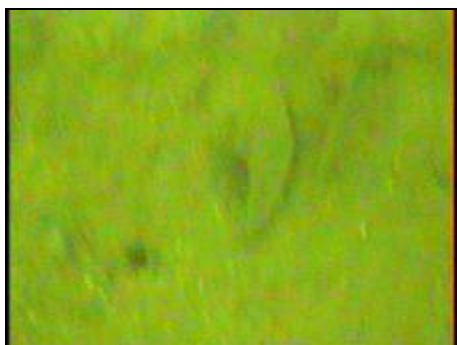
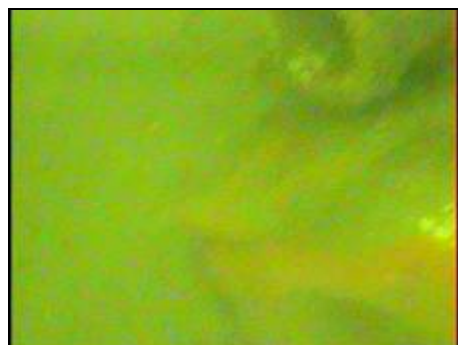
Figure 6.3 Benthic habitat at Barangaroo captured on video transects.

No seagrass was observed during spot dives, or on the video transects undertaken at the study site. The water depth (~ 13 m) and associated low light penetration would presumably restrict the growth of seagrasses in the footprint of the proposed Lend Lease development. No mangroves or areas of saltmarsh were observed at, or near, the proposed development during the site visit. The site currently lacks appropriate substrate and habitat for such vegetation to occur.

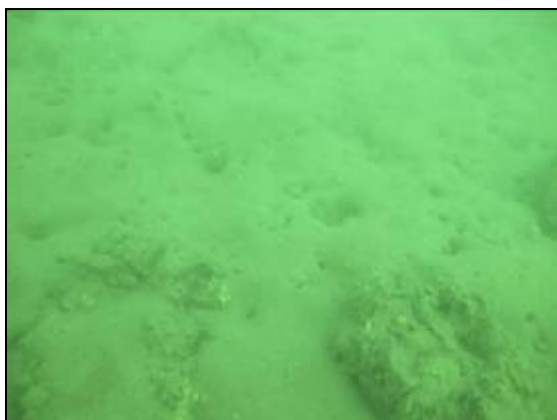
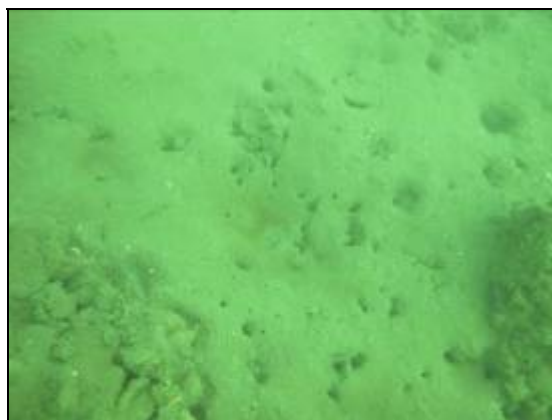
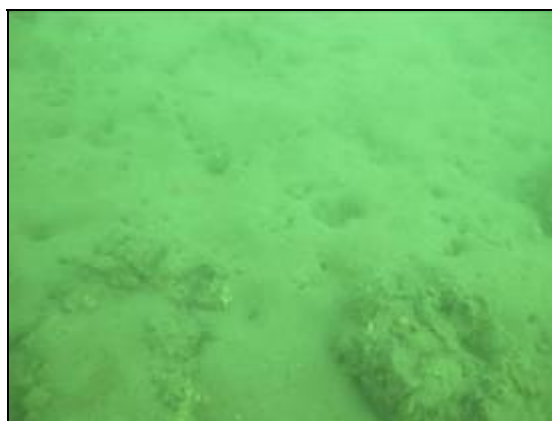
Figure 6.4 Benthic habitat at Berrys Bay captured by diver photography.

The benthic habitat at Berrys Bay consisted of silty sediments, with coral rubble and patchy subtidal reef evident at Sites 1, 2 and 4. At these sites, sponges and colonial ascidians were present. Bioturbation of the sediments was observed at all sites within Berrys Bay, but no aquatic vegetation was observed during any of the spot dives that were undertaken.

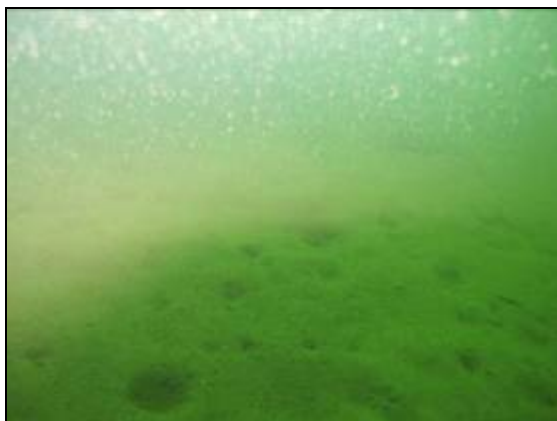
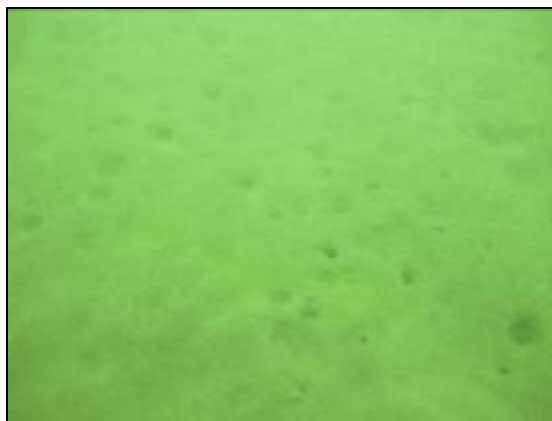
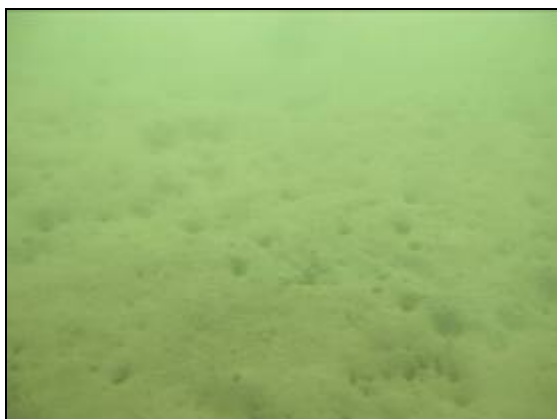
Figure 6.5 Benthic habitat at Snails Bay captured by diver photography.

The benthic habitat at Snails Bay was comprised of soft silty sand. Bioturbation was apparent at all sites, with evidence of burrowing invertebrate crustaceans and polychaete worms. A small clump of the large brown macroalgae, *Ecklonia radiata*, was observed at Site 4, close to the shoreline. Aquatic fauna including a Numb Ray (*Hypnos monopterygium*) and a number of unidentified fish species were also observed in Snails Bay.
