The Barangaroo development site currently has a Part 3A concept plan approval. This Aboriginal archaeological assessment report forms part of the Environmental Assessment Lend Lease is completing for the Project Approval under Part 3A.

**Barangaroo Stage 1- Archaeological Assessment : Environmental conditions encountered during Data Gap Investigations within VMP and PDA Remediation Works Area and Other Remediation Works (South) Area**

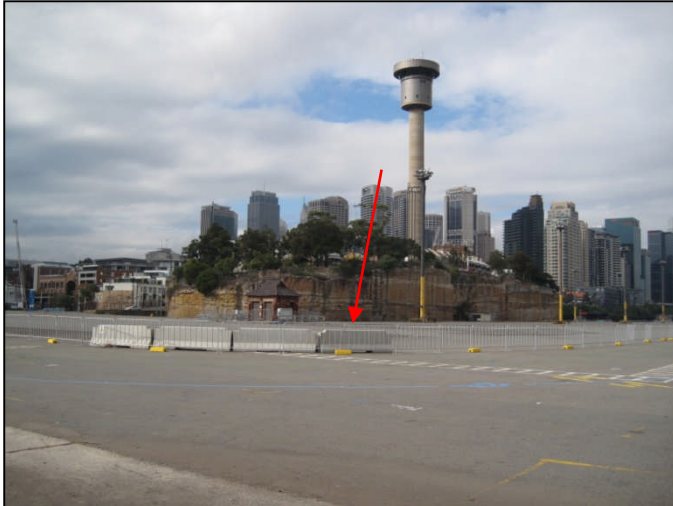
**Photograph 1:**

Looking east within the northern portion of Barangaroo at the area within the original shoreline, indicated by the red arrow.

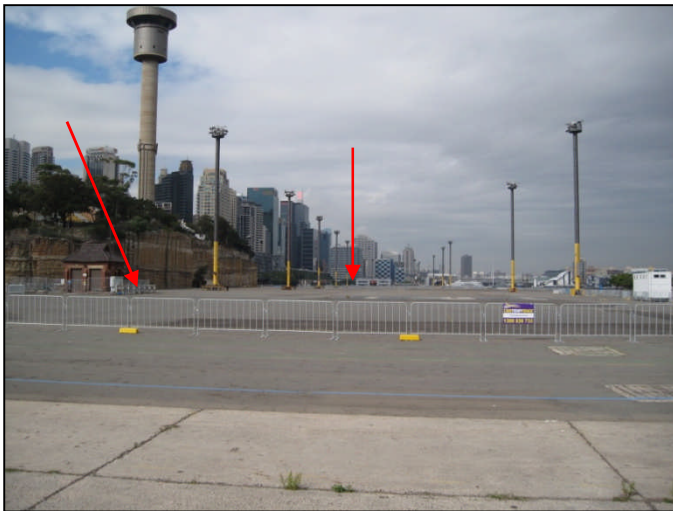
**Photograph 2:**

Looking south within the northern portion of Barangaroo. The area is the foreground and surrounding the sandstone outcrop is within the original shoreline. The area in the background is the location of Stage 1. The locations of areas within the original shoreline are approximately indicated by the red arrows.

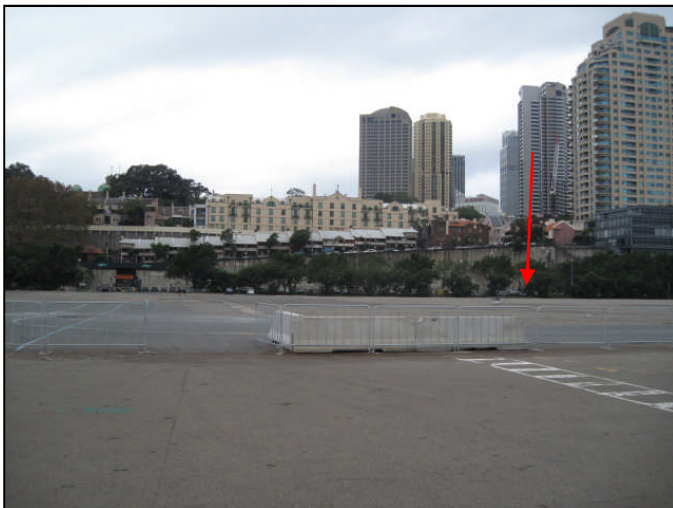
**Photograph 3:**

Facing east looking across Barangaroo towards Hickson Road. The location of the original shoreline is approximately indicated by the red arrow.

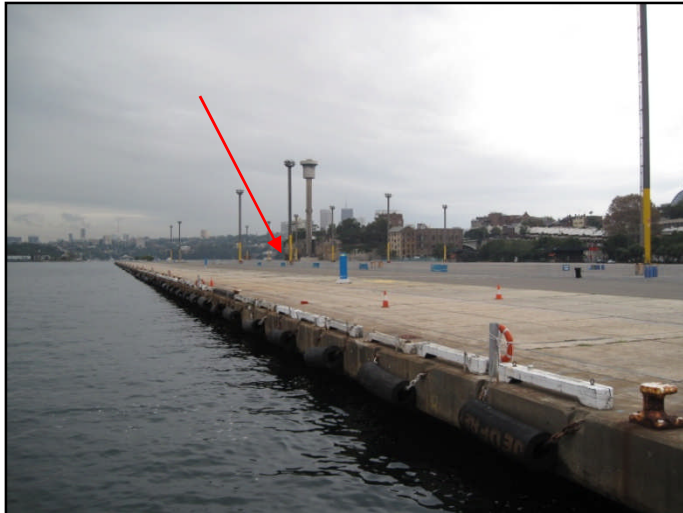
**Photograph 7:**

Looking north east across Barangaroo. The location of the area within the original shoreline is indicated by the red arrow.
