Aquatic Flora & Fauna Survey
Rainbow Beach, Bonny Hills – St Vincents Foundation

April 2008

The Ecology Lab Pty Ltd

Report Number – 41/0708A

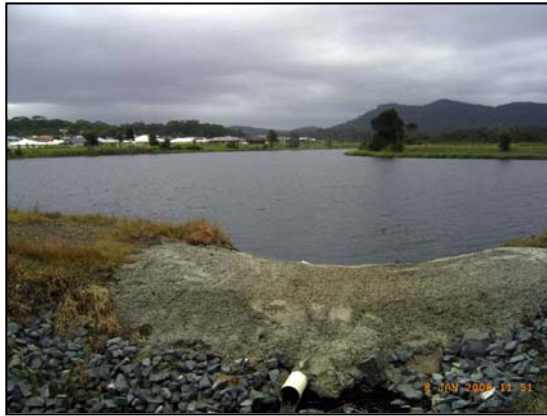
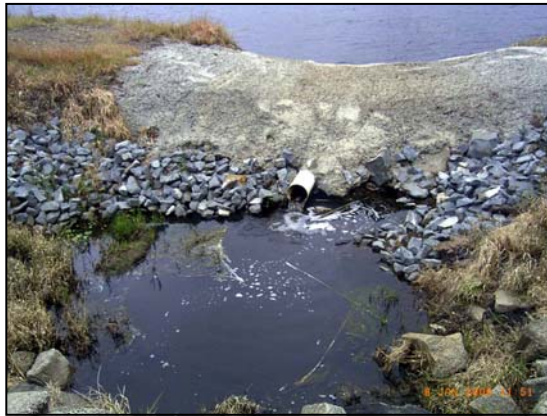
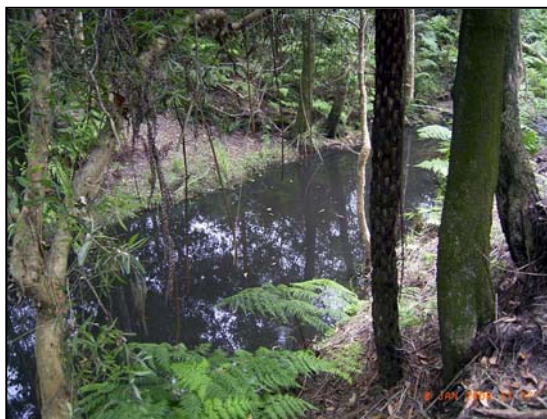
Plate 1. Photographs of the temporary outlet of the subject waterbody and the channel between the Big (E3) and Little (E2) lakes. a) Culvert and upstream view to Big Lake; b) Culvert – Temporary weir structure showing in- and outflow; c) Pool below temporary weir structure; d) outlet downstream of culvert; e) main channel downstream of culvert (upstream of confluence with Duchess Gully; f) narrow channel between Big and Little lakes – arrow shows direction of flow out from Little Lake during the site visit. Plate 1f also shows dense growth of torpedo grass along shore.

The subject water body comprises two lakes (Figure 1). The larger lake (E2) is on the eastern side and contains the outlet to Duchess Gully. The outlet passes through a small culvert comprising a small pipe encased in concrete, which forms a low weir (Plate 1a - c). The water level of the water body can be regulated somewhat by a swivelling pvc pipe which can be adjusted in relation to the water levels of the water body (Plate 1b). This configuration, which is temporary, would allow passage of small fish and invertebrates from the water body into Duchess Gully. It would, however, limit upstream movement unless the weir is overtopping, which does occur from time to time (Tierney Property Services, personal communication). Below the outlet there is a relatively broad channel (4 – 6 m wide) flowing to Duchess Gully (Plates 1 d, e,; and 2a). Between the two lakes of the water body is a small channel (< 0.5 m wide) fringed by a dense growth of torpedo grass (Plate 1f). During the visit water was flowing from the small lake (E2) into E3. A stormwater treatment area (E1) treats some, but not all, stormwater entering the water bodies.

5. Redesign the existing, temporary outlet to Duchess Gully to facilitate fish passage between the water bodies and the gully. Similarly, design the outlet of the proposed new water bodies to optimise fish passage.

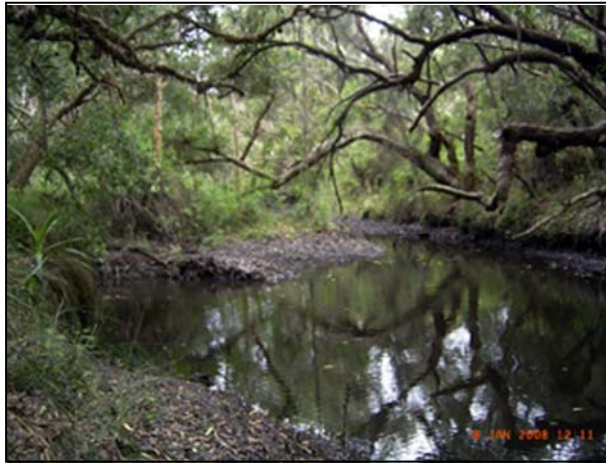
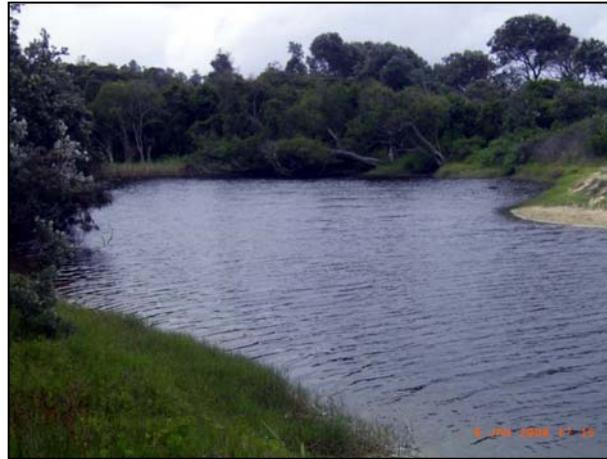
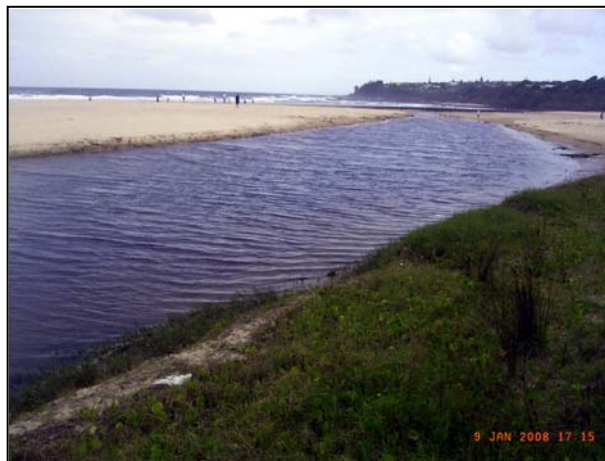
Plate 2. Photographs of Duchess Gully a) Confluence of Duchess Gully with the outlet of the outlet of the subject waterbody; b) Duchess Gully looking upstream from rainbow Beach; c) Duchess Gully looking downstream across Rainbow Beach towards its opening to the sea.

Duchess Gully flows over a wide beach berm at Rainbow Beach (Plate 2b, c). Water throughout the system was dark brown during the visit, possibly reflecting tea-tree staining

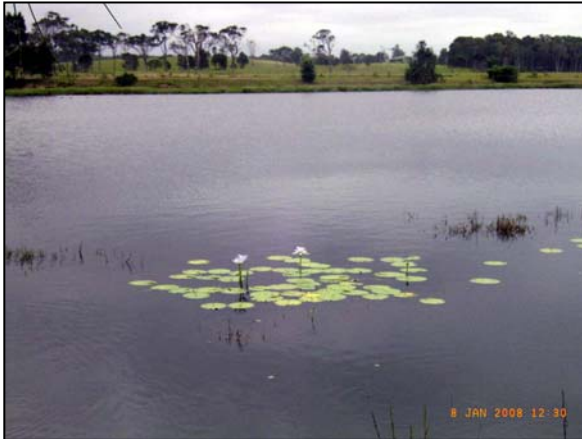
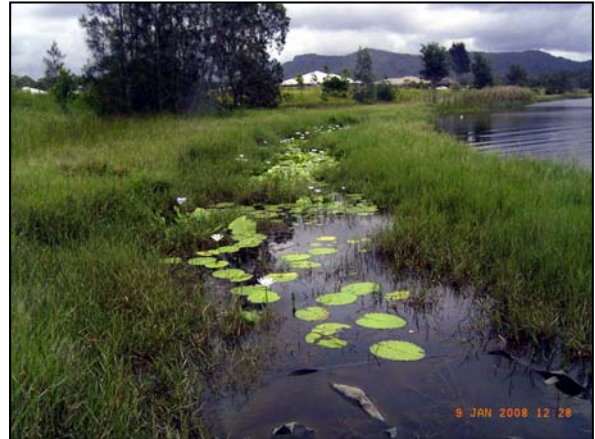
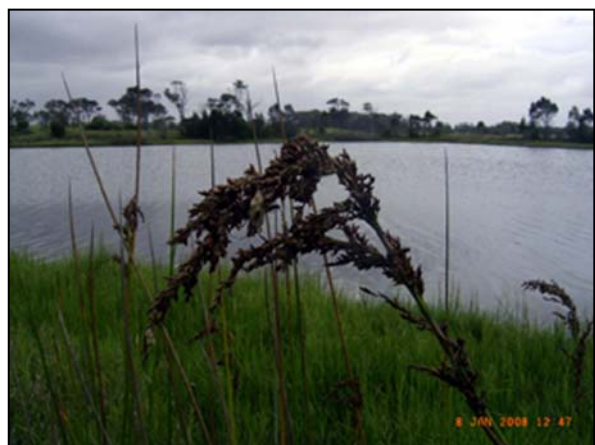
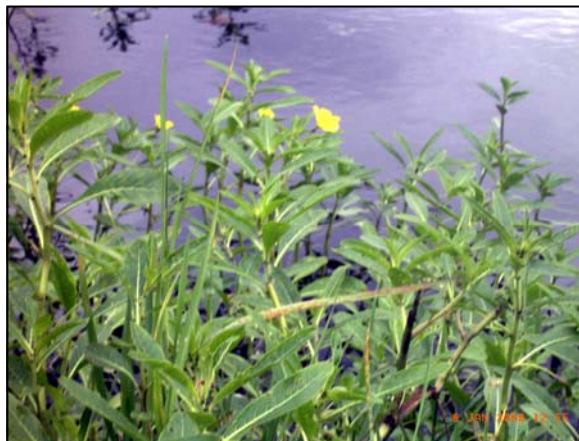
Plate 3. Photographs of various macrophytes on and around the subject water body. a) Cape waterlily (*Nymphaea caerulea*, syn: *N. capensis*) and unidentified emergent plant; b) Cape waterlily and Florida torpedo grass (*Panicum repens*); c) Cumbungi (field identified as *Typha orientalis*); d) Torpedo grass with jointed twigrush (*Baumea articulata*) in foreground; and e) Water primrose (*Ludwigia peploides*).

As noted previously, the water body was fringed by dense growth of aquatic plants, primarily torpedo grass. Notwithstanding the dominance of this species, there were numerous other species recorded at the site, both during the site visit and by other workers (Table 2, Plate 3). During the visit we observed areas of dense growth of a submerged plant, identified as *Vallisneria nana*, which was prevalent at the western end of E3 and in parts of E2.

4. Continue ongoing management of torpedo grass and establishment of native macrophytes.
